**AUTOMATIC TRANSMISSION SERVICE GROUP**

### **Chrysler A604**

Since the introduction of the Chrysler A604 Transaxle in model year 1990, there have been many engineering changes to improve Pleaseability, Driveability, and Durability concerns. These changes have affected many parts used in the A604 transaxle. This "update handbook" will explain each change, and any parts interchangeability problem created by the change, along with any part numbers deemed necessary.

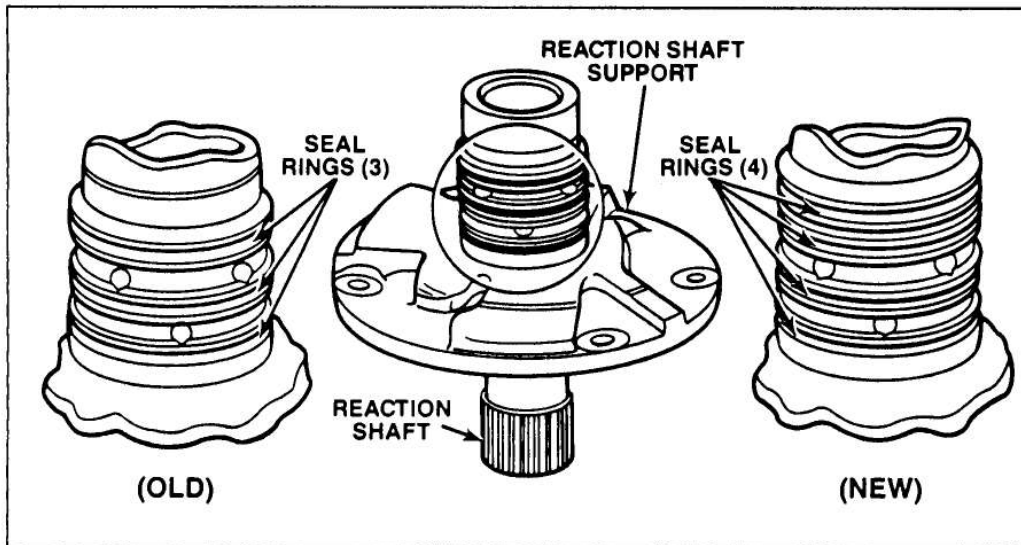
Figure 1

**CHANGE:** Beginning in April, 1989 a new Reaction Shaft Support (Stator) was introduced, with the addition of another ring groove and sealing ring. The old support has 3 sealing rings, and the new support has 4 sealing rings (See Figure 1).

- (1) REACTION SHAFT SUPPORT - The new support is longer, and has 4 sealing rings, where the old support only has three (See Figure 1).
- (2) INPUT SHAFT/CLUTCH HUB - The new Input Clutch Hub bore is machined deeper to accommodate the additional length of the reaction shaft, created by the added sealing ring (See Figure 2).  
The "O" Ring grooves are also cut shallower than the old input clutch hub, which increases the groove diameter, and provides improved compression or "Crush", between the "O" rings and the input clutch retainer. (See Figure 2).

ALWAYS UPDATE to the four ring reaction shaft support. There is now available a repair package, OEM part number 4549248, that includes the following:

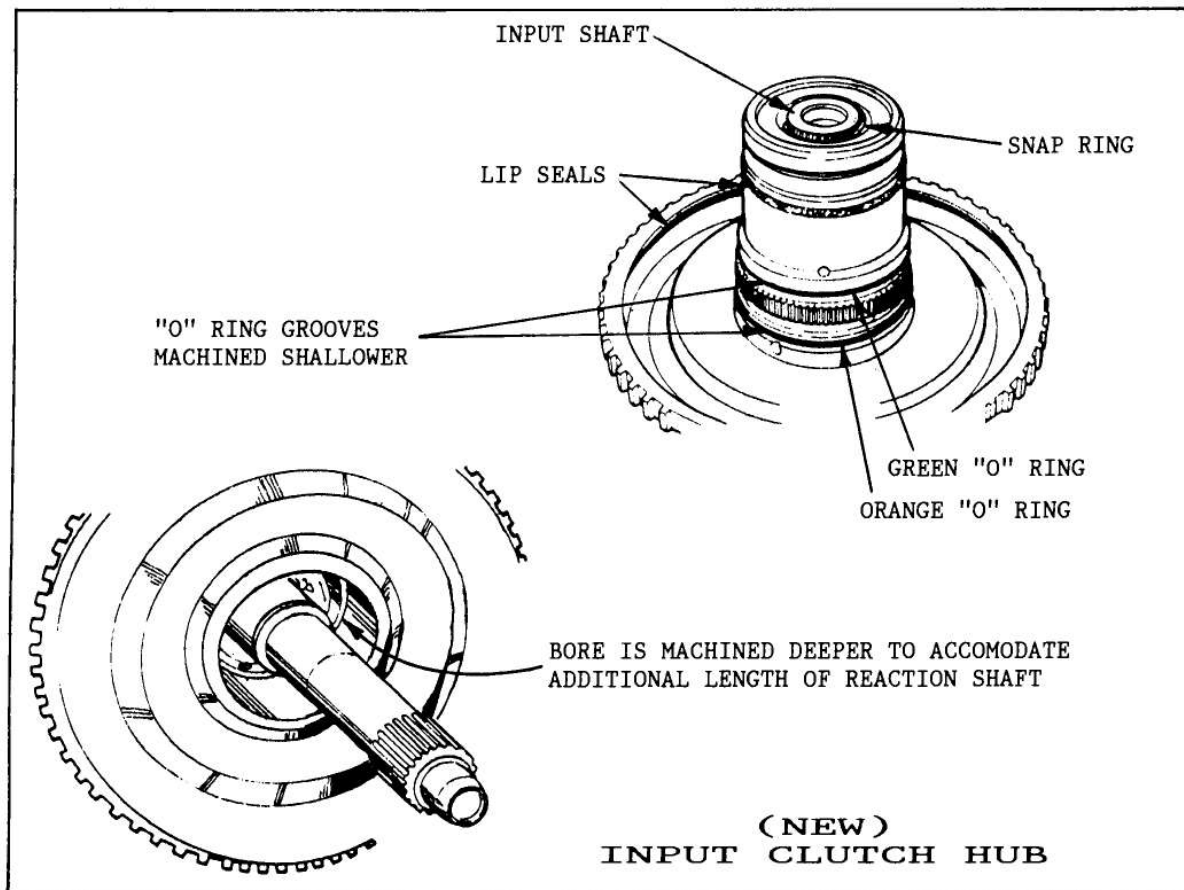
Figure 2

- (3) INPUT SHAFT/CLUTCH HUB "O" RINGS - The new "O" Rings are "Teflon Coated" for greater tear resistance during the assembly process. The coatings also identify the locations for the "O" Rings. The orange ring goes to the front, and the green one goes to the rear (See Figure 2). The early "O" rings were black.

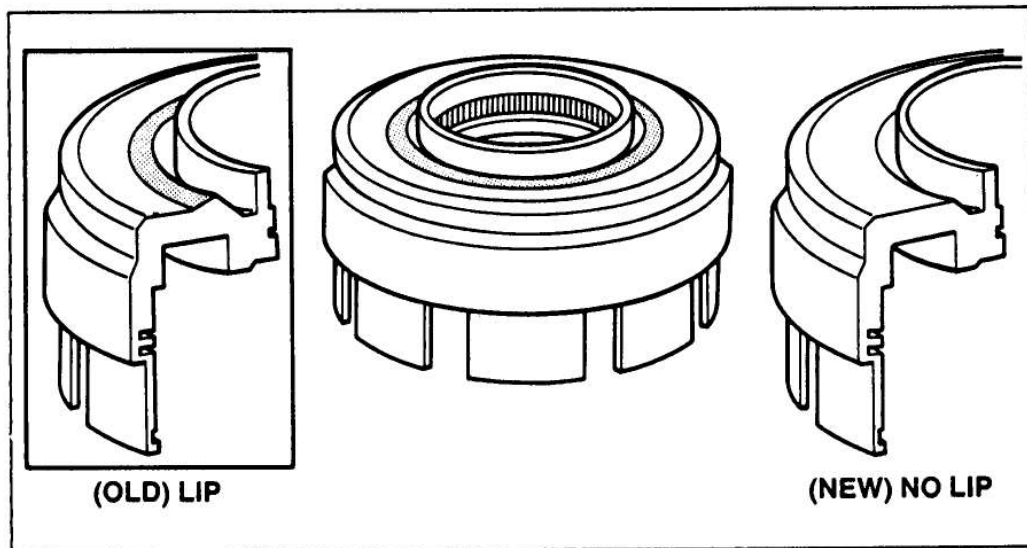
Figure 3

- (4) INPUT CLUTCH RETAINER - The Input Clutch Retainer was modified, by machining off the "Lip" (See Figure 3), to allow more travel of the overdrive/reverse piston. The old Input Clutch Retainer can be machined at the local machine shop if necessary.

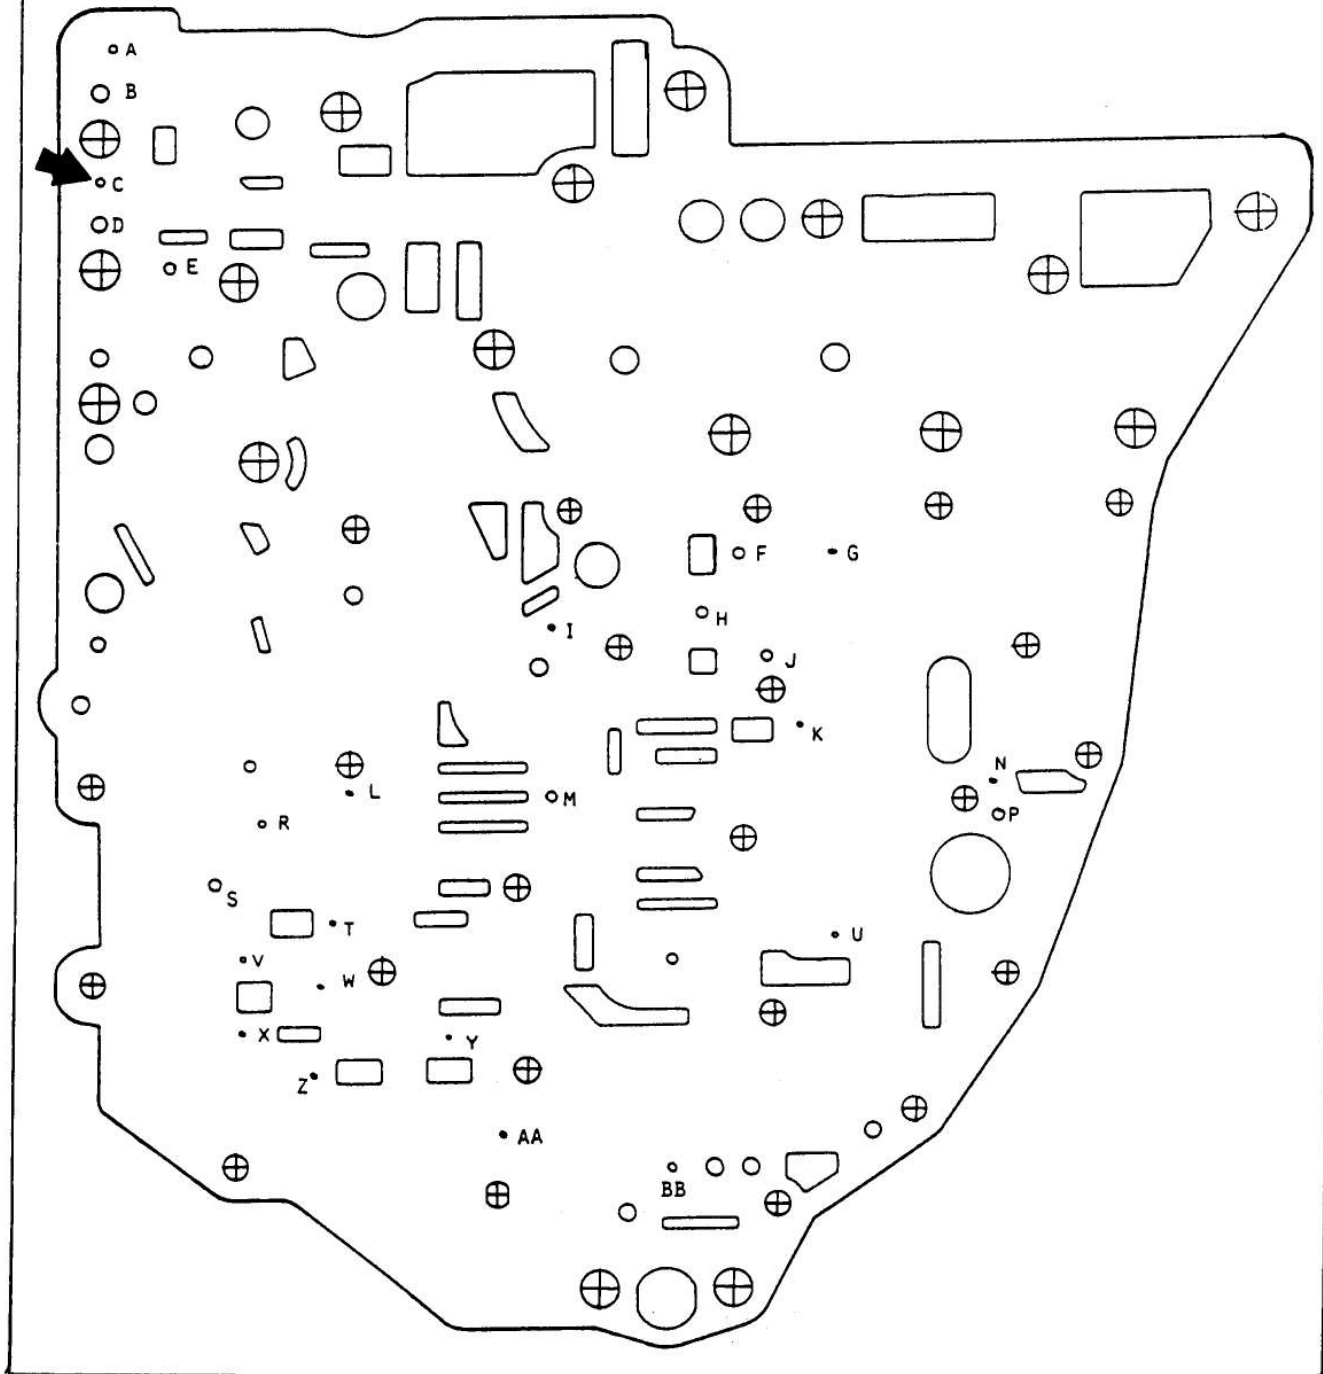
Figure 4

- (5) SPACER PLATE - The new Spacer Plate has a larger (.105") overdrive clutch feed orifice to provide increased oil flow to the overdrive clutch circuit (See Figure 4).

HOLE "C" ENLARGED TO .105" FOR INCREASED OIL FLOW

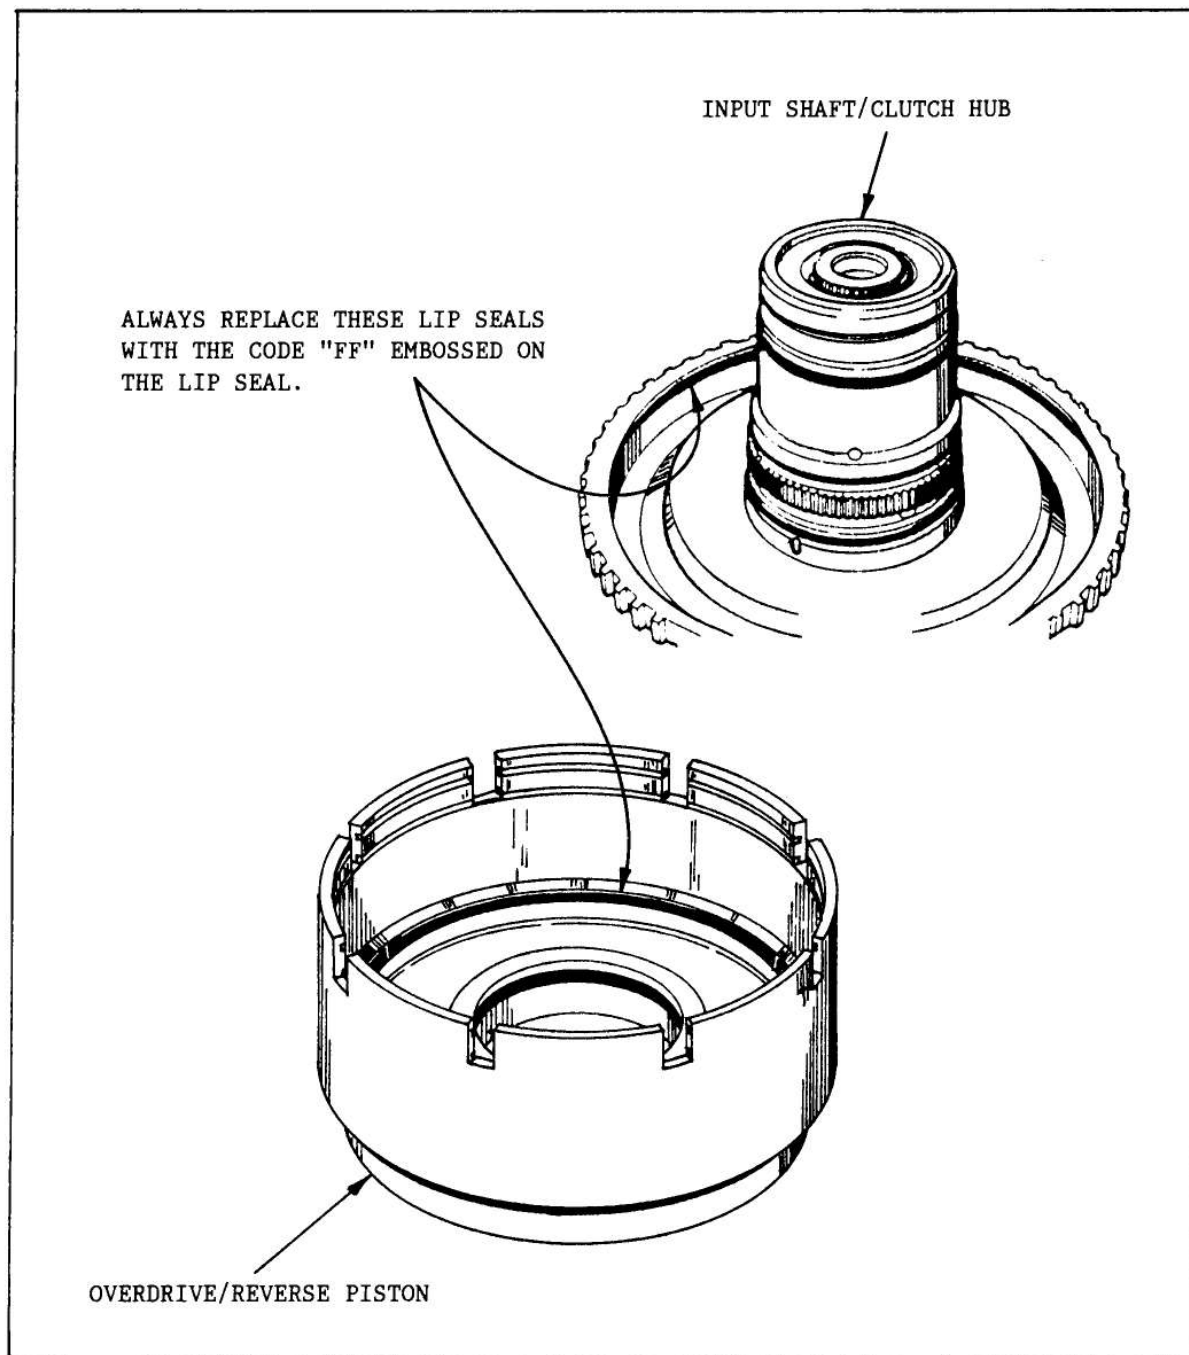
Figure 5

**CHANGE:** The lip seals in the Overdrive/Reverse Clutch Piston and the Input Shaft/Clutch Hub are now replaced with lip seals made of different material (See Figure 5).

- (1) OD/REVERSE PISTON LIP SEAL - No dimensional changes, but the material changes, and the new lip seals can be identified by the code "FF" embossed into the seal. The old lip seal is embossed with the code "IPC", and should not be used (See Figure 5).
- (2) INPUT CLUTCH HUB OUTER LIP SEAL - No dimensional changes, but the material changes, and the new lip seals can be identified by the code "FF" embossed into the seal. The old lip seal is embossed with the code "IPC", and should not be used (See Figure 5).

THE NEW LIP SEALS EMBOSSED WITH THE CODE "FF" WILL RETRO-FIT BACK TO ALL PREVIOUS MODELS, AND SHOULD BE USED DURING OVERHAUL.

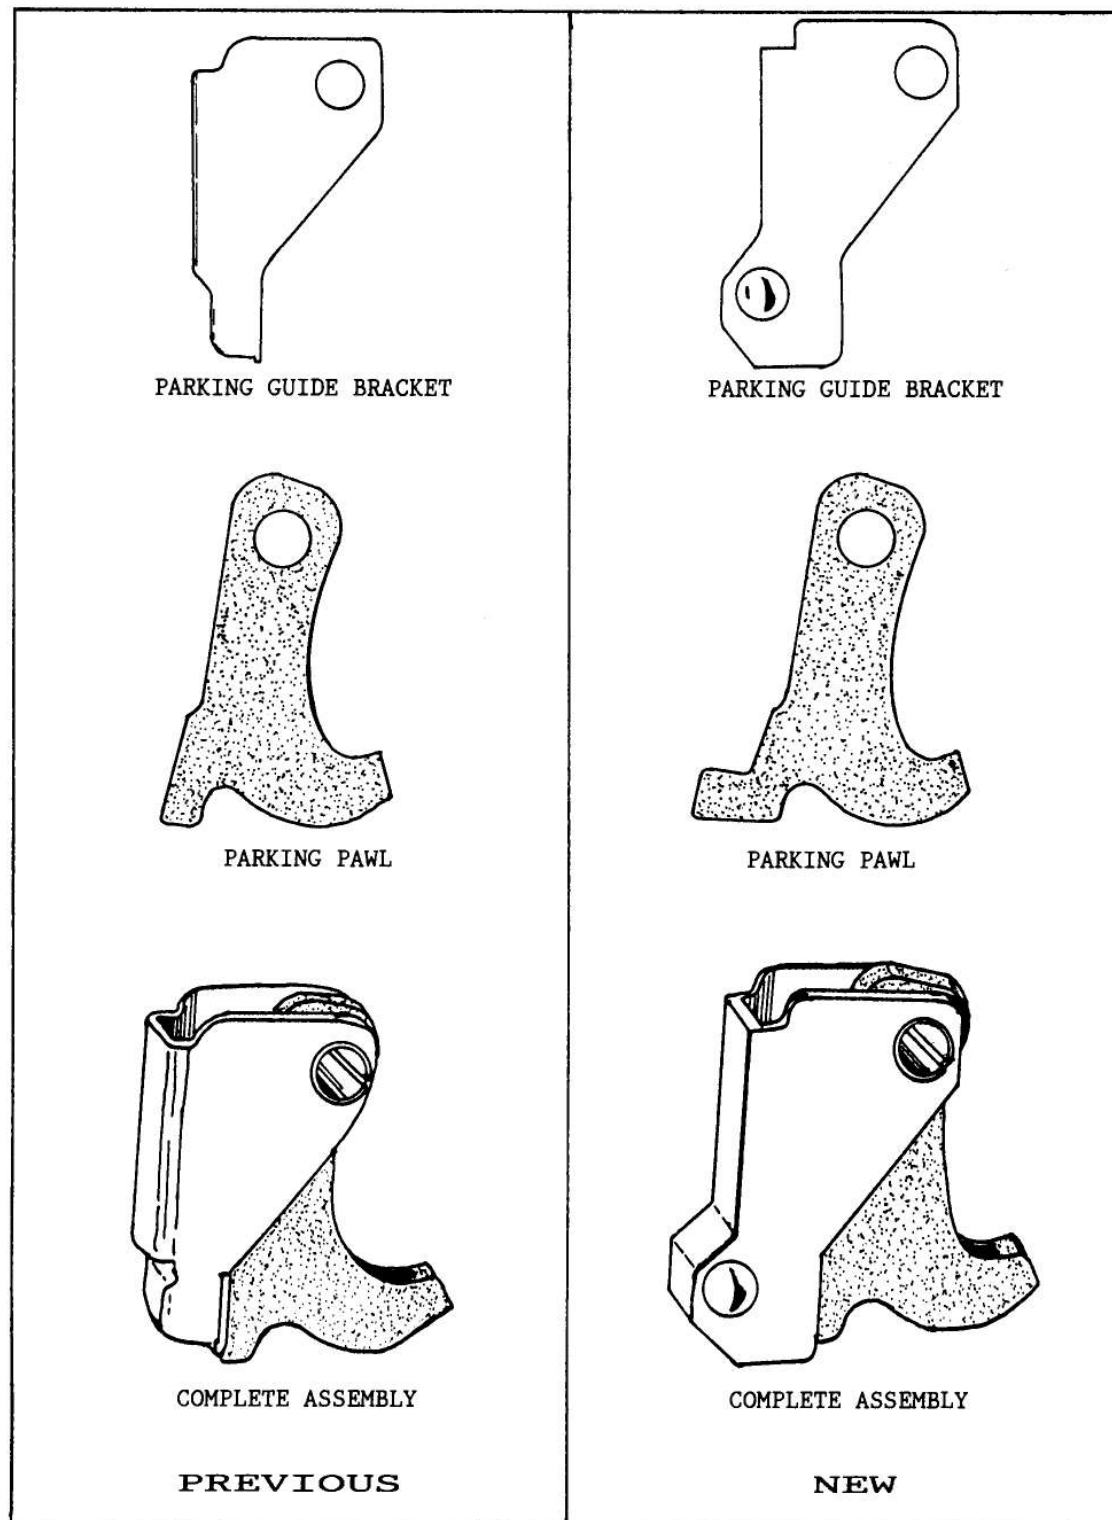
**CHANGE:** A new Parking Sprag Guide Bracket and Parking Pawl has been introduced as a 1989 running change (See Figure 6).

- (1) **PARKING GUIDE BRACKET** - Previously the Parking Guide Bracket was a stamped steel unit, and has been replaced by a high quality casting, along with dimensional changes. See Figure 6 for identification.
- (2) **PARKING PAWL** - The new Parking Pawl, or "Boot", also required some dimensional changes. The heel of the new "Boot" is wider than the previous models, as shown in Figure 6.

The new parts will retro-fit back to all previous models, but both pieces must be replaced as an assembly. (See Figure 6).

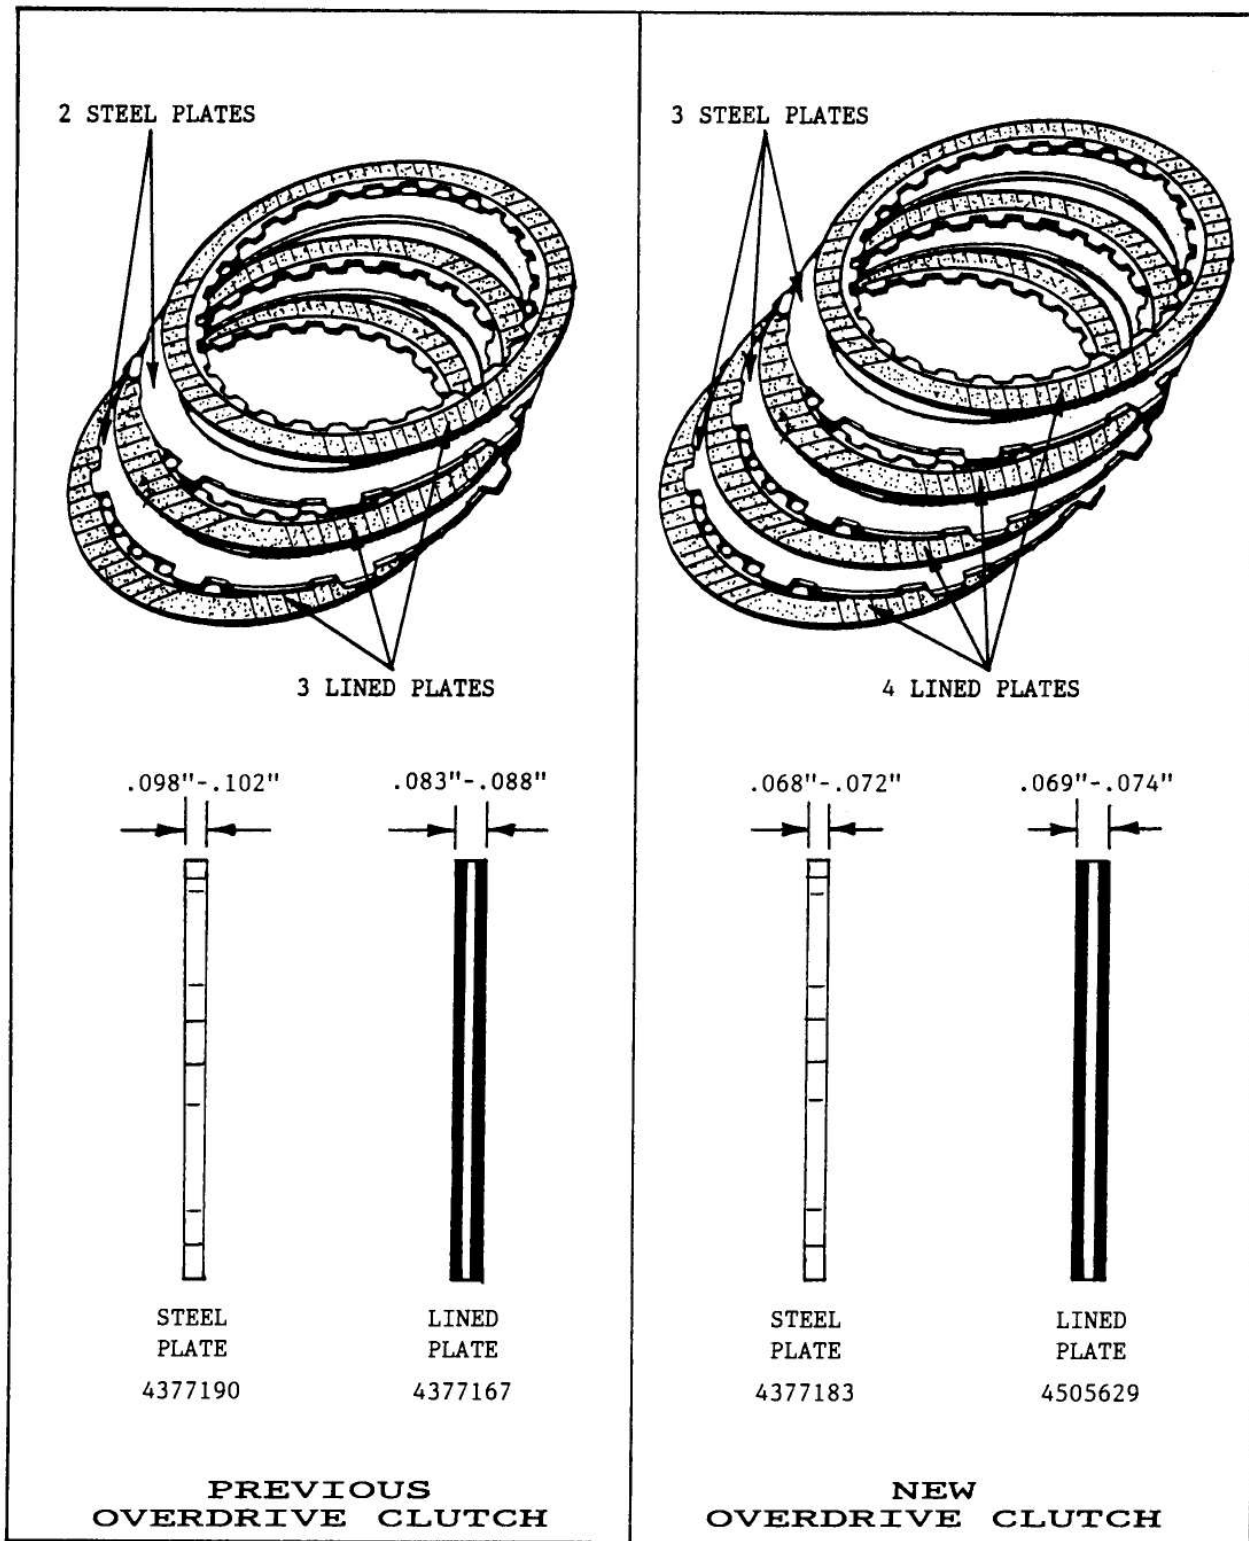
Figure 13

**CHANGE:** A running change for 1990 model A604 transaxles was the introduction of a four (4) disc Overdrive Clutch Assembly, to replace the previous three (3) disc assembly (See Figure 13).

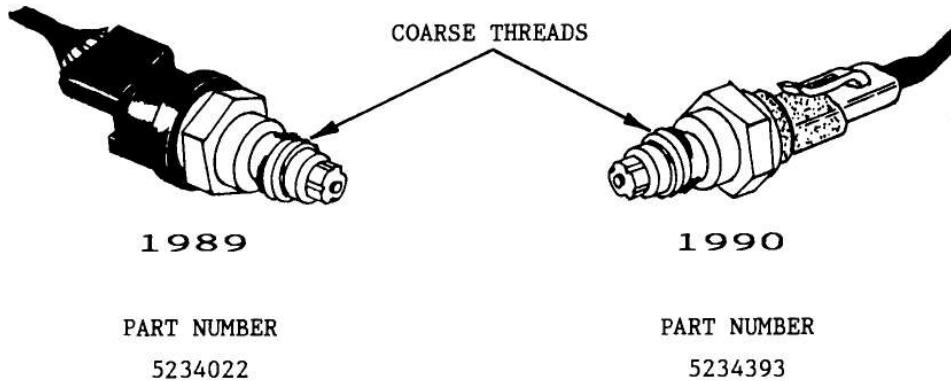
FIGURE 18

THESE PRNODL SWITCHES WILL NOT INTERCHANGE.

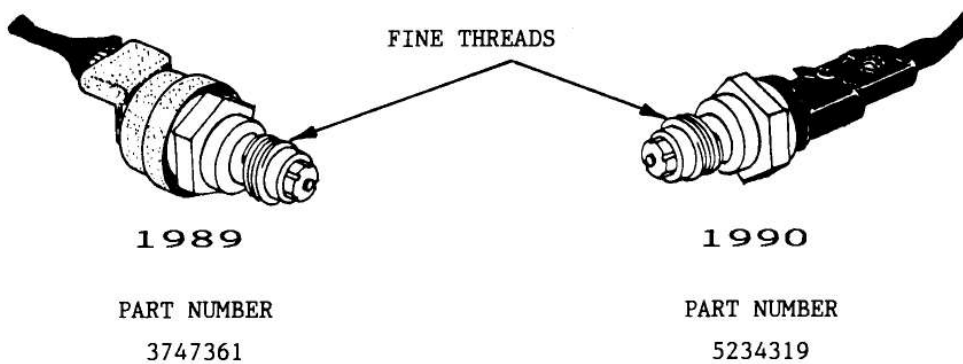
FIGURE 19

THESE NEUTRAL SWITCHES WILL NOT INTERCHANGE.

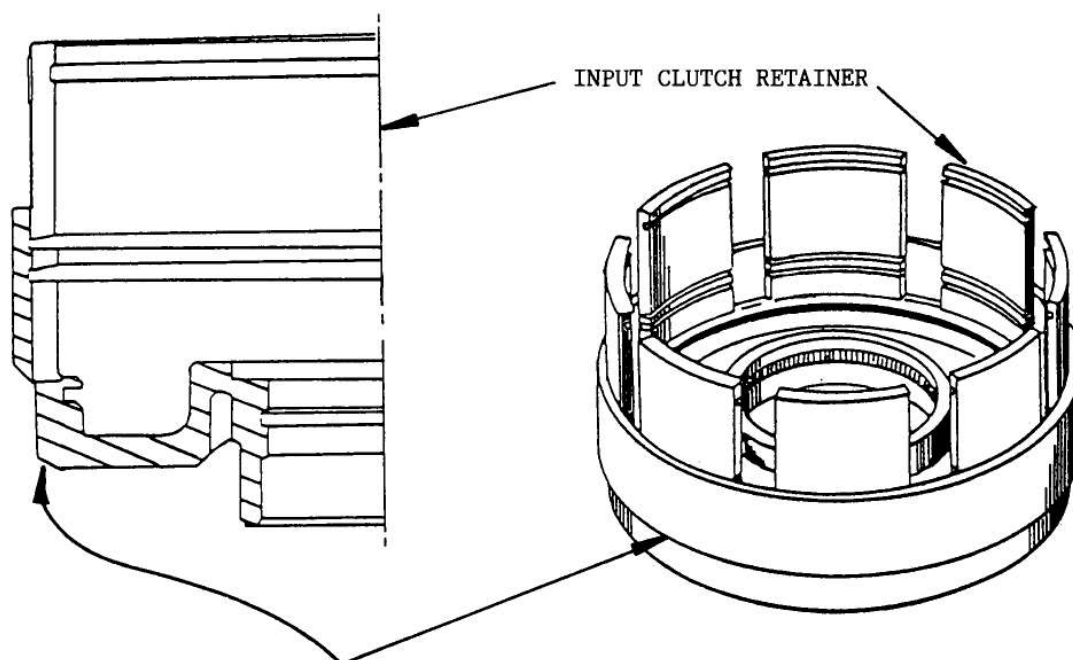
Figure 28

1990 1/4 INPUT CLUTCH RETAINER HAS A REVISED RADIUS, LOCATED HERE, ON THE OUTSIDE DIAMETER TO REDUCE THE CHANCE OF DAMAGE TO LIP SEAL.

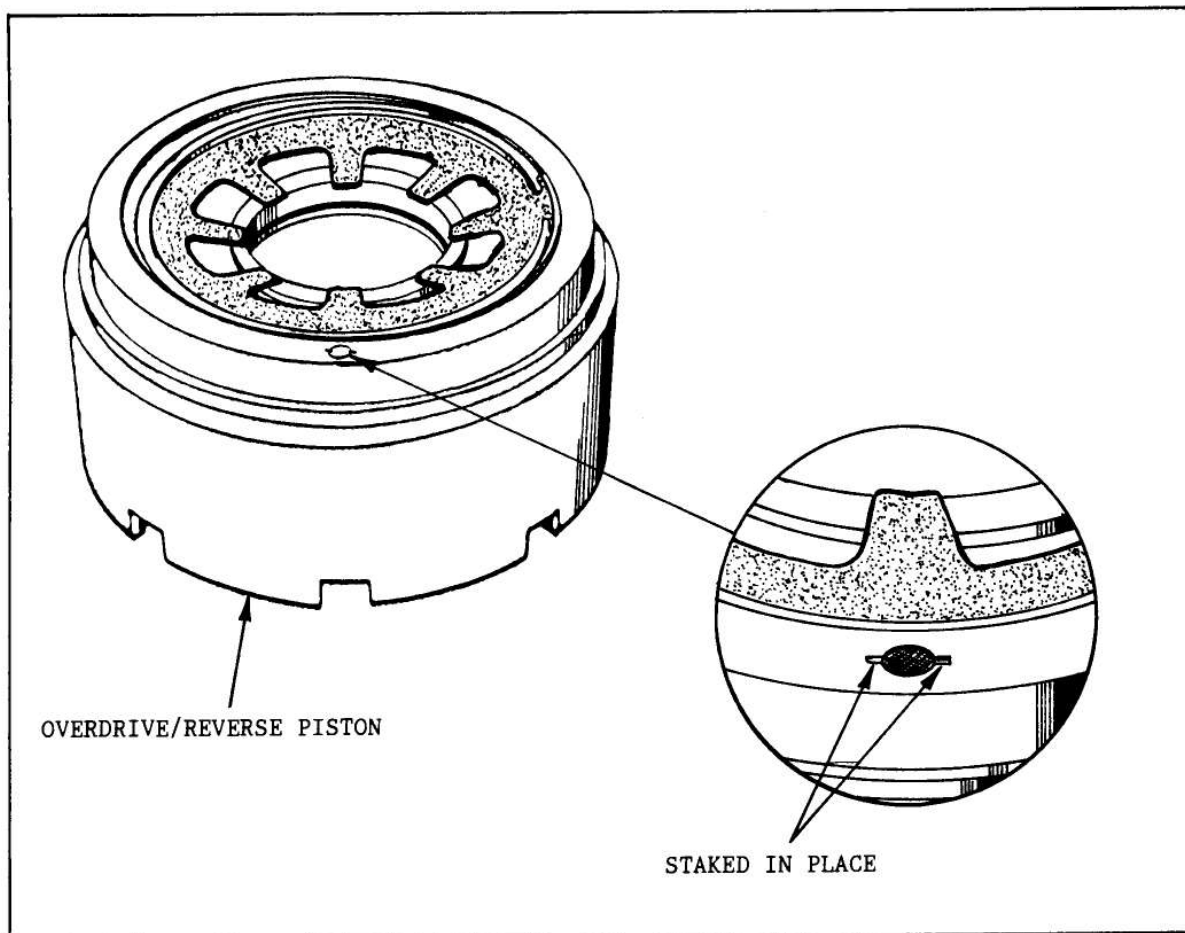
Figure 34

**COMPLAINT:** Premature failure of the overdrive and the reverse clutch plates, and all lip seals and "O" rings are good.

**CAUSE:** The cause may be an orifice and screen assembly blown out of the overdrive/reverse piston (See Figure 34).

**CORRECTION:** Replace the Orifice/Screen Assembly with a new one, available under OEM part number 4531903, and stake the new assembly in place (See Figure 34). They were not all staked in place at the factory.
