## UPDATE HANDBOOK AODE, 4R70W, 4R70E, 4R75E

# INTRODUCTION

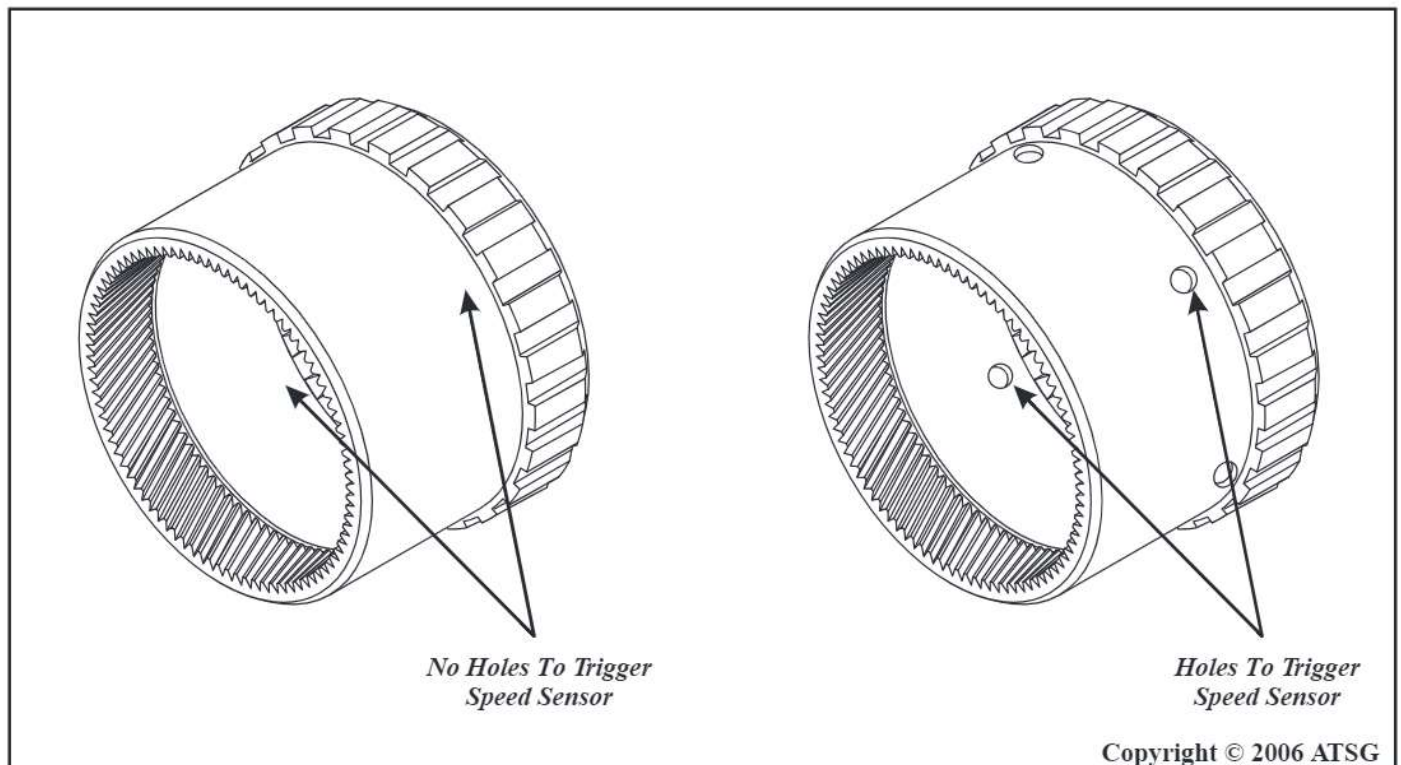
Figure 8

**CAUSE:** The cause may be, AOD internal ring gear that has no holes to trigger the output speed sensor has been installed by mistake.

**CORRECTION:** Install the AODE internal ring gear with the holes to trigger the output speed sensor, as shown in Figure 8.

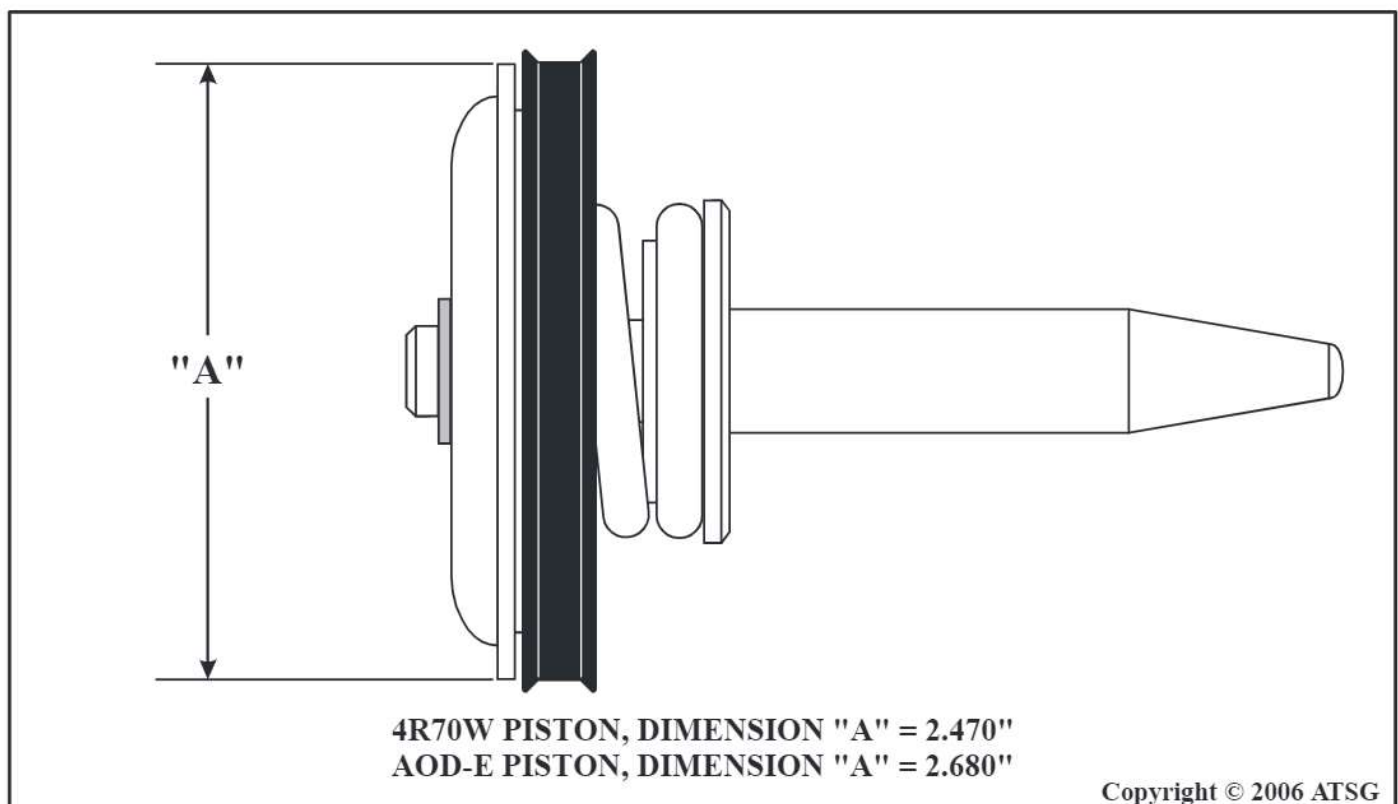
Figure 18

**CAUSE:** The cause may be, a mis-assembled Overdrive Servo Assembly, with the "Rubber Coated Sleeve" omitted. The 4R70W transmission is calibrated with a smaller diameter overdrive servo piston than is the AOD-E transmission. To retain a common case between the two transmissions, an additional "Rubber Coated Sleeve" is required on the 4R70W Overdrive Servo Assembly, as shown in Figure 19.

**CORRECTION:** Install the "Rubber Coated Sleeve" in the Overdrive Servo Assembly case bore, as shown in Figure 19. If your rubber coated sleeve is missing or lost, you *must* purchase the complete Overdrive Servo Assembly, available under part number F3LY-7H188-A. It is not available individually.  
Overdrive servo piston dimensions are shown in Figure 18, to identify the two different overdrive servo pistons.

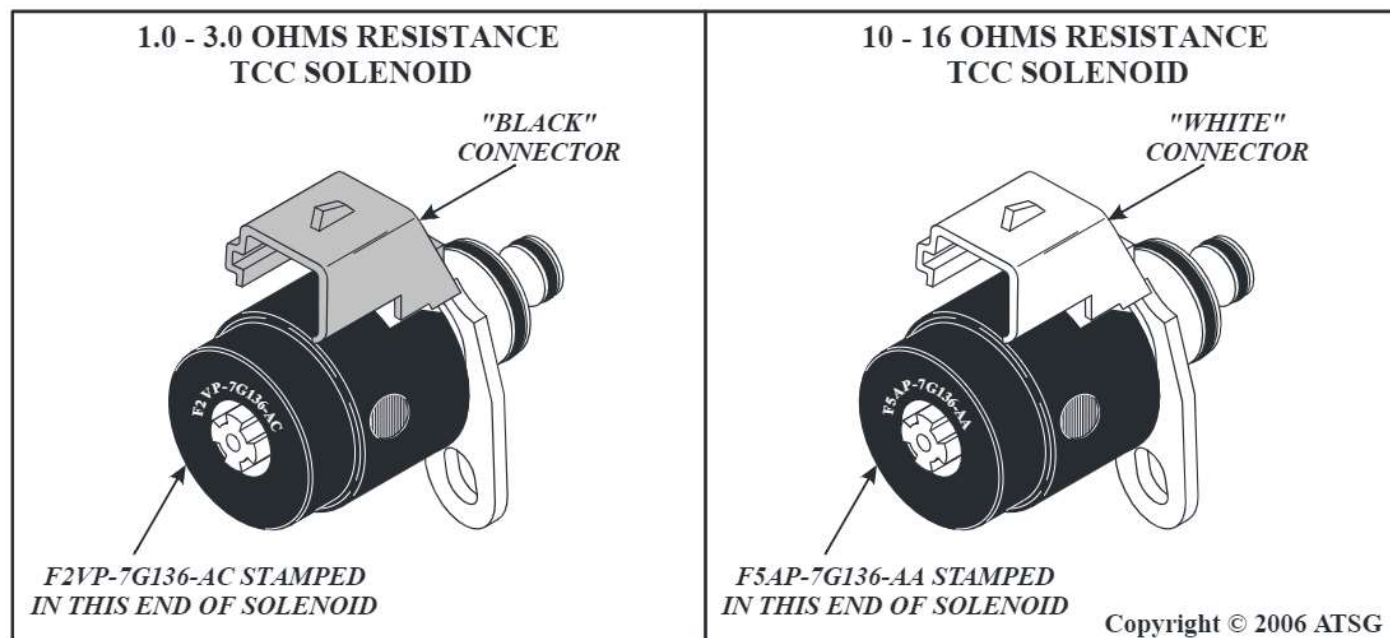
Figure 20

**CAUSE:** The cause may be, an incorrect Torque Converter Clutch (TCC) Solenoid, with low resistance (1.0 - 3.0 ohms), mistakenly installed in *some* 4R70W transmissions, as shown in Figure 20. The resistance should be 10-16 ohms on *some* models.

*Step 3:* If the valve body I.D. code is G2T, G3T, or G2U, *and* resistance on the TCC solenoid measures 1.0-3.0 ohms, *replace* the TCC Solenoid with OEM part number F5AZ-7G136-A. The resistance on these models should be 10-16 ohms.

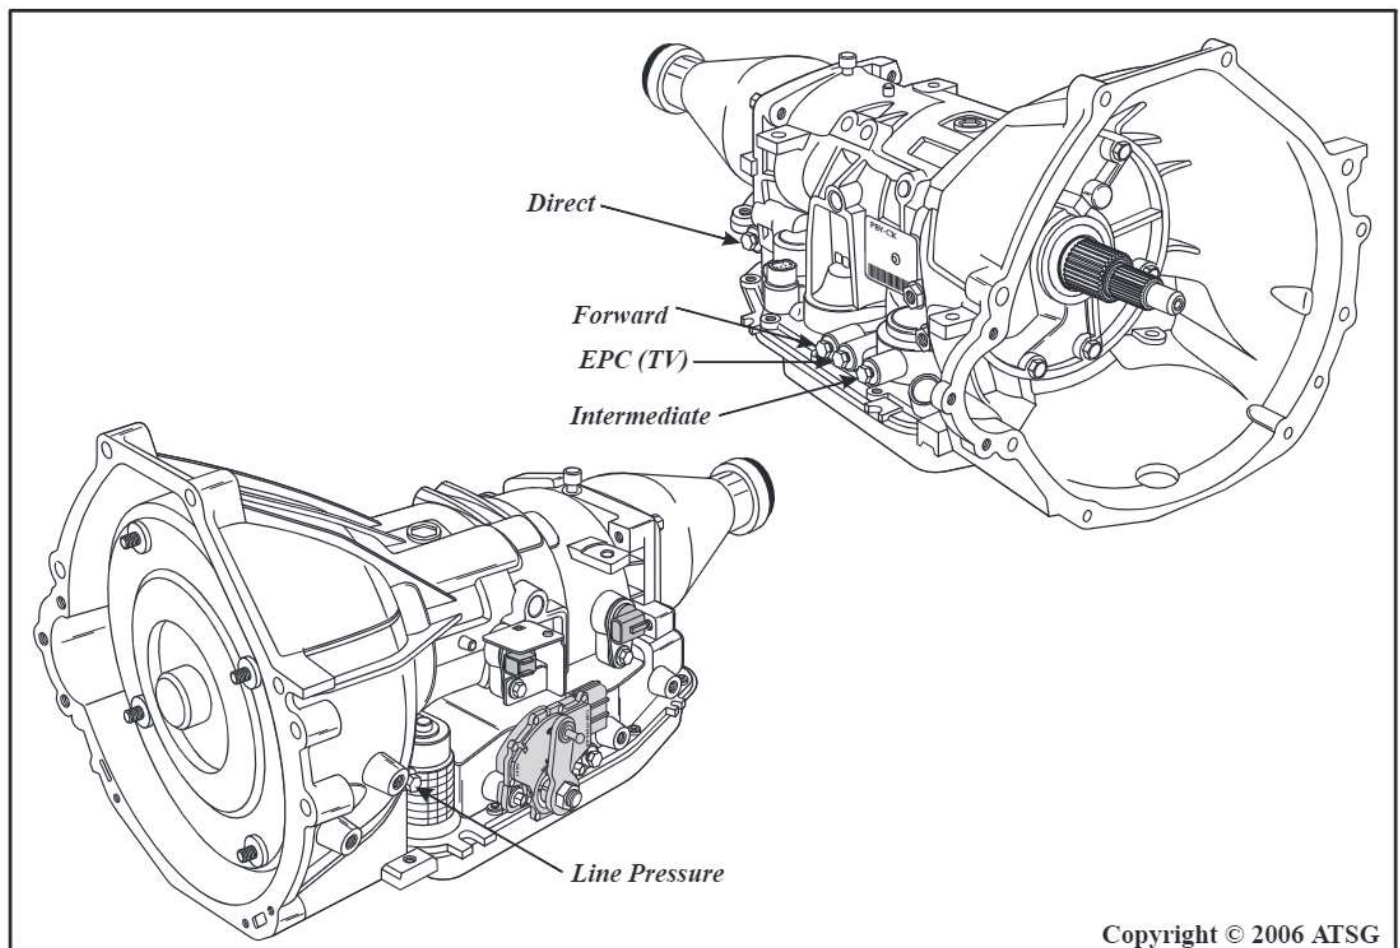
Figure 22

**CAUSE:** The cause may be, a partially clogged Shift Solenoid No. 2, which will stroke the 3-4 shift valve far enough to exhaust *some* of the forward clutch oil.

**CORRECTION:** Install two pressure gages to check line pressure and forward clutch pressure, as shown in Figure 22. With the transmission in Drive, both gages should read the same and should be approximately 55-75 PSI. If the forward clutch gage reads lower than the line pressure gage, *and all internal parts are known to be good*, replace the Shift Solenoid Assembly with OEM part number F5AZ-7G484-A (See Figure 23).

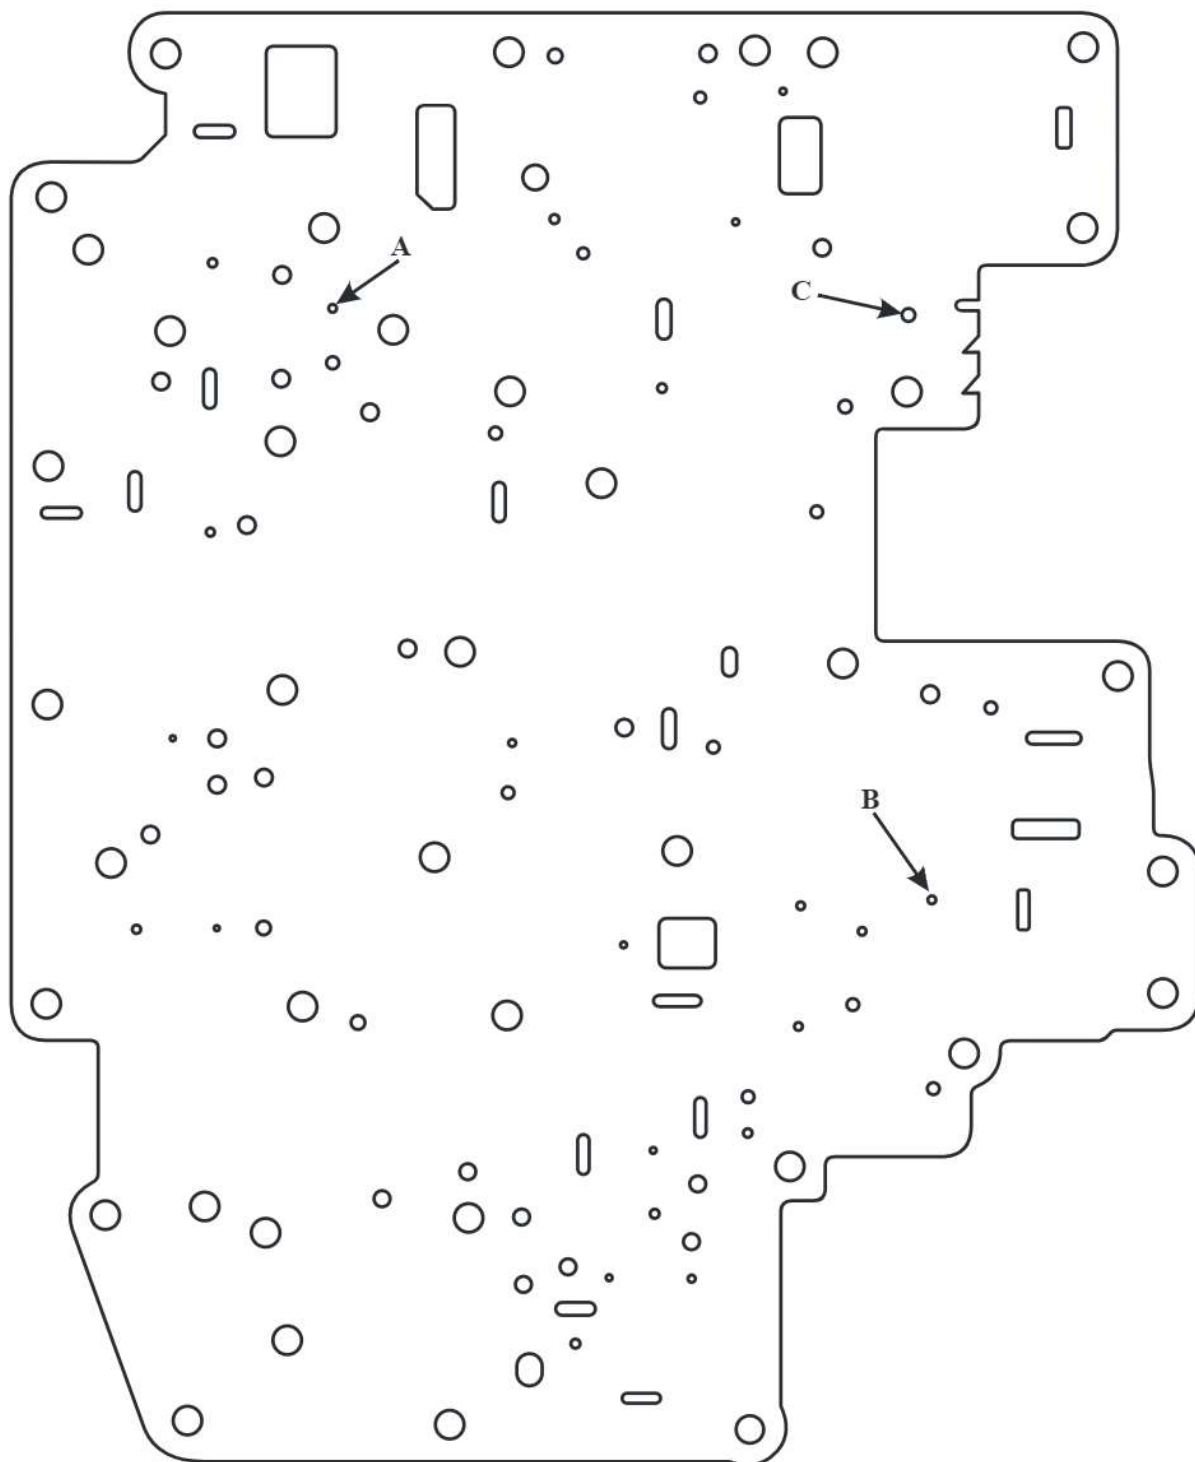
**CAUSE:** The cause may be, not enough oil to the converter clutch apply circuit.

*Restrict* the hole marked "C" in Figure 24, to approximately .030" using a cotter key, which ensures that apply oil can overcome this balance circuit.

1. DRILL HOLE MARKED "A" OUT TO .062".
2. DRILL HOLE MARKED "B" OUT TO .062".
3. INSTALL COTTER PIN IN HOLE MARKED "C" TO REDUCE SIZE TO APPROXIMATELY .030".

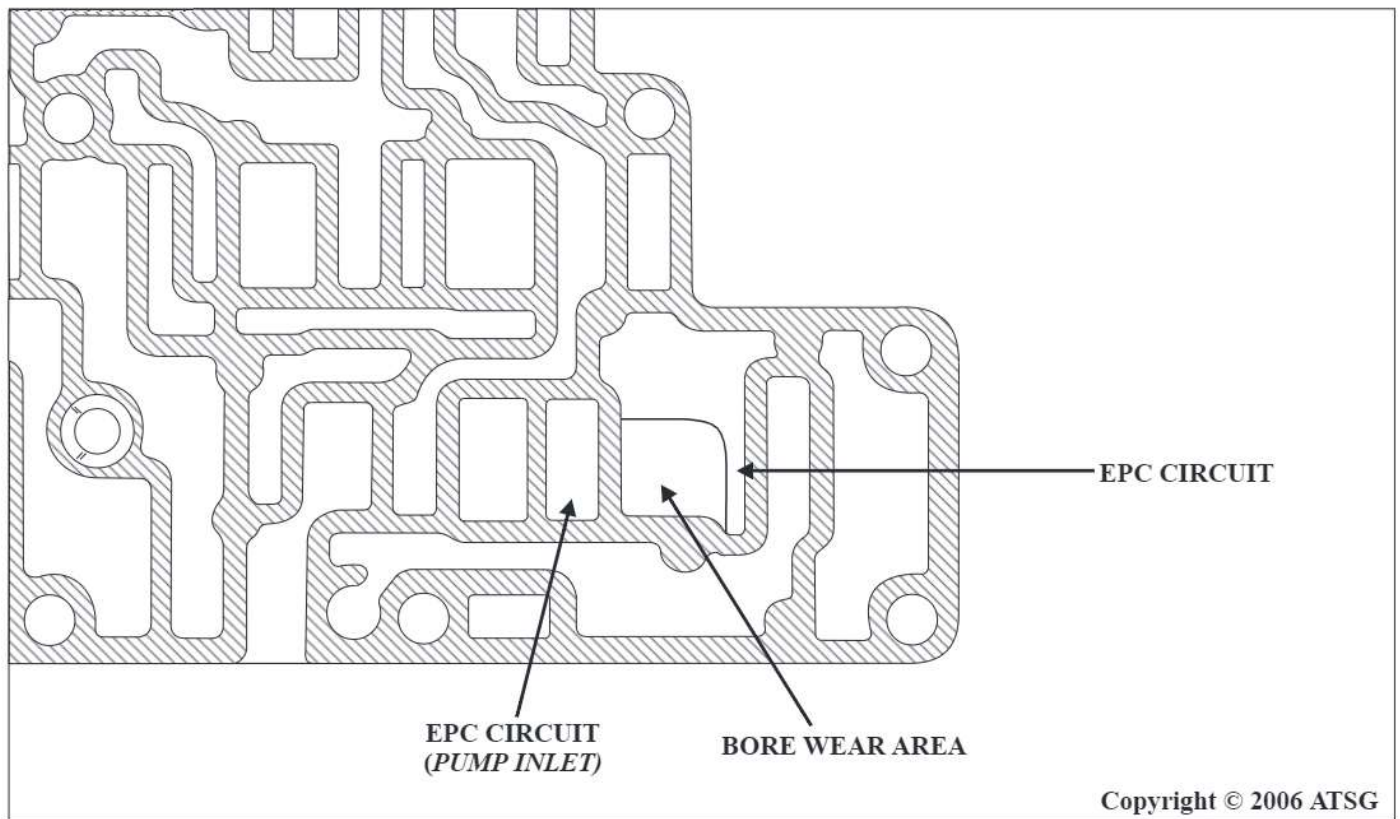
**COMPLAINT:** The transmission is slipping in all gears as well as during shifts. When line pressure is checked, the gauge indicates little or no line rise. A check of EPC pressure reveals a near zero reading. EPC solenoid amperage is correct and replacement of the EPC solenoid did not cure the complaint.

**CAUSE:** EPC pressure is routed to the Pressure Regulator Valve along side of a circuit that Ford identifies as the Boost Circuit. These oil passages can be identified in both the valve body and the case as seen in Figure 75 and 76. This is illustrated by the hydraulic schematic shown in Figure 77. This circuit is routed back to the inlet side of the pump. When the Pressure Regulator Valve or its bore is worn, (See Figure 78), EPC pressure is allowed to be sucked away by pump suction, (See Figure 79 and 80), preventing any line pressure rise from occurring when the throttle is opened.

**CORRECTION:** Always check the Pressure Regulator Valve and its bore for wear during the repair process. If it is worn use one of the repair kits that are available from Sonnax® to repair this condition, or, you must replace the valve body.

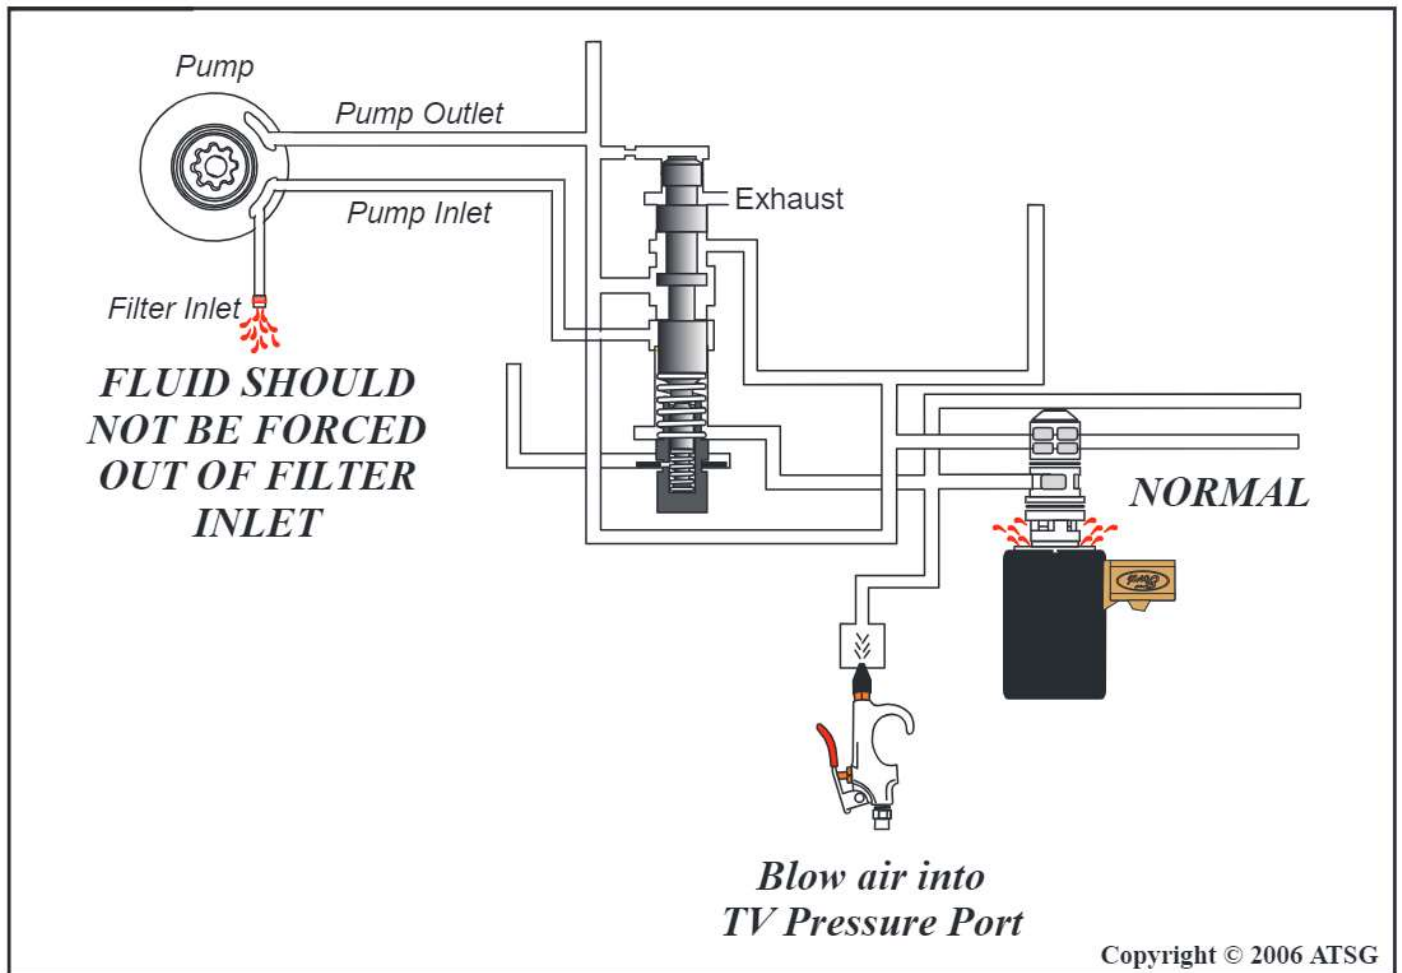
Figure 81

A quick test can be performed to verify if this condition exists. Remove the pan and filter. Blow compressed air into the TV pressure port in the case. It is normal to see some leakage around the EPC solenoid, but if you see *any* oil forced out of the filter neck bore by the air pressure, (Refer to Figure 81), ***PR valve and/or bore wear is the reason.***

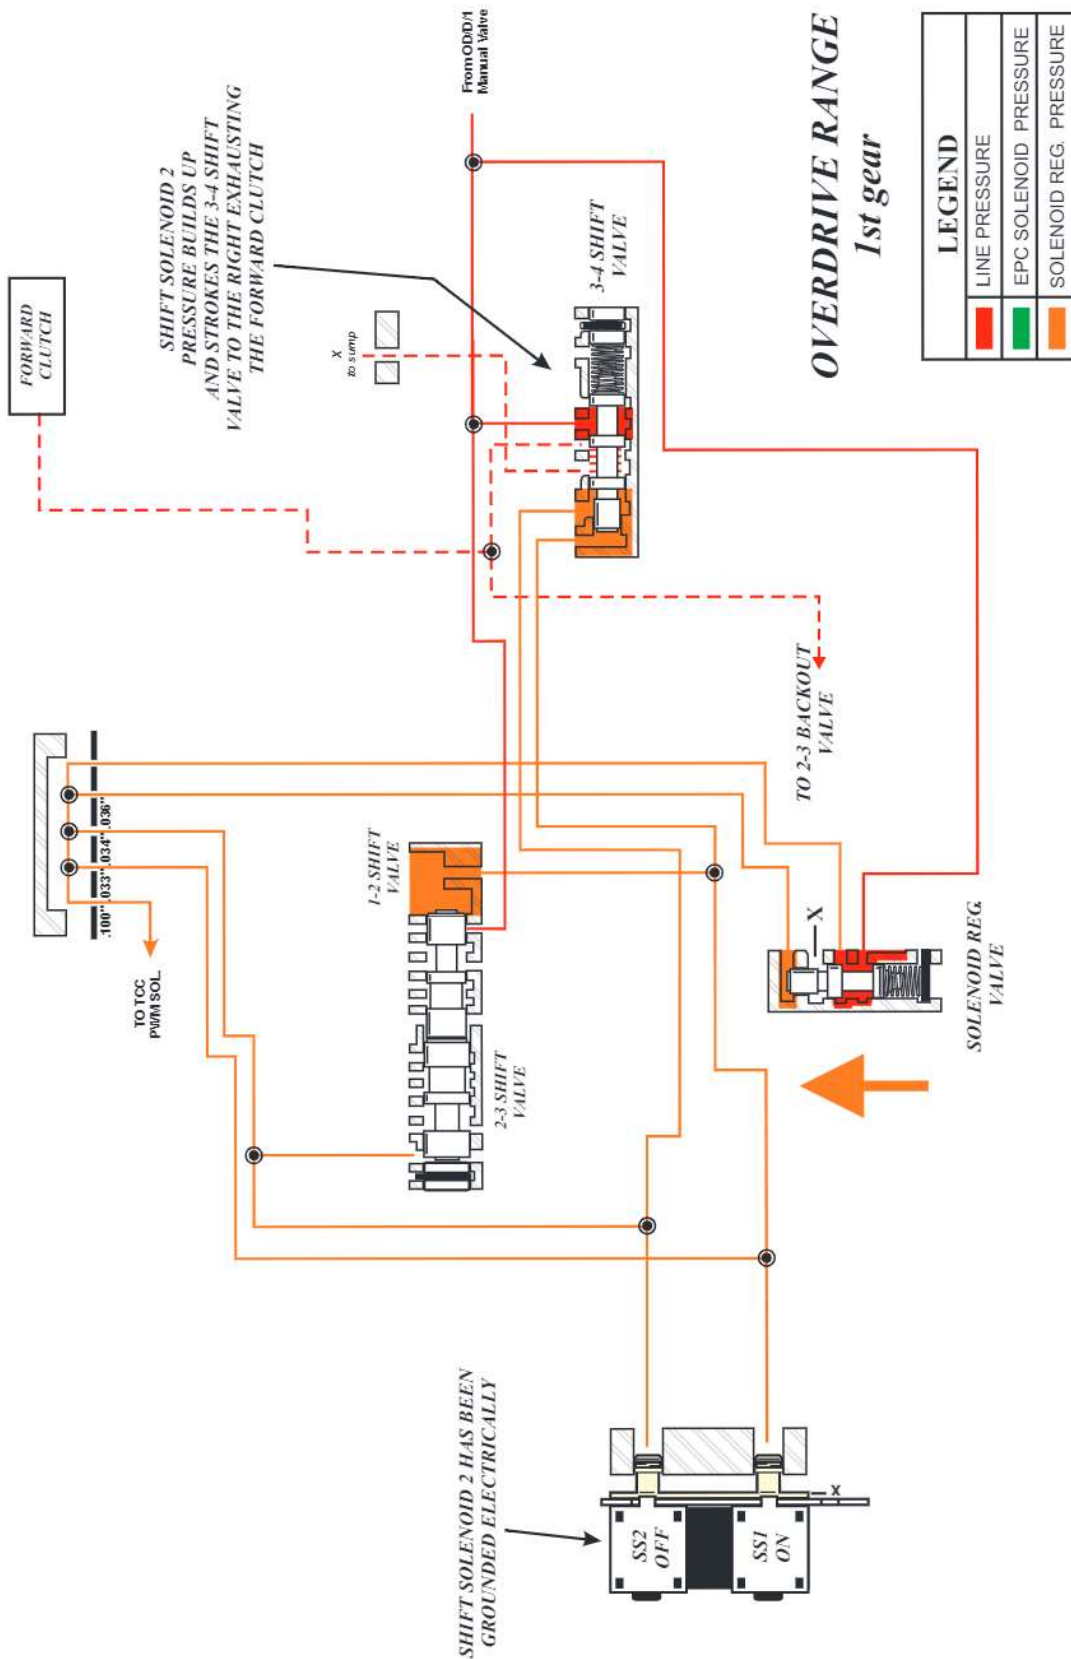
**CAUSE NO 1:** One cause for this condition may be that the PPL/ORG or VIO/ORG wire, which is model dependant, and controls Shift Solenoid 2, may have rubbed on the rear of the engine, causing the circuit to become grounded. When this occurs with the transmission in first gear, Shift Solenoid 2 closes and fluid pressure acts to stroke the 3-4 Shift Valve to the right, causing the Forward Clutch oil to exhaust through the 3-4 Shift Valve, creating the neutral condition. Refer to Figure 86 for hydraulic schematic. Diagnostic Trouble Code (DTC) P0755 may also be stored in memory.

*Summary: SS1 is ON and SS2 has become energized, which in-turn strokes the 3-4 Shift Valve turning the Forward Clutch OFF.*

- (1) Repair or replace the damaged Shift Solenoid 2 wire. Refer to Figure 92, for an index to locate the proper year and model vehicle that you are working on, and refer to schematic for that vehicle. Wire schematics have been provided in Figures 93, 94, 95 and 96.
- (2) Locate the Solenoid Regulator Valve in the Valve Body, as shown in Figure 88. To repair a sticking Solenoid Regulator Valve, it may become necessary to replace the valve assembly. There are replacement Solenoid Regulator Valve Kits available from aftermarket suppliers.
- (3) Replace the complete Shift Solenoid Assembly.

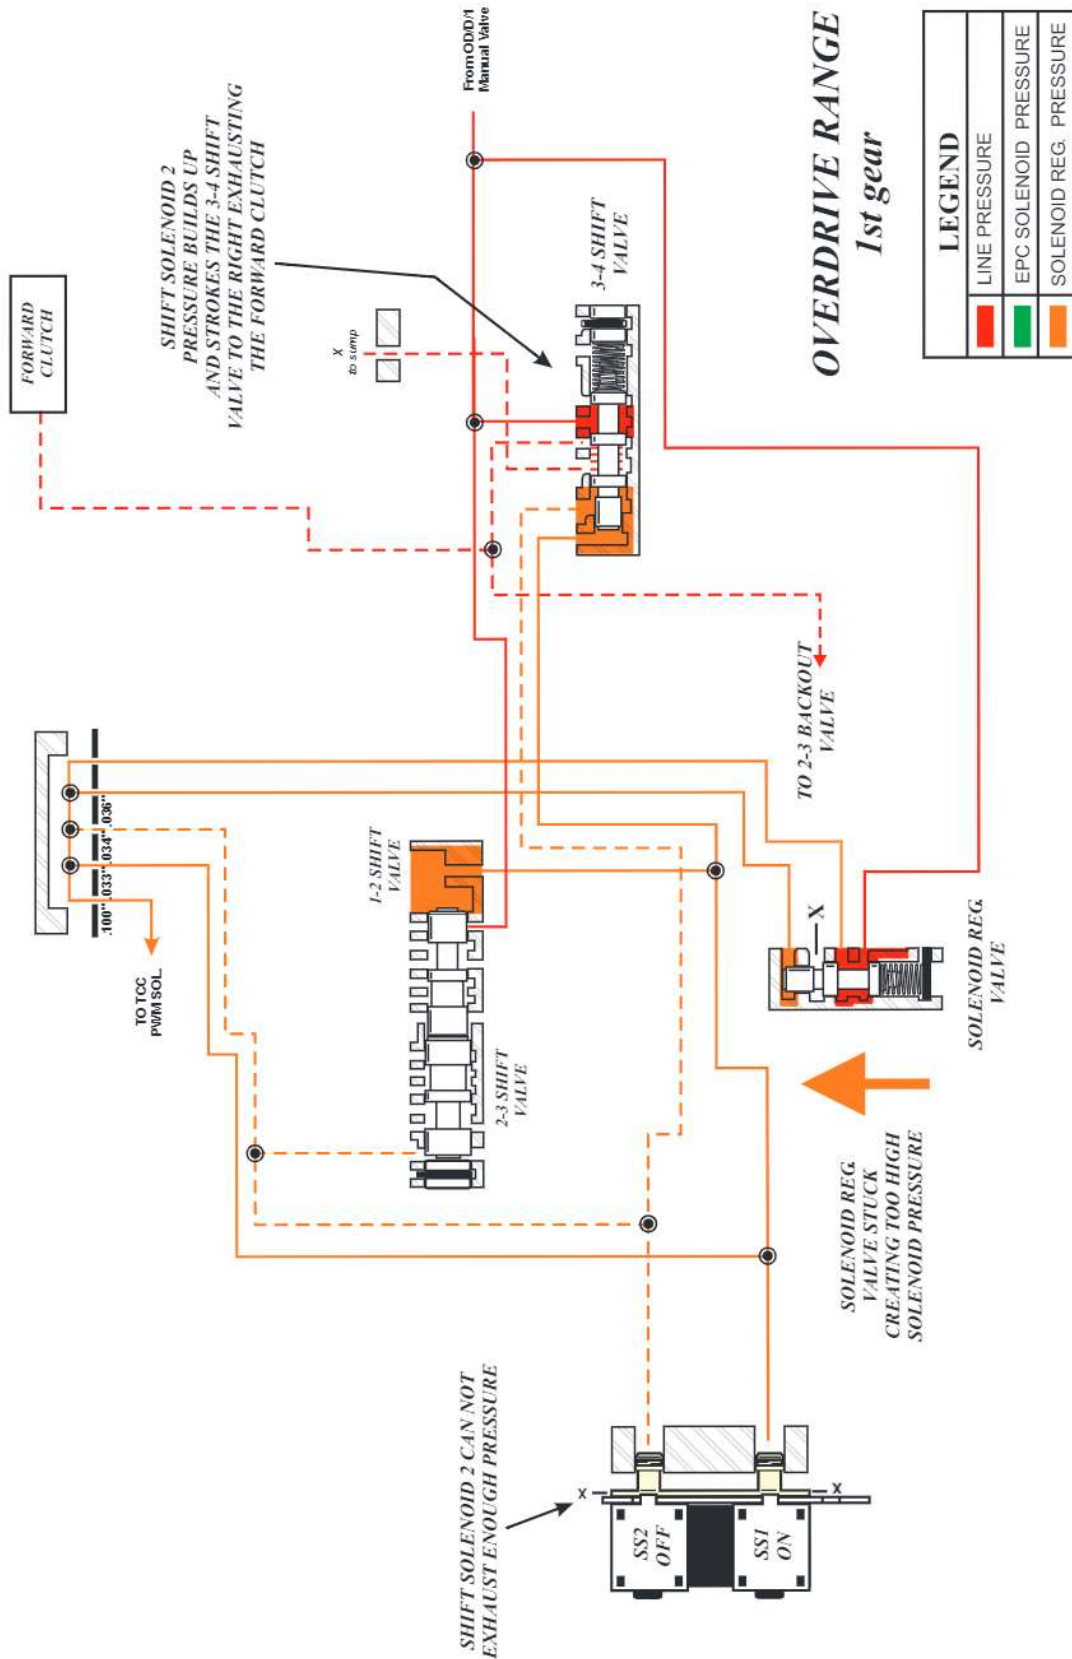
**CAUSE NO 3:** Cause 3 is almost identical to Cause 2 with the exception being that Shift Solenoid 2 is sticking closed, or has debris built up at the solenoid exhaust hole, which will allow Shift Solenoid 2 pressure to build up which causes the 3-4 Shift Valve to move to the right exhausting the Forward Clutch oil, and once again creating the neutral condition. Refer to Figure 87 for hydraulic schematic. No Diagnostic Trouble Codes will be stored.

**Summary:** SS1 is ON and SS2 can not exhaust the High Solenoid Reg. pressure, which in-turn strokes the 3-4 Shift Valve turning the Forward Clutch OFF.

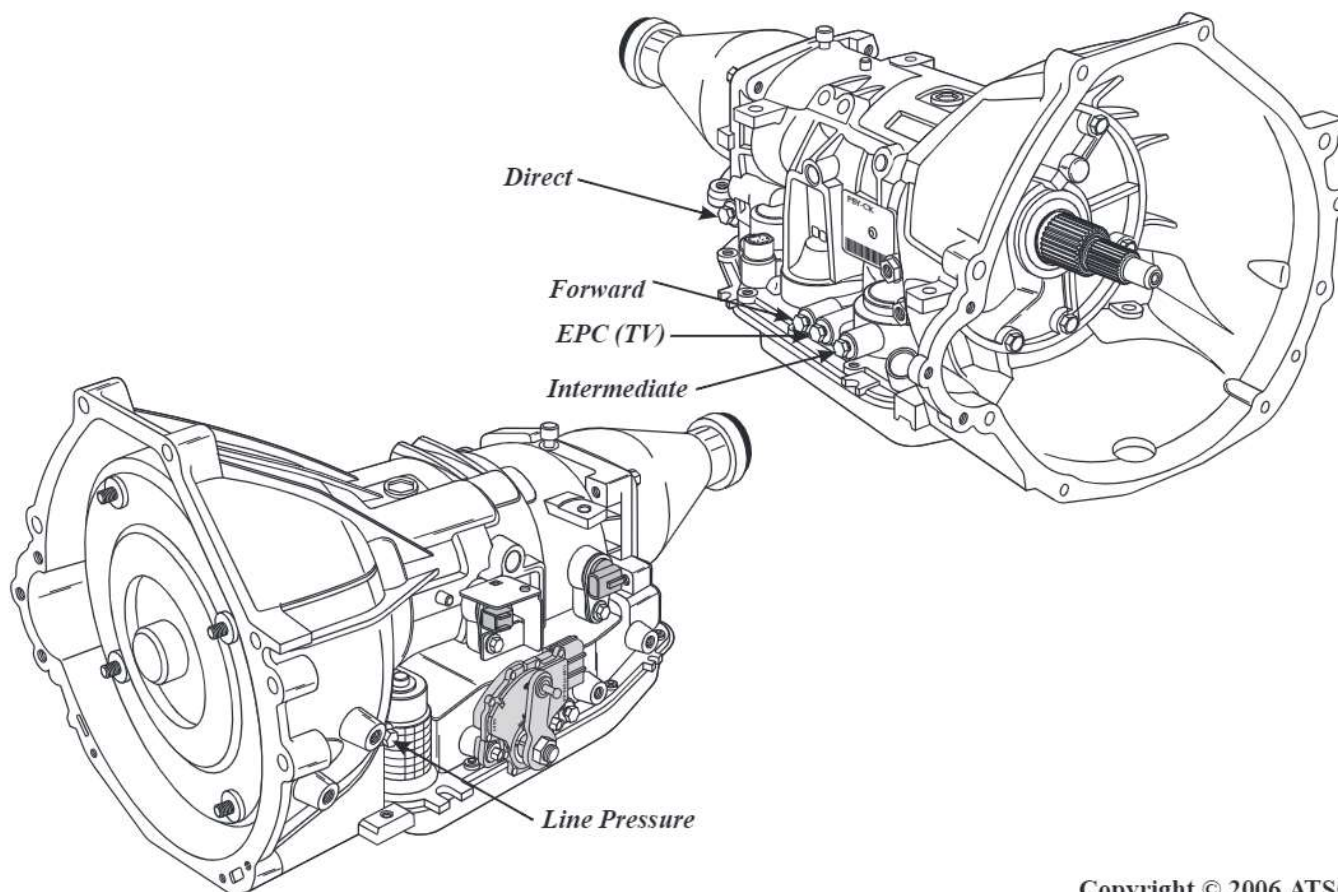
Figure 90

**CORRECTION:** To follow proper diagnostic procedure for this problem, attach a pressure gauge to the Forward Clutch Pressure Port which is located on the right hand side of the transmission, as shown in Figure 90. Normally when the Forward Clutch is applied, the pressure will be equal to the Main Line pressure, as shown in Figure 91. When the above causes take place, the pressure seen at the Forward Clutch will suddenly drop to zero, and this is when the neutral condition will be felt.
