## AXOD/AXODE (AX4S) UPDATE HANDBOOK

# Technical Service Information

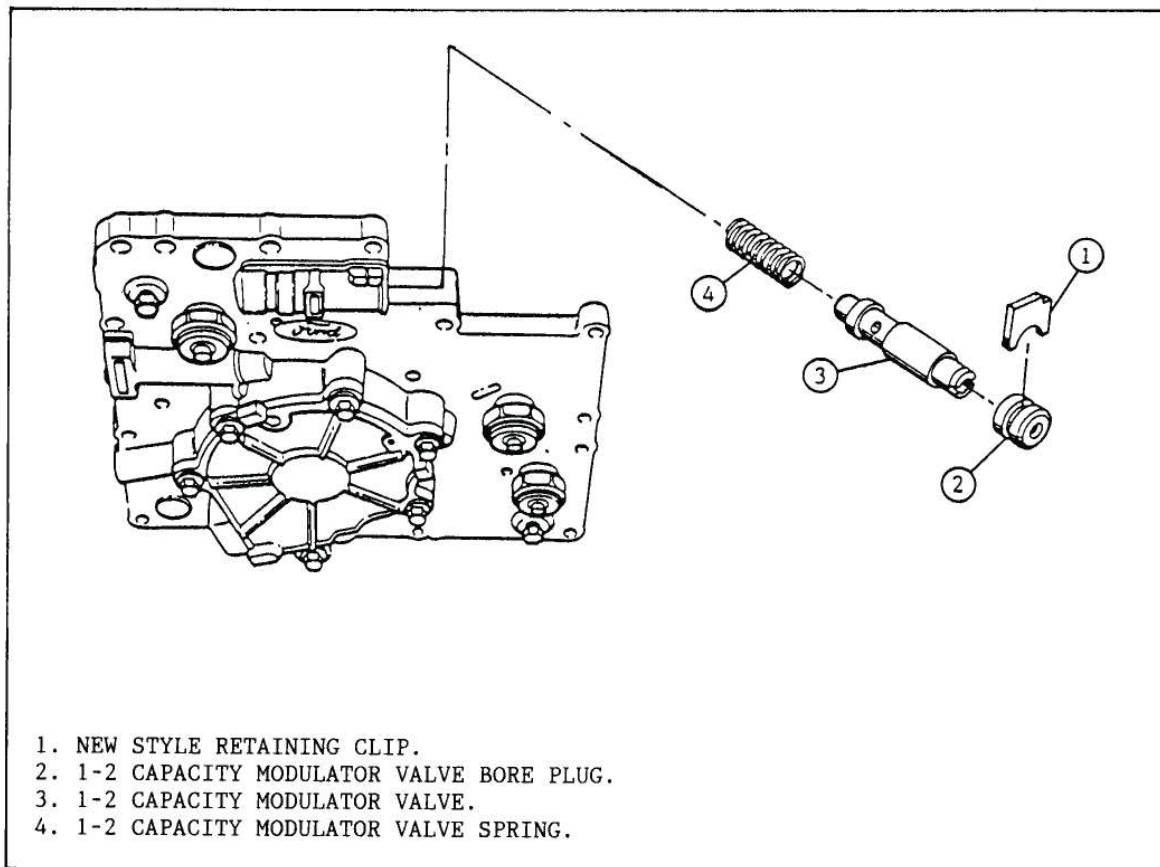
Figure 18

CAUSE: The cause may be a lack of oil volume to the intermediate and/or direct clutch packs.

Replace the 1-2 capacity modulator valve spring with the Red spring manufactured by Shift Technology Products (Part #K006). The kit also comes with a new style bore plug retaining clip. Assemble into the oil pump as shown in Figure 18. This modification should be made on all AXOD'S during rebuild.

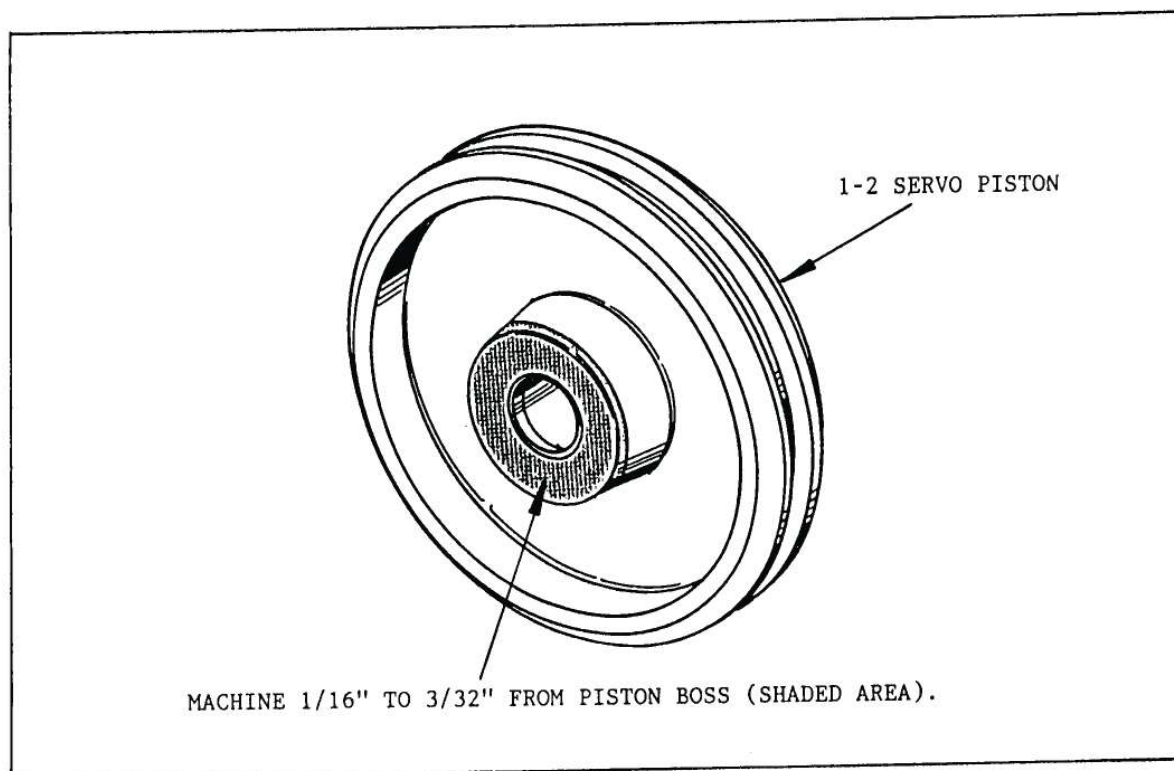
Figure 40

CAUSE: Insufficient travel of the 1-2 piston against the cushion spring.

CORRECTION: Remove  $1/16$ " to  $3/32$ " from the boss on the inside of the 1-2 servo piston as shown in Figure 40. We have shaded the area to be machined (See Figure 40).

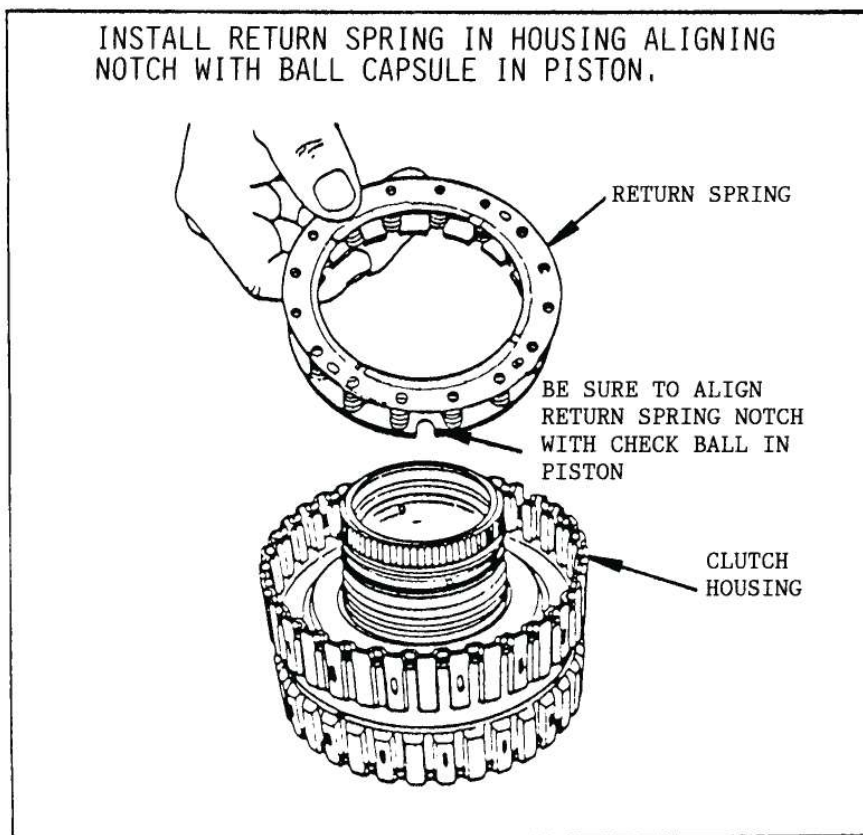
Figure 41

- COMPLAINT:** An extended 3-4 shift with possible direct clutch failure or a NO 3-4 shift condition.
- CAUSE:** This condition may be caused by a partially or fully blocked oil flow of the direct clutch piston check ball assembly.
- CORRECTION:** Special care must be taken during the overhaul operation when re-assembling the direct clutch return spring over the direct clutch piston. Make sure that the notch in the spring bottom retainer (See Figure 41) is positioned properly over the check ball capsule so as not to block or restrict oil flow of the check ball assembly. Refer to Figure 41.

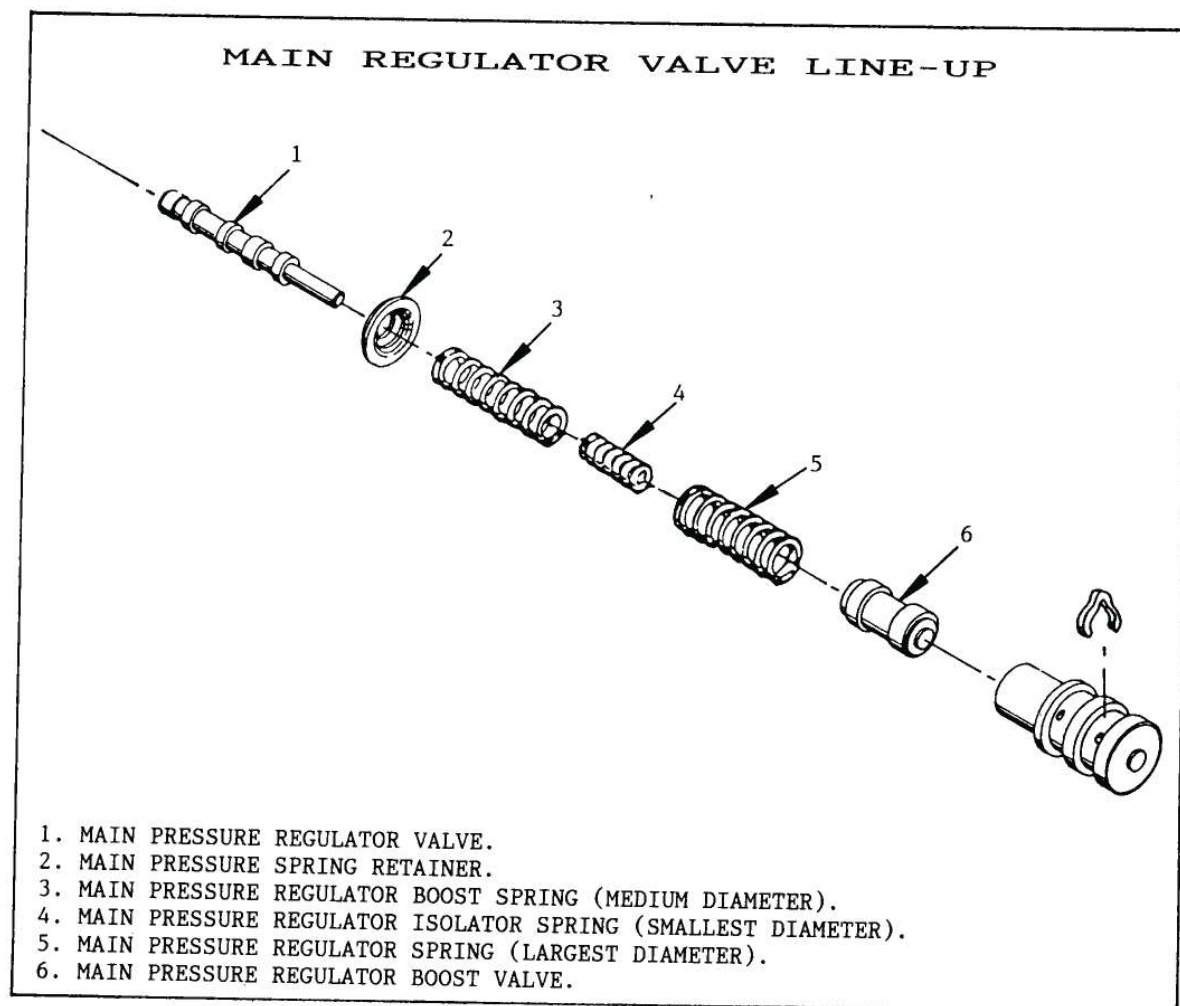
Figure 43

- NO. 2. Delayed upshifts after cleaning the valve body.
- CAUSE: NO. 1. A "Shudder" during a 1-2 upshift will occur if the main pressure regulator "Isolator" spring is not installed after cleaning the valve body (See Figure 43). This is caused by fluctuations in main line pressure at the time of the 1-2 shift.

- NO. 2. Delayed upshifts can be caused by the pressure regulator spring retainer being installed backwards (See Figure 43). This will create low main line pressure.

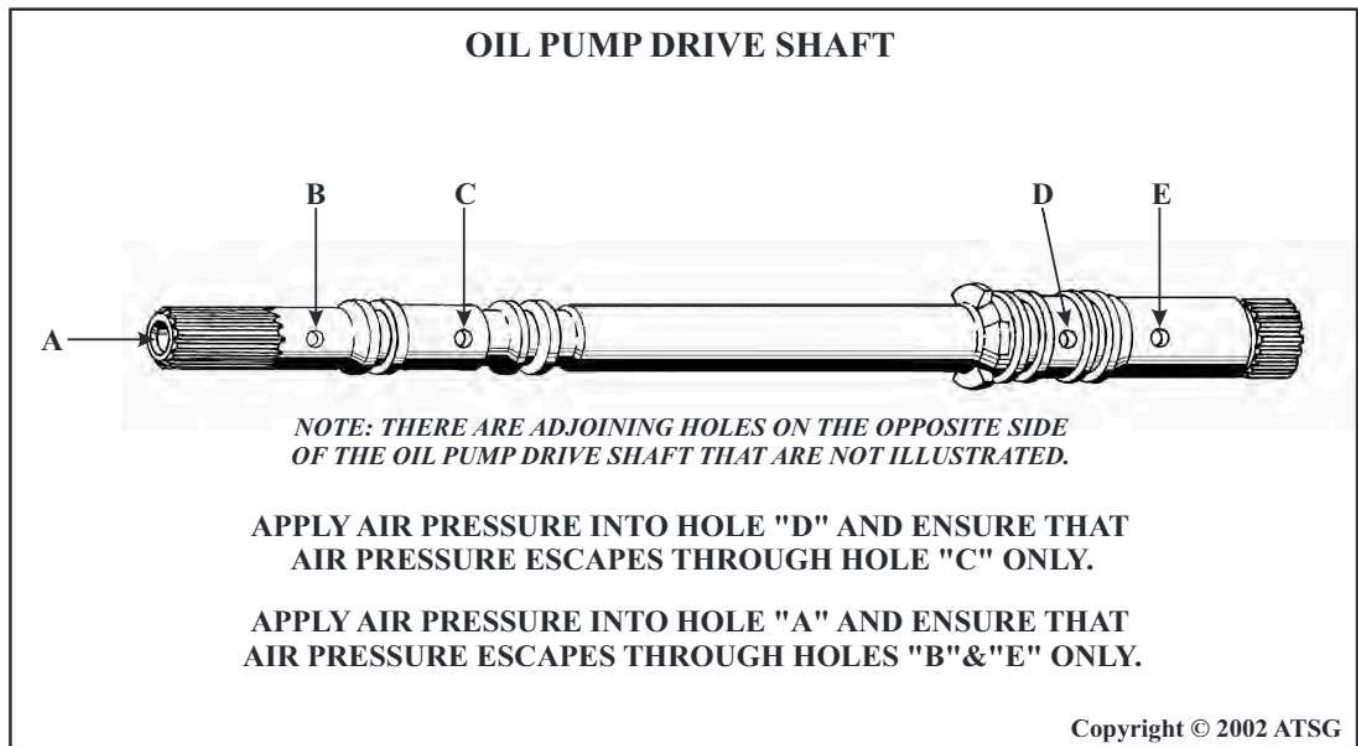
1. *The converter feed passage in the Oil Pump Drive Shaft blocked with debris or was not machined properly to allow converter feed oil to enter the converter.*
2. *The Oil Pump Drive Shaft leaking or not machined properly, allowing converter feed passage and converter release passage to be connected.*

**NOTE:** *We have seen some replacement shafts, both reman and new that were leaking between the converter apply and release passages.*

**CORRECTION:** Refer to Figure 64 to check the Oil Pump Drive Shaft, and clean or replace as necessary.

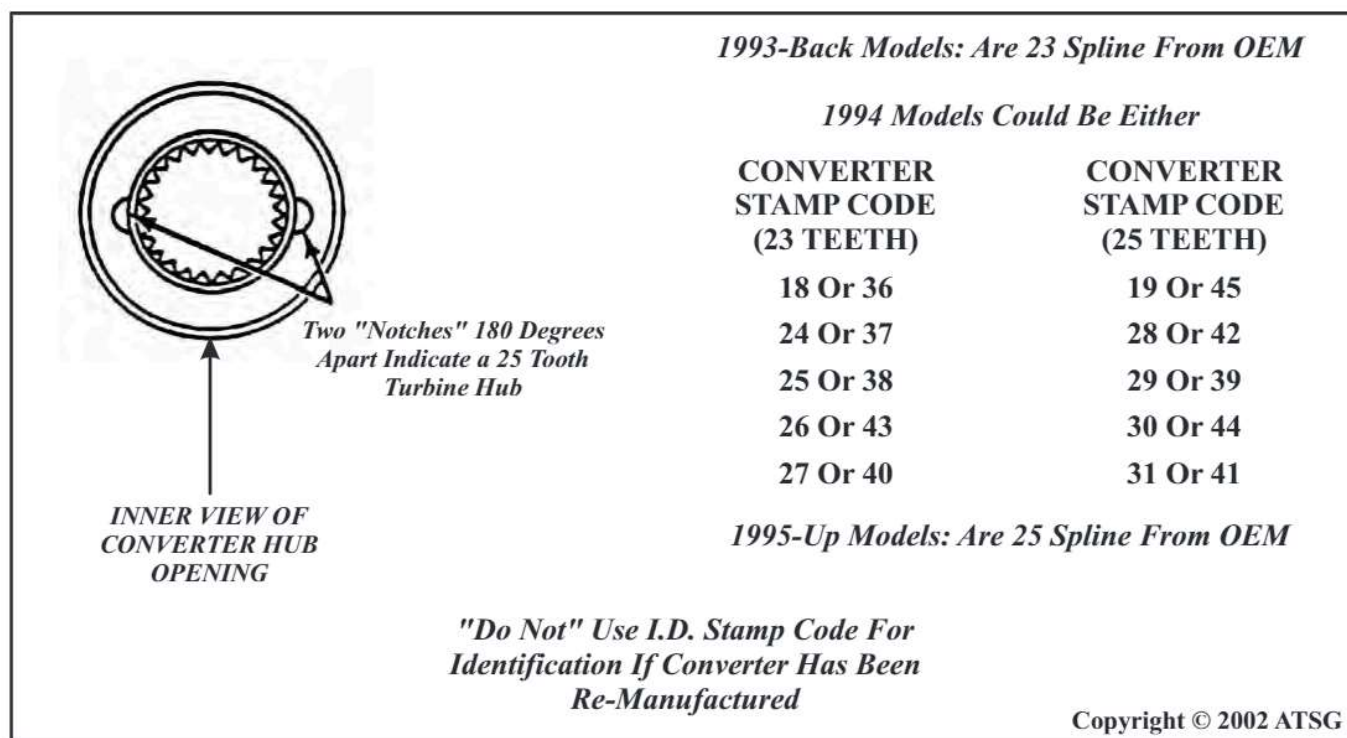
- (1) **TORQUE CONVERTER** - Converter turbine splines changed from 23 splines to 25 splines. To identify this change, the converter "Stamp Code" was changed. Refer to the chart found in Figure 67 for identification, if the converter has not been rebuilt.
- (2) **TURBINE SHAFT** - Splines changed from 23 splines to 25 splines. Count the number of splines on turbine shaft for positive identification.

**CAUTION:** *It is possible to install a 25 Spline converter onto a 23 Spline turbine shaft. If this occurs, the vehicle will have a "No Movement" condition and after the engine is started will usually twist off the stator shaft (Drive Sprocket Support).*

If replacement of either torque converter and/or turbine shaft is necessary, ensure that equal number of splines exist on the mating parts.

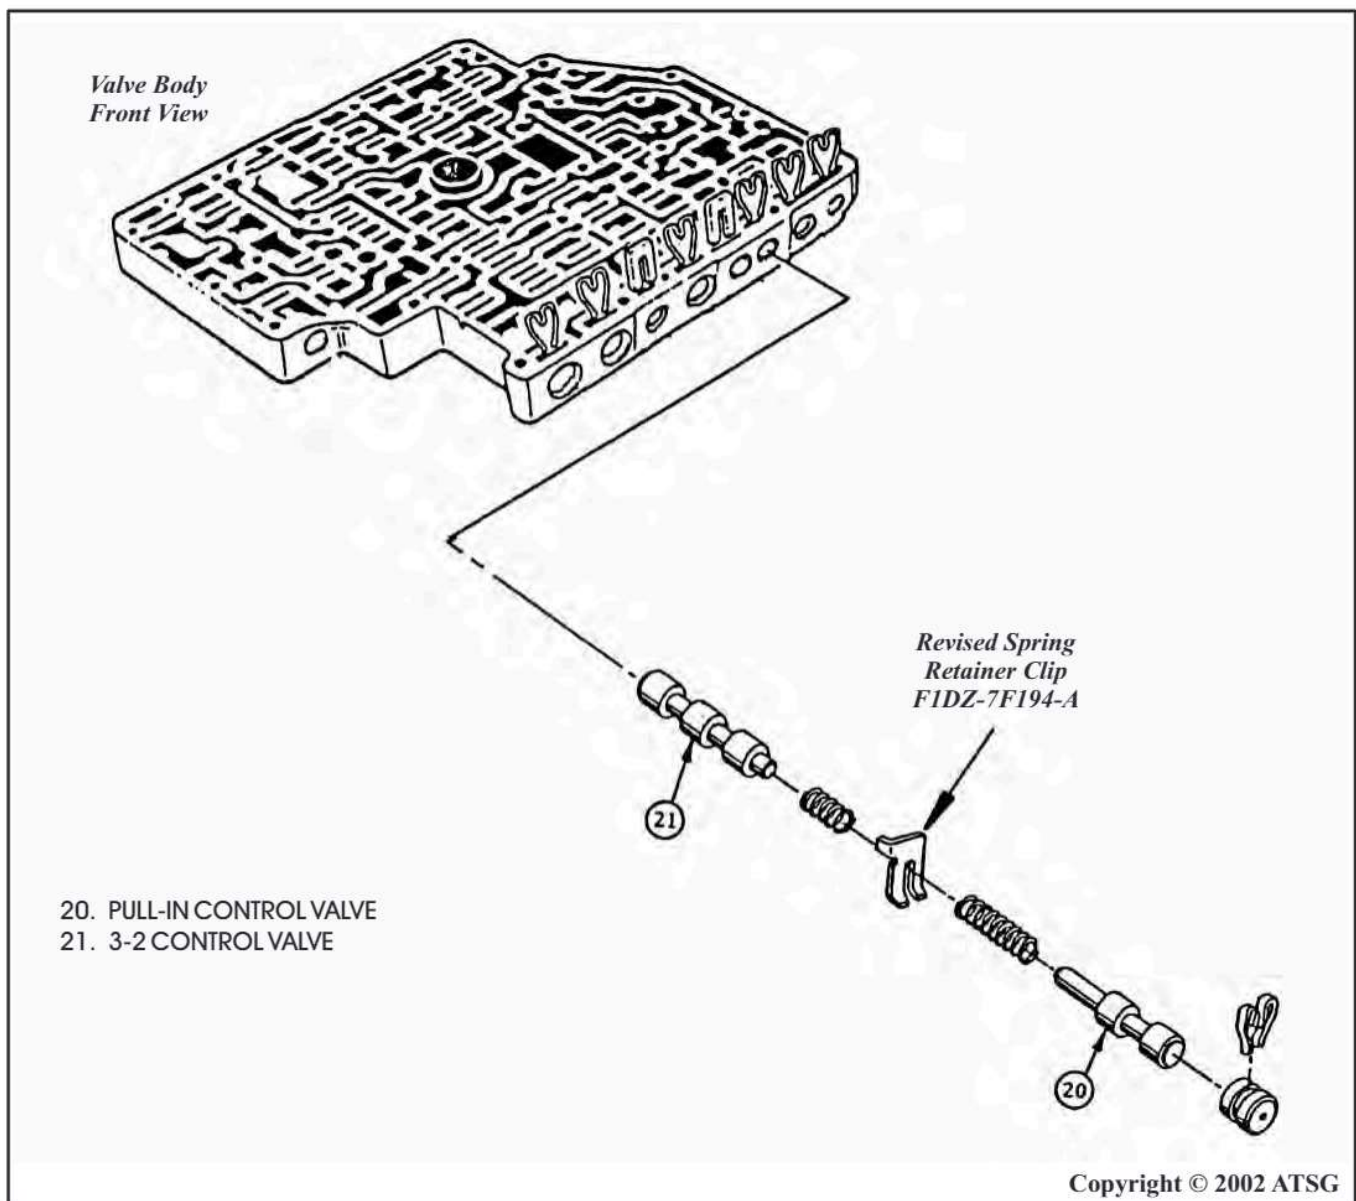
Figure 75

**CAUSE:** The cause may be, a broken spring retainer clip between the pull-in control valve spring and the 3-2 control valve spring, as shown in Figure 75.

**CORRECTION:** Replace the spring retainer clip with OEM part number F1DZ-7F194-A, as shown in Figure 75.

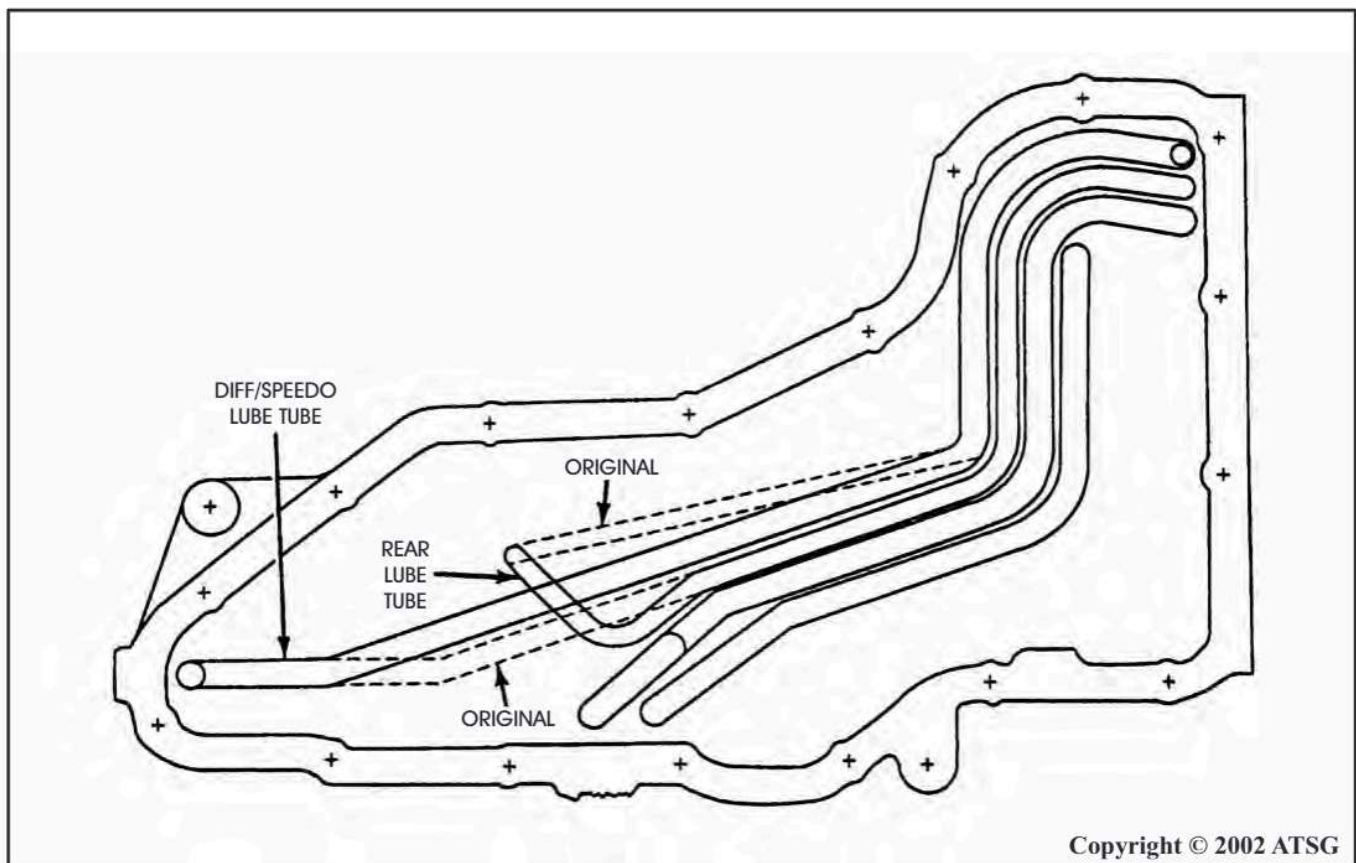
Figure 83

**COMPLAINT:** Front planetary and gear train failure with no visible root cause.

**CAUSE:** The cause may be, a limited volume of lube oil to the front planetary due to hydraulic control system demands.

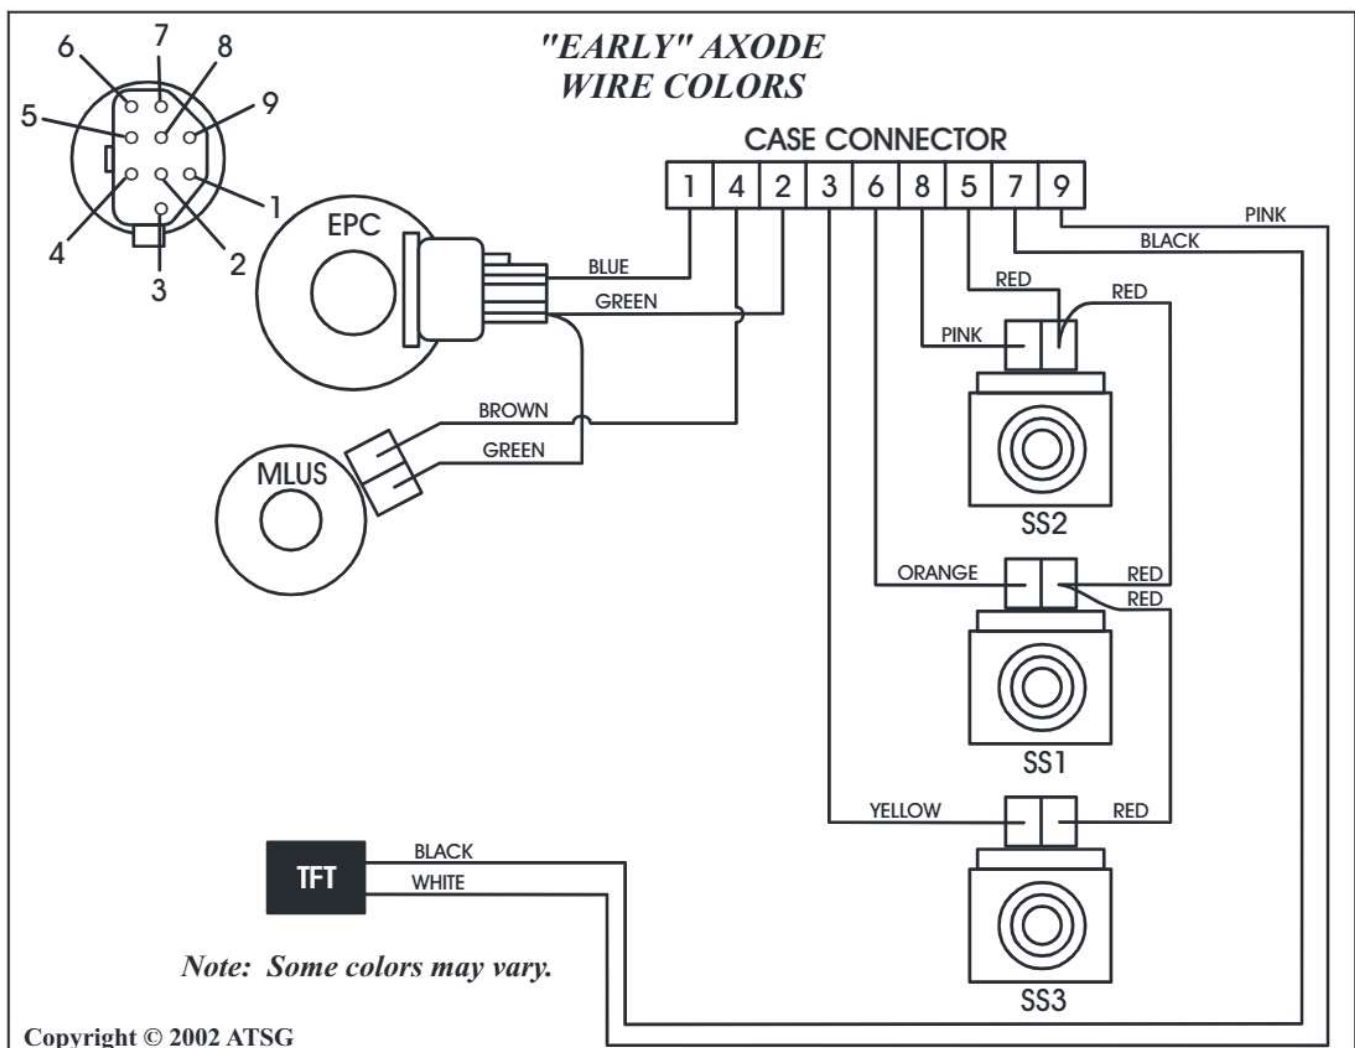
**COMPLAINT:** *After rebuild*, harsh shifts (High Line) and/or a "Clicking" or cycling noise may be heard from the side cover area, that is usually accompanied by an ON/OFF bind-up sensation that coincides with the "Clicking" noise. These symptoms may be accompanied with Diagnostic Trouble Code (DTC) 652 (MLUS Shorted or Open Circuit), DTC 624 (EPC Circuit Failure), and/or one Shift Solenoid DTC 621, 622, or 624.

**CAUSE:** The cause may be, solenoid wire connectors installed on the wrong solenoids.

**CORRECTION:** Connect the internal wiring harness connectors to their proper solenoids, *using the wire colors*, as shown in Figure 90 and 91. Proper connection of solenoids can also be verified externally through the case connector using the Ohms chart in Figure 91.

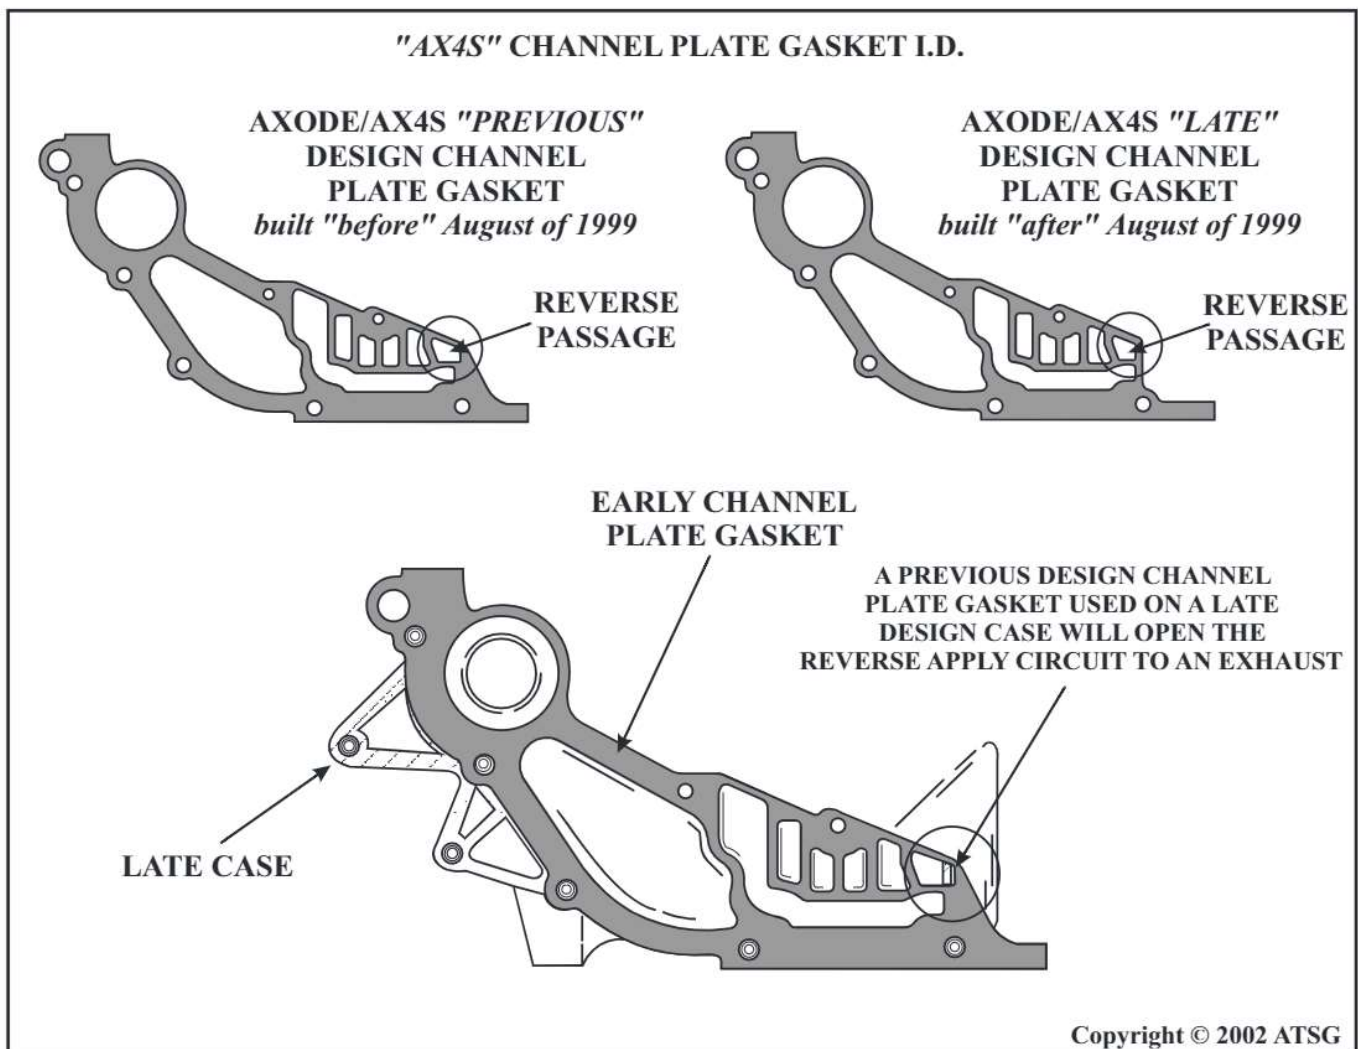
**CAUSE:** The cause may be, that the *Previous Design* Channel Plate Gasket, was used on a *Late Design* case as shown in Figure 103. When this happens, Reverse apply pressure will be exhausted back into the case because of the gasket hanging over the case casting.

**CORRECTION:** AX4S-Refer to Figure 103 to identify the correct Channel Plate Gasket for the application of vehicle you are working on.  
AX4N-Refer to Figure 104 to identify the correct Channel Plate Gasket for the application of vehicle you are working on.
