## AUTOMATIC TRANSMISSION SERVICE GROUP

### THM 125C

Since the introduction of the THM 125 transaxle in model year 1980, there have been many major engineering changes. These changes have affected nearly every part used in the 125 and 125c.

This Update Handbook will explain each change, the parts affected by the change, any parts interchangeability problems created by the change. This Update Handbook will cover all of the changes from start of production up through and including model year 1987, along with common problems, and fixes, for the THM 125 transaxle.

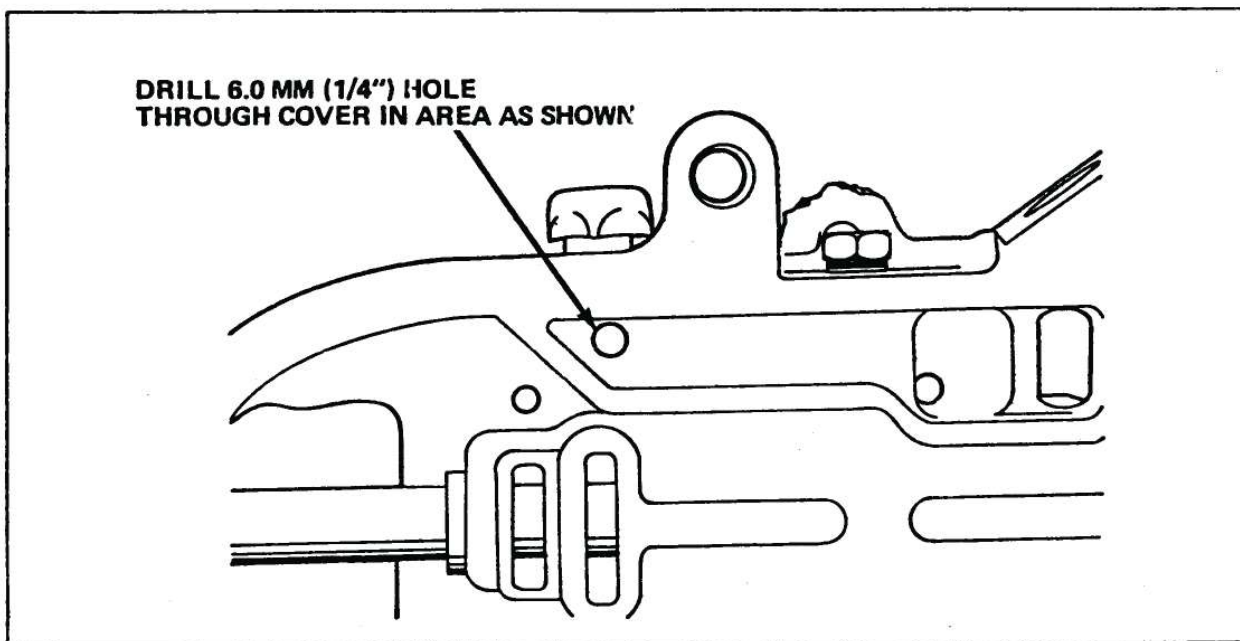
Figure 3

In late 1980, the case cover was modified with an extra hole cast into it, to eliminate the possibility of an "oil out the vent" condition.

If you should encounter a case cover without the hole, use a 1/4" drill, and make a 1/4" hole through the case cover under the breather as shown in Figure 3.

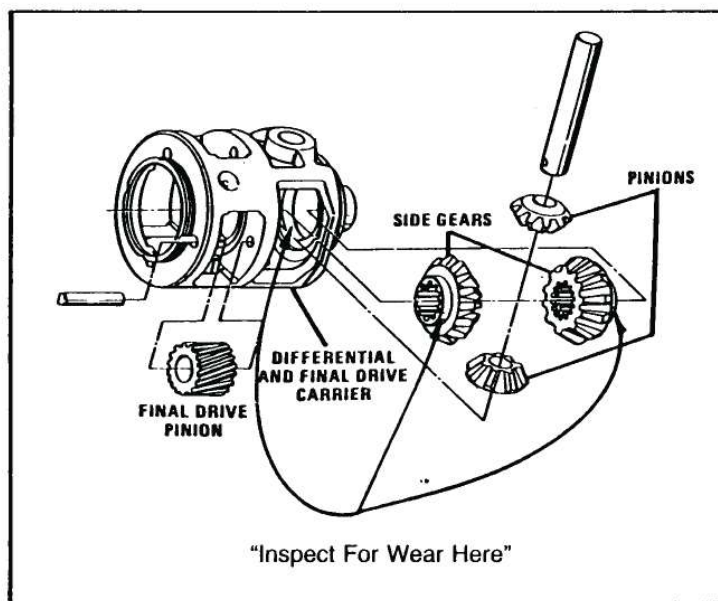
Figure 13

The extra lubrication was to help eliminate wear patterns in the final drive carrier and on the side gears (See Figure 13).

When the final drive carrier would wear it would first show up as an oil leak at the right hand axle seal. The final drive carrier was also later changed to a hardened surface (Identified by its blackened color), to help eliminate wear in this area.

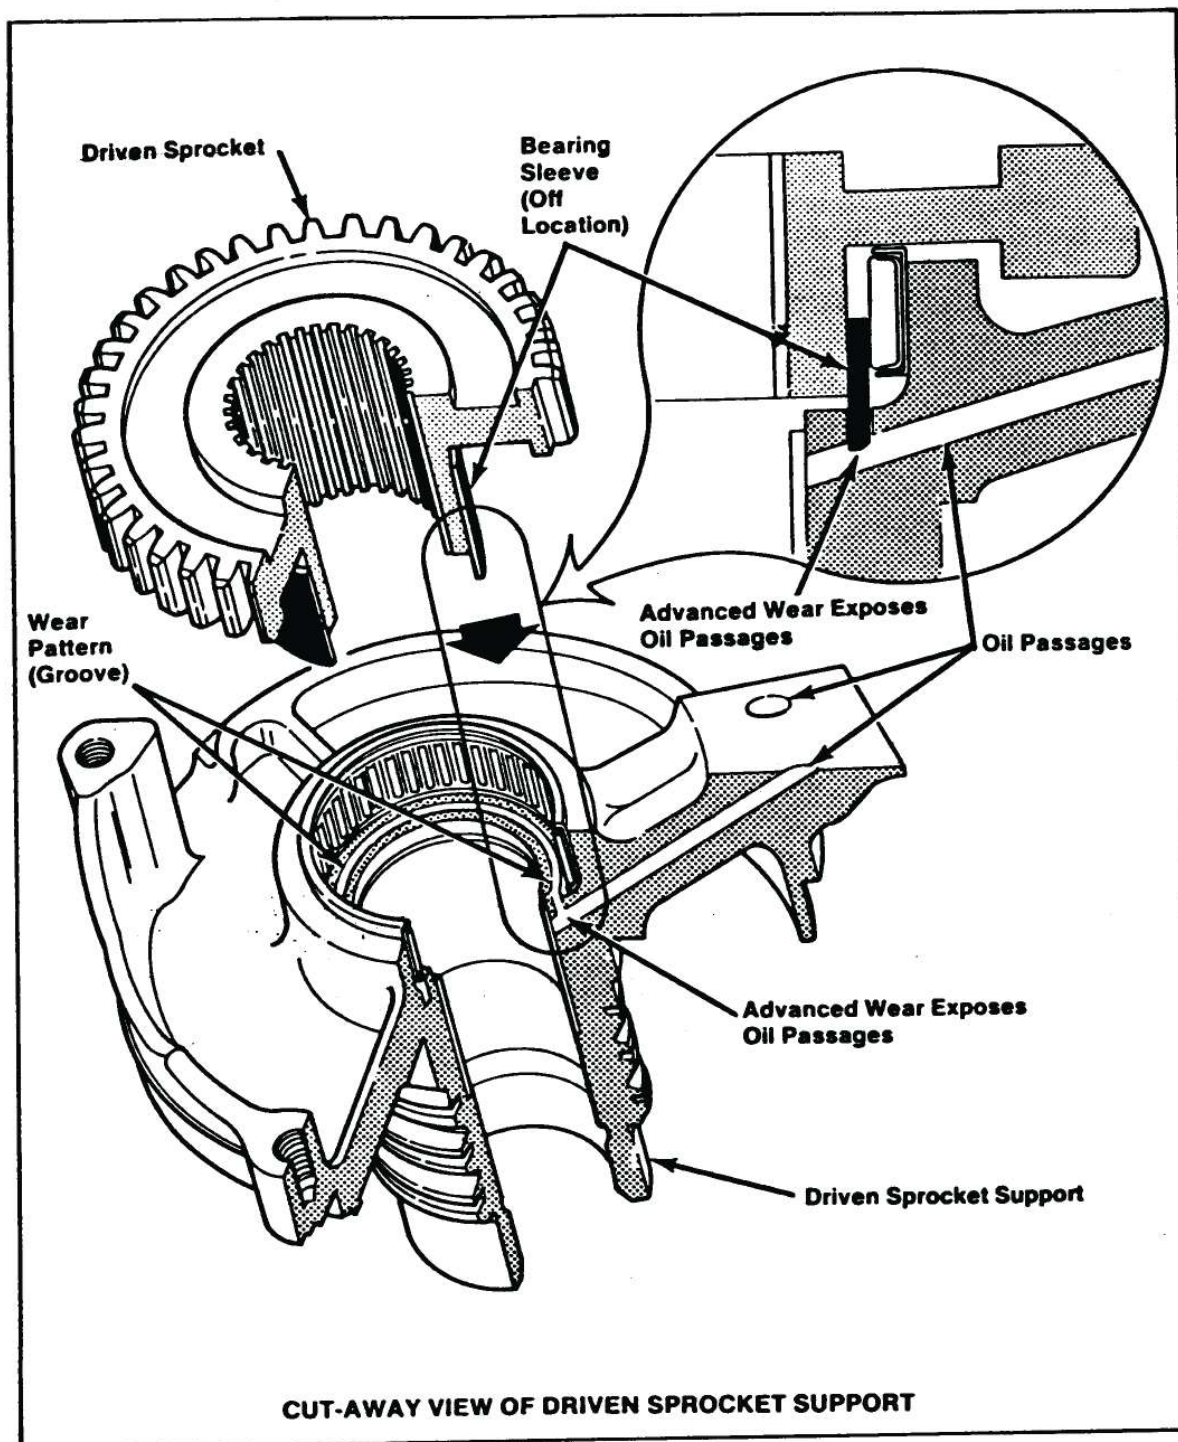
Figure 15

When diagnosing a THM 125 transaxle for lack of drive, slipping shifts, or erratic shifts, be sure to check the driven sprocket support for wear as shown in figure 15.

This wear pattern, if present, is caused by the bearing sleeve on the outside hub of the driven sprocket moving off and wearing into the driven sprocket support. As this wear condition reaches an advanced state the oil feed passages in the driven sprocket support are exposed, allowing an oil pressure leak.

The bearing sleeve on the driven sprocket may, after causing the indicated wear pattern (Groove), move back to the proper location and appear to be normal. Consequently, if this condition is present, be certain to check both the driven sprocket and driven sprocket support as shown in Figure 15.

If the above condition exists, replace the driven sprocket, driven sprocket support, and any other affected parts. Be sure also to check the direct and forward clutch packs, as well as the intermediate band for wear.

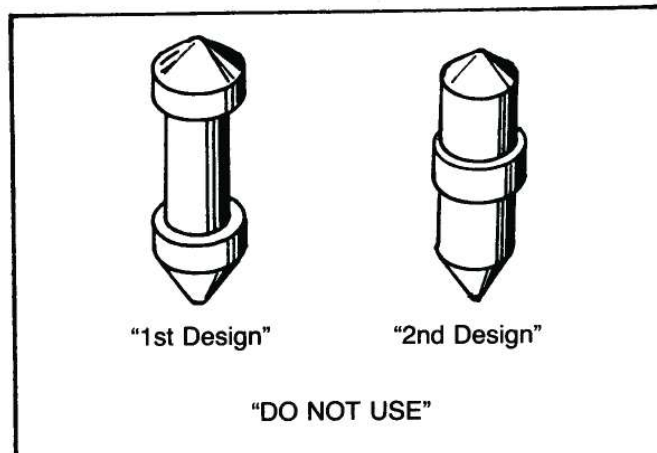
Figure 17

If this valve is leaking the result will be a burnt intermediate band and burnt direct clutch.

If you find a 3rd accumulator check valve like the ones shown in Figure 17, discard them and replace with the 3rd design (8643964).

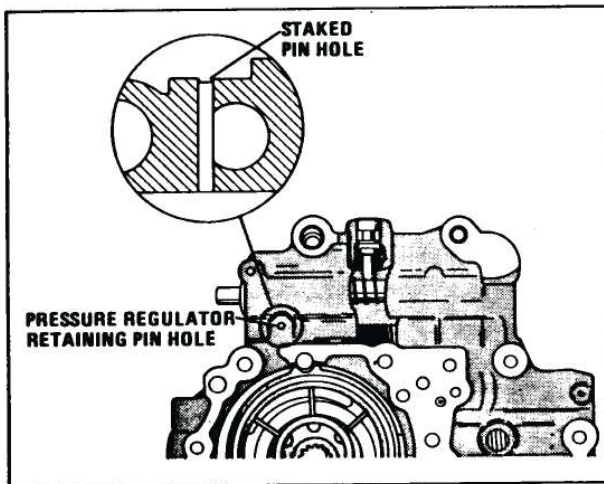
When diagnosing any THM 125/125C transaxle for no drive or harsh shift conditions, check the valve body assembly for a worn (Nibbled) or missing pressure regulator valve retaining pin. See Figure 21 for retaining pin location.

If the pressure regulator valve retaining pin is worn (Nibbled), or missing, use a 1/4" drift punch and stake the pressure regulator valve retaining pin hole part of the way shut. See inset Figure 21. Stake the pin hole only enough to hold the new retaining pin in place after assembly.

After assembling the pressure regulator valve train, retain the valve train with a new solid steel retaining pin, OEM part number 112496. The new pin must be inserted from, and flush with, the machined surface of the valve body assembly.

This new solid steel retaining pin should be used in "ALL" THM 125/125C transaxles, in the pressure regulator line up.

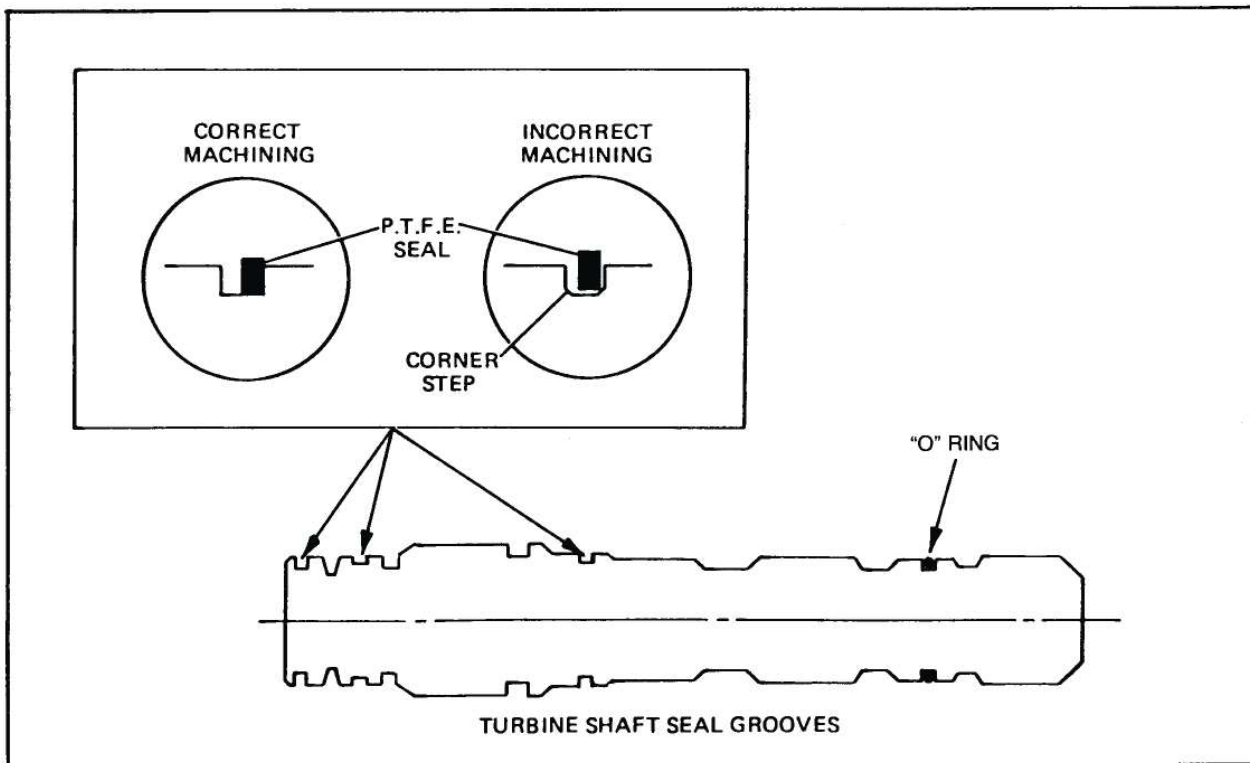
Figure 27

Some 1982 and 1983 THM 125C transaxles may experience a torque converter shudder condition immediately following engagement of the torque converter clutch.

The cause could be an incorrectly machined seal groove on the turbine shaft. A step in the bottom corners of the seal groove (Figure 27) will prevent the solid Teflon seal from contacting the side wall of the groove and will not seal properly. If this condition is found, replace both the turbine shaft and the turbine shaft seals.

You should replace scarf cut seals with the solid Teflon seals, and install the solid seals in all three locations that are shown in Figure 27. Follow service manual procedures for installing and sizing the new seals.

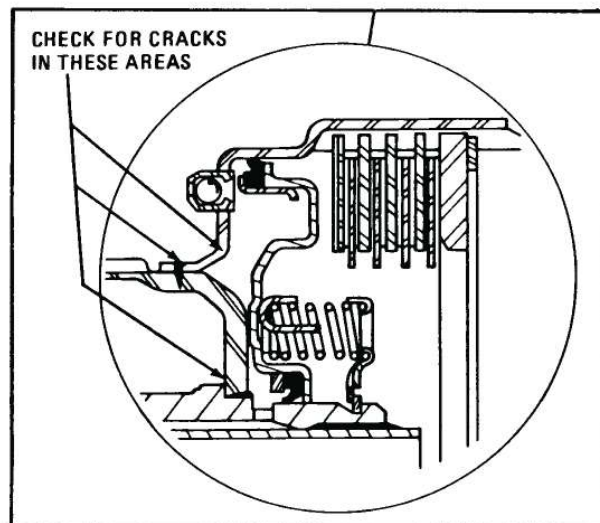
The forward clutch housing on the THM 125/125C is prone to cracking, and we have shown in Figure 29 where to inspect for cracks.

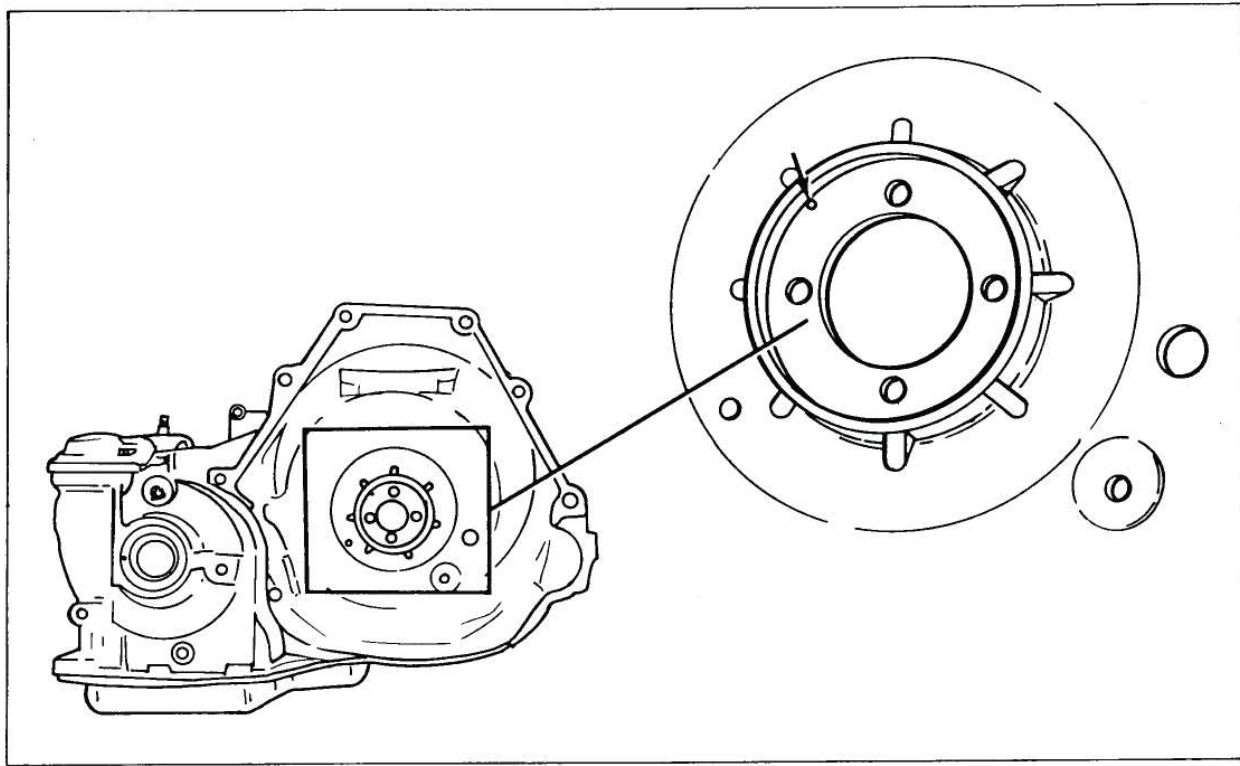
Figure 31

Some THM 125/125C transaxles may experience an oil leak from the bell housing area, which is due to the front converter seal coming out of the case bore. This condition results from an oil pressure build up behind the converter seal, which forces the converter seal out of its seat in the case bore.

When servicing any THM 125/125C transaxle for this condition, it is recommended that an oil drainback hole be drilled into the converter seal bore of the transaxle case (See Figure 31).

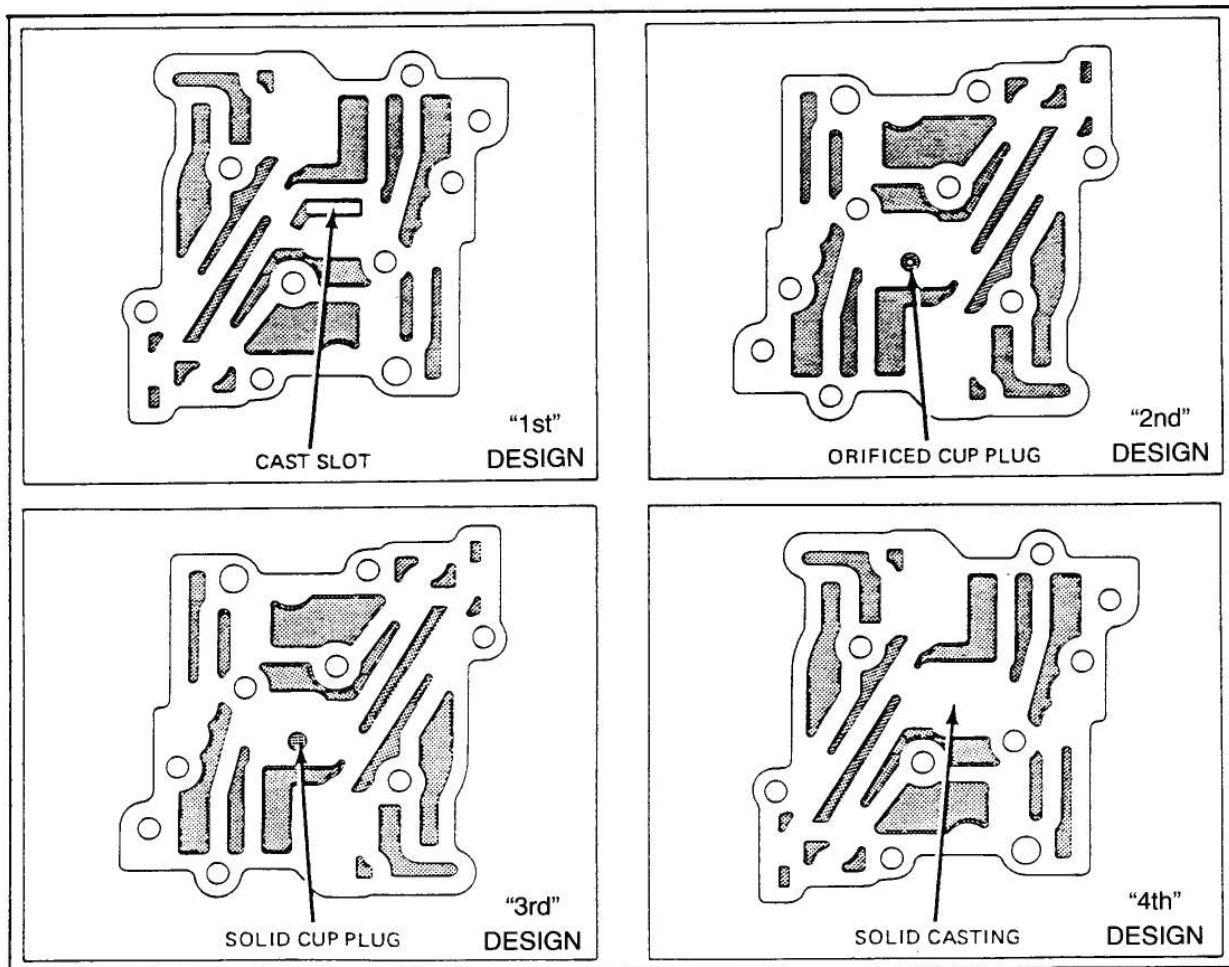
Figure 35

Since the start of production, 1982, the THM 125C transaxle has had several changes in the auxiliary valve body cover. The changes were implemented to eliminate a light throttle converter clutch shudder condition.

When servicing any THM 125C transaxle, use only the 3rd design or the 4th design auxiliary valve body covers. You can use the 2nd design if you install a solid cup plug.

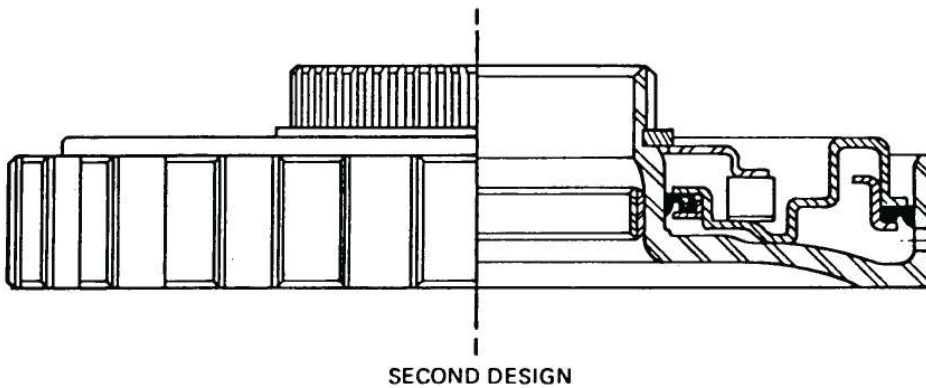
Figure 37

- 1) Low and reverse piston redesigned and apply ring eliminated. See Figure 37. This design allowed the lip seal retainer to become separated from the low and reverse piston assembly, creating a no reverse, or neutral to reverse delayed engagement condition. Do not use this type.

Our recommendation is to use only the 3rd design low and reverse piston, and the oil displacement insert when servicing any THM 125 or THM 125C up through model year 1983.

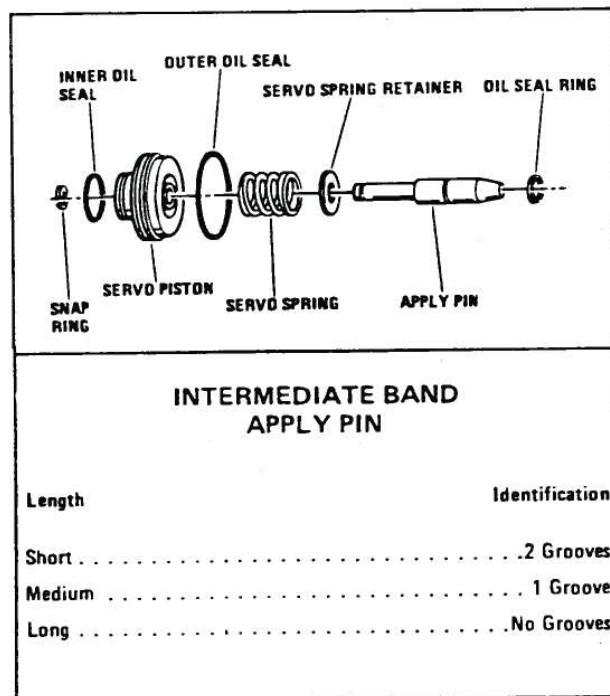
Figure 39

Some 1983 THM 125C transaxles may exhibit a 3-2 coastdown clunk condition that is most noticeable at approximately 15 miles per hour when decelerating. This 3-2 coastdown clunk condition may be caused by a broken intermediate servo cushion spring (Figure 39).

If the intermediate servo cushion spring is cracked, broken, or damaged, replace it with OEM part number 8652057.

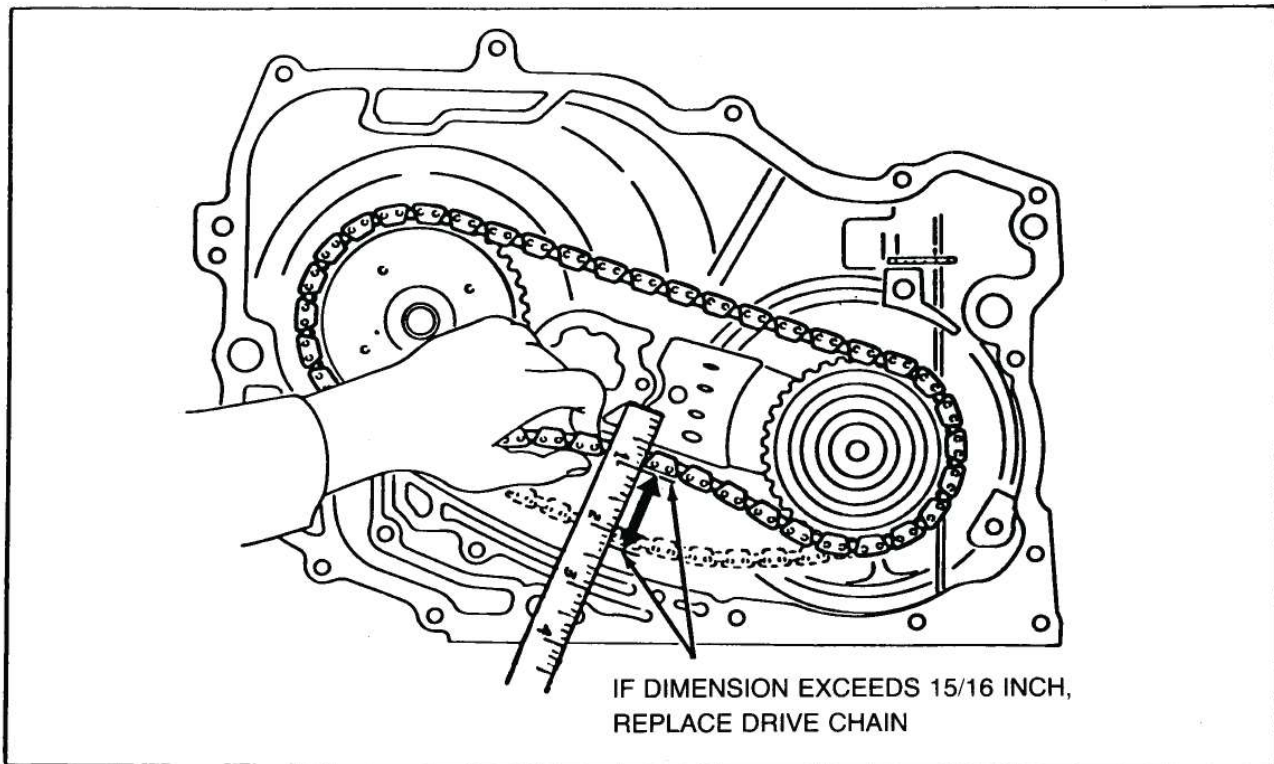
Figure 49

When checking the Drive Chain for possible wear on the THM 125/125C transaxle, use the following procedure.

- 1) Midway between the sprockets and at right angles to the chain, push the slack of the chain up until finger tight (Figure 49).
- 2) Lay a ruler on the face of the case and line up the inch mark with the outside edge of the drive chain (Figure 49).
- 3) Push down in the same manner until the slack is finger tight, while holding the ruler down on the case face in the same position that you started (Figure 49). If this dimension exceeds 15/16 inch, replace the drive chain.

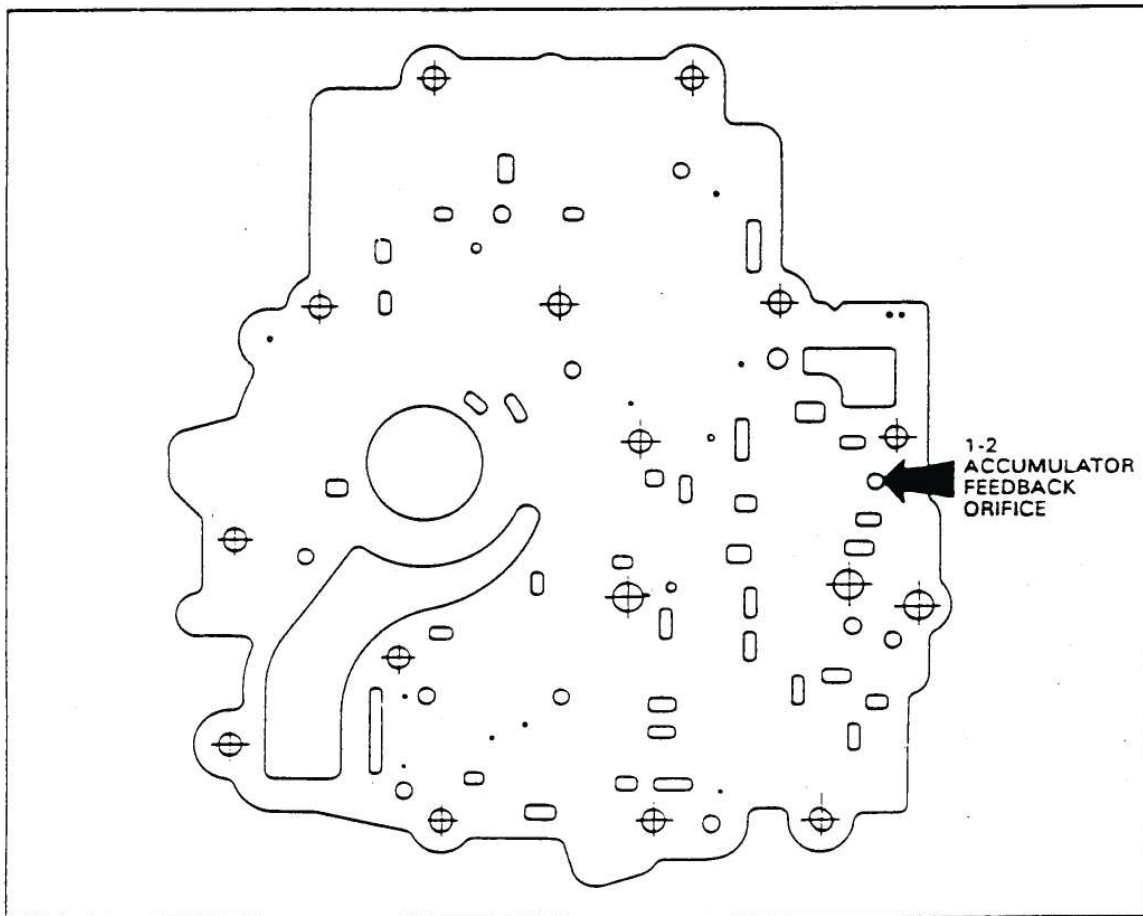
Figure 63

**CAUSE:** Too small an orifice in separator plate (.040) 1-2 ACCUMULATOR FEED BACK ORIFICE.

**CORRECTION:** Drill orifice to (.125) or replace with part number 8660581.

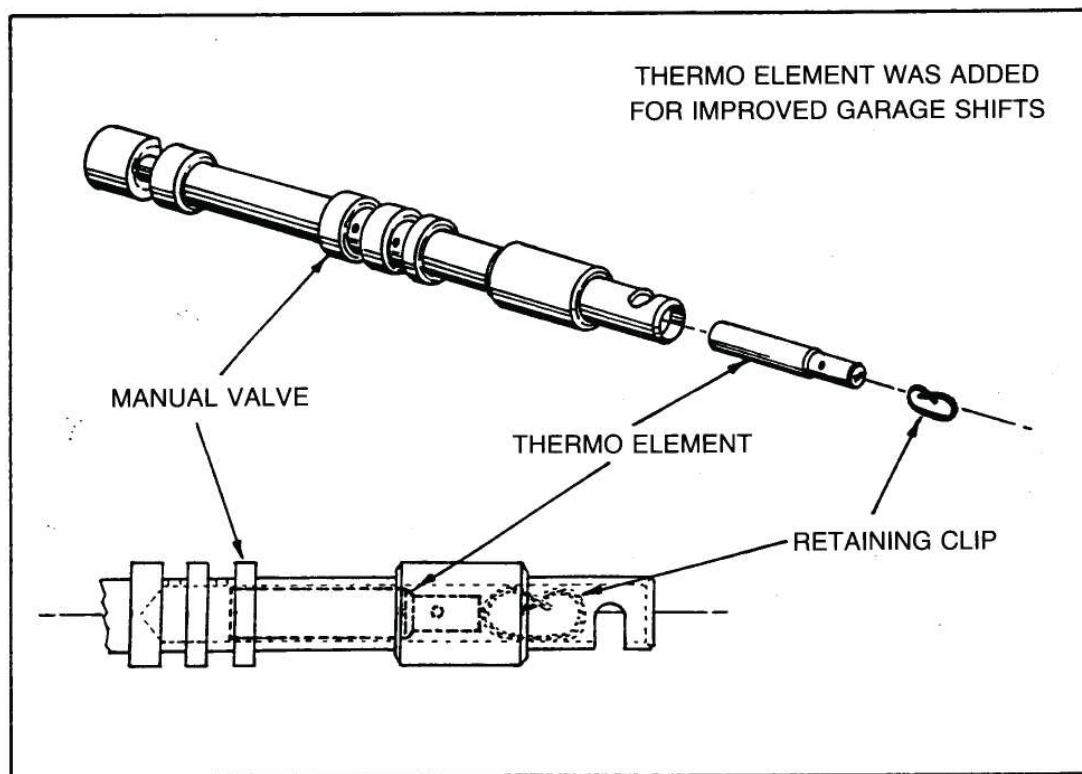
Figure 75

The retaining clip for the thermo element may break allowing the thermo element to move forward, allowing drive and/or reverse oil to exhaust (See Figure 75). A retaining clip that has broken and fallen out can usually be located in the bottom pan.

The retaining clip is not presently available as a service item. You must purchase the complete manual valve assembly. The previous design manual valve will fit the bore of the case cover, and work fine.
