**AUTOMATIC TRANSMISSION SERVICE GROUP**

**REVISED EDITION**

## INTRODUCTION

Since the introduction of the THM 440-T4 Transaxle in April, 1984, there have been many major engineering design changes. These changes have affected nearly every part used in the THM 440-T4. This Update Handbook will explain each change, the parts affected by the change, and any parts interchangeability problems created by the change.

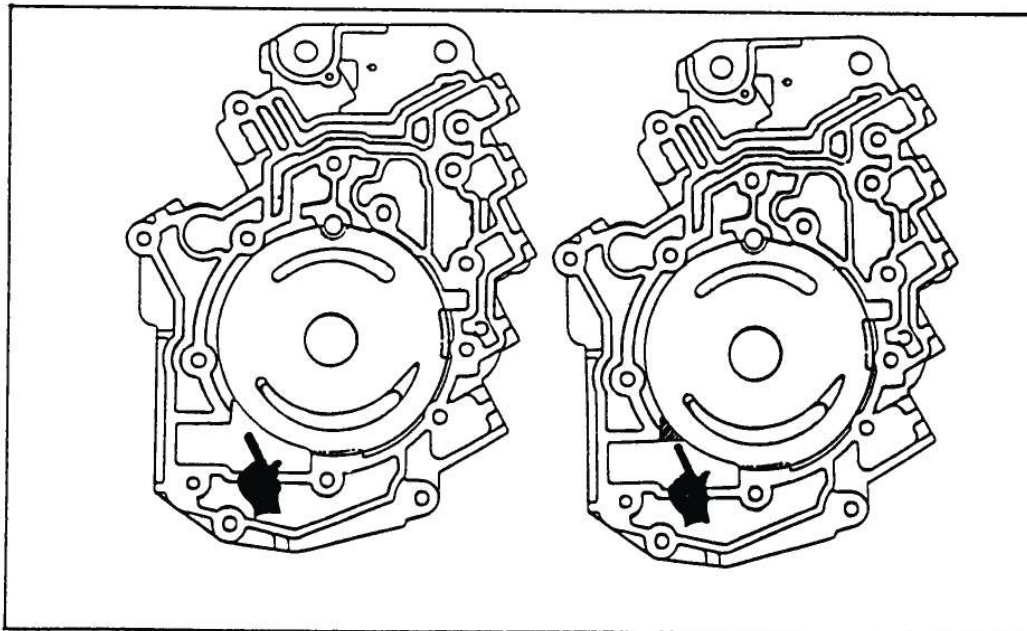
Figure 7

Some 1987 440-T4 transaxles built between November 26, 1986 (Julian Date 330) and January 12, 1987 (Julian Date 012), may exhibit a slip or no drive condition as a result of low line pressure.

This condition may be caused by the pump slide binding on excessive casting flash when the slide is in the low pressure position.

If pressures do not vary with vacuum signal changes, inspect for pump slide bind by removing the oil pump cover and slide springs. If present, excessive flash will cause the slide to bind when the cover is on and torqued.

If flash is present you will have to replace the oil pump assembly, or use a Dremel Tool with a carbide bit and remove flash from 87 model to match contour of 86 model (See Figure 7).

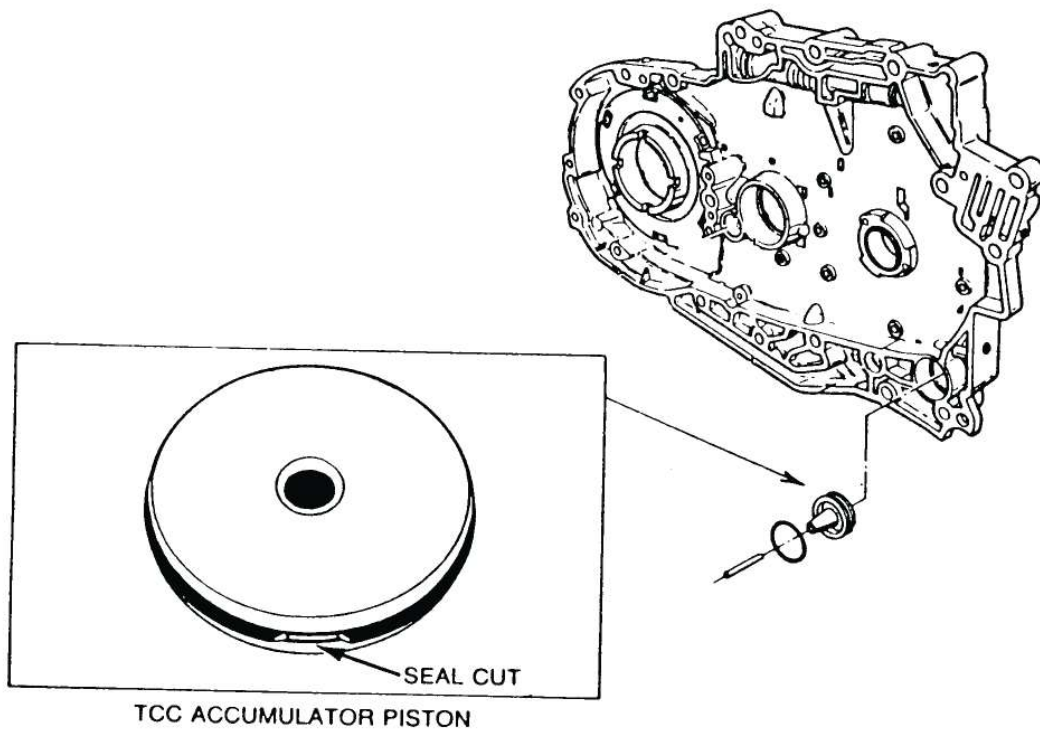
Figure 24

CAUSE: Some 1984 and some early 1985 THM 440-T4 transaxles may experience a no Torque Converter Clutch (TCC) apply or TCC shudder condition, which may be due to a cut or rolled TCC accumulator piston seal (See Figure 24).

CORRECTION: Install updated service package 8646926.  
Updated service package 8646926 contains the following:

1. 1-TCC ACCUMULATOR PISTON
2. 1-TCC ACCUMULATOR PISTON PIN
3. 1-TCC ACCUMULATOR PISTON SEAL

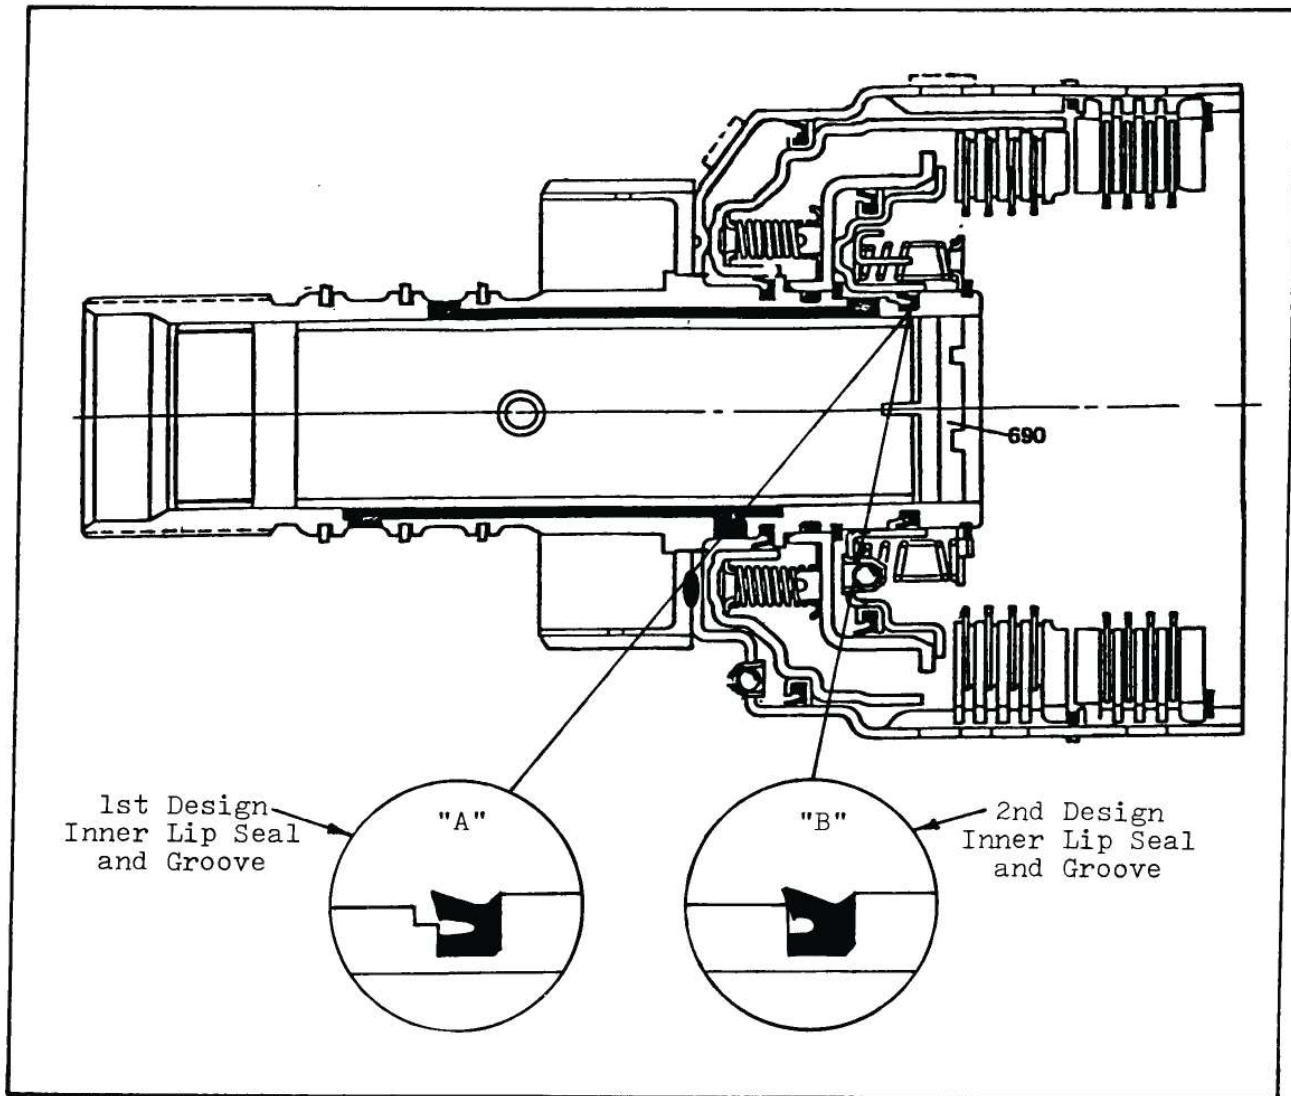
Figure 52

- 1) 3rd Clutch Inner Lip Seal - Thicker profile to help prevent seal from rolling (See Inset, Figure 52).

Will retro fit backwards, and is recommended. New OEM Part No. is 8662673 on the new 3rd clutch lip seal. For positive identification of the new seal, check for hash marks on inside diameter of lip seal (See Inset, Figure 51). For difference in profile compare Inset "A" and "B" in Figure 52.

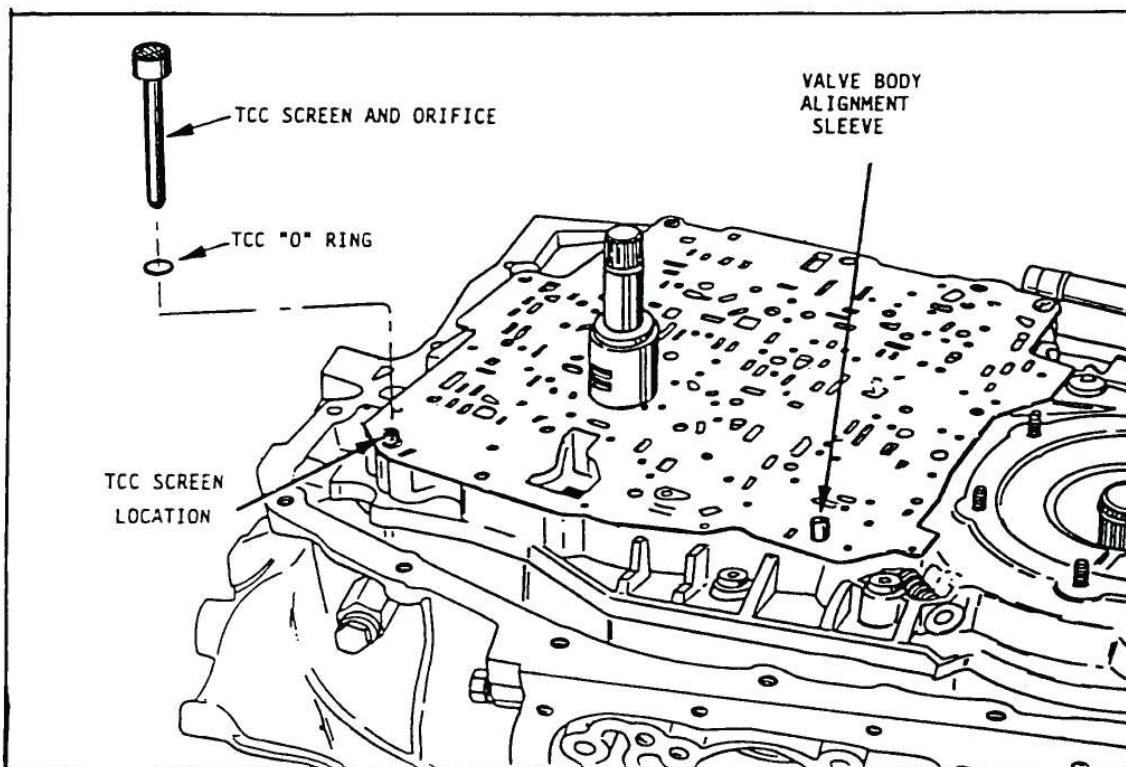
Figure 62

**CAUSE:** The cause may be a missing TCC screen and orifice (See Figure 62). If the TCC screen and orifice are left out of the 440-T4, the converter clutch will apply on the 1-2 shift because of the solenoids inability to exhaust TCC signal oil there by stroking the lock-up valve. The TCC screen and orifice must be in place, as well as the "O" ring (See Figure 62). The TCC screen "Snaps" into the spacer plate.

TCC Screen and Orifice ..... 8658060

"O" Ring, TCC Screen ..... 8658109

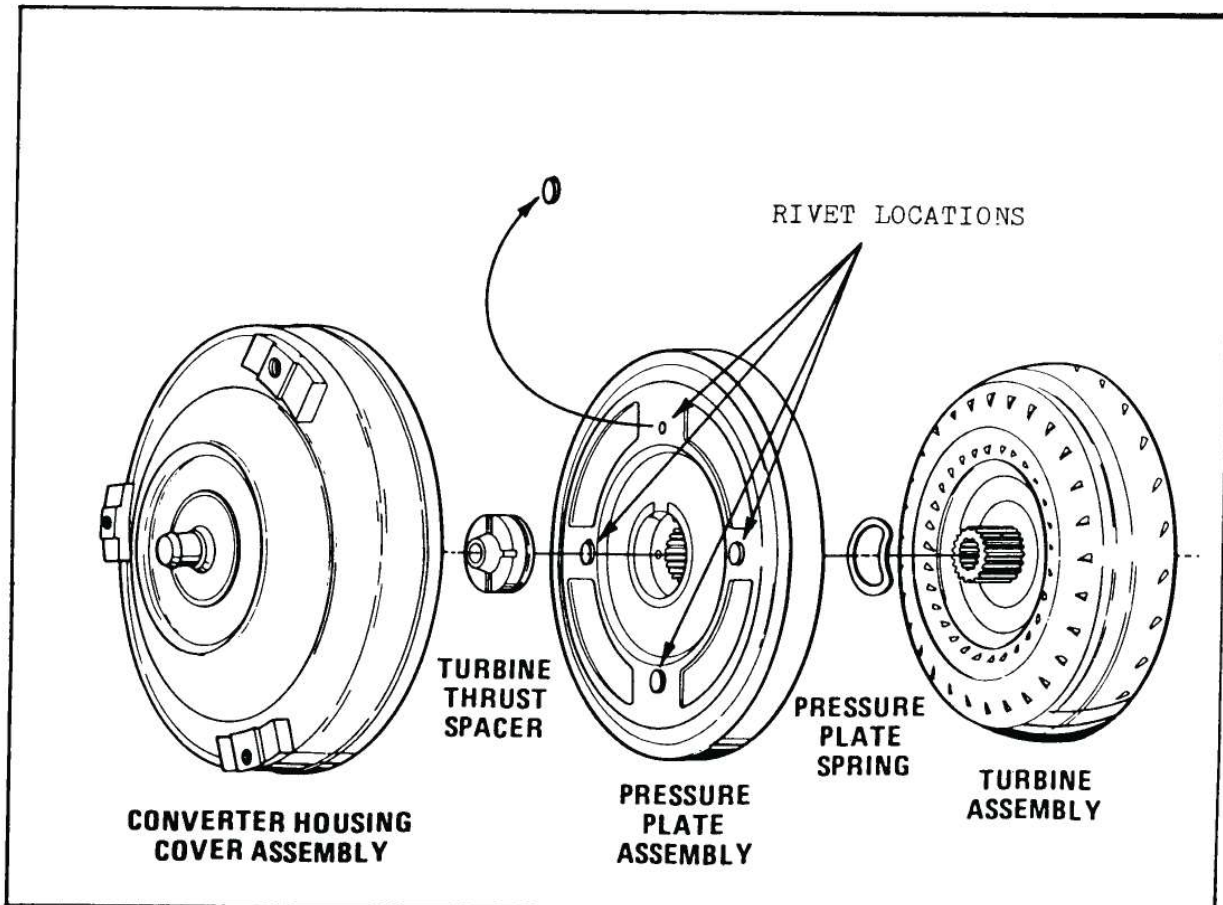
Figure 67

Some models of the THM 440-T4, usually with the 3.8L engine, may exhibit a TCC shudder condition or no torque converter clutch, because of a rivet head popping off that retains the damper assembly to the pressure plate (See Figure 67).

Great care must be exercised in the diagnosis procedure before making any modifications to cure TCC shudder. The check ball behind the TCC regulator valve will not fix a vehicle with this condition.

A torque converter checking fixture should be used on all 3.8L converters to verify converter clutch operation before installation.

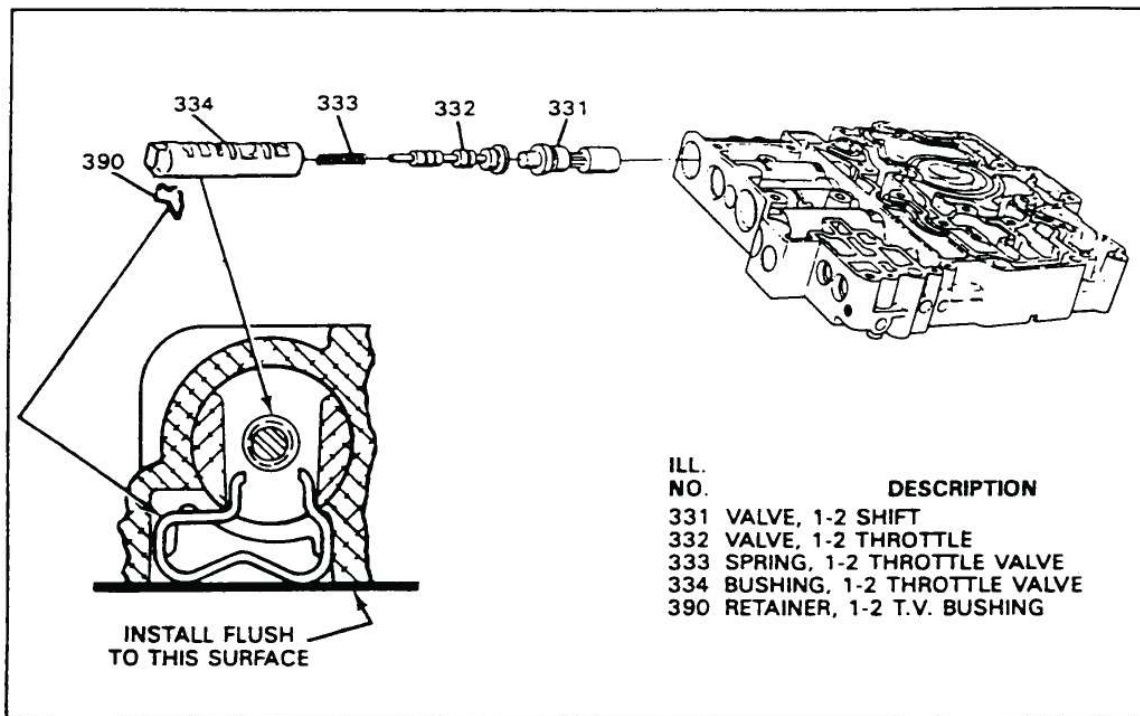
Figure 69

**CAUSE:** The cause may be the 1-2 throttle valve bushing retainer (390) pushed in too far (See Figure 69). If the retainer is pushed in too far the "Legs" of the retainer will grab hold of the 1-2 throttle valve, and the result will be 2nd gear starts.

**CORRECTION:** Install the retainer so that it is flush with the machined surface of the valve body (See Figure 69).

**NOTE:** The bushing must be installed as shown in Figure 69, with the angled surface on the end of the bushing toward the channel plate.

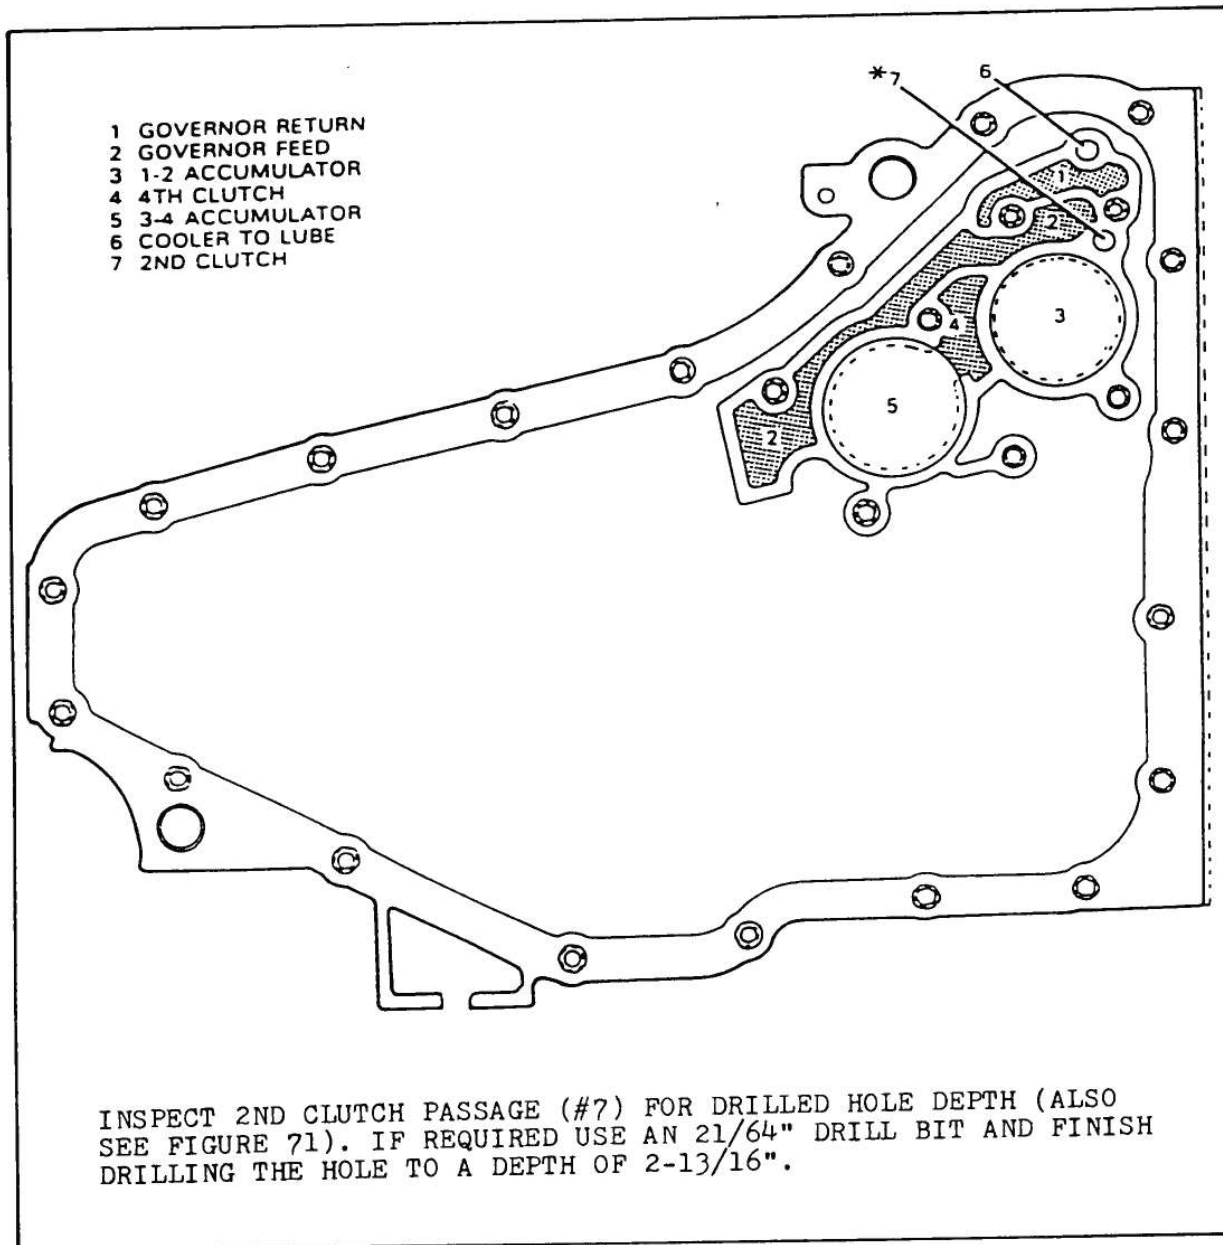
Figure 70

**COMPLAINT:** Consistently harsh 1-2 shift condition at any throttle angle and any altitude.

**CAUSE:** This harsh shift condition may be caused by a blocked, or partially drilled 2nd clutch feed passage in the case.

**CORRECTION:** To repair this condition inspect the 2nd feed passage, #7 in Figure 70, for blockage or incomplete drilling operation. To perform this inspection, remove the transaxle oil pan, filter, accumulator cover (With feed pipes and retainer), accumulator cover spacer plate and gaskets. Inspect the 2nd clutch passage by measuring the depth of the hole, which should be a minimum of 2-13/16" as shown in Figures 70 and 71.

**NOTE:** DRILLING TOO DEEP INTO THE 2ND CLUTCH PASSAGE WILL RESULT IN DAMAGE TO THE CASE.

3. Remove metal chips caused by drilling and thoroughly flush the repaired case passages with clean solvent.
4. Reassemble the transaxle.

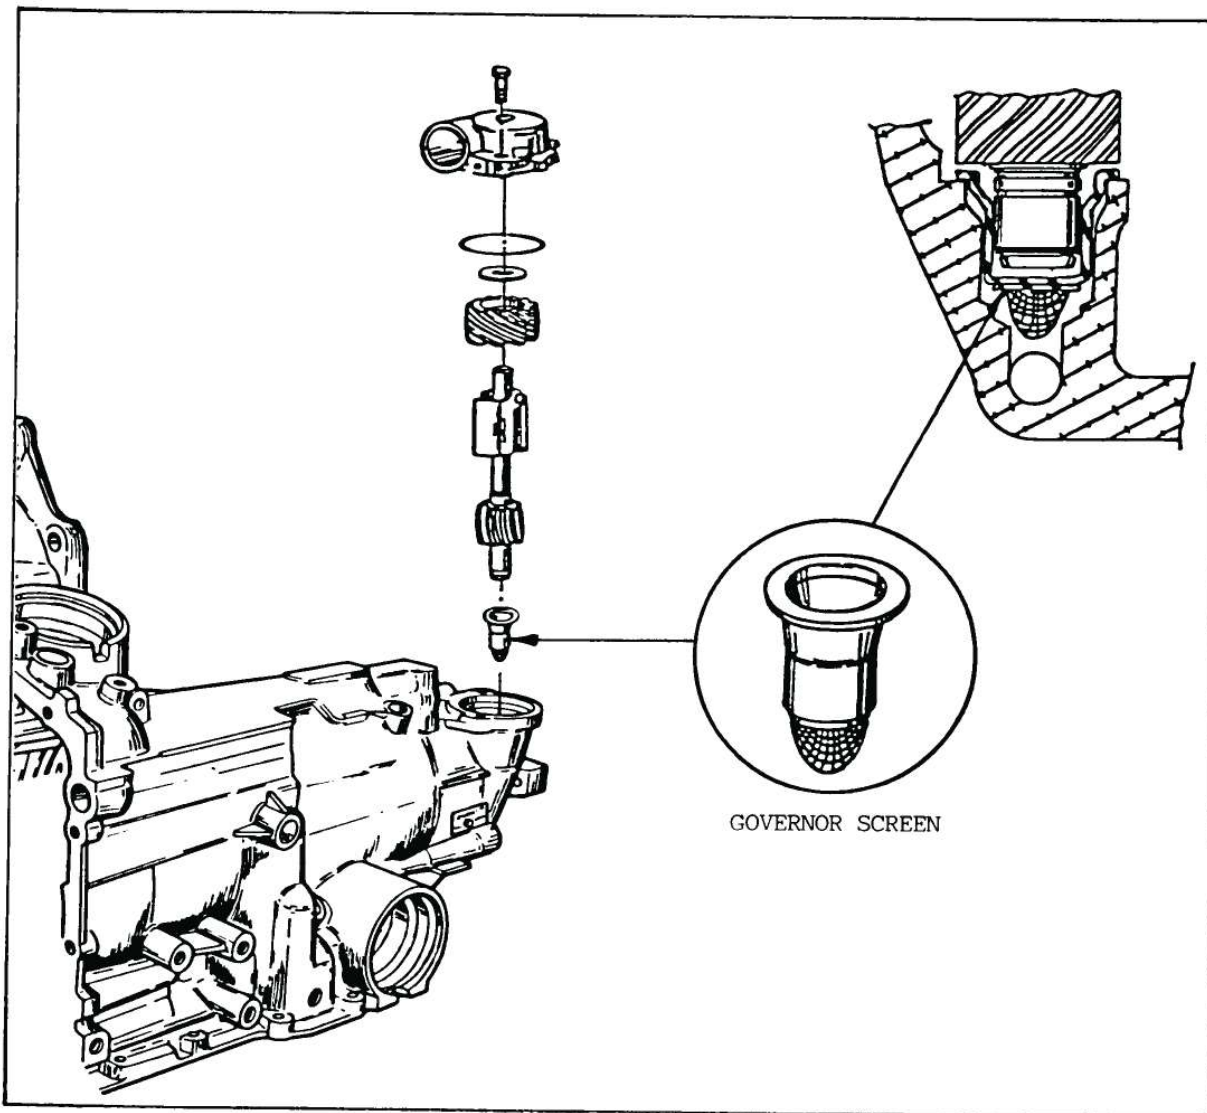
Figure 96

The governor screen was added in 1989 to the governor sleeve in the case, to minimize the possibility of sediment entering the governor assembly and preventing the governor balls from seating properly. (See Figure 96).

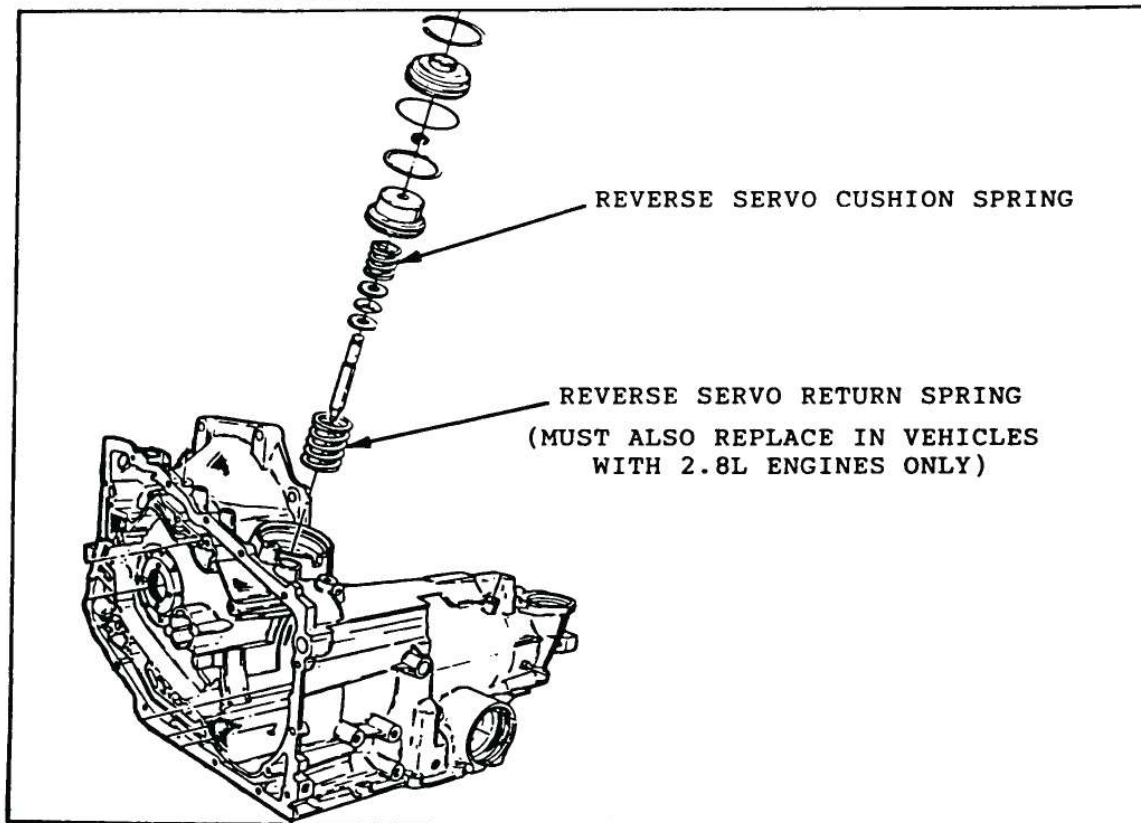
Figure 97

**CAUSE:** The cause may be:

1. Low vacuum supply to the vacuum modulator.
2. Stuck modulator valve in case.
3. No. 9 checkball missing or off location.

**CORRECTION:** AFTER ALL OF THE ABOVE ARE ELIMINATED:  
There is now available a new Reverse Servo Cushion Spring, and a new Reverse Servo Return Spring. Replacing these springs should correct the harsh reverse condition. The reverse servo return spring should only be replaced on the 2.8L engines.

Spring, Reverse Servo Cushion (All).....8668121  
Spring, Reverse Servo Return (2.8L Only)...8668127

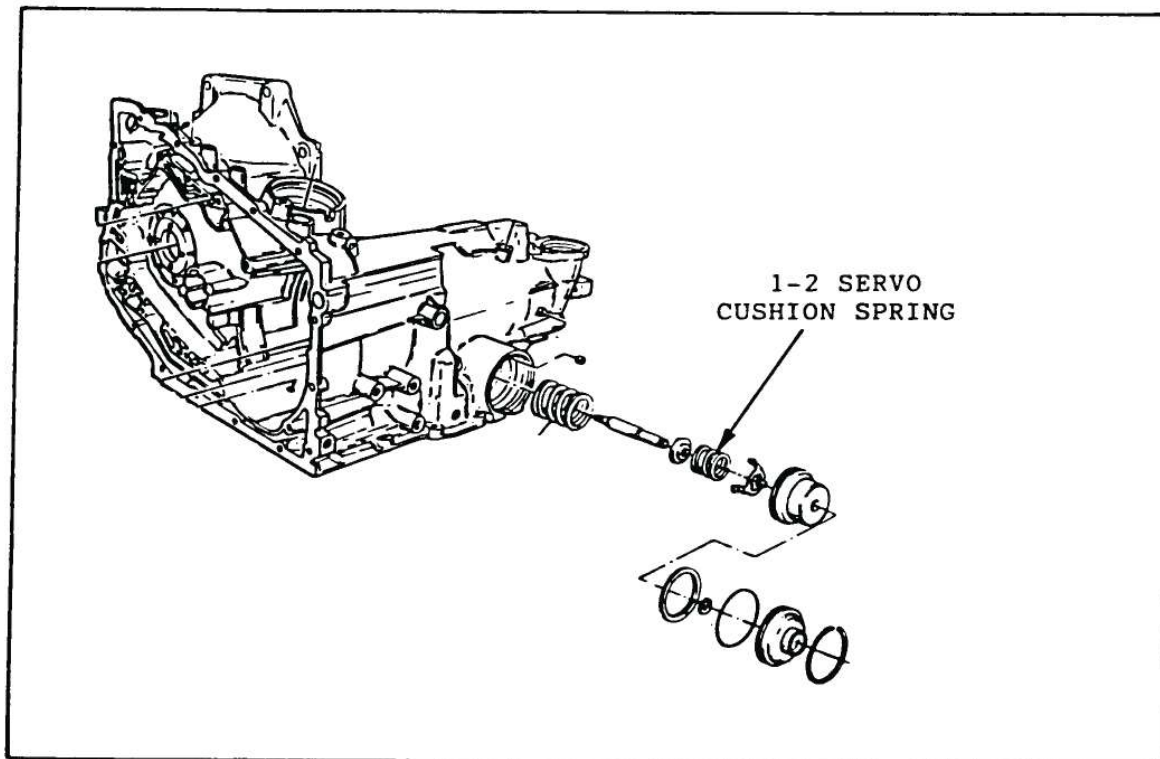
Figure 98

**CAUSE:** The cause may be:

1. Low vacuum supply to vacuum modulator.
2. Stuck modulator valve in case.
3. No. 12 checkball missing or off location.

**CORRECTION:** AFTER ALL OF THE ABOVE ARE ELIMINATED:  
There is now available a new 1-2 Servo Cushion Spring.  
Replacing this spring should correct the harsh drive condition (See Figure 1).

Spring, 1-2 Servo Cushion (All).....8668123
