## THM 4L60-E/4L65-E "UPDATE HANDBOOK"

***AUTOMATIC TRANSMISSION SERVICE GROUP***

*Updated  
January, 2003*

### **THM 4L60-E/4L65-E**

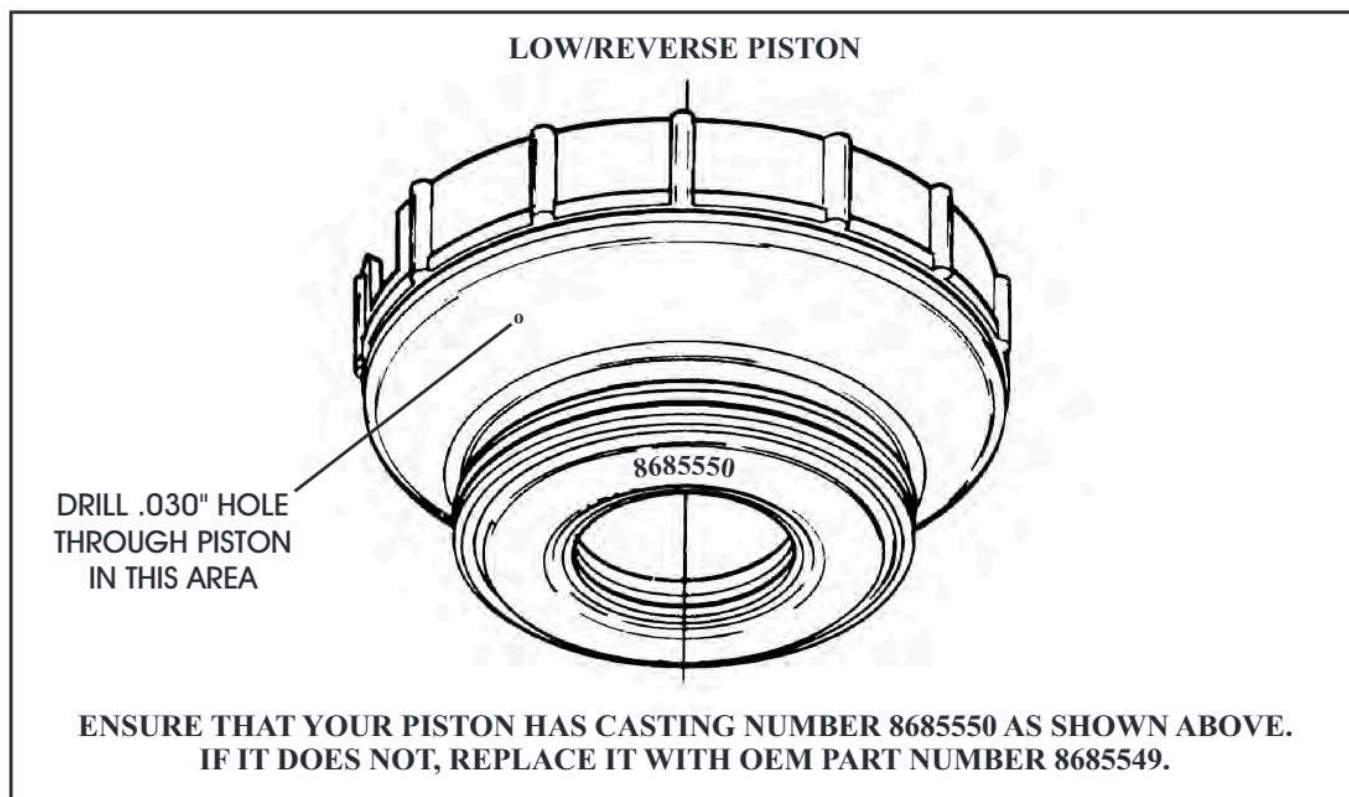
Figure 1

**COMPLAINT:** Premature and/or repeat failure of the Low/Reverse Clutch pack, on 1993-1995 models only, and may occur in as little as 5000 miles.

**CAUSE:** The cause may be, the Low/Reverse Clutch not totally exhausting the apply oil when the shift lever is moved from Park to the Drive position. On 1993-1995 models, the exhaust path for L/R apply oil is not large enough.

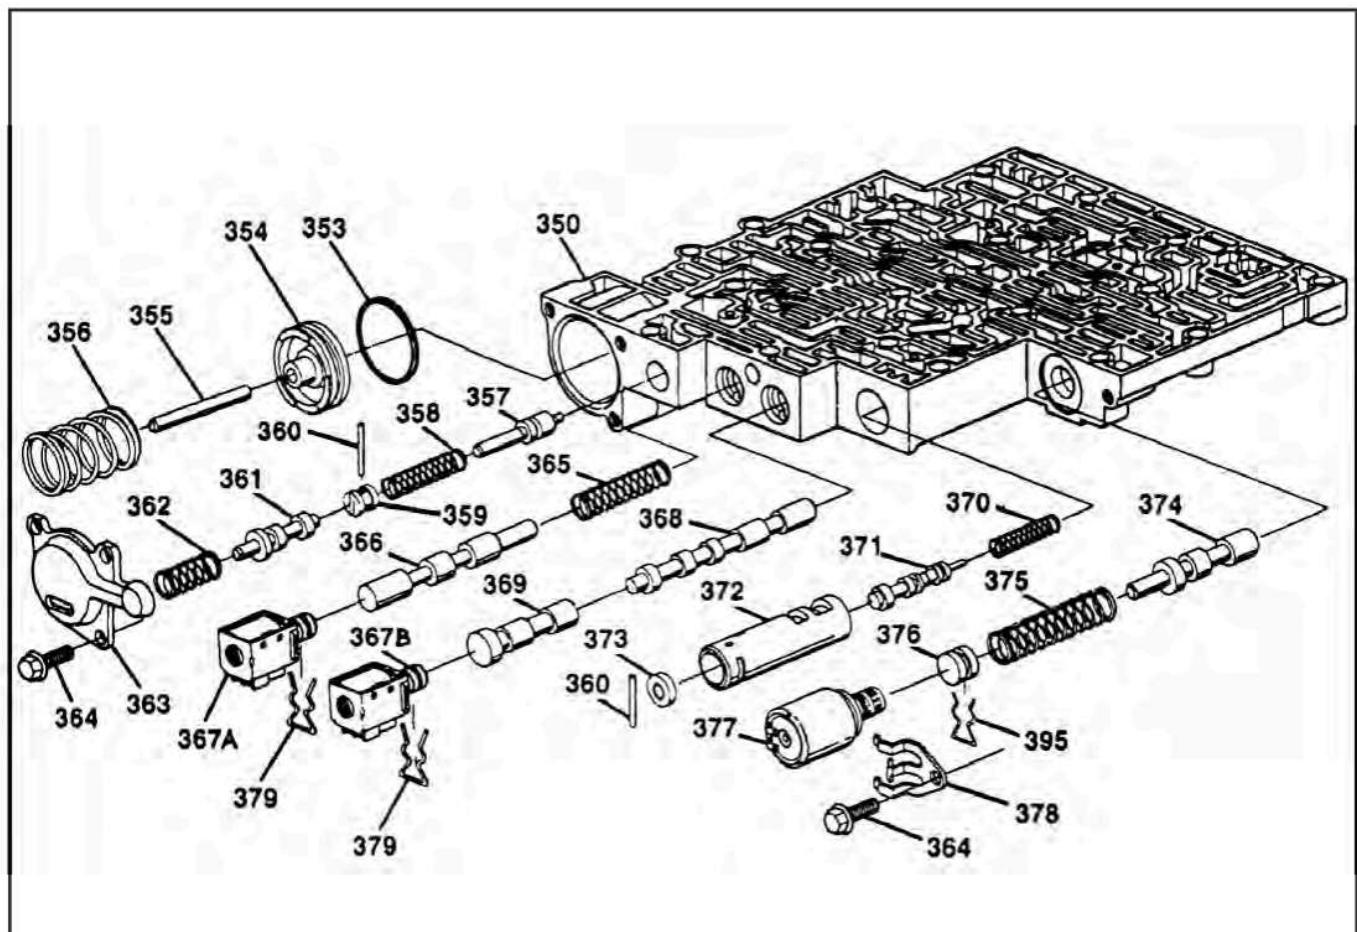
Figure 1

**COMPLAINT:** Some 1994 model vehicles, equipped with the THM 4L60-E transmission may exhibit a soft 1-2 upshift condition.

**CAUSE:** The cause may be, calibration of the 1-2 accumulator valve in the valve body.

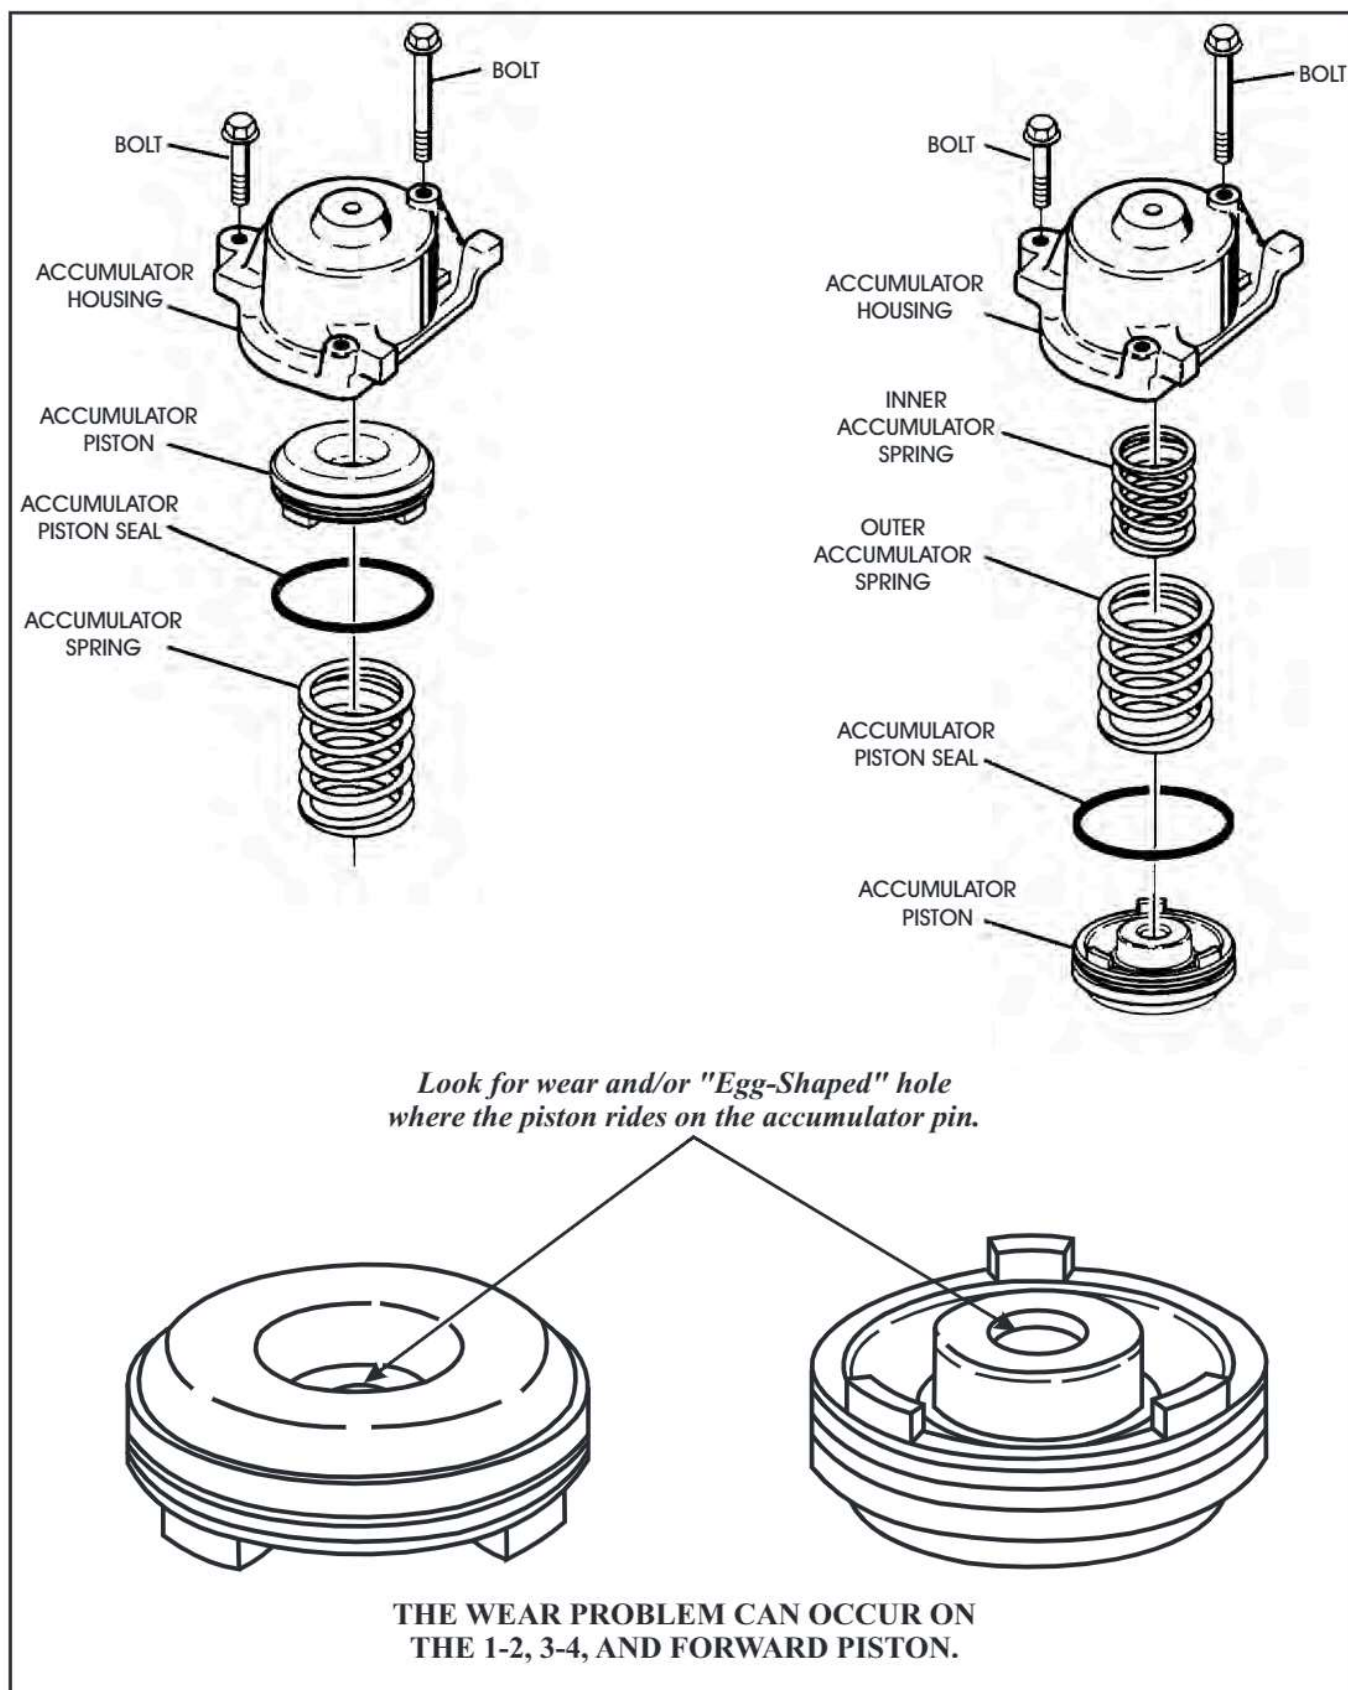
Figure 1

**COMPLAINT:** When the accumulator piston wears with an "Egg-Shaped" hole where the accumulator piston strokes, it can create a delayed engagement to drive, slipping condition in forward gears, slipping 1-2 shift, slipping 3-4 shift, depending on which accumulator piston is worn, and how bad it is worn.

**CAUSE:** The cause may be, a worn accumulator piston pin bore (See Figure 1).

The THM 4L60-E, 1-2 accumulator piston has a smaller pin diameter.

The THM 4L60-E, forward accumulator piston is a smaller outside diameter.

**CORRECTION:** Replace the accumulator piston with the proper part number from "Service Information" as shown below.

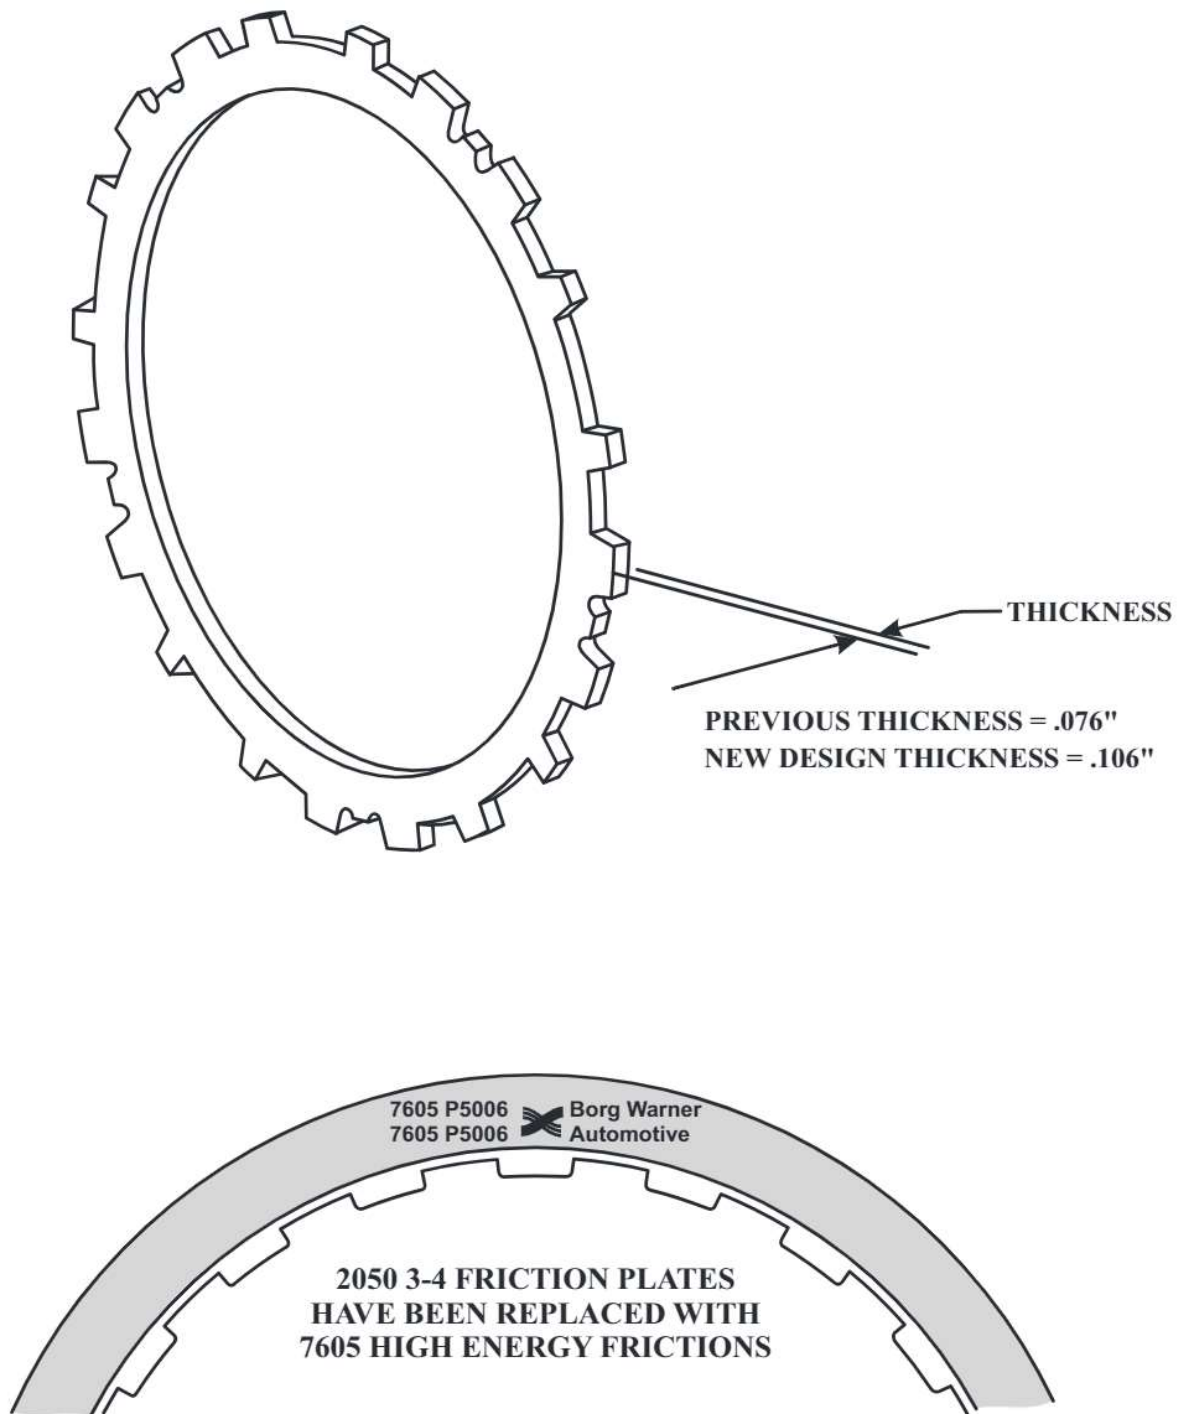
Figure 1

**COMPLAINT:** After rebuild, the vehicle exhibits premature 3-4 clutch failure, sometimes in as little as 2000 miles of use. Usually associated with Police, Taxi, or heavy duty use.

**CAUSE:** The cause may be, not using the high energy clutch plates, and the thick (.106") steel plates, or not enough line pressure rise with throttle opening.

**RE-USE THE 3-4 LOAD RELEASE SPRINGS  
IN THE NEW DESIGN CLUTCH PACK ONLY**

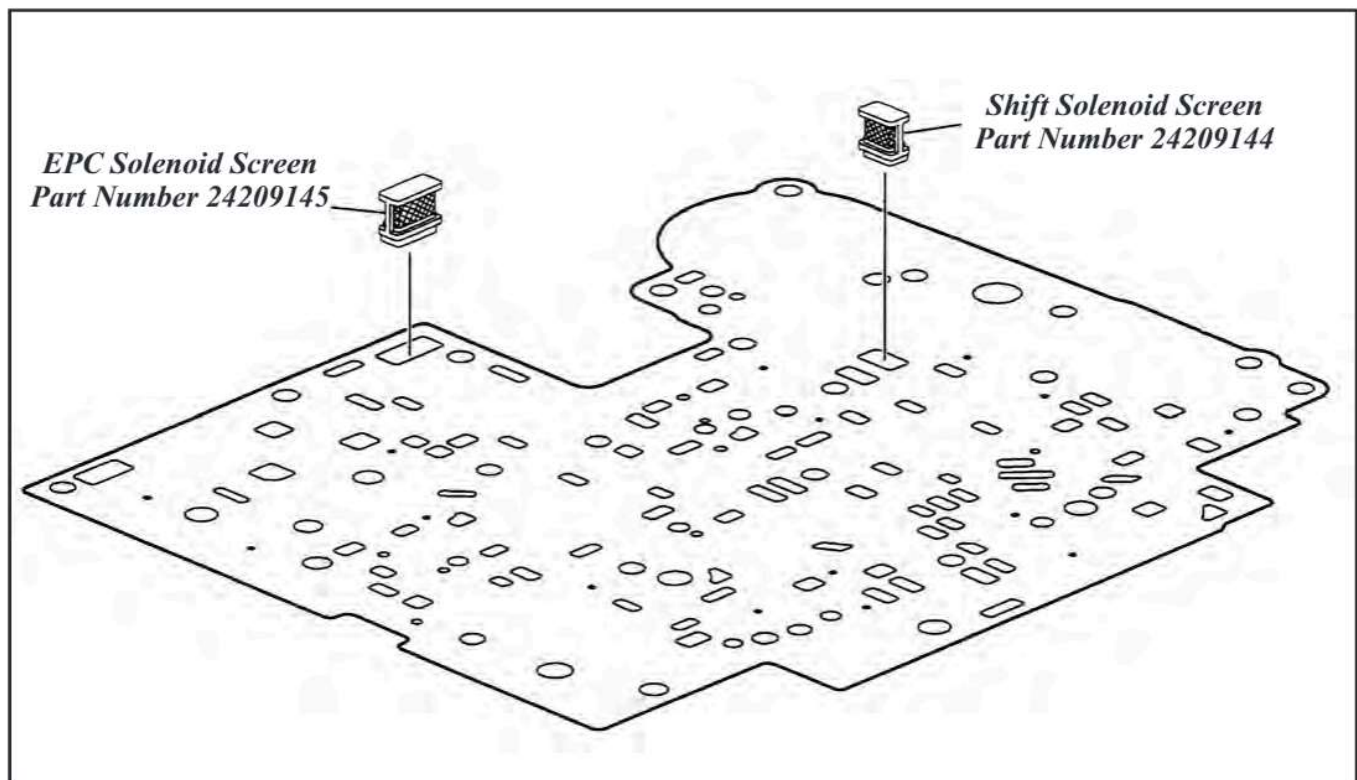
Figure 1

**CAUSE:** The cause may be, one or both of the screens in the spacer plate collapsed shut, and restricting solenoid feed oil or actuator feed oil to the Pressure Control Solenoid.

**CORRECTION:** Replace both screens in the spacer plate as shown in Figure 1, with the part numbers listed below. These **new part numbers** are screens with a larger micron screen that will pass more oil easier.

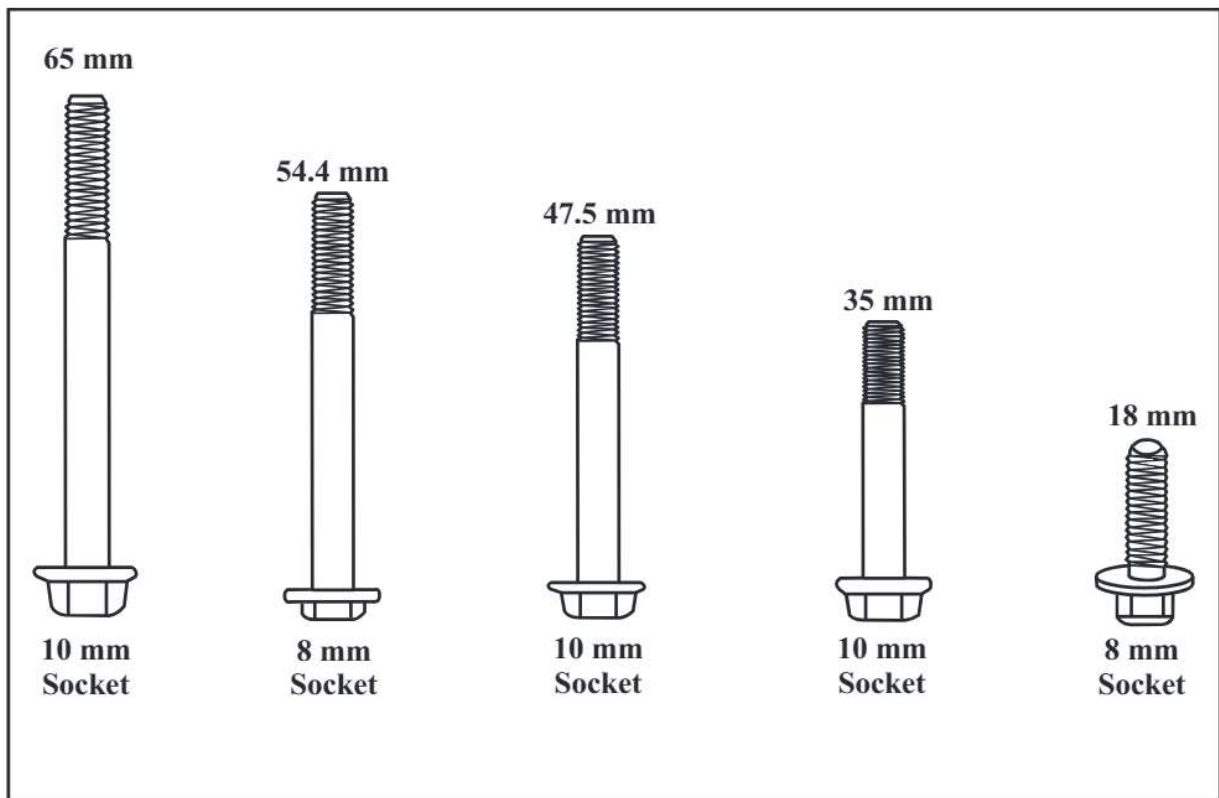
Figure 1

**CAUSE:** There are different length valve body bolts which can be easily mis-positioned (See Figure 1). A **common** error is placing a 54.4 millimeter length bolt into a location designed for a 47.5 millimeter length bolt (See Figure 2). The mis-located bolt will extend into the barrel of the case and into the sun shell. The bolt now being screwed into the sun shell inhibits the rotation of the shell causing the above complaint.

**CORRECTION:** Relocate the necessary valve body bolts to their proper location. Use figure 3 to locate the proper positions for the 47.5 and 54.4 millimeter bolt lengths. In severe cases, it may be necessary to remove the transmission in order to replace the damaged sun shell.

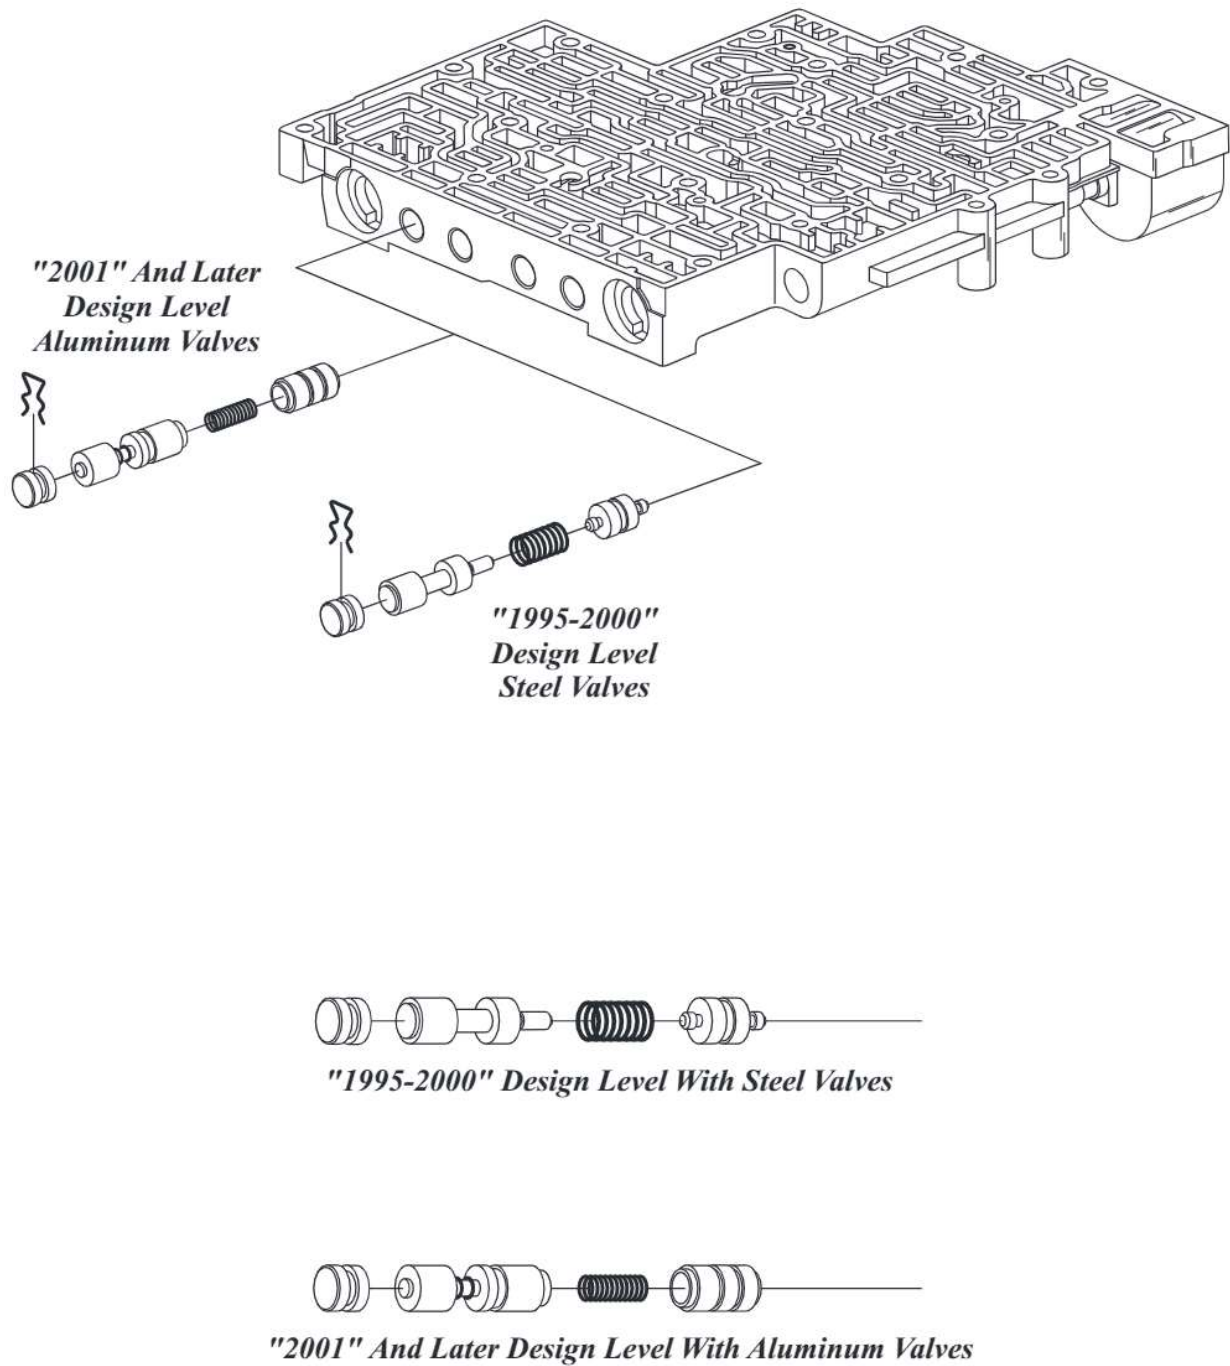
**CAUSE:** The cause is usually Torque Converter Clutch slippage, created by a badly worn valve body casting in the Converter Clutch Regulator Valve bore.

**CORRECTION:** Sonnax manufactures two different kits to repair the current valve body castings, both of which require a reamer, also available from Sonnax. One of the kits, Sonnax part number 77754-03K, fits 1993 thru 1997 model transmissions, but they require different assembly processes. Refer to Figure 1 for the 1994-1994 models and Figure 2 for the 1995-1997 models, for the proper assembly. The other kit, Sonnax part number 77754-04K, fits only the 1998 and later ECCC models, as it is a different calibration. Refer to Figure 3 for proper assembly of the 1998 and later models. The reamer required is the same for either kit and is available under Sonnax part number 77754-R2.
