## CHRYSLER A604 (41TE) UPDATE HANDBOOK

# **INTRODUCTION**

## **CHRYSLER A604 (41TE)**

### **"UPDATE HANDBOOK"**

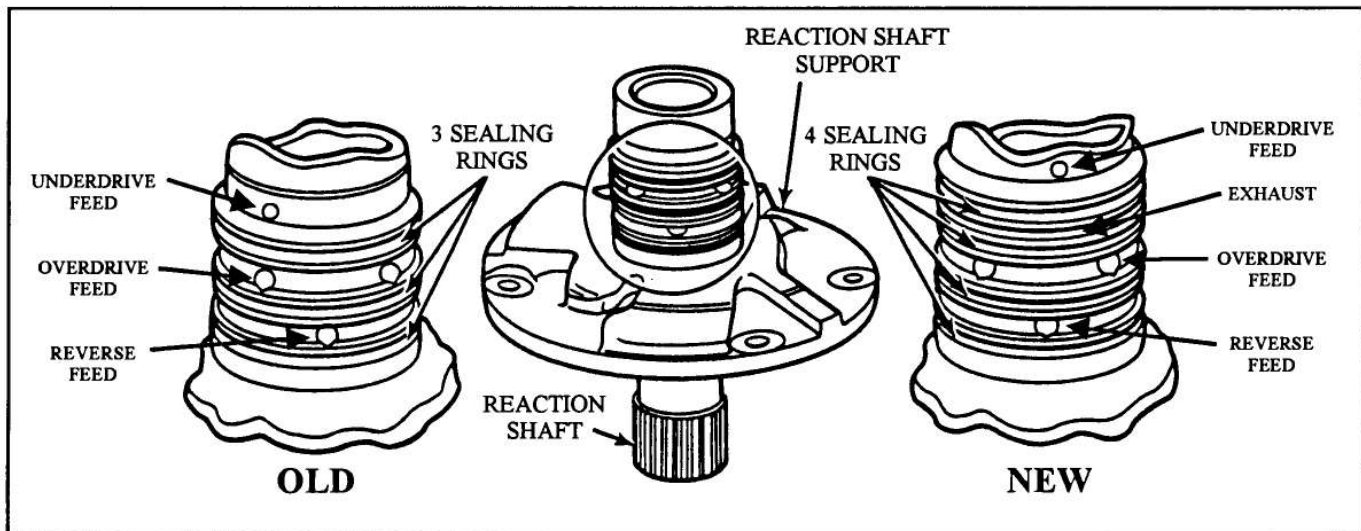
Figure 1

**CHANGE:** Beginning in April, 1989 a new Reaction Shaft Support (Stator) was introduced, with the addition of another ring groove and sealing ring. The old support has 3 sealing rings, and the new support has 4 sealing rings (See Figure 1).

- (1) **REACTION SHAFT SUPPORT** - The new support is longer, and has 4 sealing rings, where the old support only has three (See Figure 1).
- (2) **INPUT SHAFT/CLUTCH HUB** - The new Input Clutch Hub bore is machined deeper to accommodate the additional length of the reaction shaft, created by the added sealing ring (See Figure 2). The "O" Ring grooves are also cut shallower than the old input clutch hub, which increases the groove diameter, and provides improved compression or "Crush", between the "O" rings and the input clutch retainer. (See Figure 3).

ALWAYS UPDATE to the four ring reaction shaft support. There is now available a repair package, OEM part number 4549248, that includes the following:

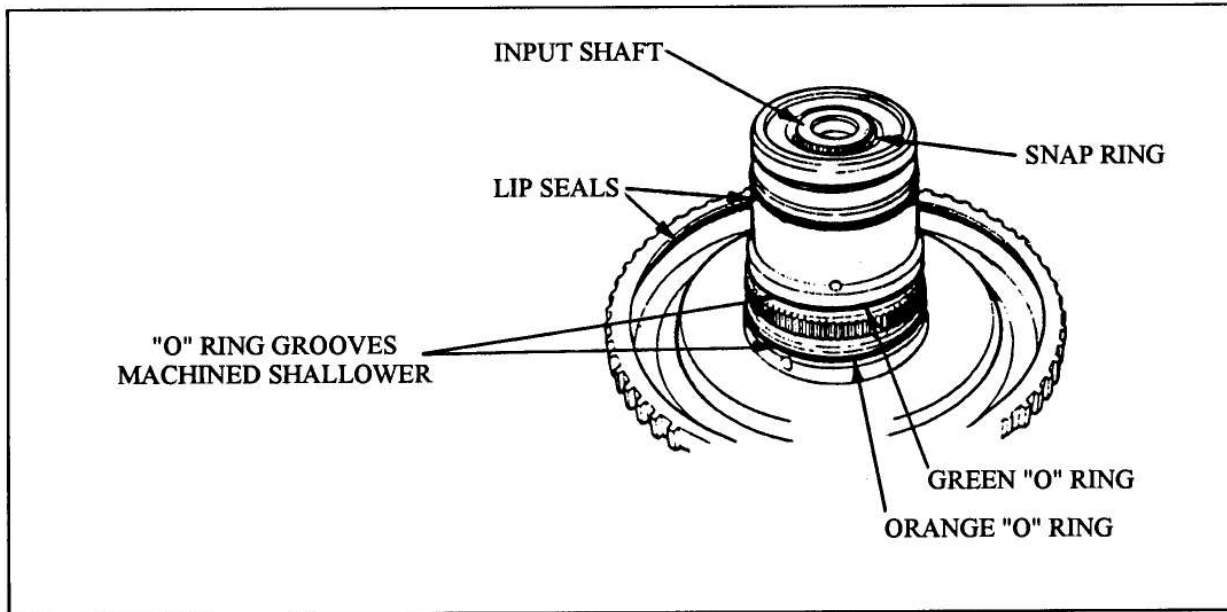
Figure 3

- (3) **INPUT SHAFT/CLUTCH HUB "O" RINGS** - The new "O" Rings are "Teflon Coated" for greater tear resistance during the assembly process. The coatings also identify the locations for the "O" Rings. The orange ring goes to the front, and the green one goes to the rear (See Figure 3). The early "O" rings were black.

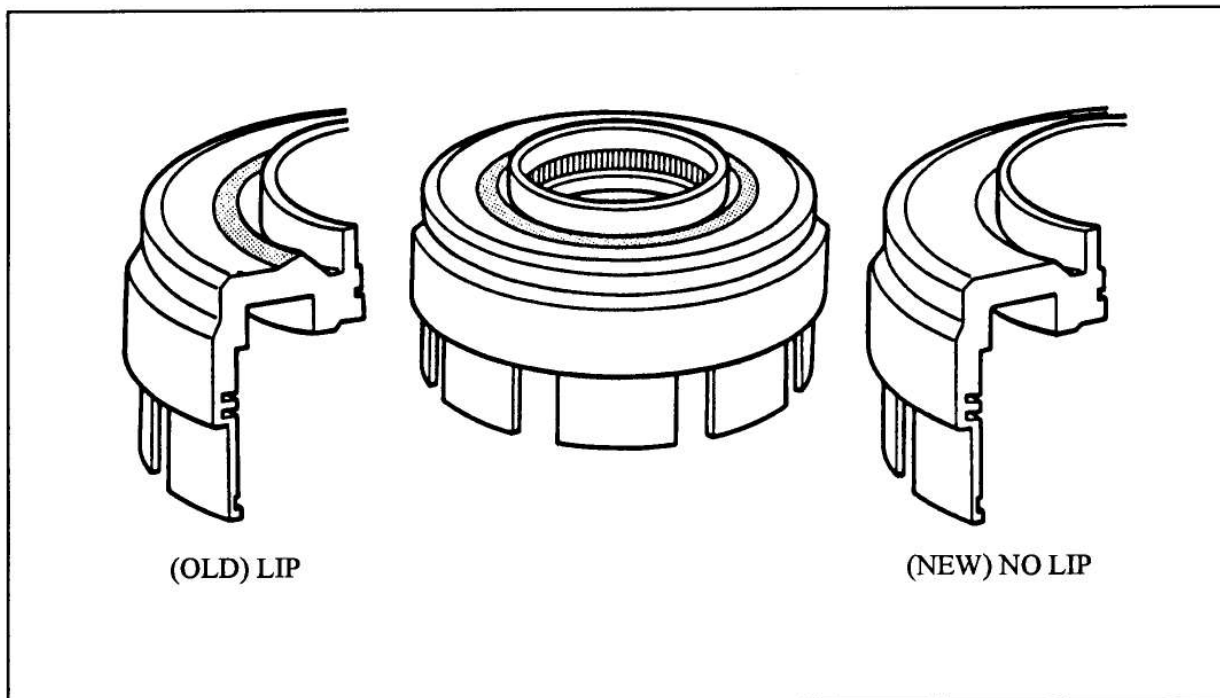
Figure 4

- (4) **INPUT CLUTCH RETAINER** - The Input Clutch Retainer was modified, by machining off the "Lip" (See Figure 4), to allow more travel of the overdrive/reverse piston. The old Input Clutch Retainer can be machined at the local machine shop if necessary.

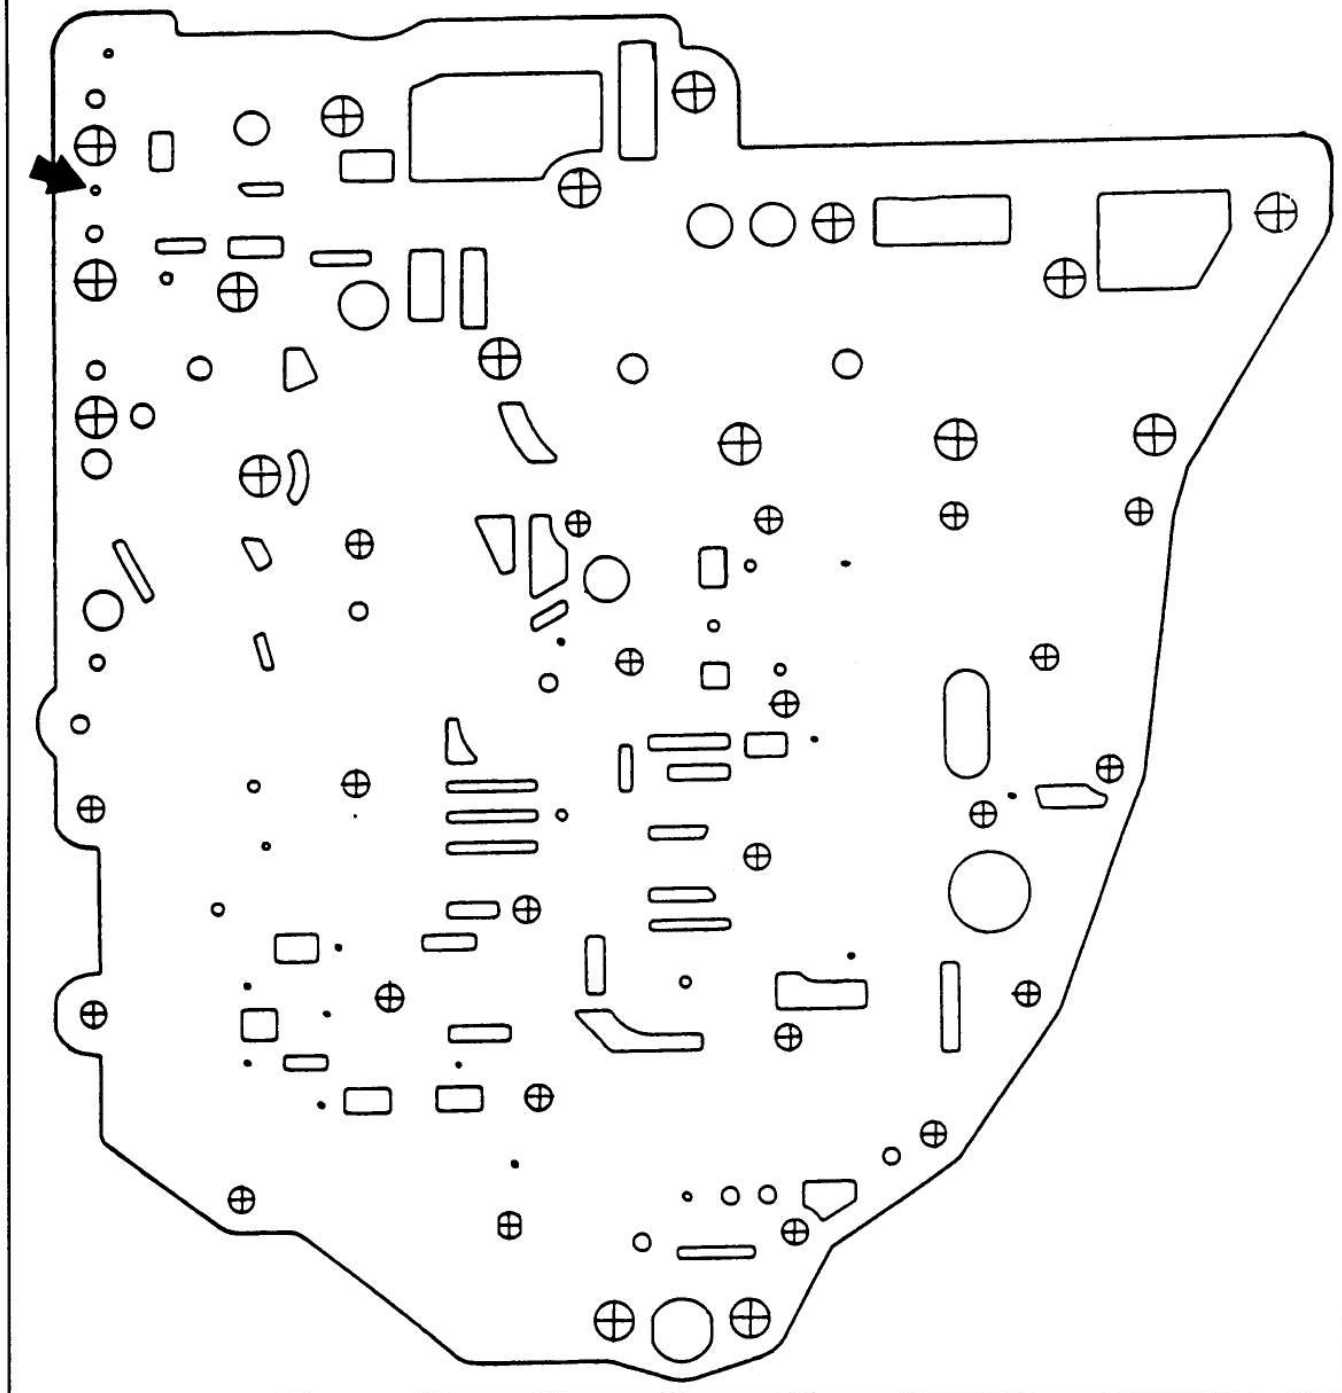
Figure 5

**A604 SPACER PLATE**

THE HOLE INDICATED BY THE ARROW BELOW HAS BEEN ENLARGED TO .105" FOR INCREASED OIL FLOW TO THE OVERDRIVE CLUTCH CIRCUIT.

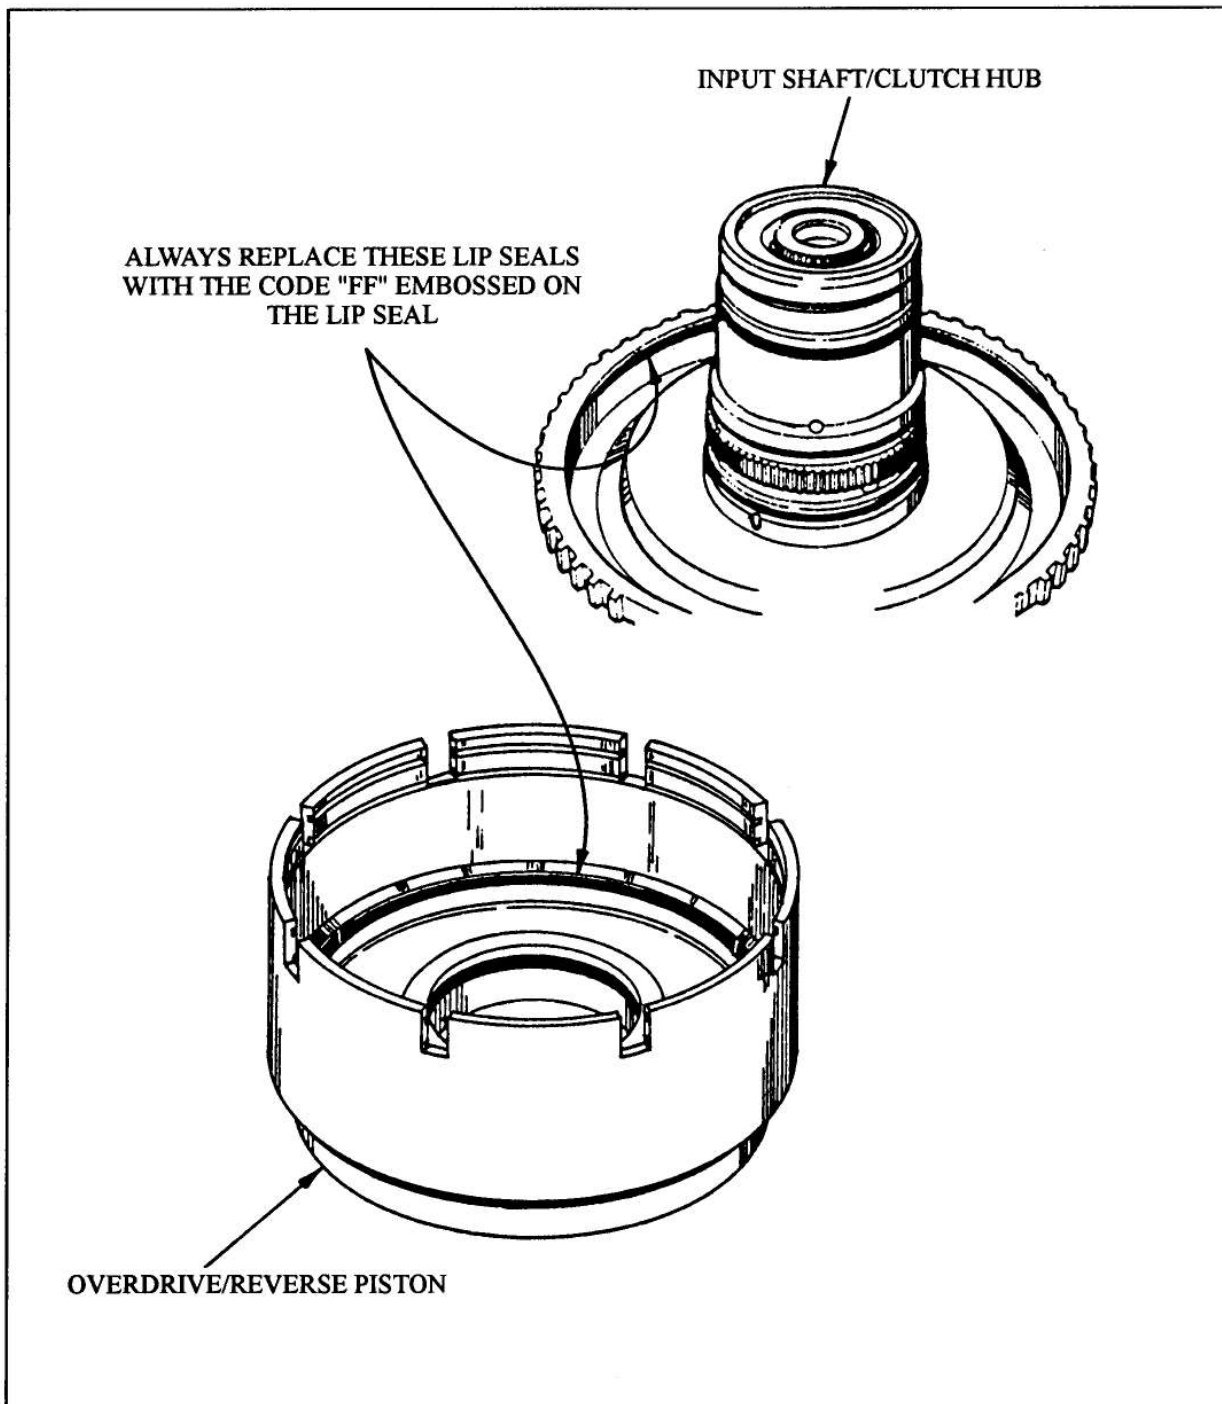
Figure 6

**CHANGE:** The lip seals in the Overdrive/Reverse Clutch Piston and the Input Shaft/Clutch Hub are now replaced with lip seals made of different material (See Figure 6).

**THE NEW LIP SEALS EMBOSSED WITH THE CODE "FF" WILL RETROFIT BACK TO ALL PREVIOUS MODELS, AND SHOULD BE USED DURING OVERHAUL.**

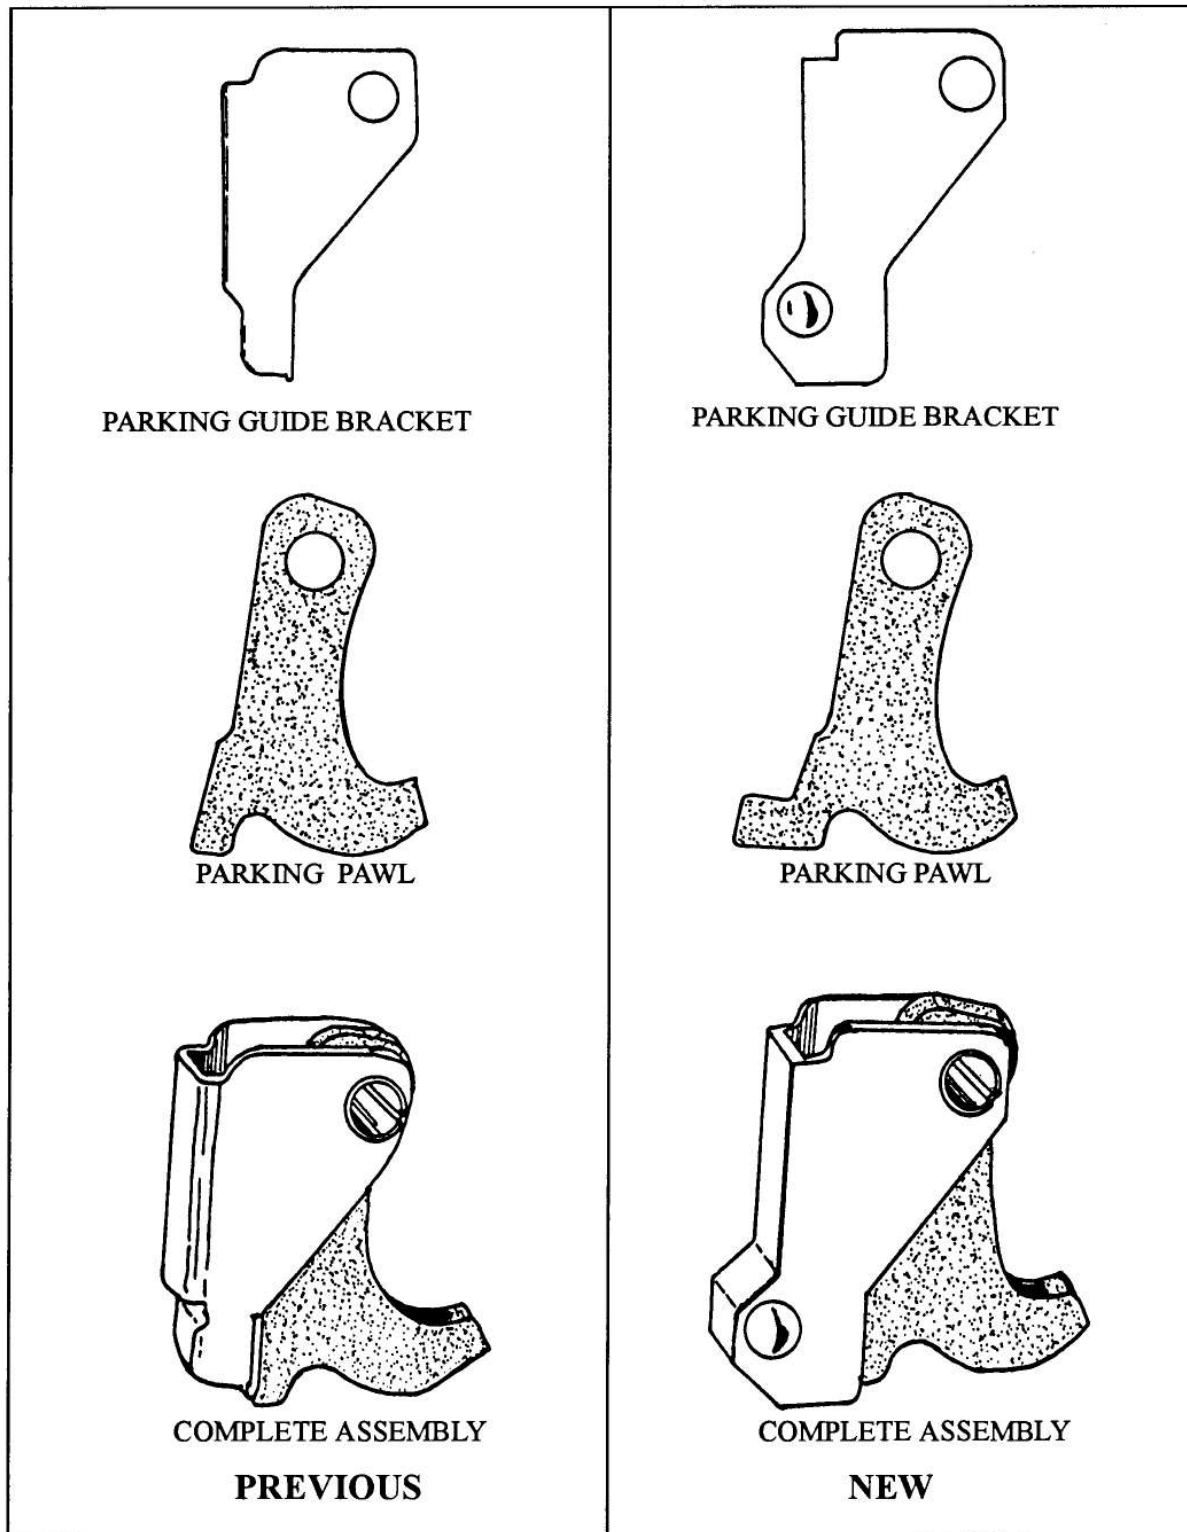
- (1) **PARKING GUIDE BRACKET** - Previously the Parking Guide Bracket was a stamped steel unit, and has been replaced by a high quality casting, along with dimensional changes. See Figure 7 for identification.
- (2) **PARKING PAWL** - The new Parking Pawl, or "Boot", also required some dimensional changes. The heel of the new "Boot" is wider than the previous models, as shown in Figure 7.

The new parts will retrofit back to all previous models, but both pieces must be replaced as an assembly. (See Figure 7).

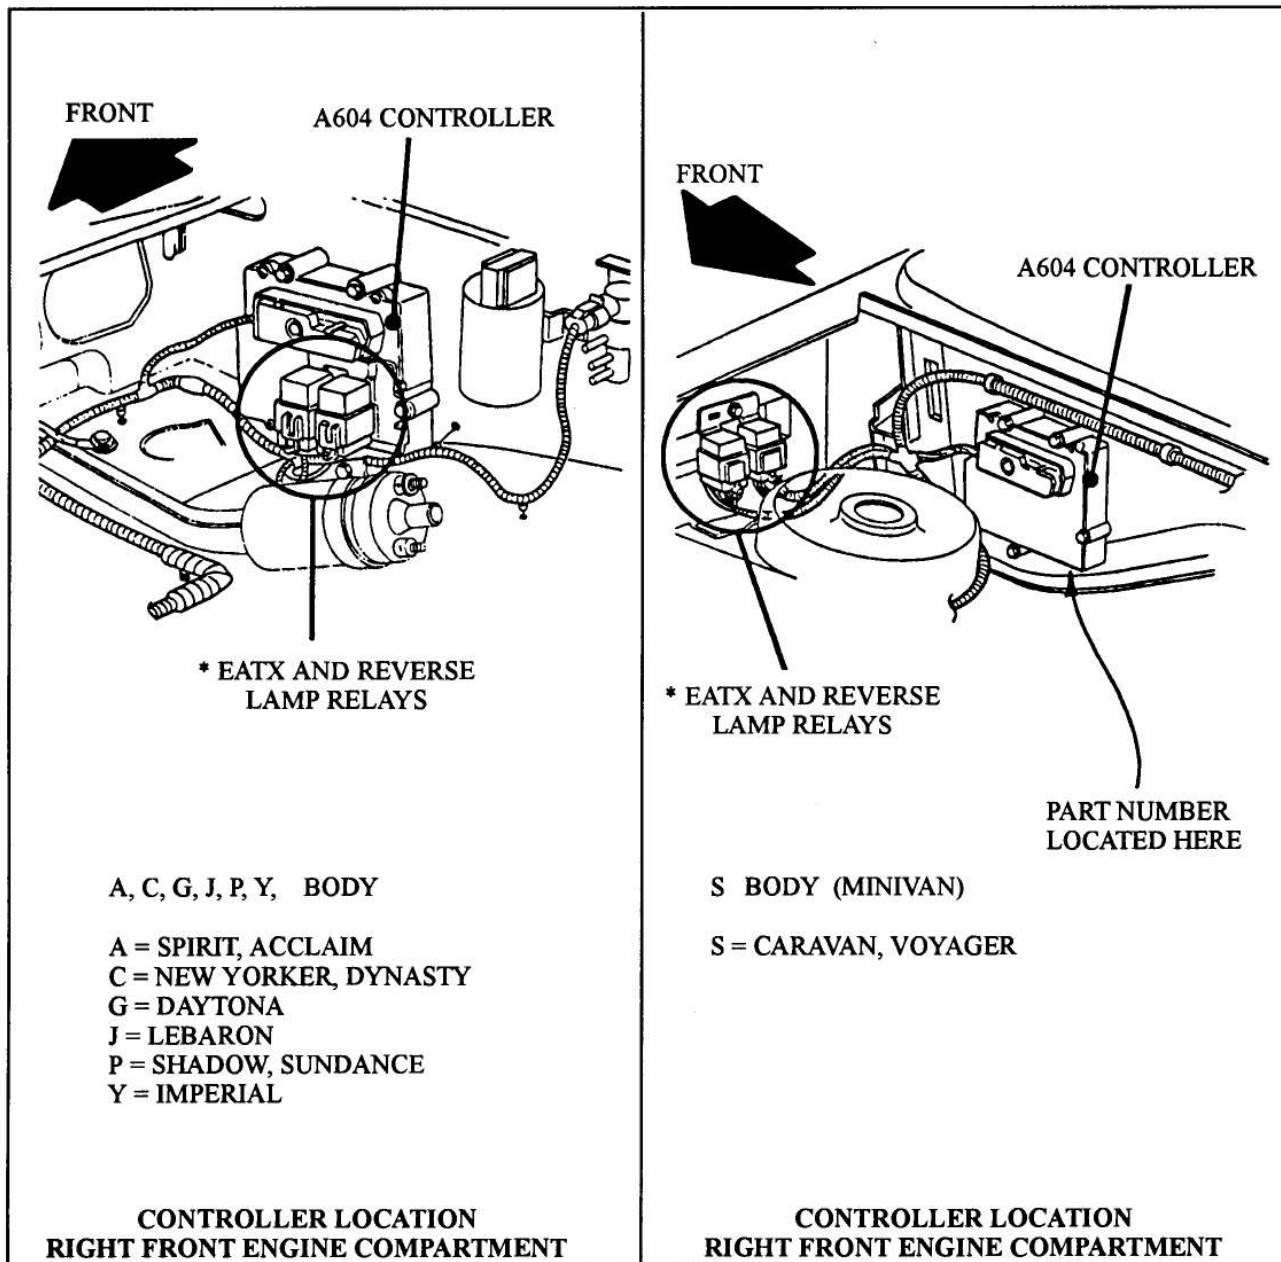
Figure 8

- (1) **TRANSAXLE CONTROLLER** - Controllers can be identified by the OEM part number that is printed on a sticker. This sticker can be located on the bottom of the transaxle controller as shown in figure 8. If the sticker is missing, scanners will also provide controller identification by providing the OEM part number of the controller that is in the vehicle. Refer to the chart on the following page for a brief overview of past controllers.  
The locations of the controllers will vary depending on the model of the vehicle. Refer to figure 8 for the different locations. Figures 8 and 9 also shows the locations of the EATX relay, as their location will vary depending on the model of the vehicle.

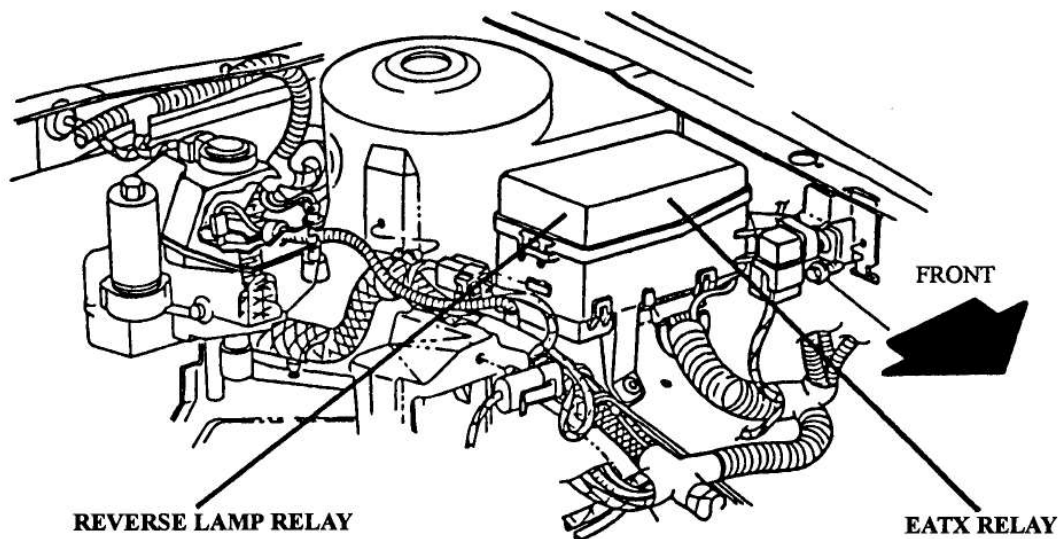
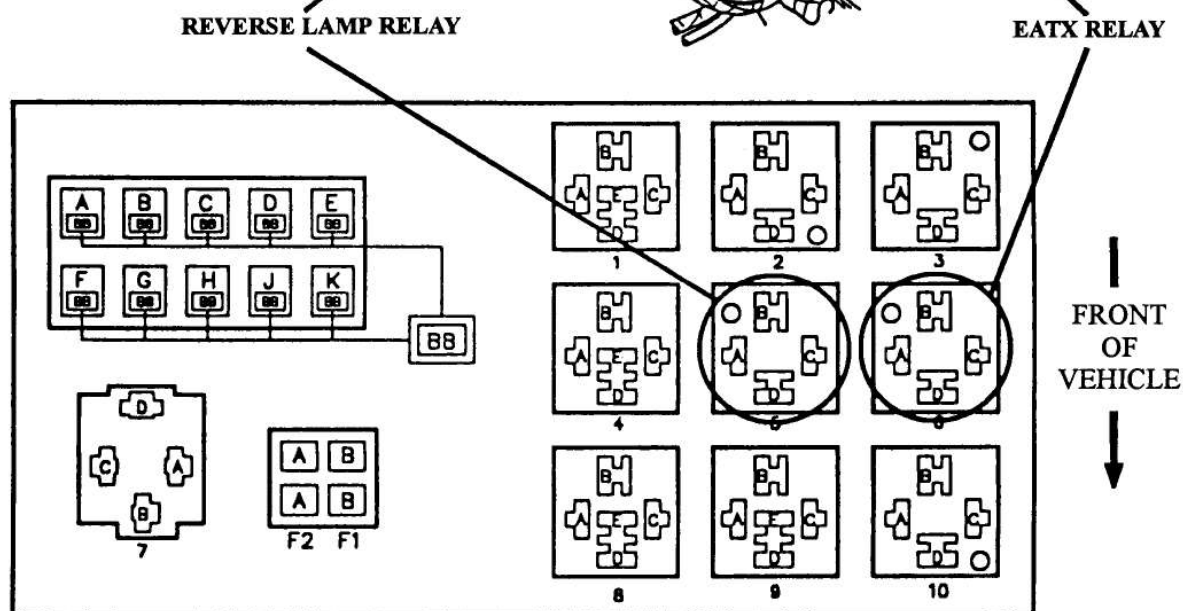
Figure 9

**\* NOTE:** Since the EATX and the reverse Lamp Relay connectors could be installed in either position, you must use the wire colors in the connectors to identify the correct relay.

- (1) The EATX relay has a Red and a Light Green wire in its connector.
- (2) The Reverse Lamp Relay has a White and a Violet wire in its connector.

## EATX/REVERSE LAMP RELAY NEW YORKER, DYNASTY, IMPERIAL

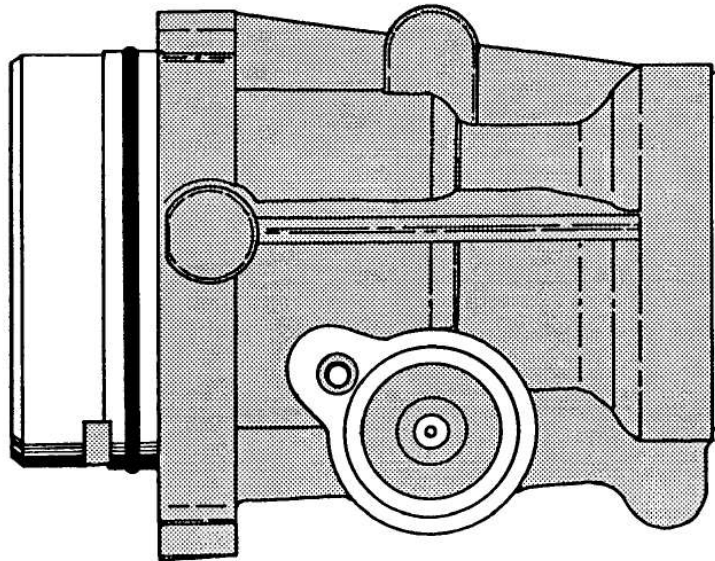
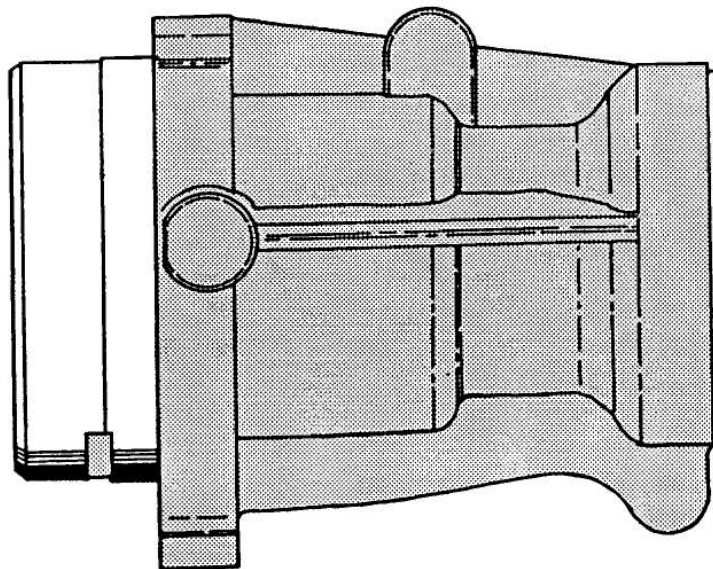
Figure 10

**1989 TO 1992 A604 EXTENSION HOUSING  
WITH SPEEDOMETER BORE**

**1993 AND UP A604 EXTENSION HOUSING  
WITHOUT SPEEDOMETER BORE**

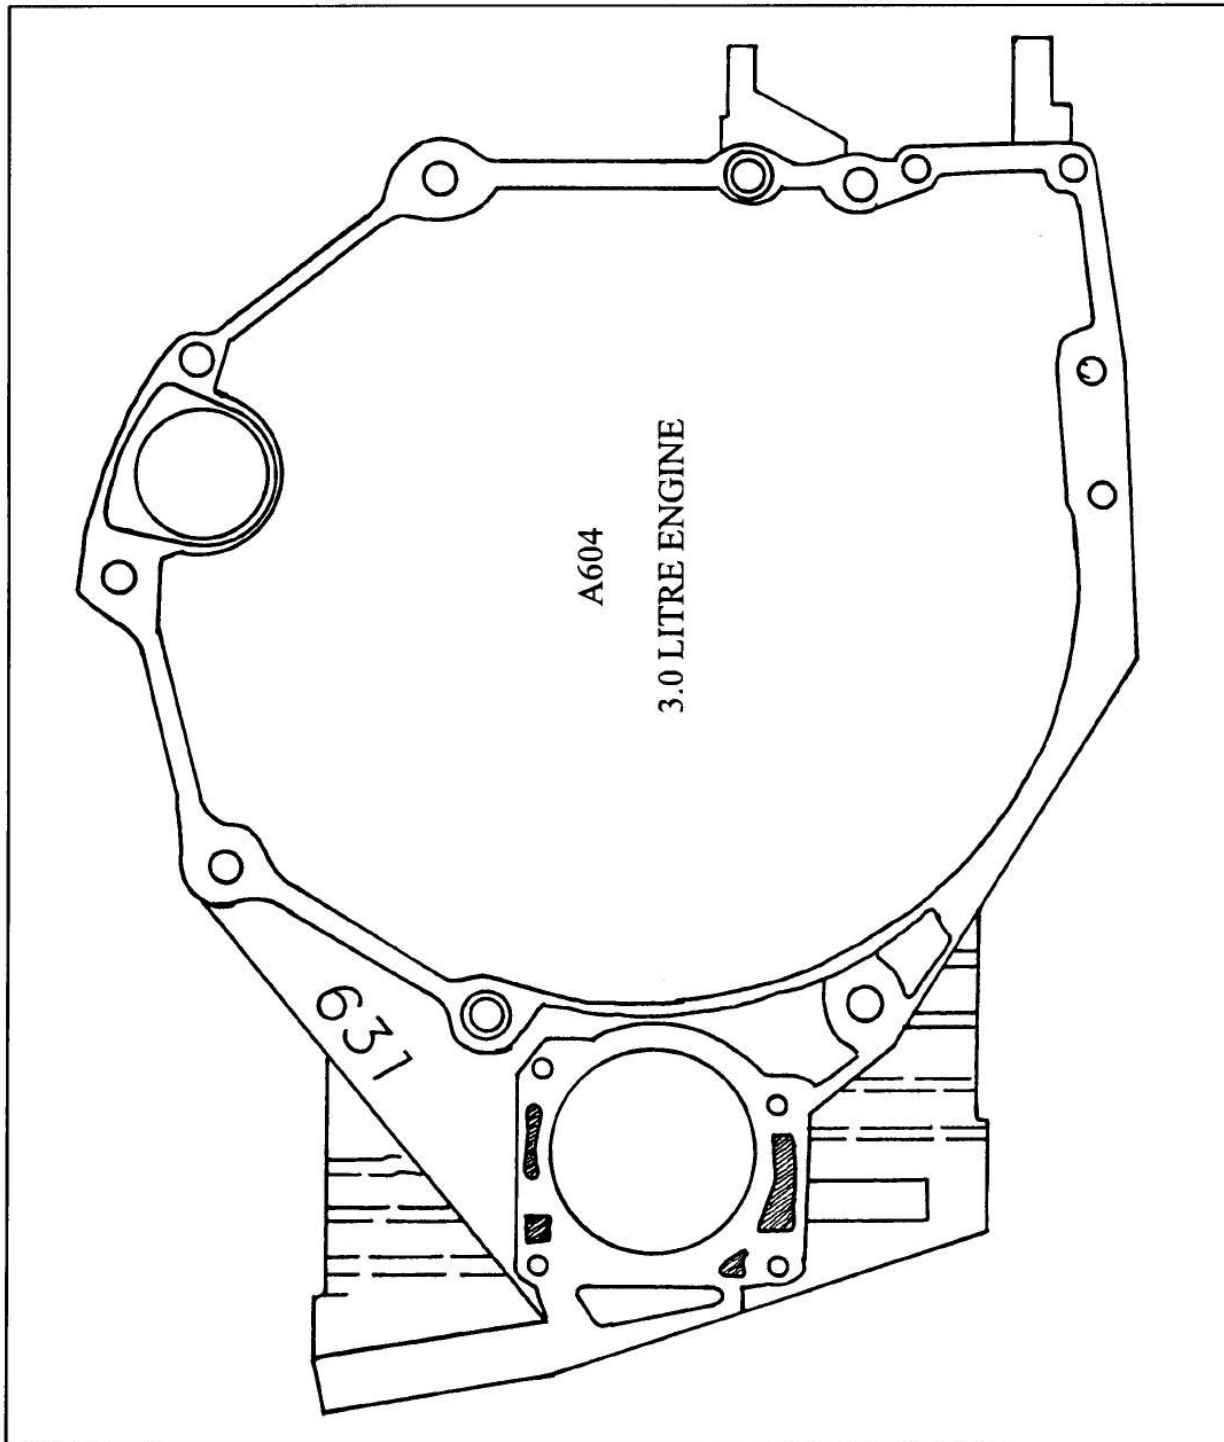
Figure 12

For the 3.0 Litre Bell Housing pattern, refer to Figure 12.

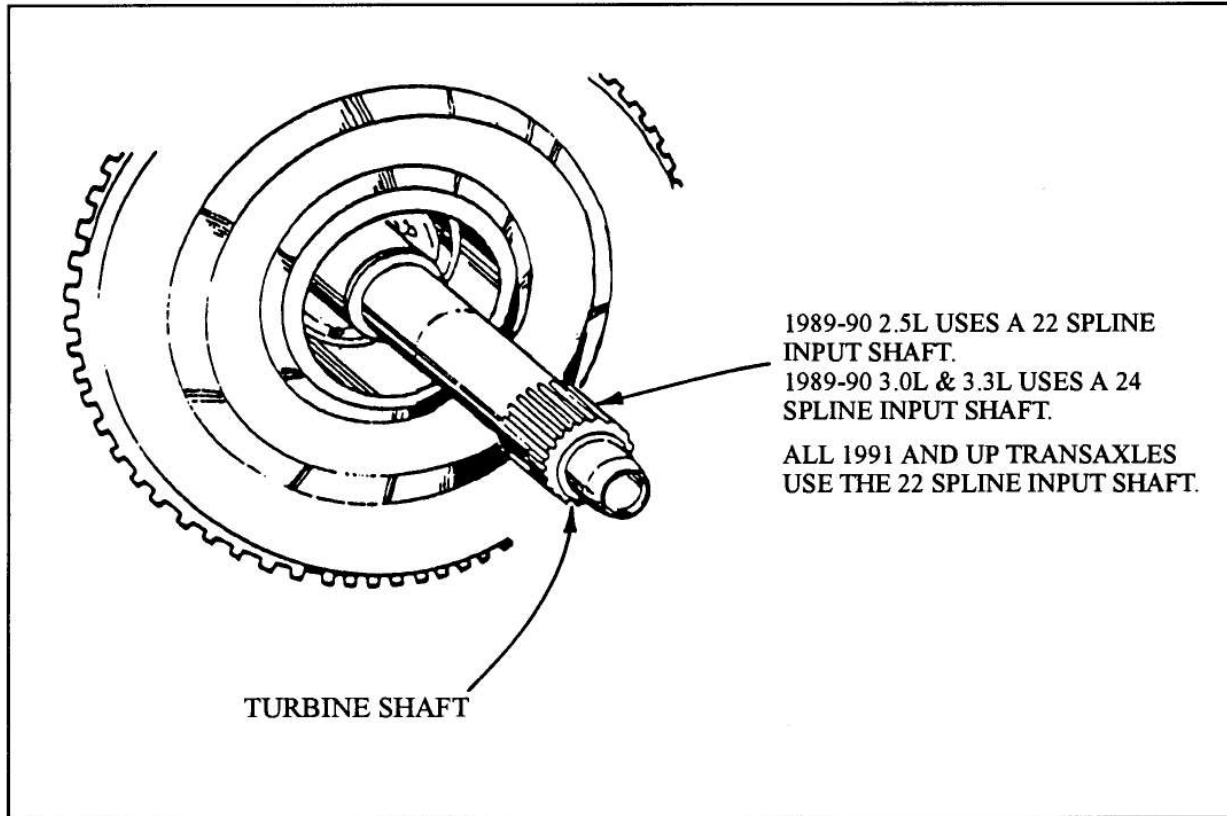
Figure 14

- (2) **TURBINE SHAFT SPLINES** - 1989-1990 2.5 Litre engine uses a turbine shaft with 22 splines for the torque converter, and the 1989-1990 3.0 and 3.3 Litre engines will use the a 24 spline turbine shaft (See Figure 14).

**NOTE:** All 1991 and up A604 transaxles will use a 22 spline input shaft to fit a new torque converter with a torsional vibration damper (See Figure 14).

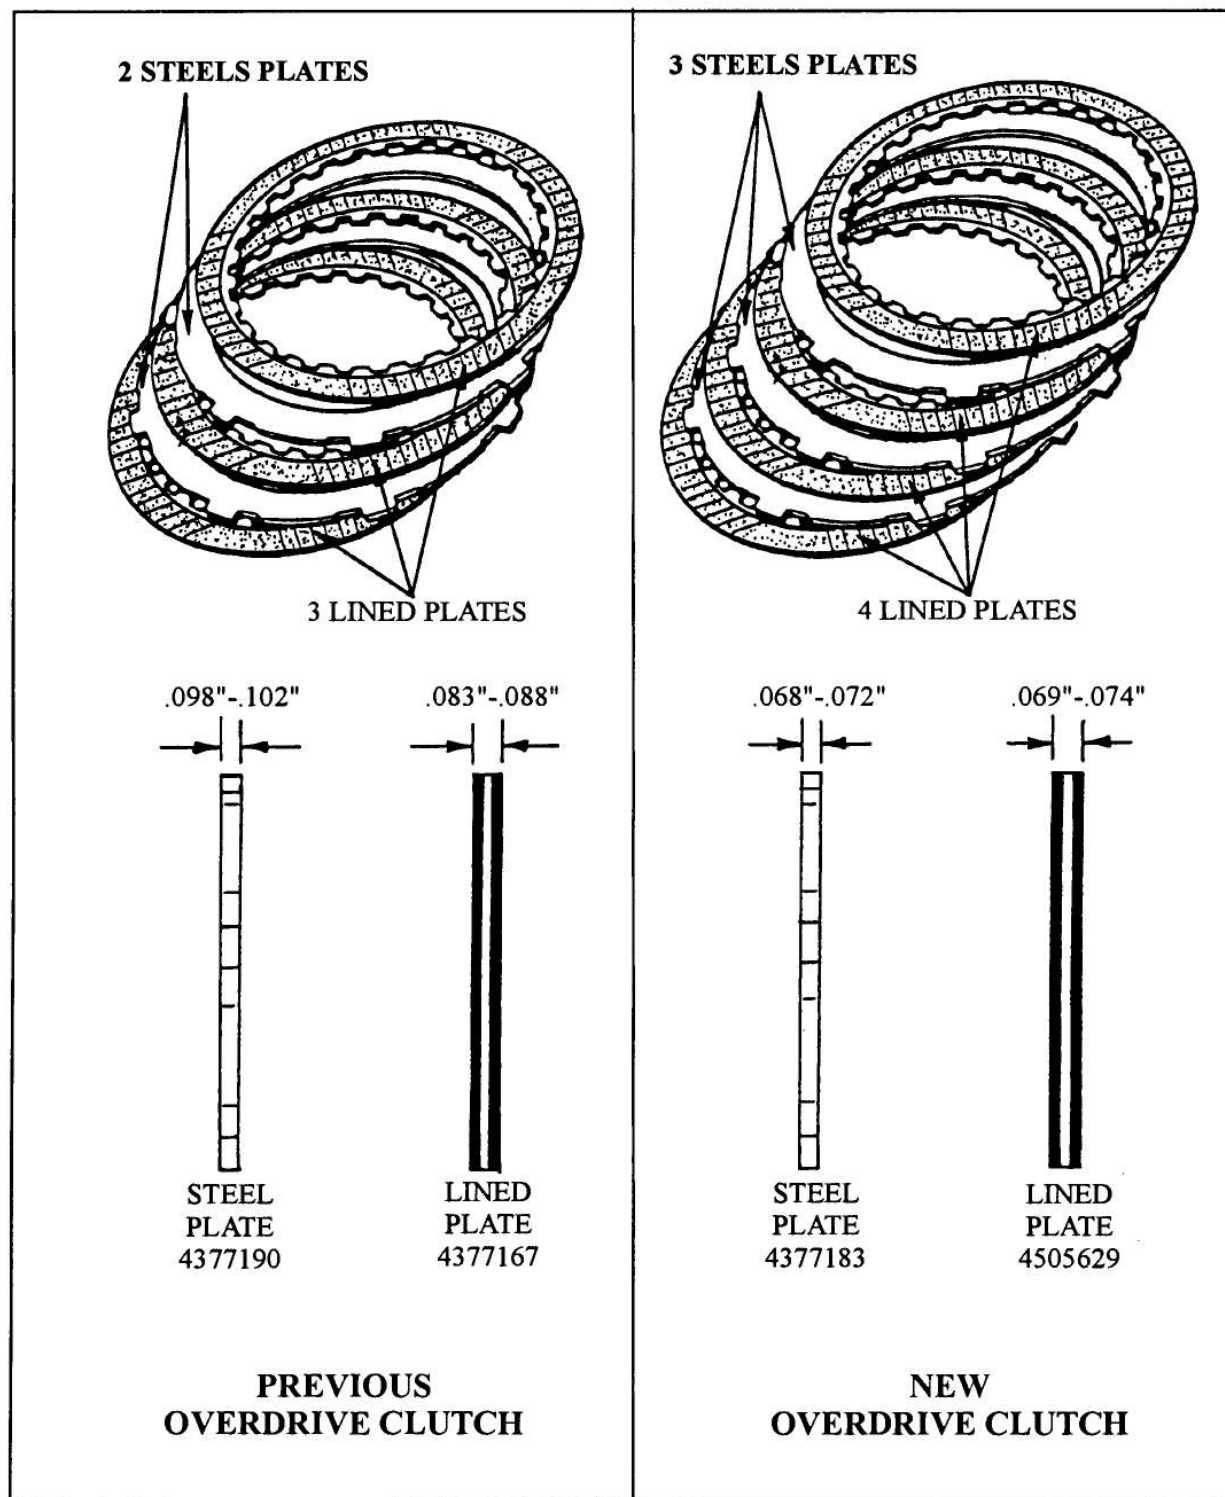
Figure 15

**CHANGE:** A running change for 1990 model A604 transaxles was the introduction of a four (4) disc Overdrive Clutch Assembly, to replace the previous three (3) disc clutch assembly (See Figure 15).

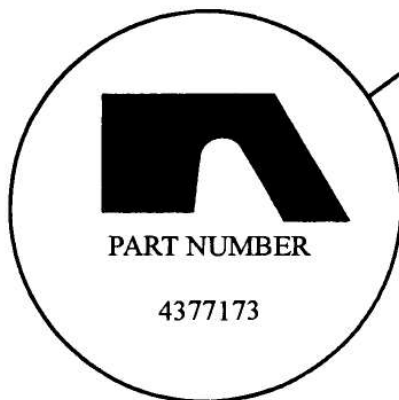
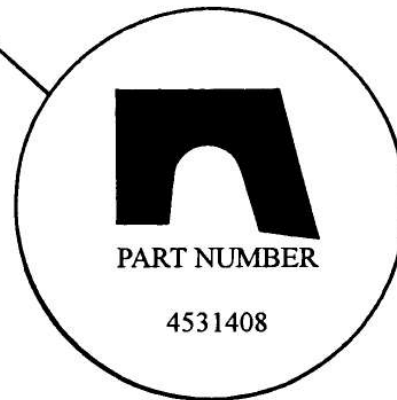
## UNDERDRIVE CLUTCH OUTER LIP SEAL

**1989 MODEL**

**3 OD CLUTCH DRUM**

**1990 AND UP MODEL**

**4 OD CLUTCH DRUM**

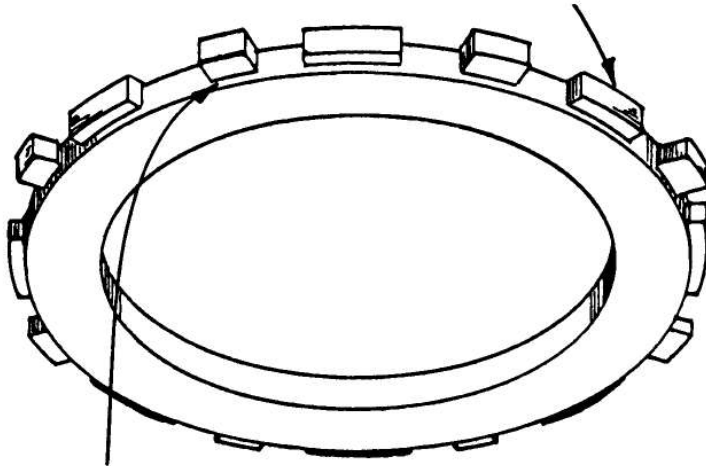
## UNDERDRIVE/OVERDRIVE REACTION PLATE

RELIEF CUT ON UPDATED REACTION  
PLATE FACES UP TOWARD TAPERED SNAP RING

SQUARE CUT FACES DOWN  
TOWARD FLAT SNAP RING

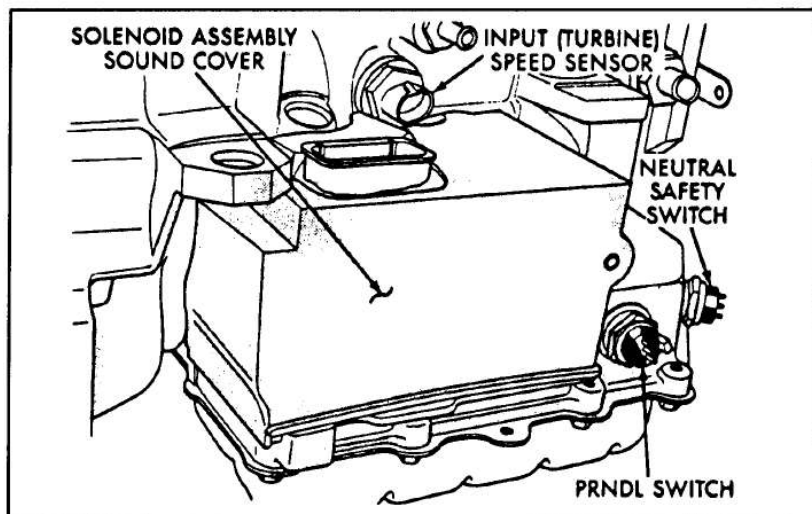
**CHANGE:** PRNODL Switch and Neutral Safety Switch have been changed for the 1990 model year, as well as the vehicle wiring harness connectors. Refer to Figure 20 for location of switches on the transaxle.

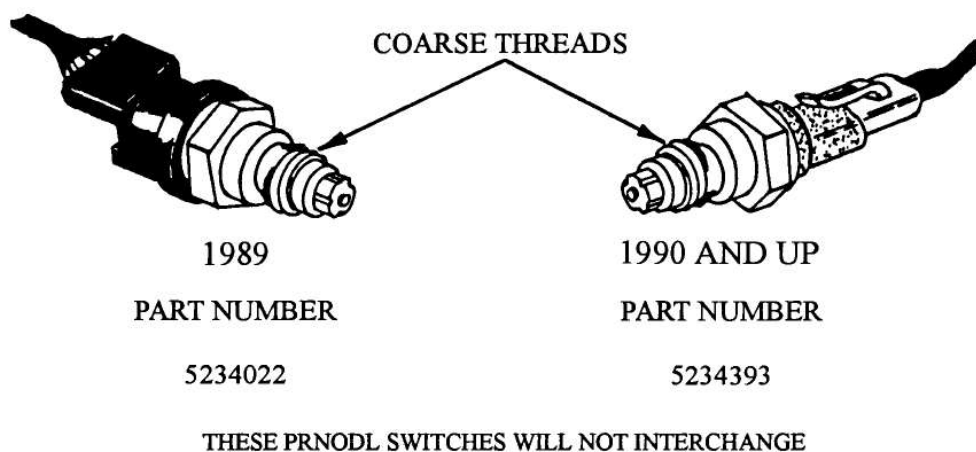
Figure 21

- (1) **PRNODL SWITCH AND CONNECTOR** - The PRNODL Switch and its wiring harness connector have changed for 1990, and can be identified visually (See Figure 21). These PRNODL Switches **WILL NOT** interchange with one another.
- (2) **NEUTRAL SAFETY SWITCH AND CONNECTOR** - The Neutral Safety Switch and its wiring harness connector have changed for 1990, and can be identified visually (See Figure 22). These Neutral Safety Switches **WILL NOT** interchange with one another.

**NOTE:** Each of the new for 1990 switches may look similar at first glance, but the PRNODL switch features a "Coarse" thread, while the Neutral Safety switch is black and features "Fine" threads. (See Figures 21 and 22).

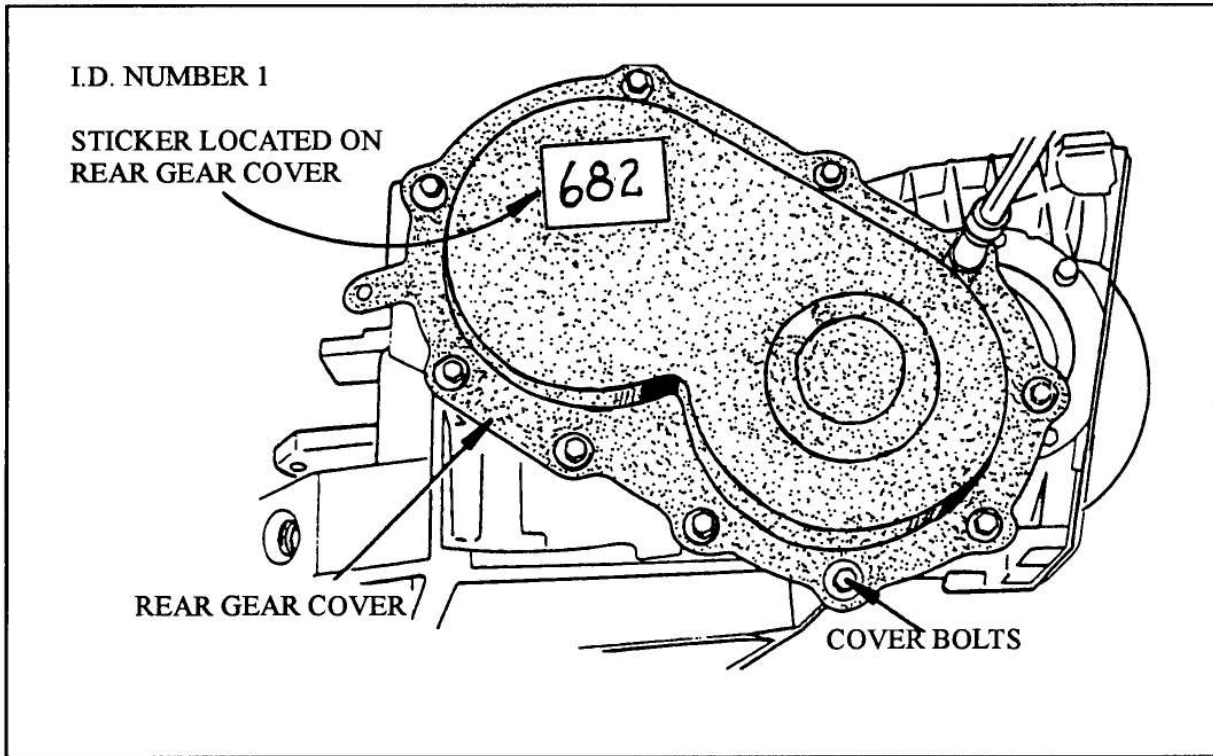
Figure 24

**NOT INTERCHANGEABLE.** It will be imperative that you identify the transaxle properly. The transaxle is identified by the "Last 3 Digits" of the OEM part number, and is found on a sticker located on the rear gear cover (See Figure 24). Then refer to the chart in Figure 27 for proper applications.

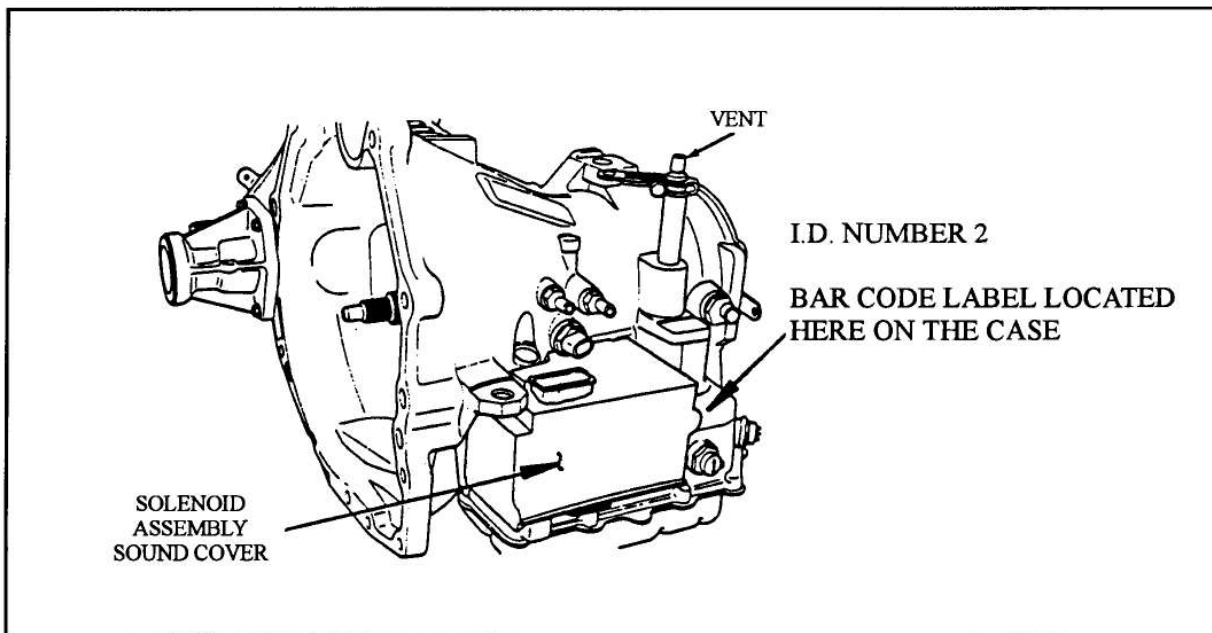
Figure 25

If that sticker is missing, or painted over, there is another bar code decal located on the case directly above the PRNODL and neutral safety switches (See Figure 25).

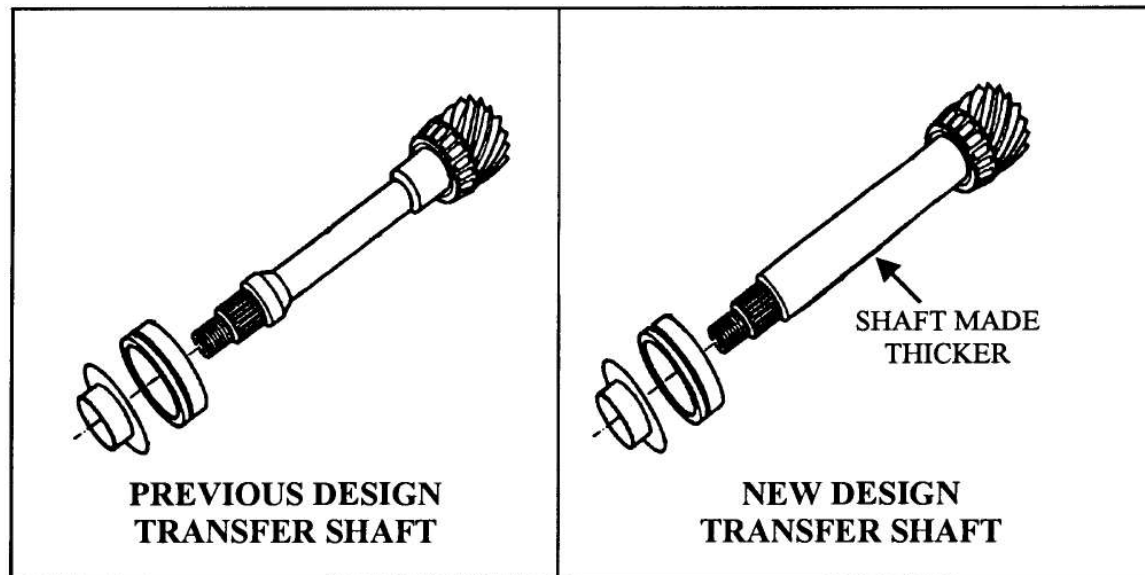
Figure 28

**CHANGE:** A thicker transfer shaft was made as a running change in 1990 and continues through to current production (See Figure 28).

- (1) **TRANSFER SHAFT** - The transfer shaft between the transfer gear end and the threaded end of the shaft increased in diameter to accommodate torque transfer (See Figure 28).

Transfer shaft, 17 T was part number 4377126 and was superseded to part number.....4531978

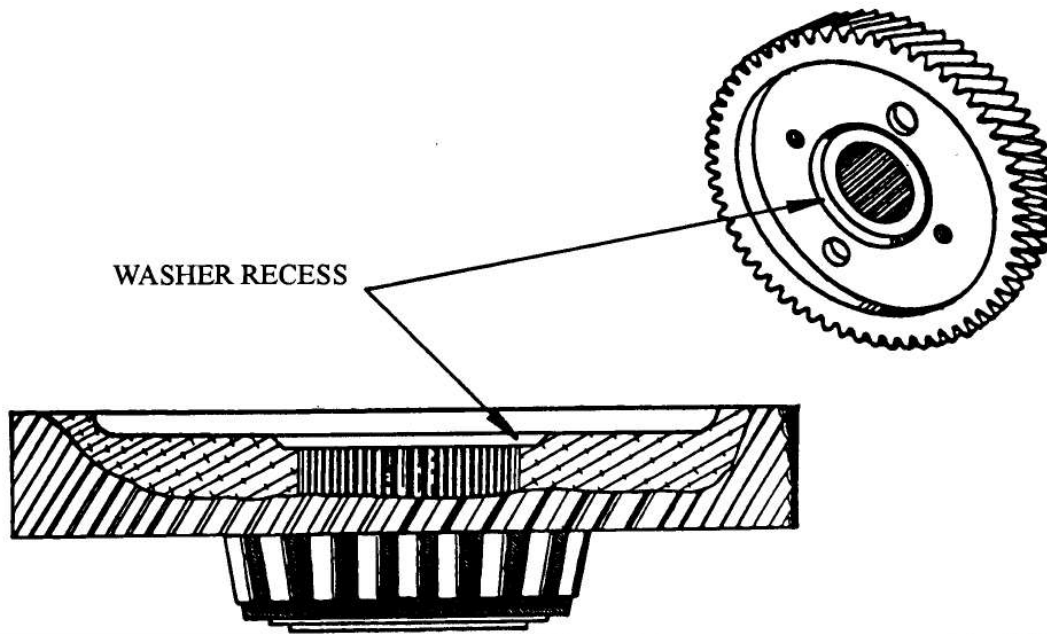
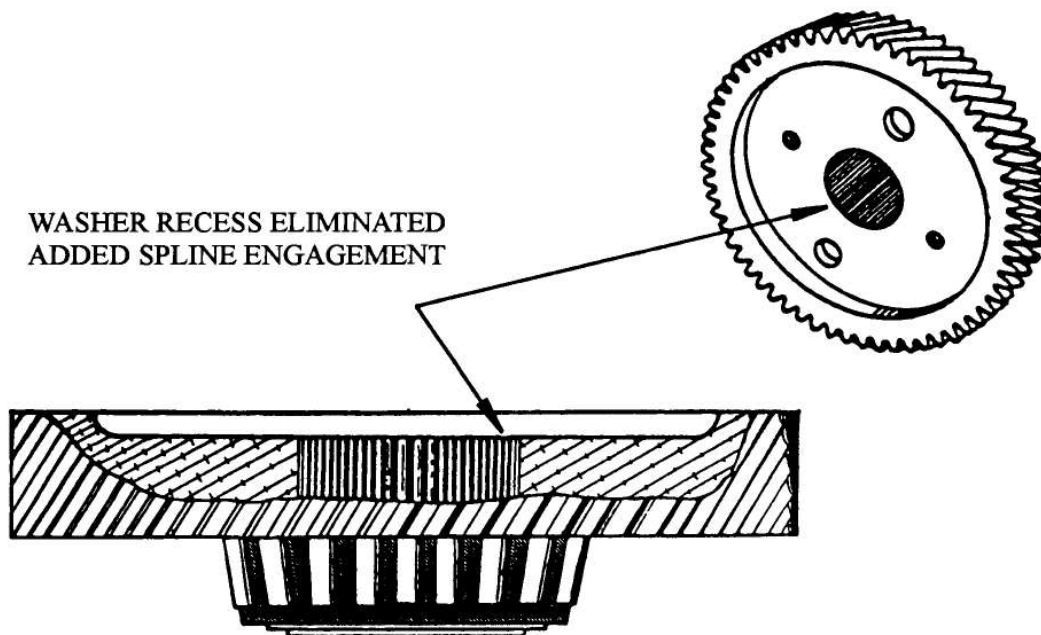
Figure 29

**CHRYSLER A 604 TRANSFER GEARS  
27.5 DEGREES HELIX**

**CHRYSLER A 604 TRANSFER GEARS  
32 DEGREES HELIX**
