## CHRYSLER A604 (41TE) UPDATE HANDBOOK

# **INTRODUCTION**

## **CHRYSLER A604 (41TE)**

### **"UPDATE HANDBOOK"**

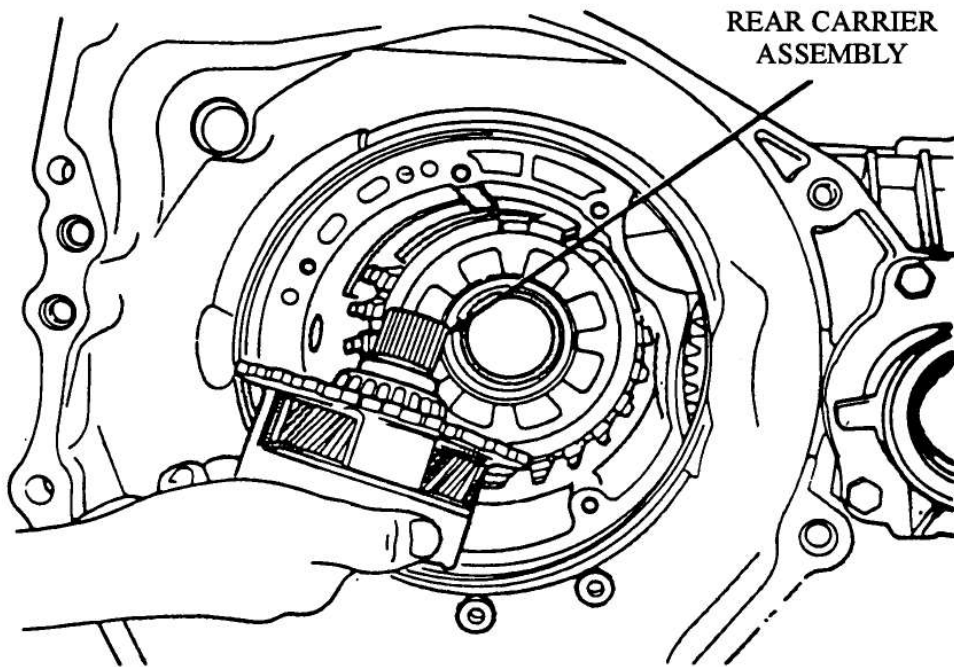
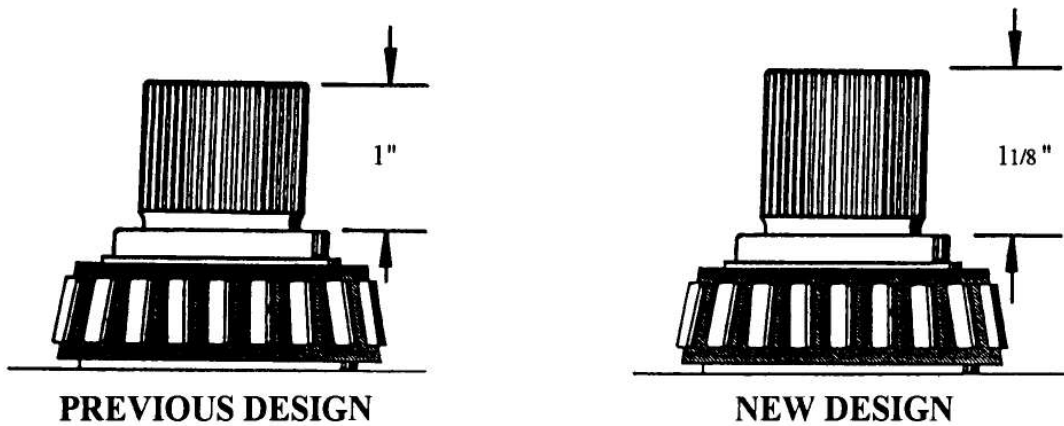
Figure 30

- (2) **REAR PLANETARY CARRIER** - The spline area of the output shaft was increased by 1/8" to accommodate the increased spline area in the transfer gear, as shown in Figure 30.

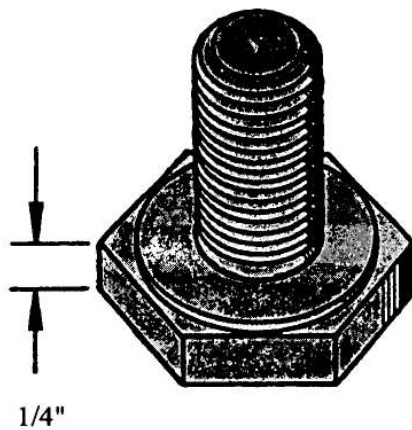
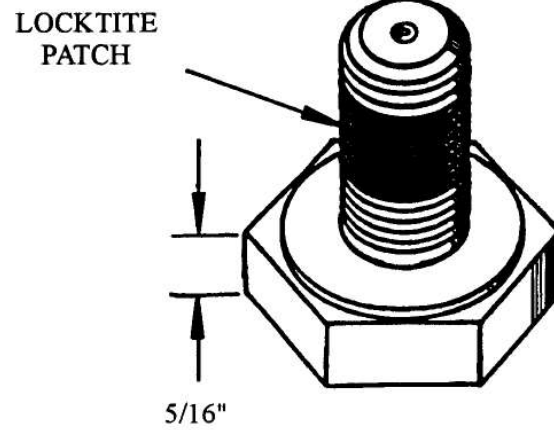
Figure 31

- (3) **OUTPUT SHAFT BOLT** - New output shaft bolt was introduced at the same time with a Locktite patch added to the thread area, and the bolt was cadmium plated. The new design bolt has a 5/16" head thickness instead of the previous 1/4" head thickness, as shown in Figure 31. All of this was done for a more stable torque retention.

**PREVIOUS DESIGN**

**NEW DESIGN**

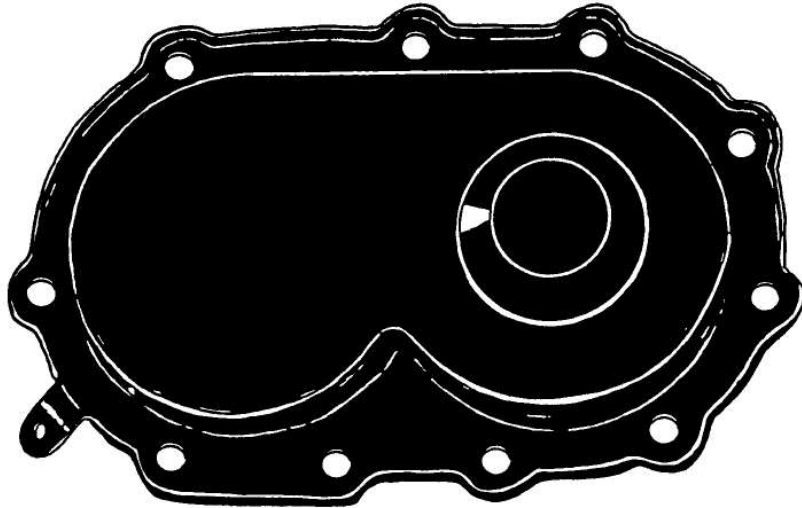
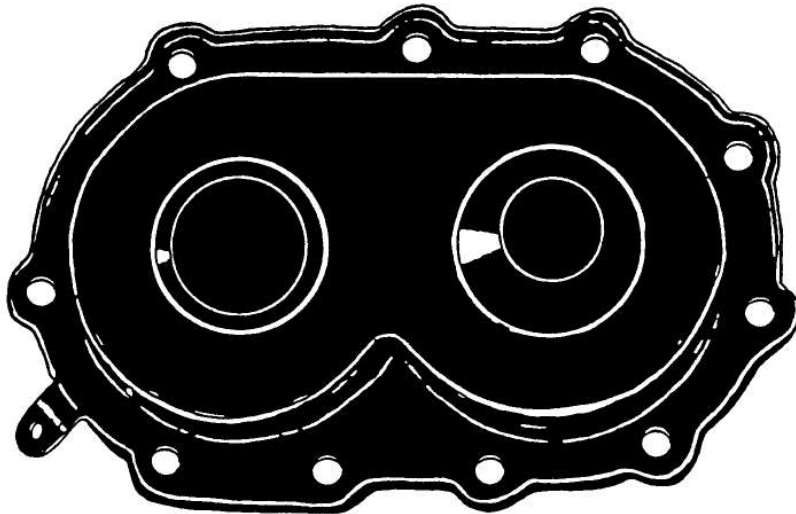
Figure 32

- (4) **TRANSFER SHAFT NUT** - Added Locktite patch to the thread area and cadmium plated for a more stable torque retention.
- (5) **TRANSFER GEAR COVER** - Has an added dimple in the cover to accommodate the increased head thickness of the output shaft bolt as shown in Figure 32.

**PREVIOUS DESIGN**

**NEW DESIGN**

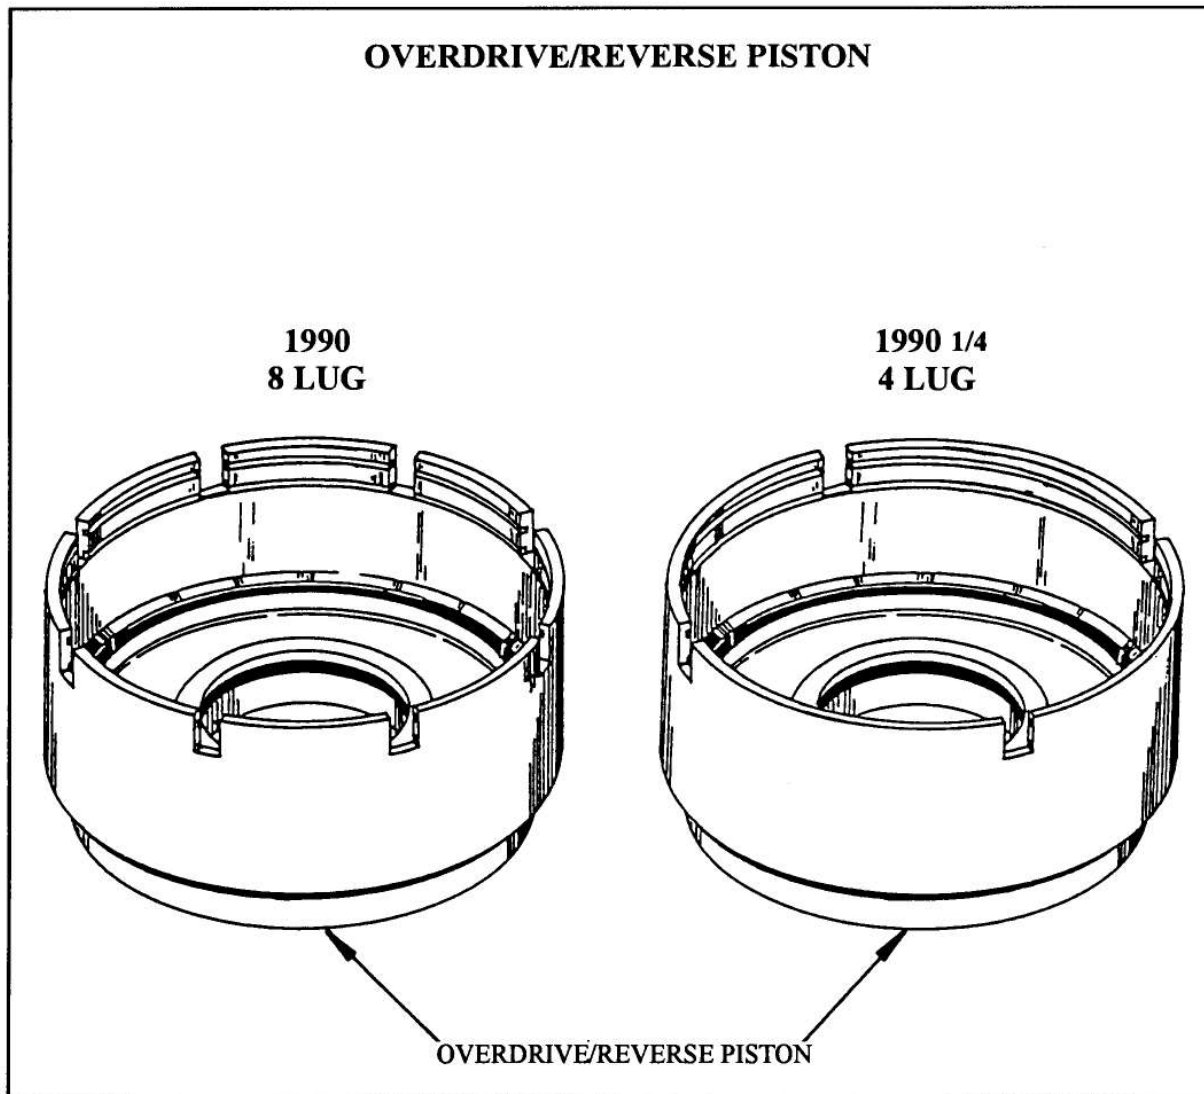
Figure 34

**CHANGE:** A new Overdrive/Reverse Piston has been introduced for 1990 1/4 model transaxles, and features four reaction plate slots instead of eight slots (See Figure 34).

**1990 1/4 OVERDRIVE/REVERSE PISTON  
WITH FOUR SLOTS**

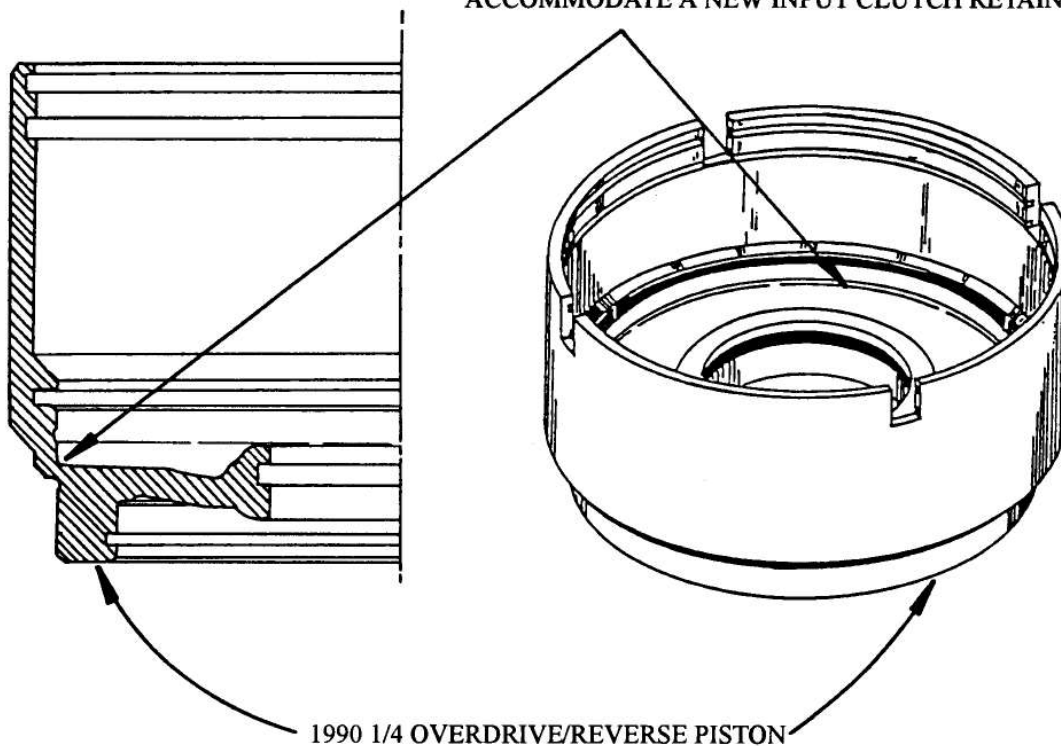
Figure 35

RADIUS CHANGES IN THIS AREA OF THE  
NEW OVERDRIVE/REVERSE PISTON TO  
ACCOMMODATE A NEW INPUT CLUTCH RETAINER

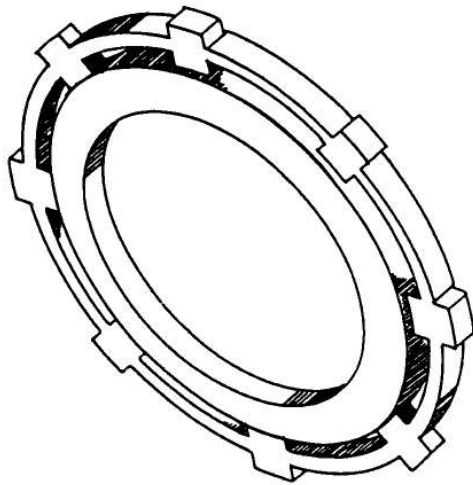
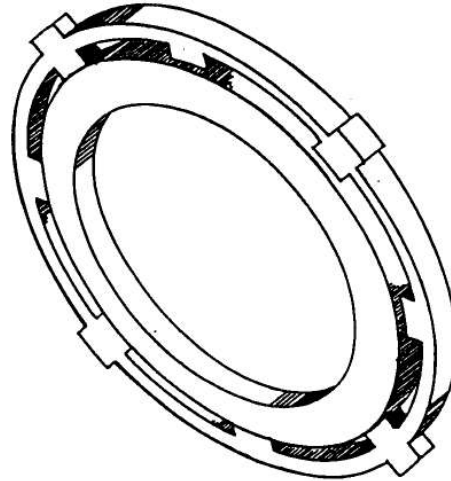
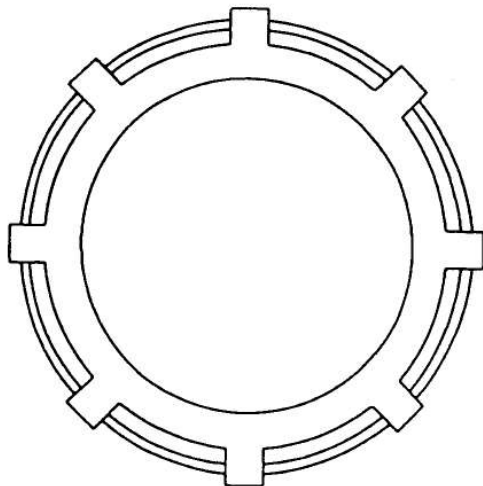
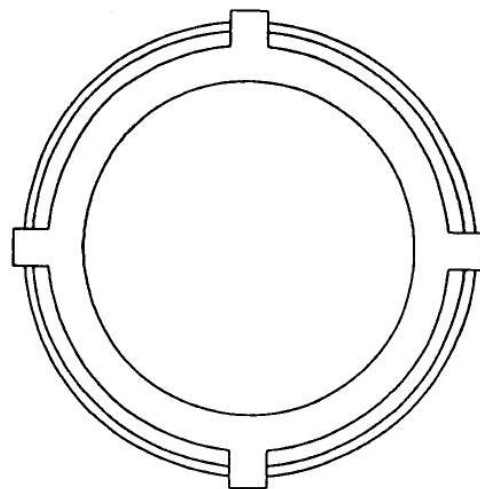
Figure 36

**OVERDRIVE/REVERSE PRESSURE PLATE**

**1990  
8 LUG**

**1990 1/4  
4 LUG**

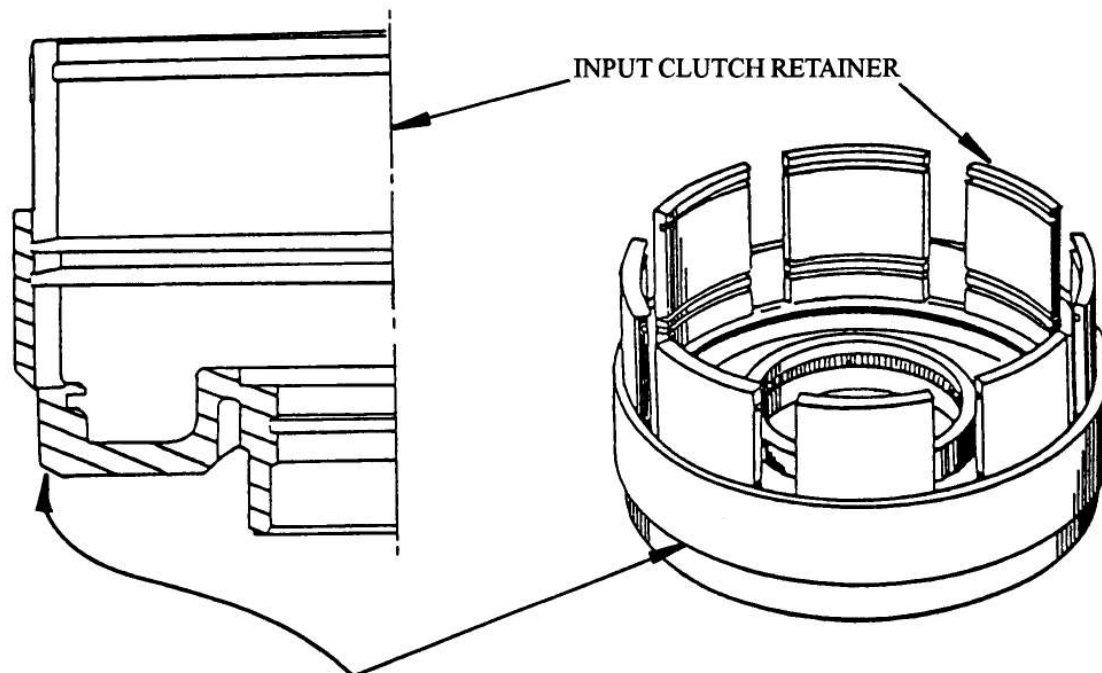
Figure 37

**1990 1/4 INPUT CLUTCH RETAINER**

1990 1/4 INPUT CLUTCH RETAINER HAS A REVISED  
RADIUS LOCATED HERE, ON THE OUTSIDE DIAMETER  
TO REDUCE THE CHANCE OF DAMAGE TO LIP SEAL

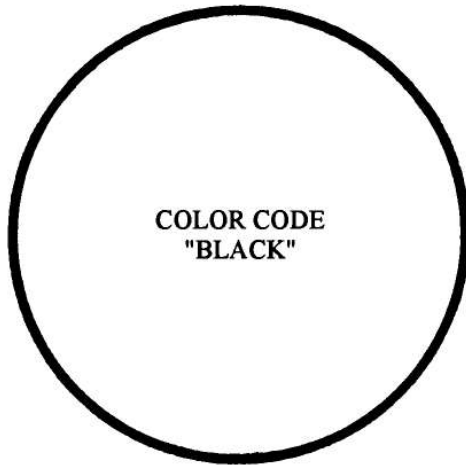
## FRONT INPUT CLUTCH HUB "O" RING

COLOR CODE  
"BLACK"

1989 - FRONT "O" RING  
.070" CROSS SECTION  
PART NUMBER 6501574

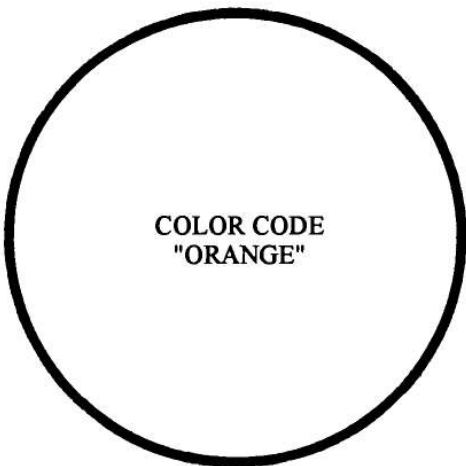
COLOR CODE  
"ORANGE"

89-90 - FRONT "O" RING  
.070" CROSS SECTION  
PART NUMBER 6502272

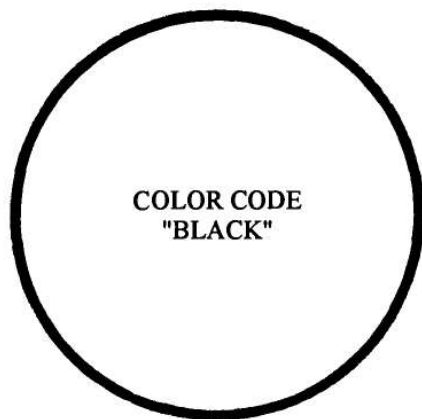
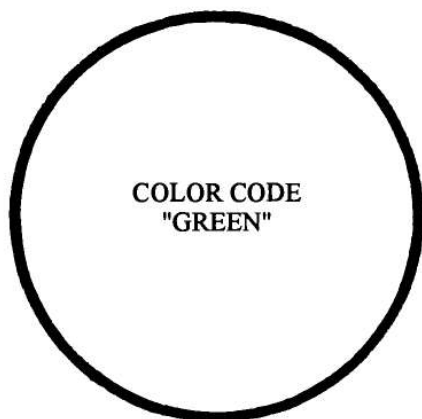
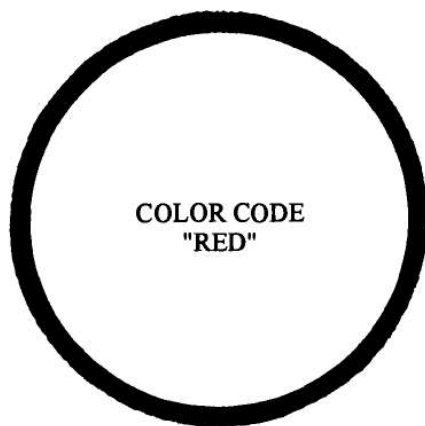
Figure 41

**REAR INPUT CLUTCH HUB "O" RING**

COLOR CODE  
"BLACK"

1989 - REAR "O" RING  
.070" CROSS SECTION  
PART NUMBER 6501548

COLOR CODE  
"GREEN"

89-90 - REAR "O" RING  
.070" CROSS SECTION  
PART NUMBER 6502270

COLOR CODE  
"RED"

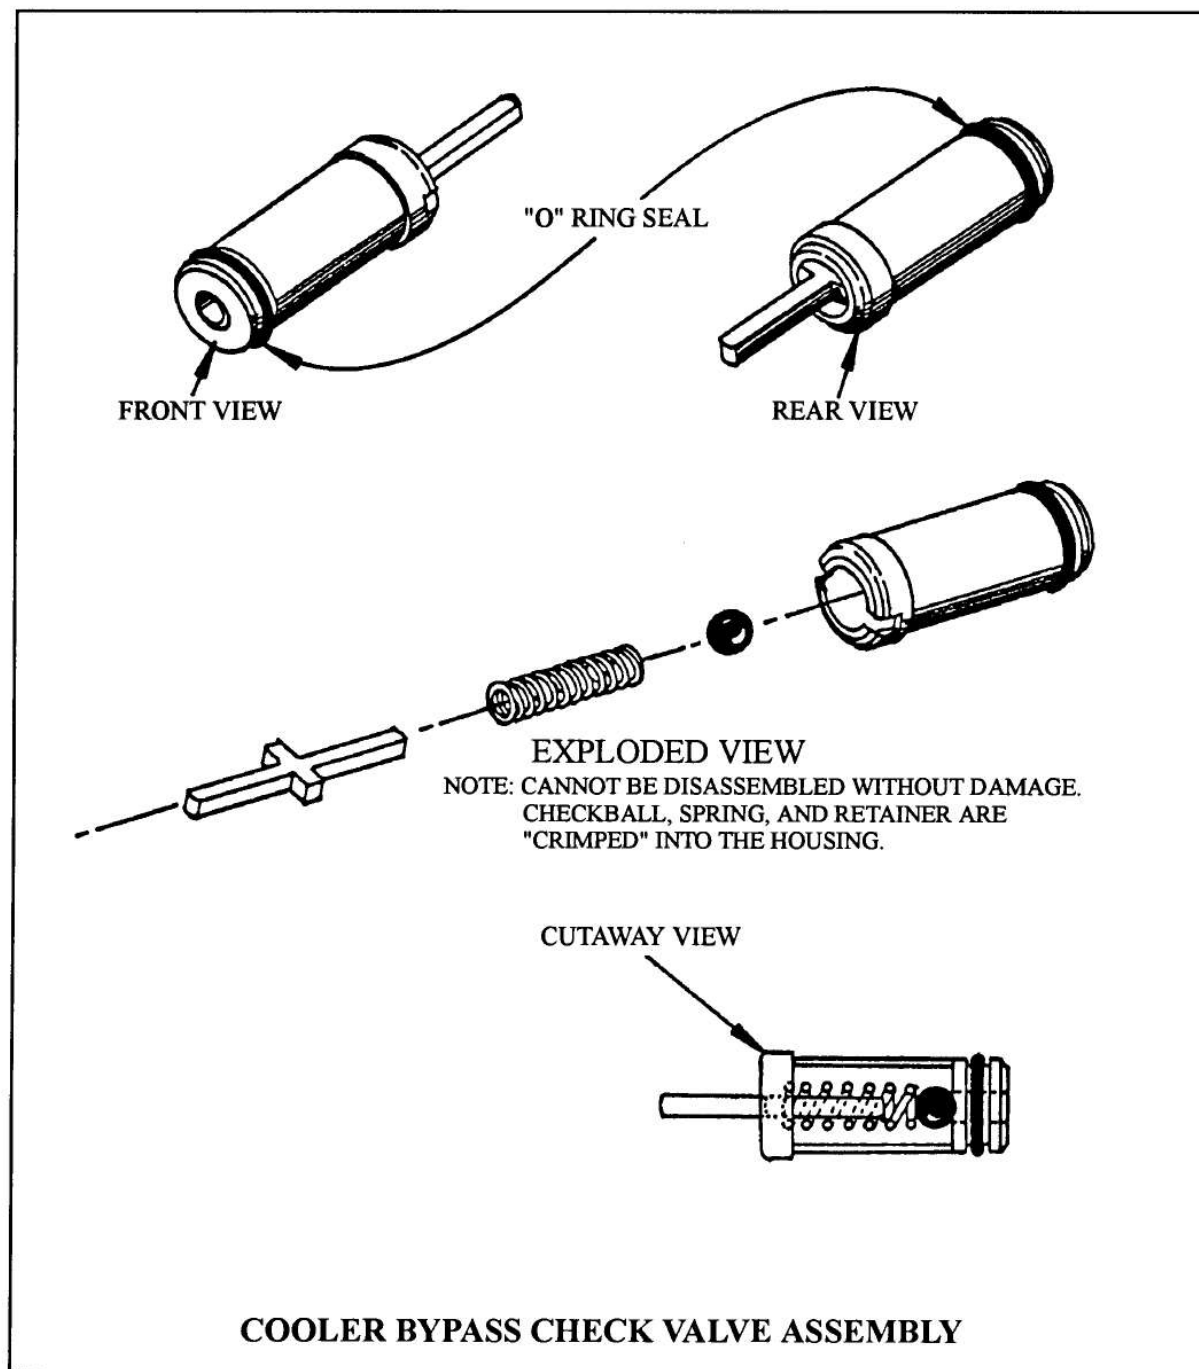
Figure 42

**CHANGE:** Beginning in 1991 model A604 transaxles, there has been a "Cooler Bypass Check Valve Assembly" added in the transaxle case behind the oil pump. (See Figures 42 and 43).

- (1) **COOLER BYPASS CHECK VALVE** - added into the case cooler passage behind the oil pump (See Figure 43). If cooler oil flow is restricted, or blocked, the new check valve will open, and allow cooler feed oil direct into the lube circuit to prevent transaxle damage. Normal operation is resumed after oil temperature is warm enough to again flow through the cooler. (See Figure 42).  
**NOTE:** Customers should be advised to let the vehicle warm-up thoroughly before attempting to drive the vehicle, especially in the colder climates.
- (2) **TRANSAXLE CASE** - The new case has added material between the two cooler line fittings, to accommodate the machining process needed for the new cooler bypass check valve assembly (See Figure 43).
- (3) **VALVE BODY SPACER PLATE** - Lube feed hole in spacer plate has been enlarged to .112", as shown in Figure 44.

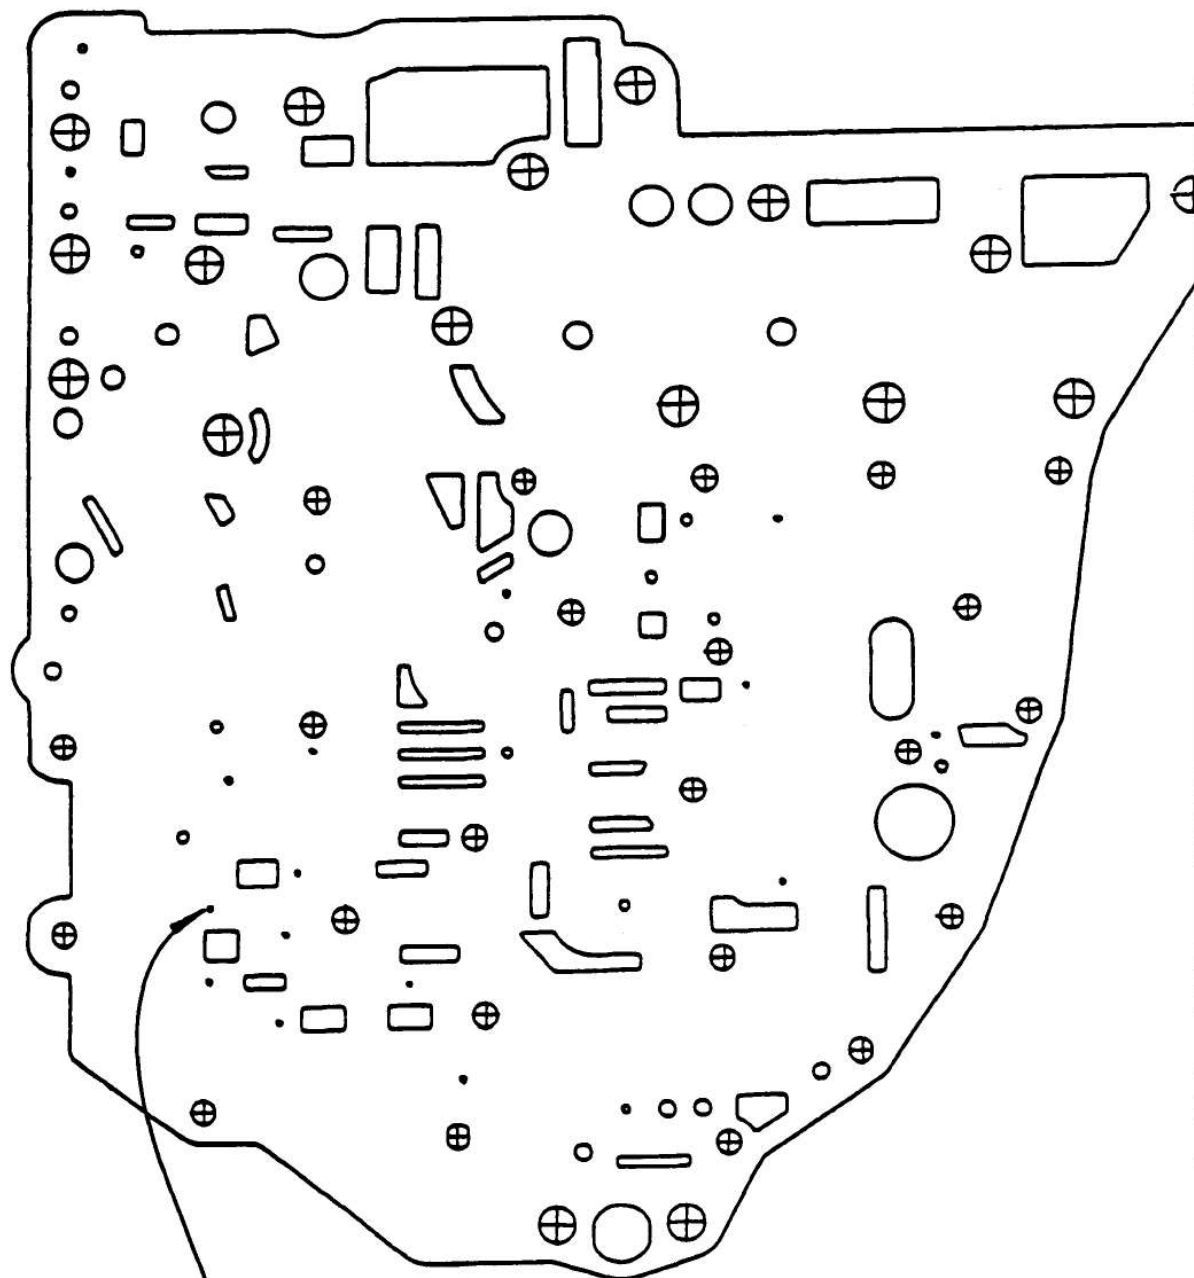
Figure 44

**A604 SPACER PLATE**

ENLARGE THE HOLE INDICTAED BY  
THE ARROW ABOVE TO .112" ON ALL  
MODELS TO IMPROVE LUBE OIL FLOW

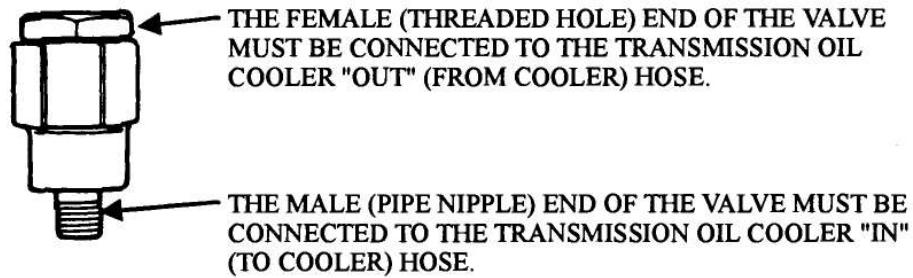
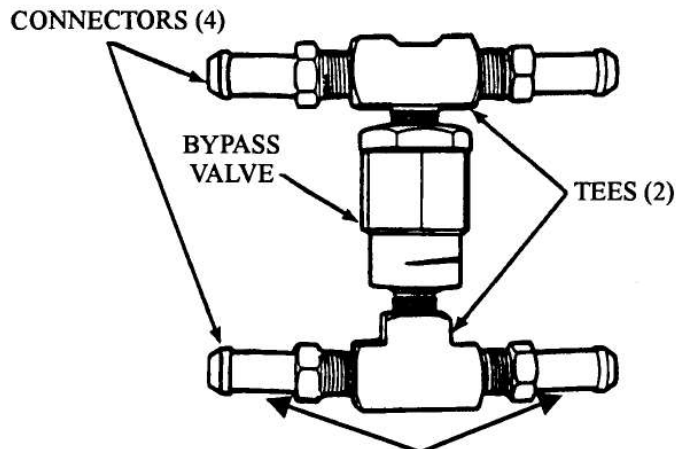
Figure 45

THIS SIDE OF THE BYPASS VALVE ASSEMBLY "MUST" BE CONNECTED TO THE TRANSMISSION OIL "IN" (TO COOLER) HOSE.

NOTE: THE BYPASS VALVE IS DIRECTIONAL. IF IT IS NOT CONNECTED TO THE TRANSAXLE OIL COOLER HOSES IN THE CORRECT OIL FLOW DIRECTION, THE BYPASS VALVE WILL NOT FUNCTION.

1. Using thread sealer on all connections, assemble the supplied bypass valve, tees, and hose connectors as shown in Figure 45.
2. Raise the vehicle on a hoist for working access to the transmission oil cooler hoses, that are routed along the inboard side of the left front frame rail.
3. Place an oil drain pan under the vehicle to catch oil leakage. Oil loss will be very minimal.
4. Referring to Figure 46, follow the cooler hoses routed from the transaxle to **CLEARLY IDENTIFY THE COOLER "IN" (TO COOLER) HOSE**.
5. Install the bypass valve assembly as per the following instruction sheets, as installation procedures vary depending on vehicle model.

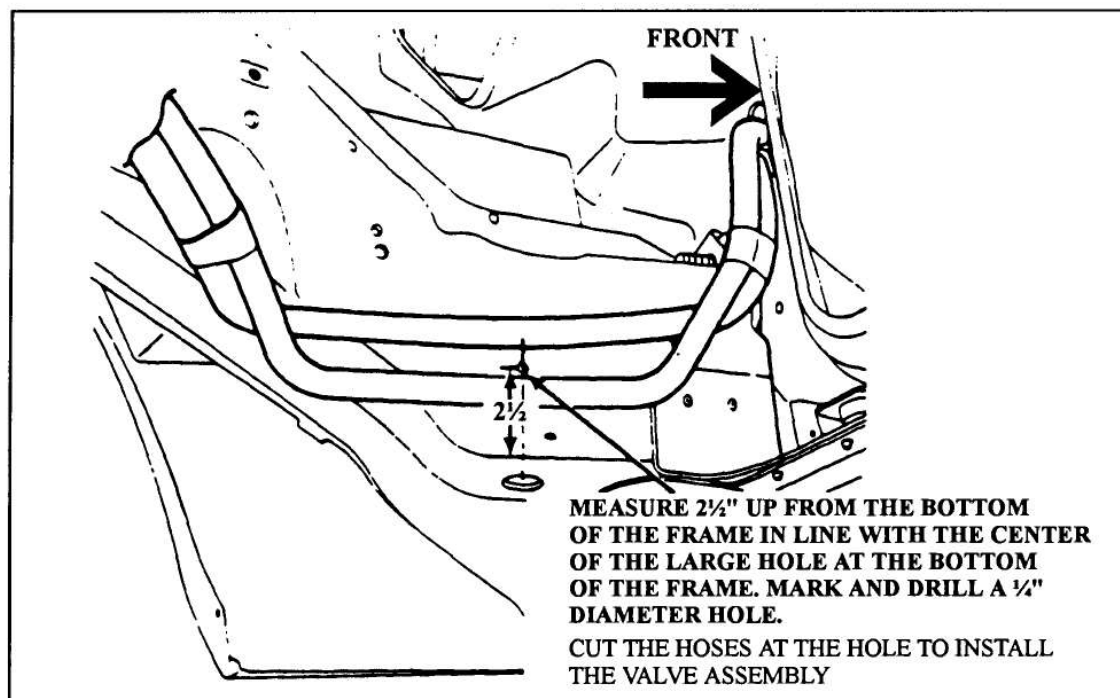
Figure 47

6. Now cut the other hose, cooler "out" (from cooler) at the drilled hole (Figure 47), allow oil to drain, and connect the hose ends to the bypass valve assembly connectors in the same manner as above.

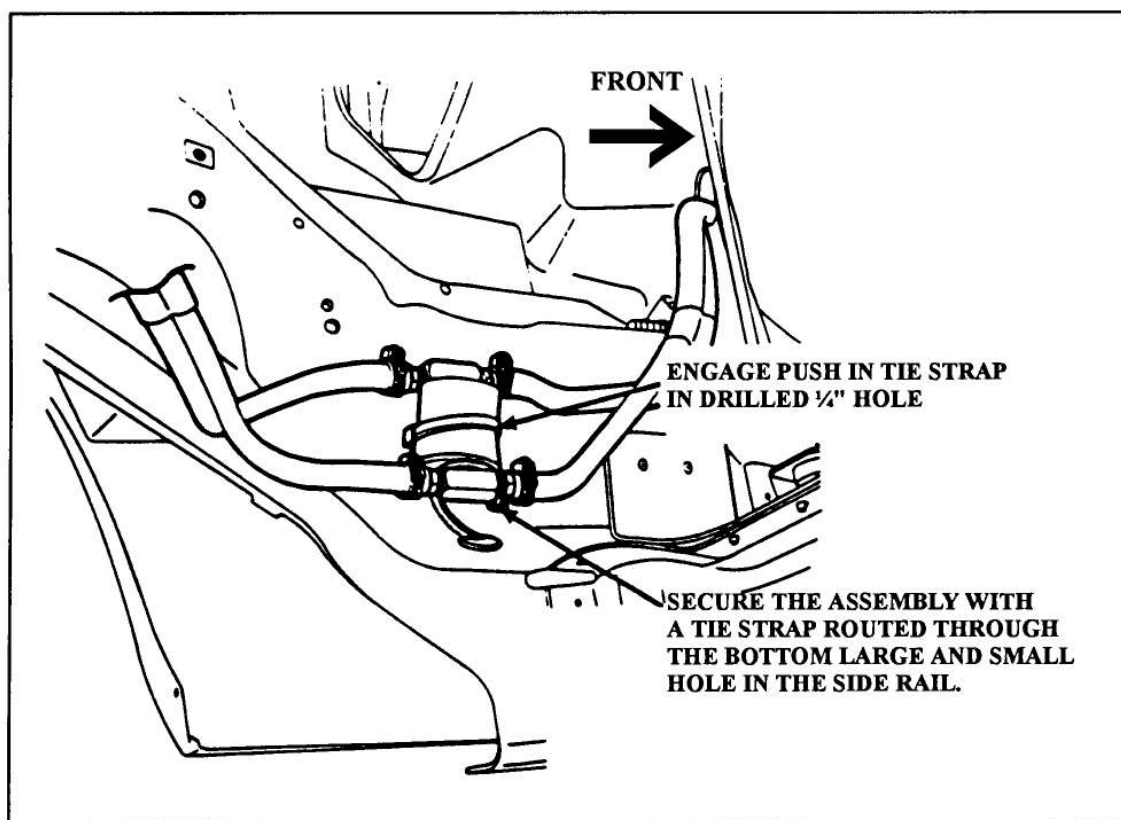
Figure 48

7. Cut the supplied foam tube and wrap it around the bypass valve (Figure 48).
8. Tighten the supplied "Push-in" tie strap around the foam tubing and cut off the excess strap (See Figure 48).

9. Engage the "Push-in" tie strap into the drilled 1/4 inch hole (See Figure 48).
10. The bypass valve assembly **MUST** be positioned vertically (See Figure 48).
11. Tighten all hose clamps.
12. Install the other supplied tie strap to secure the bypass valve assembly to the frame rail, as shown in Figure 48, and cut off excess tie strap.
13. Start the engine and inspect for leaks. Check transaxle fluid level and fill as necessary.

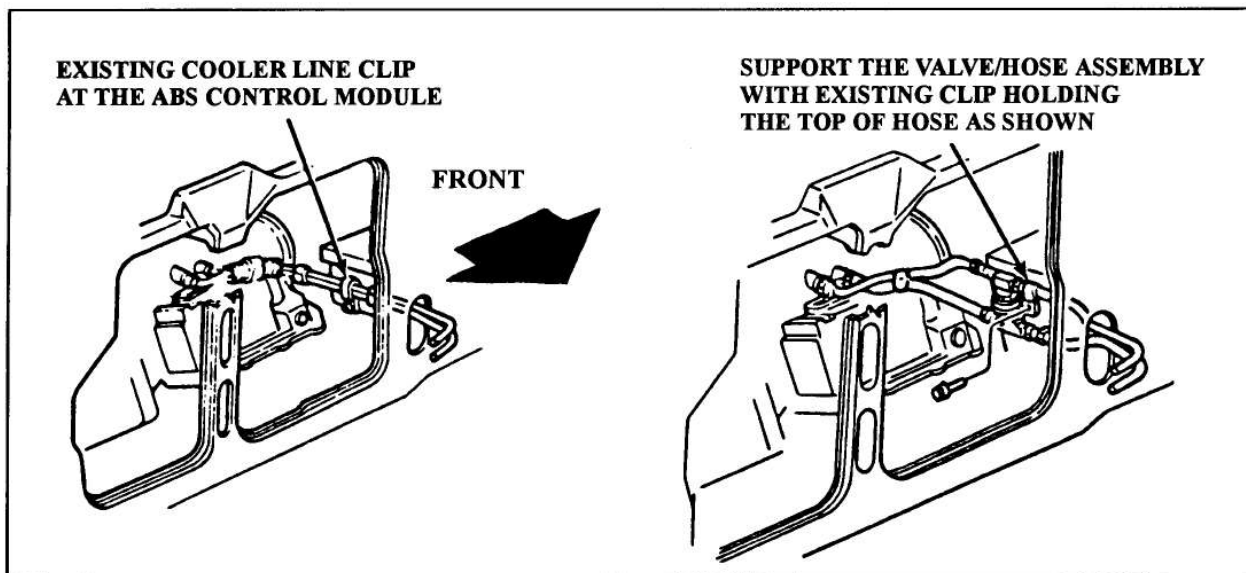
Figure 49

7. Reinstall the retaining clip to support the bypass valve assembly, as shown in Figure 49, and tighten all hose clamps and retaining clip.
8. The bypass valve assembly MUST be positioned vertically (See Figure 49).

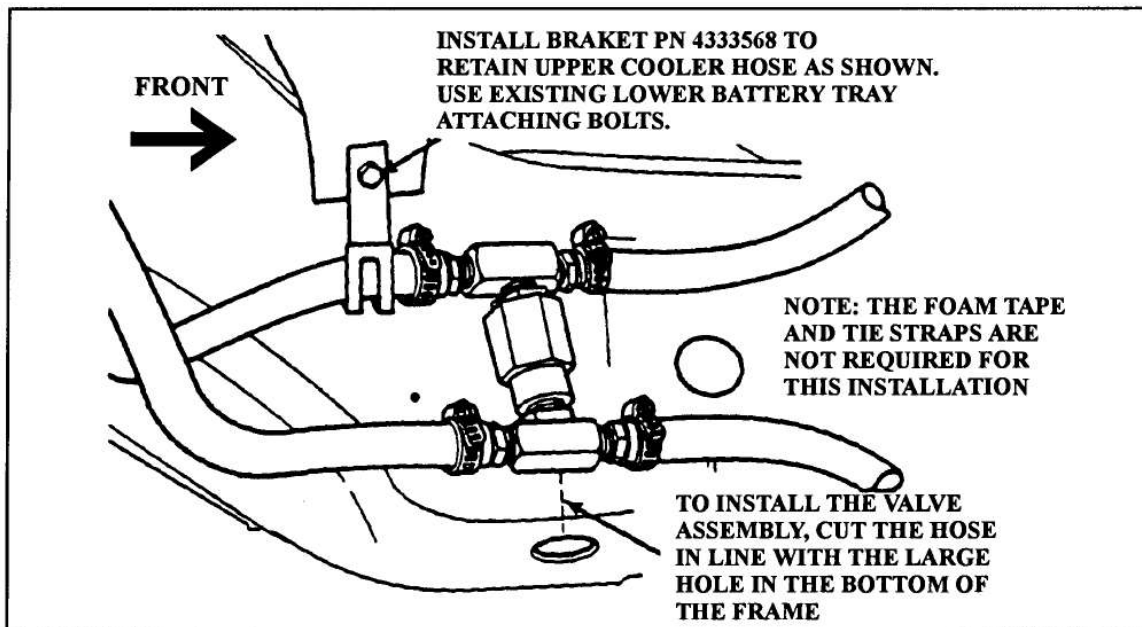
Figure 50

8. Connect the other hose ends to the bypass valve assembly in the same manner as above.
9. Tighten all clamps, and position the valve and hose assembly in the clip as shown in Figure 50.

10. Since the bypass valve assembly will be clear of the frame rail with this installation, the anti-rattle foam tape and tie strap are not required.
11. Start the engine and inspect for leaks. Check transaxle fluid level and fill as necessary.

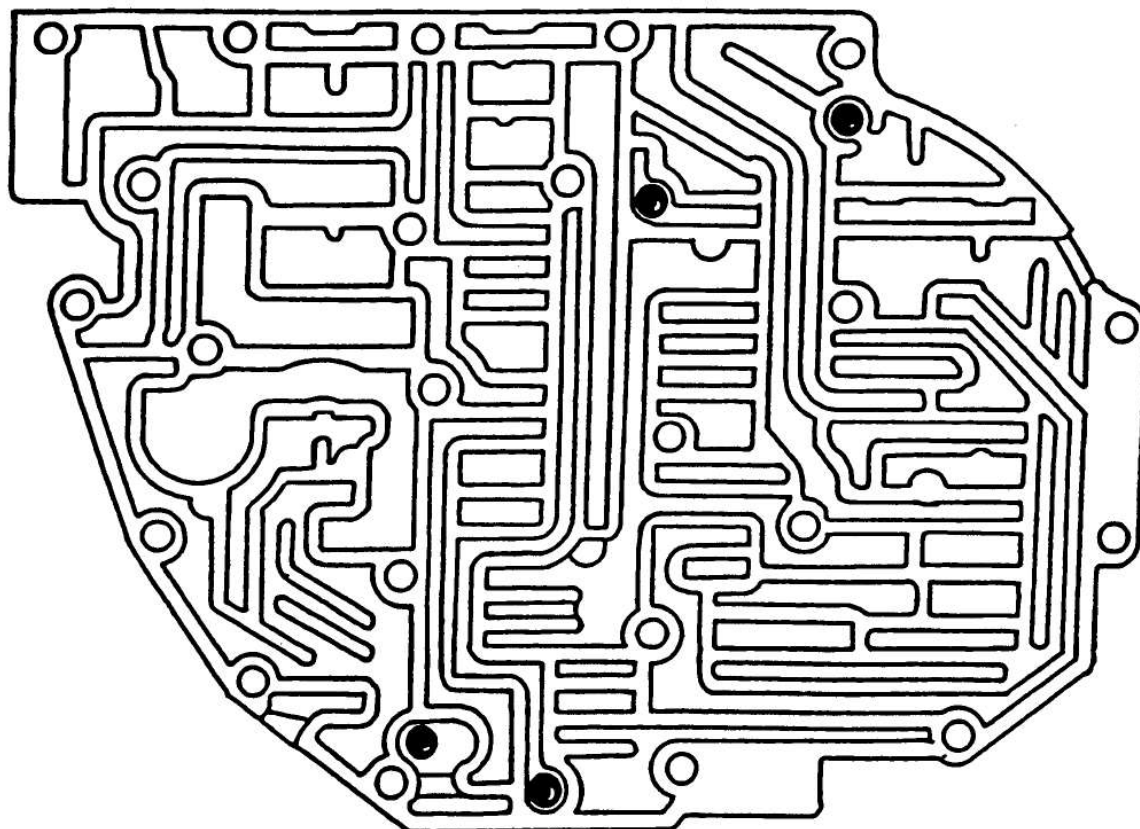
Figure 51

**VALVE BODY CASTING NUMBER 4446639  
(FITS MODEL YEARS 1989-1991)**

**NOTE: REQUIRES FOUR CHECK BALLS IN THE LOCATIONS SHOWN ABOVE.**

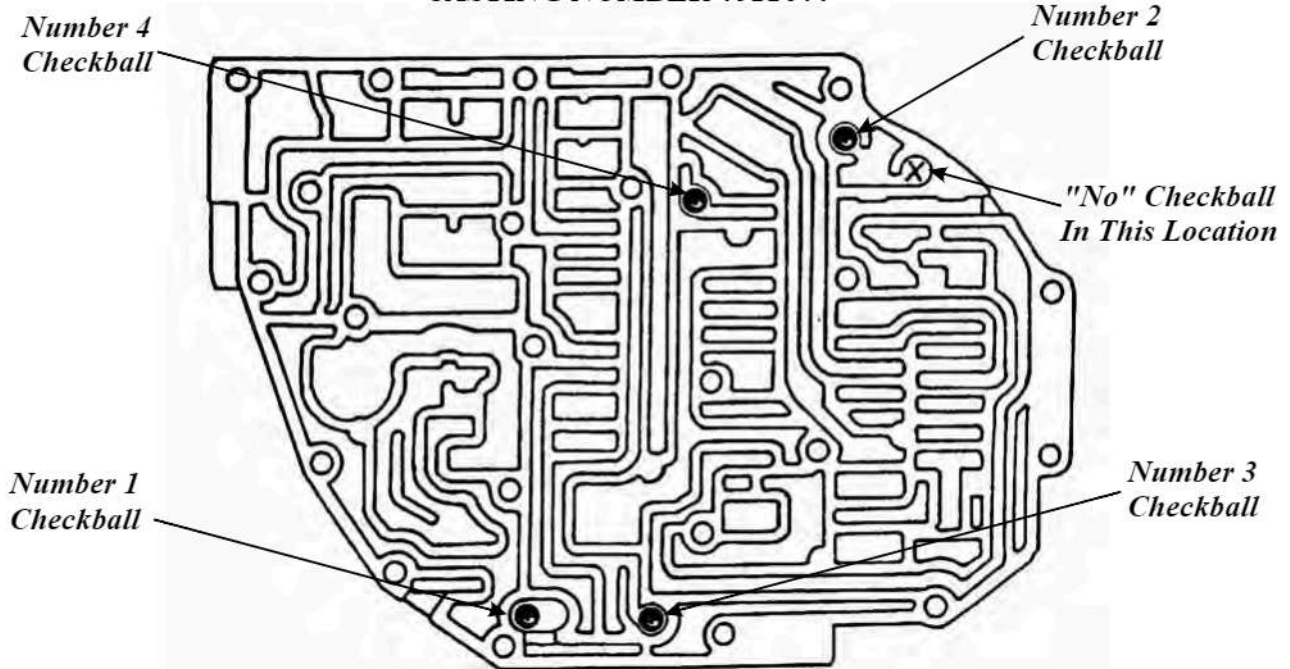
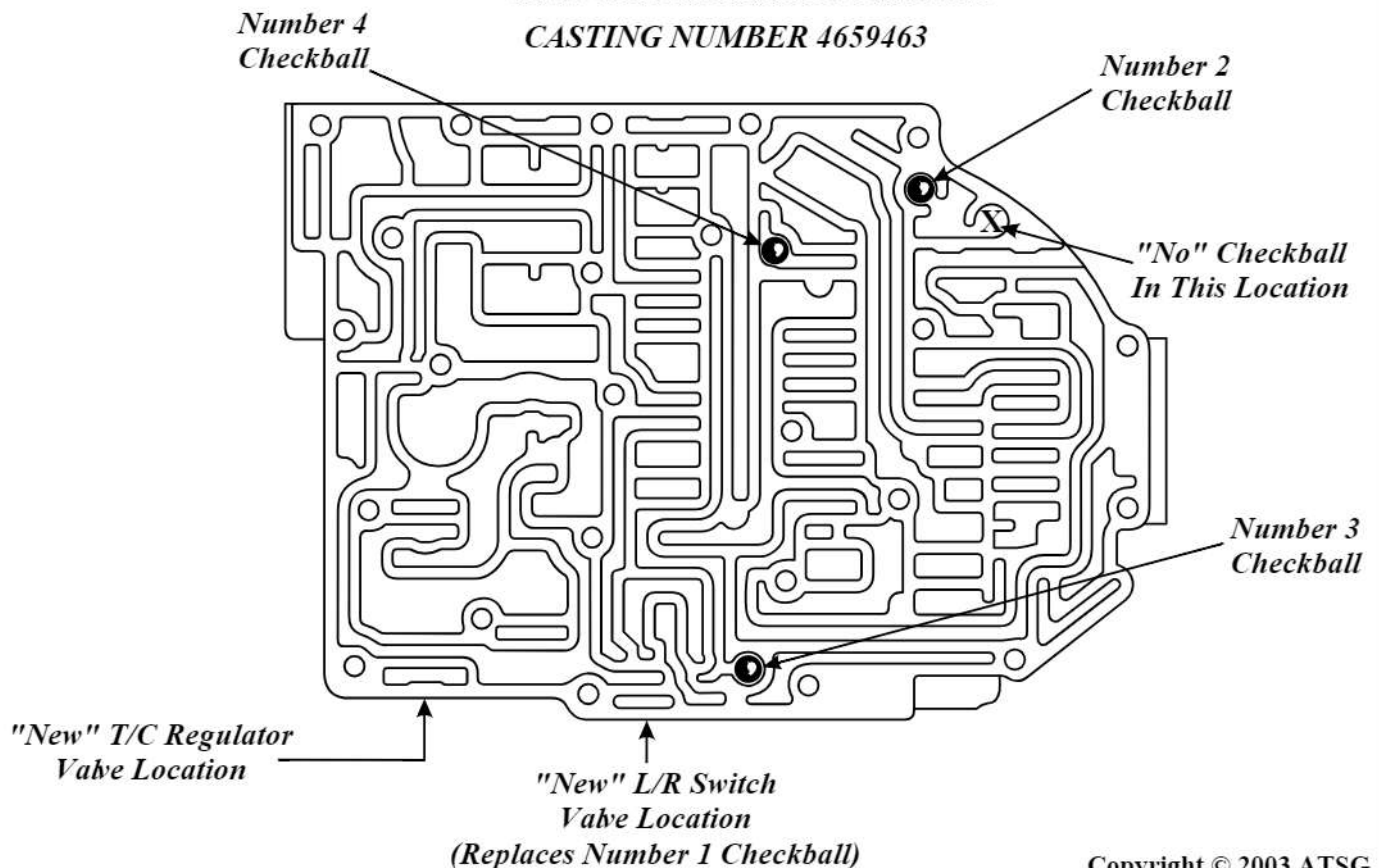
Figure 52  
Automatic Transmission Service Group

## 1992-94 VALVE BODY CHECKBALL LOCATIONS CASTING NUMBER 4511644

## 1995 A604 VALVE BODY CHANNELS AND CHECKBALL LOCATIONS CASTING NUMBER 4659463

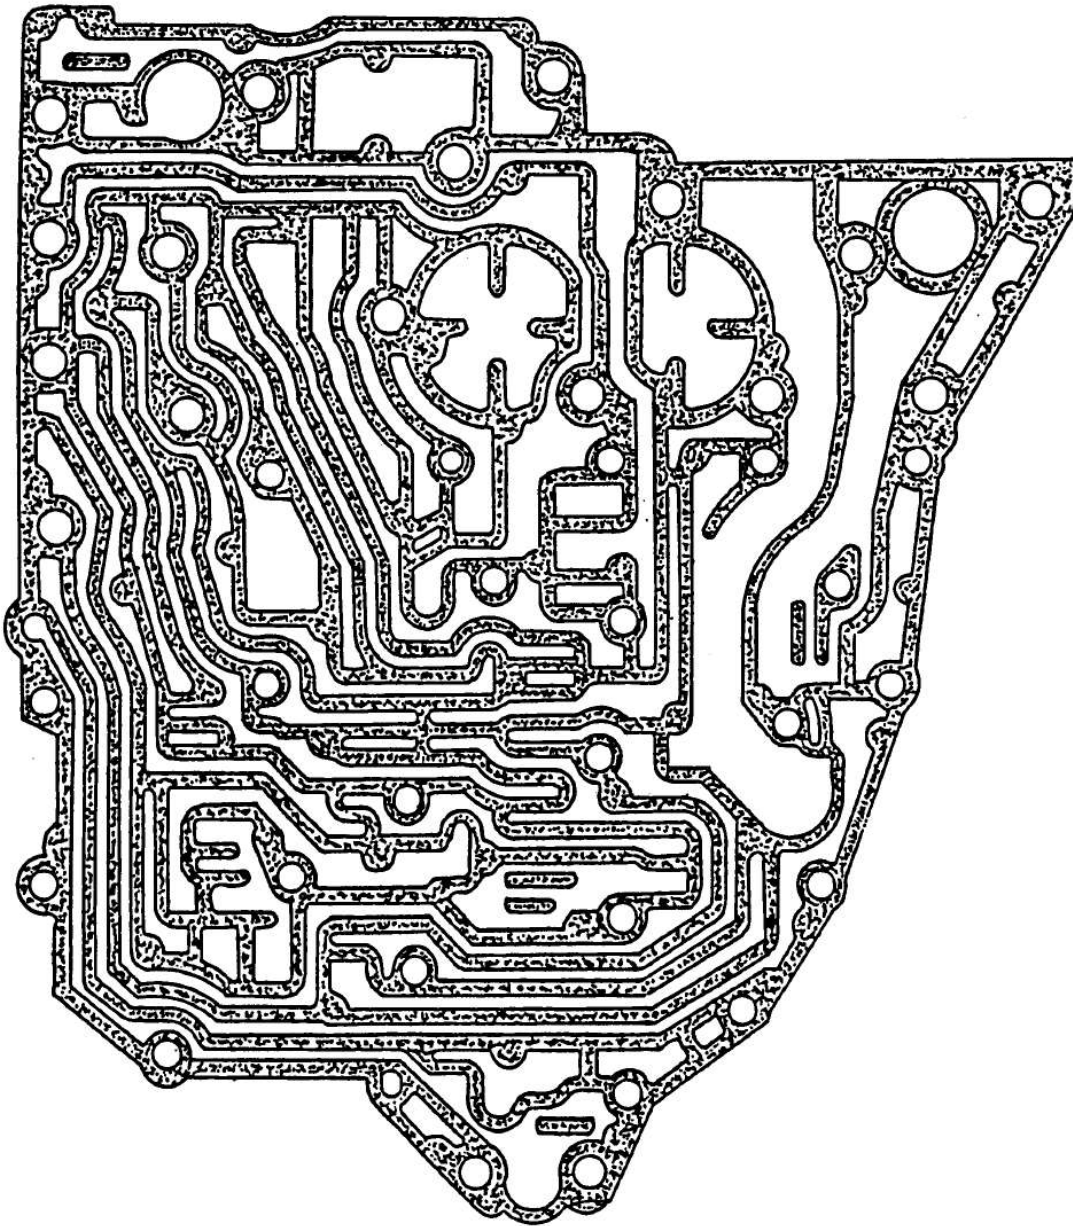
Figure 53

**CHRYSLER A604 TRANSFER PLATE  
CASTING NUMBER 4446640  
(FITS MODEL YEARS 1989-1991)**

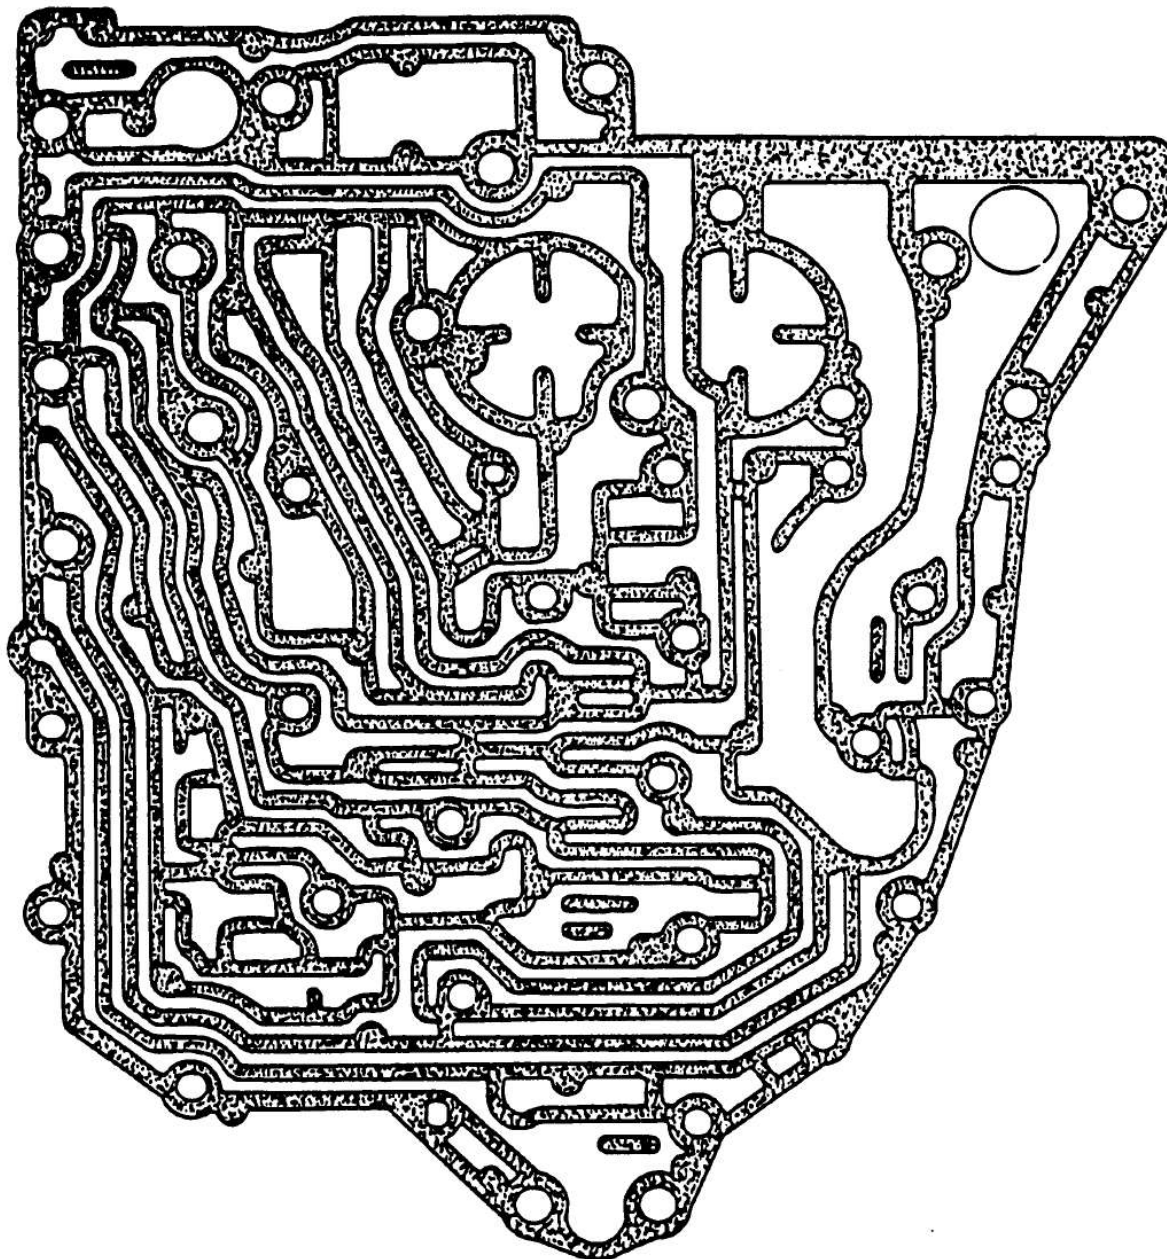
**CHRYSLER A604 TRANSFER PLATE  
CASTING NUMBER 4511645  
(IMPLEMENTED 1992 MODEL YEAR)**

The new "82" spacer plate replaces the previous "96" spacer plate and can retrofit back to all valve bodies and Transfer Plates that use the # 96 spacer plate **provided that the new pressure regulator valve is used together with the # 82 spacer plate.** Valve bodies that use a 96 spacer plate has a casting number of 4511644 (See Figure 52 on Page 68). Transfer Plates that use the # 96 spacer plate has a casting number of 4511645 (See Figure 54 on Page 70).

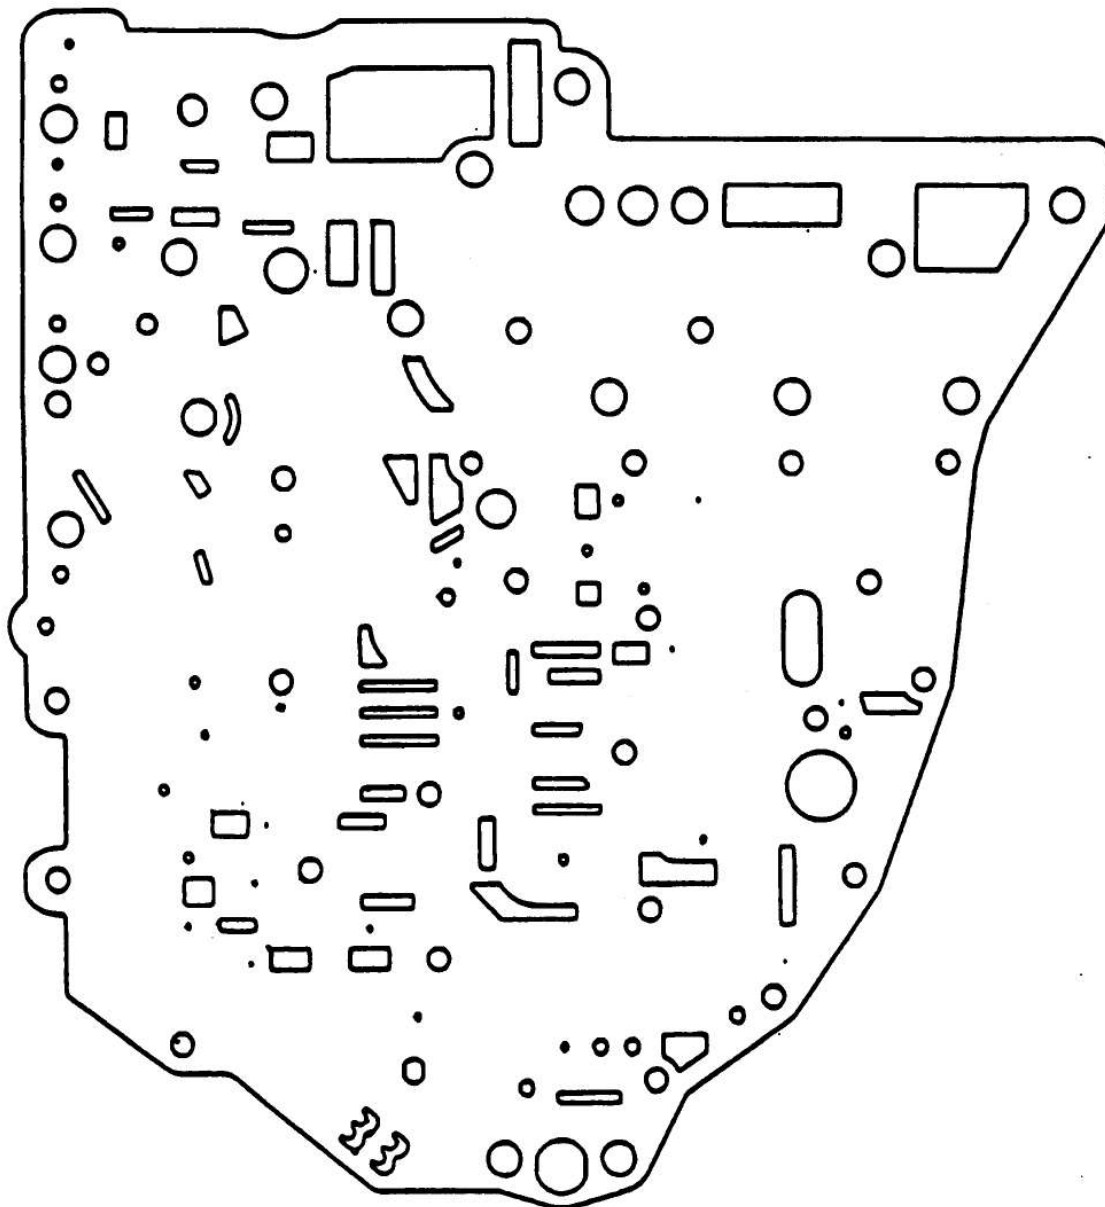
### **CHRYSLER A604 1ST DESIGN "33" SPACER PLATE**

**FITS ONLY VALVE BODY CASTING NUMBER 4446639**

**FITS ONLY TRANSFER PLATE CASTING NUMBER 4446640**
