## CHRYSLER A604 (41TE) UPDATE HANDBOOK

# **INTRODUCTION**

## **CHRYSLER A604 (41TE)**

### **"UPDATE HANDBOOK"**

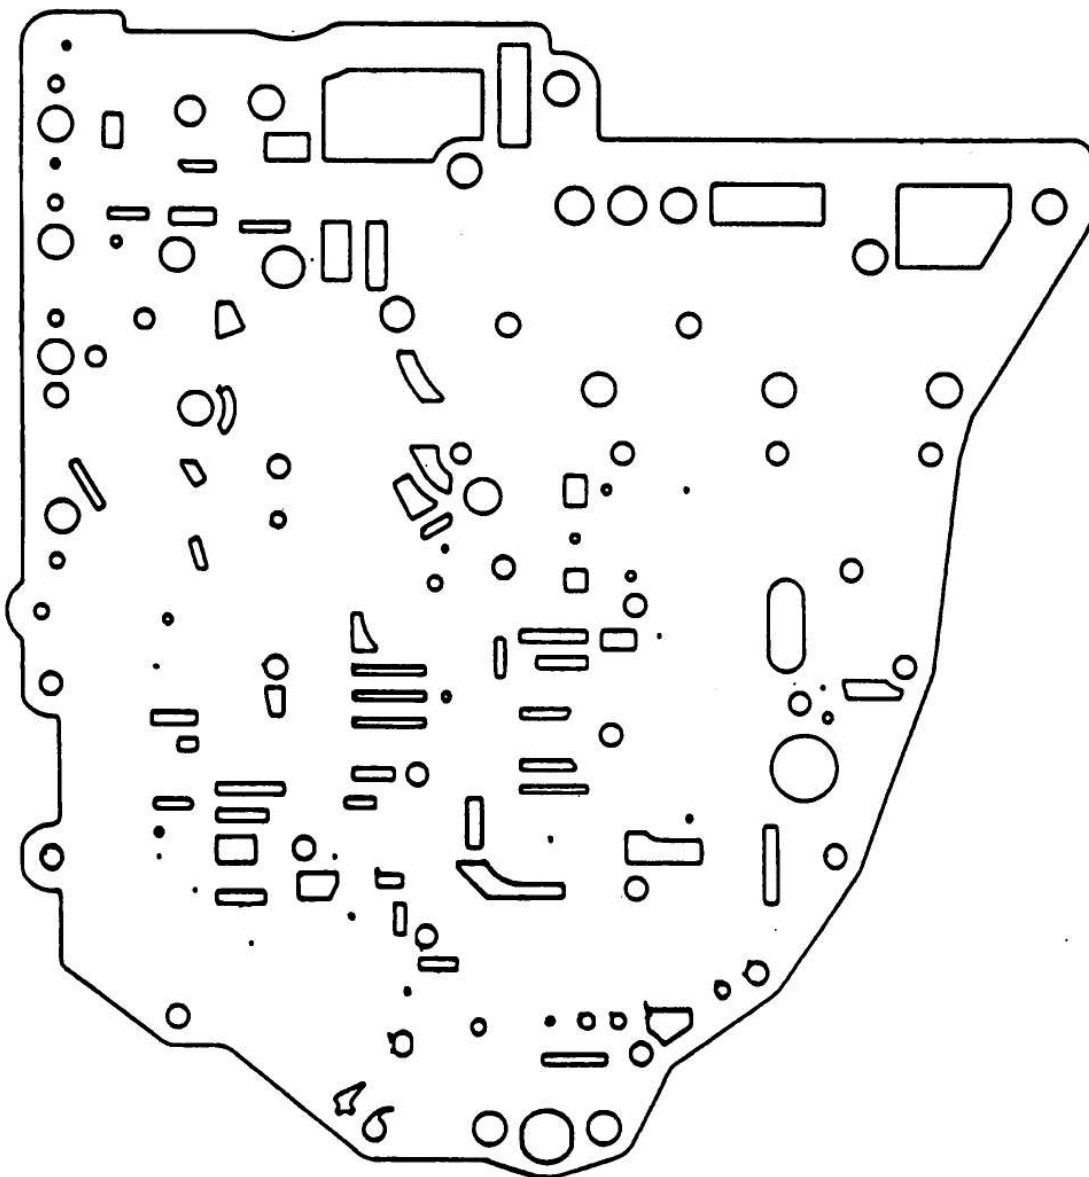
### **CHRYSLER A604 2nd DESIGN "46" SPACER PLATE**

**FITS ONLY VALVE BODY CASTING NUMBER 4511644**

**FITS ONLY TRANSFER PLATE CASTING NUMBER 4511645**

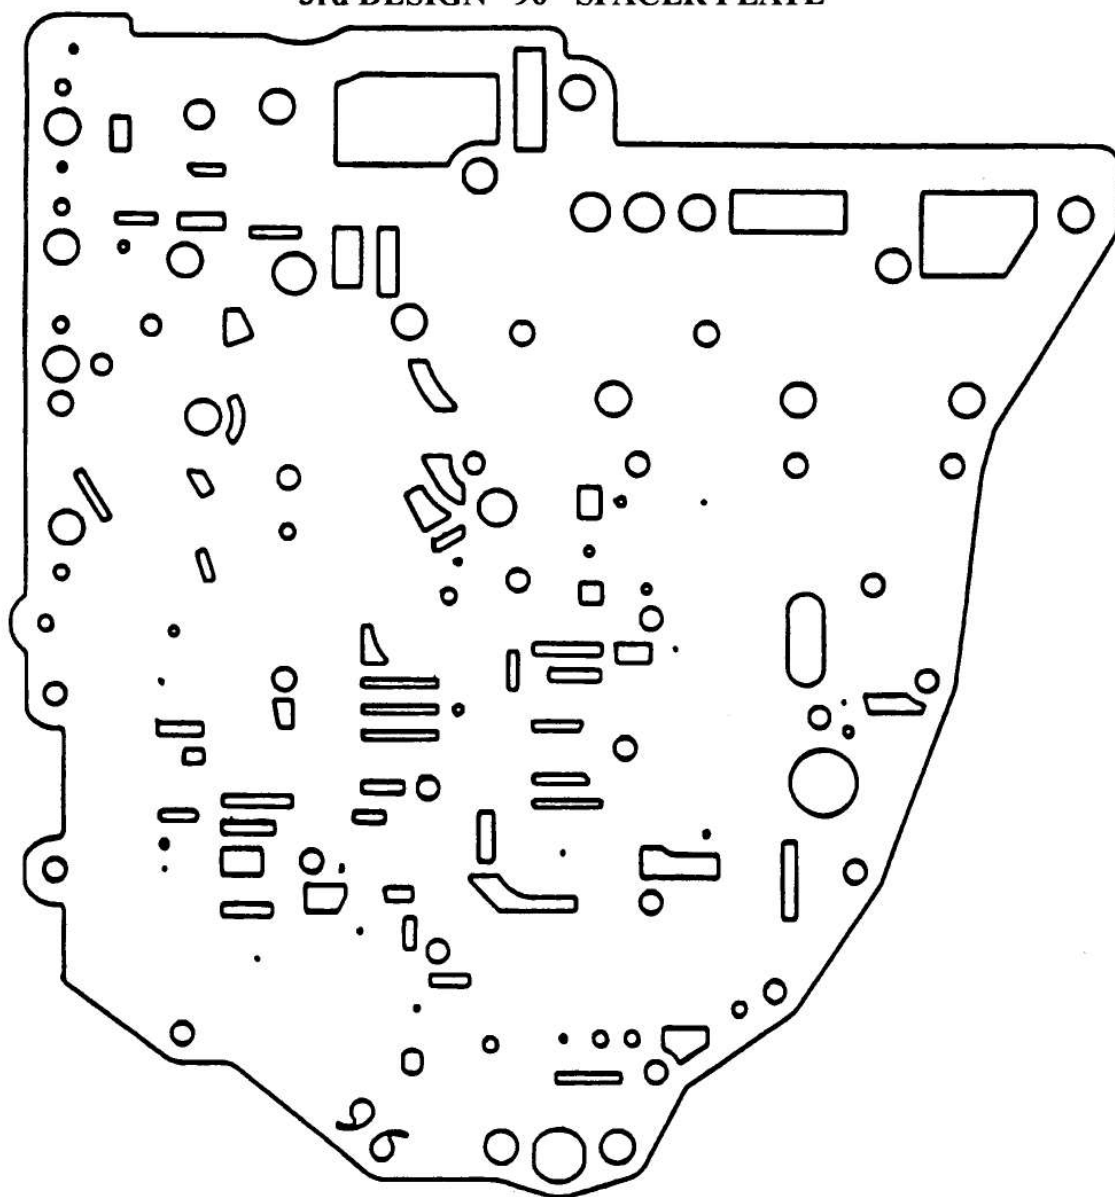
**CHRYSLER A604**  
**3rd DESIGN "96" SPACER PLATE**

**FITS ONLY VALVE BODY CASTING NUMBER 4511644**

**FITS ONLY TRANSFER PLATE CASTING NUMBER 4511645**

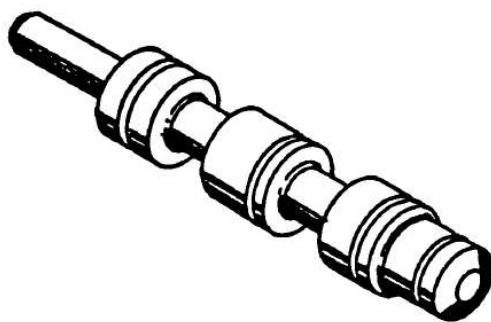
**CHRYSLER A604  
TORQUE CONVERTER CONTROL VALVE**

**1ST DESIGN**

**1ST DESIGN USES "33" SPACER PLATE**

- (3) **TORQUE CONVERTER CONTROL VALVE** - 2nd design valve is made of aluminum instead of steel, and the land configuration is different than the 1st design (See Figure 58 and 59).

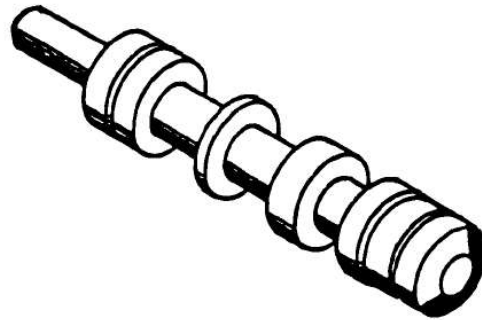
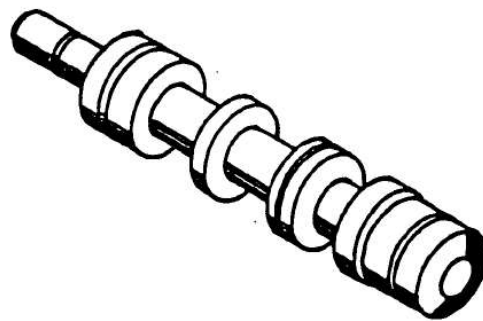
Figure 59

**CHRYSLER A604  
T/C CONTROL VALVE CHANGES  
(TO REDUCE REVERSE BUZZ)**

**2ND DESIGN**

**3RD DESIGN**

**2ND DESIGN USES "46" SPACER PLATE  
3RD DESIGN USES "96" SPACER PLATE**

- (1) TORQUE CONVERTER CONTROL VALVE - 3rd design valve has two of the lands made .020" thicker than the previous, and has "Groove" cut into stem for I.D. (See Figure 59).
- (2) TORQUE CONVERTER CONTROL VALVE SPRING - Calibration changes to accommodate the new design TCC Control valve.
- (3) VALVE BODY SPACER PLATE - 3rd design is identified with "96" stamped in plate, and 2nd design is identified with "46" stamped in plate. The 3rd design "96" spacer plate has calibration changes to the new TCC control valve. (See Figures 56 and 57).

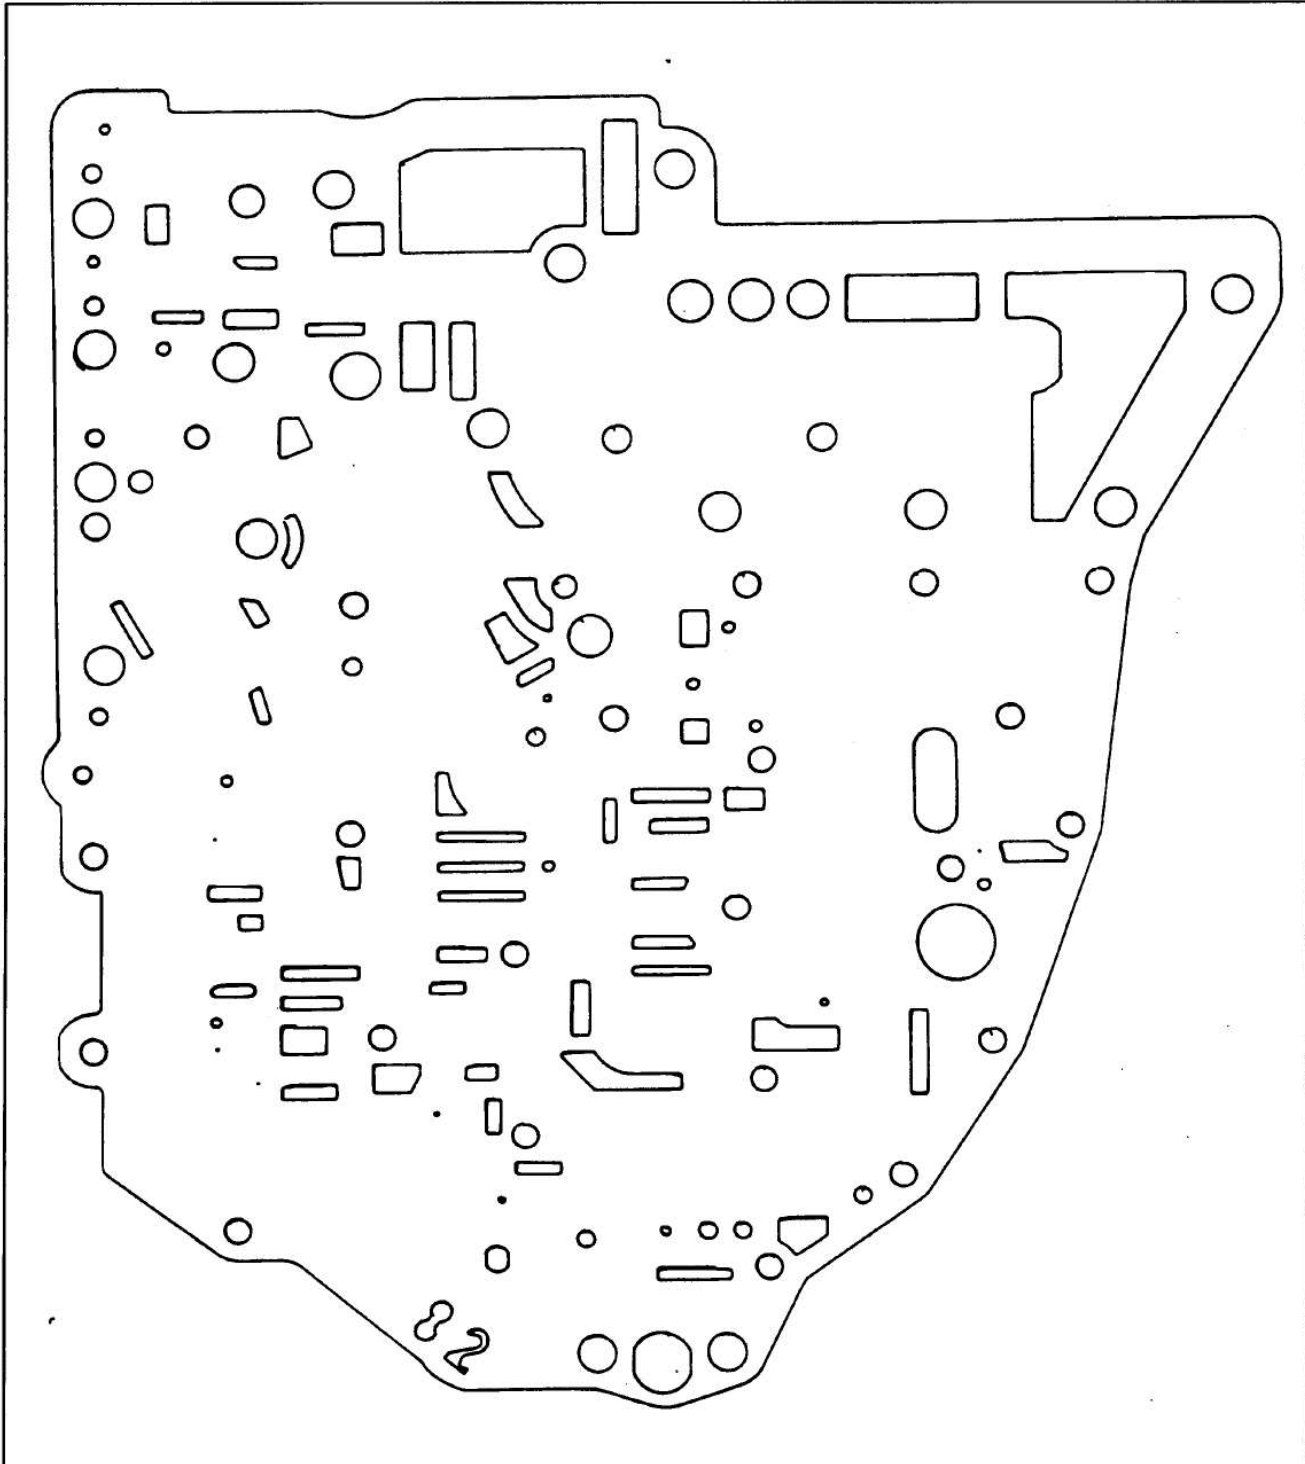
Figure 60

**NEW A604 SPACER PLATE**

The new "82" spacer plate replaces the previous "96" spacer plate and can retrofit back to all valve bodies and Transfer Plates that use the # 96 spacer plate **provided that the new pressure regulator valve is used together with the # 82 spacer plate.** Valve bodies that use a 96 spacer plate has a casting number of 4511644 (See Figure 52 on Page 68). Transfer Plates that use the # 96 spacer plate has a casting number of 4511645 (See Figure 54 on Page 70).

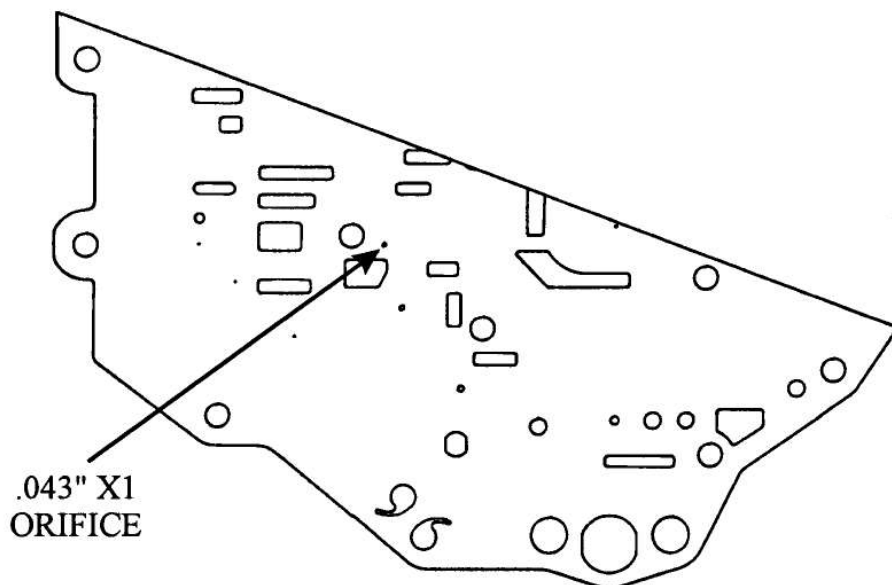
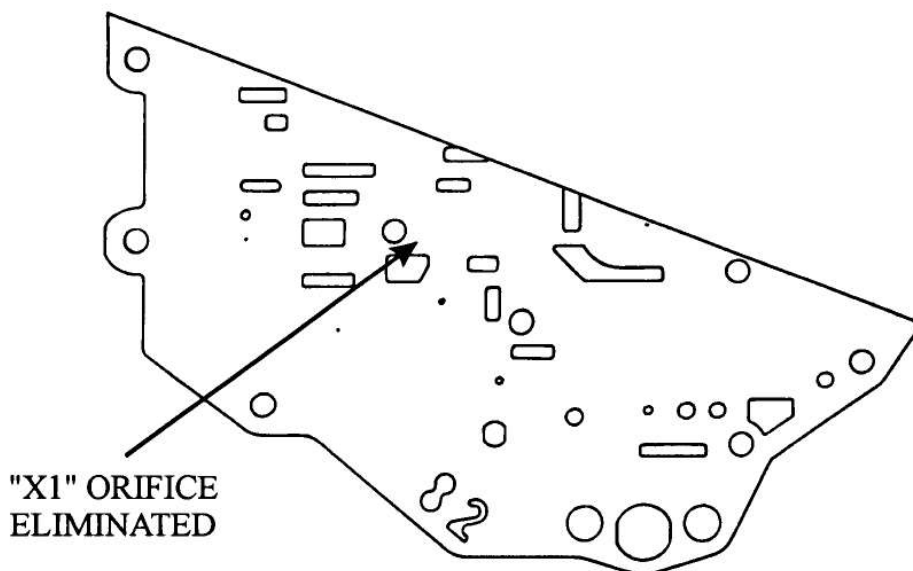
Figure 62

.043" X1  
ORIFICE

**PREVIOUS # 96 SPACER PLATE WITH THE "X1" (.042") ORIFICE**

"X1" ORIFICE  
ELIMINATED

**NEW # 82 SPACER PLATE WITH THE "X1" ORIFICE ELIMINATED**

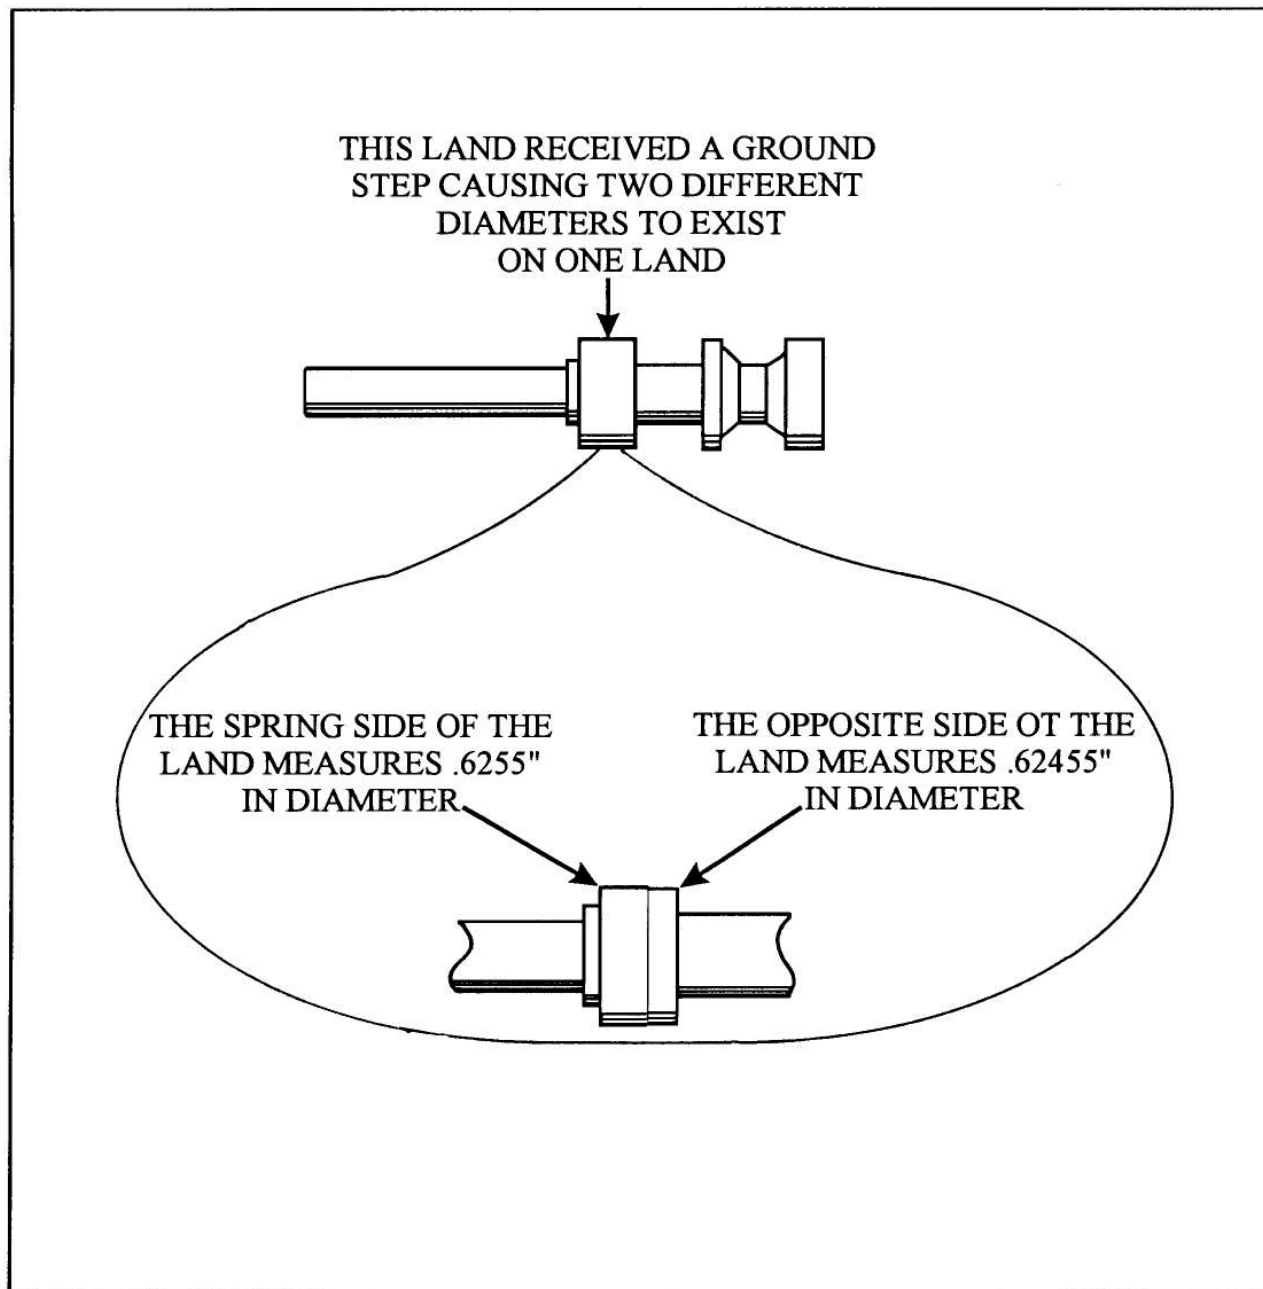
Figure 63

### PRESSURE REGULATOR VALVE

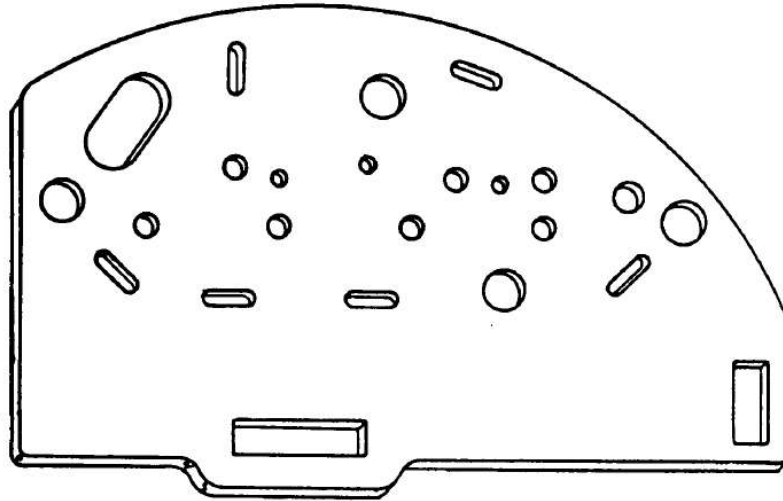
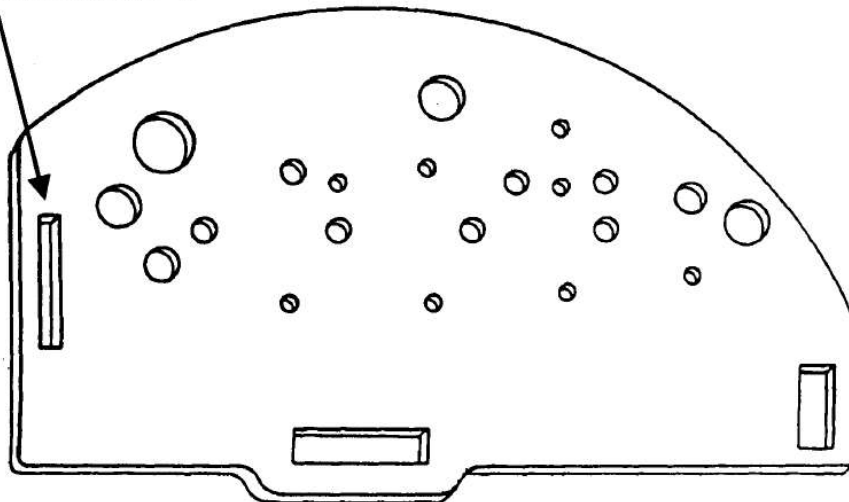
Figure 64

### CHRYSLER A604 REVISED SOLENOID PLATE

**PREVIOUS DESIGN**

**SLOT FOR LOCKING  
TAB ADDED HERE**

**NEW DESIGN**

- (1): **SOLENOID SOUND COVER** - An additional locking tab was added to the sound cover for a more secure fit to the solenoid spacer plate.
- (2): **SOLENOID SPACER PLATE** - The solenoid spacer plate received an added slot to accommodate the additional locking tab made to the solenoid sound cover. There were also subtle changes made to the venting holes and slots found in the spacer plate (See Figure 64).

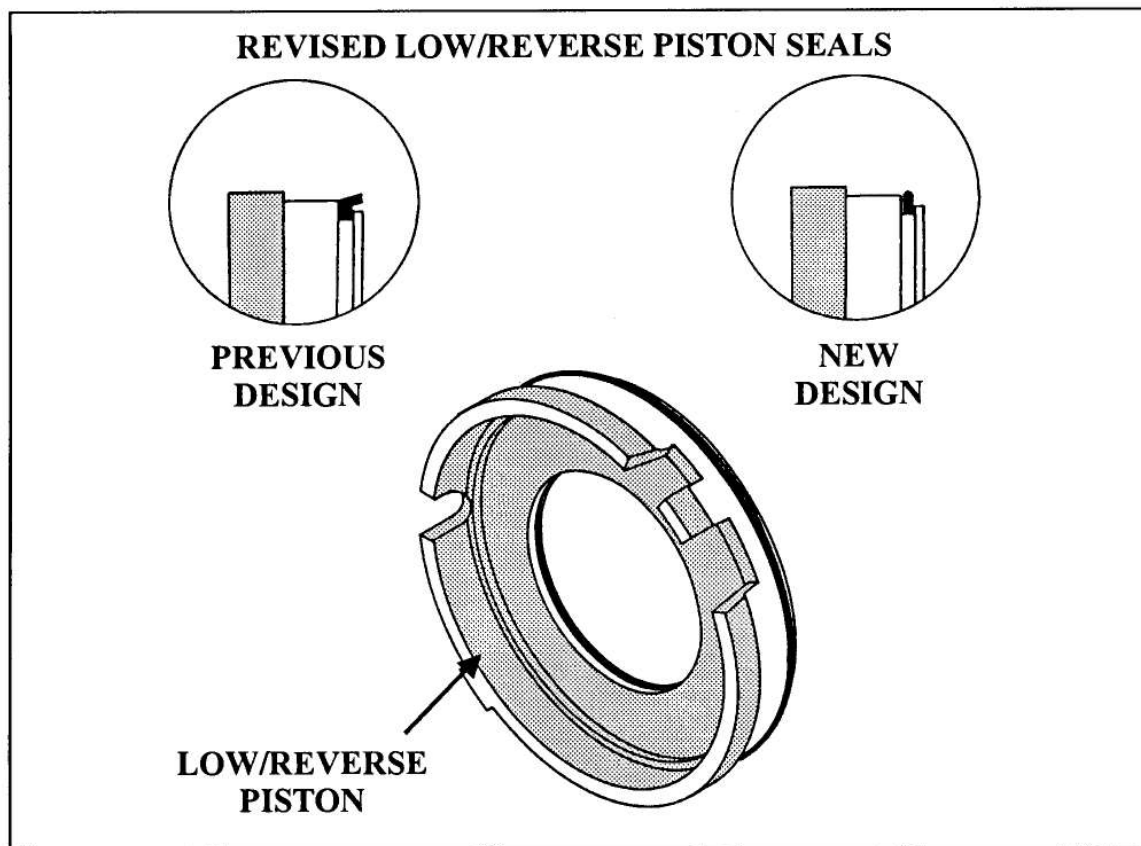
Figure 65

**CHANGE:** Beginning at the start of production for 1995 model year, all Chrysler A604 (41TE) and A606 (42LE) transaxles were produced using revised seals for the Low/Reverse piston. The previous "Lip" type seals have been replaced by a "D" Ring type seal for both inner and outer seals, as shown in Figure 65.

- (1) **LOW/REVERSE PISTON SEALS** - Both the inner and outer lip seals have been replaced by a "D" Ring type seal, as shown in Figure 65. There were no dimensional changes necessary to the Low/Reverse piston to accommodate the new "D" Ring seals. The seals are available under OEM part number 4659185 for the outer seal, and 4659184 for the inner seal.

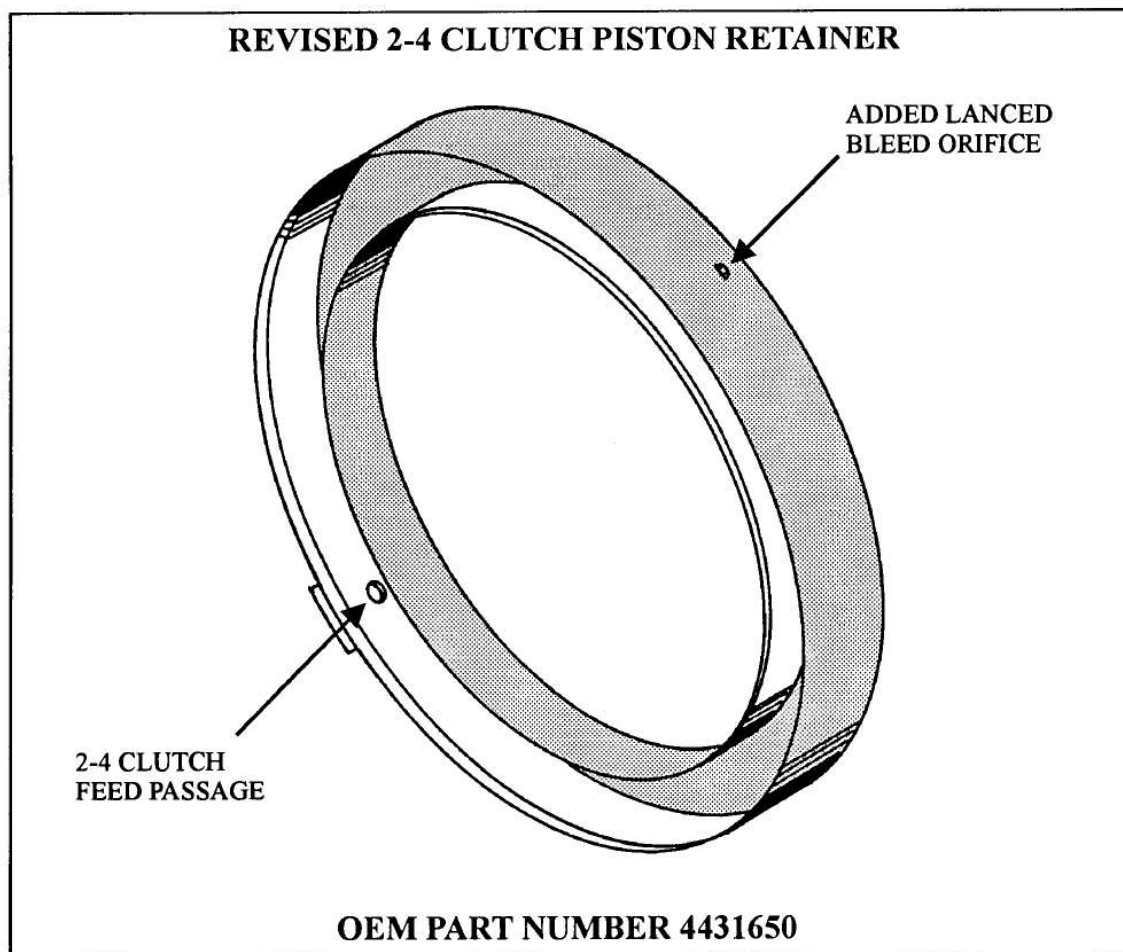
Figure 66

**CHANGE:** Beginning at the start of production for the 1995 model year, all Chrysler A604 (41TE) and A606 (42LE) transaxles were produced using a revised 2-4 Clutch Piston Retainer with an added lanced bleed orifice (See Figure 66).

- (1) 2-4 CLUTCH PISTON RETAINER - Lanced bleed orifice added to the retainer in the location shown in Figure 66.

The revised 2-4 Clutch Piston Retainer with the added lanced bleed orifice will back service ALL previous models of Chrysler A606 (41TE) and A606 (42LE) transaxles. There was not a part number change, so the revised retainer is available under OEM part number 4431650.

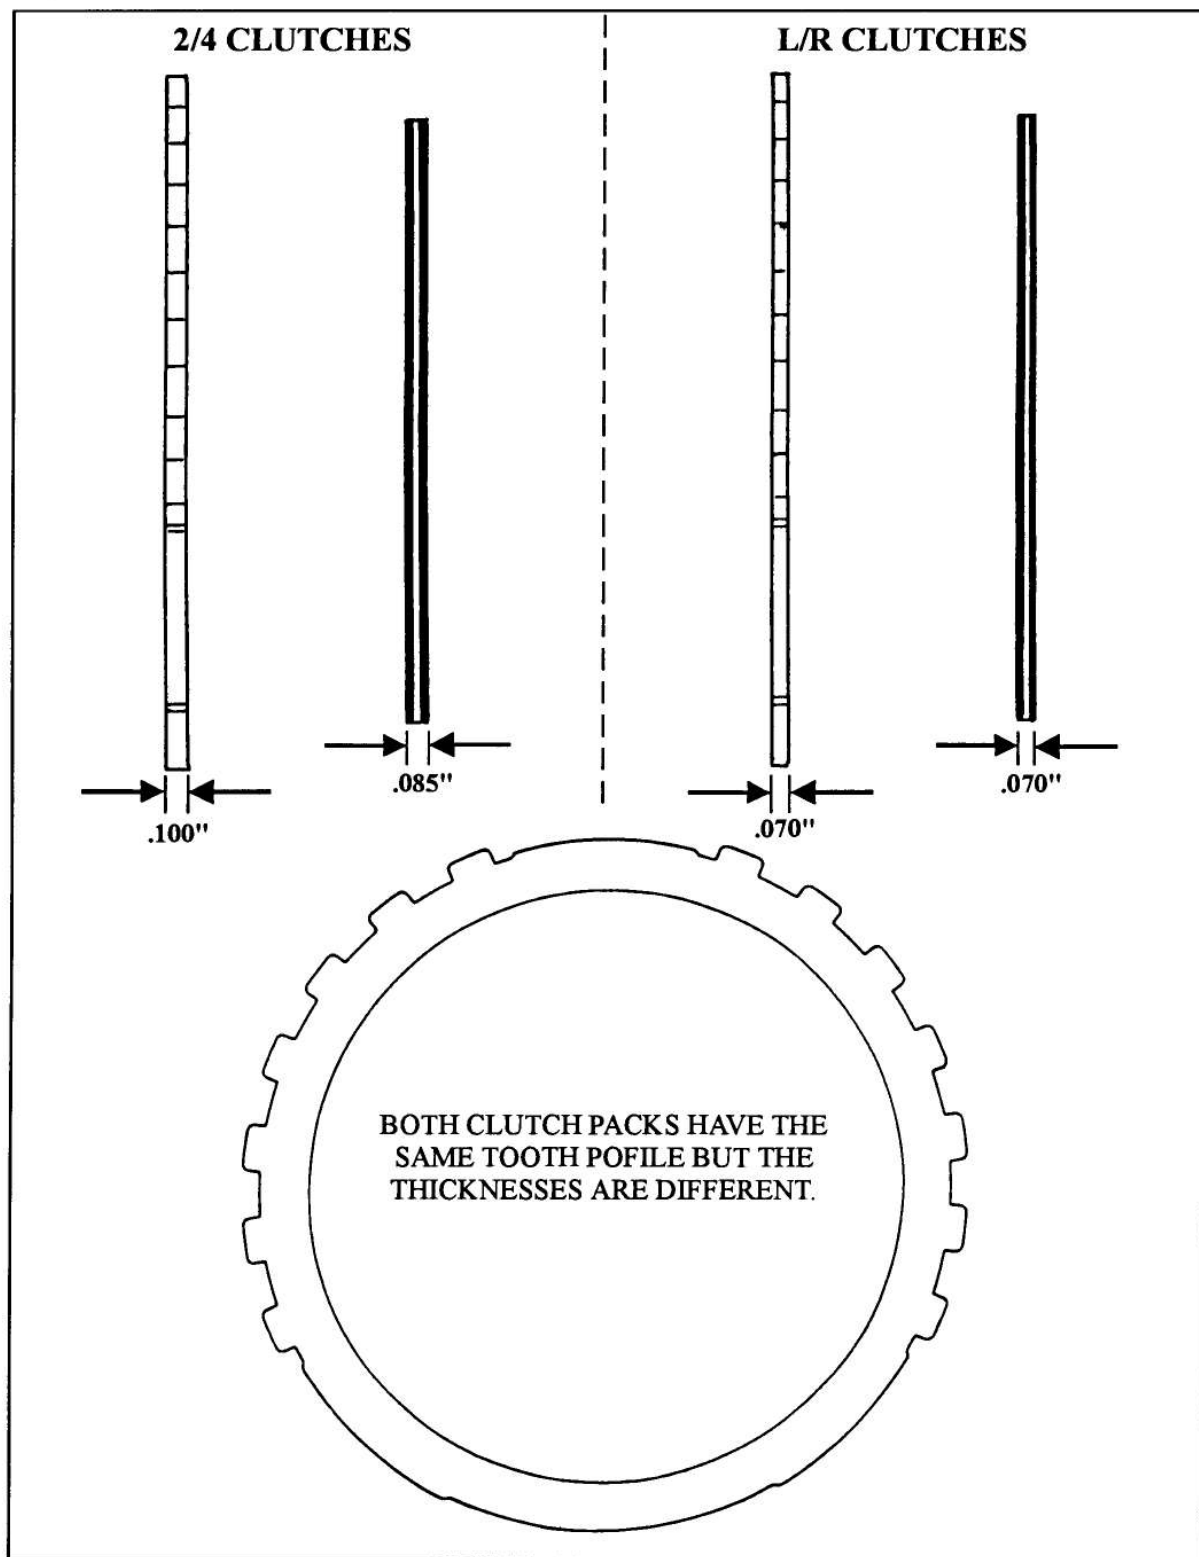
Figure 67

- (1) Both clutch packs, on the steel plates, have the same tooth profile, but the thicknesses are different (See Figure 67).
  - A. 2/4 STEEL PLATE THICKNESS IS .100" (4 Required).
  - B. L/R STEEL PLATE THICKNESS IS .070" (5 Required).
- (2) Both clutch packs, on the lined plates, have the same tooth count and the same lining, but the thicknesses are different (See Figure 67).
  - A. 2/4 LINED PLATE THICKNESS IS .085" (4 Required).
  - B. L/R LINED PLATE THICKNESS IS .070" (5 Required).

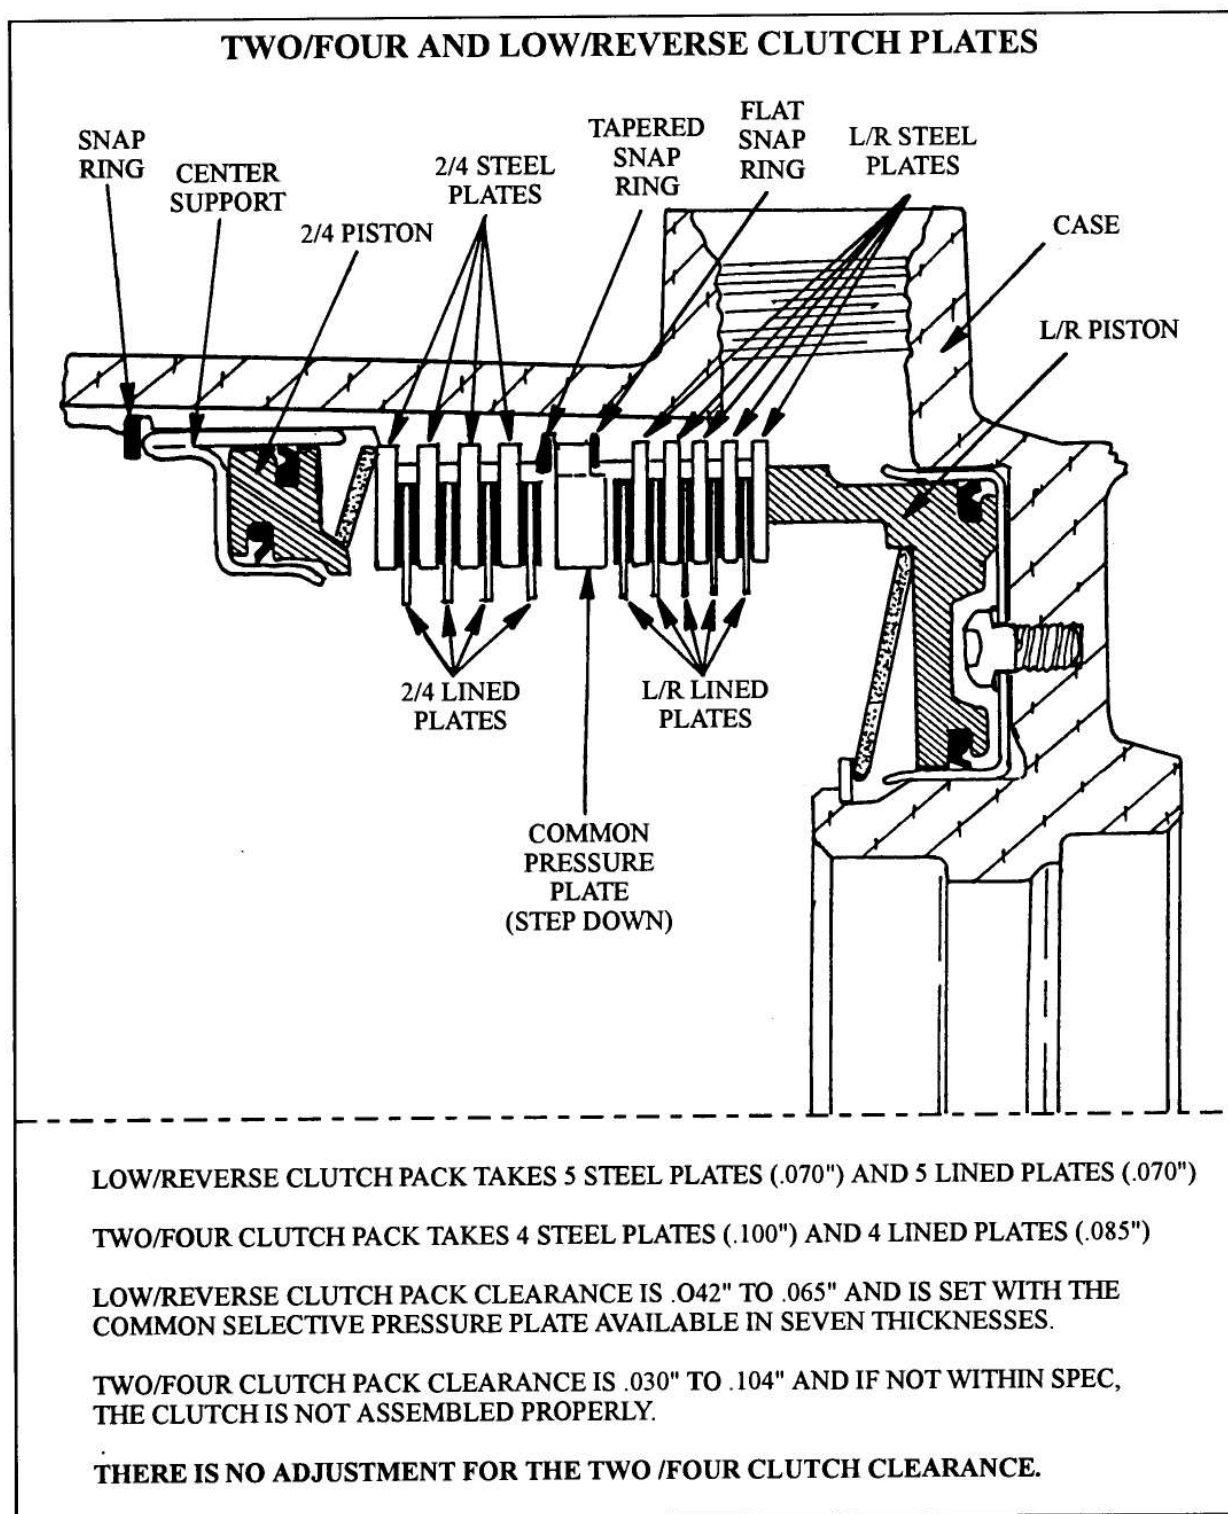
We have provided you with the correct clutch plate arrangement to assist you with proper assembly of the 2/4 and L/R clutch packs. Refer to Figure 68 for proper assembly procedures.

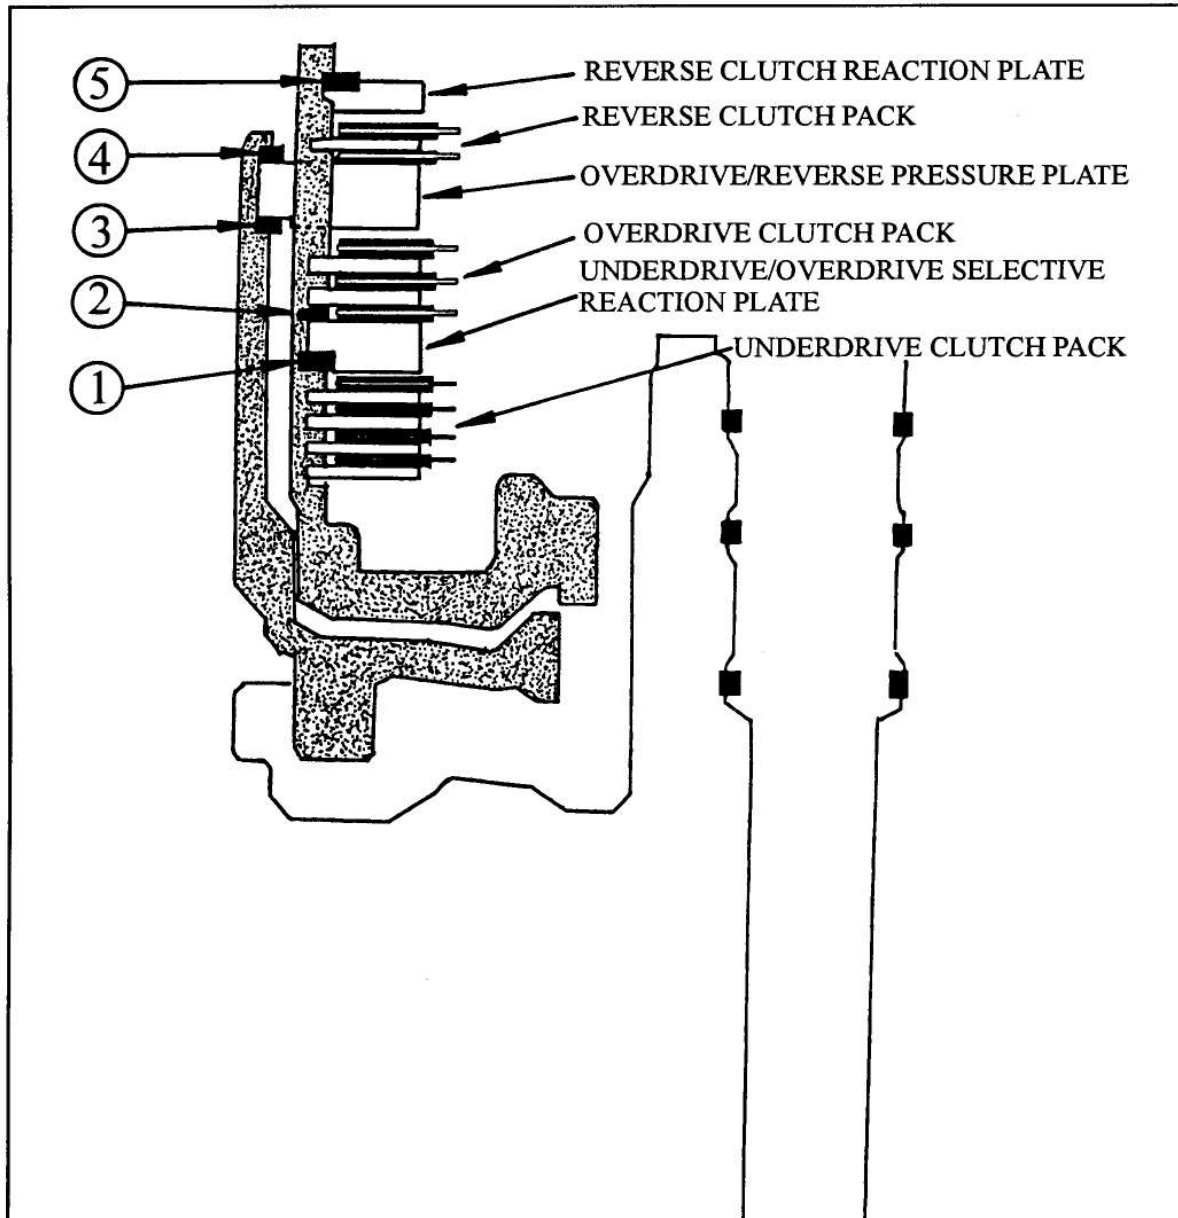
Figure 69

## CHRYSLER A604 INPUT CLUTCH RETAINER SNAP RING LOCATION AND IDENTIFICATION

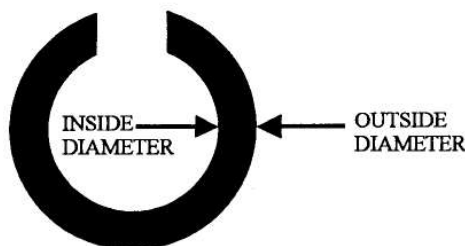
This is a FLAT "Non-Selective" snap ring used on the bottom side of Underdrive/ Overdrive Selective Reaction Plate, and is approximately .060" thick. This snap ring is often confused with the Reverse Clutch reaction Plate "Selective" Snap Ring (Snap Ring No. 5). Refer to the selective chart under snap ring No. 5, and notice that the the snap ring could be .061" thick, so both snap rings could be installed in the wrong locations. **TO IDENTIFY THE PROPER SNAP RING** - Measure the width of the snap ring from the inside diameter to the outside diameter (See Illustration Below).

Ring No. 1, Underdrive/Overdrive Non-Selective Snap Ring is approximately .173"

Ring No. 5, Reverse Clutch Selective Snap Ring is approximately..... .153"

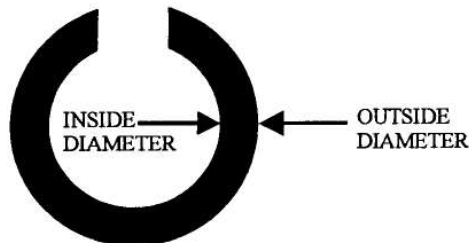
This is a FLAT "Selective" snap ring used on top of the Reverse Clutch Reaction Plate. There are 4 different selective thickness snap rings to set the reverse clutch pack clearance, and are listed in the chart below along with their part numbers. This flat snap ring is often confused with the flat snap ring used on the bottom side of the Underdrive/Overdrive Reaction Plate (Snap Ring No. 1), which is approximately .060" thick. Refer to the chart below, and notice that the reverse clutch selective snap ring could be .061" thick, so both snap rings could be installed in the wrong locations.

**TO IDENTIFY THE PROPER SNAP RING** - Measure the width of the snap ring from the inside diameter to the outside diameter (See Illustration Below).

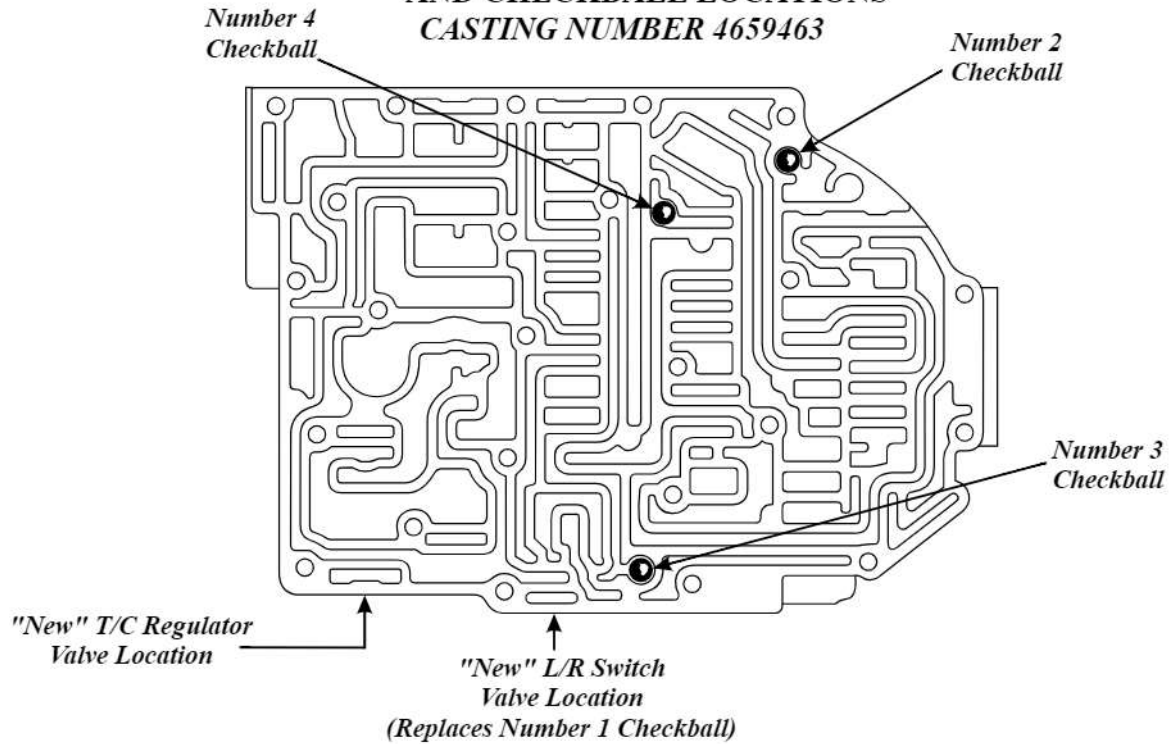
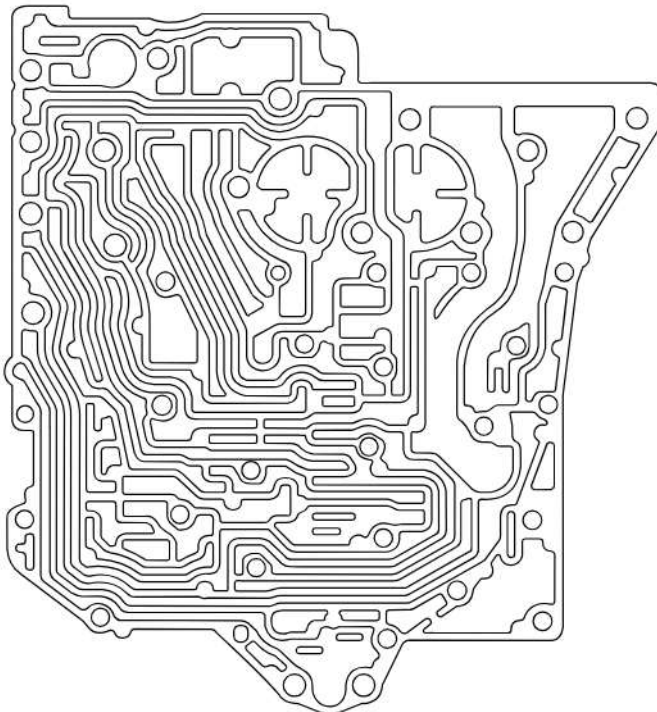
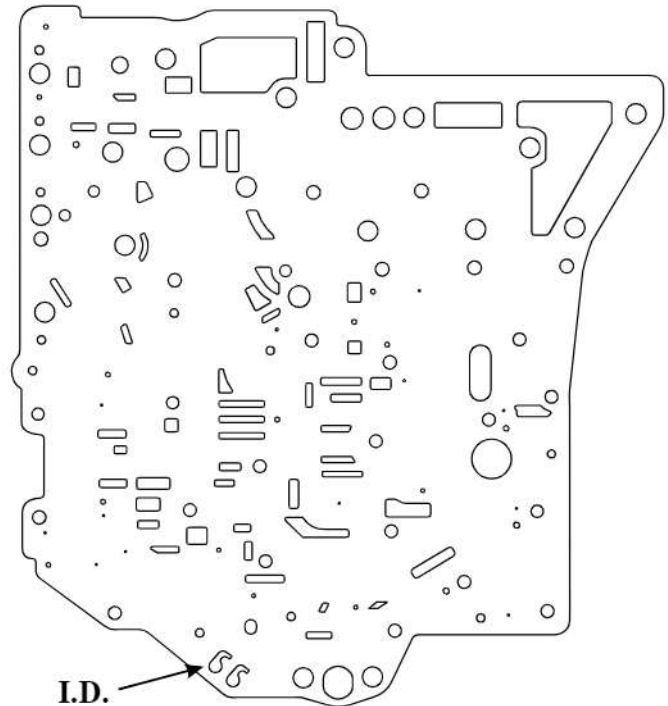
Figure 72  
Automatic Transmission Service Group

Number stamped for identification into new spacer plate is "66" (See Figure 72).

## 1995 A604 VALVE BODY CHANNELS AND CHECKBALL LOCATIONS CASTING NUMBER 4659463

## 1995 A604 TRANSFER PLATE OIL CHANNELS CASTING NUMBER 4659465

## 1995 A604 SPACER PLATE

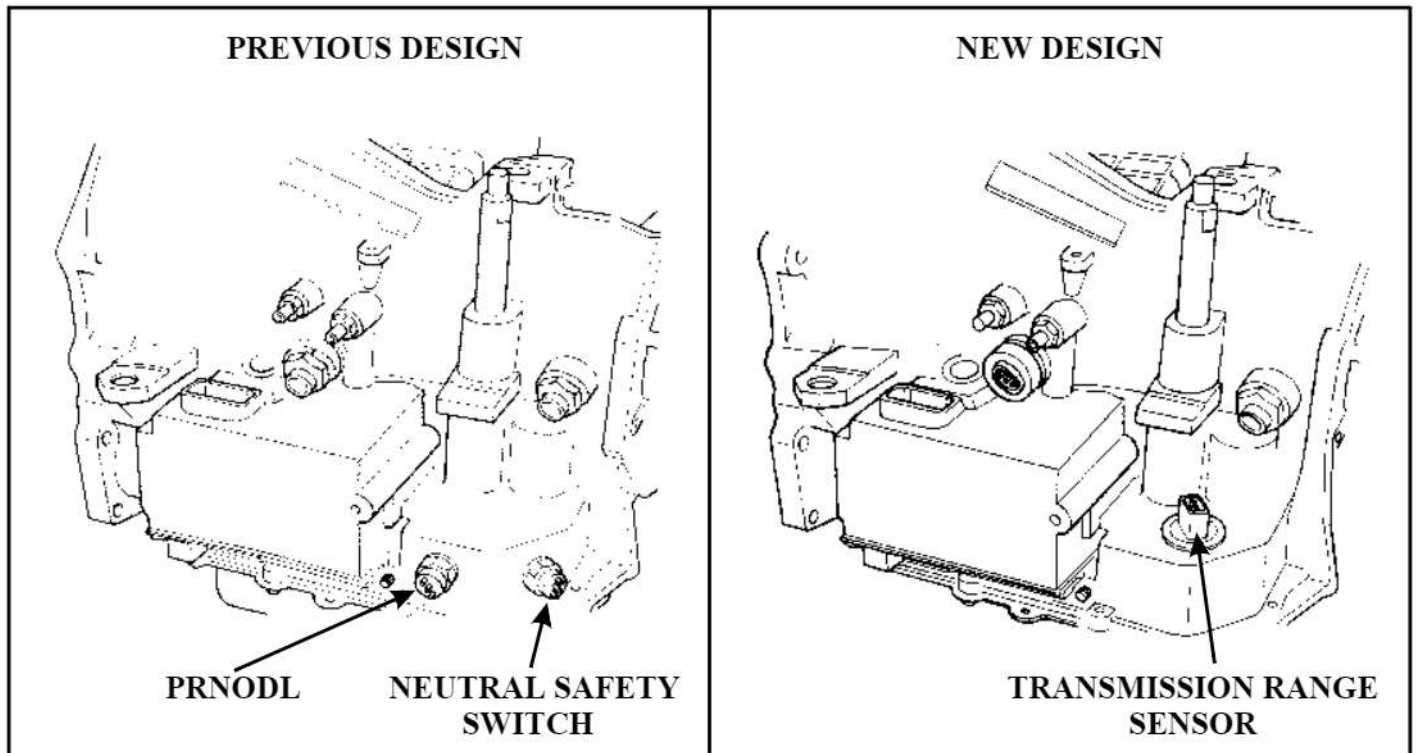
Figure 73

**CHANGE:** Beginning at the start of production 1996, some models equipped with the 41TE (A604) transaxle replaced the PRNODL and Neutral Safety Switch with a Transmission Range Sensor as seen in Figure 73.

- (1) PRNODL SWITCH - The previously used Park, Reverse, Neutral, Overdrive, Drive, Low Switch (PRNODL) has been eliminated and replaced with the new Transmission Range Sensor (See Figure 73).

- (2) NEUTRAL SWITCH - The previously used Neutral Switch has been eliminated and replaced with the new Transmission Range Sensor (See Figure 73).
- (3) TRANSAXLE CASE - The casting of the case change with the elimination of the two threaded holes for the PRNODL and Neutral Safety Switch. An access hole has been added to accommodate the new TRS sensor connector as the switch which is mounted on the valve body (See Figure 73).

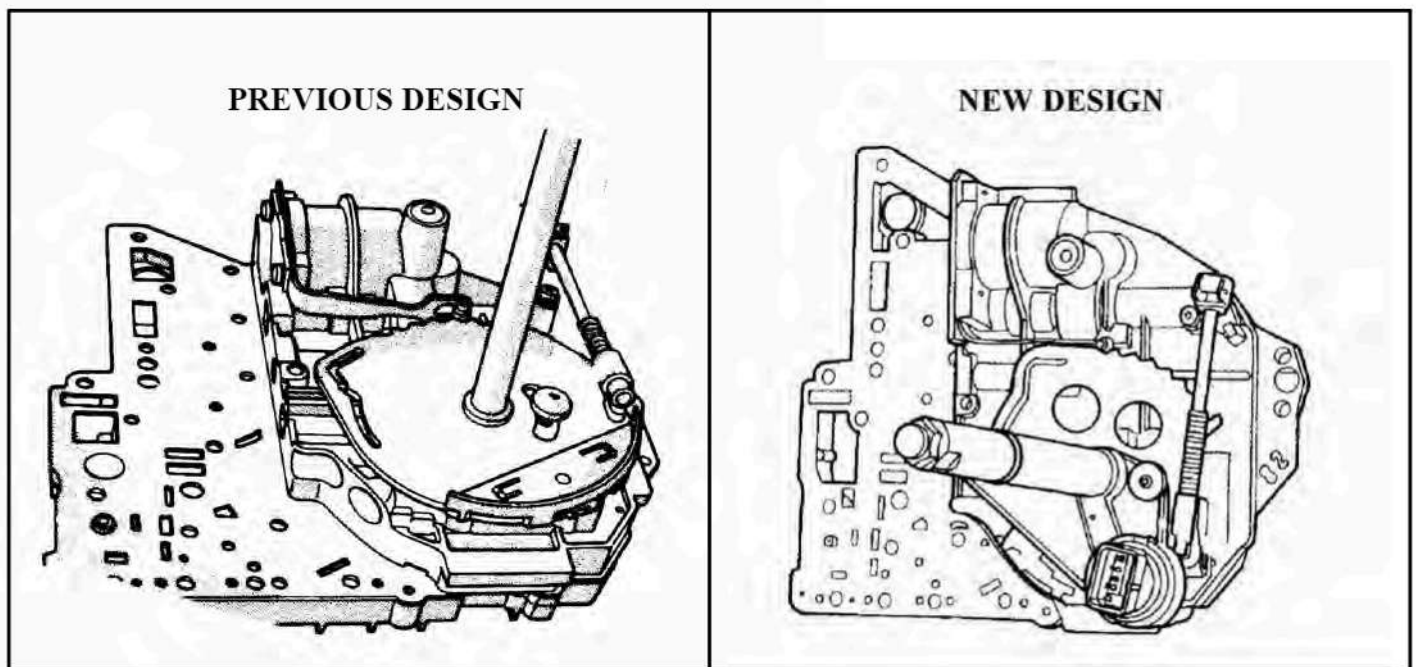
Figure 74

- (4) VALVE BODY - The manual arm shaft and rooster comb assembly and the valve body changed in design to accommodate the mounting of the new TRS sensor (See Figure 74).

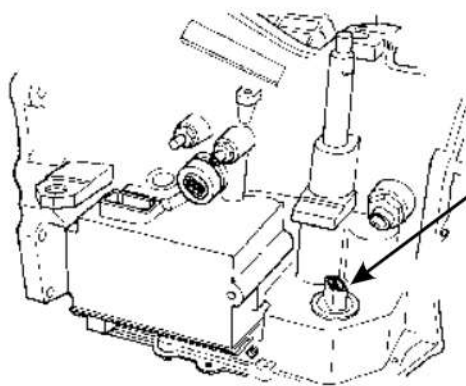
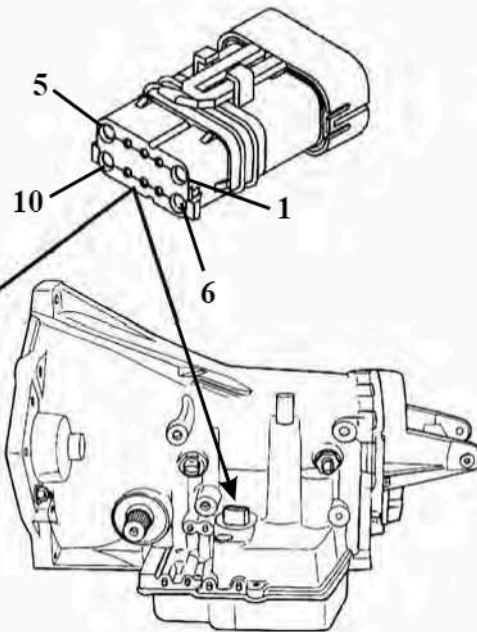
A scanner can be used to observe the OPEN/CLOSED state of the C1/T41, C2/T42, C3/T3 and the C4/T1 circuits. This can be especially helpful in determining which exact circuit is malfunctioning. Refer to Figure 75 for the Open/Closed status chart and circuit identification. Refer to Pages 99 and 100 for diagnostic routines for the new TRS.

## TRANSMISSION RANGE SENSOR (TRS)

41TE

42LE

Once the circuit which malfunctioned has been identified, a continuity check should be made on that circuit. Use the chart found in Figure 75 to assist in identifying the specific circuit or circuits in question. For example, if the scanner reveals that the T3 (C3) circuit does not close when the selector lever is placed in Park, 3 or 1, that specific circuit will need to be checked. In the chart below circuit T3 is the wire which runs from the number eight cavity in the TRS connector to the number three cavity in the TCM connector.
