## CHRYSLER A604 (41TE) UPDATE HANDBOOK

# **INTRODUCTION**

## **CHRYSLER A604 (41TE)**

### **"UPDATE HANDBOOK"**

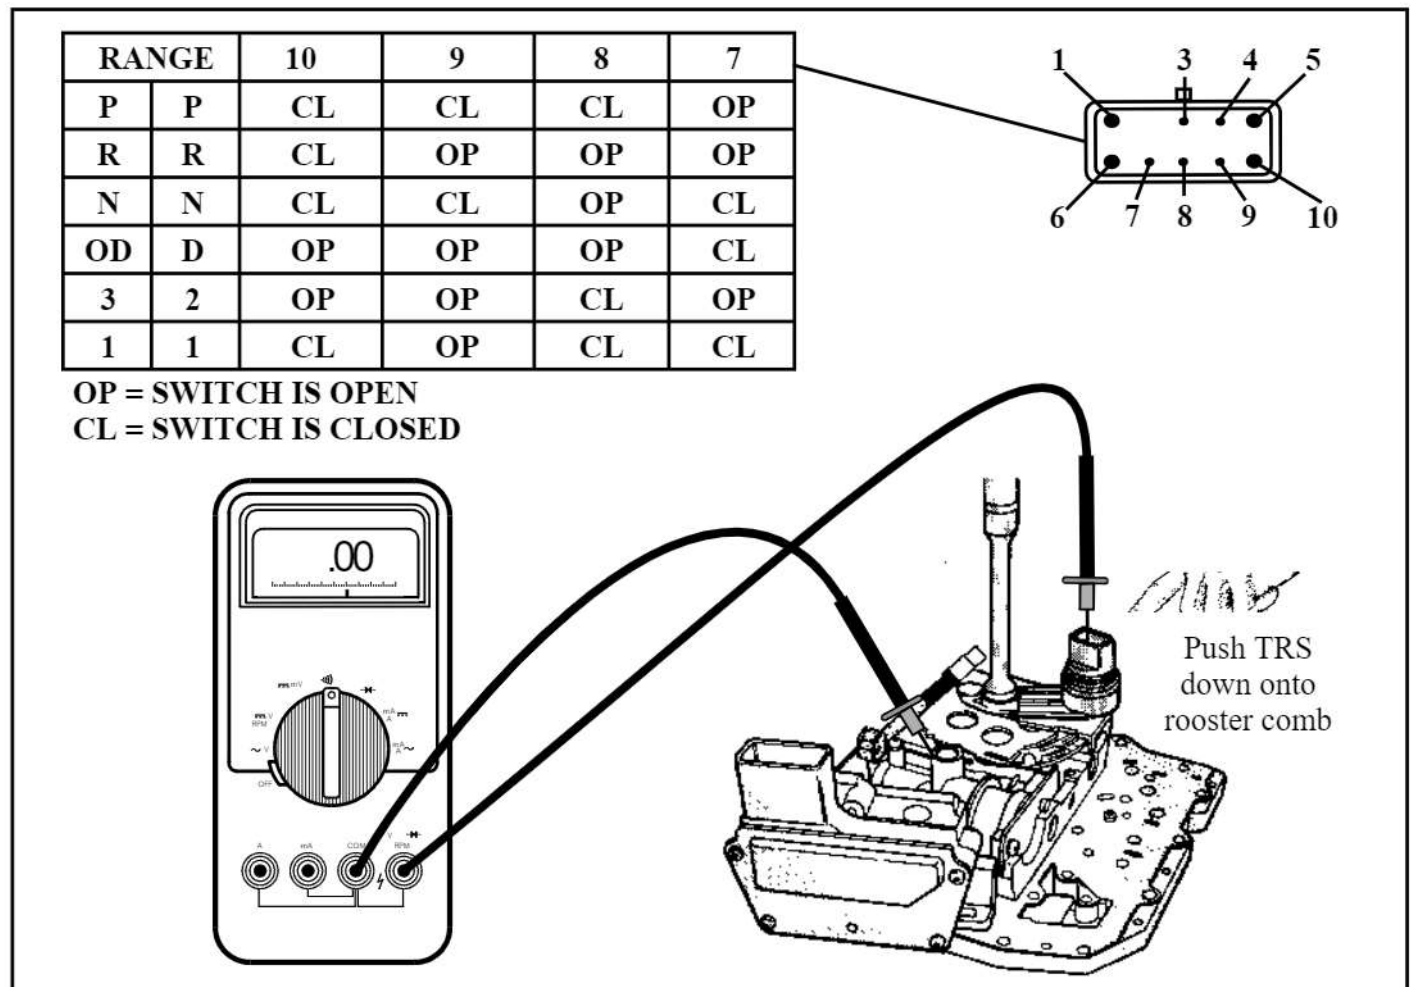
If an open circuit is seen when checking for continuity across any one of the Transmission Range Sensor wires, repair or replace the wire or wires. If continuity is seen, inspect both the TCM and TRS connector cavities for drag and that they have not been pushed back into the connector. The shank end of a drill bit may be employed to check for pin drag in the TRS connector. For cavities 7, 8 and 9, use a .035" wire gauge or a # 65 drill bit. For cavity 10, use an .089" wire gauge or a # 43 drill bit. If pin cavities are not pushed back and they have a good drag on the wire gauge test remove the valve body from the transmission. With the TRS still mounted to the valve body, place the manual valve in the park position. Fasten the negative meter lead to the metal portion of the rooster comb (See Figure 5). While pushing the switch down onto the rooster comb with one hand, use the positive meter lead to make contact with pins 7, 8, 9 and 10 individually. Approximately .05 to 1.5 ohms should be seen on each pin except # 7, it should read open. Use the chart in Figure 76 to check the TRS in each manual valve selection. Replace the TRS sensor if necessary. If all ranges test good, replace the TCM.

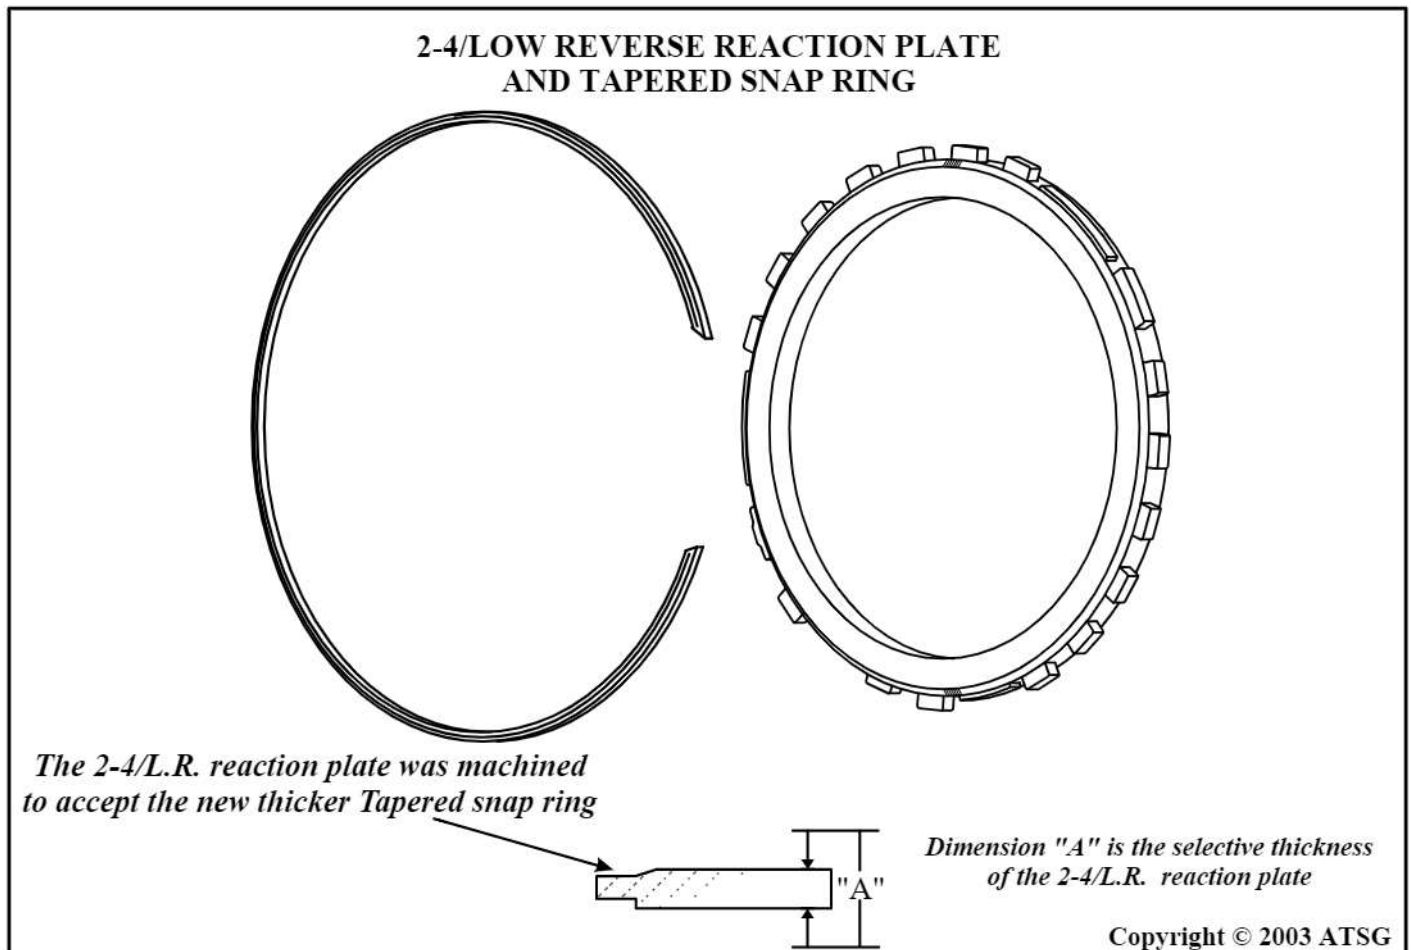
Figure 77  
Automatic Transmission Service Group

**CHANGE:** Some time in 1999, four of the previous 2-4/Low Reverse Reaction Plate selectives were changed to accommodate a new Tapered Snap Ring as shown in Figure 77.

**NOTE:** *The thicker tapered snap ring is included in the new 2-4/Low Reverse Reaction Plate package when the Part Number ends with "AA."*

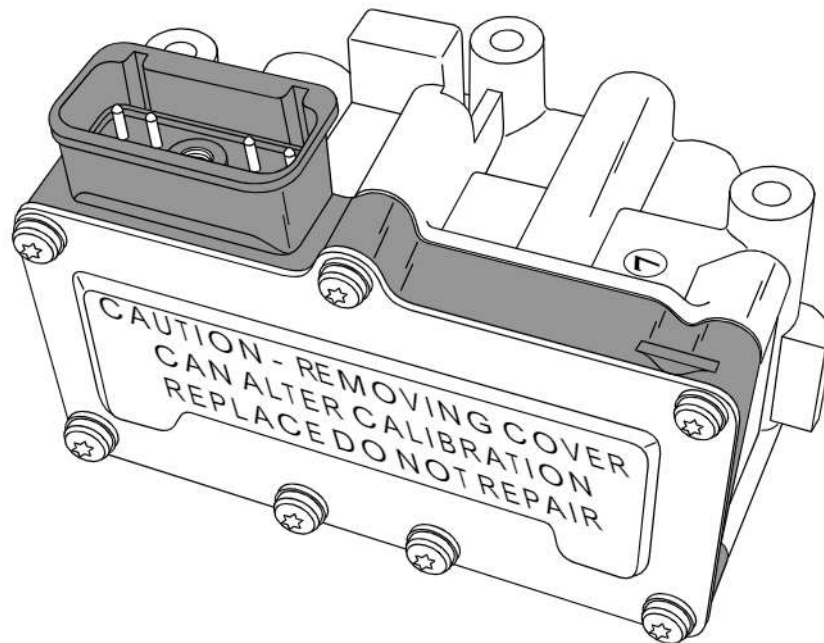
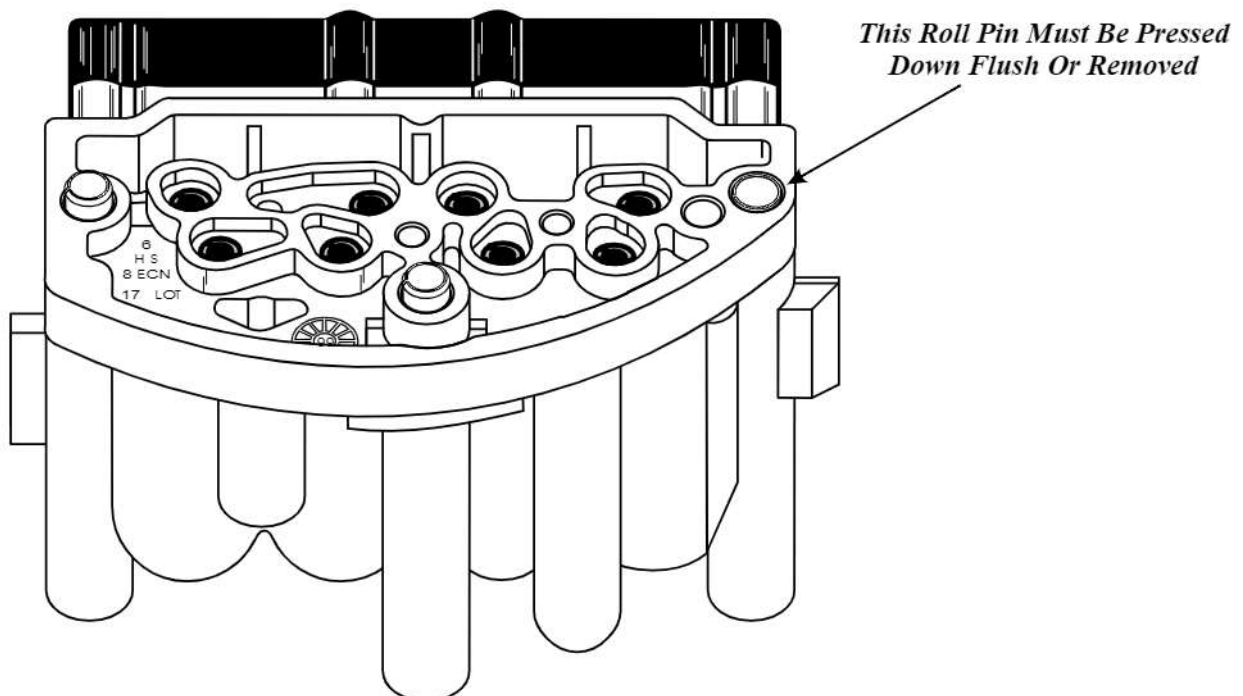
Figure 78

**CHANGE:** A new design Solenoid Pack has been introduced as a running change in the 1999 model year for *all* 41TE (A604) transaxles, as shown in Figure 78. This new design Solenoid Pack, available under OEM part number 5015646AB, will also be used for service, as the previous design solenoid pack is no longer available from Chrysler.

***Special Note: Most early cases will require that you either press the rear roll pin in so that it is flush with the body, or remove it, as shown in Figure 78, so that new Solenoid Body will bolt down flush with the case surface.***

## *NEW DESIGN SOLENOID PACK*

*NEW DESIGN SOLENOID PACK  
(BOTTOM VIEW)*

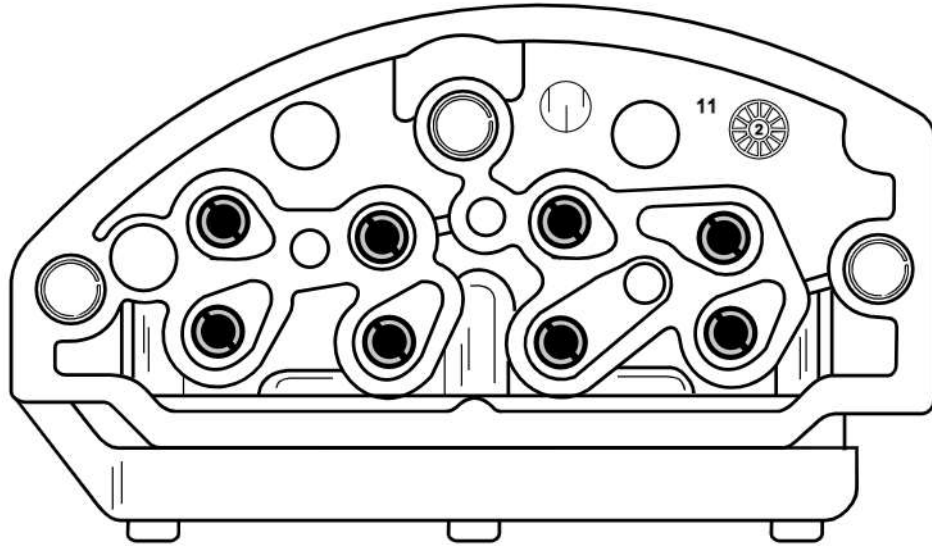
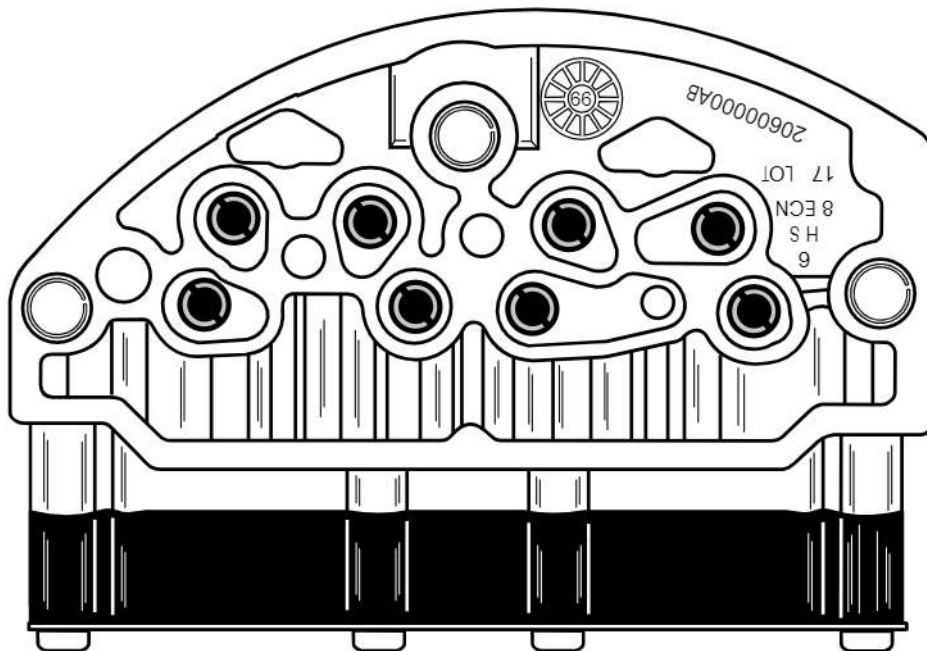
Figure 79  
*Automatic Transmission Service Group*

*Early Solenoid Pack  
(Bottom View)*

*Late Solenoid Pack  
(Bottom View)*

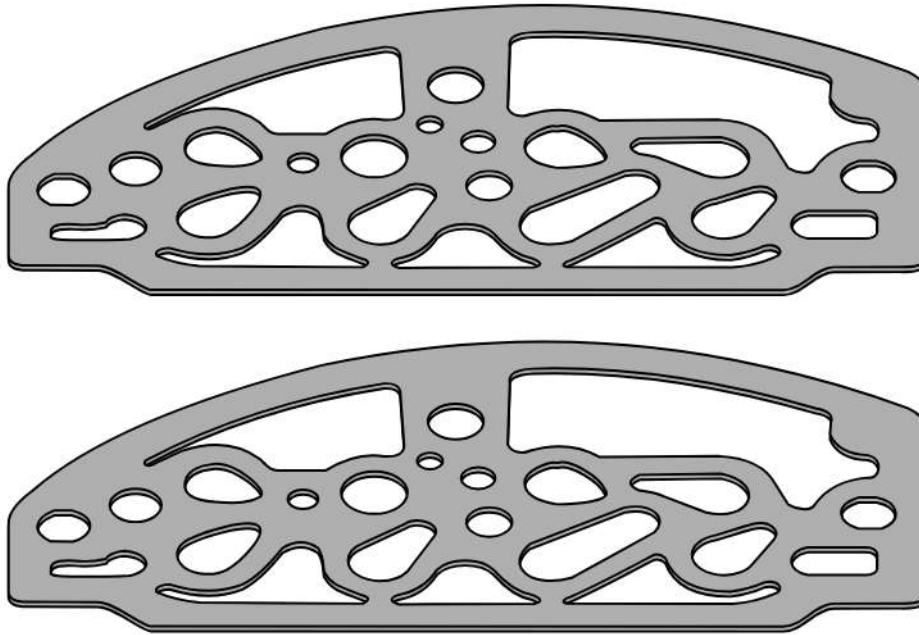
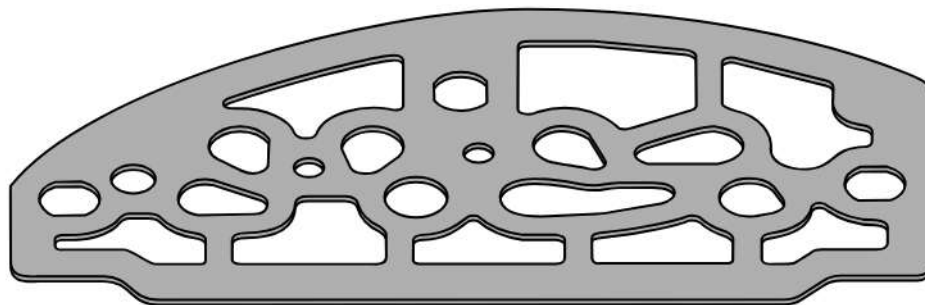
*Early Solenoid Gaskets*

*Late Solenoid Gasket*

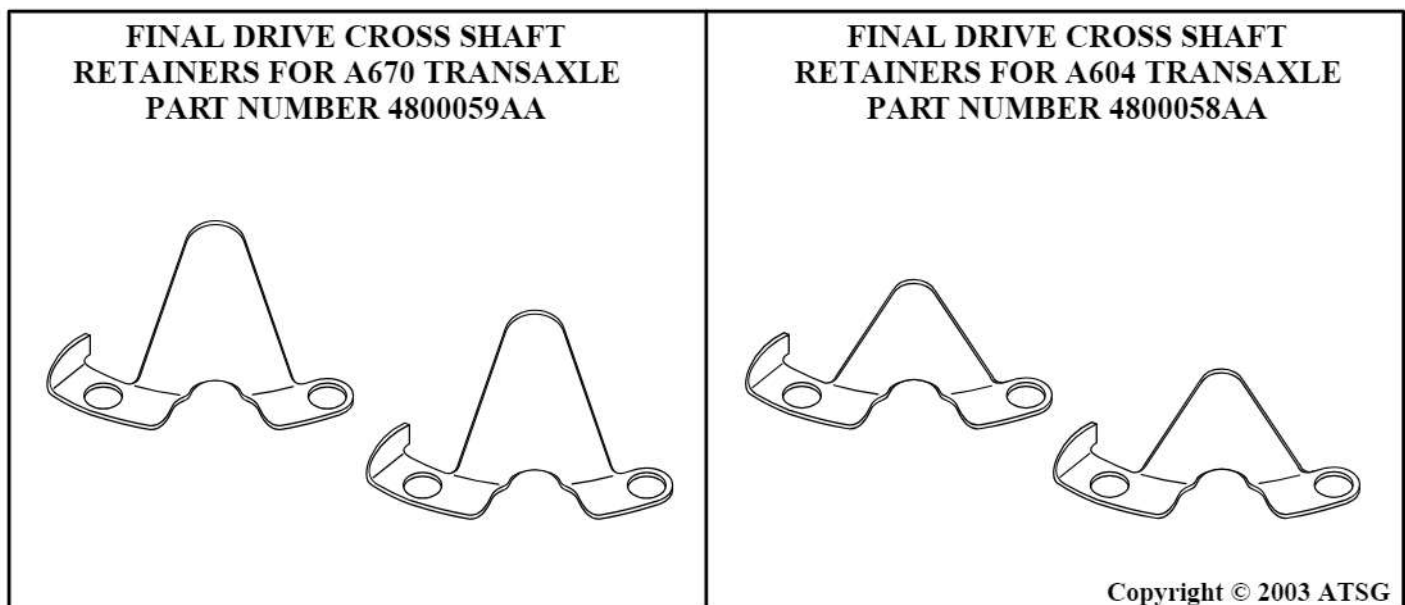
Figure 81

**CHANGE:** Beginning in the model year 2000, as a running change, Chrysler introduced a new design final drive cross shaft retainer and eliminated the retaining pin. The new design retainers are held in place by two of the ring gear retaining bolts (See Figure 81).

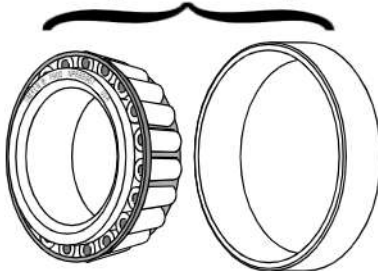
*New Large  
Tapered Bearing*

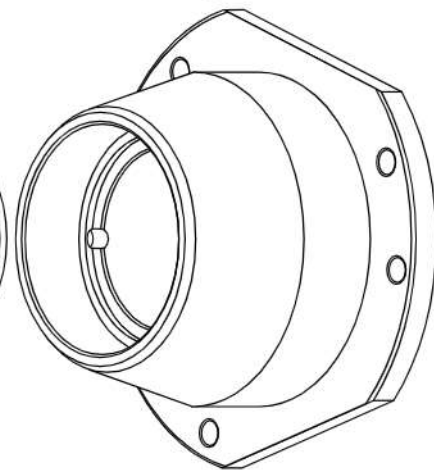
*Bearing Retainer*

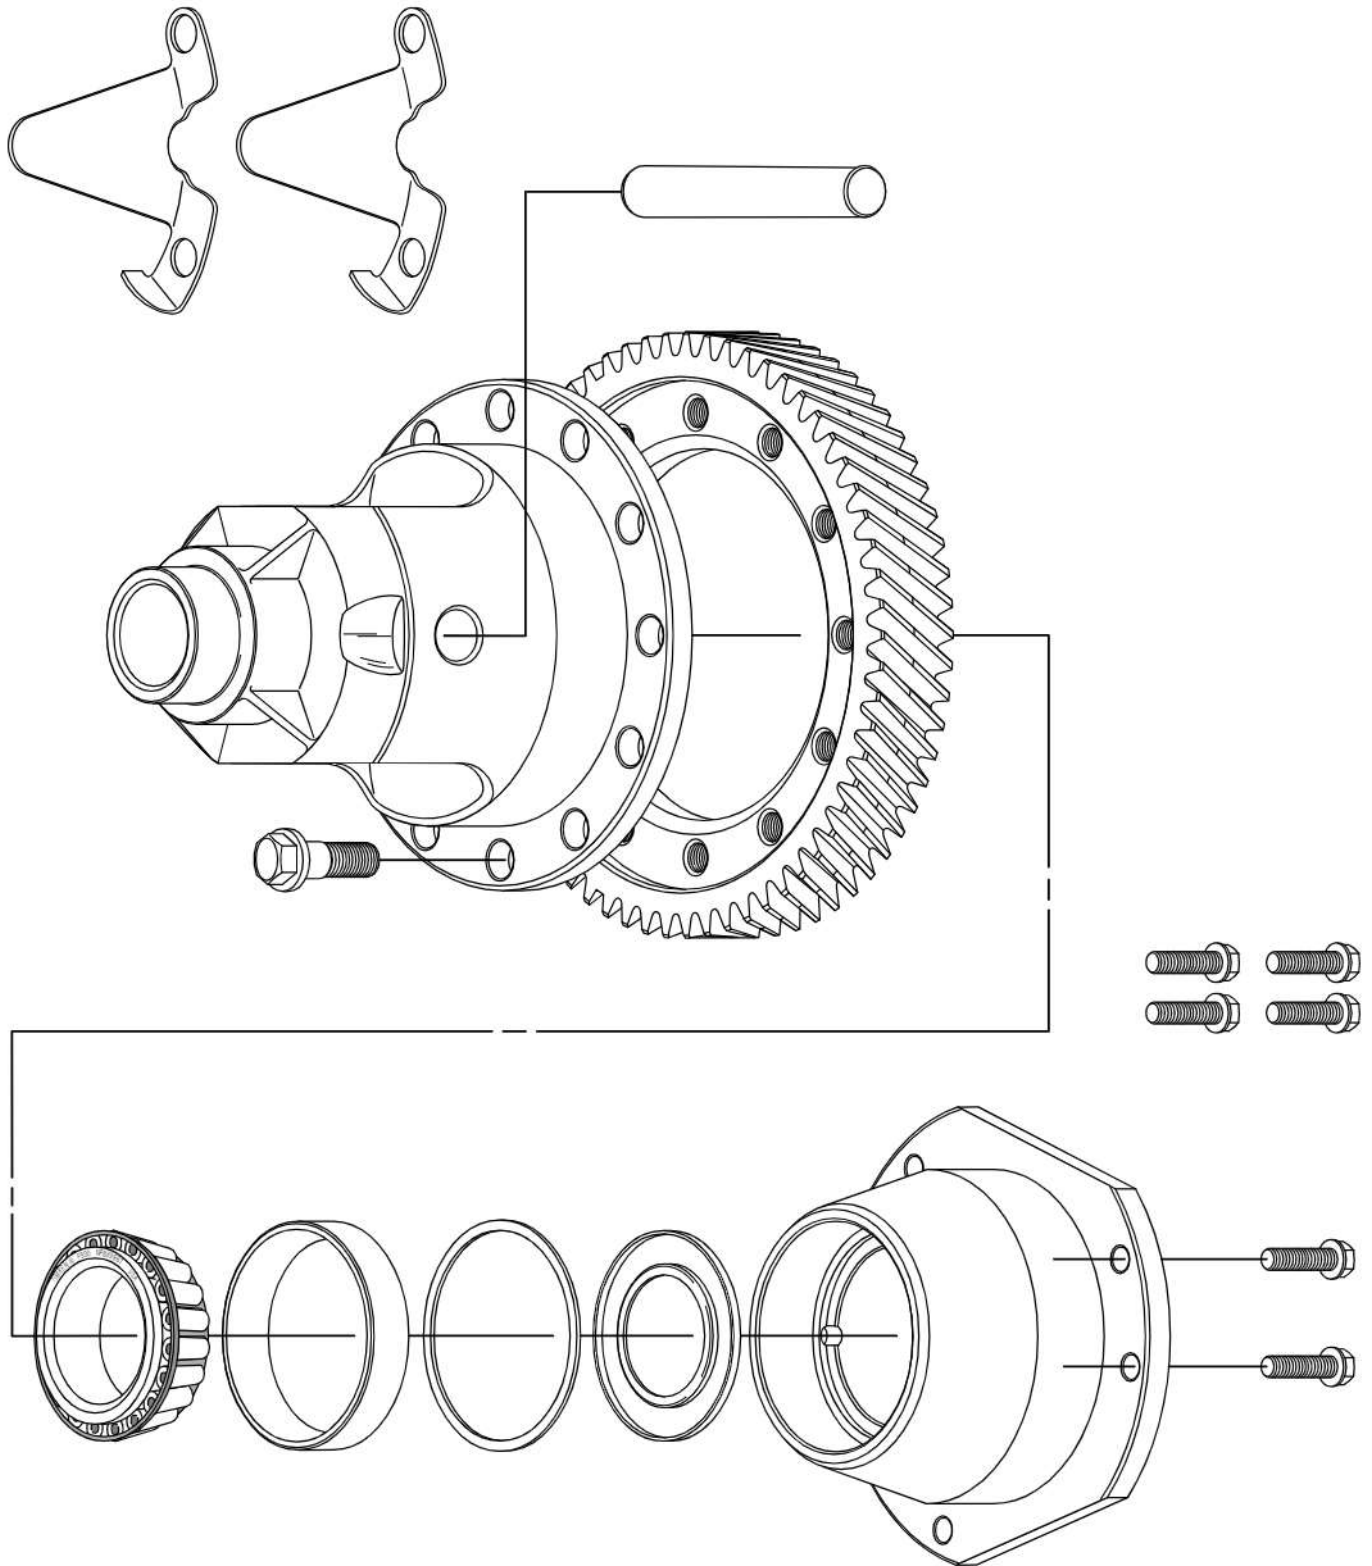
Figure 83  
Automatic Transmission Service Group

- (1) FINAL DRIVE HOUSING - Retaining pin hole eliminated (See Figure 82).
- (2) CROSS SHAFT - Retaining pin hole eliminated (See Figure 82).
- (3) CROSS SHAFT RETAINER - New design cross shaft retainer to replace the previous design retaining pin (See Figure 82).

## ASSEMBLY PROCEDURE

The new design retainers are also available individually from the OEM, and are installed as shown in Figures 83 and 84.

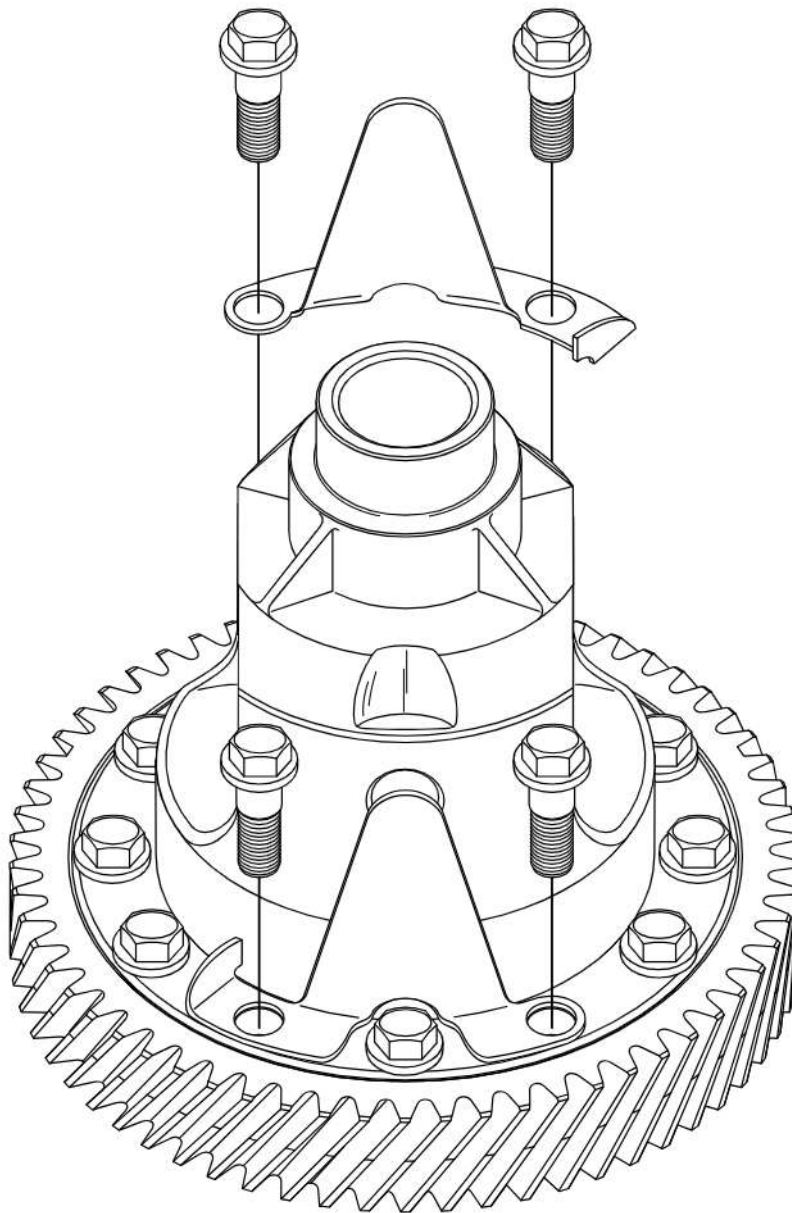
Figure 84  
*Automatic Transmission Service Group*

## NEW DESIGN CROSS SHAFT RETAINER INSTALLATION

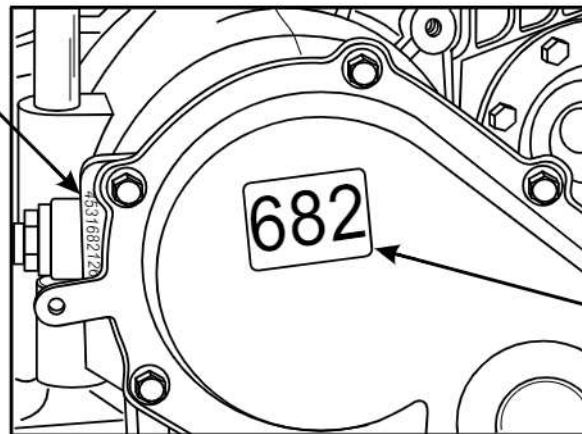
(ETCHED ON CASE)

NUMBER ON TAG ON  
GEAR COVER IS LAST 3  
OF PART NUMBER)

*Example given reveals a 1990 3.3L transaxle  
with a 2.36 overall ratio that has 27.5 degree  
transfer and output gears (54T/59T) and a  
16T/60T ring and pinion gear set.  
(Refer to Figures 2 through 10)*
