## FORD 4R100 "UPDATE HANDBOOK"

### FORD 4R100 "UPDATE HANDBOOK"

Since the introduction of the 4R100 transmission in model year 1998, there have been many engineering changes to improve Pleaseability, Reliability and Durability concerns. These changes have affected most every part used in this transmission. This "Update Handbook" will explain each change, the reason for the change, and any parts interchangeability concerns created by the change, along with any part numbers needed to update your transmission.

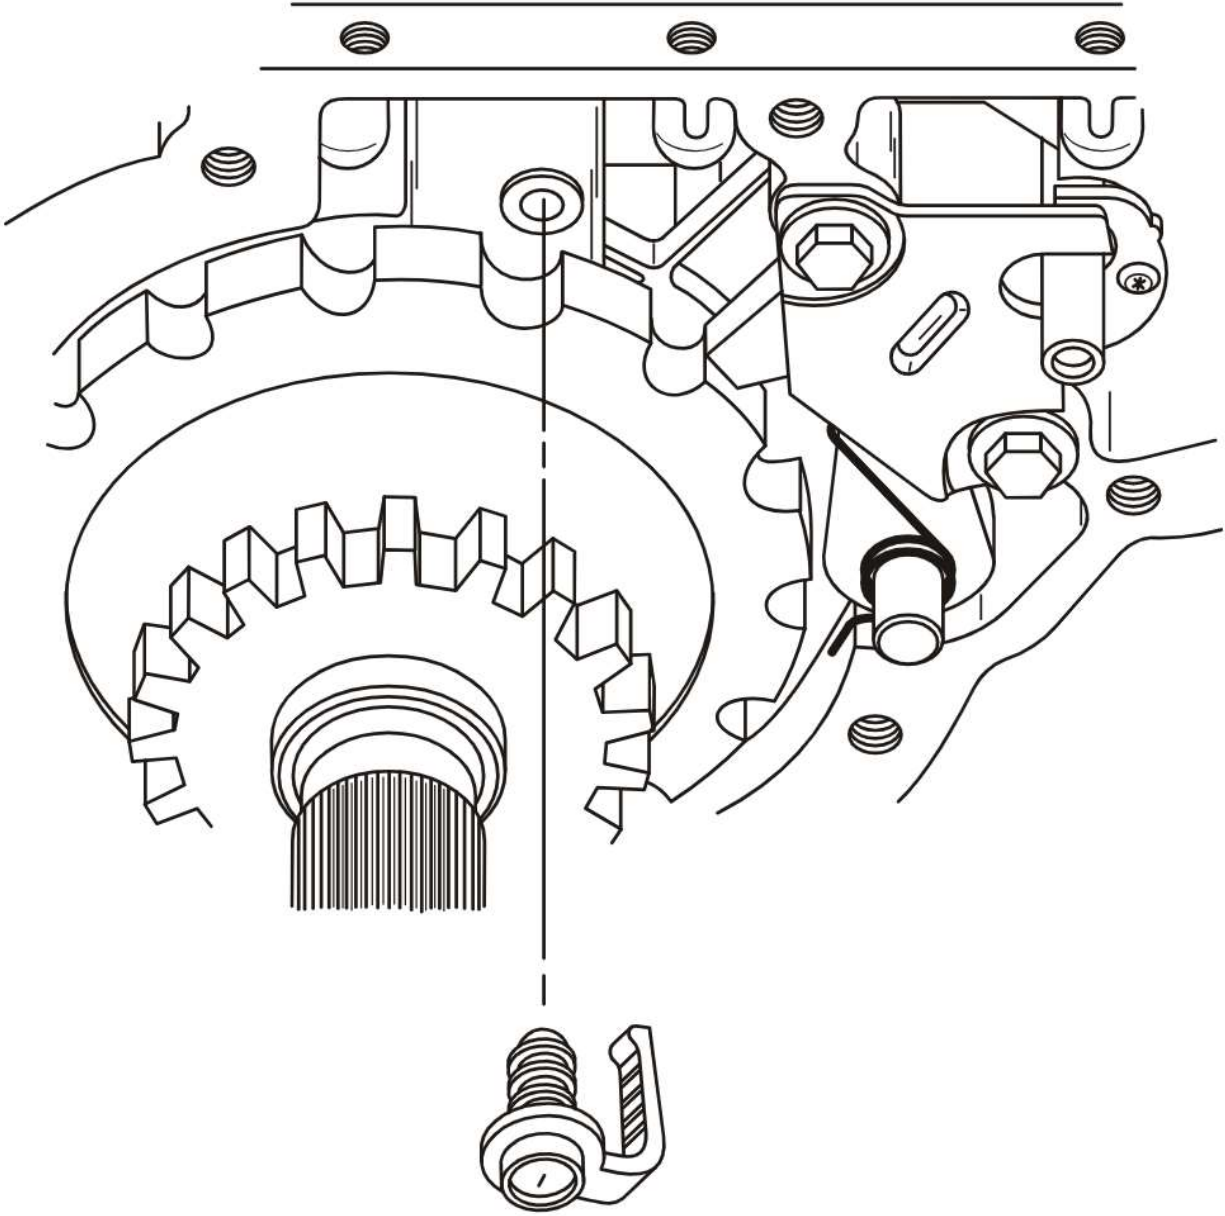
Figure 4

**FORD 4R100  
LUBE ORIFICE LOCATION**

**LUBE ORIFICE PLUG  
FORD PART NUMBER  
F81Z-7E380-AA**

- (4) **LUBE ORIFICE PLUG** - Added to the rear of the case in the lube circuit to provide added lubrication to the extension housing bushing on 2WD models. To retain common cases the 4WD models will also have the lube orifice plug installed, as well as E4OD cases produced after July 24, 1997. Lube Orifice Plug is available under OEM part number F81Z-7E380-AA, and should be replaced on rebuild. Refer to Figure 4.

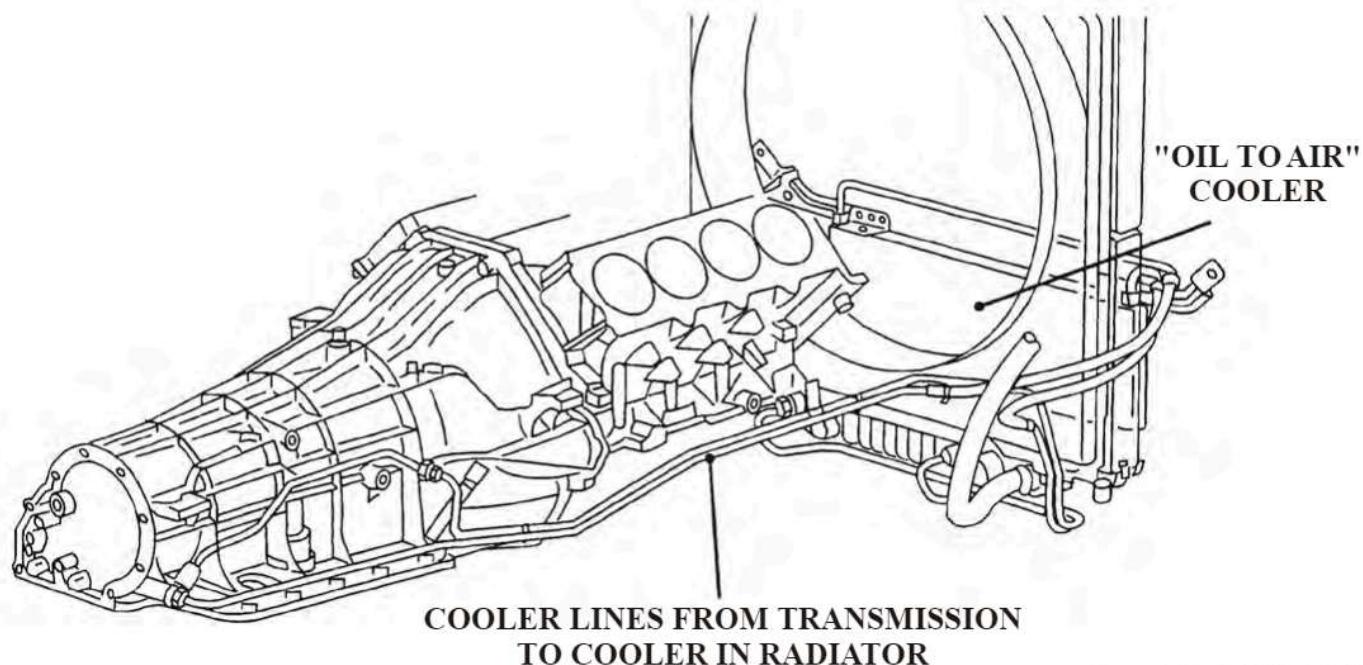
*Most F-Series vehicles over 8500 GVW equipped with the 4R100 transmission have an external "Oil-To-Air" cooler only. Due to the internal design the "Oil-To-Air" cooler cannot be adequately flushed to remove contaminants, and requires replacement during transmission rebuild.*

*The only exception is that F-Series vehicles over 8500 GVW equipped with the 5.4L engine also uses a radiator "In-Tank" cooler in addition to the "Oil-To-Air" cooler.*

- (8) **TRANSMISSION COOLERS** - Most F-Series vehicles over 8500 GVW equipped with the 4R100 transmission have an external "Oil-To-Air" cooler *only*. Due to the internal design of the "Oil-To-Air" cooler, it cannot be adequately flushed to remove contaminants, and requires replacement during transmission rebuild. The only exception is that F-Series vehicles over 8500 GVW equipped with the 5.4L engine also uses a radiator "In-Tank" cooler in addition to the "Oil-To-Air" cooler. Refer to Figure 8 for transmission cooler information.

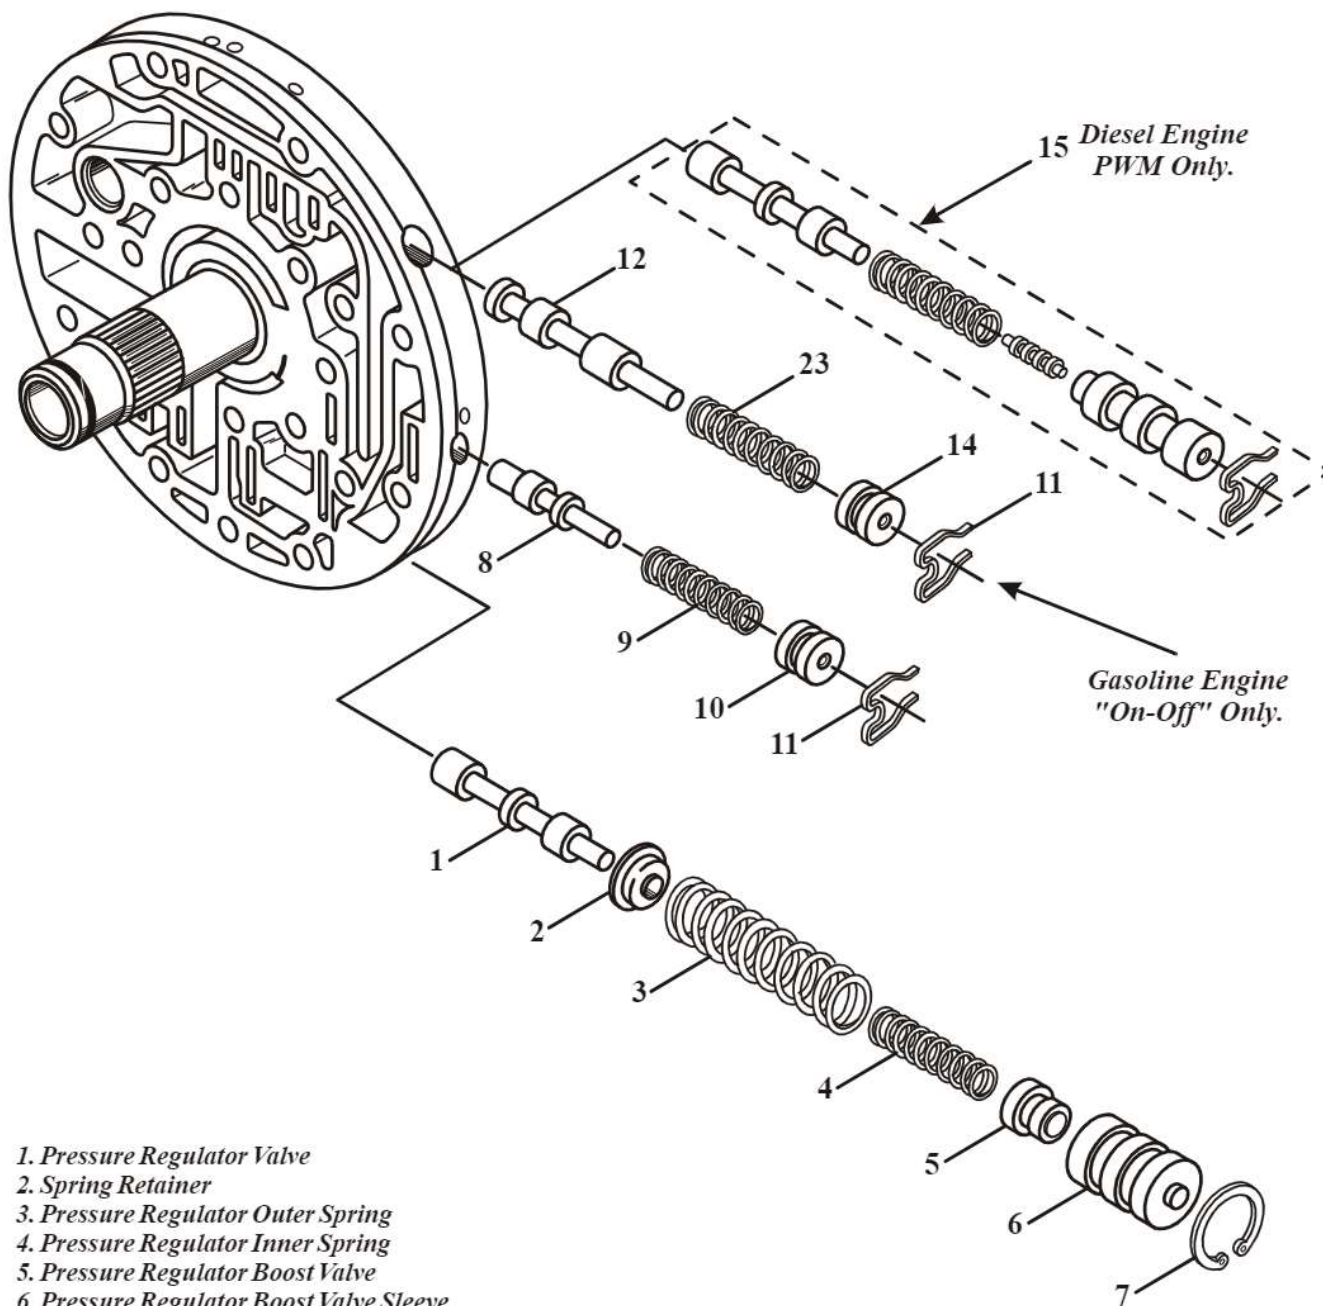
## FORD 4R100 VALVE LINE-UPS IN PUMP ASSEMBLY

1. Pressure Regulator Valve
2. Spring Retainer
3. Pressure Regulator Outer Spring
4. Pressure Regulator Inner Spring
5. Pressure Regulator Boost Valve
6. Pressure Regulator Boost Valve Sleeve
7. Snap Ring
8. Converter Clutch Regulator Valve
9. Converter Clutch Regulator Spring
10. Converter Clutch Regulator Bore Plug
11. Bore Plug Retainer
12. Converter Clutch Control Valve (Gas "On-Off" Only)
13. Converter Clutch Control Spring (Gas "On-Off" Only)
14. Converter Clutch Control Bore Plug
15. Converter Clutch Control Line-up (Diesel "PWM" Only)

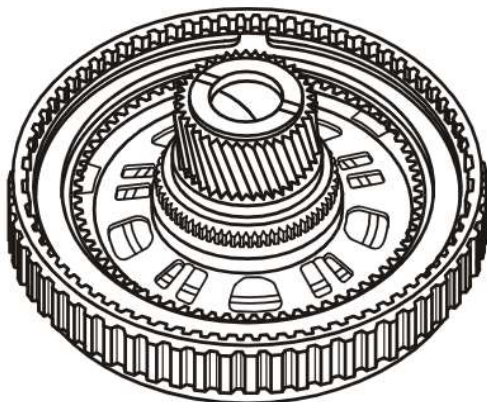
Figure 10

**"CAST IRON" COAST CLUTCH DRUM USED  
WITH 5.4L AND 6.8L "WITHOUT" PTO OPTION**

- (10) **FRONT PUMP STATOR SHAFT** - With the addition of the PTO gear on the front of the coast clutch drum, it was necessary to move the coast clutch sealing ring grooves up on the pump stator shaft to accommodate the coast clutch drum moving. There are currently three different Pump Stator Shafts used in production and all three are illustrated in Figure 10. One is the current E4OD shaft which is used with the "Cast Iron" coast clutch drum with 5.4L and 6.8L engines *without* the PTO option. Two is the shaft with the relocated sealing rings and a bushing in the pump tower, which is used with the "Stamped Steel" coast clutch drum with 5.4L and 6.8L engines *without* the PTO option. Third is the shaft with the relocated sealing rings and a caged needle bearing in the pump tower, which is used with the "Stamped Steel" coast clutch drum with 6.8L and 7.3L engines *with* the PTO option. Refer to Figure 10.

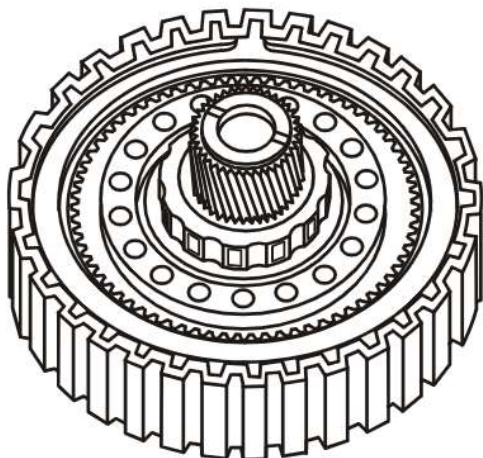
**"STAMPED STEEL" COAST CLUTCH DRUM USED  
WITH 5.4L AND 6.8L "WITHOUT" PTO OPTION**

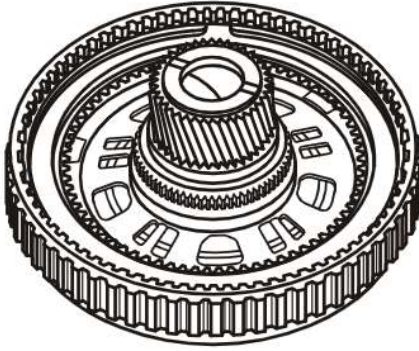
Figure 13

**"CAST IRON" COAST CLUTCH DRUM USED  
WITH 5.4L AND 6.8L "WITHOUT" PTO OPTION**

- (13) **OVERDRIVE ROLLER CLUTCH** - The overdrive roller clutch inner cam is now made onto the new design coast clutch drum, instead of being splined like the previous models were, and is illustrated in Figure 13. The new design overdrive roller clutch assembly is now assembled onto the inner cam on the new design drum. The overdrive roller clutch outer race is still located in the overdrive ring gear next to the overdrive carrier and the number 13 thrust washer between the two is now plastic, but the cage and roller assembly are now assembled over the inner race on the new design coast clutch drum. Refer to Figure 13.

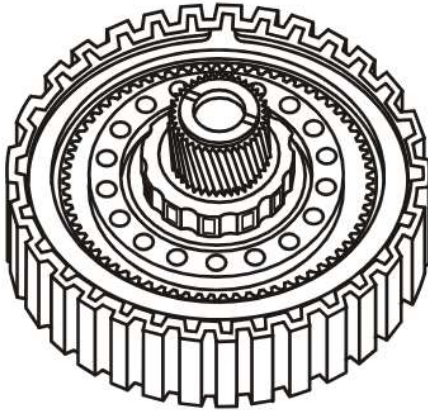
**"STAMPED STEEL" COAST CLUTCH DRUM USED  
WITH 5.4L AND 6.8L "WITHOUT" PTO OPTION**

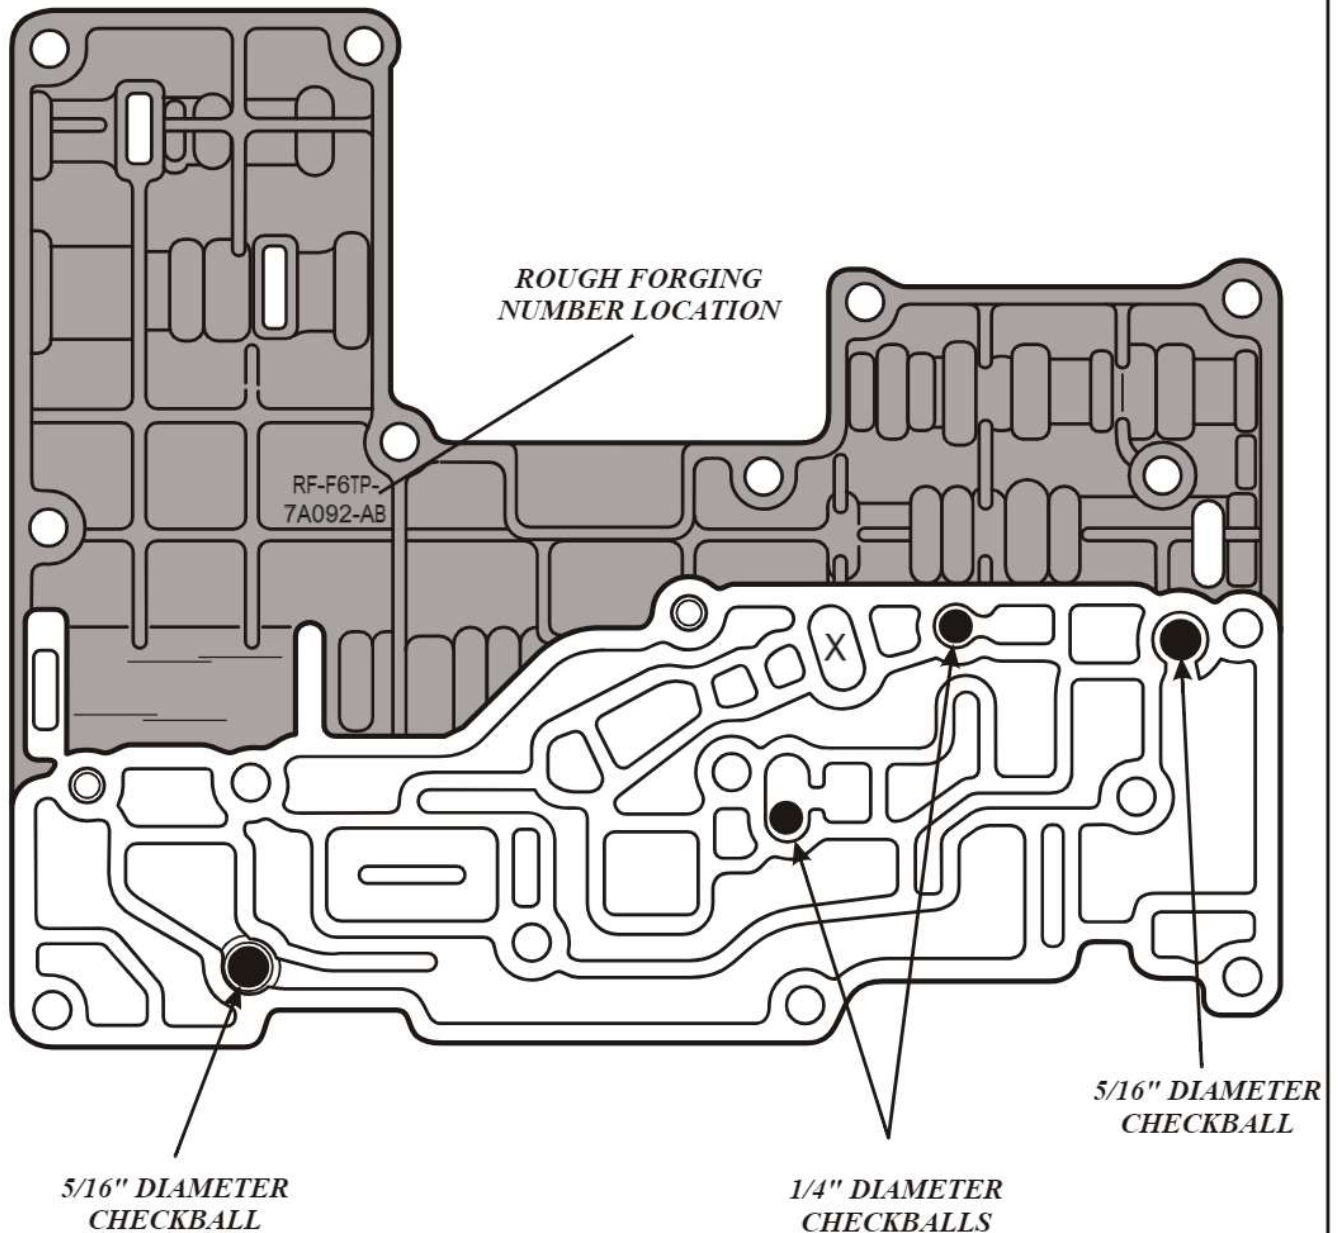
Figure 15

**4R100 VALVE BODY CHECKBALL LOCATIONS  
REQUIRES TWO 1/4" RUBBER BALLS,  
AND TWO 5/16" RUBBER BALLS**

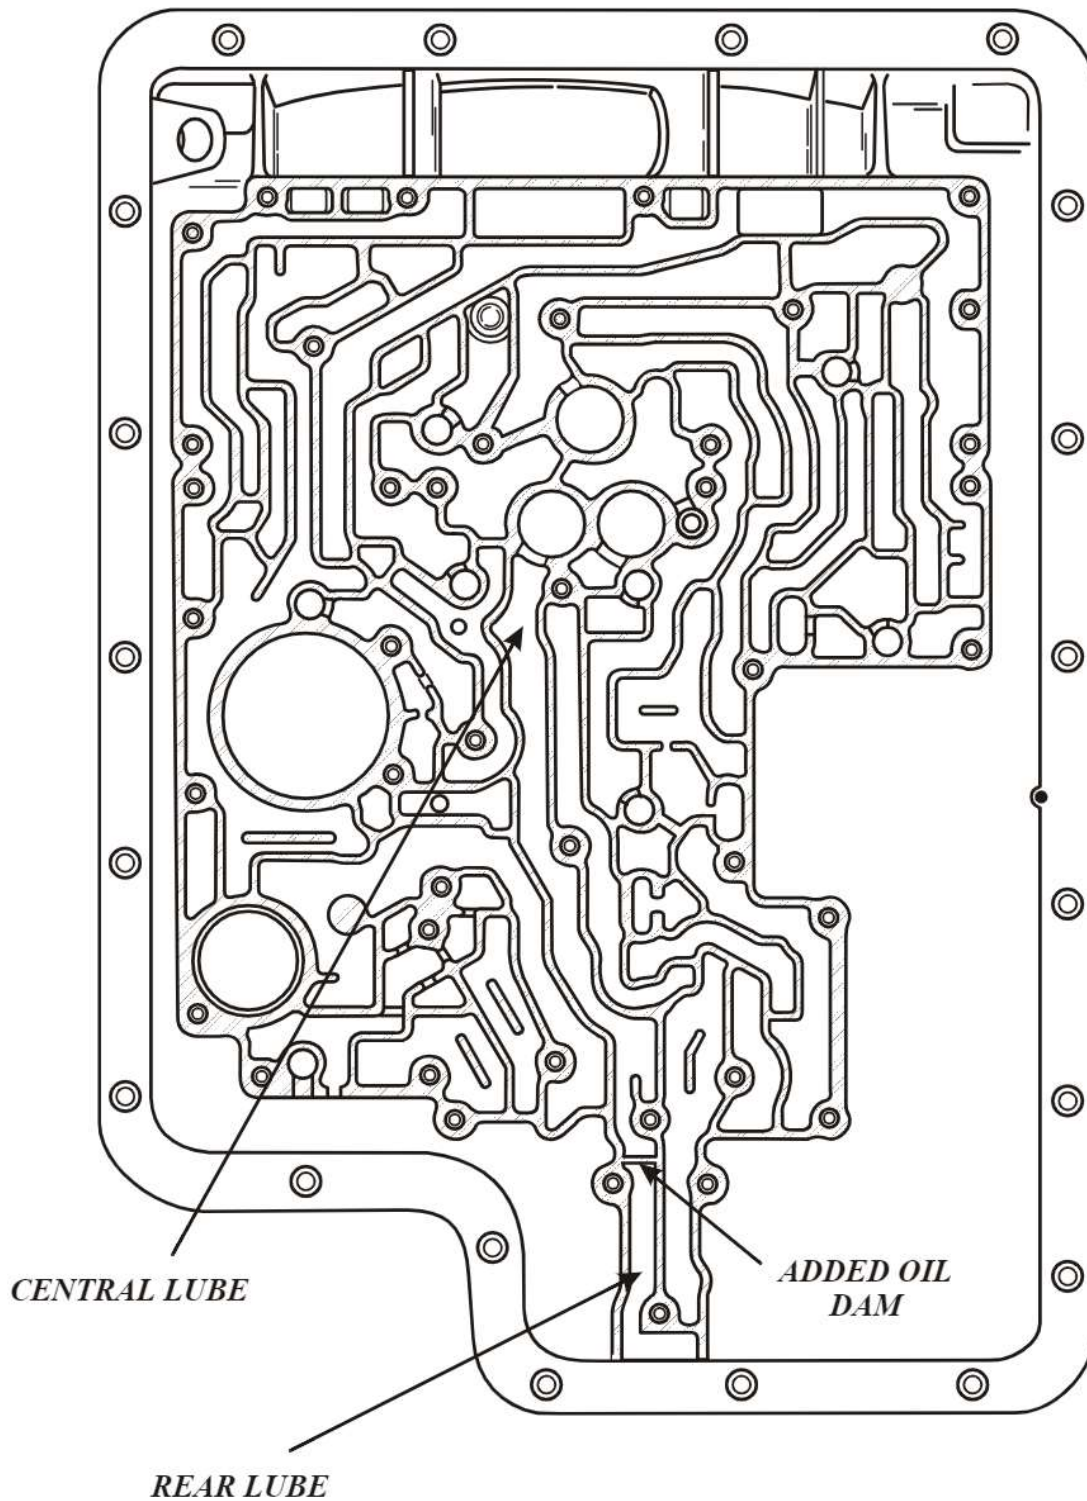
Figure 30

**4R100 CASE "NON-PTO" AND "PTO"**

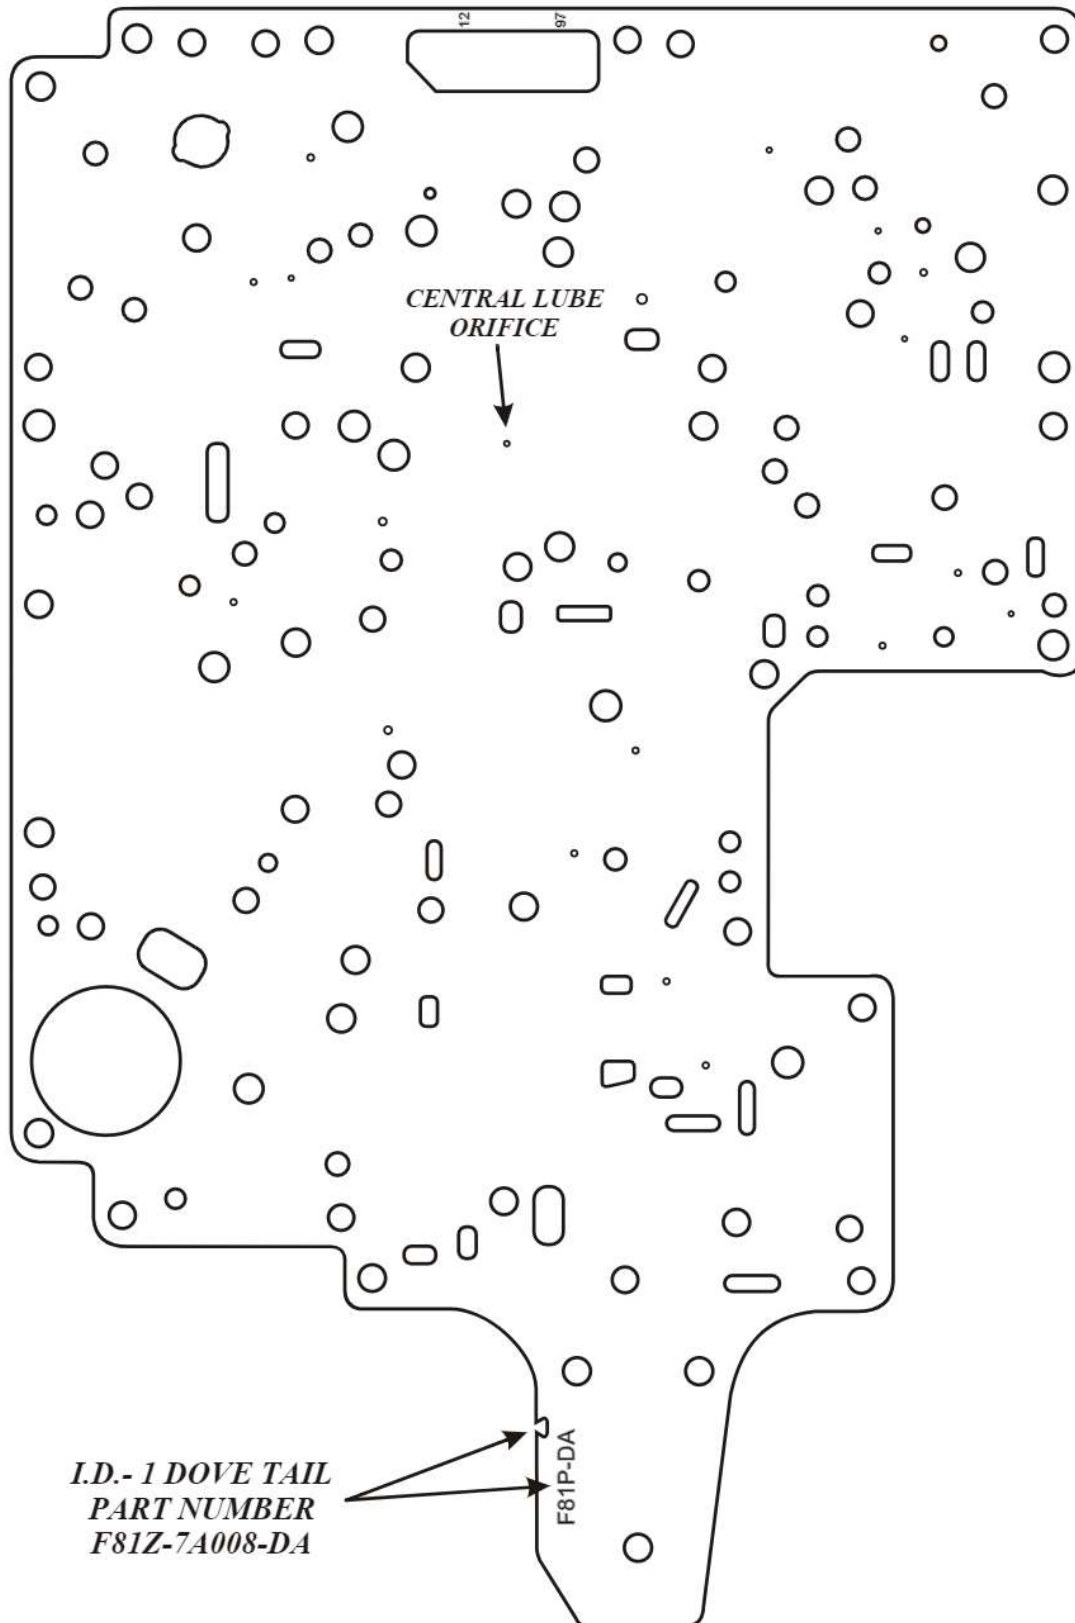
Figure 31

## 4R100 MAIN SPACER PLATE "NON-PTO"

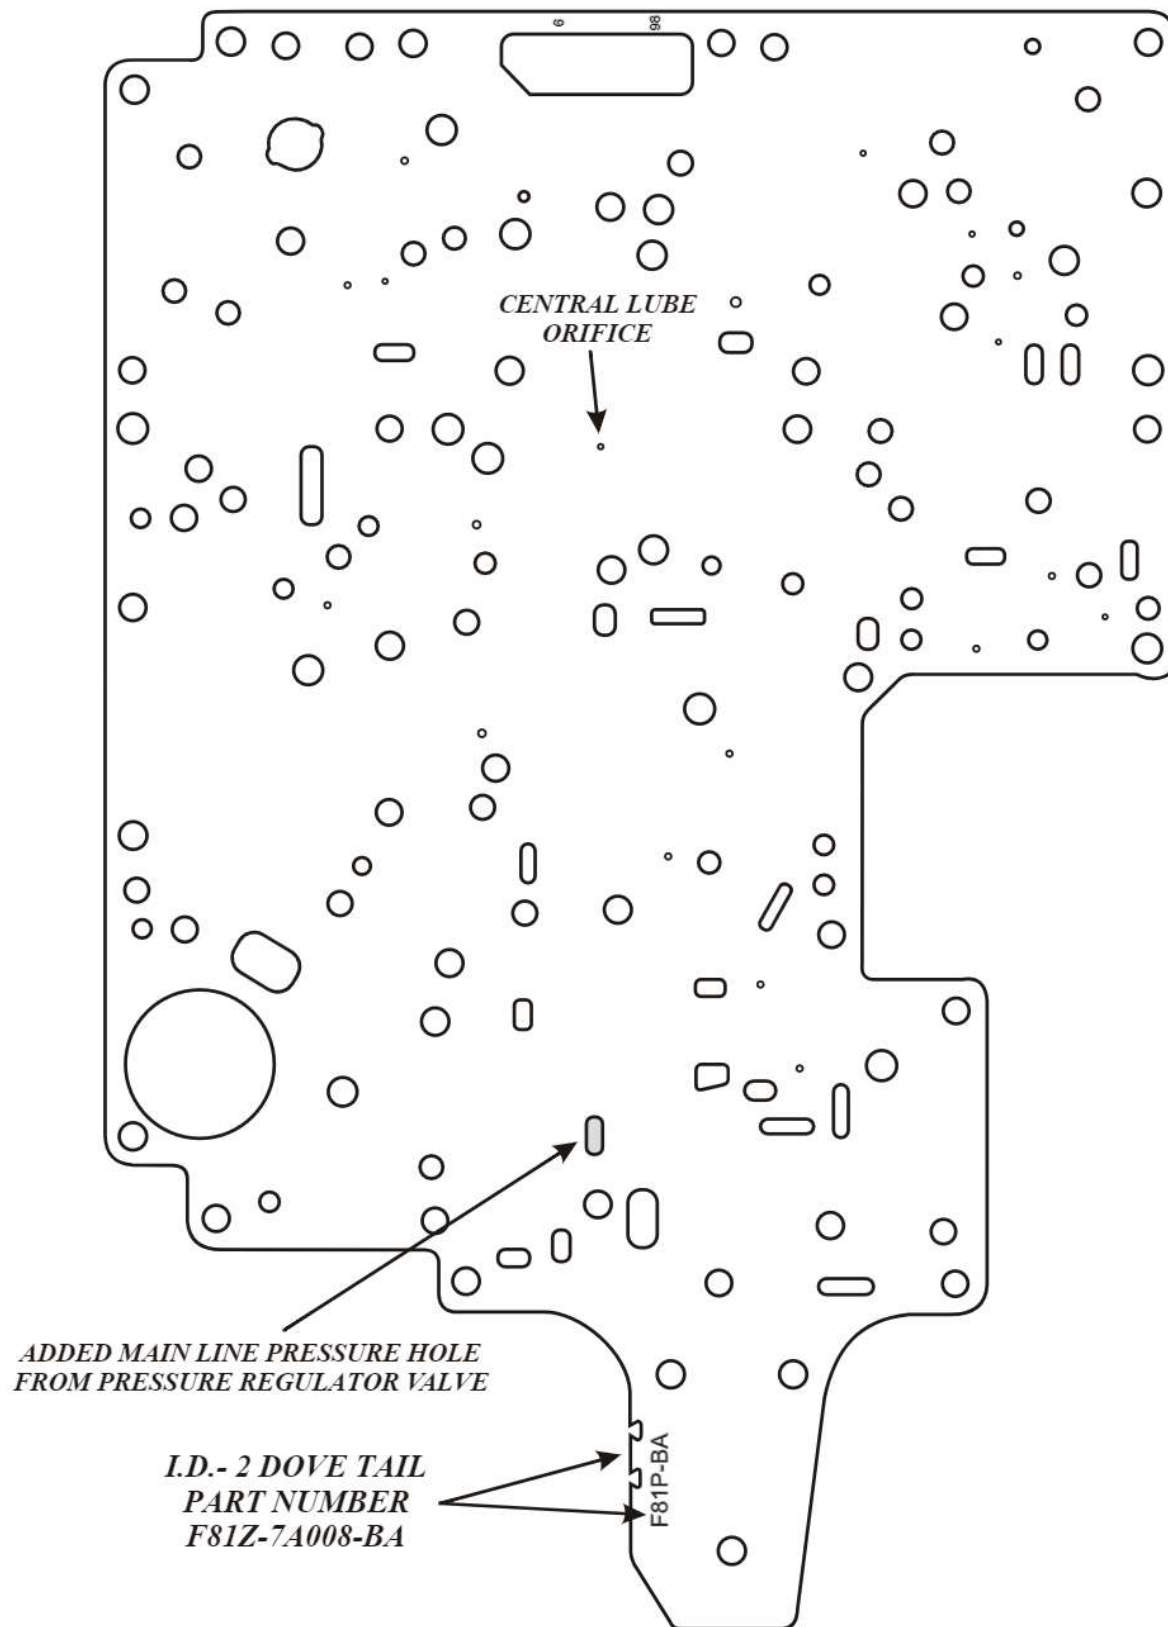
Figure 32

## 4R100 MAIN SPACER PLATE "PTO"

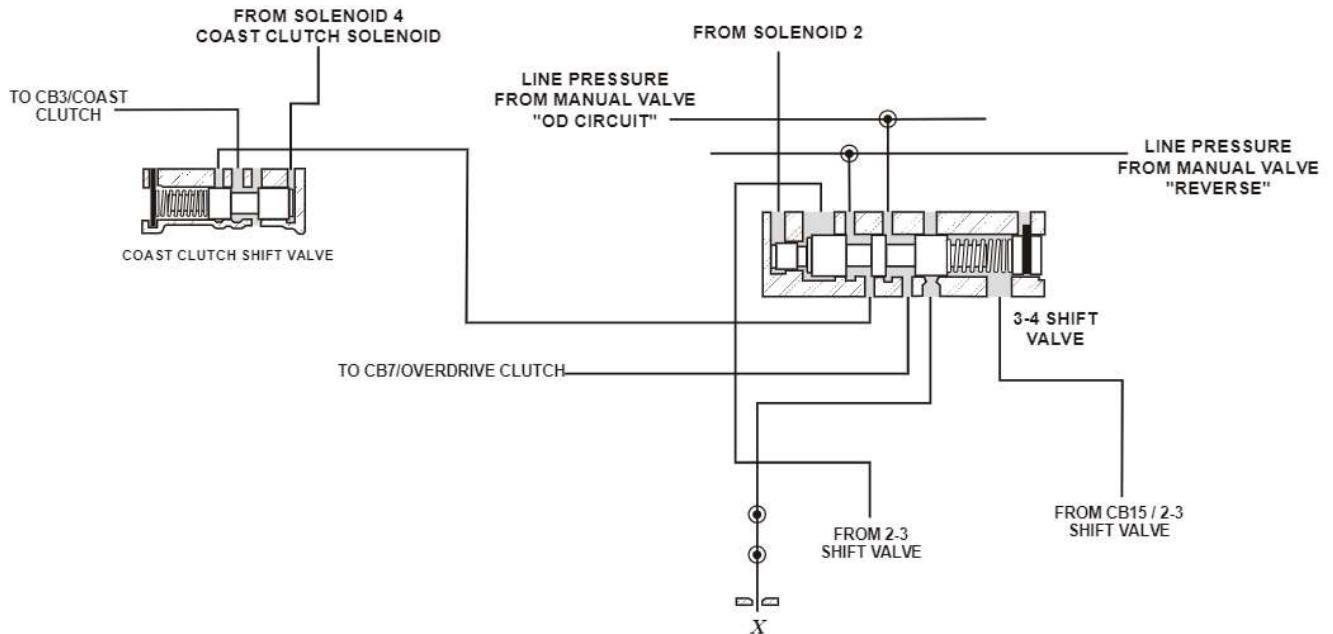
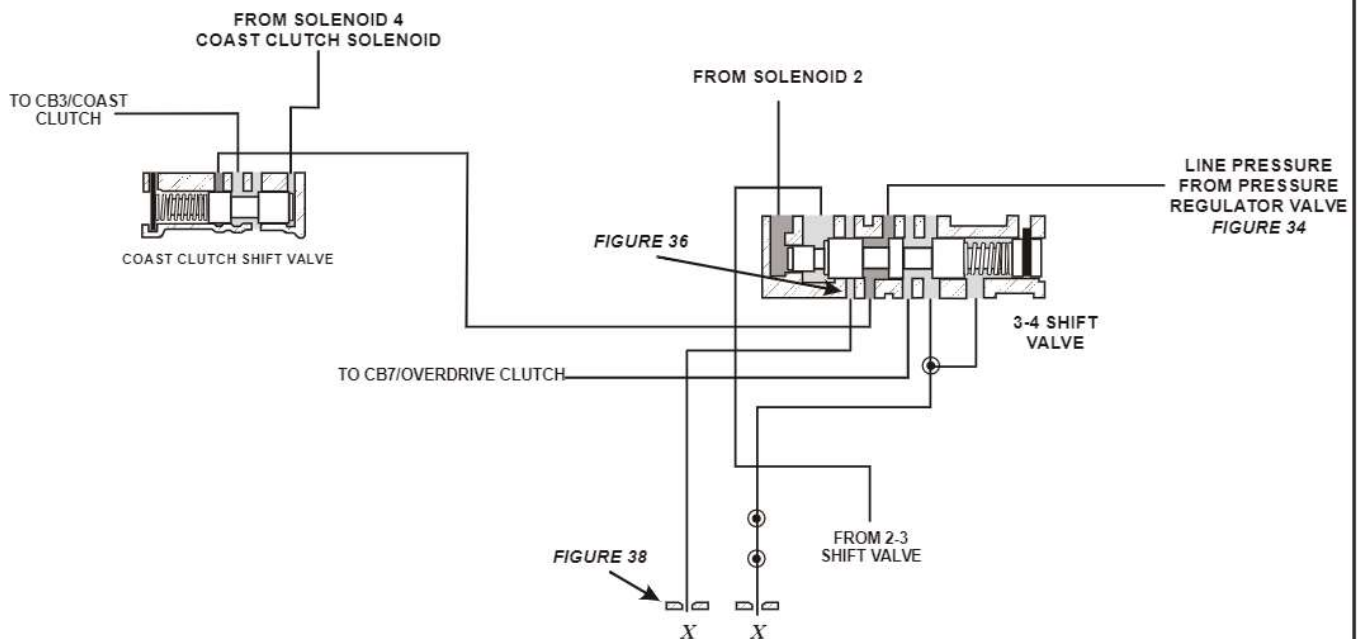
Figure 40

## "NON-PTO" 3-4 SHIFT VALVE HYDRAULIC CIRCUIT

## "PTO" 3-4 SHIFT VALVE HYDRAULIC CIRCUIT

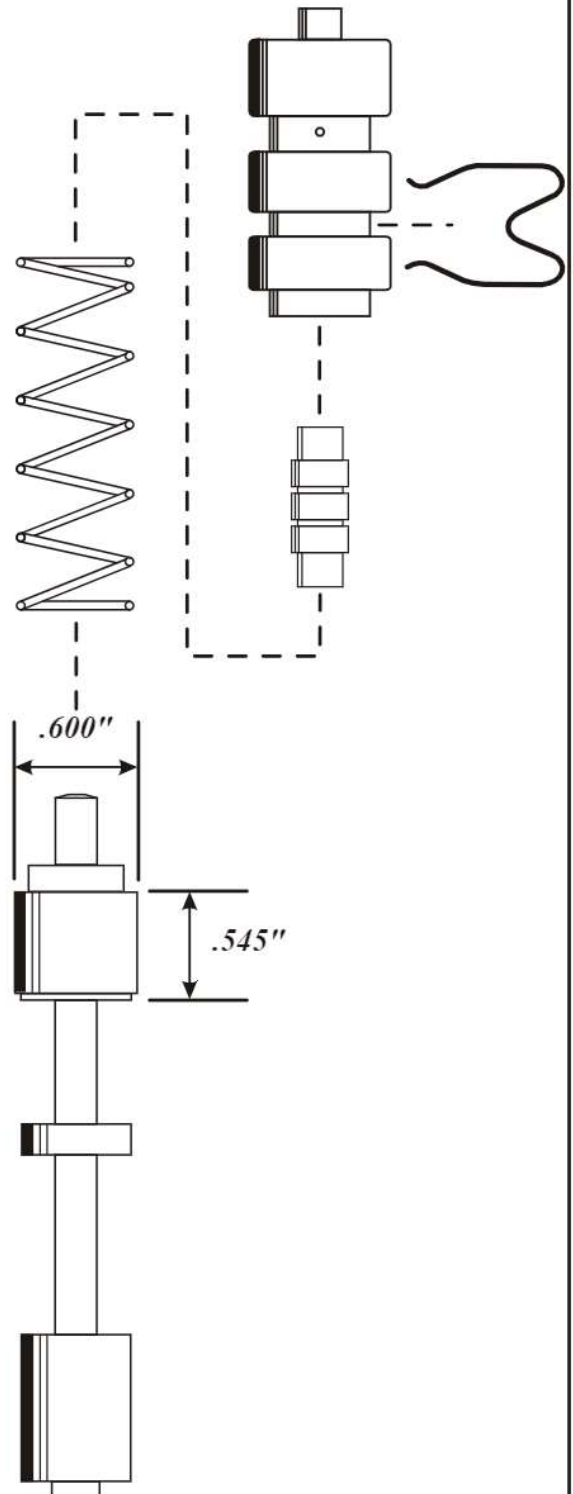
Figure 41

THE DIAMETER AND THE LENGTH OF THE SPOOL ON THE VALVE LAND SHOWN ABOVE, WERE INCREASED ON PWM VERSIONS. THE BORE IN THE PUMP WAS ALSO ENLARGED APPROXIMATELY .070" TO ACCOMMODATE THE CHANGES IN THE DIAMETER OF THE VALVE

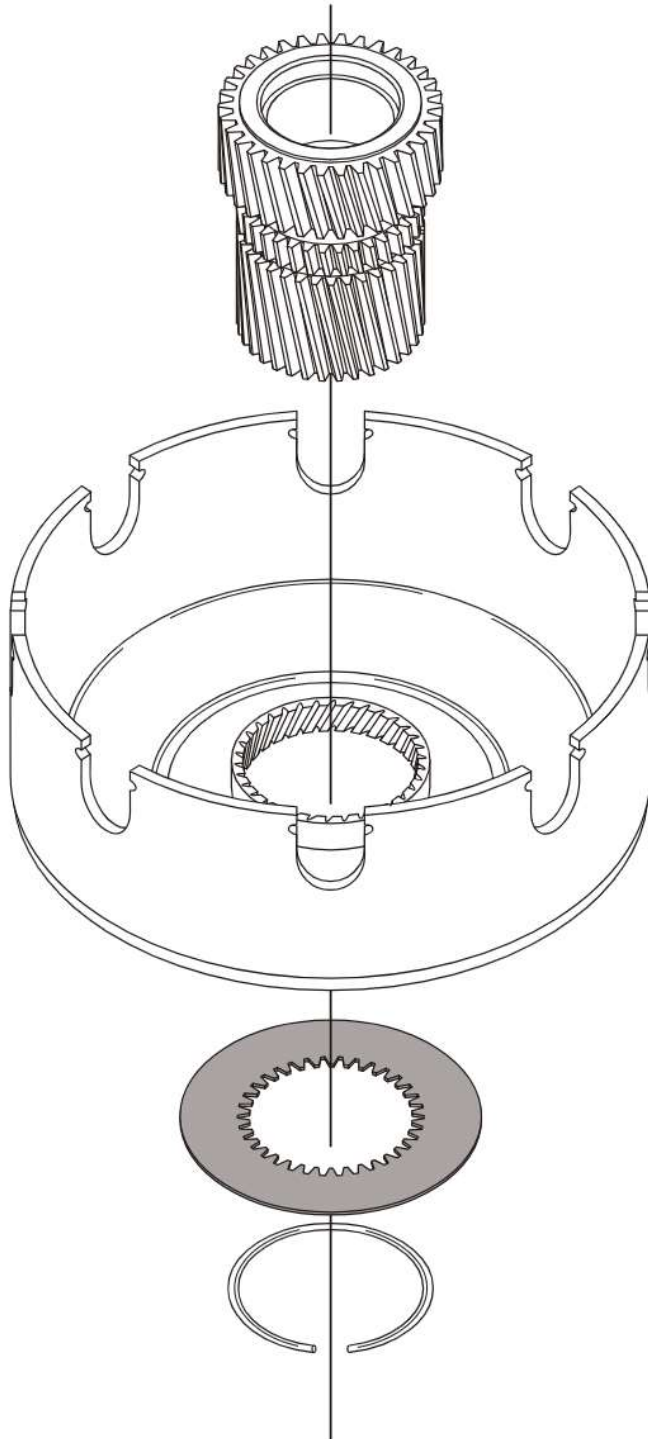
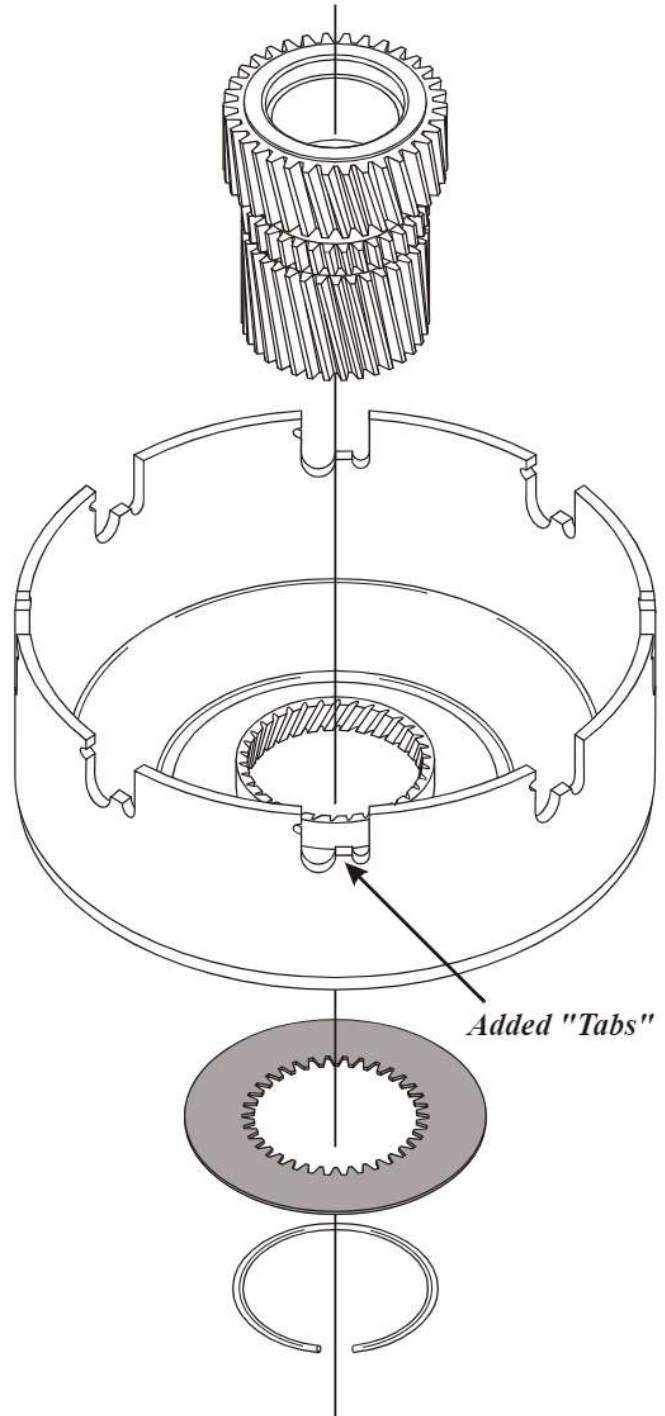
## PREVIOUS DESIGN SUN SHELL *"No Longer Available From Ford"*

*May Be Used With "ONLY"  
The Previous Design Direct Drum  
And Requires The No. 8 Washer  
(See Figure 50)*

## NEW DESIGN SUN SHELL *Hardened = YC3Z-7D064-BA Regular = YC3Z-7D064-AA*

*May Be Used With  
Both Design Direct Drums  
With Or Without Washer  
(See Figure 50)*

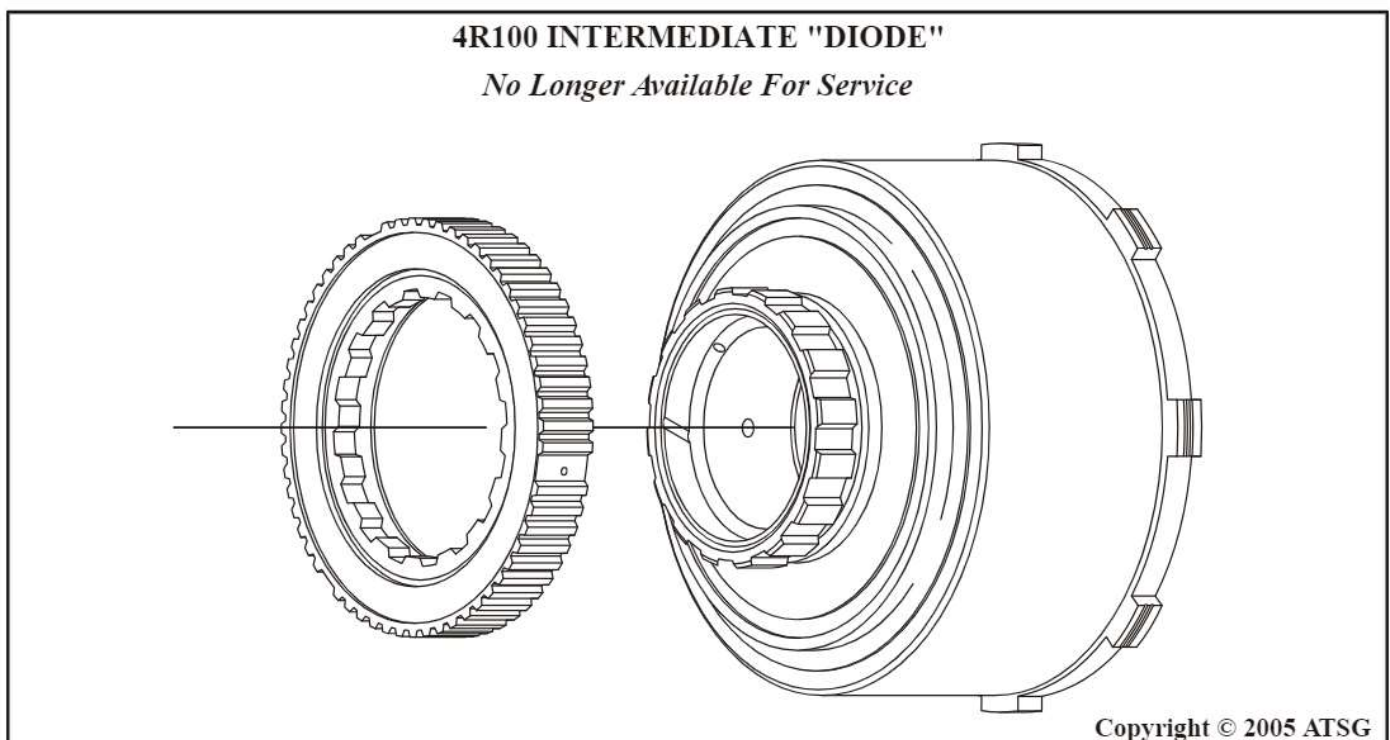
Figure 52

**COMPLAINT:** Some Ford Motor Company vehicles equipped with the 4R100 transmission may exhibit premature failure of the newly introduced Intermediate "Diode" Freewheel device that was installed in model year 2001 and illustrated in Figure 52.

**CAUSE:** The cause may be, more than expected load factors.

**CORRECTION:** The Intermediate "Diode" is *no longer serviced* by Ford Motor Company. The part number now supercedes to all of the previous design level parts, which include the direct clutch housing, intermediate sprag assembly, outer race to direct drum thrust washer, and the intermediate friction plates. All of the previous design level parts are illustrated in Figure 53, with the OEM part numbers. The intermediate frictions must be replaced because the tooth count on the outer race between the diode and the sprag are different.

*Special Note: ATSG recommends replacing the Intermediate "Diode" during service, even if it has not yet failed, to protect yourself from possible future failures.*

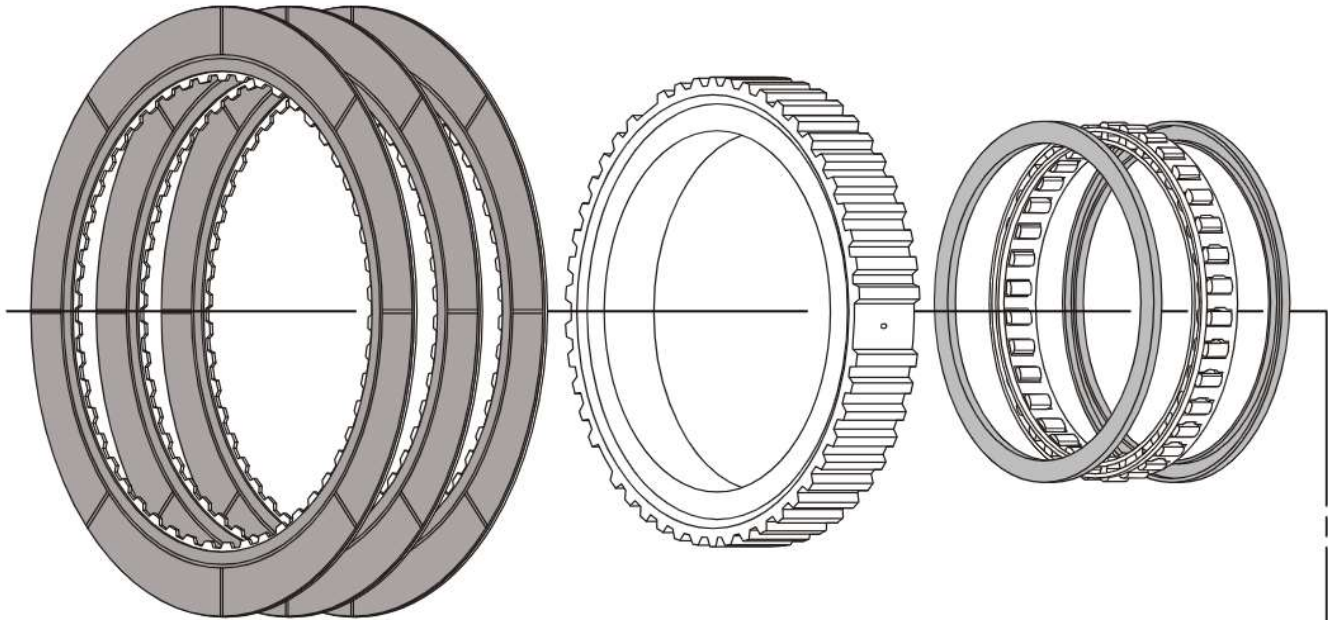
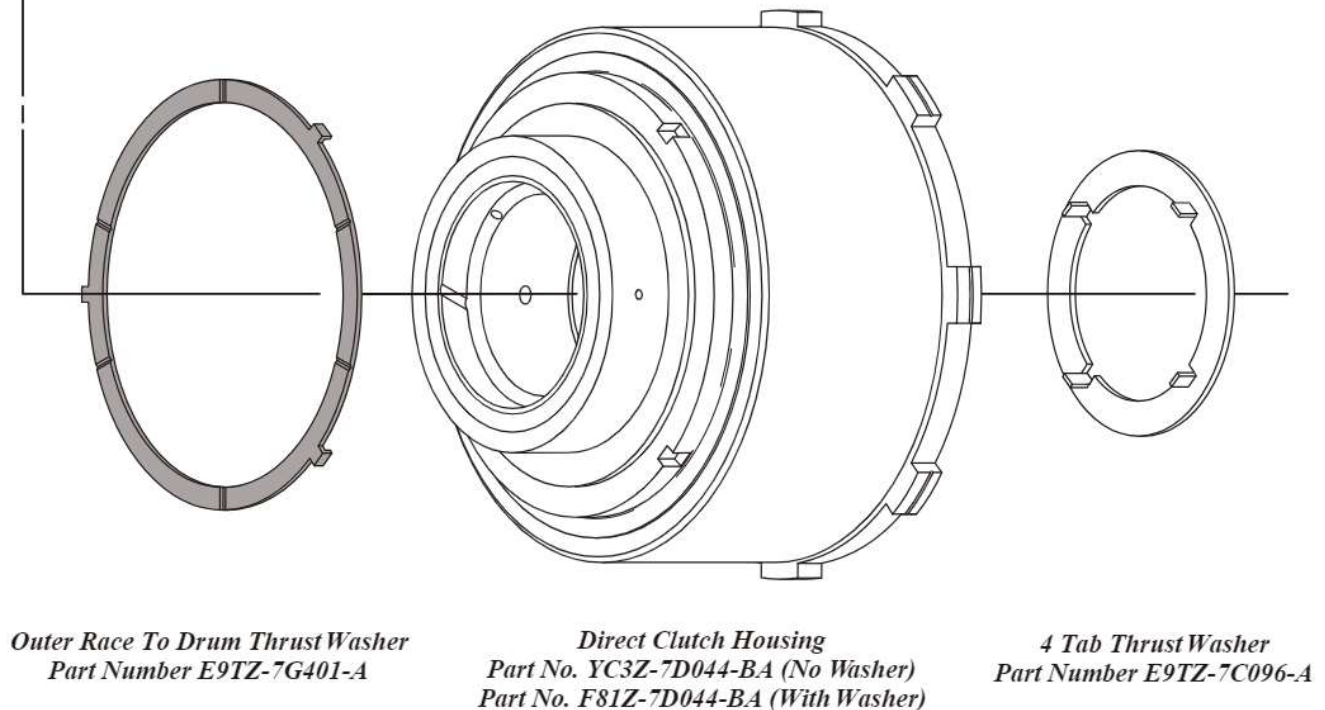
Figure 53

## PARTS NEEDED TO REPLACE INTERMEDIATE DIODE

*Intermediate Friction Plates*  
Part Number 1C3Z-7B164-BA  
(Or Raybestos Plates OK)  
(3 Required)

*Intermediate Sprag Assembly*  
Part Number E9TZ-7A089-B

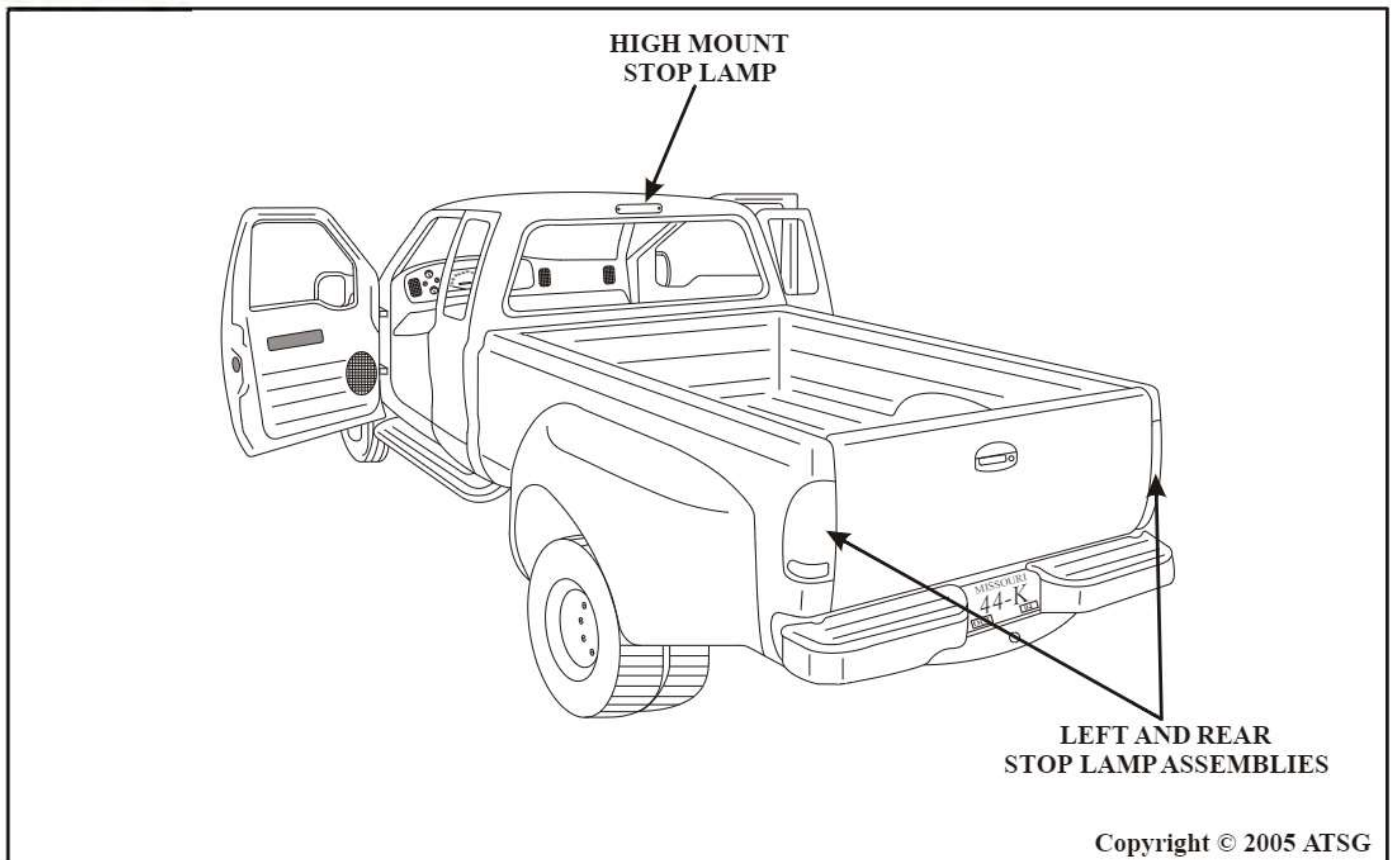
Figure 65

**CAUSE NO. 1:** One cause for this condition may be that one or more of the vehicle brake light bulbs, including the High Mount brake light may be burned out, or have a damaged filament (See Figure 65). When this condition is present, the PCM will detect an open in the brake lamp circuit, and due to a pull-up resistor in the PCM, will output voltage from PCM terminal 92 to the brake on-off switch (See Figure 66). As a result, the Torque Converter Clutch will not be applied at less than 30 percent throttle.

Replace any burned out brake lamp bulbs, including the High Mount brake lamp bulb, as shown in Figure 65. It is also important to note, that a bad ground for the rear lamp assembly, has also been known to cause the identical symptom. Refer to Figure 69 for the rear lamp assemblies ground location.
