## FORD 4R100 "UPDATE HANDBOOK"

### FORD 4R100 "UPDATE HANDBOOK"

Since the introduction of the 4R100 transmission in model year 1998, there have been many engineering changes to improve Pleaseability, Reliability and Durability concerns. These changes have affected most every part used in this transmission. This "Update Handbook" will explain each change, the reason for the change, and any parts interchangeability concerns created by the change, along with any part numbers needed to update your transmission.

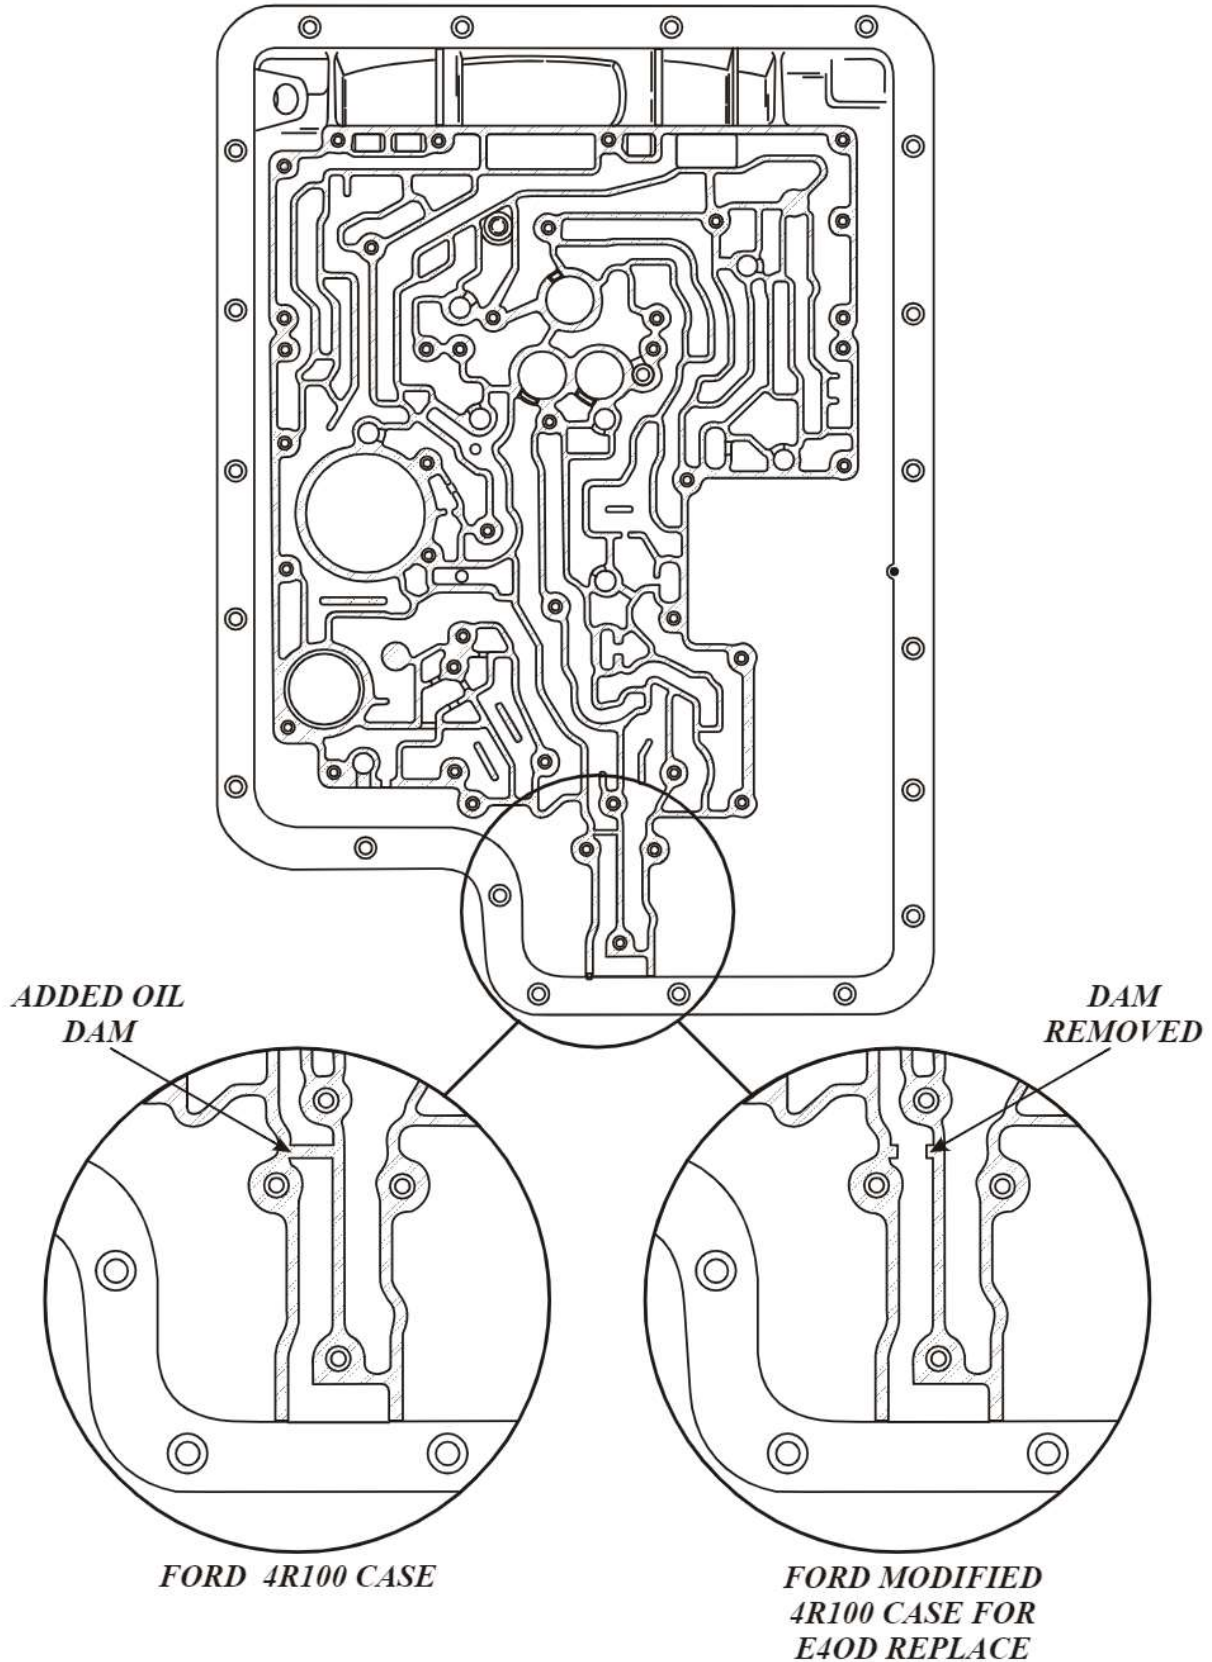
Figure 71

**CHANGE:** Currently, the *"only"* new case available from Ford Motor Company, for replacement in any E4OD equipped vehicles, is a modified 4R100 case. Ford has machined out the dam in the case that separates center and rear lube, near the rear of the case, as shown in Figure 71.

## FORD 4R100 MODIFIED CASE FOR USE IN E4OD MODELS

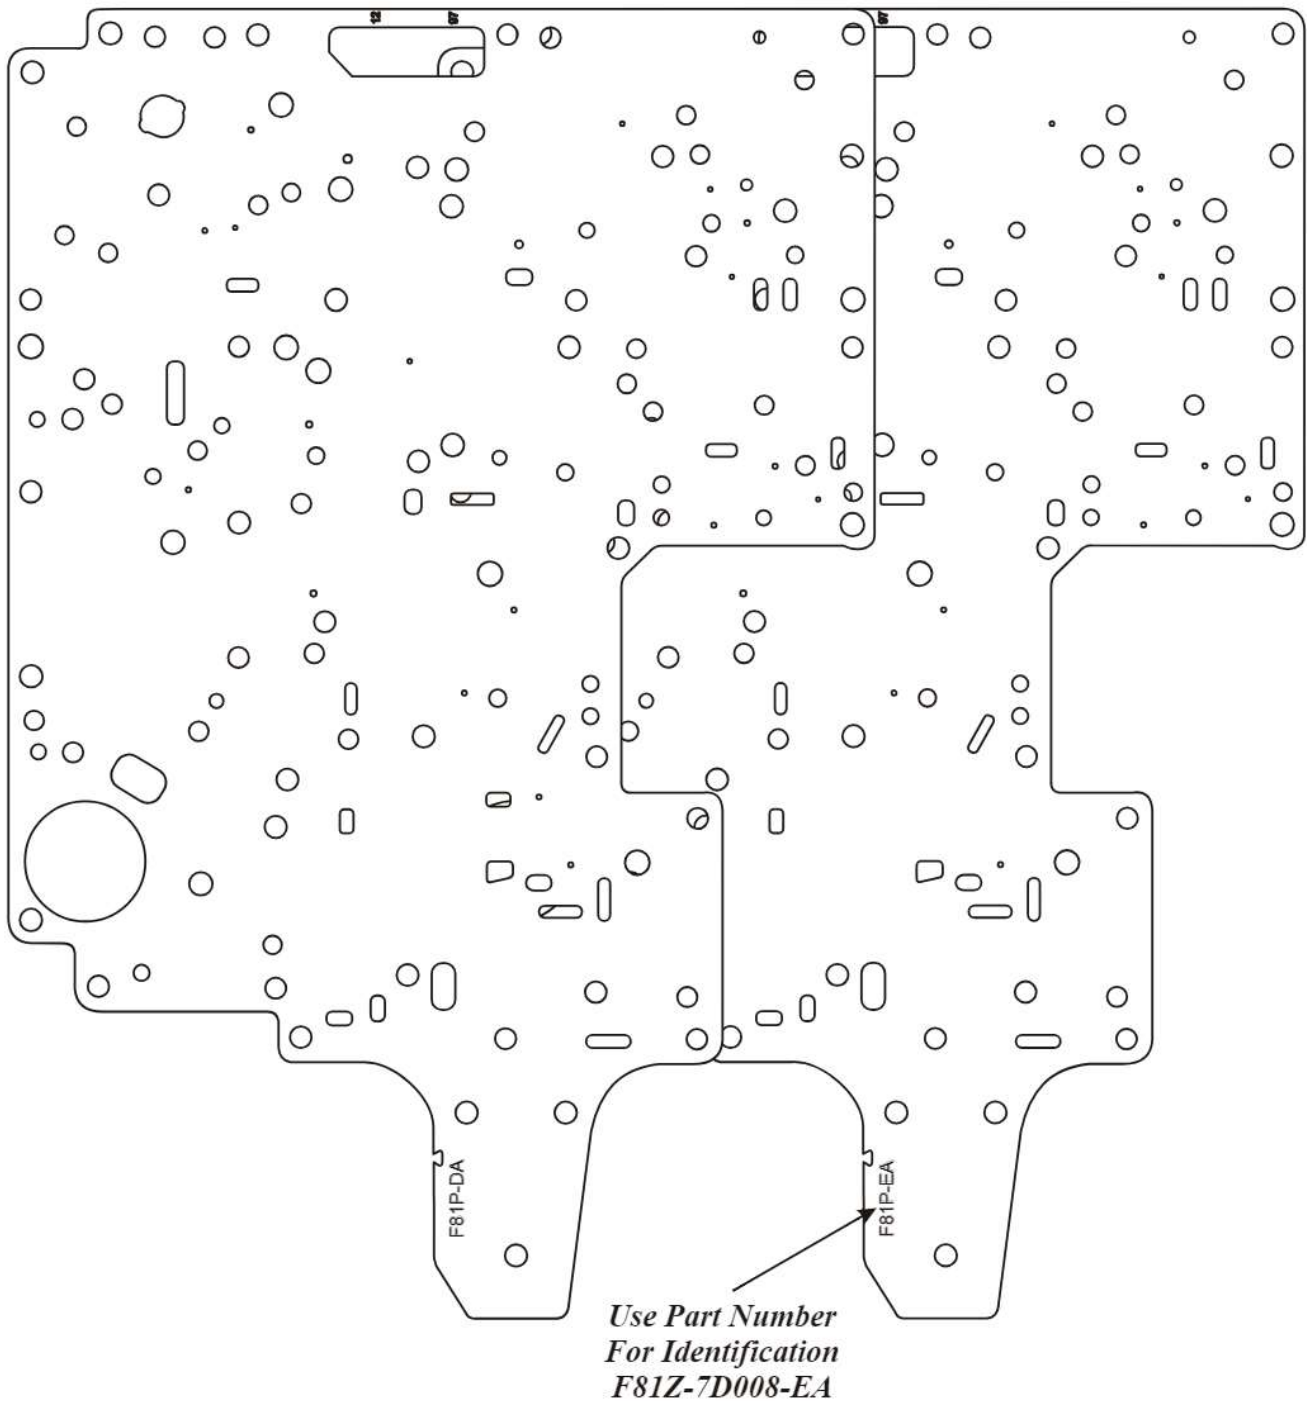
Figure 72

## "SPECIAL" MAIN SPACER PLATE REQUIRED FOR MODIFIED 4R100 CASE

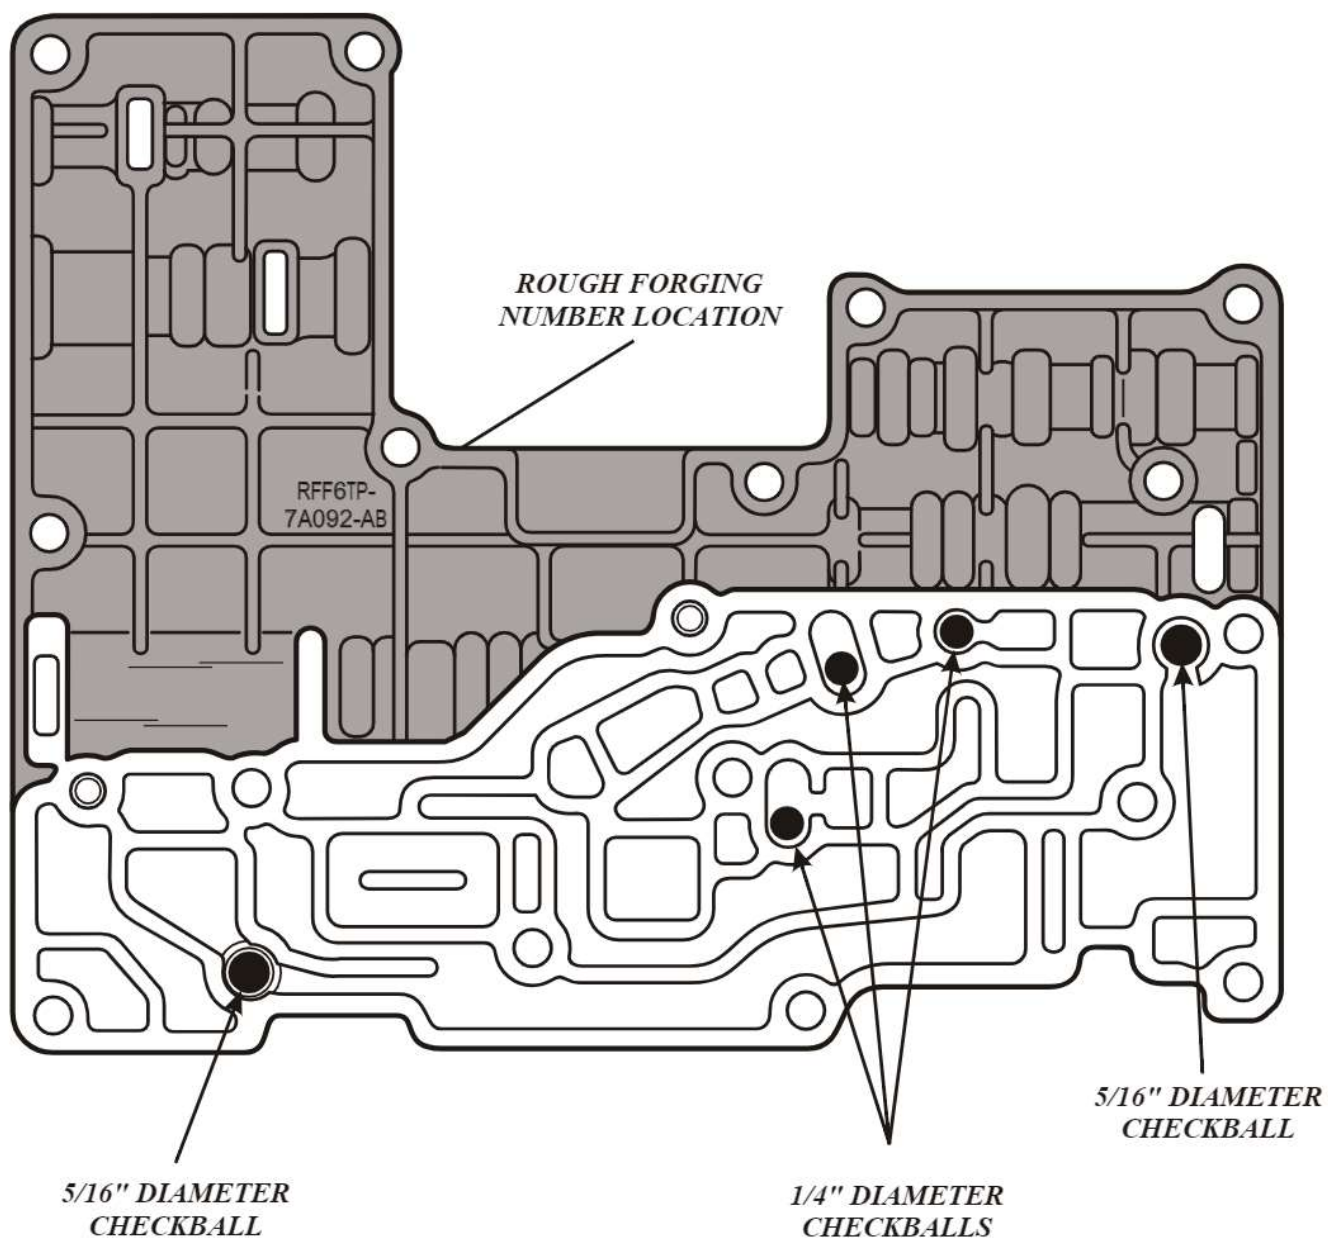
Figure 78

## VALVE BODY CHECKBALL LOCATIONS REQUIRED FOR MODIFIED 4R100 CASE

VALVE BODY CHECKBALL LOCATIONS  
REQUIRES THREE 1/4" RUBBER BALLS,  
AND TWO 5/16" RUBBER BALLS

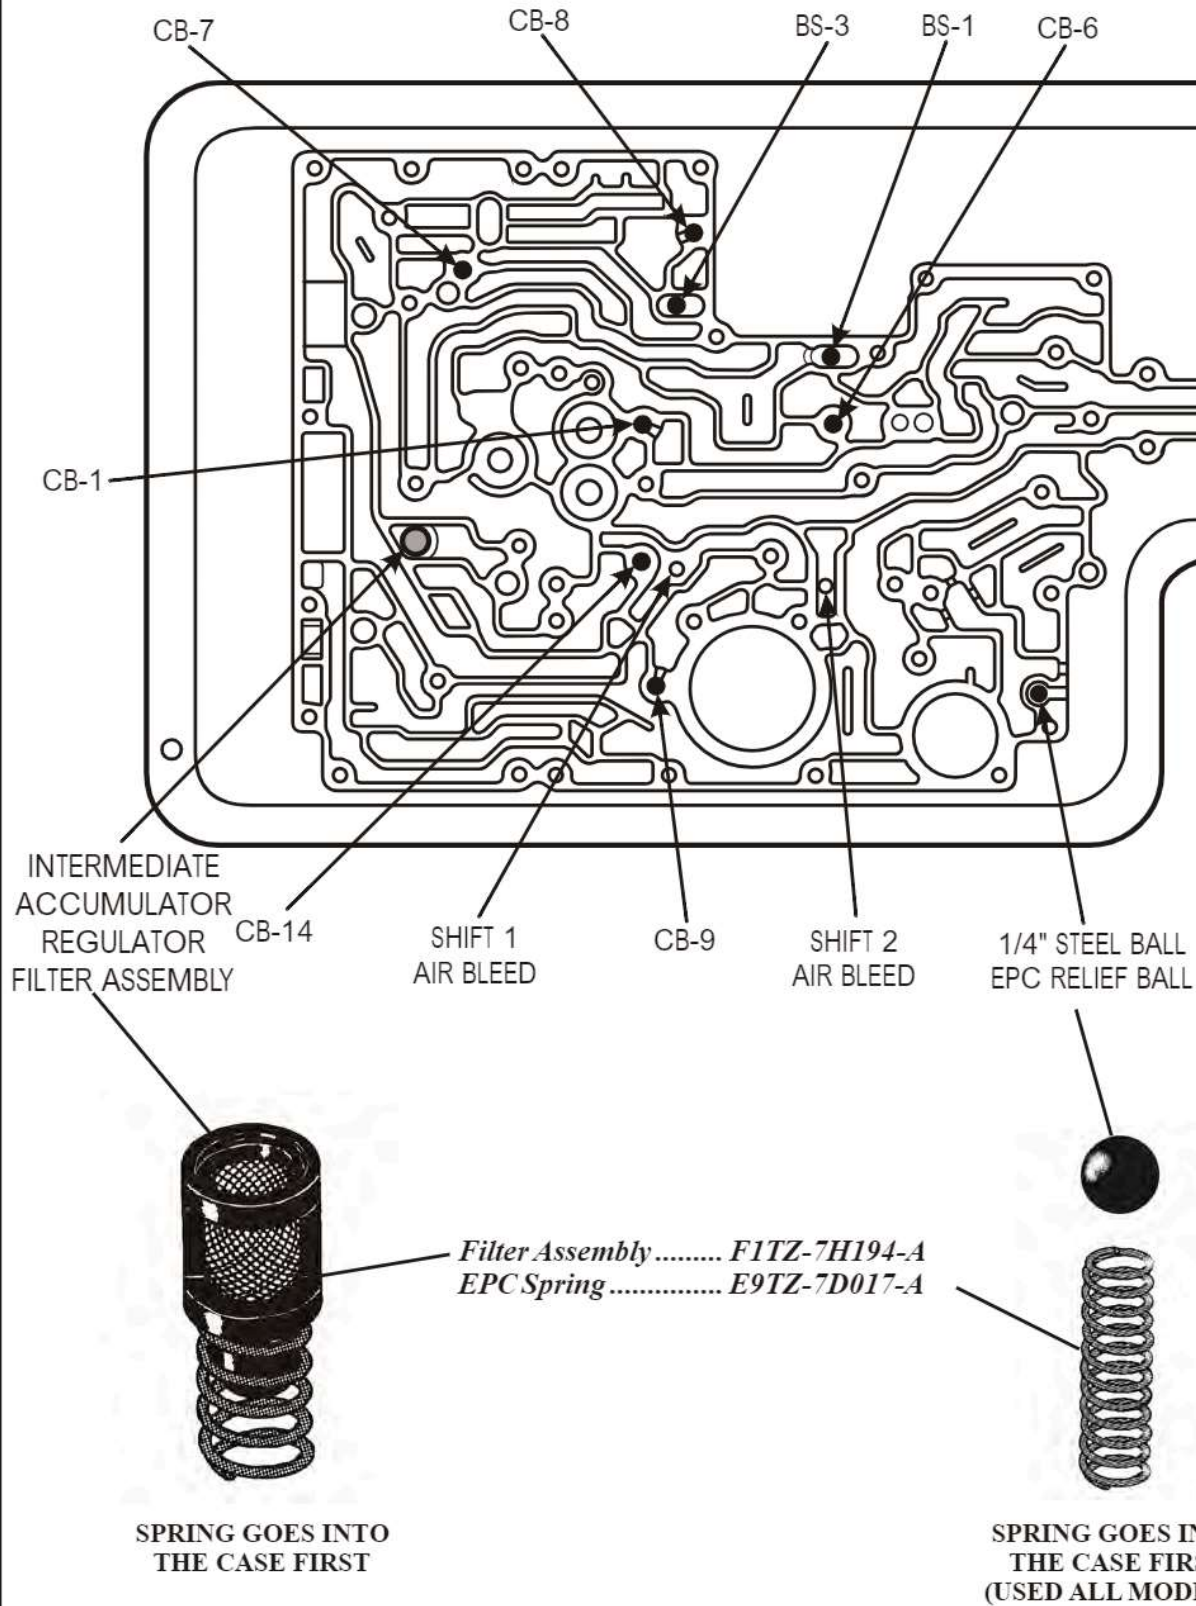
Figure 79

## 4R100 "MODIFIED" CASE CHECKBALL LOCATIONS REQUIRES EIGHT (5/16") RUBBER BALLS
