## FORD E4OD "UPDATE HANDBOOK"

AUTOMATIC TRANSMISSION SERVICE GROUP  
18639 SW 107TH AVENUE  
MIAMI, FLORIDA 33157  
(305) 670-4161

### FORD E4OD "UPDATE HANDBOOK"

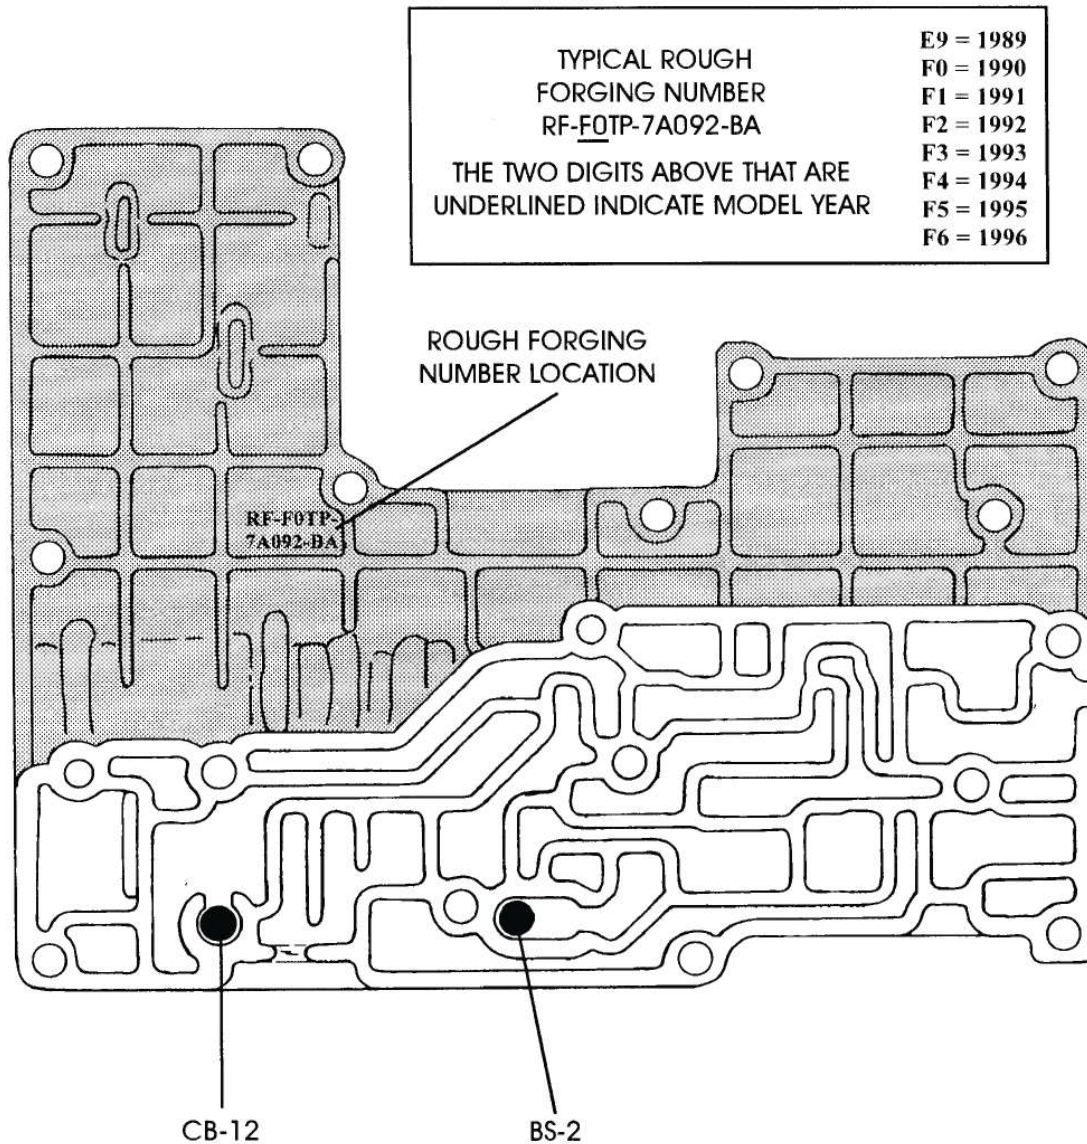
Figure 1

1989-1995 VALVE BODY CHECKBALL LOCATIONS  
TWO 5/16" RUBBER BALLS - ALL MODELS

- (7) **LOWER VALVE BODY** - The engagement control valve retaining clip on 1989 models, was replaced by a bore plug and new design clip on the 90-95 models, which also changed the worm track configuration in that area, as shown inside the circles in Figure 17.  
The 1996-Up models have a multitude of worm track location differences than the previous models, to accommodate the added valve body checkballs, as shown in Figure 17. The best, and most accurate method of identification is the rough forging number cast into the lower valve body using the formula in Figures 1 and 2.

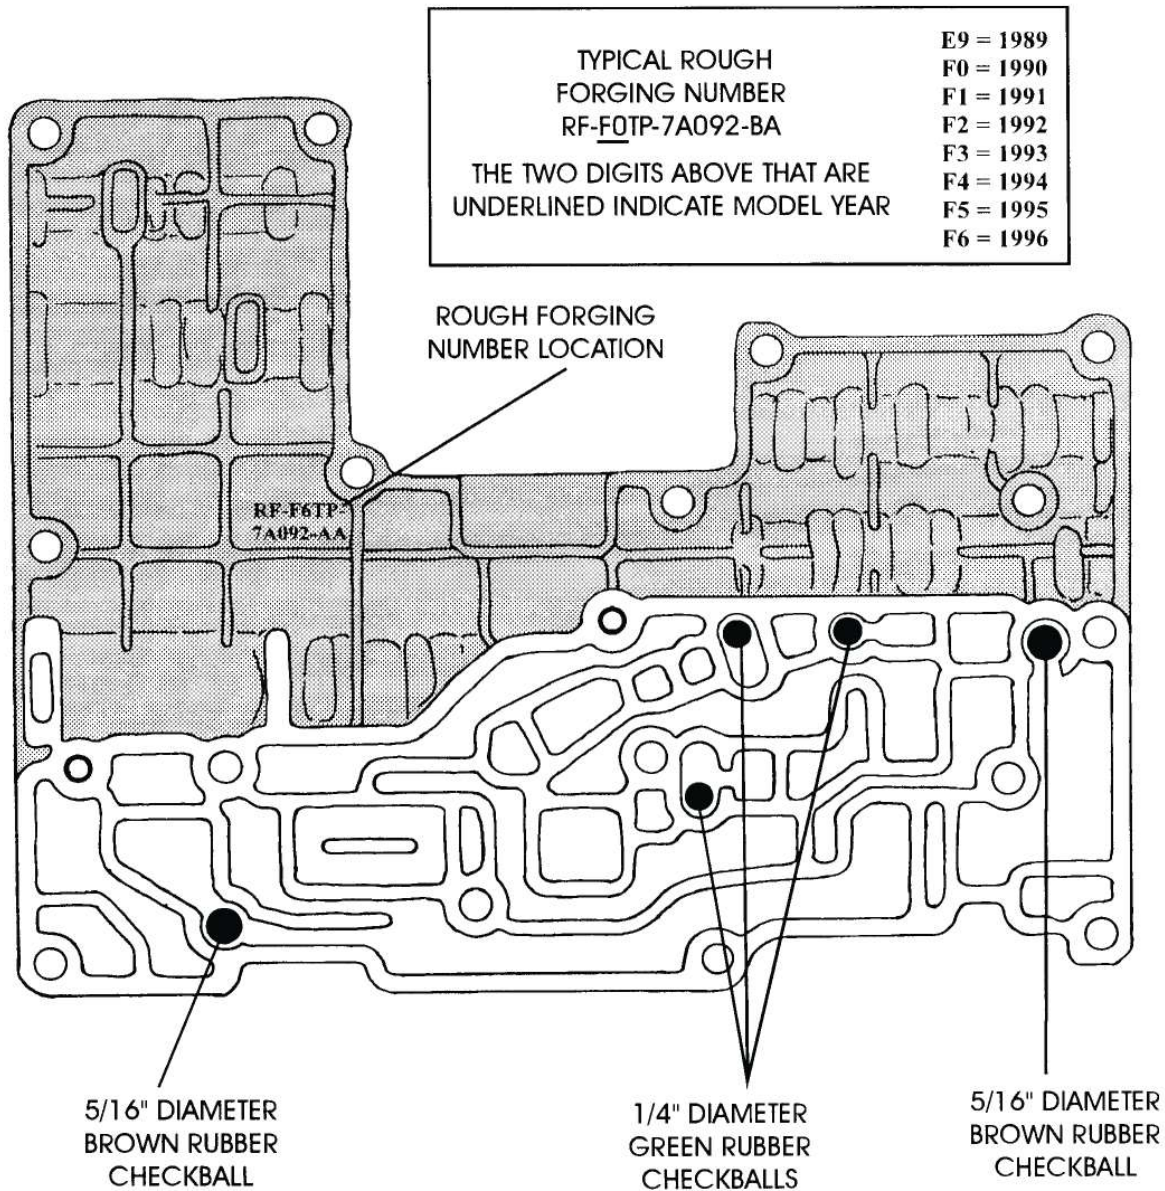
Figure 2

1996 VALVE BODY CHECKBALL LOCATIONS  
REQUIRES THREE 1/4" RUBBER BALLS,  
AND TWO 5/16" RUBBER BALLS

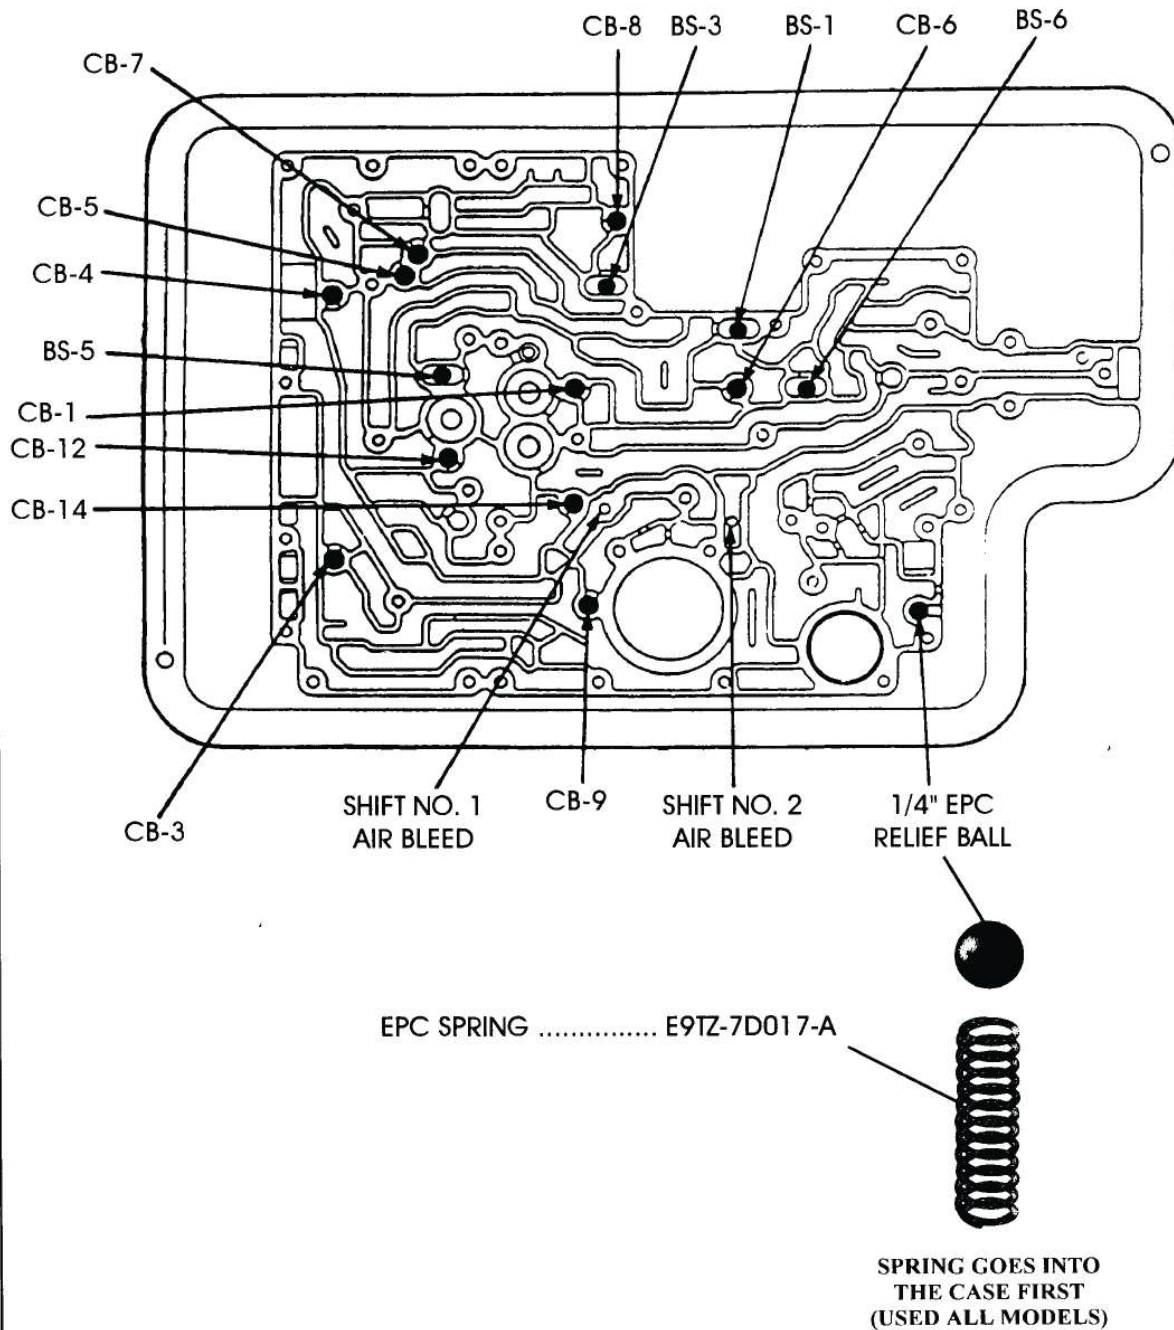
Figure 3  
AUTOMATIC TRANSMISSION SERVICE GROUP  
8

### EARLY 1989 CHECKBALL LOCATIONS FOURTEEN (5/16") RUBBER BALLS IN CASE

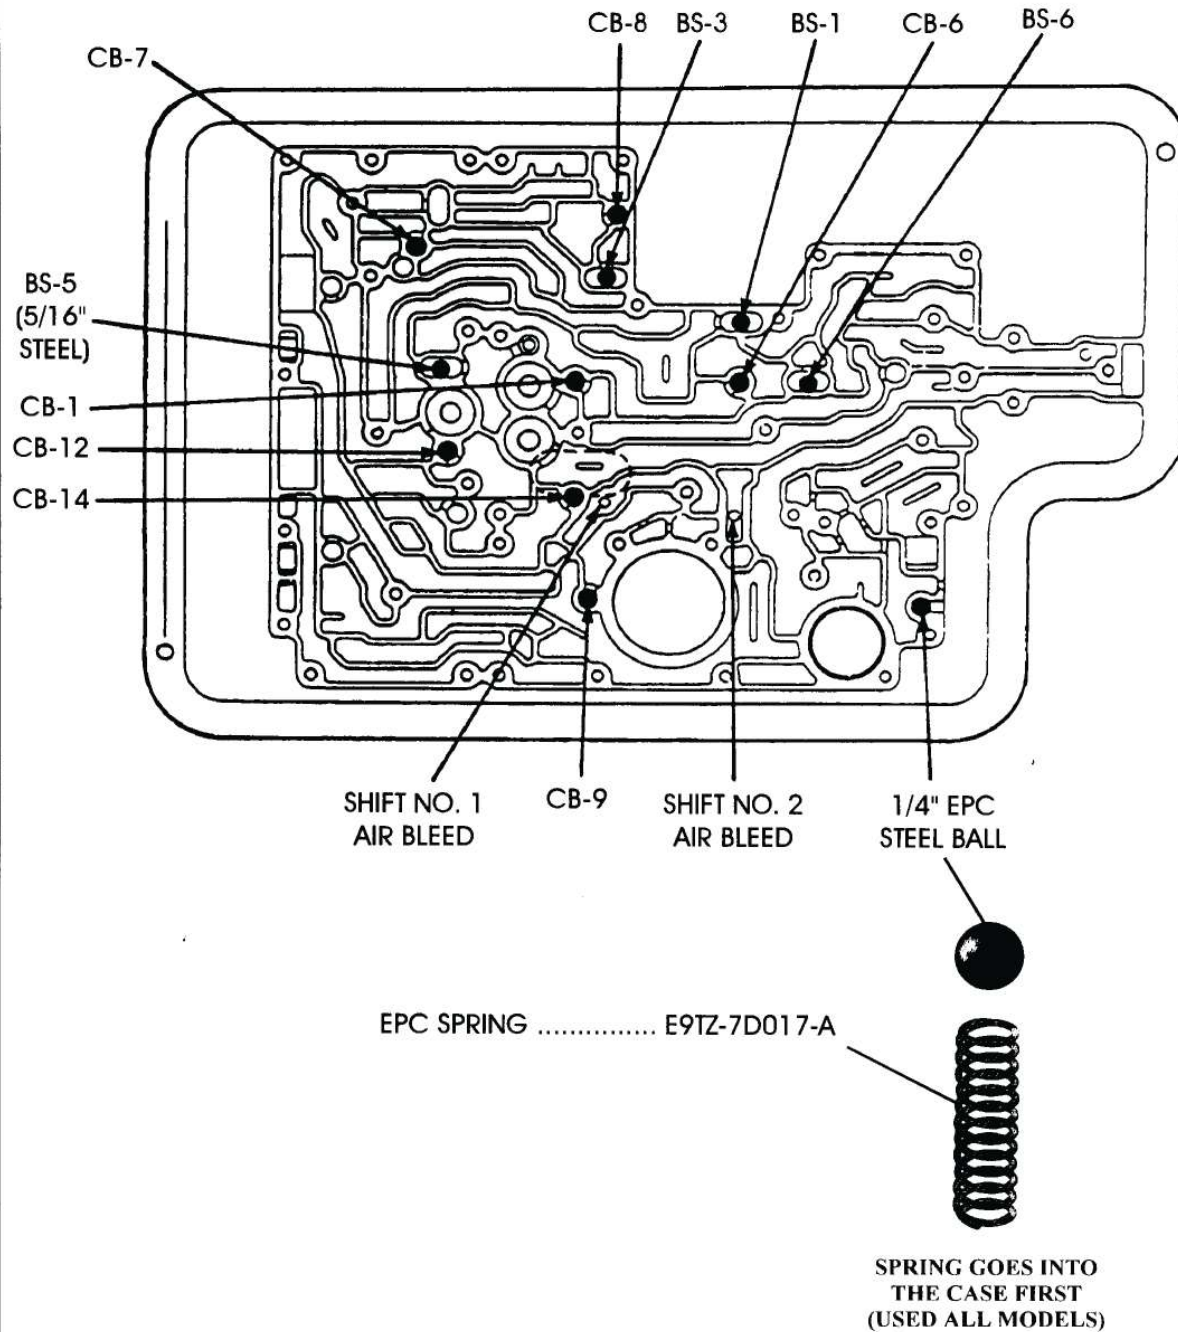
Figure 4

**LATE 1989 CHECKBALL LOCATIONS  
REQUIRES TEN (5/16") RUBBER BALLS AND  
ONE 5/16" STEEL BALL IN CASE**

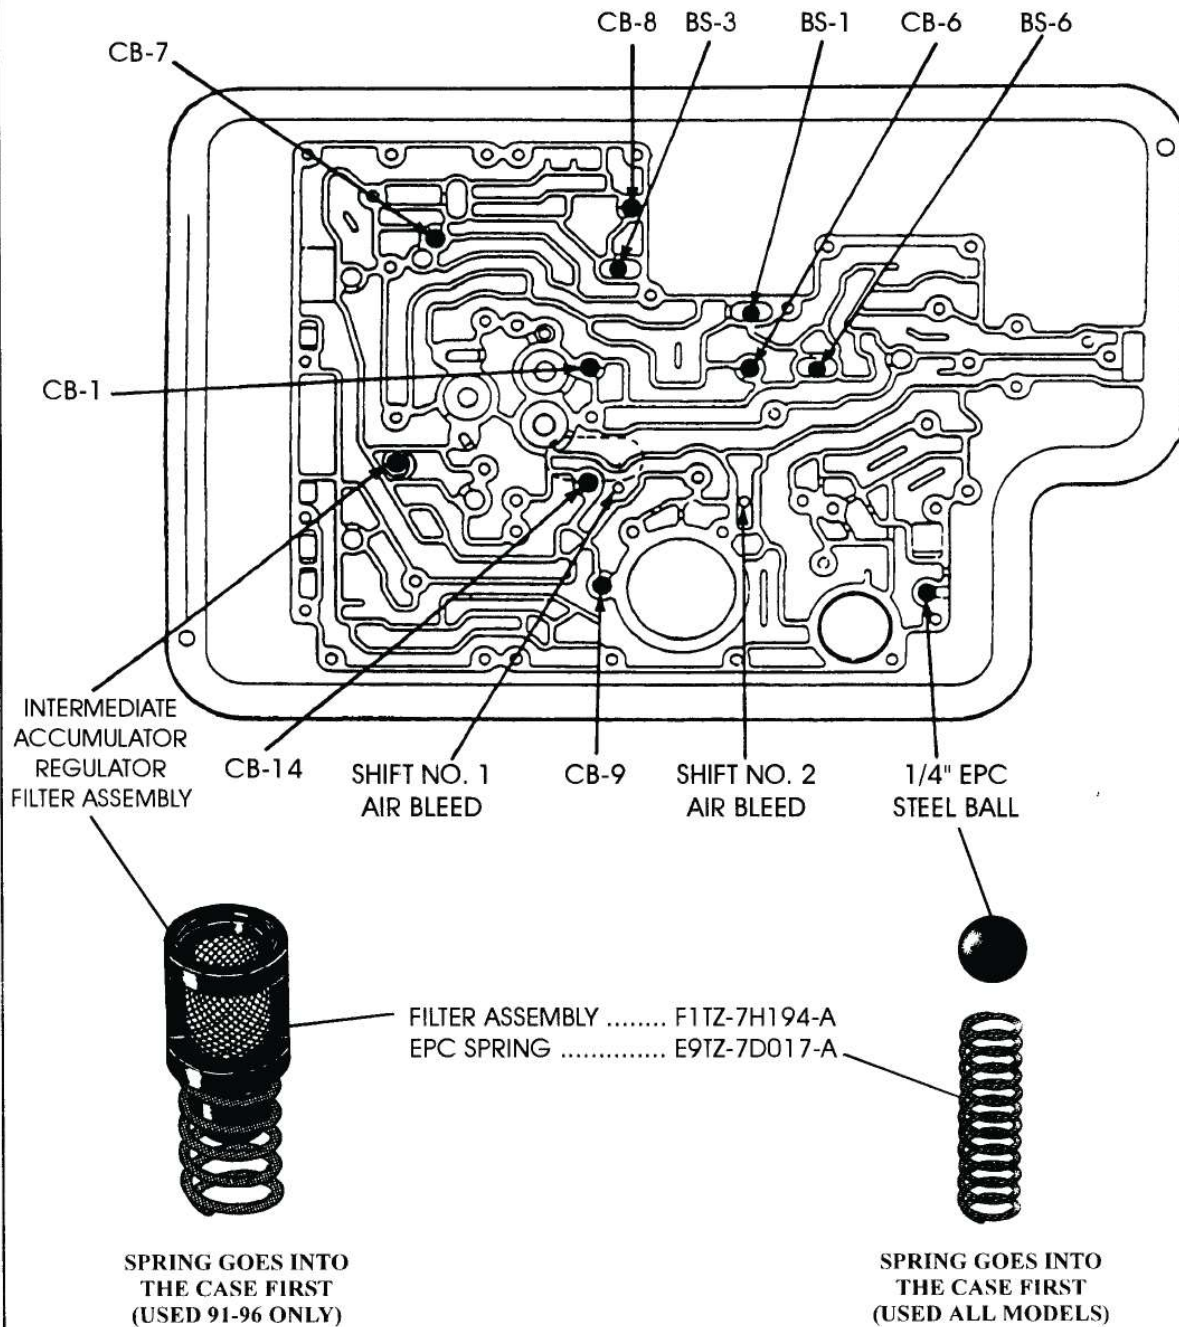
Figure 5

1990 - 1995 CHECKBALL LOCATIONS  
REQUIRES NINE (5/16") RUBBER BALLS IN CASE

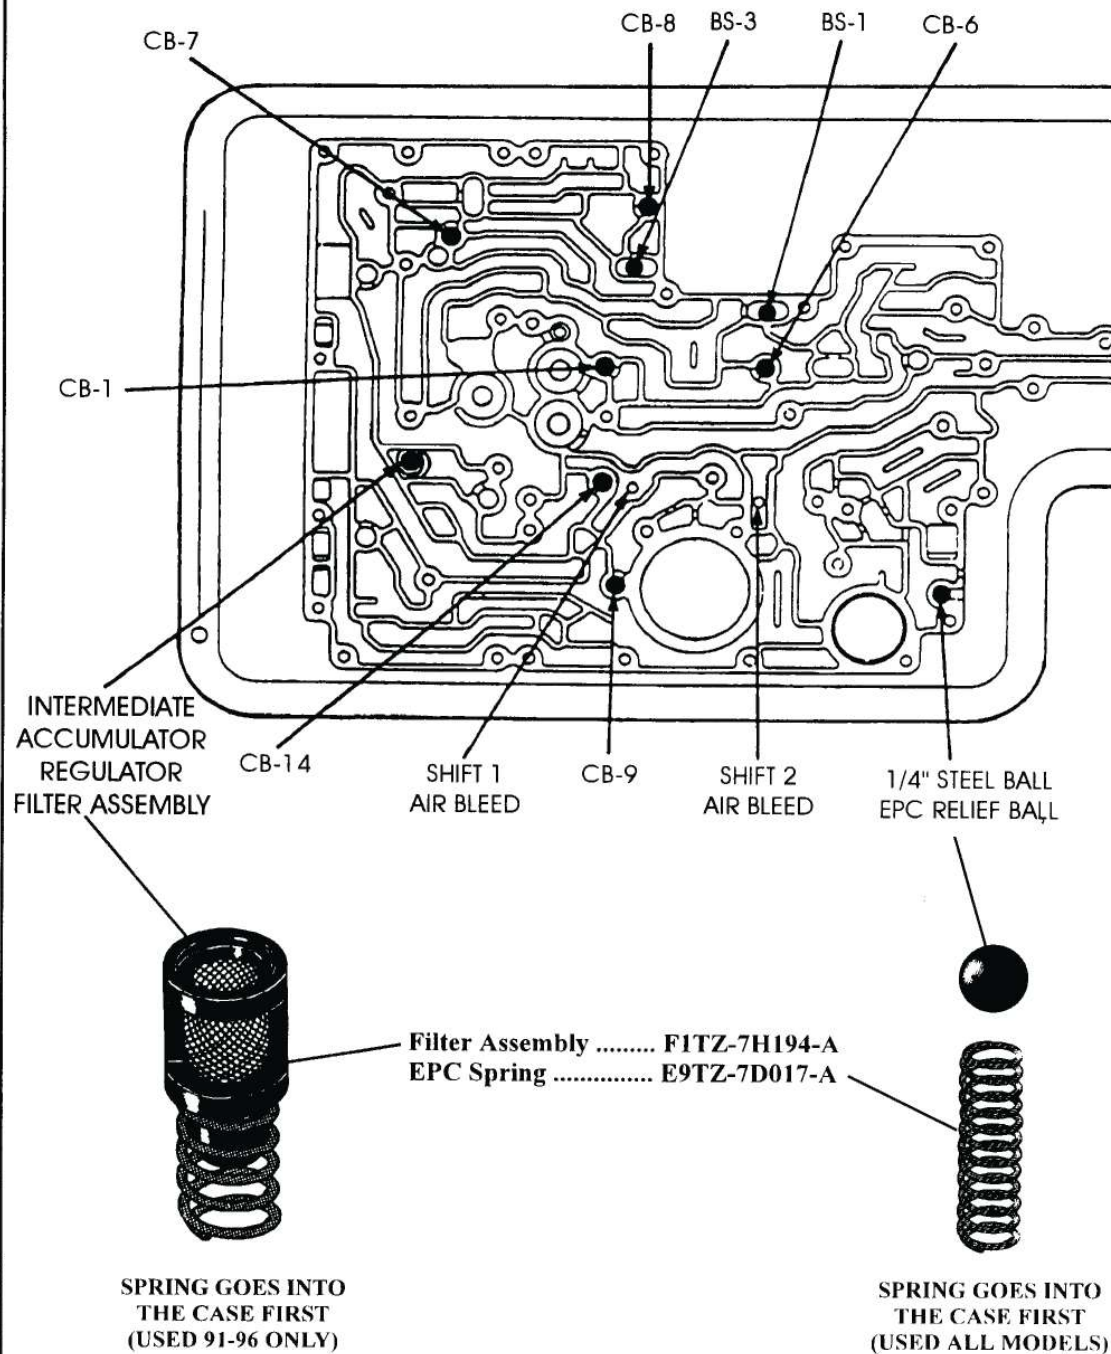
Figure 6  
AUTOMATIC TRANSMISSION SERVICE GROUP

## FORD E4OD 1996 CASE CHECKBALL LOCATIONS REQUIRES EIGHT (5/16") RUBBER BALLS

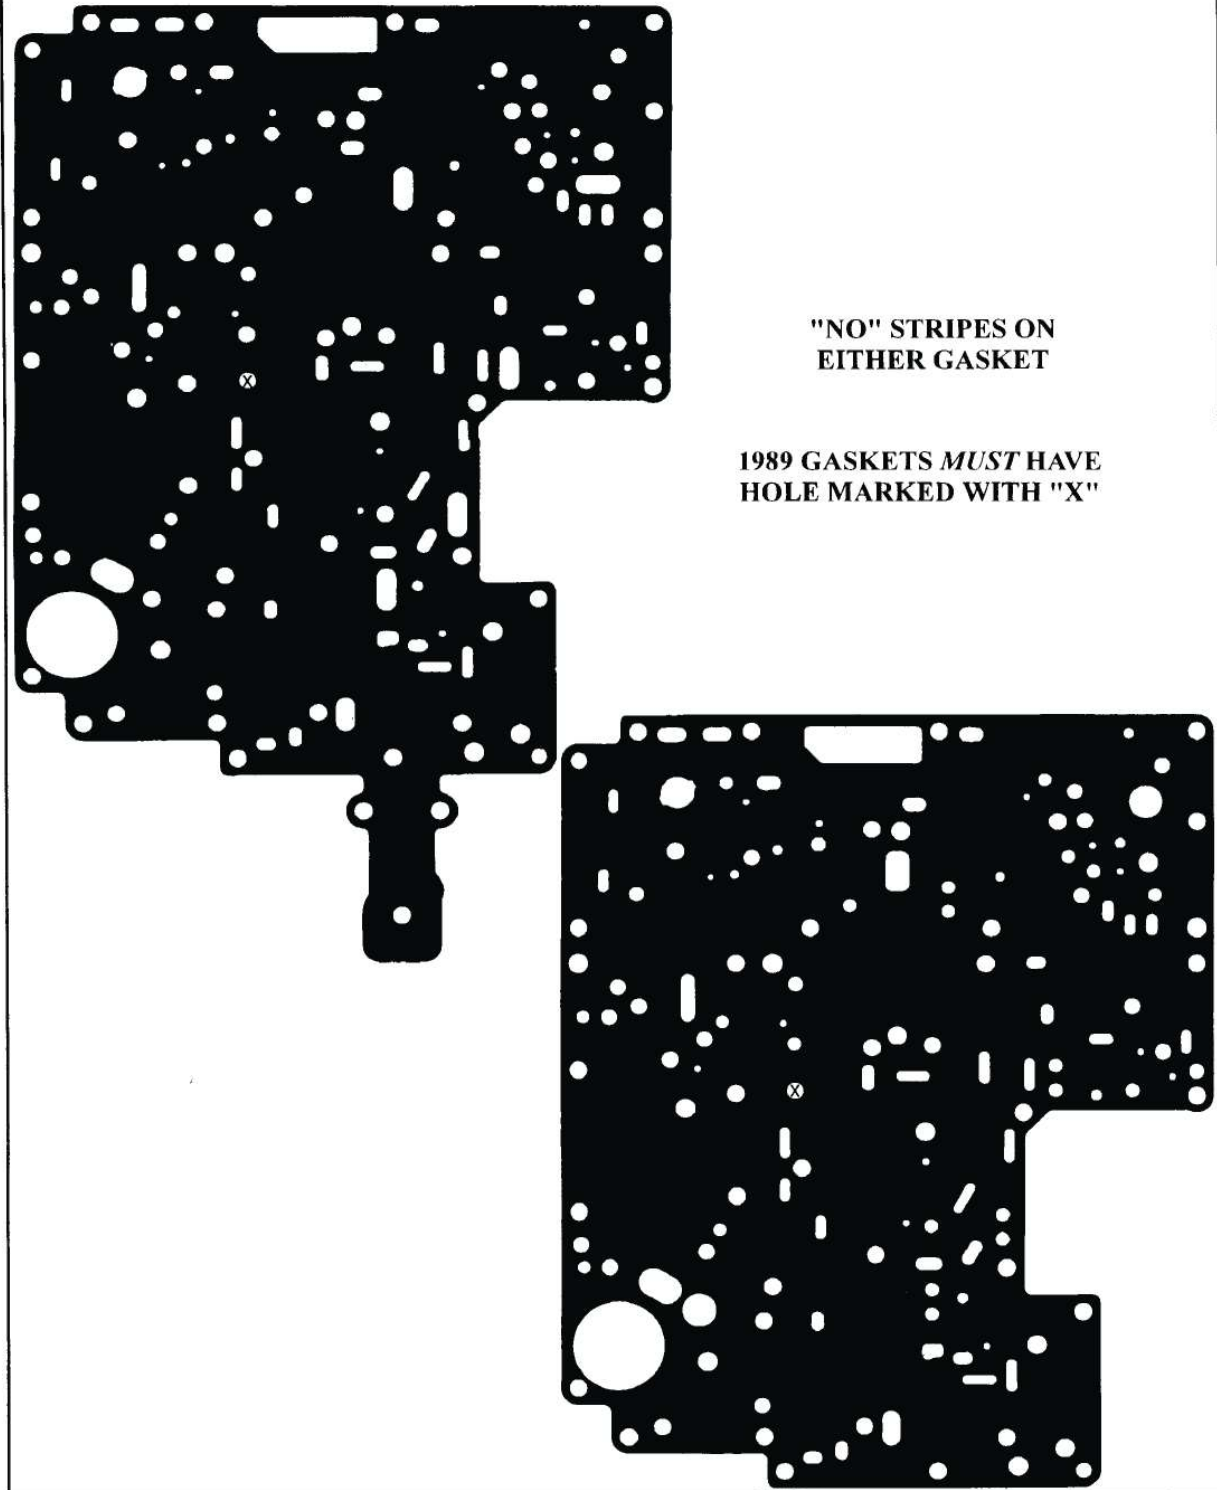
### 1989 ONLY VALVE BODY GASKETS

**"NO" STRIPES ON  
EITHER GASKET**

**1989 GASKETS *MUST* HAVE  
HOLE MARKED WITH "X"**

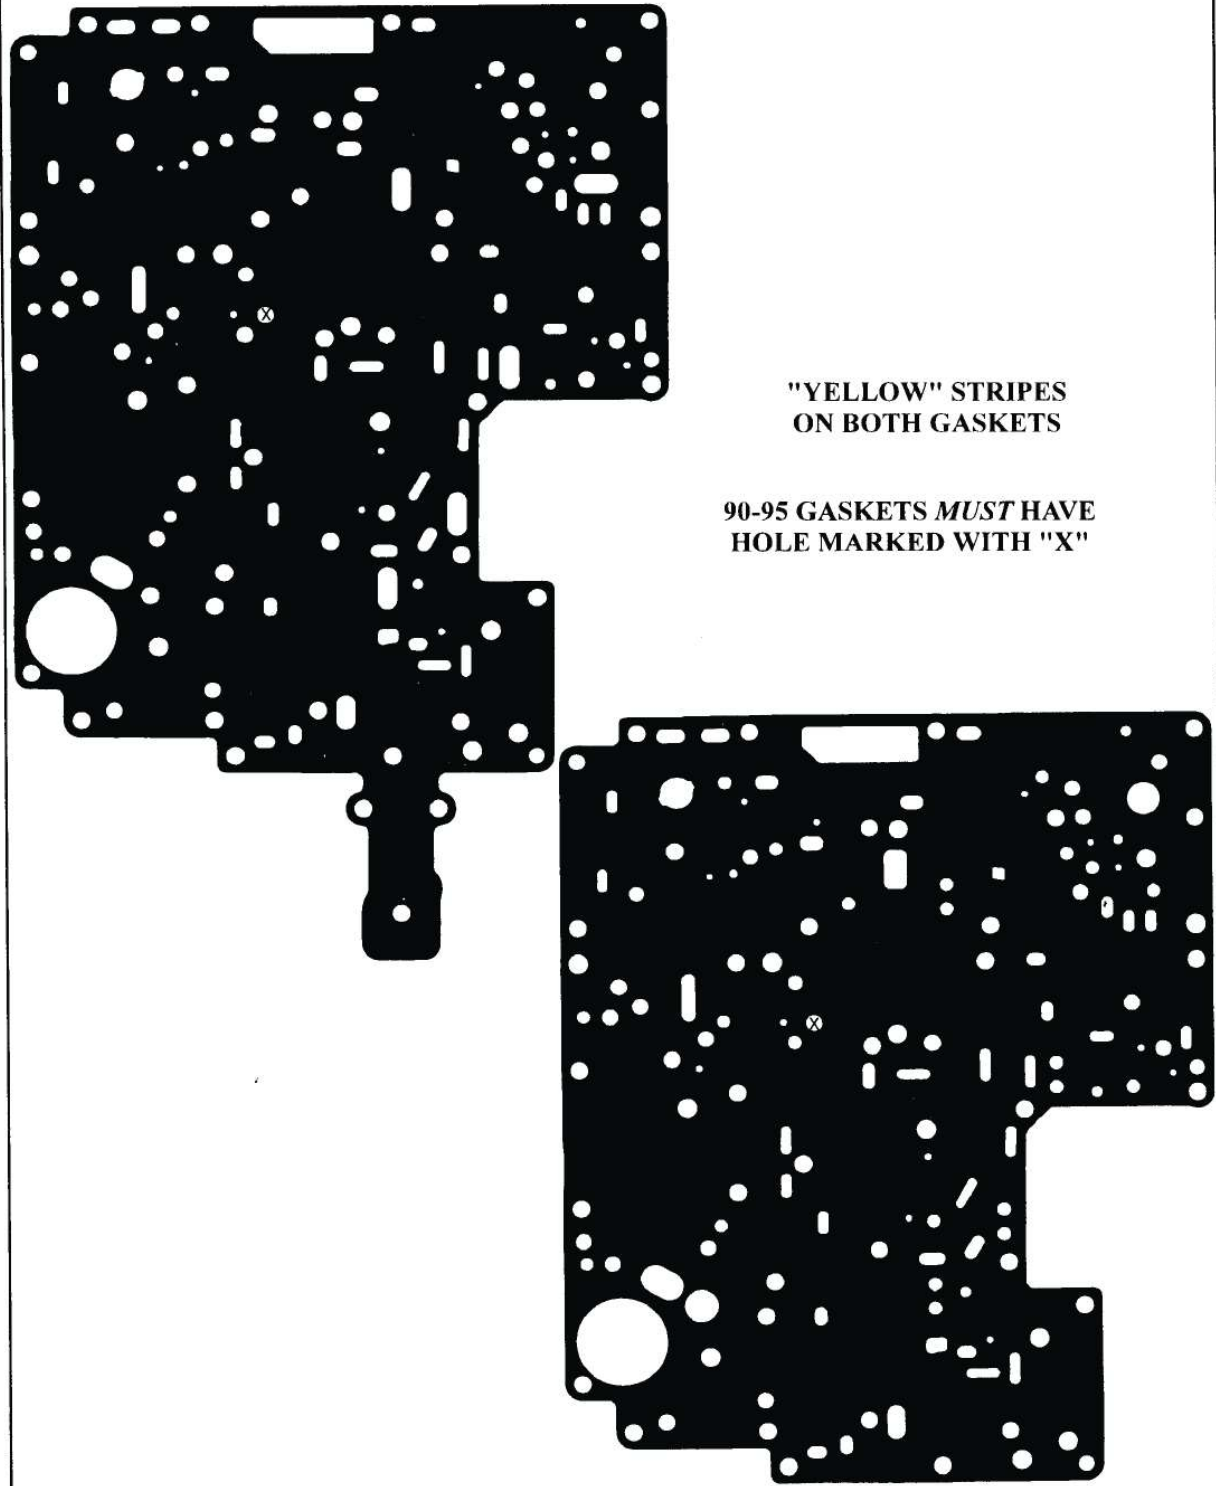
### 1990-1995 ONLY VALVE BODY GASKETS

"YELLOW" STRIPES  
ON BOTH GASKETS

90-95 GASKETS *MUST* HAVE  
HOLE MARKED WITH "X"

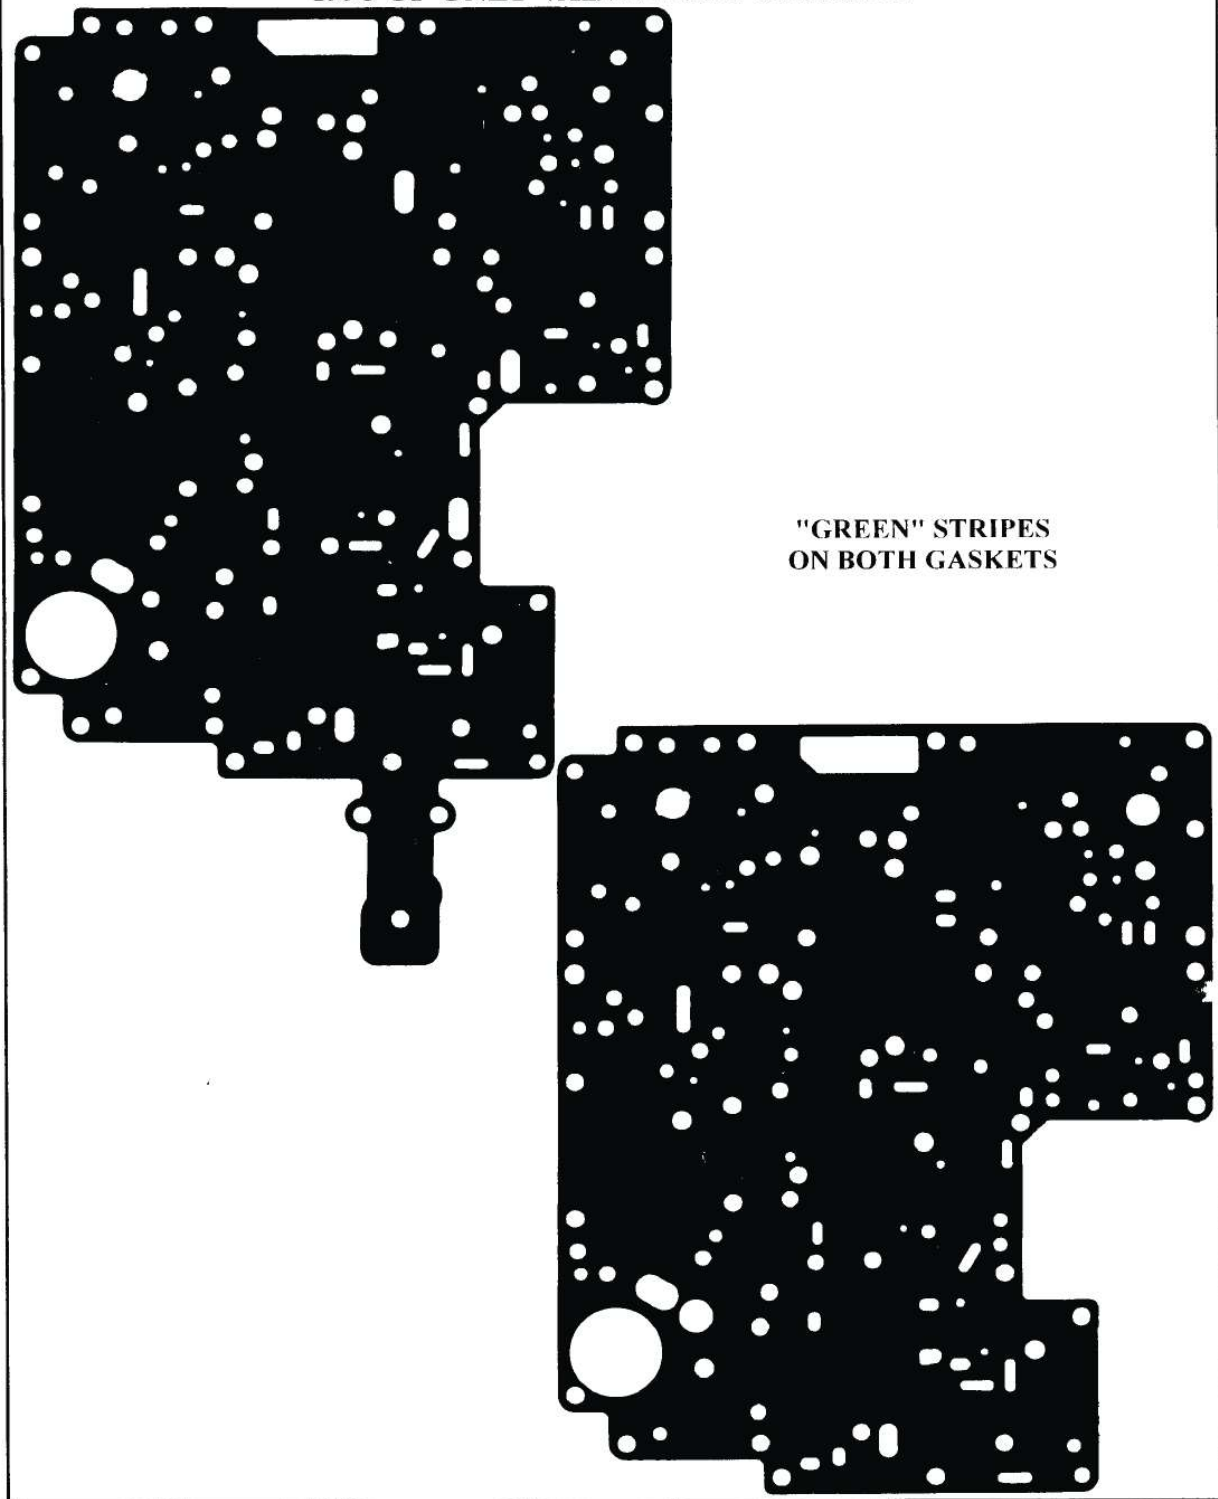
Figure 10

### 1996-UP ONLY VALVE BODY GASKETS

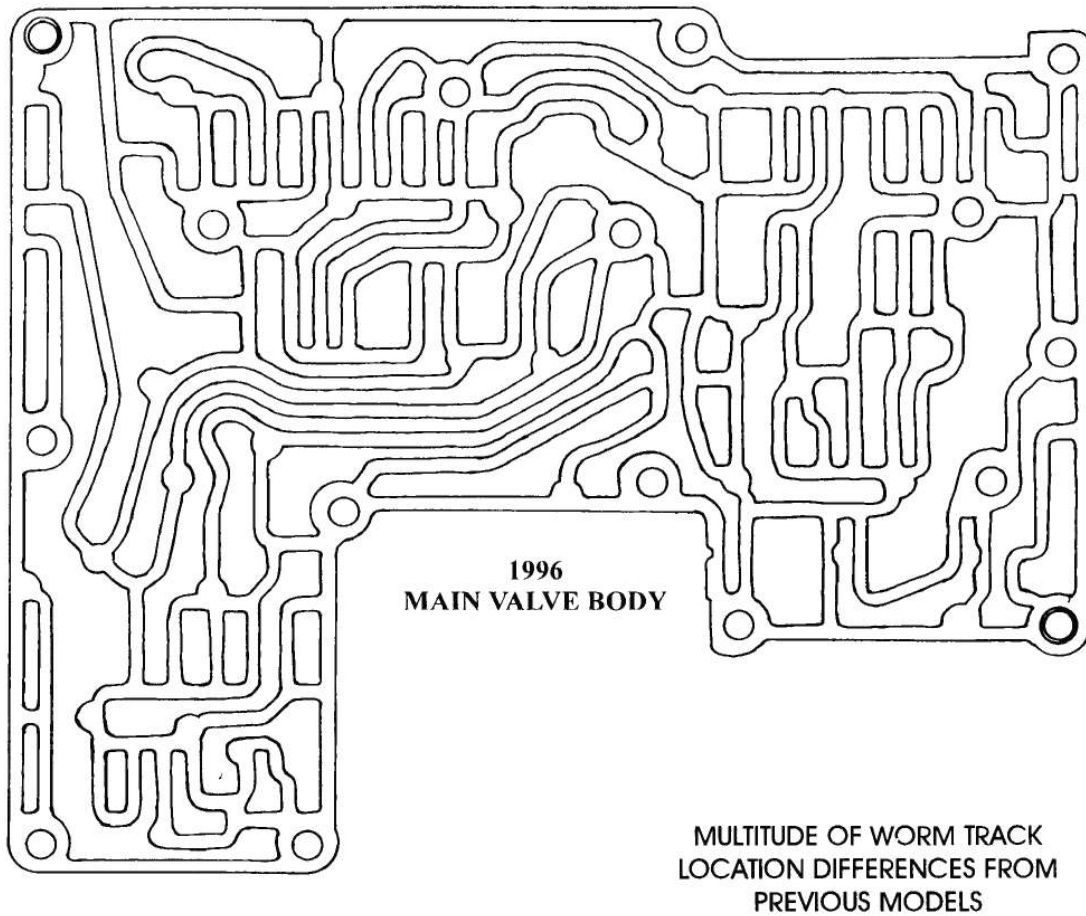
Figure 15

***IDENTIFY BY THE ROUGH FORGING  
NUMBER AS SHOWN IN FIGURES 1 AND 2***

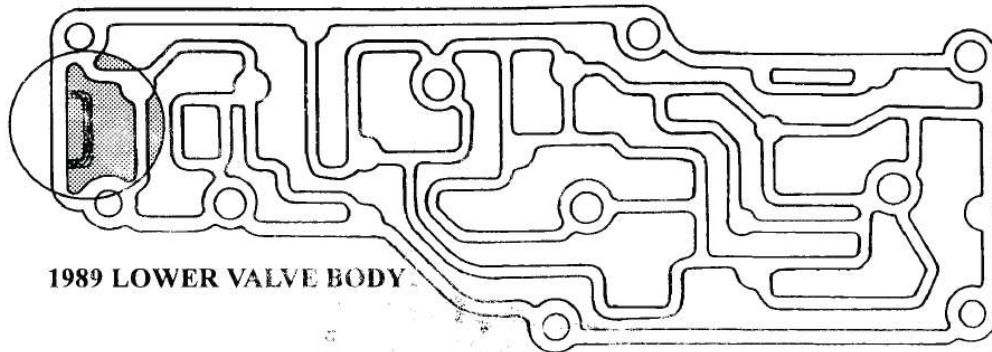
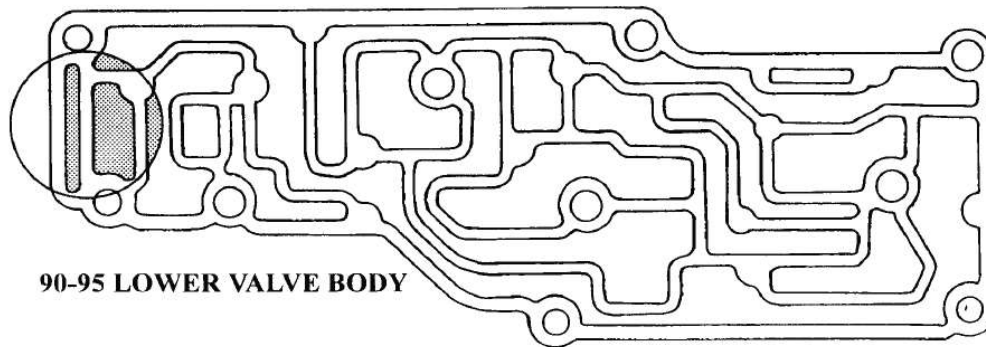
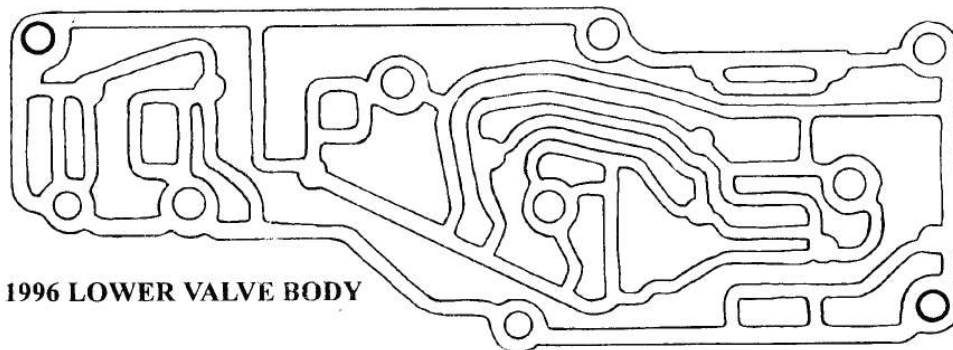
Figure 17

**E4OD LOWER VALVE BODIES**

**1989 LOWER VALVE BODY**

**90-95 LOWER VALVE BODY**

**1996 LOWER VALVE BODY**

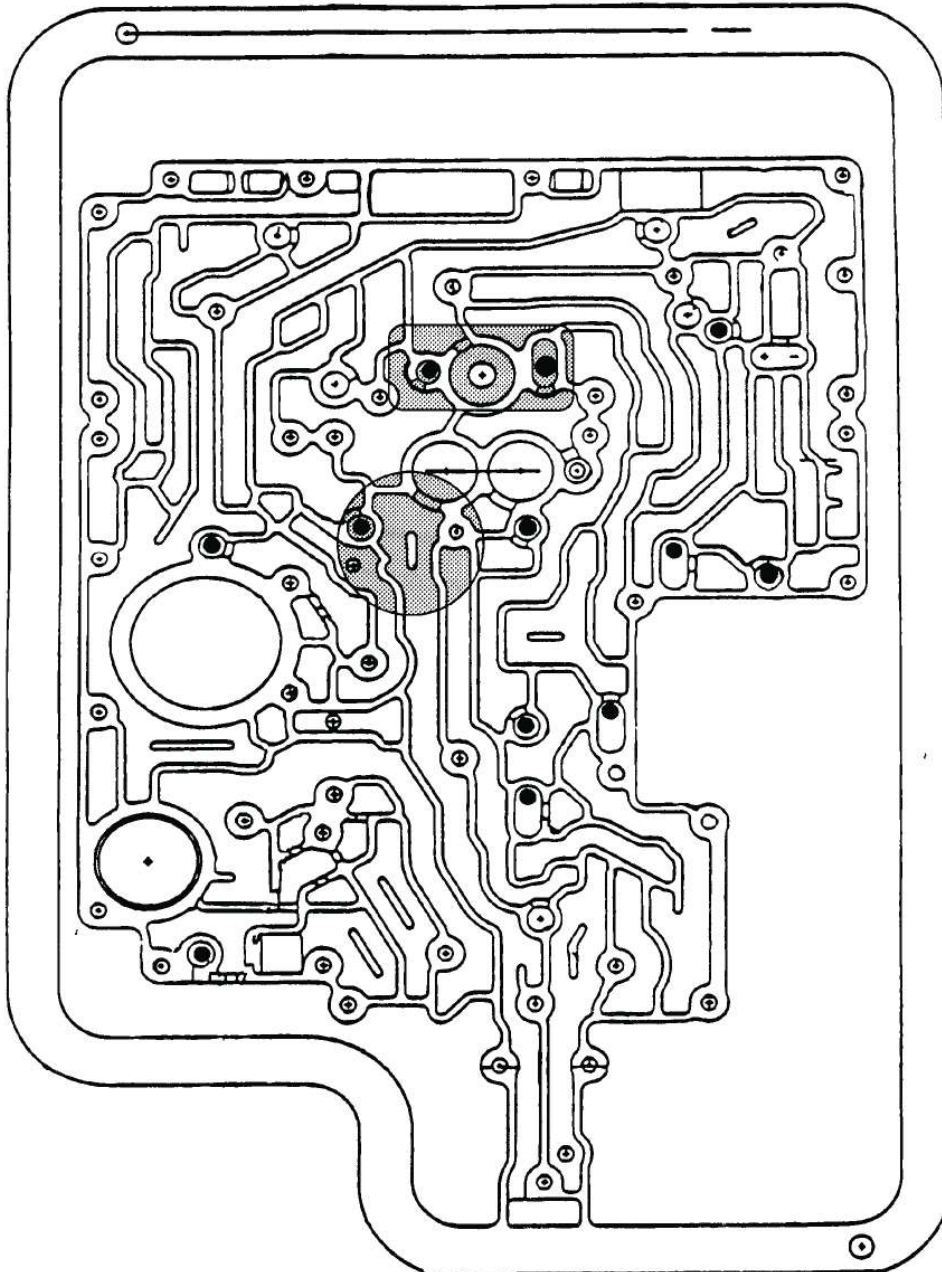
Figure 18  
AUTOMATIC TRANSMISSION SERVICE GROUP

### **1989 E4OD CASE IDENTIFICATION** *SHADED AREAS ARE DIFFERENT THAN 1990 MODEL*

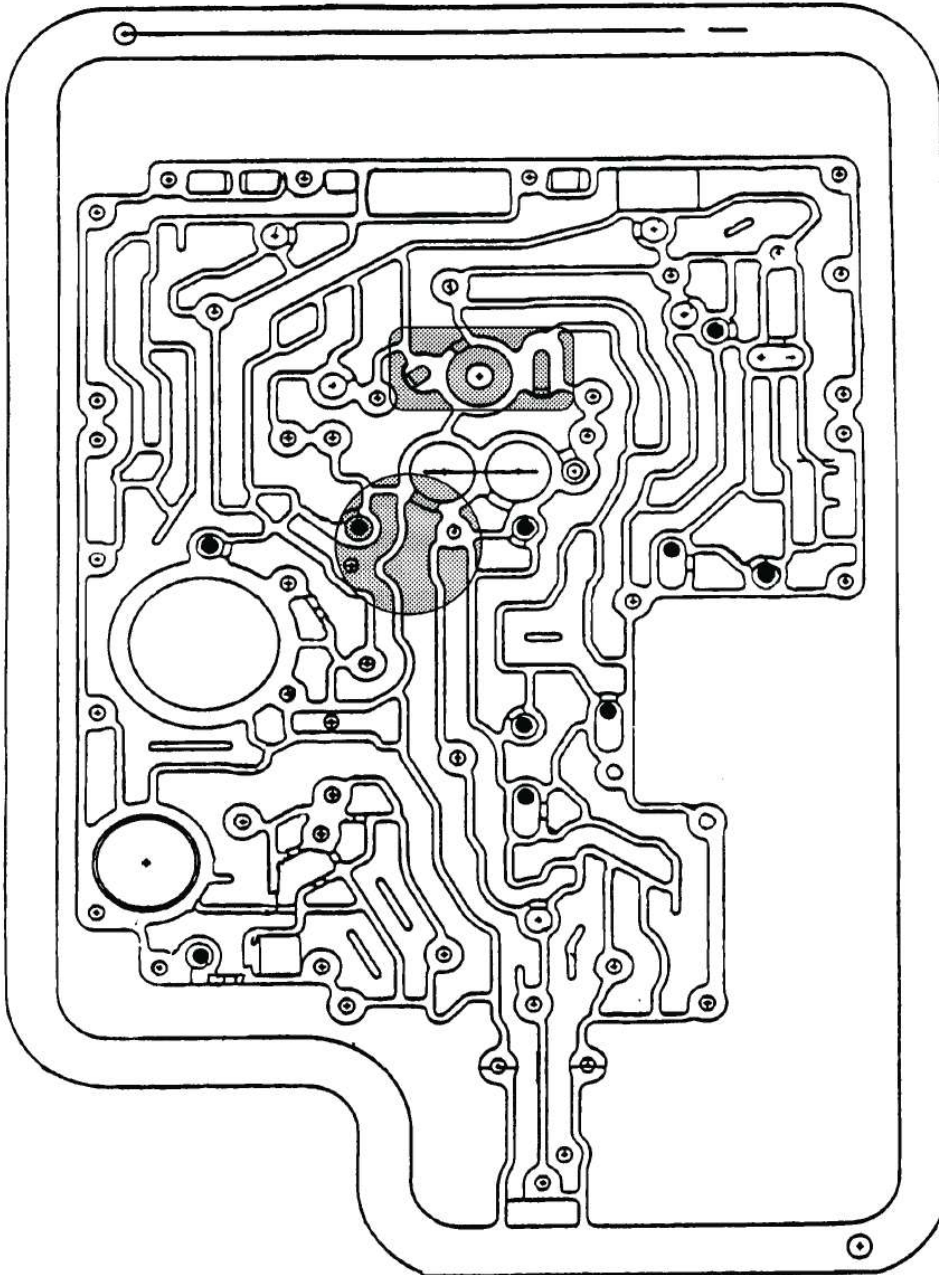
Figure 19

### 1990 E4OD CASE IDENTIFICATION

*SHADED AREAS ARE DIFFERENT THAN 1989 MODEL*

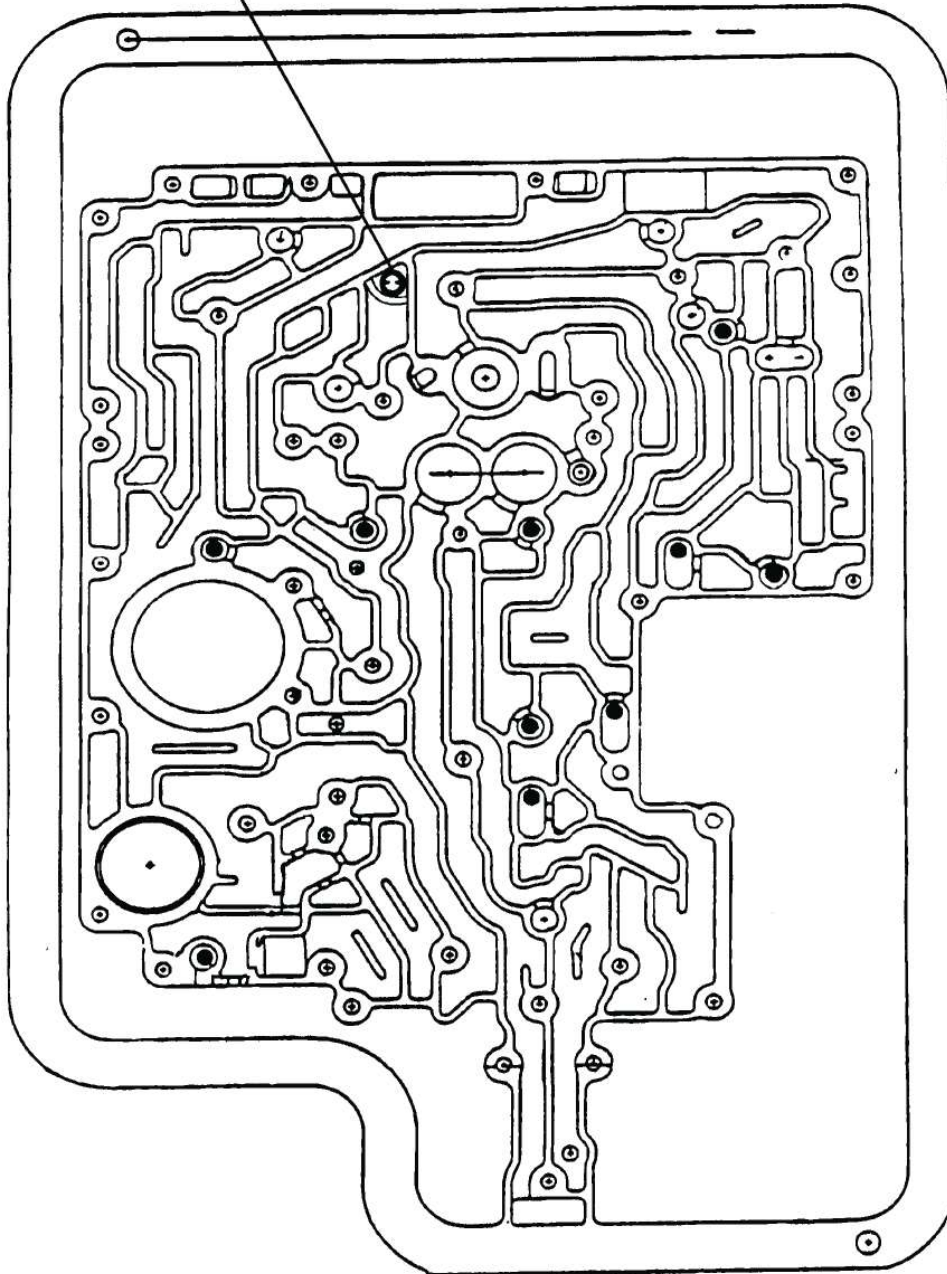
Figure 20

### 1991 E4OD CASE IDENTIFICATION

INTERMEDIATE CLUTCH ACCUMULATOR  
REGULATOR FILTER ASSEMBLY ADDED HERE

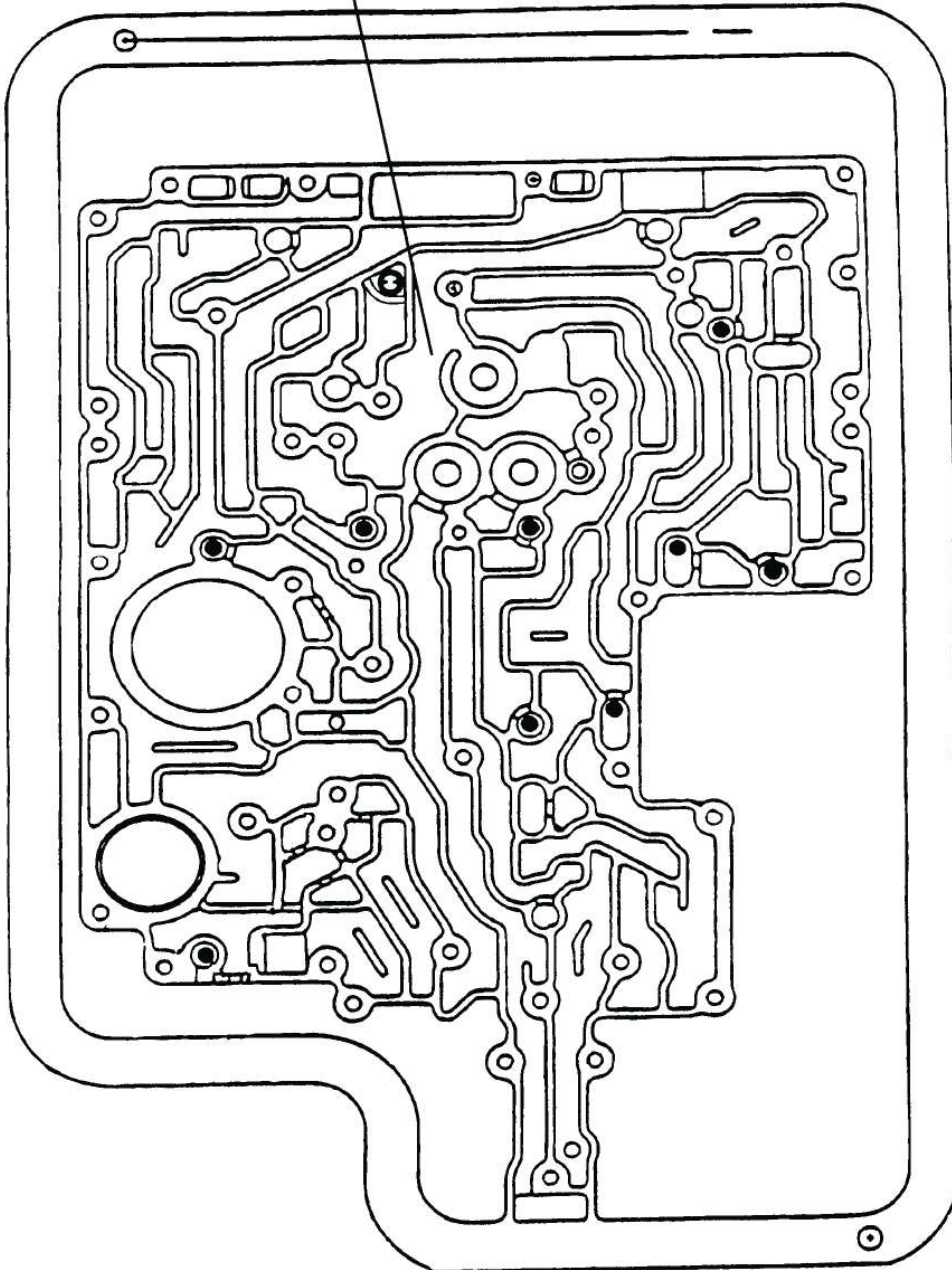
Figure 21

### 1996 E4OD CASE IDENTIFICATION

SMALL DIFFERENCES IN THIS AREA BUT  
WILL INTERCHANGE WITH 1990-UP MODELS
