## FORD E4OD "UPDATE HANDBOOK"

AUTOMATIC TRANSMISSION SERVICE GROUP  
18639 SW 107TH AVENUE  
MIAMI, FLORIDA 33157  
(305) 670-4161

### FORD E4OD "UPDATE HANDBOOK"

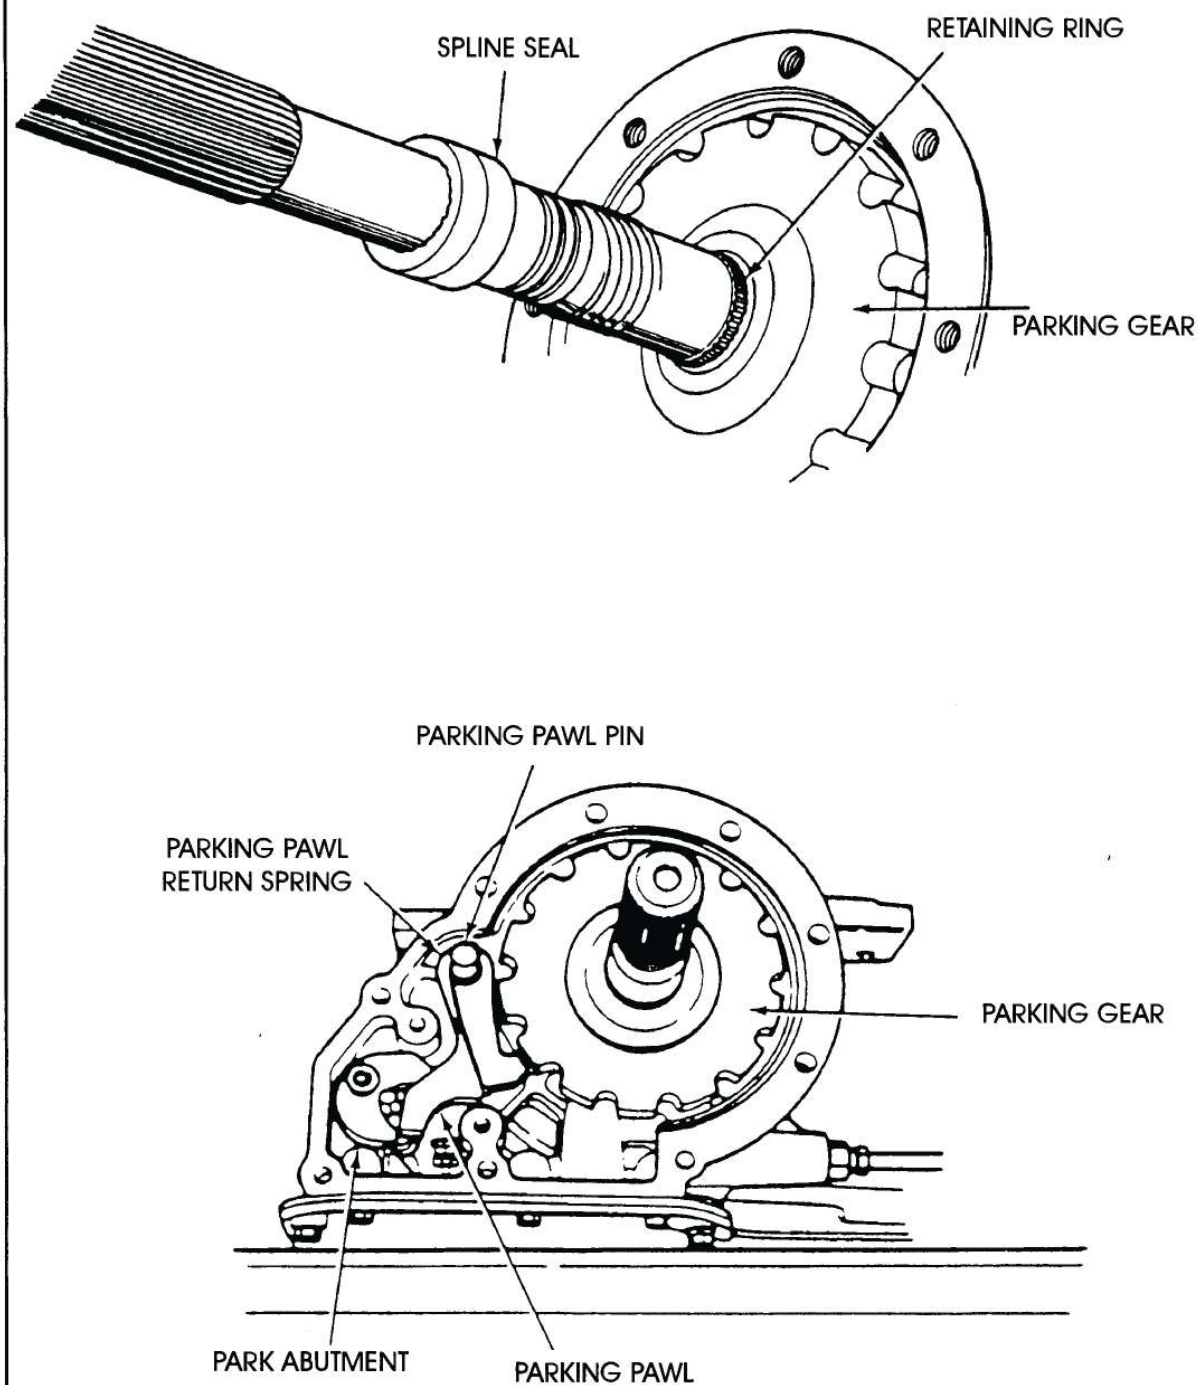
Figure 22

**CAUSE:** The cause may be a broken snap ring on the output shaft, allowing the parking gear to move rearward, and then the parking pawl cannot engage into the parking gear. Refer to Figure 22.

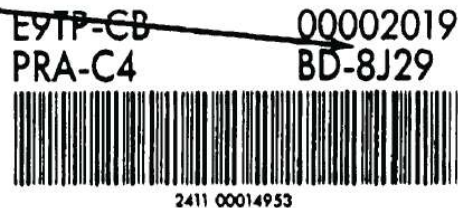
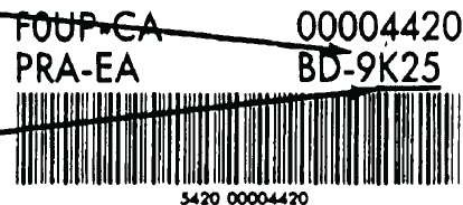
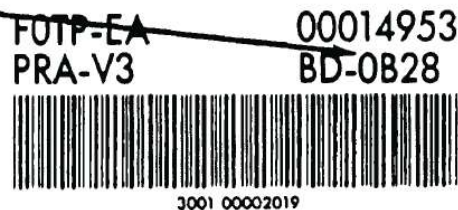
Figure 23

- 1988 — 8 before the letter  
REPAIR ALL

- 1989 — 9 before the letter

E250-E350 7.3L Diesel —  
A01 thru K26 • REPAIR  
All Other — (except 5.0L)  
A01 thru L30 • REPAIR

- 1990 — 0 before the letter  
Does Not Need Repair

- The following actions must be taken based on the build date as identified on the transmission I.D. Tag:
- E250-E350 7.3L Diesel
  - Any transmission built in 1988 must be repaired
  - Any transmission built in 1989 prior to Oct. 27, 1989 (9K27) must be repaired
- All Other Applications (except 5.0L)
  - Any transmission built in 1988 must be repaired
  - Any transmission built in 1989 prior to Dec. 1, 1989 (9M01) must be repaired
- Any transmission built in 1990 does not need repair
- BUILD DATE IDENTIFICATION IS AS FOLLOWS:

If the identification tag is missing or does not conform to the above guidelines, then unit must be repaired.

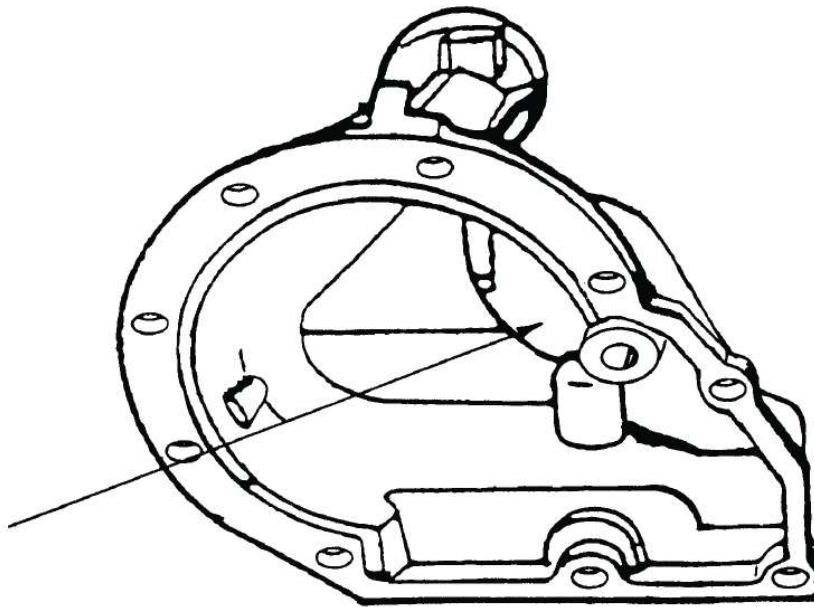
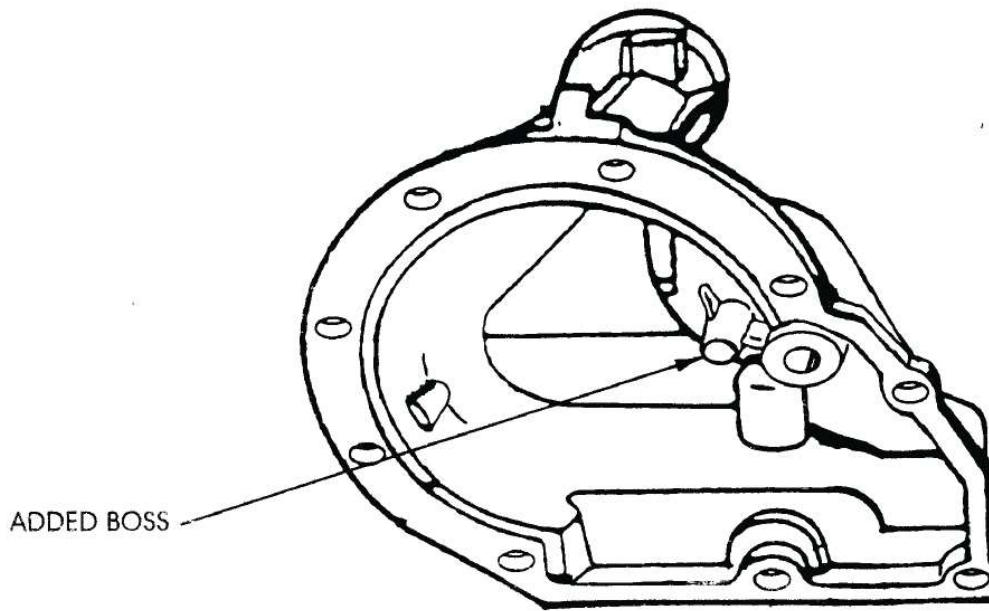
Figure 24  
AUTOMATIC TRANSMISSION SERVICE GROUP

**NEW DESIGN**

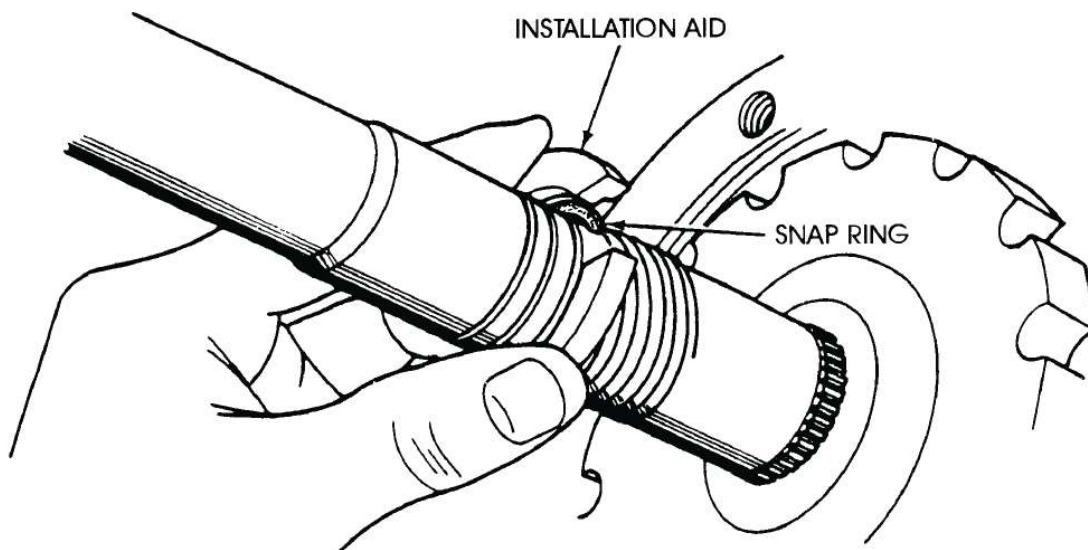
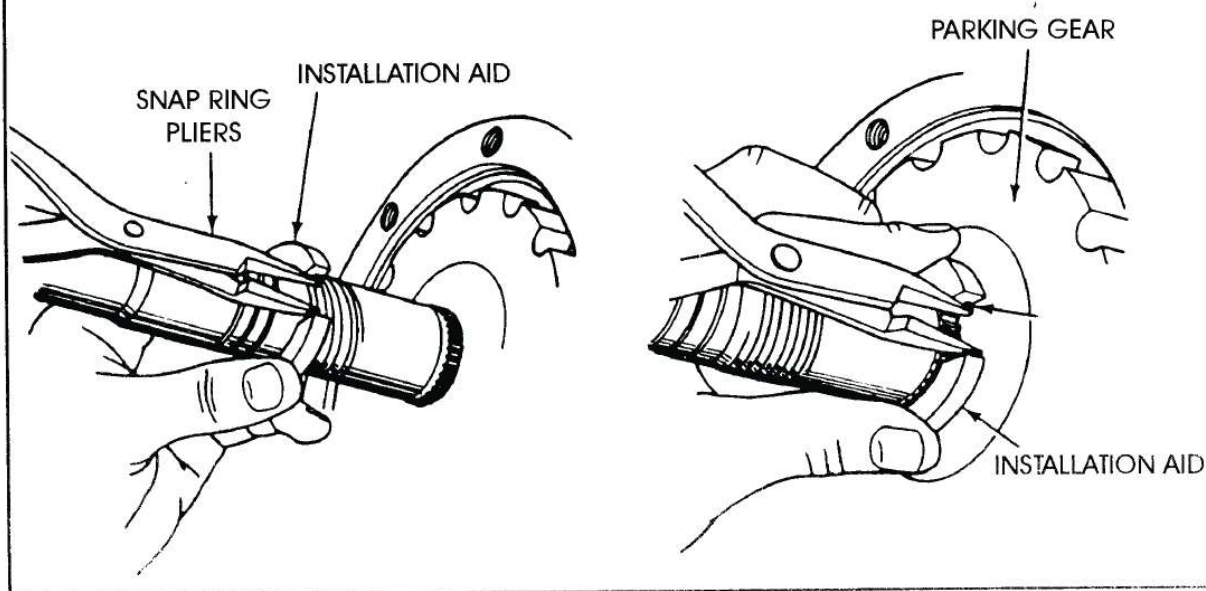
Figure 25

- (1) Remove installation aid with retaining ring from package. Hold ring in the installation aid opposite opening and place installation aid on the output shaft, just before speedo teeth, with ring facing transmission. Retaining ring ends must be in installation aid opening. Installation aid is to prevent the ring from being spread too far apart.

- (2) Hold snap ring pliers parallel to output shaft and expand snap ring within the installation aid.
- (3) Slide snap ring over the speedo teeth and release the snap ring when the installation aid is against the parking gear

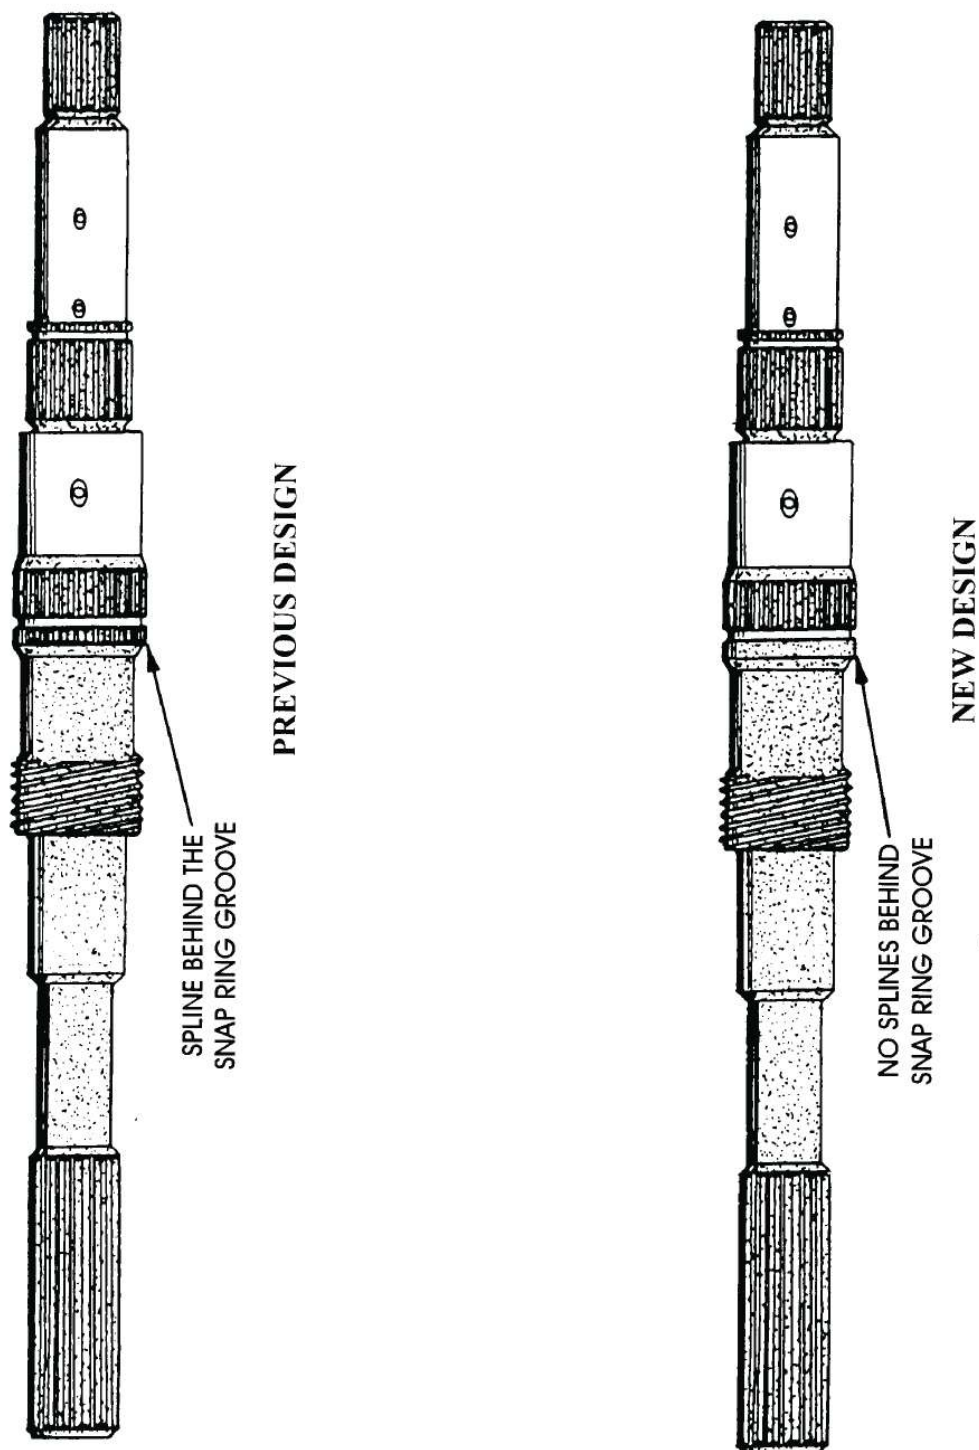
Figure 26  
AUTOMATIC TRANSMISSION SERVICE GROUP

The Output Shaft has also been redesigned for 1990 and later models, with the splines removed from behind the parking gear snap ring groove, which creates an increased shoulder for the snap ring, and helps prevent the snap ring from breaking. Refer to Figure 26.

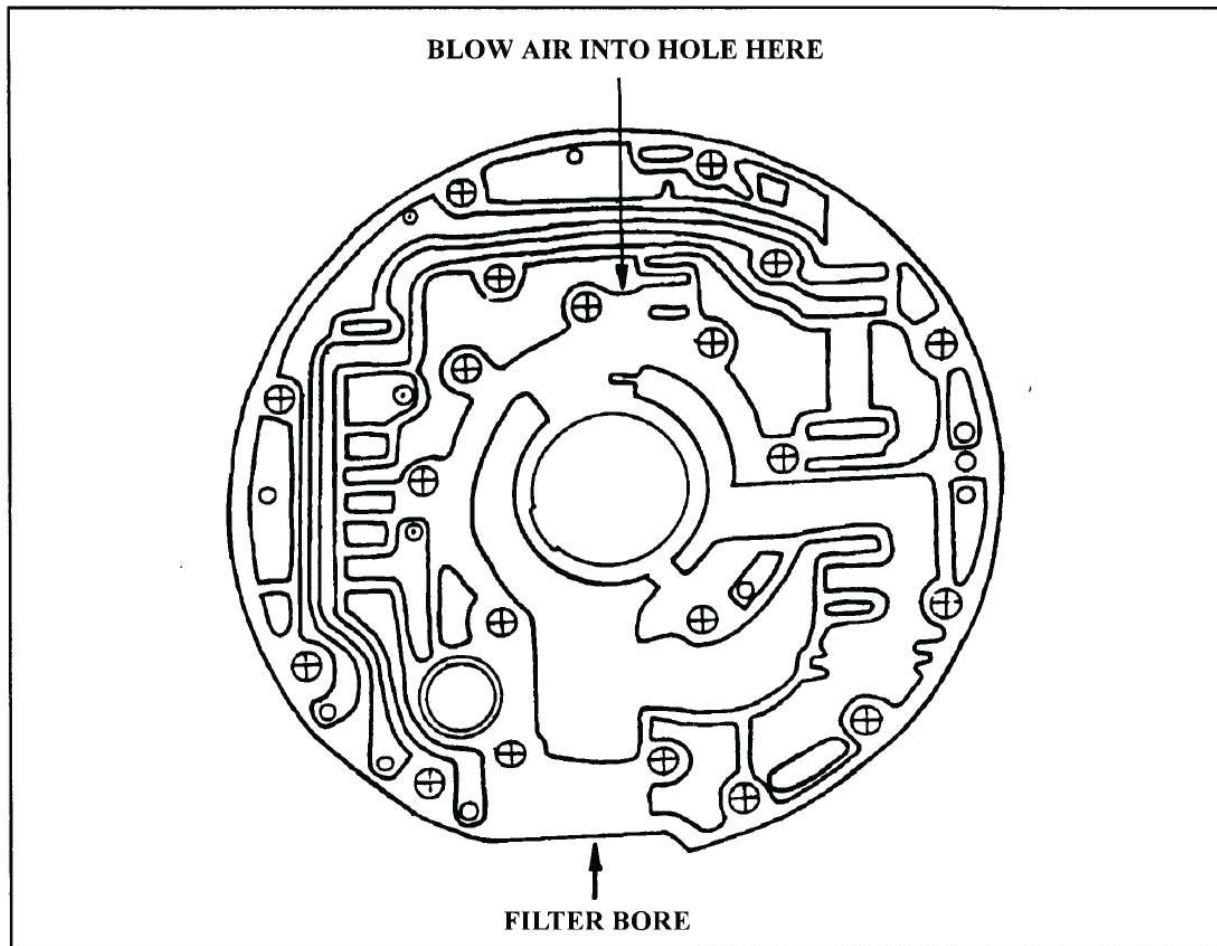
Figure 27

**COMPLAINT:** Overdrive planetary and overdrive sprag failure due to lack of lubrication.

**CAUSE:** The cause may be, a plugged or restricted lube passage in the oil pump cover. There is a valve and spring under the orificed cup plug in the pump cover. The valve is made of plastic and is prone to melting, and will restrict or block the passage.

**CORRECTION:** To check for restriction, blow air into the hole in pump cover as shown in Figure 27, and air should exit from the holes in rear of stator shaft, as shown in Figure 28. If the passage is restricted or blocked the orificed cup plug must be removed, the plastic valve assembly replaced, and the passage thoroughly cleaned (See Figure 28)

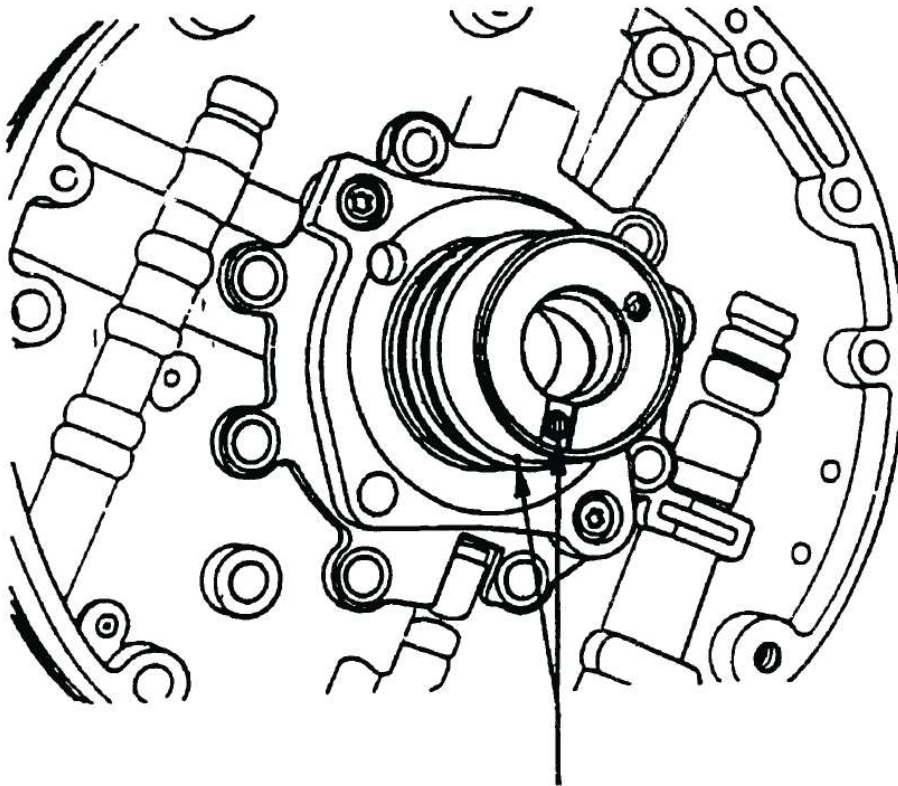
**AIR SHOULD EXIT FROM ORIFICED  
CUP PLUG AND SMALL LUBE HOLE IN  
FRONT OF BUSHING JOURNAL**

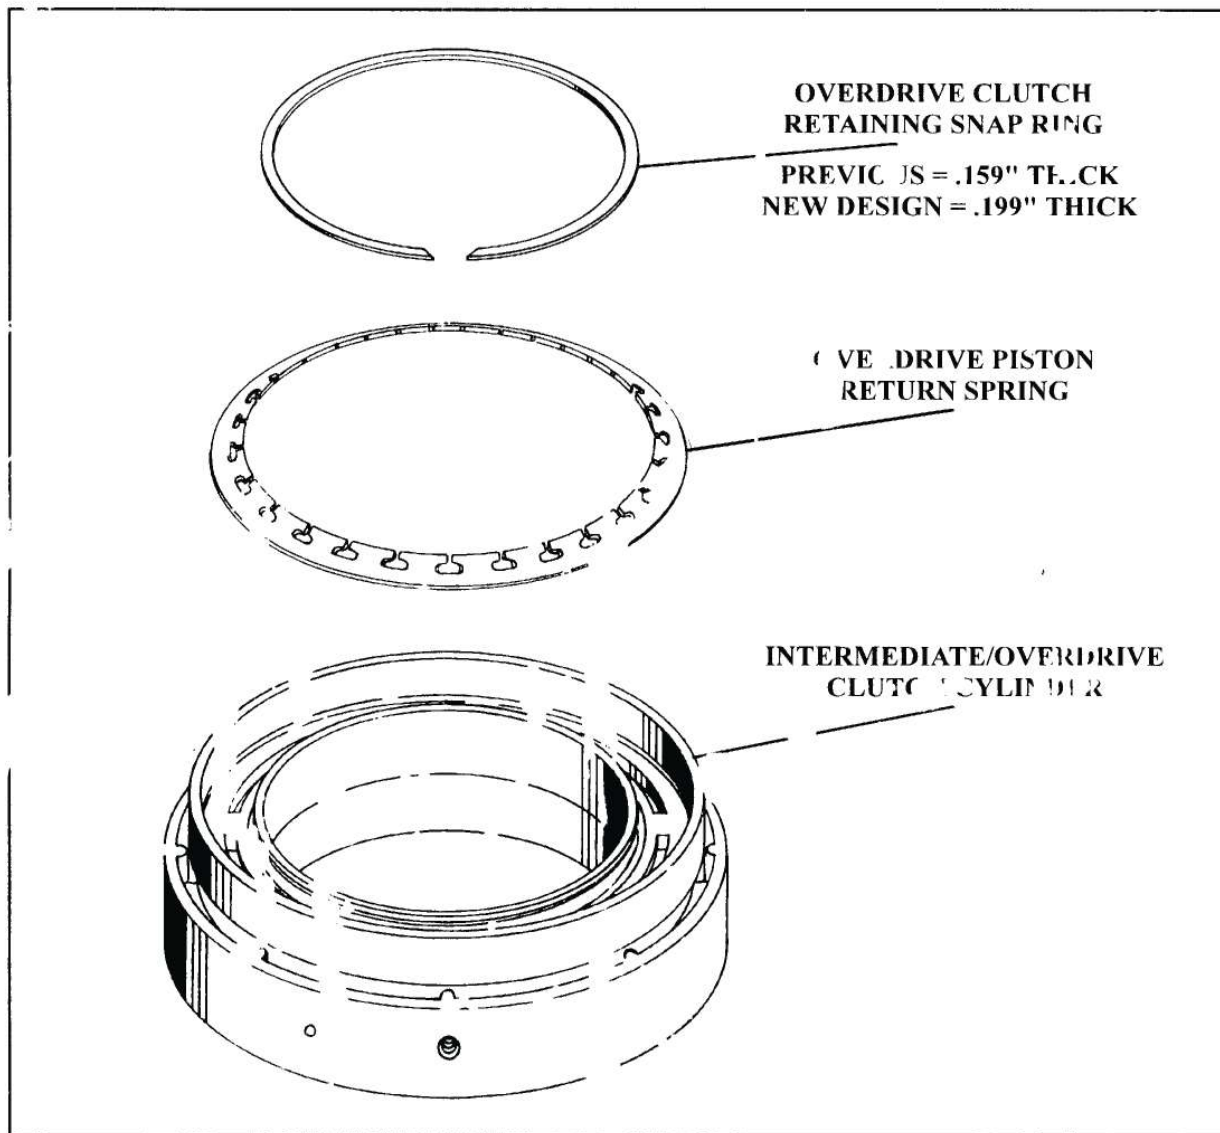
Figure 29

**CAUSE:** Insufficient tension on the Overdrive Clutch Snap Ring.

**CORRECTION:** Install a new design (Thicker) snap ring that has more tension than the previous design. The new design snap ring is .199" thick and the previous design is .159" thick, as shown in Figure 29.

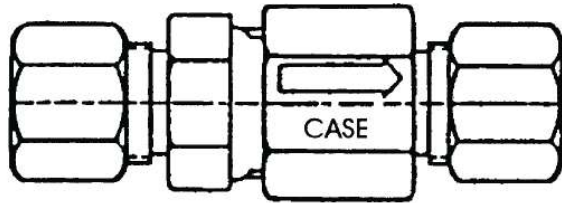
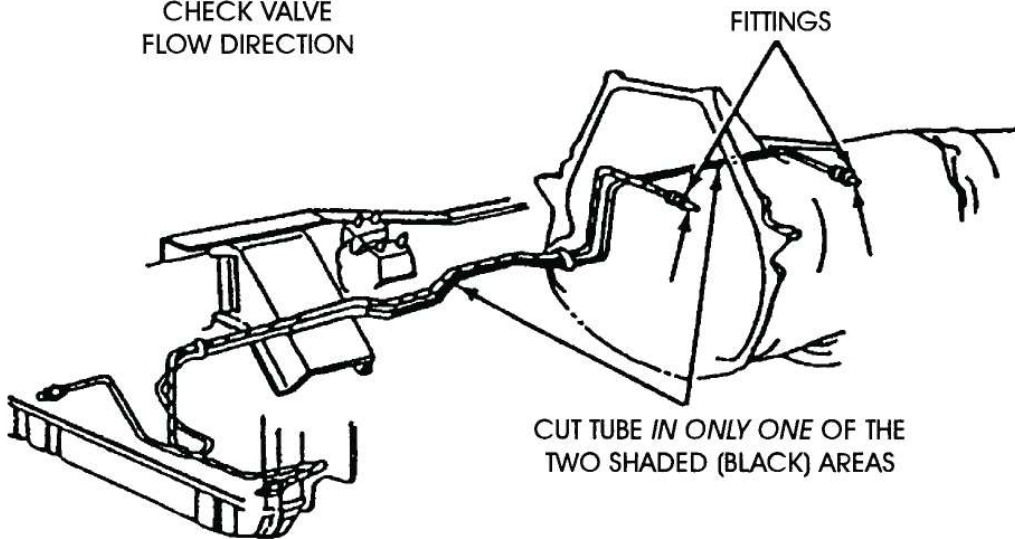
Figure 32

CHECK VALVE  
FLOW DIRECTION

INSTALL IN-LINE CHECK VALVE  
IN COOLER LINE GOING TO REAR  
TRANSMISSION CASE FITTING IN THE  
DIRECTION OF ARROW SHOWN ABOVE

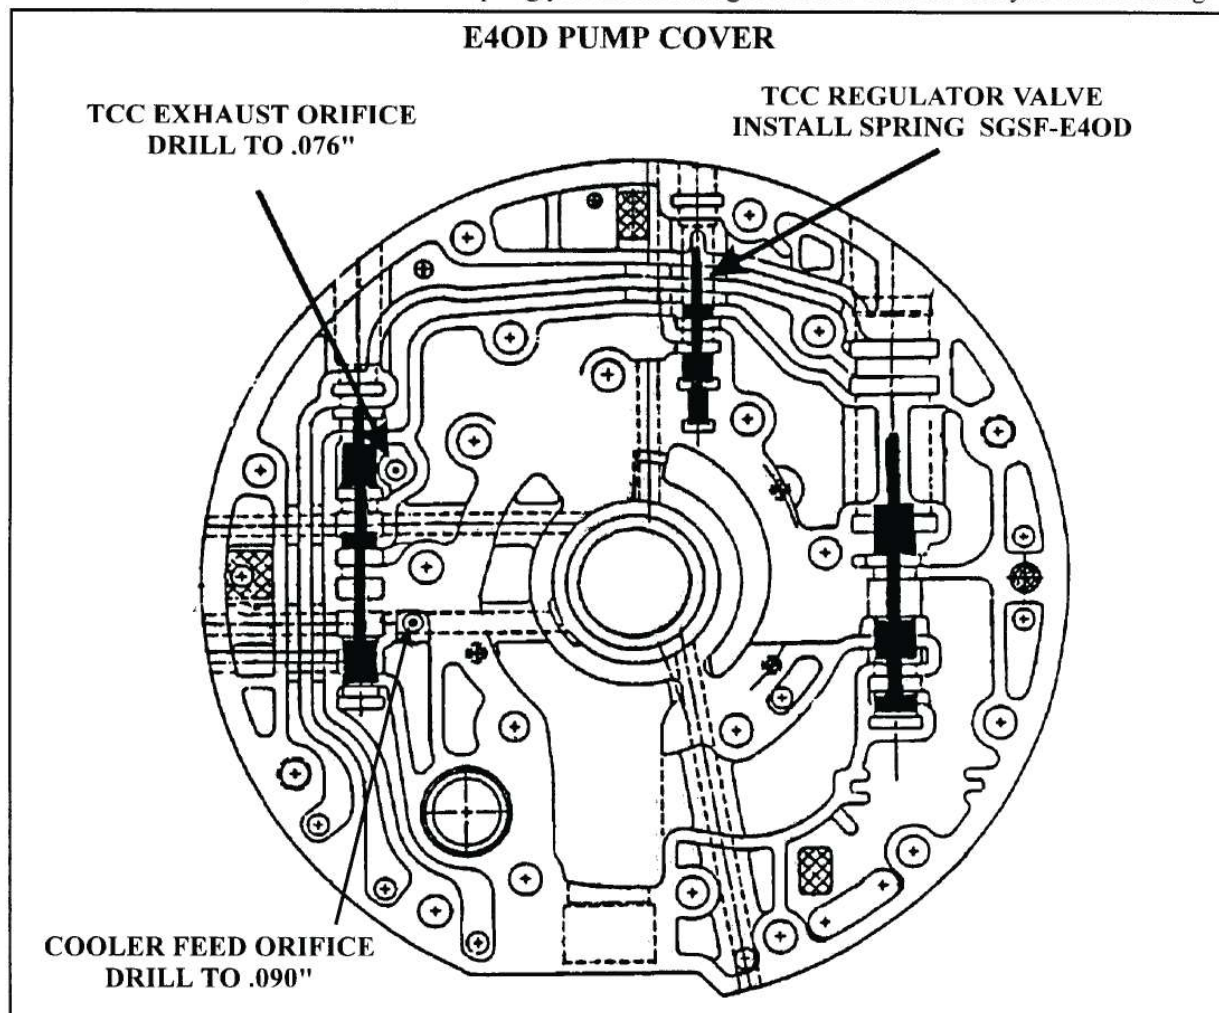
Figure 33

**CAUSE:** Low converter clutch apply pressure and/or converter clutch exhaust orifice too small.

**CORRECTION:** Replace the converter clutch regulator valve spring, located in the pump cover with a "SGSF E4OD" shudder fix spring as shown in Figure 33. Also drill the converter clutch exhaust orifice out to .076", as shown in Figure 33. It is also recommended to drill out the cooler orifice to .090" for increased lube flow, as shown in Figure 33.

**NOTE:** Ford Motor Company replaced this spring with a heavier spring in 1992 and later models, so ensure the spring you are installing is *heavier* than the one you are removing.

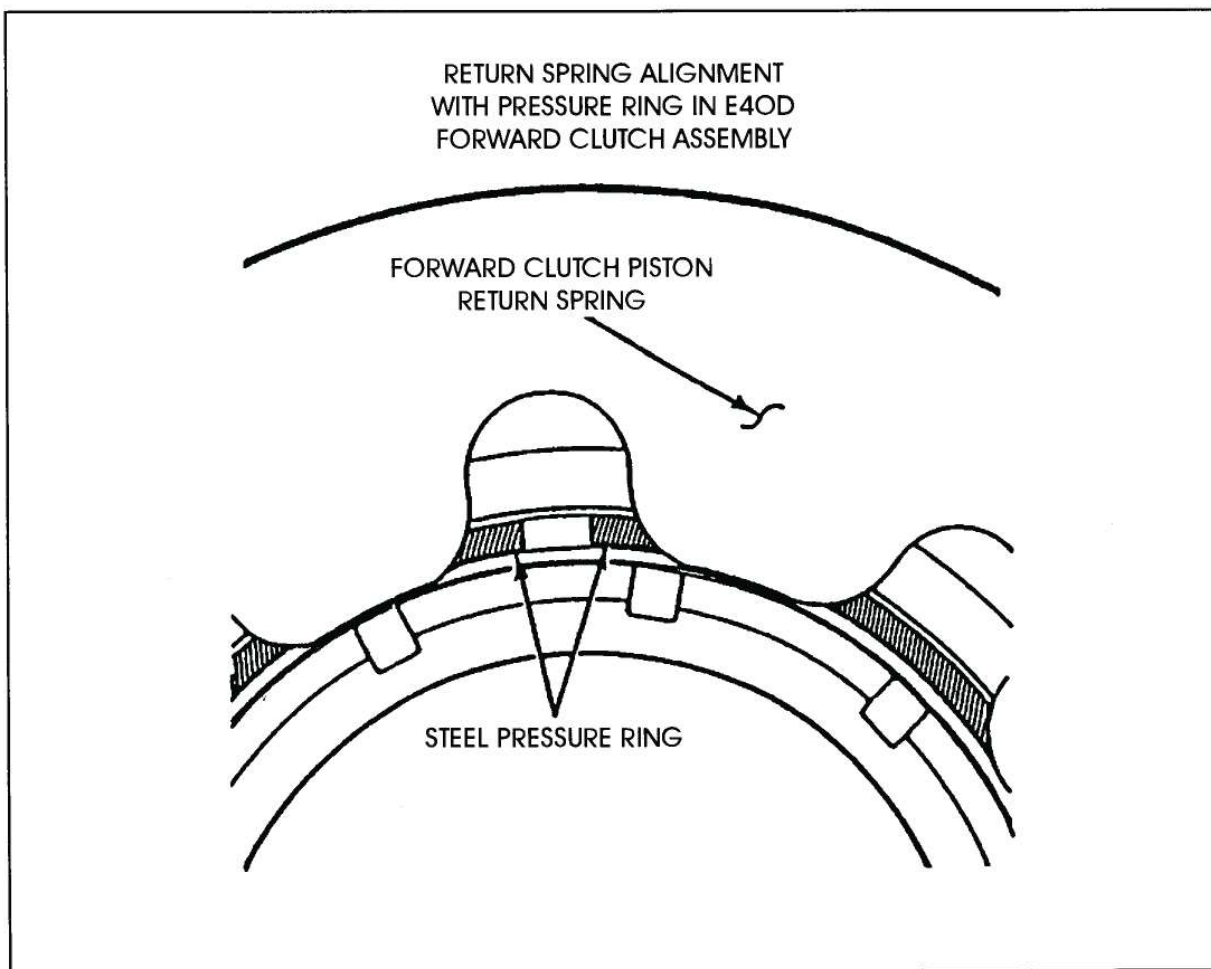
Figure 34

**COMPLAINT:** Forward clutch piston return spring fatigued, worn, and/or broken.

**CAUSE:** The cause may be, improper orientation of steel ring on top of the forward clutch piston, and the forward clutch piston return spring.

**CORRECTION:** Position the forward clutch piston return spring so that both ends of the steel ring are visible within the space between the two adjacent fingers of the return spring as shown in Figure 34.

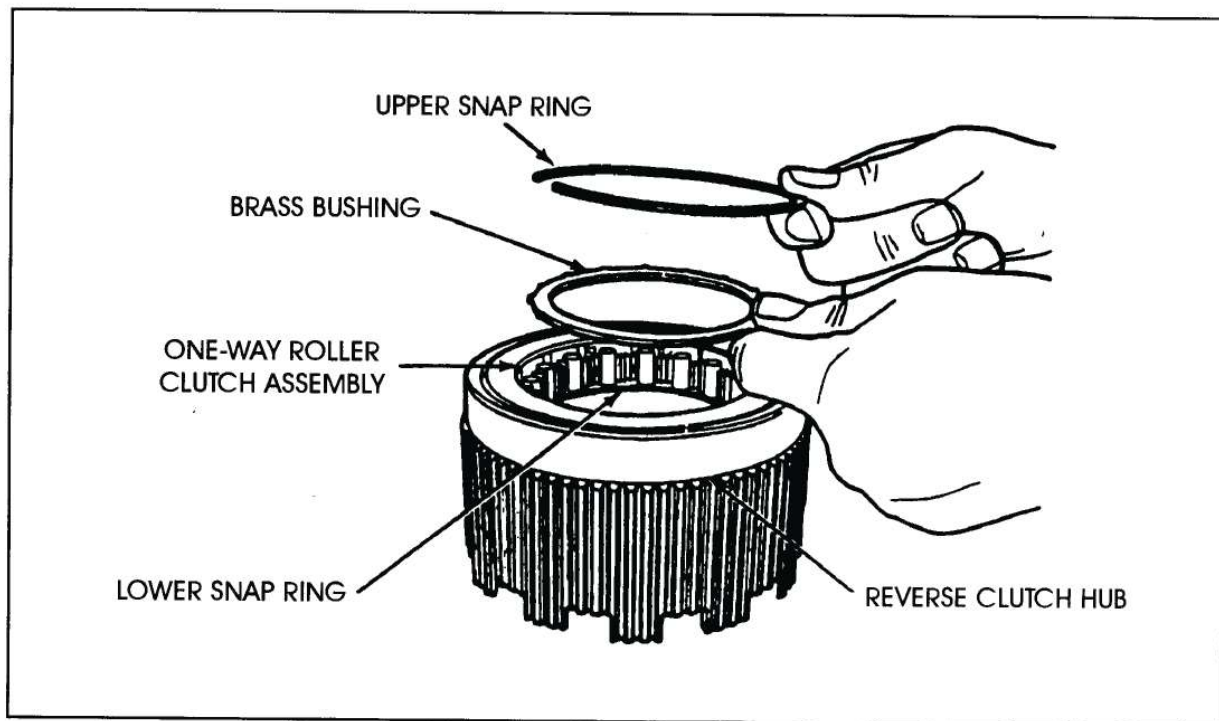
Figure 35

**COMPLAINT:** A no forward movement condition, until the manual shift lever is placed in the Manual Low position.

**CAUSE:** The cause may be, an incorrectly installed new plastic caged Low Roller Clutch Assembly, that was introduced in 1994.

**CORRECTION:** Use the following procedure any time the Low Roller Clutch is being replaced, using the New Plastic Caged Low Roller Clutch Assembly.

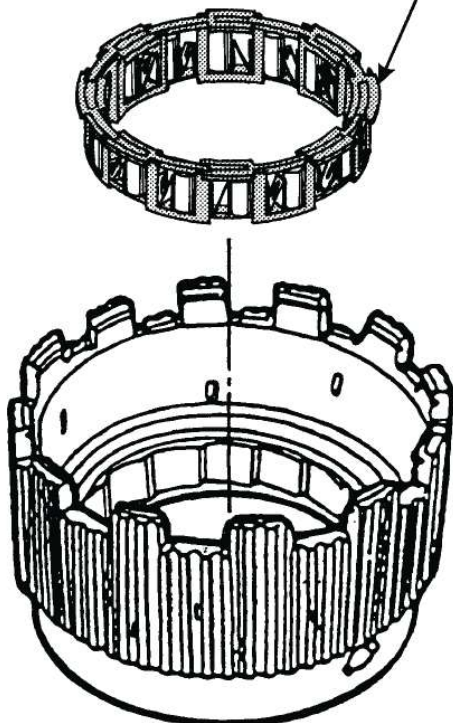
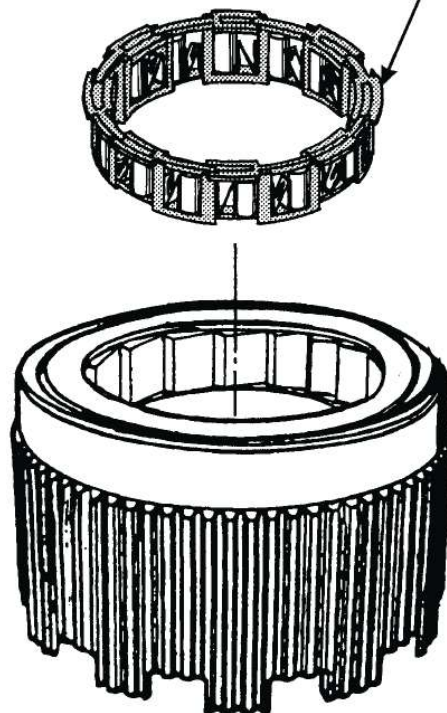
***"INCORRECTLY"  
INSTALLED***

NOTE TABS ON  
TOP OUTER EDGE

***CAUTION***

IF THE ROLLER CLUTCH IS INSTALLED IN  
THIS DIRECTION, THE REVERSE HUB WILL  
FREEWHEEL IN BOTH DIRECTIONS.

***"CORRECT"  
INSTALLATION***

DISCARD BOTH SNAP RINGS. THEY ARE NOT  
USED WITH THE PLASTIC ROLLER CLUTCH

- (1) Remove the upper snap ring, brass bushing, roller clutch assembly, and the lower snap ring, as shown in Figure 35. **Discard all parts removed!**
- (2) Install the New Plastic Cage Low Roller Clutch Assembly through the **rear** side of the Reverse Clutch Hub, with the tabs on the rear edge. Seat the Low Roller Clutch into the Reverse Clutch Hub, and rotate clockwise to seat rollers and lock tabs in place. Refer to Figure 36 for proper installation.

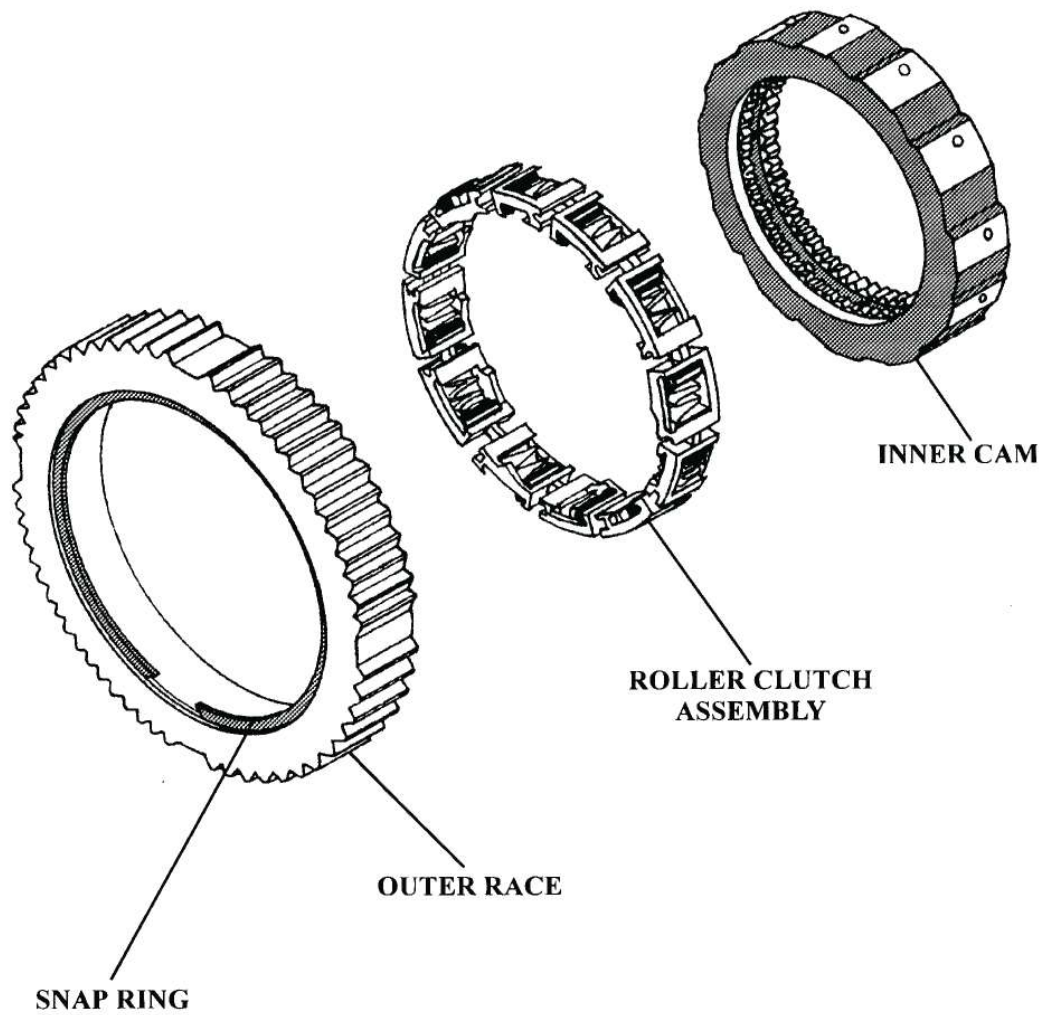
Figure 37

**OVERDRIVE ROLLER CLUTCH ASSEMBLY  
PART NUMBER F5TZ-7A089-A**

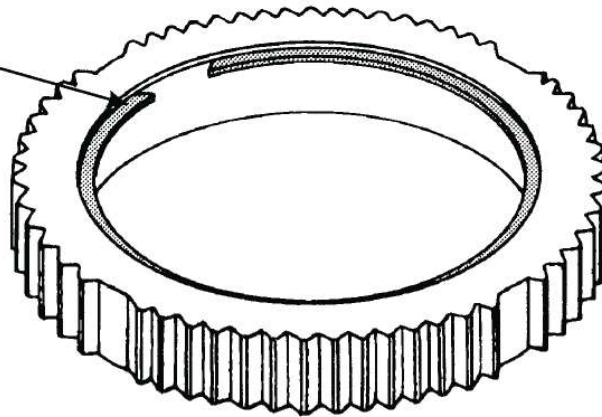
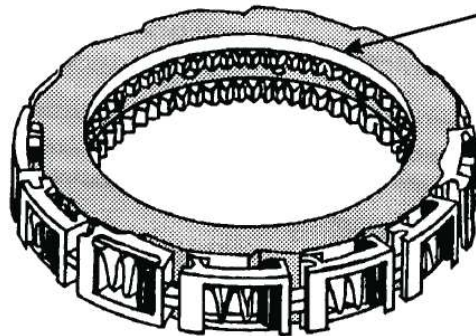
Figure 40

SNAP RING  
FACING UP

UNDERCUT  
FACING UP

- (1) Place the new inner cam on a flat work surface with the "Undercut" on the inside diameter facing **up**, as shown in Figure 38.
- (2) Install the overdrive roller clutch assembly over the inner cam, **with the 9 locking tabs on the inner diameter facing down, and the three upper locking tabs facing up**, as shown in Figure 38.
- (3) Push the overdrive roller clutch assembly all the way down, as shown in Figure 39.
- (4) Install the snap ring into the groove in the outer race, as shown in Figure 40.
- (5) Install the outer race assembly over the overdrive roller clutch, by holding the inner cam and rotating the outer race in a clockwise direction, until fully seated, as shown in Figure 41.

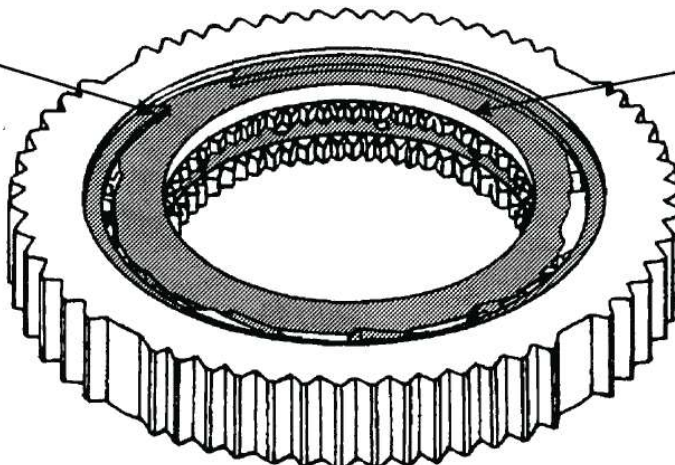
Figure 41  
AUTOMATIC TRANSMISSION SERVICE GROUP

ROTATE THE OUTER RACE CLOCKWISE UNTIL FULLY SEATED

SNAP RING  
FACING UP

UNDERCUT  
FACING UP

**"INNER RACE MUST FREEWHEEL COUNTERCLOCKWISE"**

**NOTE:** *With the outer race snap ring facing up, and the inner cam "undercut" facing up, the inner cam should freewheel in a counter-clockwise direction and lock clockwise, while holding the outer race. Refer to Figure 41.*

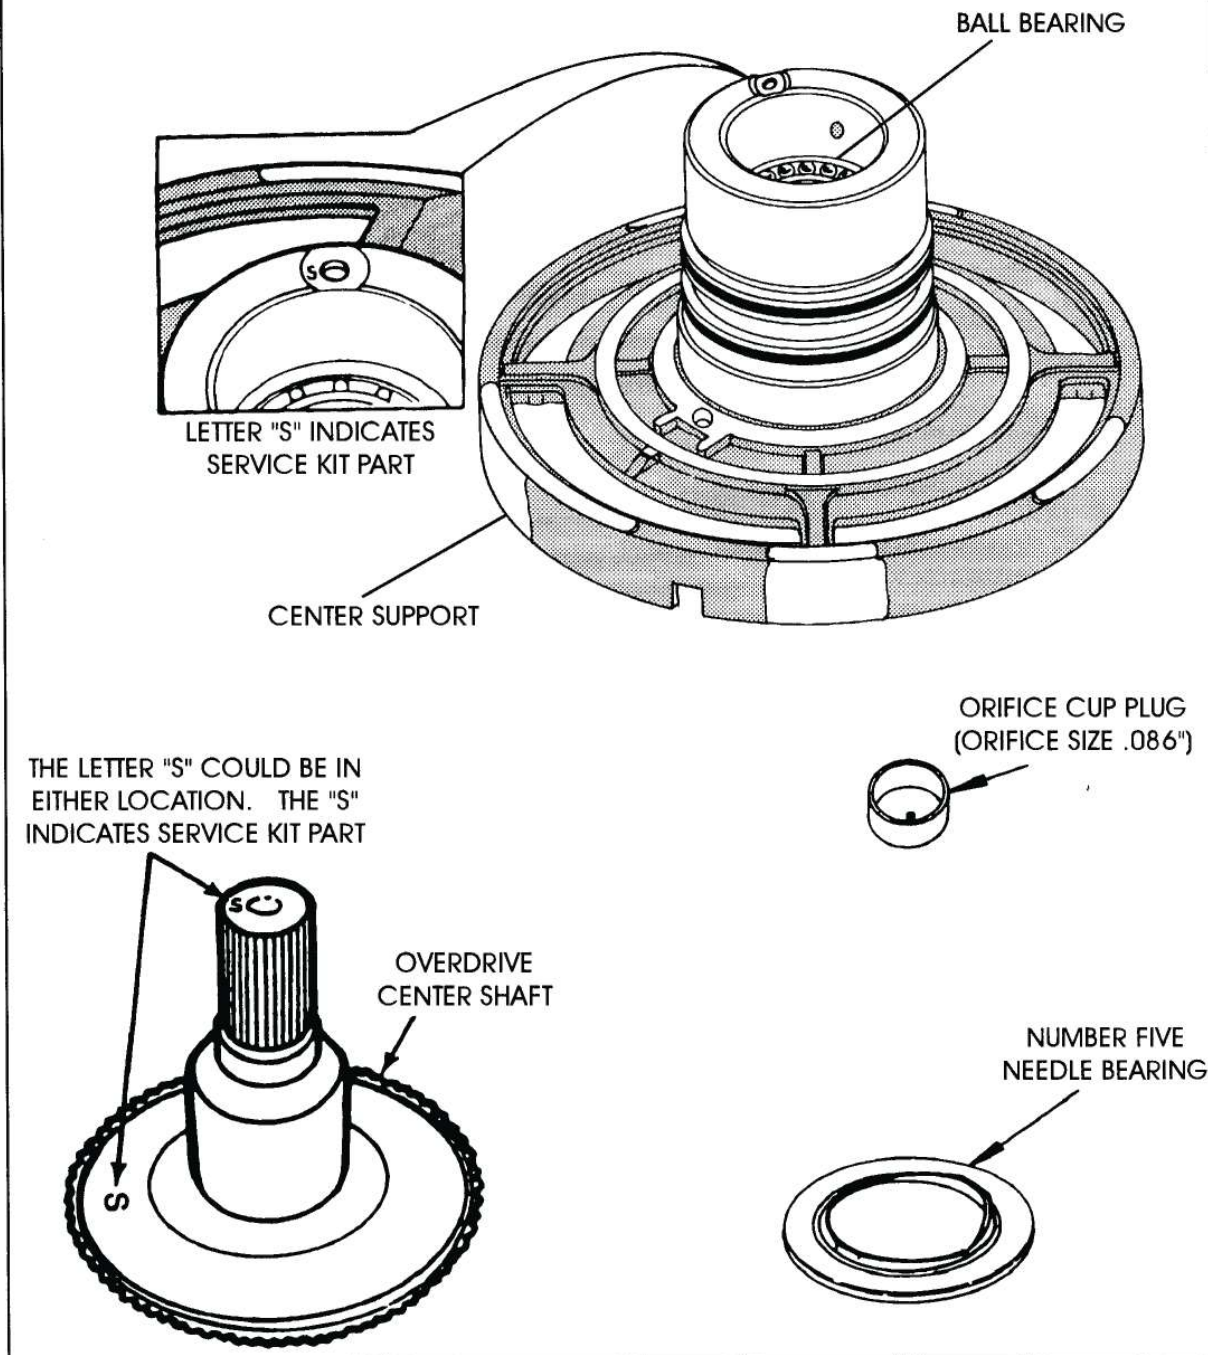
Figure 43

**F4TZ-7A130-B SERVICE KIT CONTENTS**

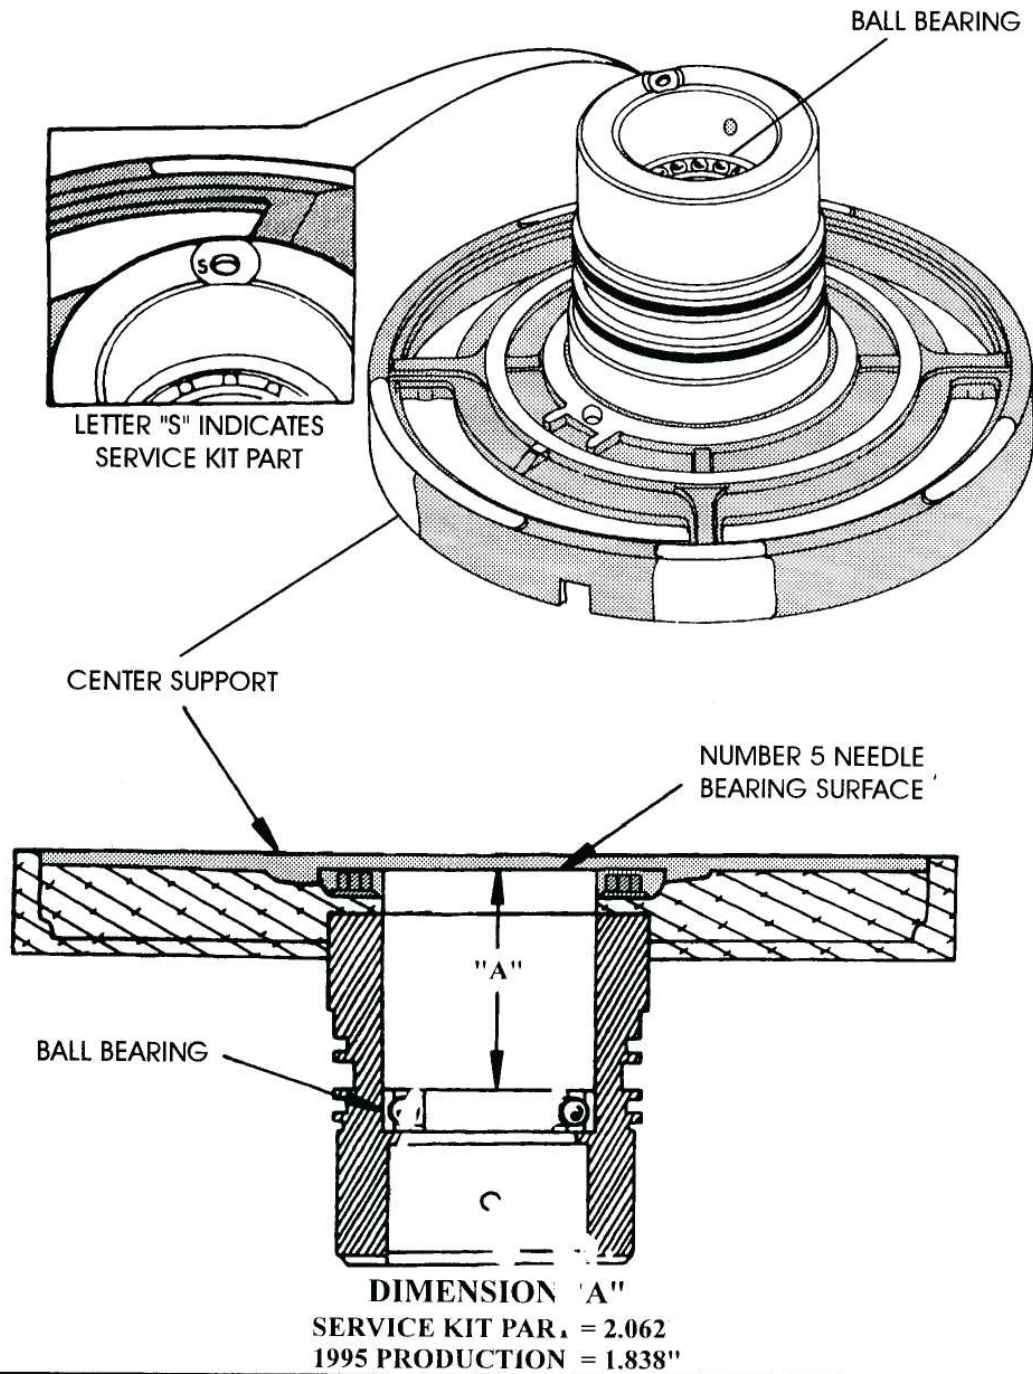
Figure 44  
 AUTOMATIC TRANSMISSION SERVICE GROUP

### BALL BEARING CENTER SUPPORT

**OVERDRIVE CENTER SHAFT****DIMENSION "A"**

- (1) **CENTER SUPPORT** - Different machining dimensions on the inside bore, to accommodate an added ball bearing that will now support the overdrive center shaft. The new design ball bearing support can be identified as a "Service Part", by the letter "S" stamped on hub, in the location shown in Figure 44. The Service Kit Ball Bearing Center Support has different dimensions than the 1995 production ball bearing center support. Refer to Dimension "A" on the cutaway drawing shown in Figure 44.

- (2) The parts in this Service Kit are different dimensions than 1995 model year production parts and **will not** interchange with 1995 model parts (See Figures 44 and 45).

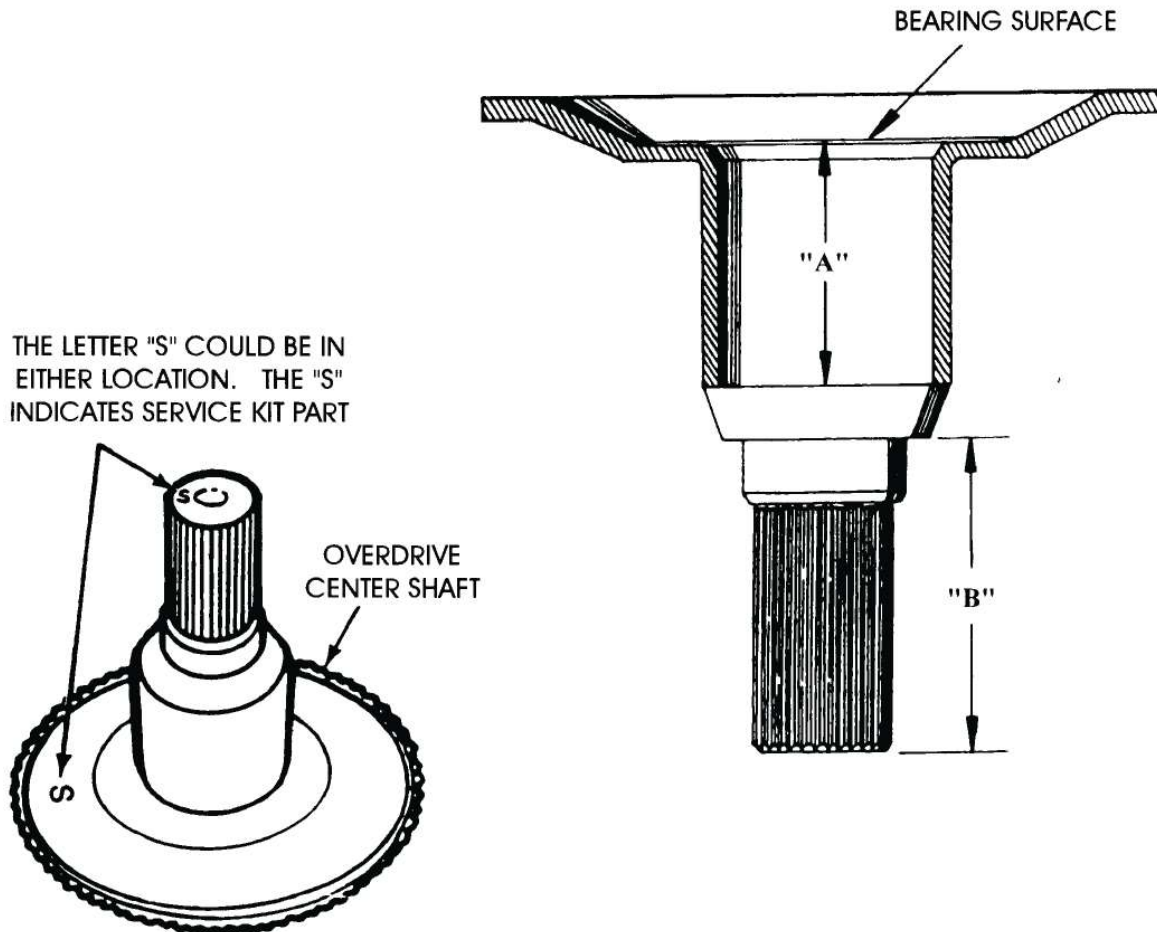
Figure 45

SERVICE KIT PART = 2.368"

1995 PRODUCTION = 2.592"

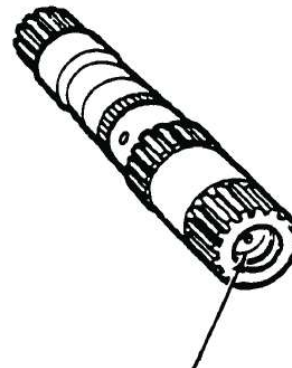
REMOVE THE  
ORIGINAL BUSHING

INSTALL THE ORIFICE CUP  
PLUG FROM THE SERVICE KIT

THE ORIFICE CUP PLUG MUST BE  
INSTALLED BELOW THIS SURFACE

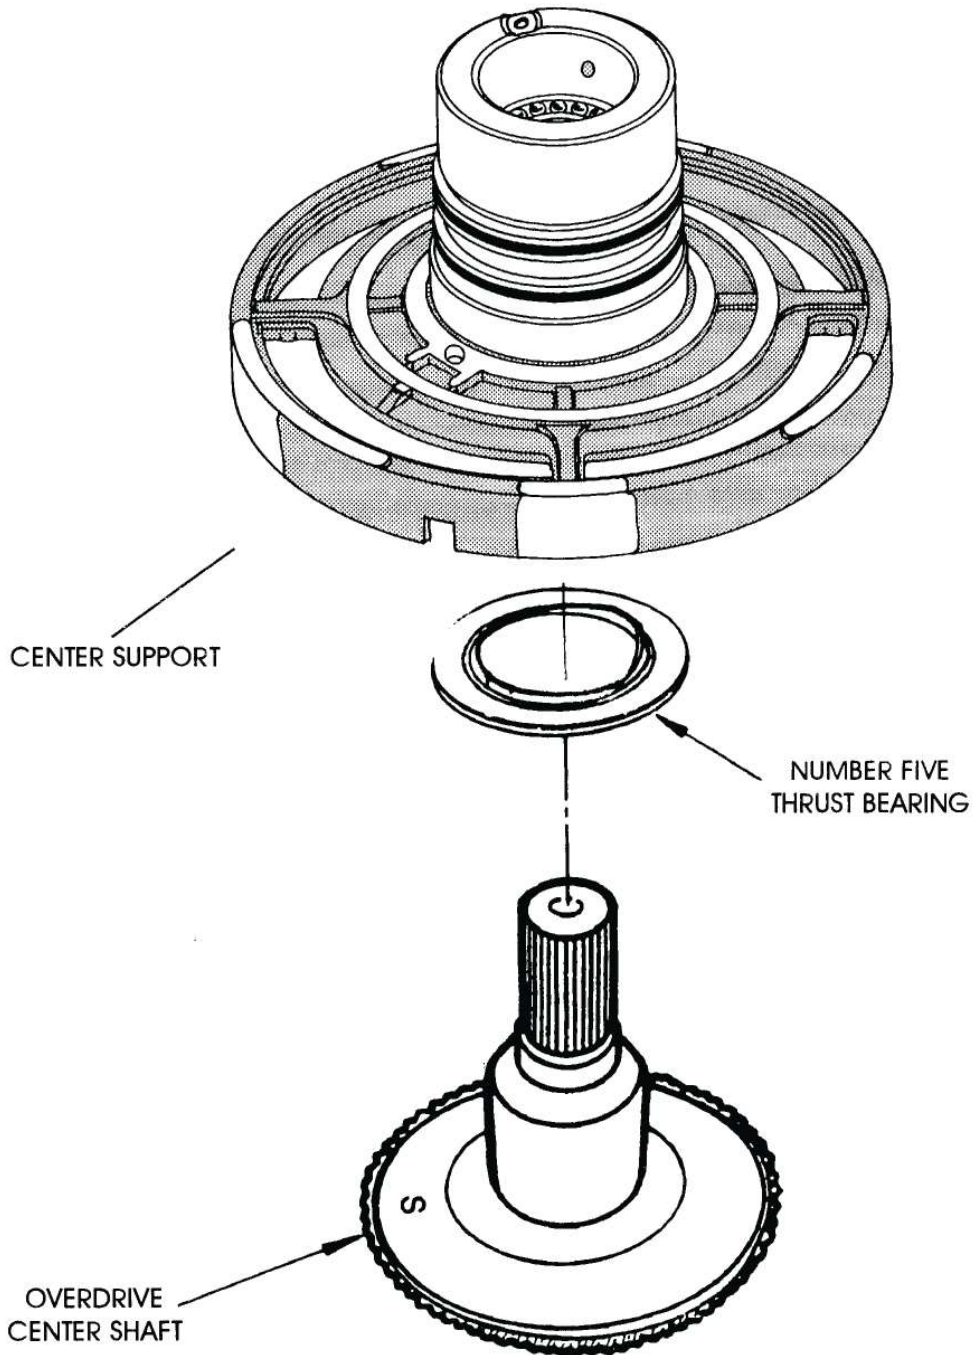
Figure 47  
AUTOMATIC TRANSMISSION SERVICE GROUP

**NUMBER 5 NEEDLE BEARING  
PROPER INSTALLATION**
