## FORD E4OD "UPDATE HANDBOOK"

AUTOMATIC TRANSMISSION SERVICE GROUP  
18639 SW 107TH AVENUE  
MIAMI, FLORIDA 33157  
(305) 670-4161

### FORD E4OD "UPDATE HANDBOOK"

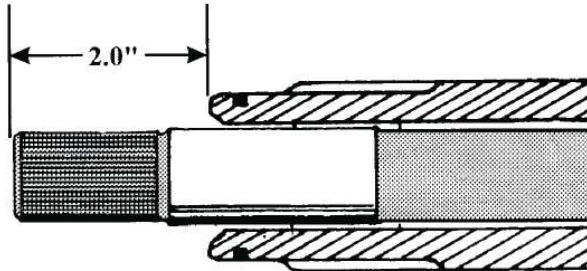
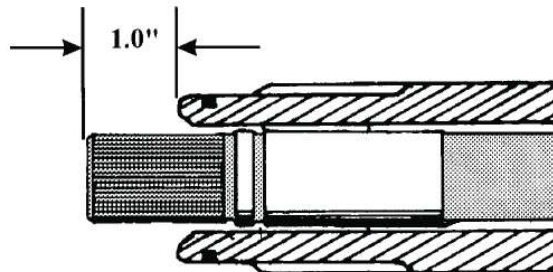
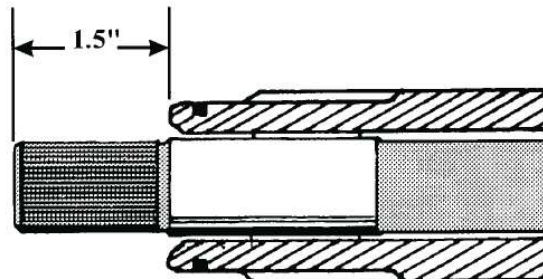
Figure 49

**"INCORRECT"**

PREVIOUS (LONG) INPUT SHAFT USED  
WITH NEW DESIGN OVERDRIVE CARRIER

NEW DESIGN (SHORT) INPUT SHAFT USED  
WITH PREVIOUS DESIGN OVERDRIVE CARRIER

**"CORRECT USAGE"**

THE INPUT SHAFT MUST EXTEND 1.5" PAST THE END OF THE PUMP STATOR  
IF THE CORRECT INPUT SHAFT AND OVERDRIVE CARRIER WERE USED

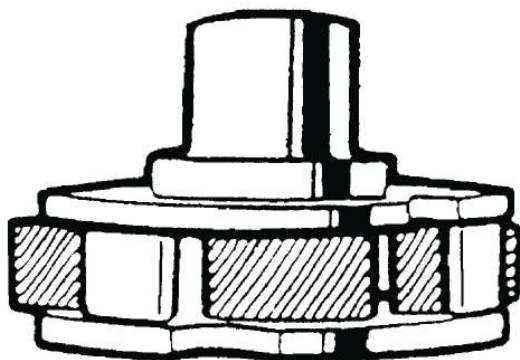
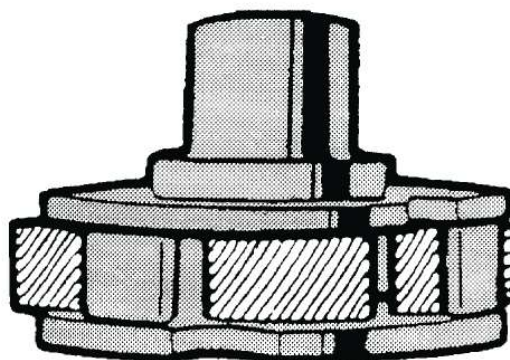
### NEW DESIGN CAST IRON OVERDRIVE CARRIER

PREVIOUS DESIGN ALUMINUM  
OVERDRIVE CARRIER

NEW DESIGN CAST IRON  
OVERDRIVE CARRIER  
F5TZ-7B446-A

THE NEW DESIGN CAST IRON OVERDRIVE CARRIER IS THE SHORTER  
VERSION OF THE PREVIOUS CARRIERS, AND **MUST** BE USED WITH THE  
SHORT INPUT SHAFT WITH I.D. GROOVE, AS SHOWN BELOW.

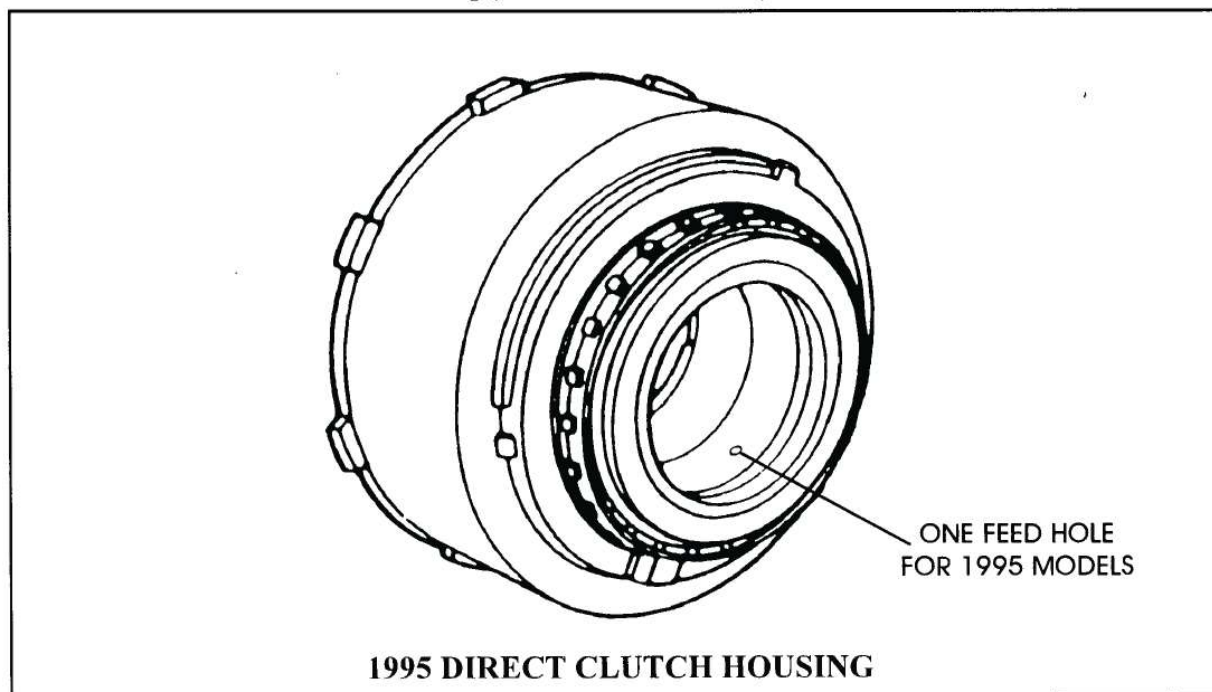
Figure 51

- (1) DIRECT CLUTCH HOUSING - 1995 models now have only *one* direct clutch apply pressure feed hole, instead of the *two* feed holes found in previous models (See Figure 51).

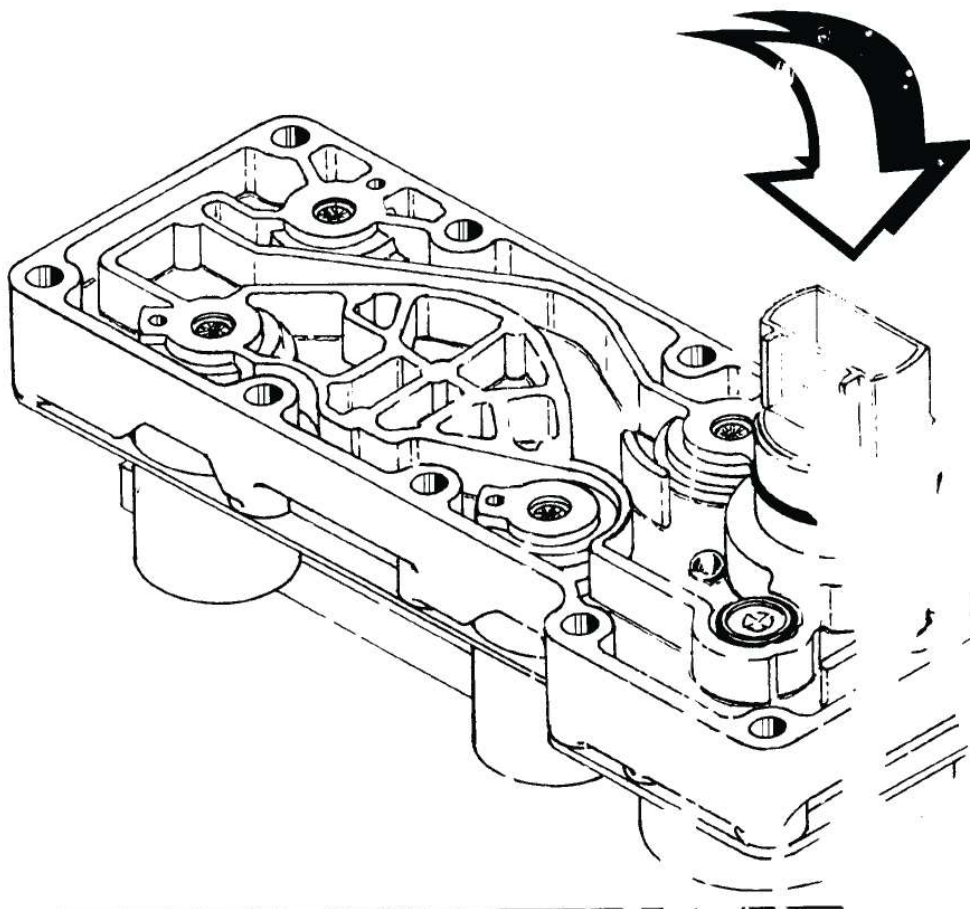
Figure 52

**VIEW LOOKING INTO SOLENOID CASE CONNECTOR**

*THERE IS NO SLEEVE ON 1995 SOLENOID PACK*

**REASON:** New design vehicle harness connector with grommet installed, to eliminate contamination from water and road debris, that may cause corrosion.

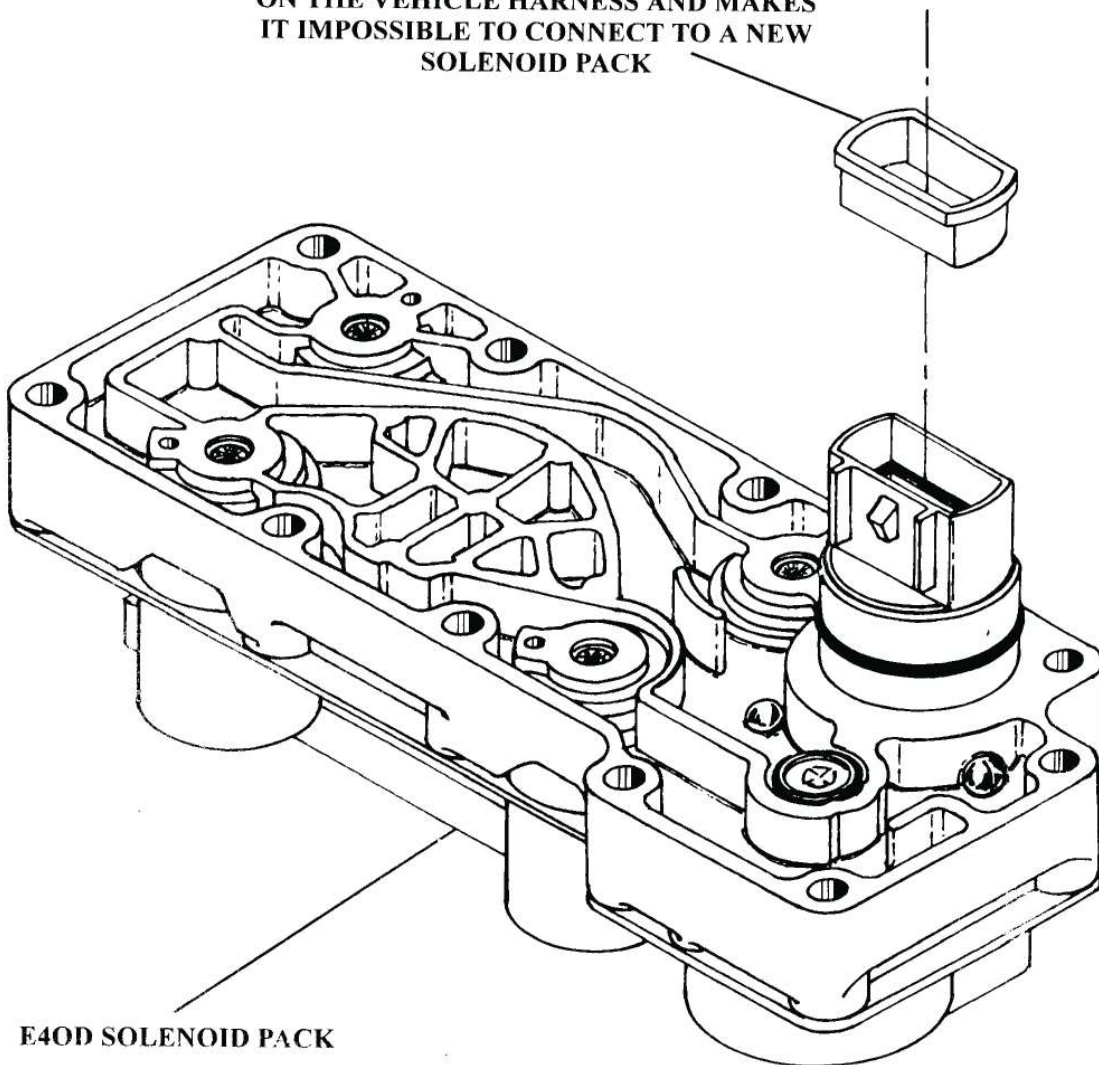
Figure 53

**1989-1994 SOLENOID PACK**

PLASTIC SLEEVE SOMETIMES REMAINS  
ON THE VEHICLE HARNESS AND MAKES  
IT IMPOSSIBLE TO CONNECT TO A NEW  
SOLENOID PACK

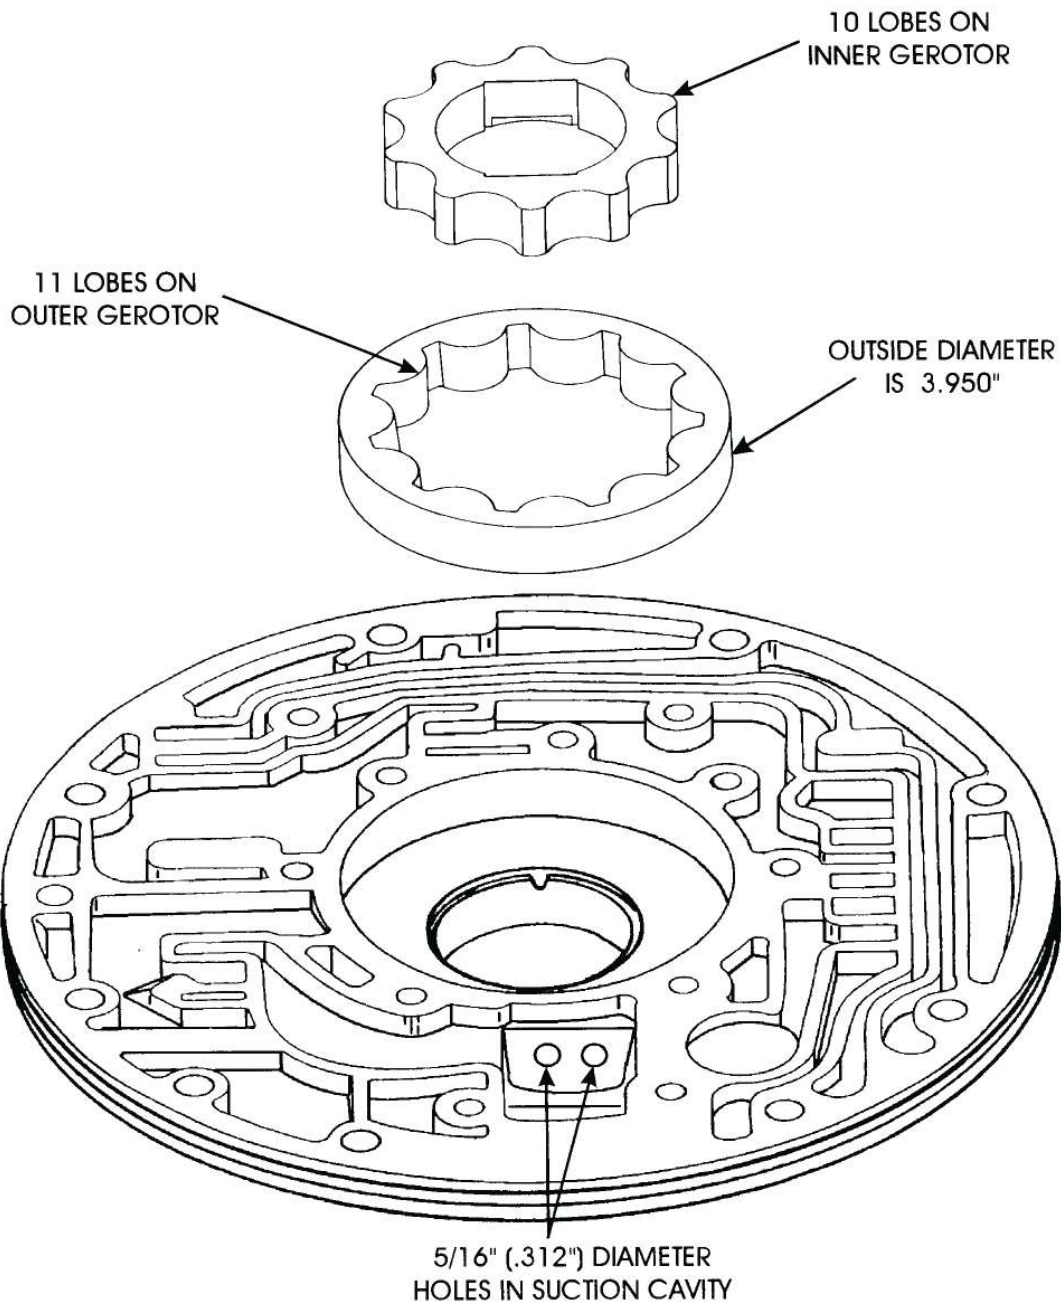
Figure 55

### 1989-1994 PUMP BODY AND GEARS ROUGH FORGING NO. E9TP-7A105-BA (PREVIOUS DESIGN)

- (1) **FRONT PUMP BODY** - Gerotor bore has an increased diameter to accommodate the new design level outer gerotor. Previous outer gerotor diameter was 3.950" and the new design level outer gerotor diameter is 4.083". Refer to Figures 55 and 56. Also, the two holes in the suction cavity were increased from .312" to .400", as shown in Figures 55 and 56. Another way to identify the new pump body is with the "Rough Forging Number" F5TP-7A105-AA, and is found on the front seal side of the pump body. All of the oil passages in the new design Front Pump Body remained the same as previous years and are identified in Figure 58.

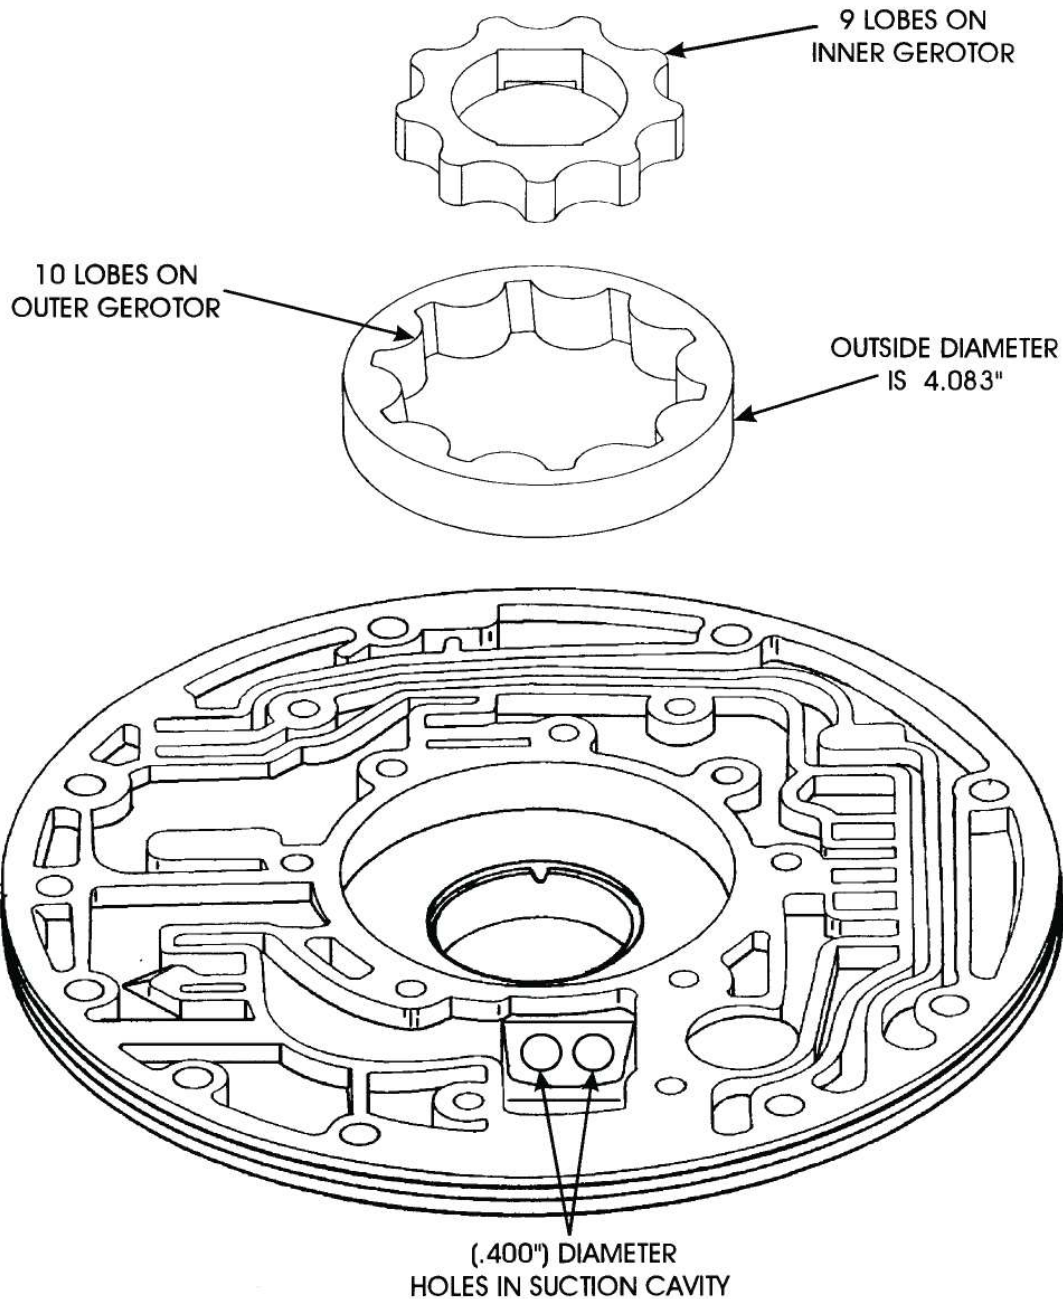
Figure 56

### 1989-1994 PUMP BODY AND GEARS ROUGH FORGING NO. F5TP-7A105-AA (NEW DESIGN)

- (1) The new design level Front Pump Assembly will retro-fit back to all previous models, when used as an assembly, and is recommended for all rebuilds. The new design Front Pump Assembly is available under OEM part number F5TZ-7A103-A.
- (2) *The new design level and previous design level gerotors will not interchange in any way.*

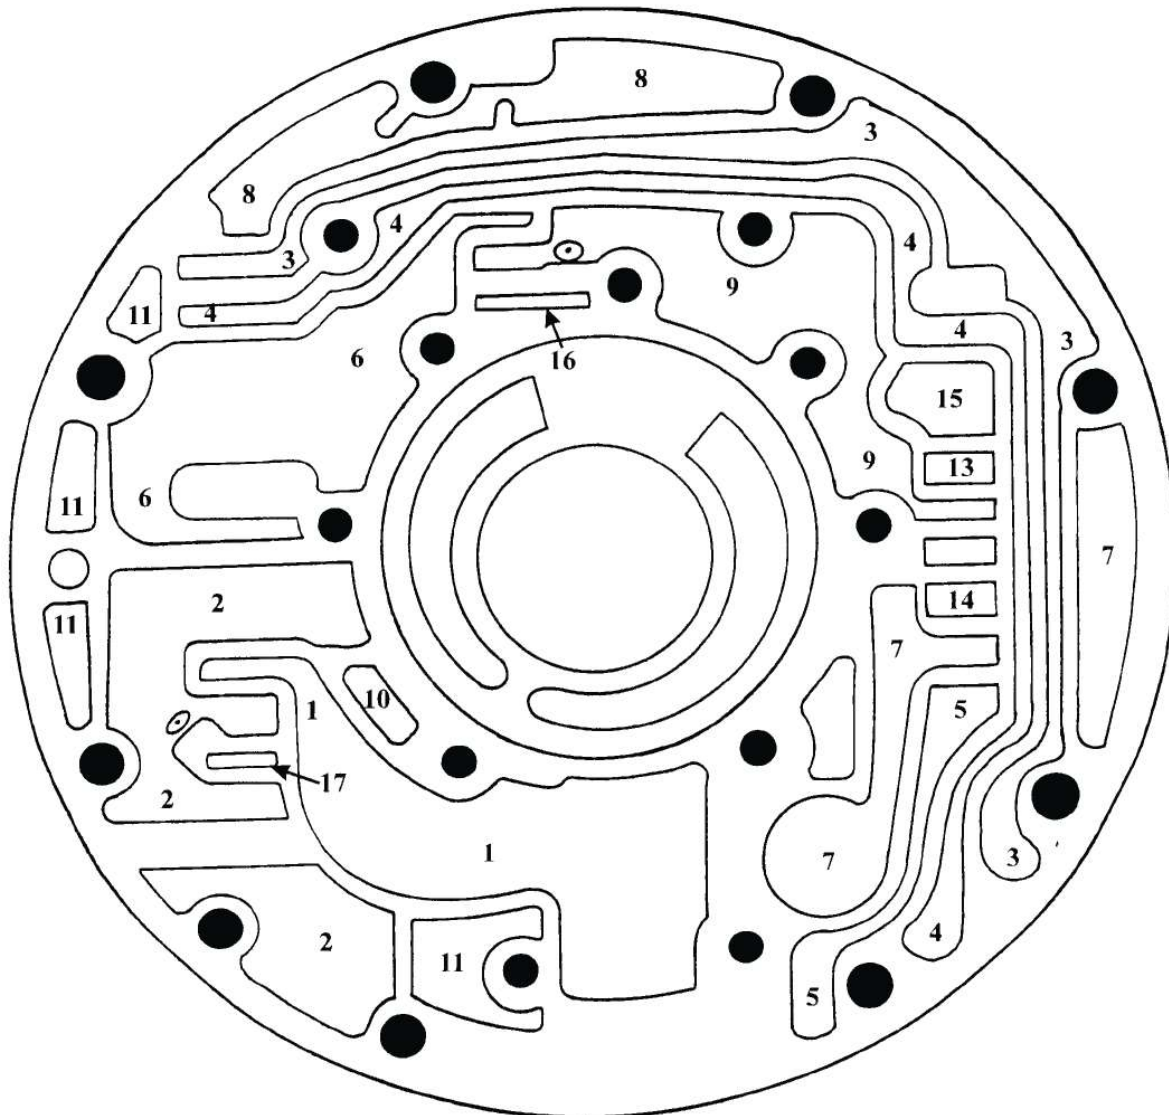
Figure 58

### E4OD PUMP BODY OIL PASSAGE IDENTIFICATION

| 1. PUMP SUCTION | 10. PUMP SEAL DRAIN |

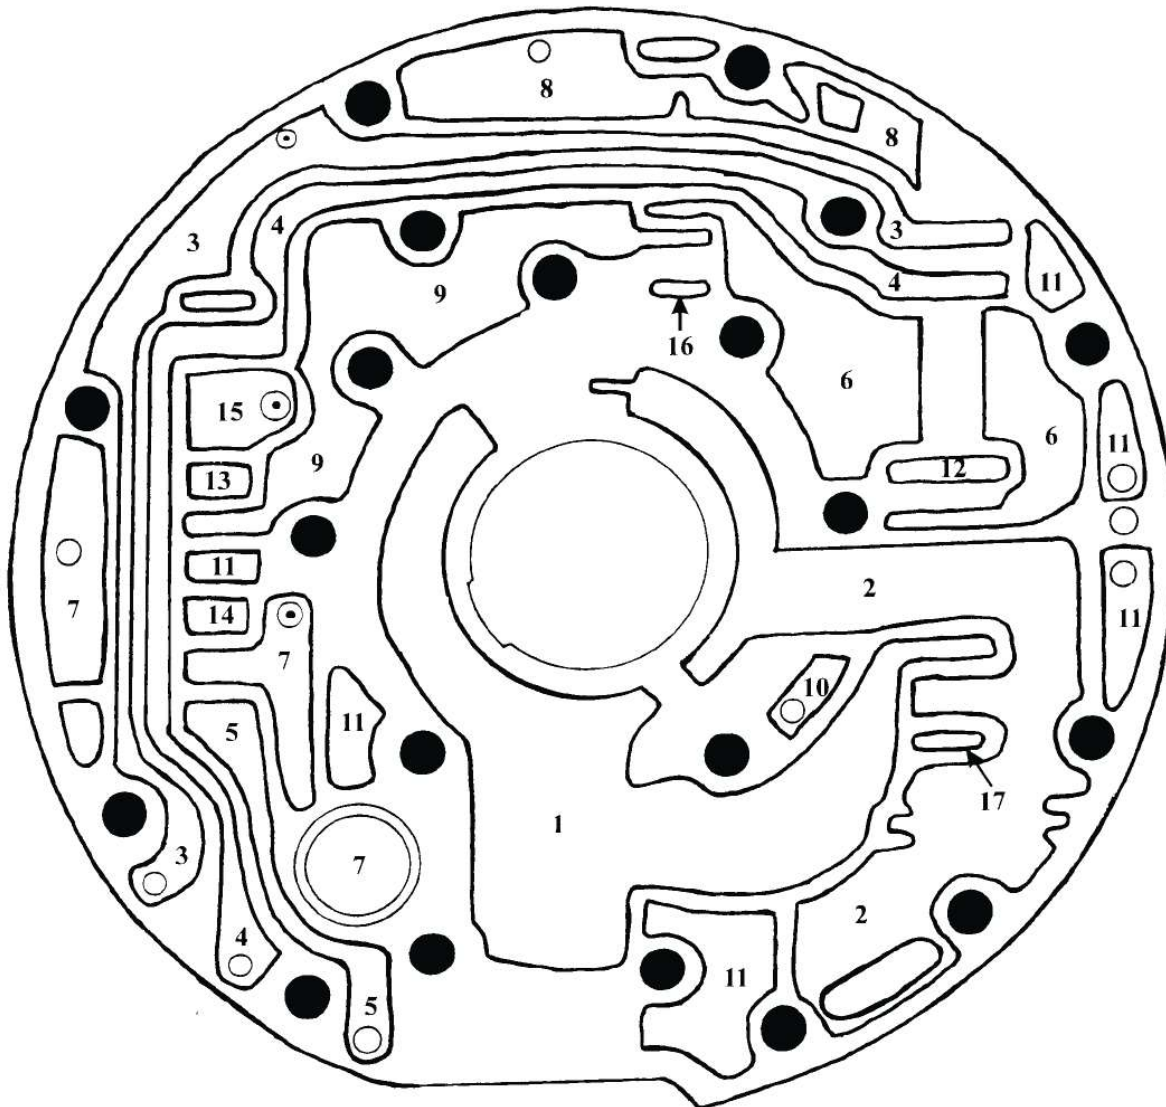
Figure 59

### E4OD PUMP COVER OIL PASSAGE IDENTIFICATION

- 1. PUMP SUCTION
- 2. LINE PRESSURE
- 3. EPC BOOST
- 4. MANUAL 1ST AND REVERSE BOOST
- 5. CONVERTER CLUTCH SIGNAL
- 6. CONVERTER FEED
- 7. TO COOLER
- 8. VENT
- 9. REGULATED CONVERTER FEED

- 10. PUMP SEAL DRAIN
- 11. VOID
- 12. EXHAUST
- 13. CONVERTER RELEASE
- 14. CONVERTER APPLY
- 15. RELEASE OIL EXHAUST
- 16. TCC REGULATOR VALVE BALANCE
- 17. P.R. VALVE BALANCE

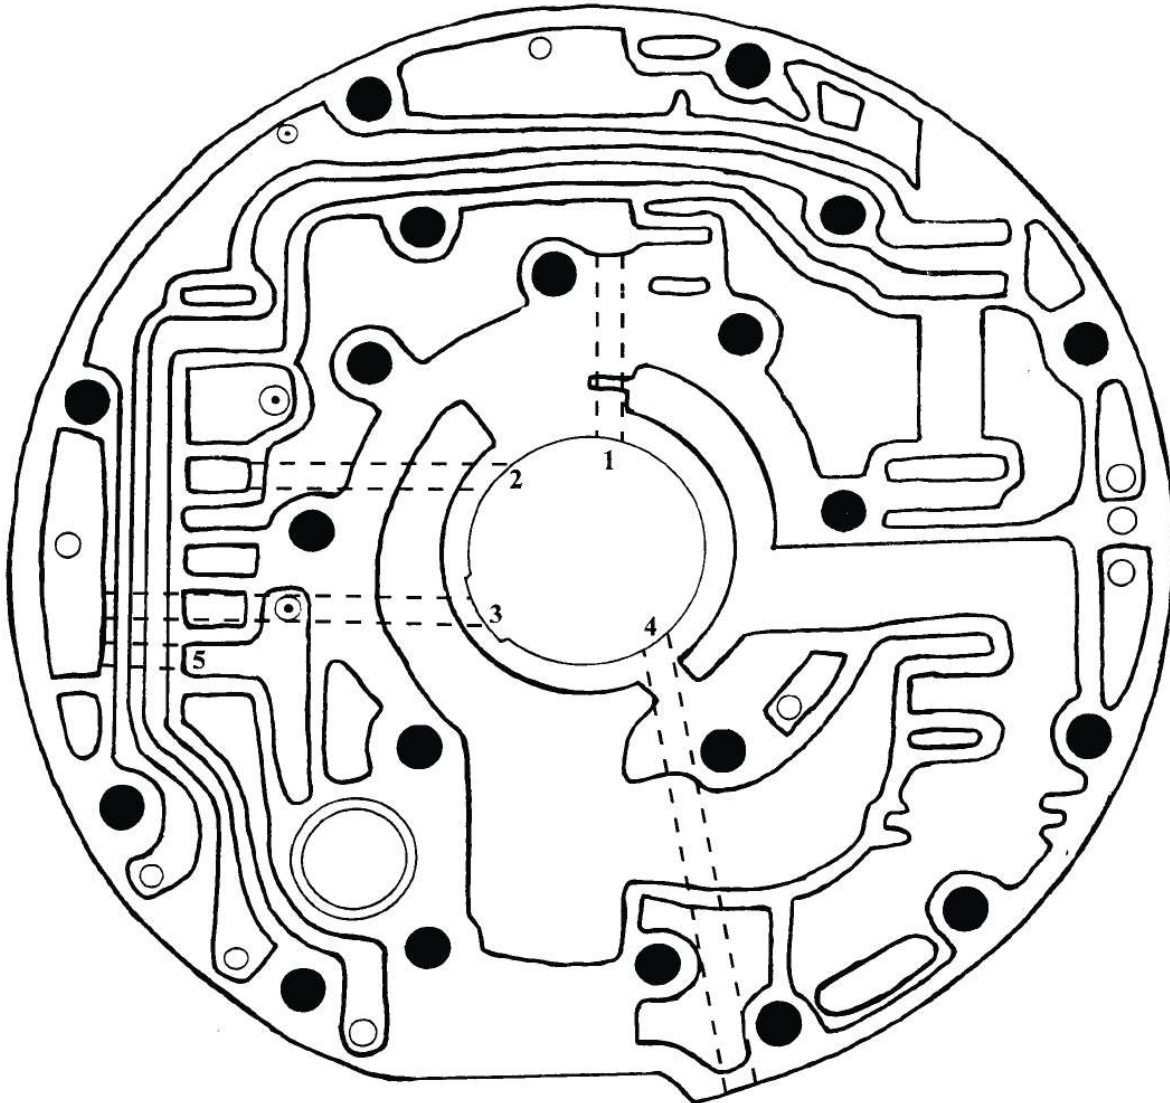
Figure 60

**E4OD PUMP COVER INTERNAL  
PASSAGE IDENTIFICATION**

- 1. FRONT LUBE SUPPLY**
- 2. CONVERTER RELEASE**
- 3. CONVERTER APPLY**
- 4. COAST CLUTCH FEED**
- 5. TO COOLER**

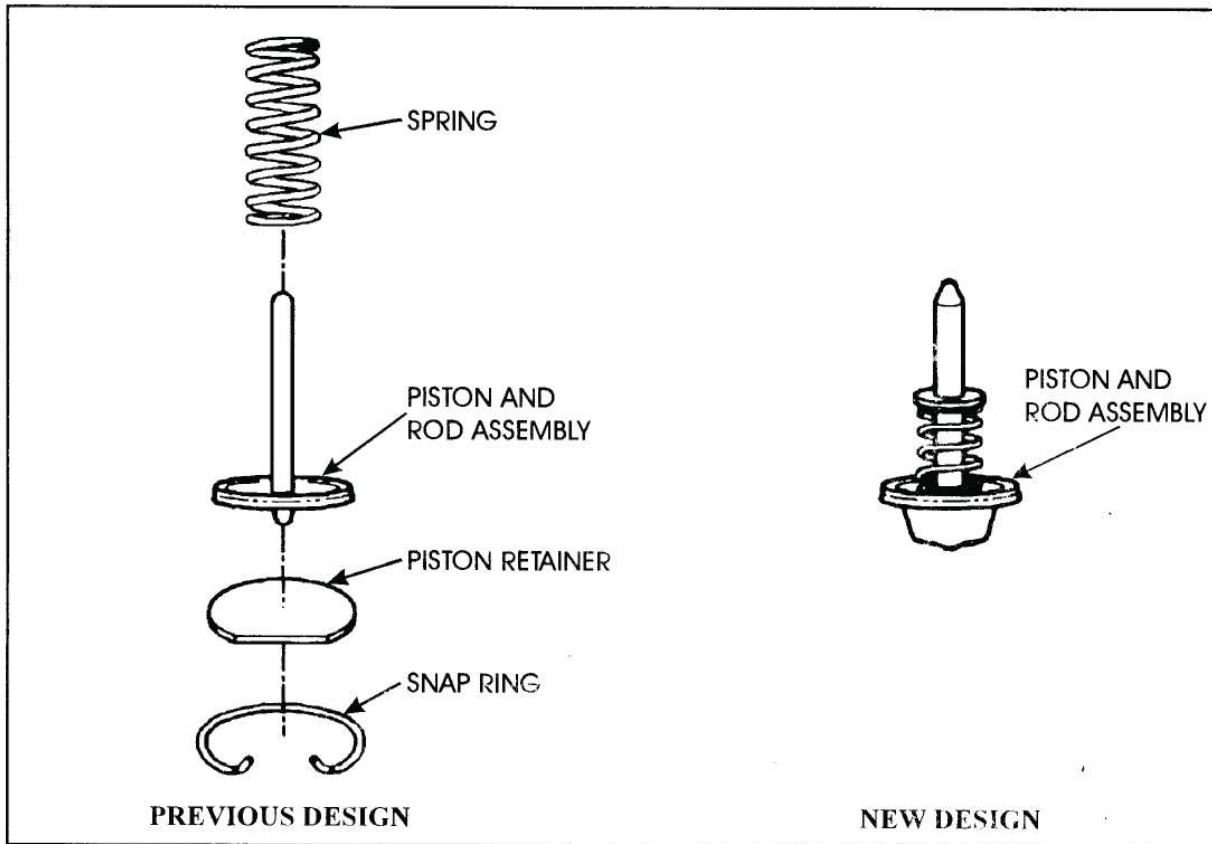
Figure 61

### FORD E4OD NEW DESIGN INTERMEDIATE SERVO PISTON ASSEMBLY

**CHANGE:** Beginning on August 8, 1995, all 1996 model E4OD transmissions were produced with a new design Intermediate Band Apply Servo Assembly (See Figure 61).

- (1) INTERMEDIATE SERVO PISTON - Total change in design, as shown in Figure 61.
- (2) SERVO PISTON RETAINER - Eliminated, as shown in Figure 61.
- (3) RETAINING SNAP RING - Eliminated, as shown in Figure 61.
- (4) TRANSMISSION CASE - Snap ring groove in the case piston bore was eliminated, as it was no longer need (See Figure 62).

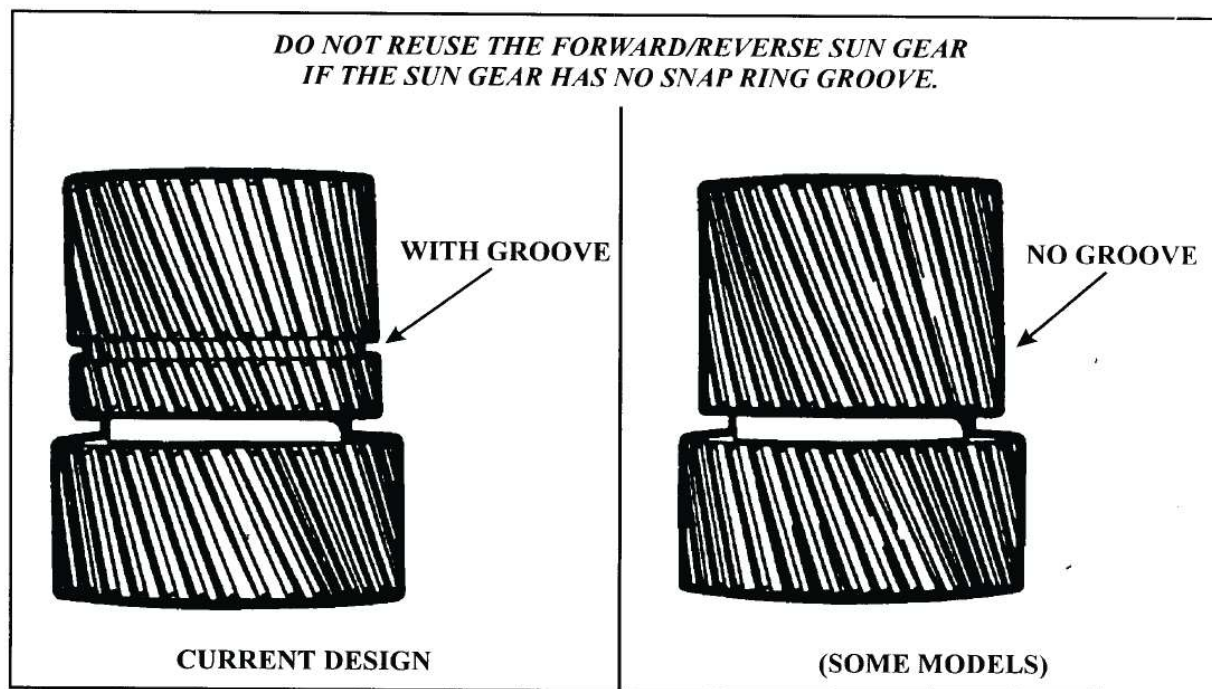
Figure 63

If internal transmission repair is required for these units, replace the Forward/Reverse Sun Gear with the current service sun gear with the snap ring groove, and the snap ring (See Figure 63).

***DO NOT REUSE THE FORWARD/REVERSE SUN GEAR  
IF THE SUN GEAR HAS NO SNAP RING GROOVE.***

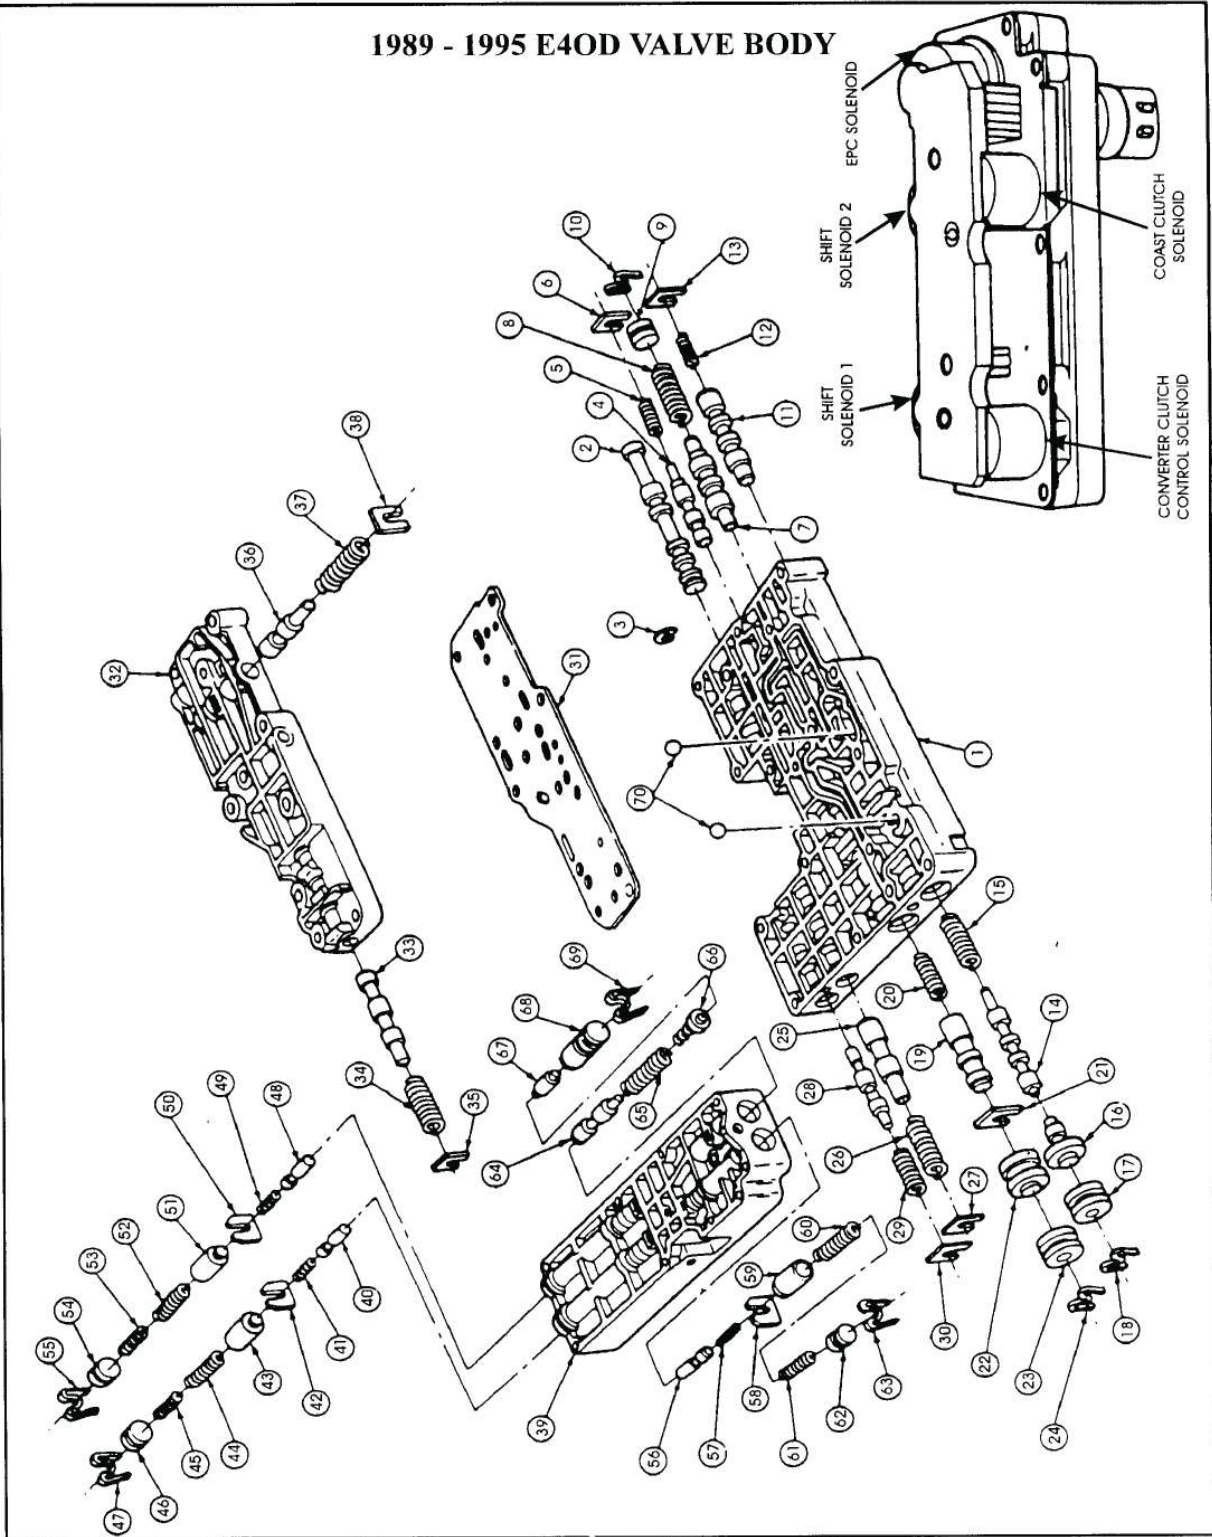
Figure 64

**1989 - 1995 E4OD VALVE BODY**

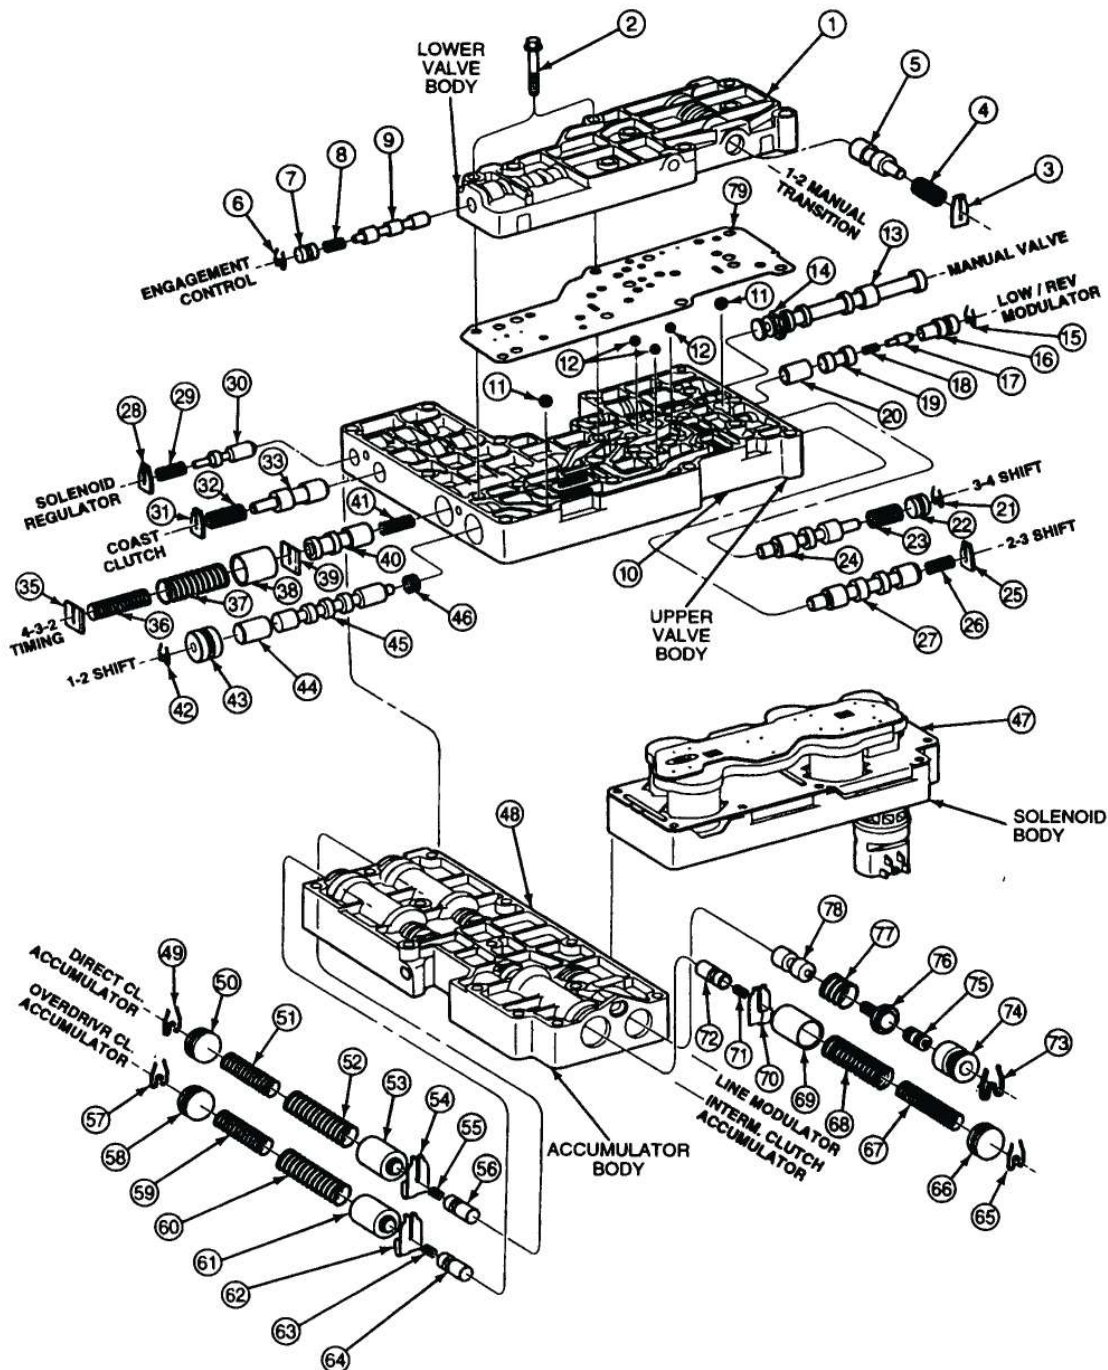
Figure 65

## 1996 E4OD VALVE BODY

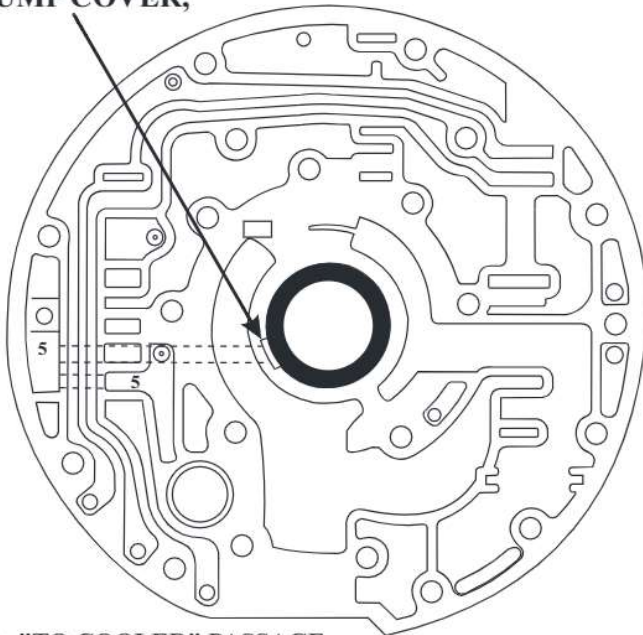
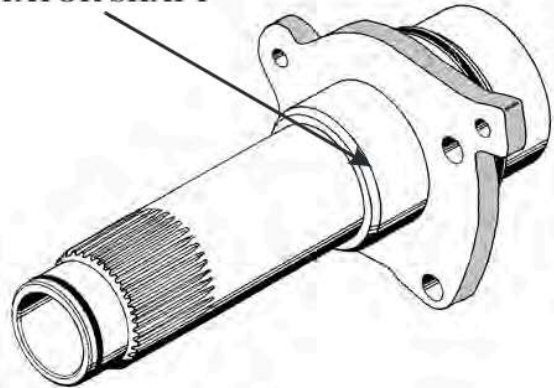
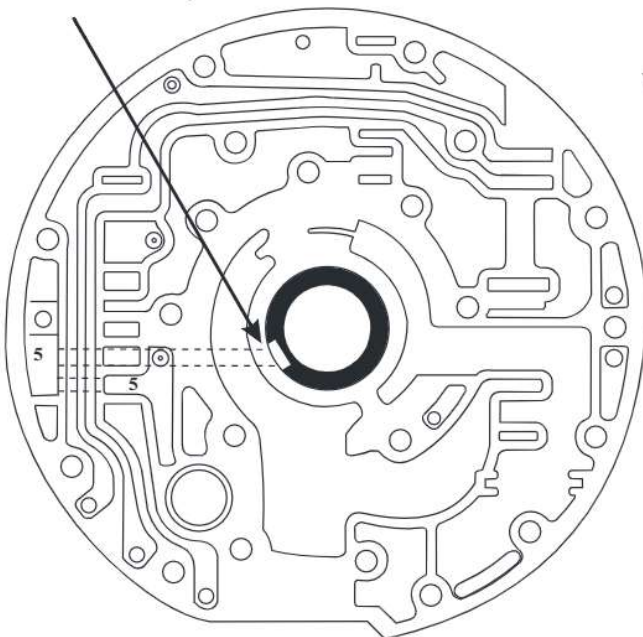
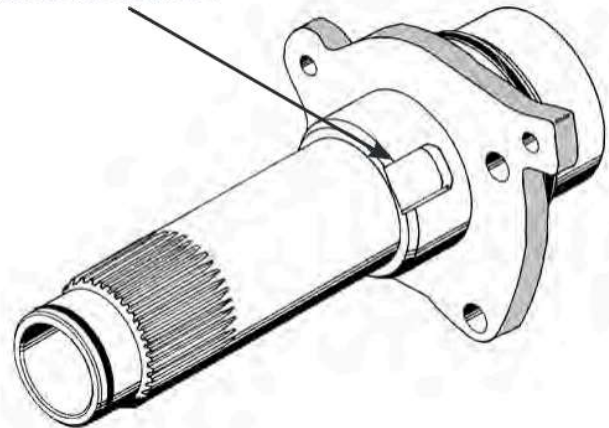
Figure 67

**89-94 PUMP STATOR (WITHOUT NOTCH)  
IN 89-94 PUMP COVER (WITH NOTCH)**

**NOTCH IN  
PUMP COVER,**

**5. "TO COOLER" PASSAGE**

**NO NOTCH IN  
STATOR SHAFT**

## **"CORRECT" ASSEMBLY**

**95-96 PUMP STATOR (WITH NOTCH)  
IN 95-96 PUMP COVER (WITHOUT NOTCH)**

**NO NOTCH IN  
PUMP COVER,**

**WITH NOTCH IN  
STATOR SHAFT**

- (1) **89-94 MODELS** - Have a relief (Notch) cut into the ***pump cover*** on the inside diameter, where the stator shaft presses into the cover, creating a passage for converter apply oil to get into the "To Cooler" passage in the pump cover. Refer to Figure 67.
- (2) **95-96 MODELS** - The relief (Notch) cut in the pump cover was eliminated from the cover, and the relief (Notch) cut was added to the ***stator shaft*** (See Figure 67).
- (3) If for any reason, it becomes necessary to install a different stator shaft into your pump cover, you ***must*** ensure that you are installing compatible parts.

**89-94 Model** pump cover ***with notch, MUST*** be used with the stator shaft ***without notch***. Refer to Figure 67.

**95-96 Model** pump cover ***without notch, MUST*** be used with the stator shaft ***with notch***. Refer to Figure 67.

If you install a 89-94 stator shaft ***without notch***, into a 95-96 pump cover ***without notch*** -- You will create a ***totally blocked "To Cooler" passage*** in the pump cover. Refer to Figure 67.

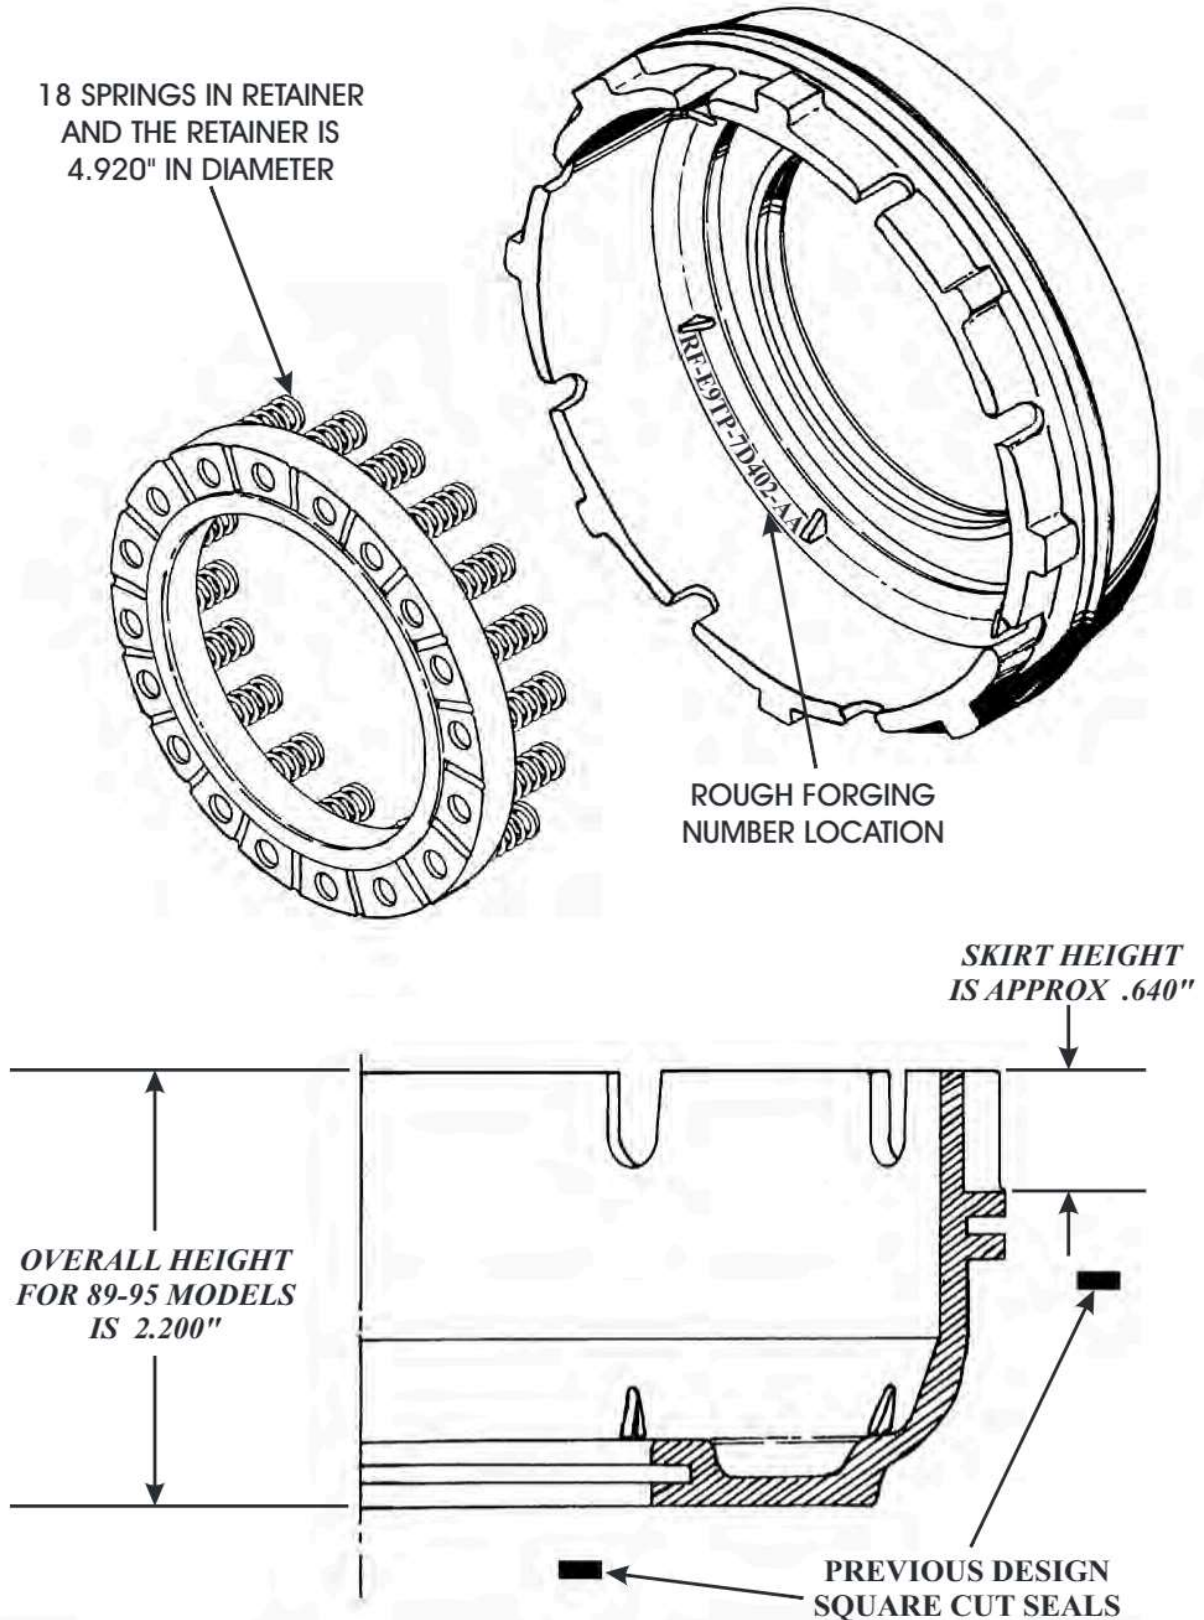
Figure 68

## 1989-1995 MODEL REVERSE CLUTCH PISTON AND SPRING RETAINER

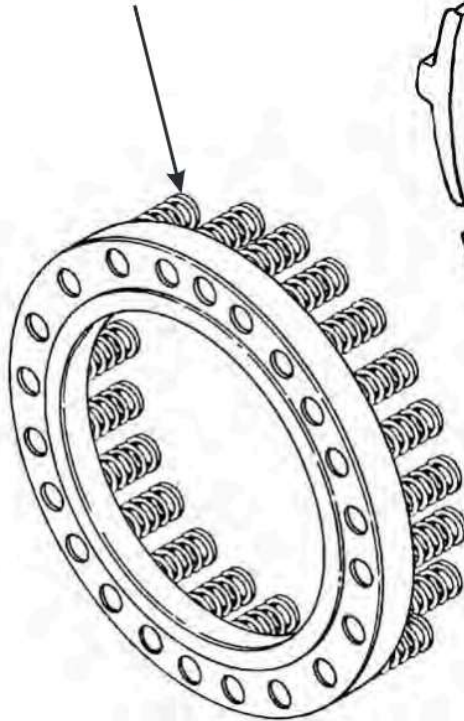
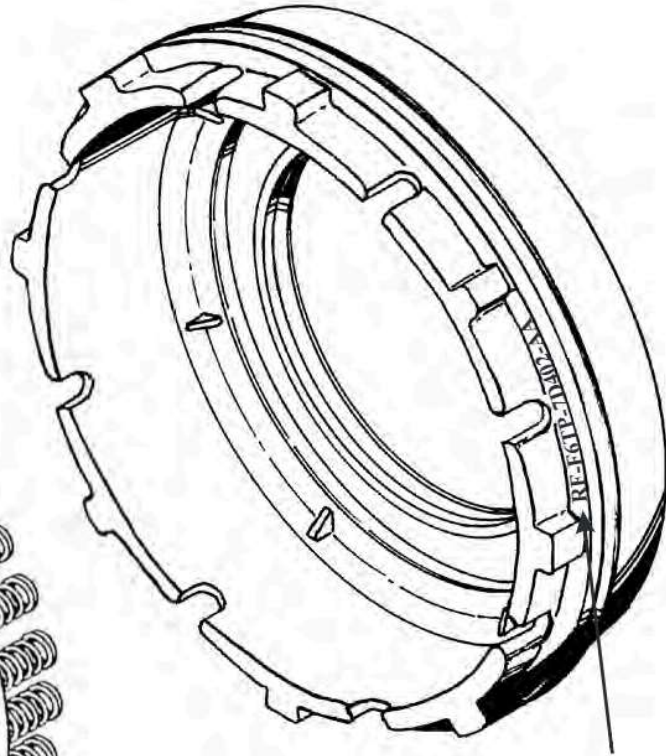
**1996 MODEL REVERSE CLUTCH  
PISTON AND SPRING RETAINER**

23 SPRINGS IN RETAINER  
AND THE RETAINER IS  
5.200" IN DIAMETER

ROUGH FORGING  
NUMBER LOCATION

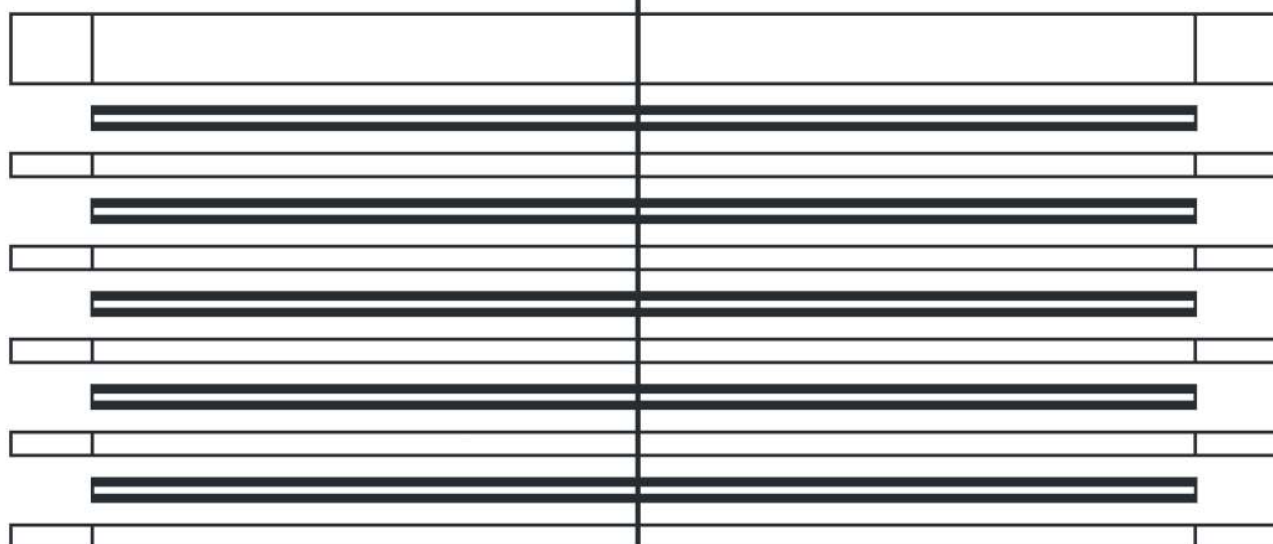
## 1996-UP MODEL REVERSE CLUTCH STACK

*NOTE: THE NUMBER OF REVERSE CLUTCH PLATES FOR THE REVERSE CLUTCH IS MODEL DEPENDENT*

PREVIOUS DESIGN  
LATHE CUT SEALS

NEW DESIGN  
LIP SEALS  
Copyright © 2004 ATSG

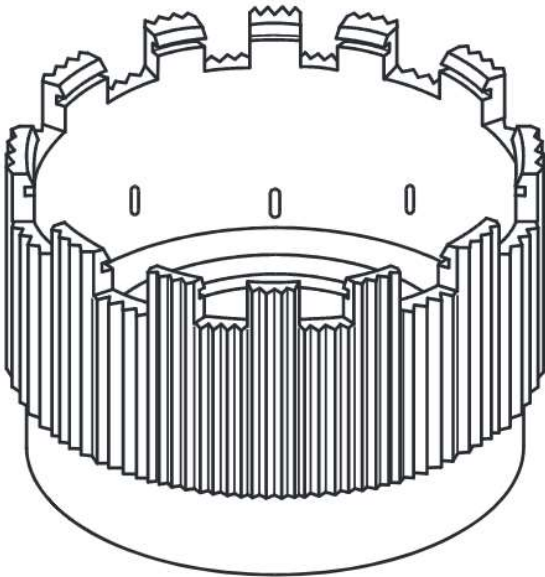
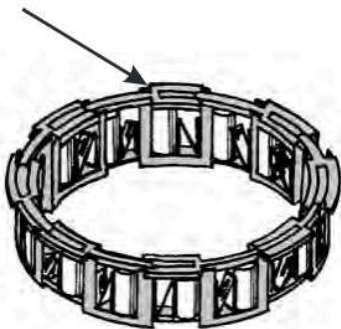
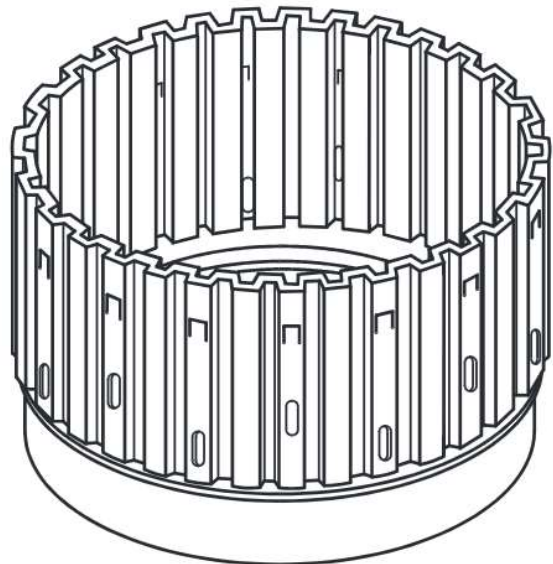
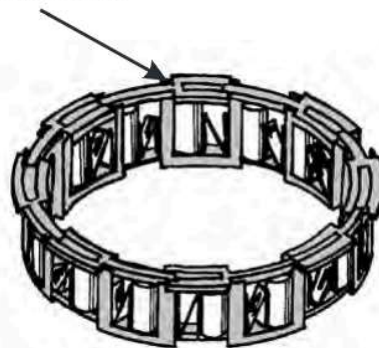
Figure 71

## 1989-1996 DESIGN LEVEL REVERSE CLUTCH HUB, LOW ROLLER CLUTCH, AND INNER RACE

### "BLACK" PLASTIC CAGE 16 ROLLERS

### LOW ROLLER INNER RACE

## 1997-UP DESIGN LEVEL REVERSE CLUTCH HUB, LOW ROLLER CLUTCH, AND INNER RACE

### "TAN" PLASTIC CAGE 17 ROLLERS

- (1) LOW ROLLER CLUTCH ASSEMBLY - New design is larger in diameter, has 17 rollers instead of the previous 16 rollers, and the plastic is "Tan" in color instead of black for easy identification. Refer to Figure 71.

- (2) LOW ROLLER CLUTCH INNER RACE - New design is 3.385" in diameter instead of the previous 3.189" diameter, to accommodate the new low roller clutch. There is no other means of identification on the inner race other than measuring the diameter. Refer to Figure 71.
