## FORD E4OD "UPDATE HANDBOOK"

AUTOMATIC TRANSMISSION SERVICE GROUP  
18639 SW 107TH AVENUE  
MIAMI, FLORIDA 33157  
(305) 670-4161

### FORD E4OD "UPDATE HANDBOOK"

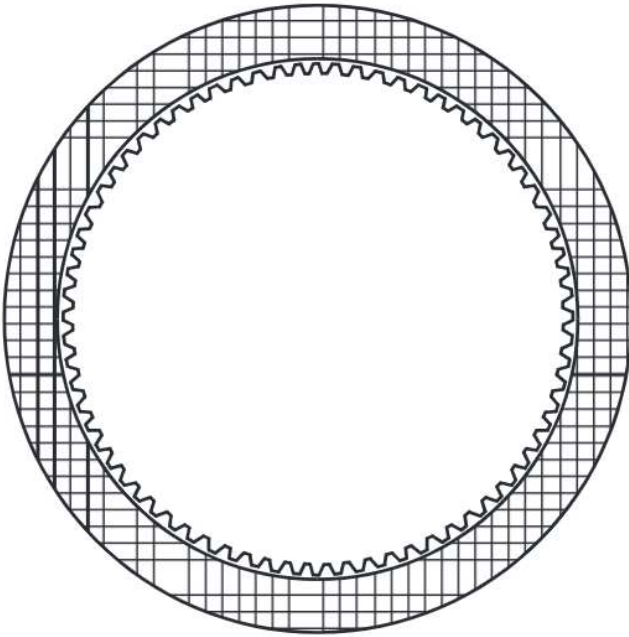
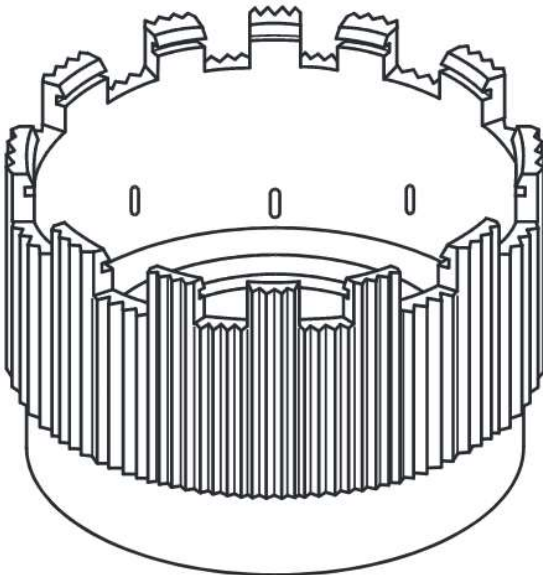
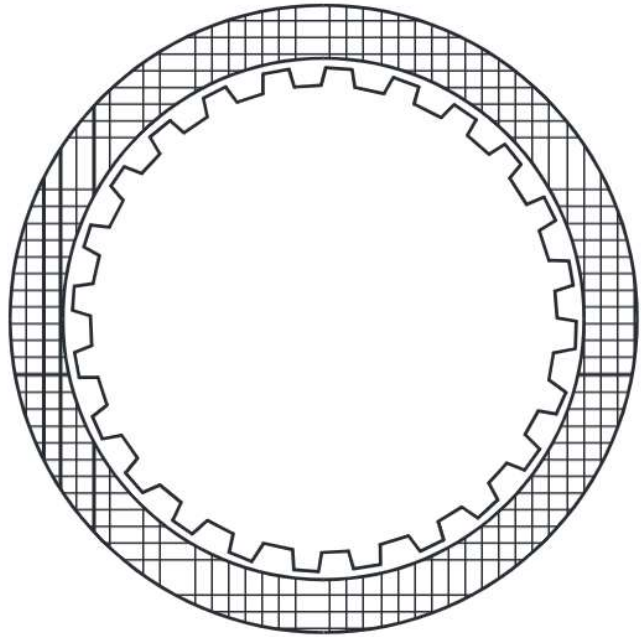
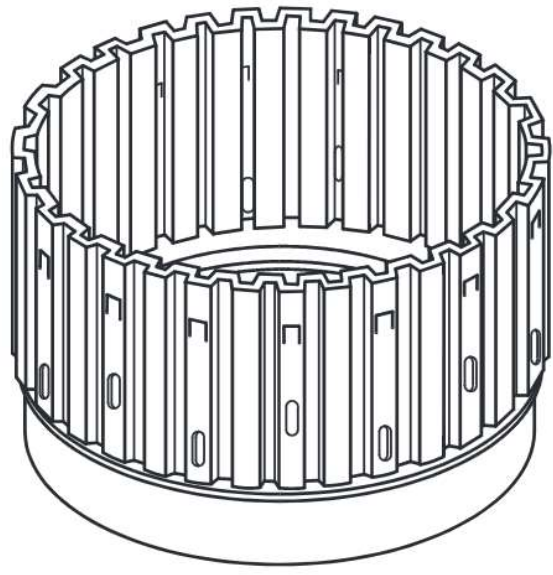
Figure 72

**1989-1996 DESIGN LEVEL  
LOW/REVERSE CLUTCH PLATE  
AND REVERSE CLUTCH HUB**

**1997-UP DESIGN LEVEL  
LOW/REVERSE CLUTCH PLATE  
AND REVERSE CLUTCH HUB**

- (3) REVERSE CLUTCH HUB - New design has a larger diameter "Cam" installed into the rear of reverse clutch hub to accommodate the larger low roller clutch, and the shell is now stamped, and has wider grooves for the reverse clutch teeth. Refer to Figure 72.

- (4) REVERSE CLUTCH FRICTION PLATES - New design friction plates are manufactured with wider teeth to fit the new design reverse clutch hub. Refer to Figure 72.

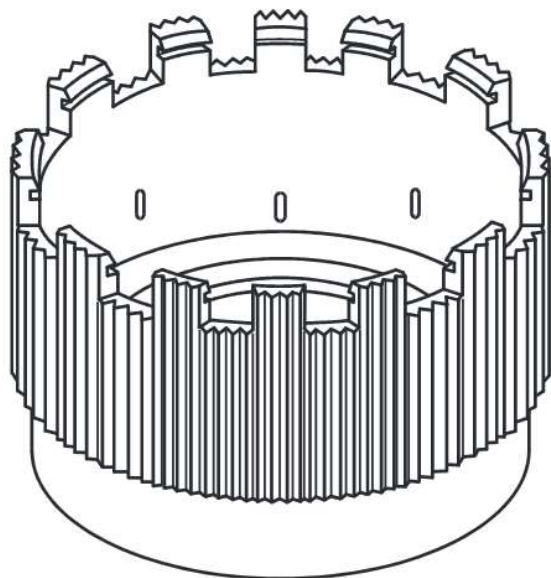
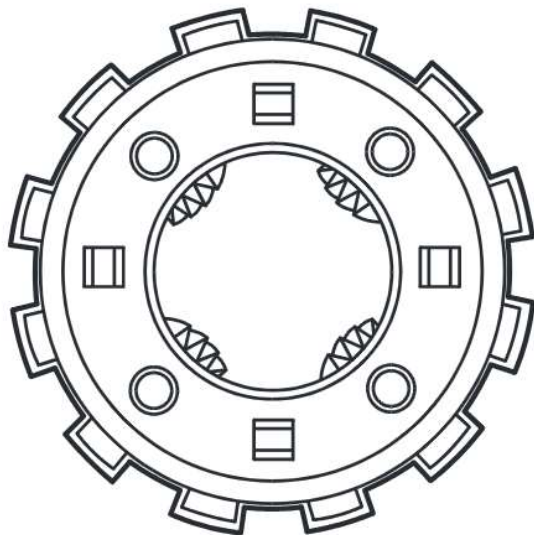
Figure 73

## 1989-1996 DESIGN LEVEL REVERSE CLUTCH HUB AND REAR PLANET ASSEMBLY

- (5) REAR PLANETARY CARRIER - New design level has narrow teeth on the outside diameter instead of the previous wide teeth, to accommodate the new design reverse clutch hub. Refer to Figures 73 and 74.

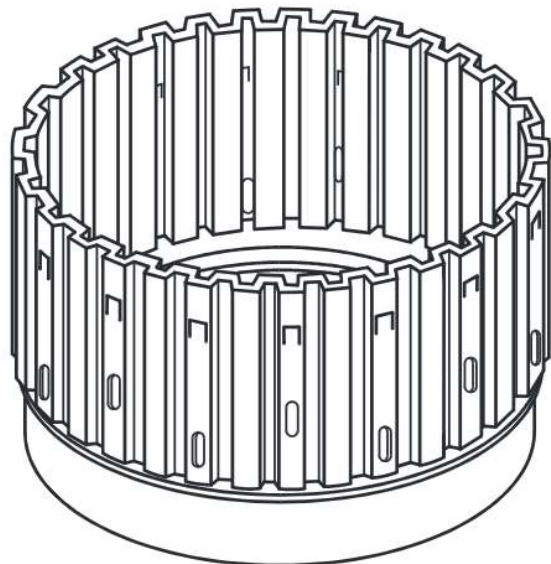
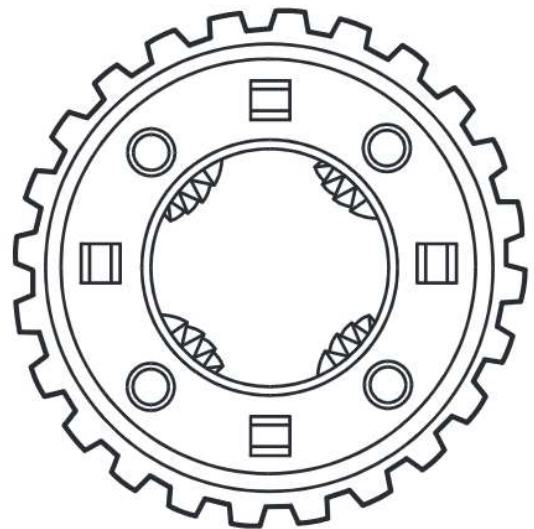
Figure 74

## 1997-UP DESIGN LEVEL REVERSE CLUTCH HUB AND REAR PLANET ASSEMBLY

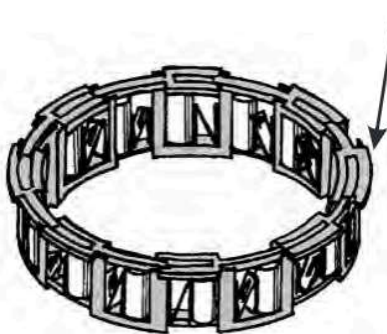
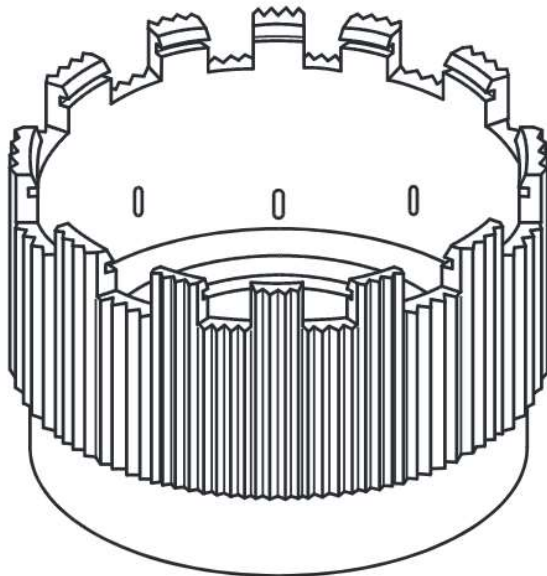
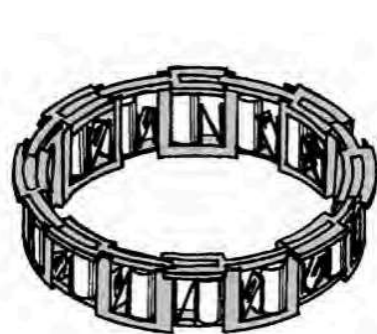
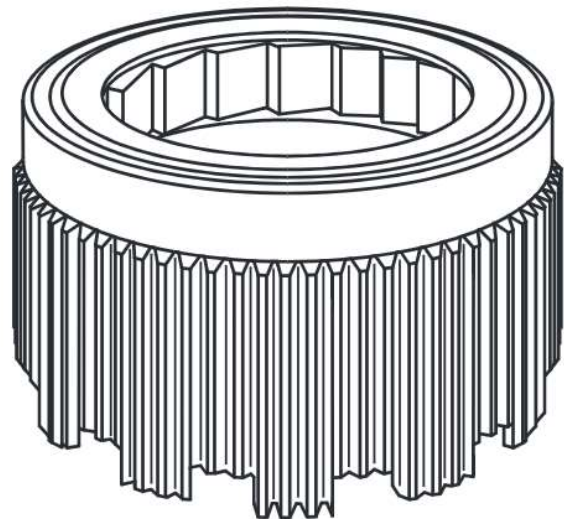
***"INCORRECTLY"  
INSTALLED***

***NOTE TABS ON  
TOP OUTER EDGE***

***CAUTION***

***IF THE ROLLER CLUTCH IS INSTALLED IN  
THIS DIRECTION, THE REVERSE HUB WILL  
FREEWHEEL IN BOTH DIRECTIONS.***

***"CORRECT"  
INSTALLATION***

***DISCARD BOTH SNAP RINGS. THEY ARE NOT  
USED WITH THE PLASTIC ROLLER CLUTCH***

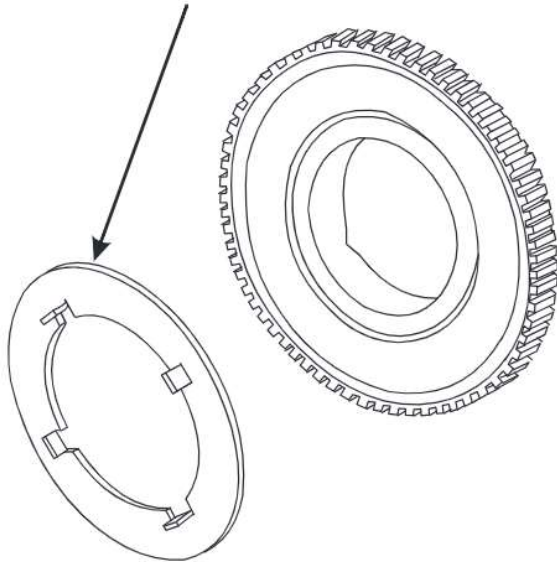
## EARLY FORWARD CLUTCH RING GEAR HUB

**1989-1996 THRUST WASHER**  
**PART NUMBER E9TZ-7A166-A**  
*(No Longer Available From Ford)*

**1989-1996 RING GEAR HUB**  
**.030" FROM WASHER SURFACE TO EDGE AS SHOWN,**  
**AND *REQUIRES* THRUST WASHER SHOWN ABOVE.**  
*(NO LONGER AVAILABLE FROM FORD)*

- (1) RING GEAR HUB - Now cut deeper on the side that goes against the forward planetary carrier by .100", to accommodate the new design bearing that replaced the thrust washer. Refer to Figure 76.
- (2) THRUST BEARING - Replaces the previous four tang thrust washer for improved durability. Refer to Figure 76.
- (3) FORWARD PLANETARY - Thrust washer slots have been eliminated, as shown in Figure 77, and there is an updated part number from Ford Motor Company, that is shown in Service Information below.

- (2) New design Thrust Bearing must be used only with the new design Ring Gear Hub. It cannot be used on any previous models (See Figure 76).
- (3) There is also a new part number for the Forward Planetary Carrier, with no dimensional changes, and will retro-fit back on all previous models, but, **some** of the new part number carriers will not be cut to accept the four tang thrust washer. In that case you will have to install the new thrust bearing, which means you will also have to replace the ring gear hub with the new design level (See Figure 77).

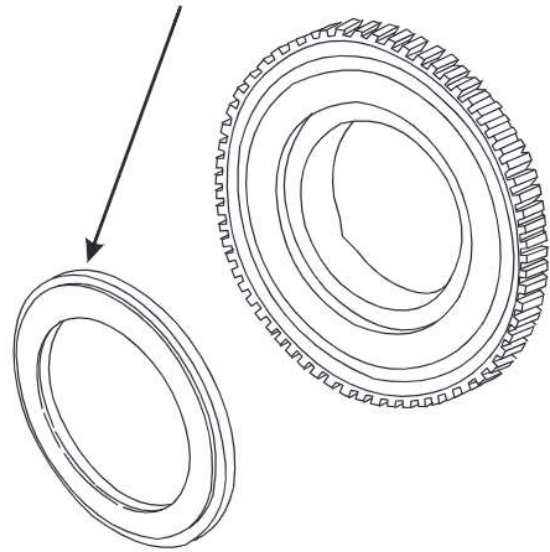
## LATE FORWARD CLUTCH RING GEAR HUB

**1997-UP THRUST BEARING**  
**PART NUMBER F81Z-7A166-AA**  
*(Now Available From Ford)*

**1997-UP RING GEAR HUB**  
**.130" FROM WASHER SURFACE TO EDGE AS SHOWN,**  
**AND *REQUIRES* THRUST BEARING SHOWN ABOVE.**  
**RING GEAR HUB PART NUMBER F7TZ-7B067-AB.**

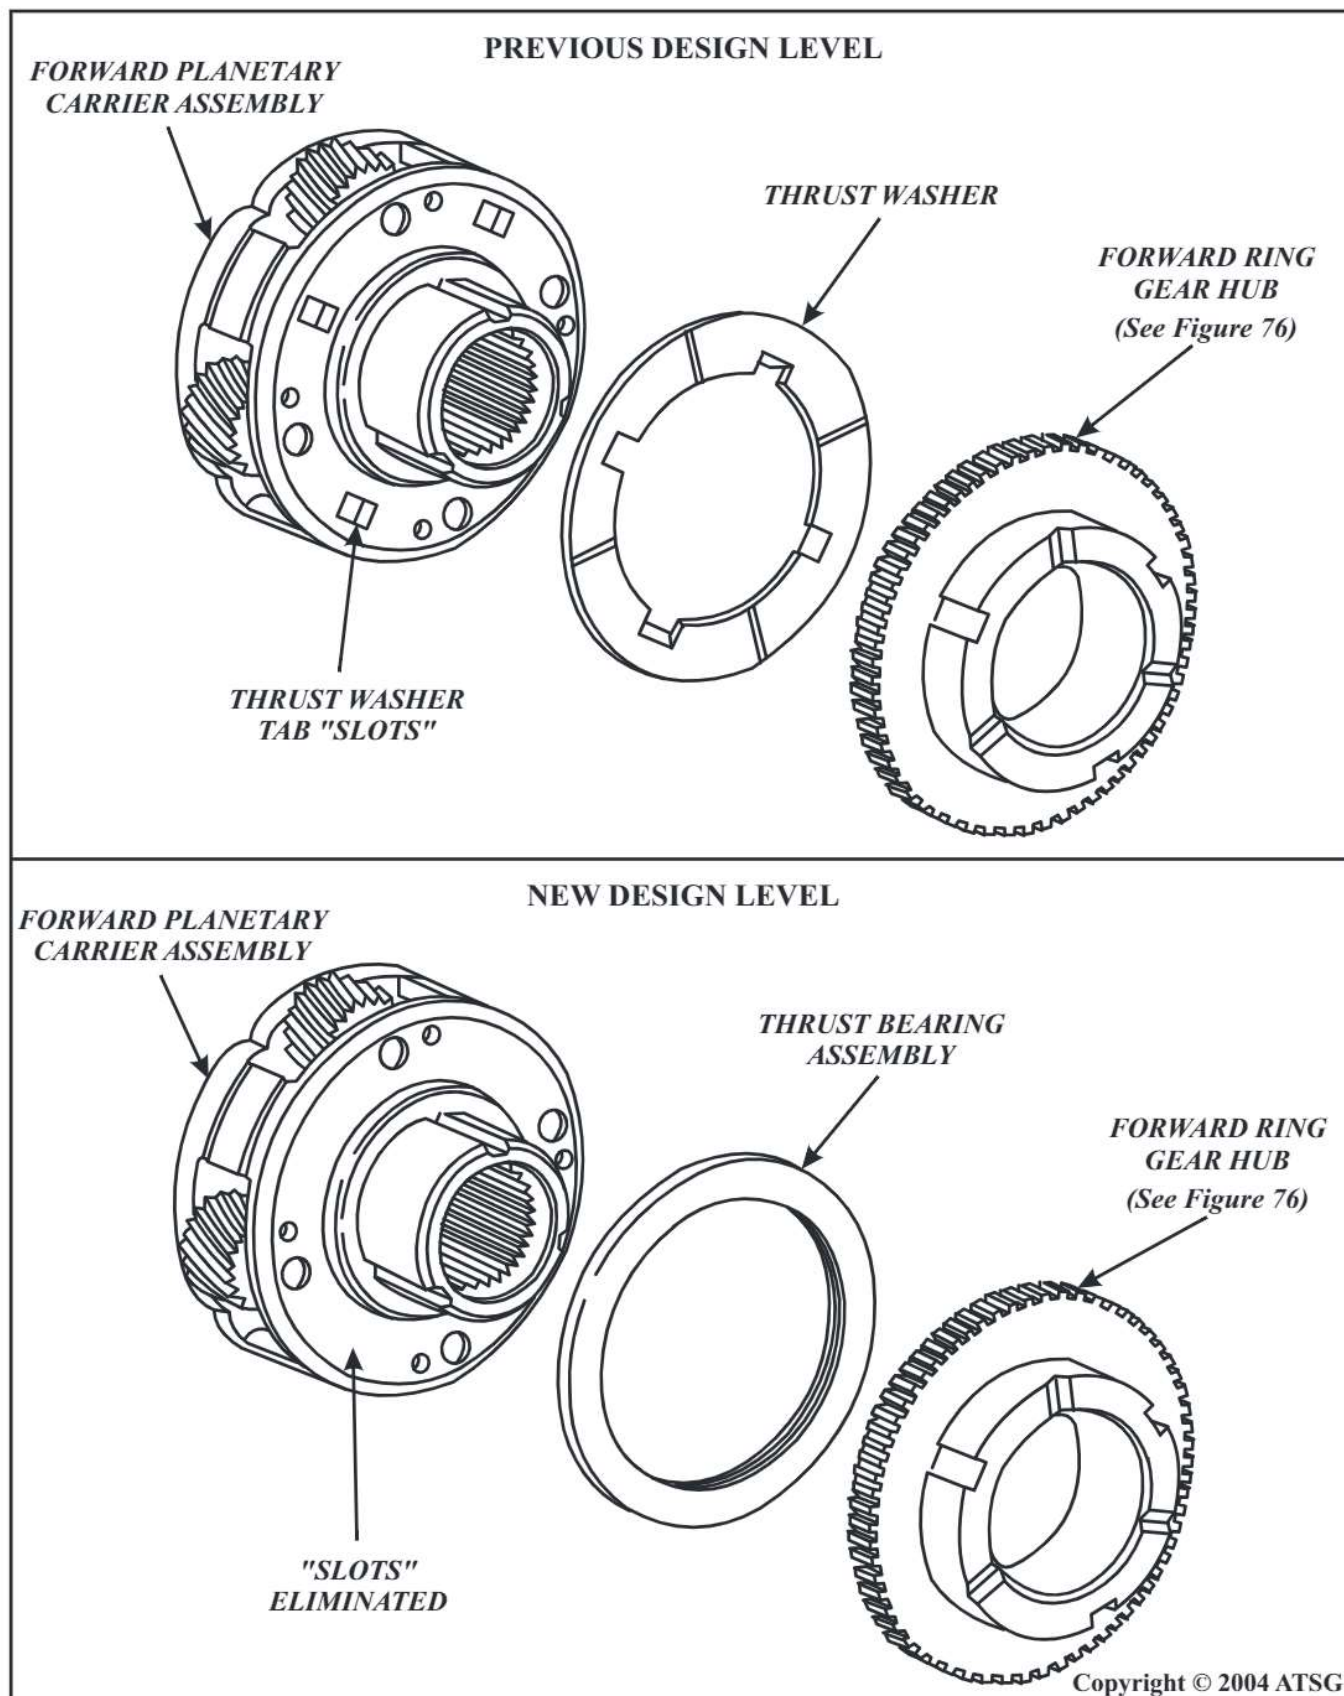
Figure 77  
AUTOMATIC TRANSMISSION SERVICE GROUP

**CHANGE:** Beginning at the start of production for the 1997 model year, Ford Motor Company introduced a new design Forward Clutch Ring Gear Hub, to accommodate a new thrust bearing, that replaces the thrust washer on the forward planetary carrier, and a new design Forward Planetary Carrier that eliminates the thrust washer tab slots (See Figures 76 and 77).

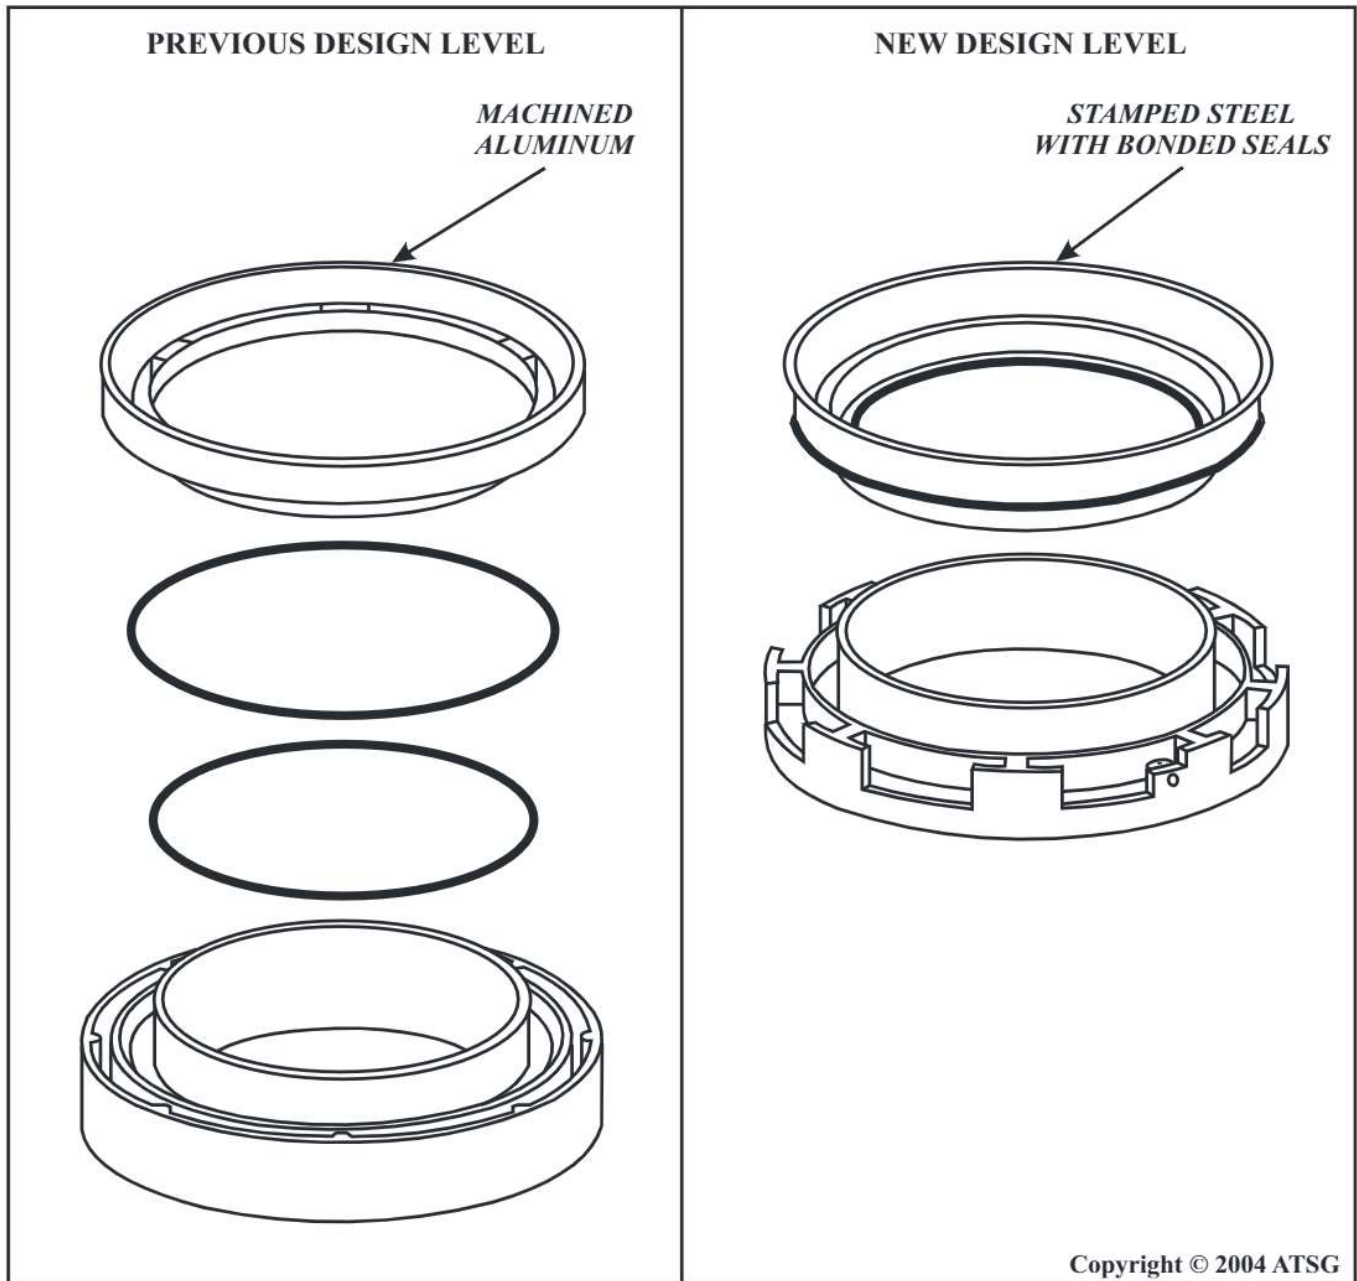
Figure 78

**CHANGE:** Some 1996-1997 vehicles equipped with the E4OD transmission were built with a new design level overdrive clutch piston, with the seals bonded to the piston (See Figure 78).

- (1) OVERDRIVE PISTON - Now stamped steel with moulded rubber inner and outer seals on the piston assembly, instead of the previous machined aluminum, as shown in Figure 78.
- (2) OVERDRIVE/INTERMEDIATE CLUTCH CYLINDER - Major casting changes to clutch cylinder, to accommodate the new design level bonded piston, as shown in Figure 78.

**Note:** *Until the new design level parts are fully stocked, the current service parts must be used to replace the new design level parts, if it becomes necessary to replace either the new design bonded seal piston or new design cylinder.*

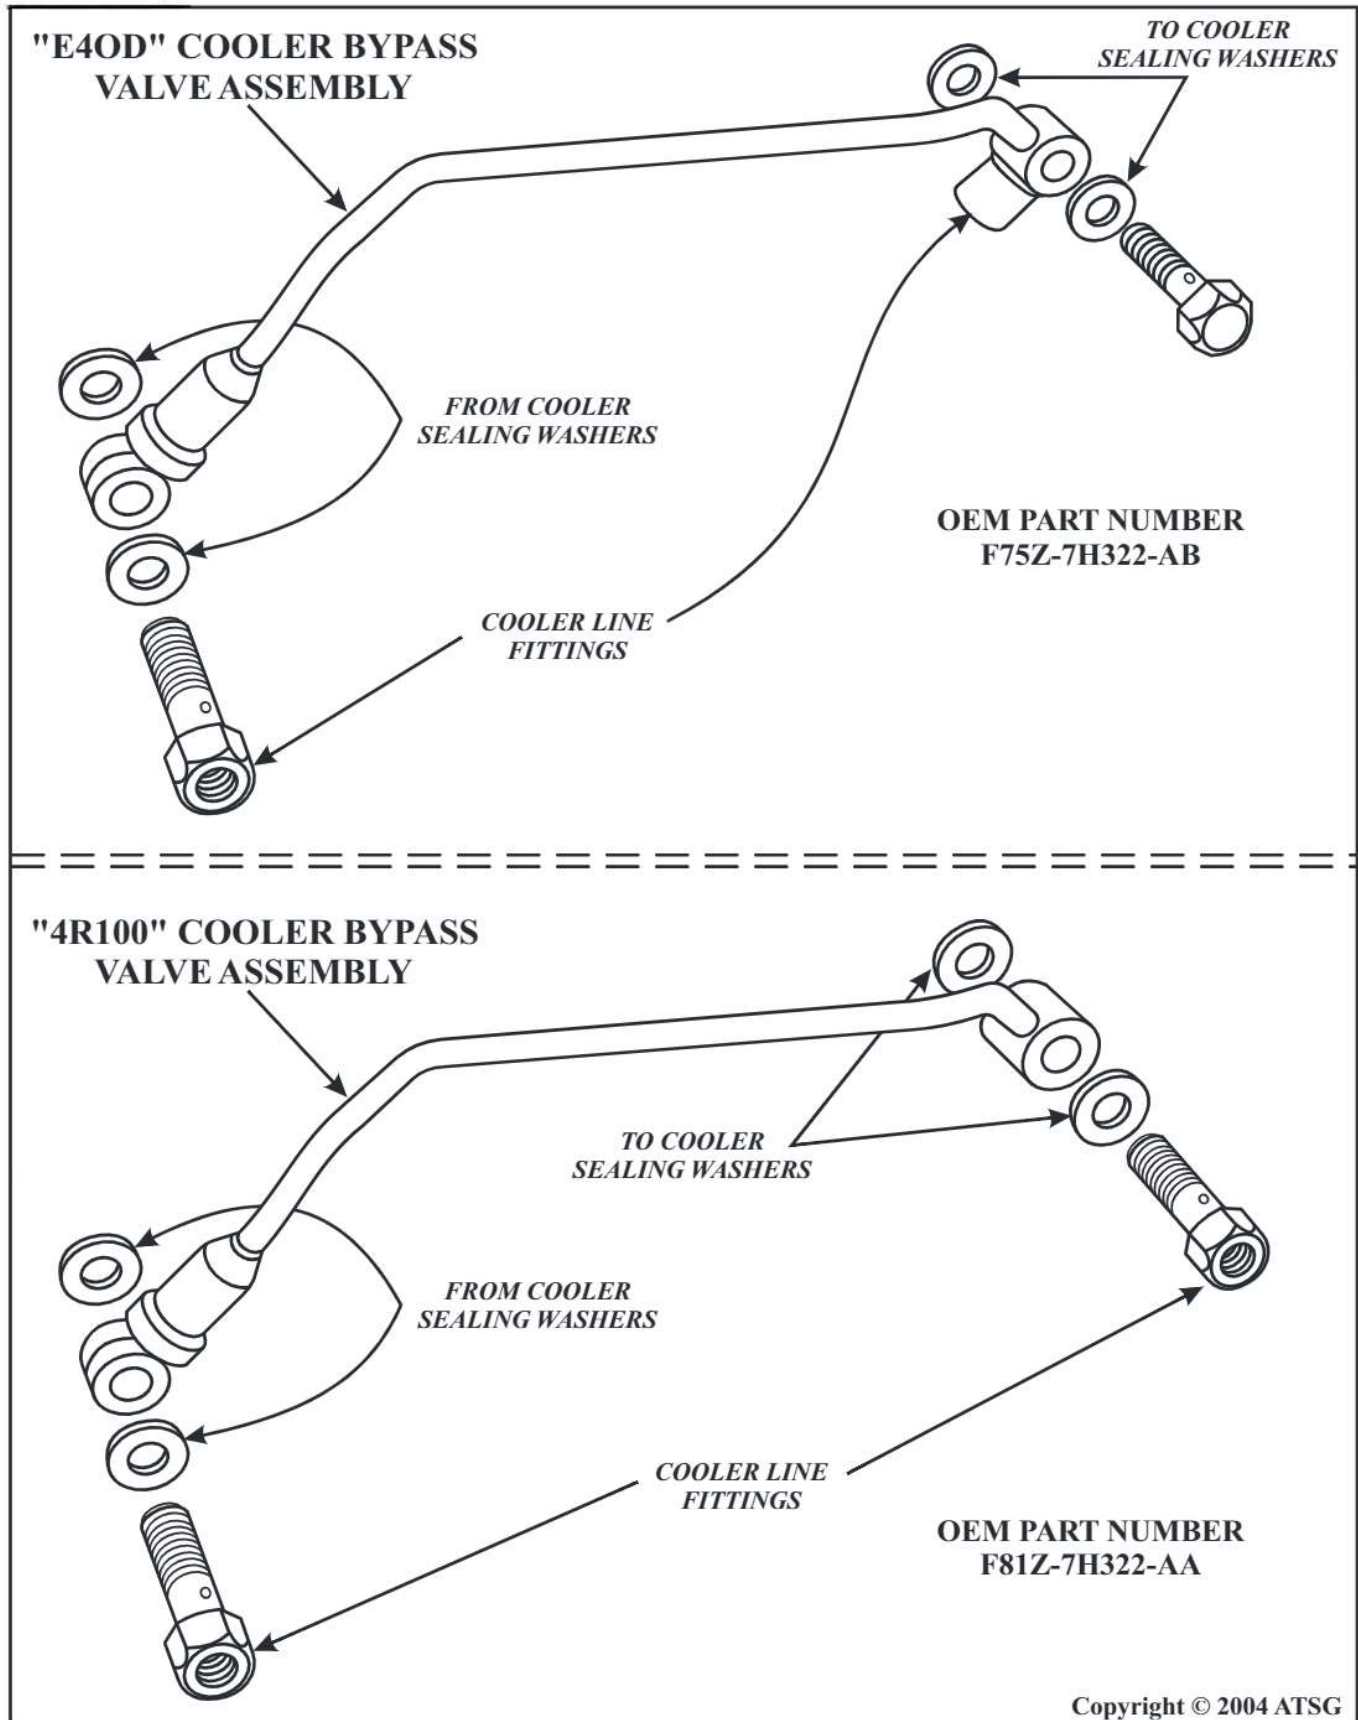
Figure 79

The new design Cooler Bypass Valve Assembly will retro-fit back to all previous models, and we would recommend the 4R100 style bypass valve assembly, as shown in Figure 79, because you do not have to bend the existing cooler line to get it hooked up.

*If a removed Cooler Bypass Valve has an "O" ring installed, remove the "O" ring prior to re-installing the assembly. The "O" rings are only used to hold the sealing washers in place for shipping purposes. If the entire Cooler Bypass Valve requires replacement, be sure to remove the shipping caps and "O" rings prior to installation.*

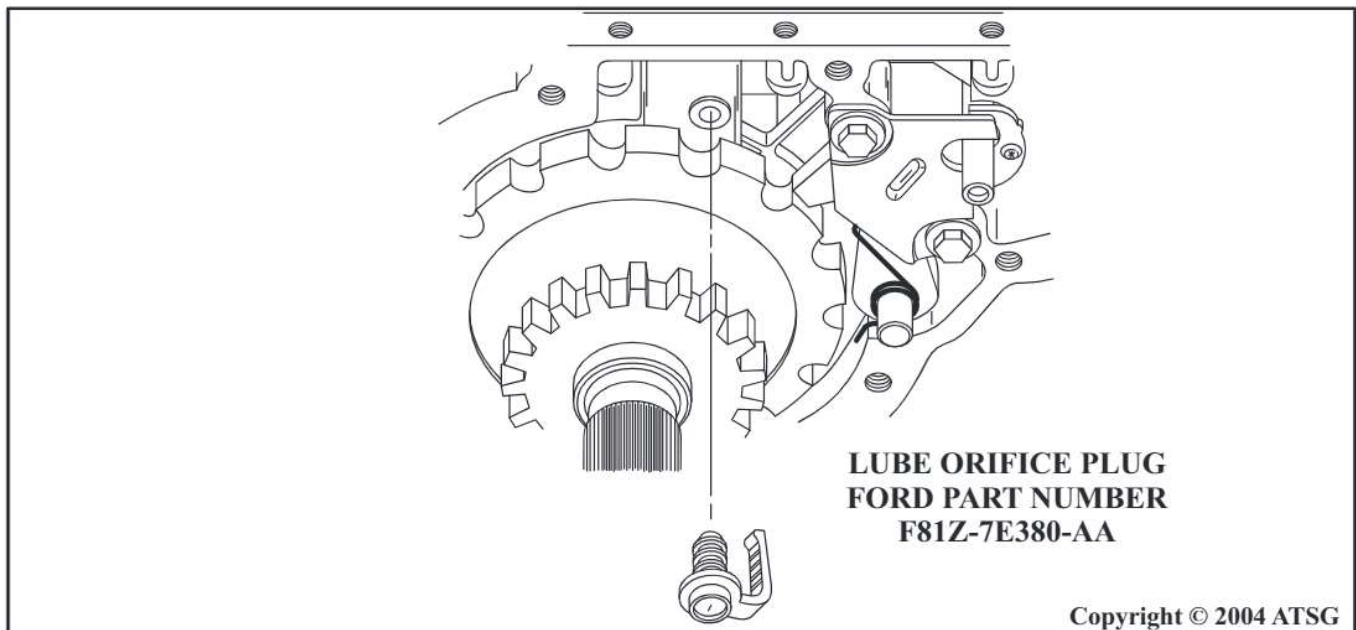
Figure 80

- (1) TRANSMISSION CASE - Added passage at the rear of transmission case to accept the added plastic lube orifice plug, as shown in Figure 80.
- (2) EXTENSION HOUSING - Added cast-in shoulder/boss that retains the added lube orifice plug in the transmission case, as shown in Figure 81.

**CHANGE:** Beginning on 7/24/97, a new design transmission case and extension housing were released for production for 1997 model Econoline, Expedition, F Super Duty, F150-350 Series Trucks and 1998 Navigator vehicles. (See Figures 80 and 81).

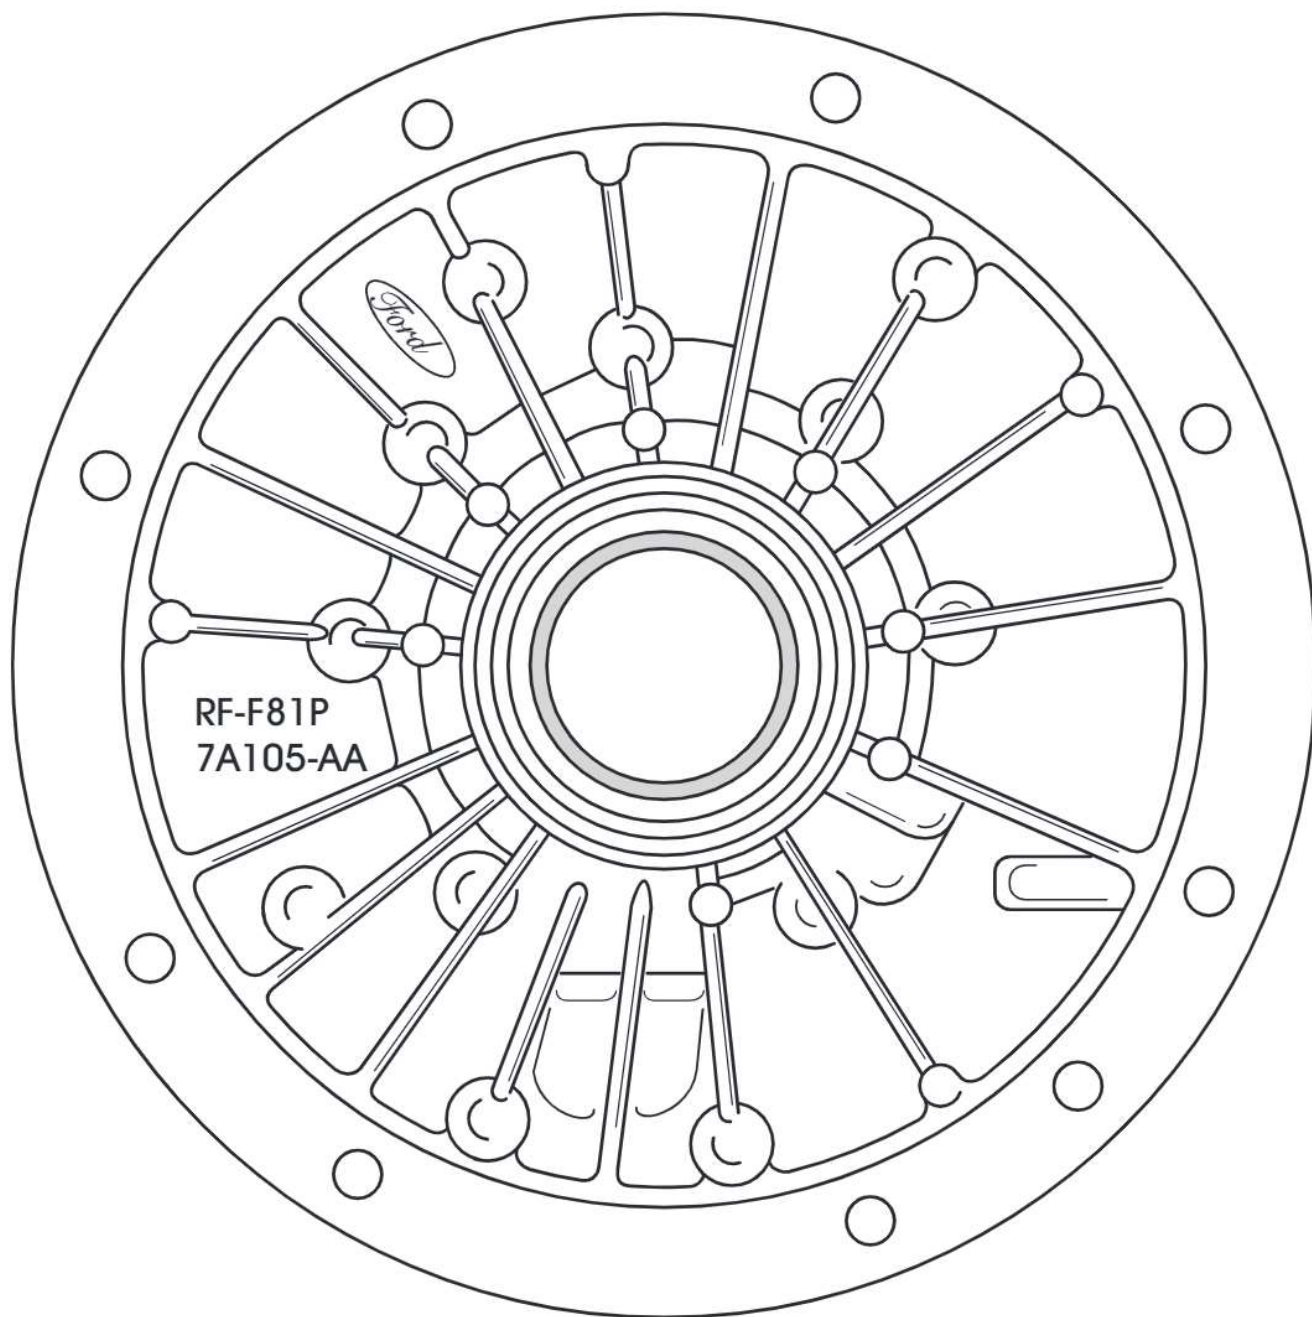
Figure 82  
AUTOMATIC TRANSMISSION SERVICE GROUP

## 1998 E4OD PUMP BODY FRONT SIDE

This new Oil Pump Assembly will retro-fit back to previous models, as long as you have the proper valve line-up in the converter clutch control valve bore. The pump halves **cannot** be inter-mixed because of the major worm track differences. All other parts listed above are model dependent and **great care must be used** when parts replacement is necessary.

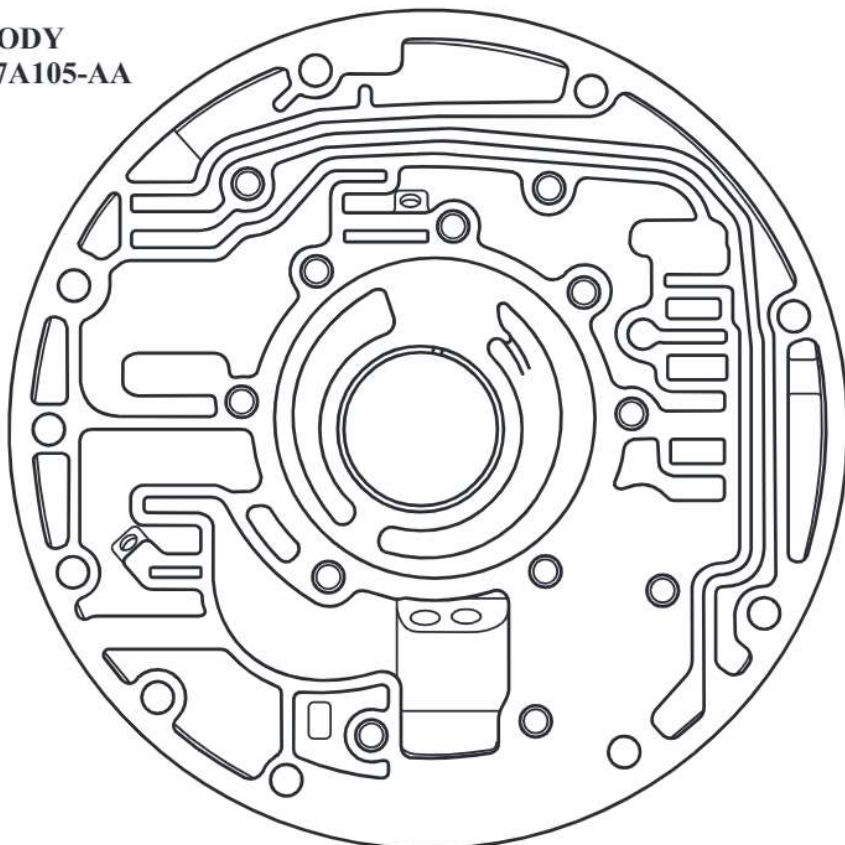
Figure 83  
AUTOMATIC TRANSMISSION SERVICE GROUP

**1998 E4OD/4R100 PUMP BODY  
CASTING NUMBER RF-F81P-7A105-AA  
WORM TRACK SIDE**

**1995 E4OD PUMP BODY  
CASTING NUMBER RF-F5TP-7A105-AA  
WORM TRACK SIDE**

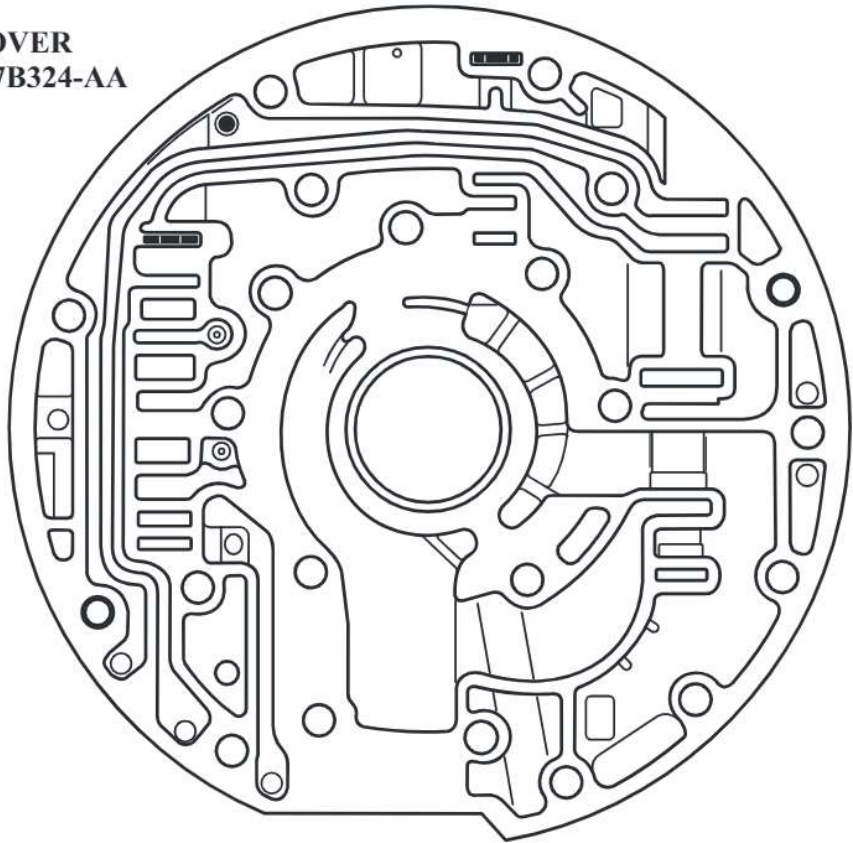
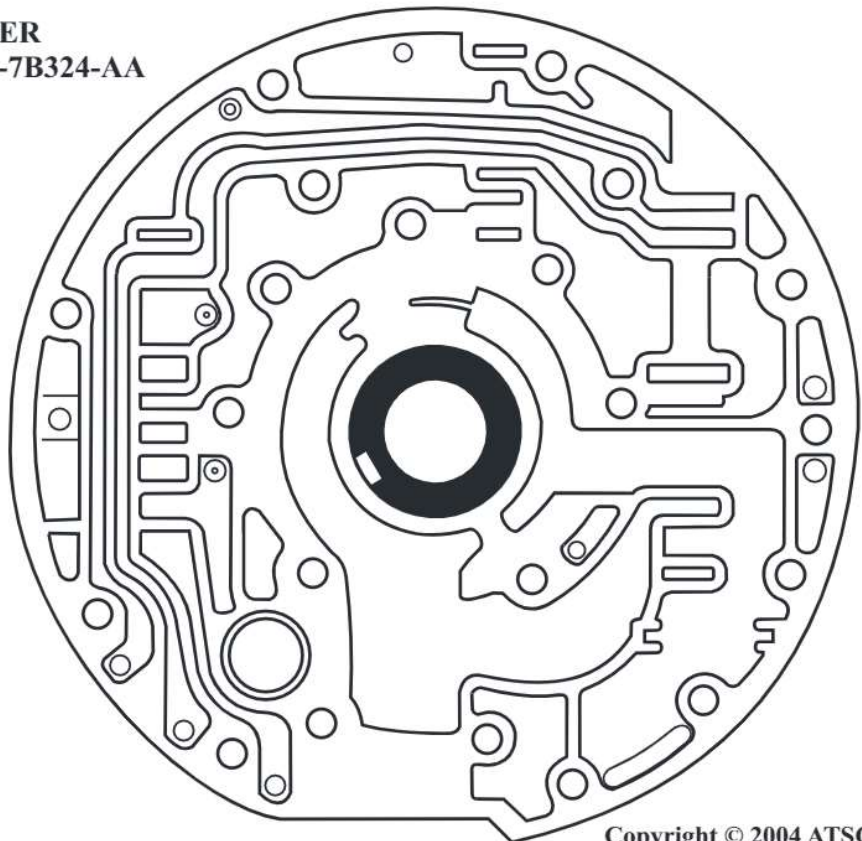
Figure 84  
AUTOMATIC TRANSMISSION SERVICE GROUP

**1998 E4OD/4R100 PUMP COVER  
CASTING NUMBER RF-F81P-7B324-AA**

**1995 E4OD PUMP COVER  
CASTING NUMBER RF-F5TP-7B324-AA**

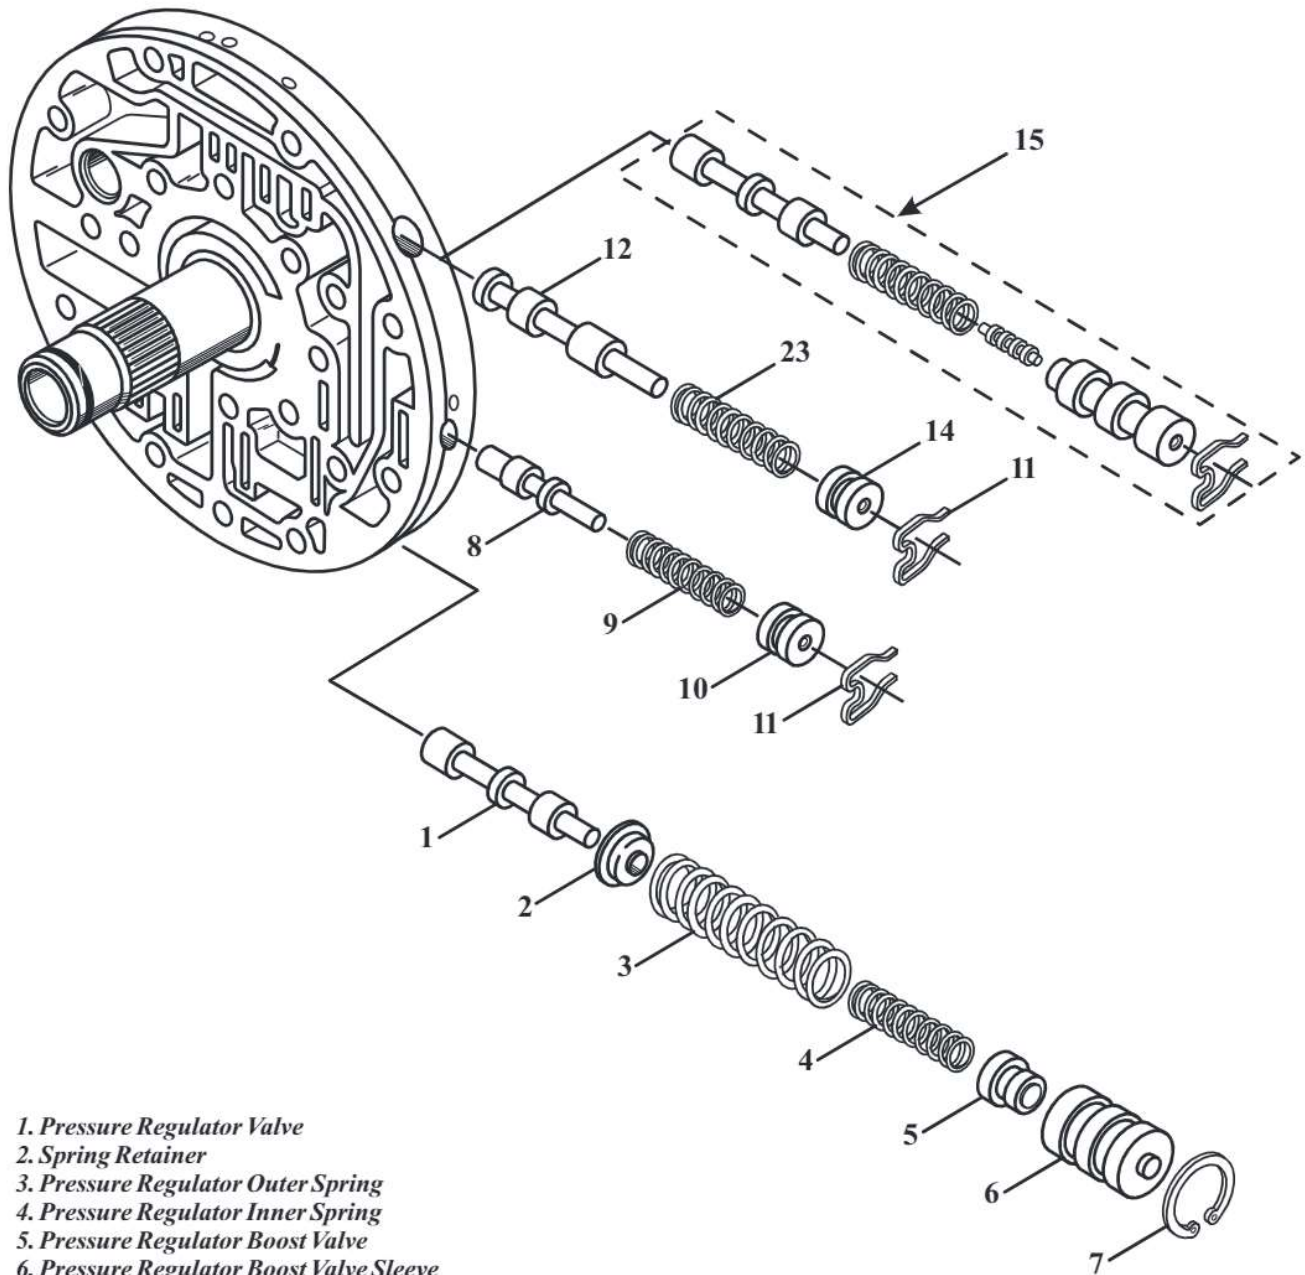
## FORD E4OD/4R100 VALVE LINE-UPS IN PUMP ASSEMBLY

1. Pressure Regulator Valve
2. Spring Retainer
3. Pressure Regulator Outer Spring
4. Pressure Regulator Inner Spring
5. Pressure Regulator Boost Valve
6. Pressure Regulator Boost Valve Sleeve
7. Snap Ring
8. Converter Clutch Regulator Valve
9. Converter Clutch Regulator Spring
10. Converter Clutch Regulator Bore Plug
11. Bore Plug Retainer
12. Converter Clutch Control Valve (Gas "On-Off" Only)
13. Converter Clutch Control Spring (Gas "On-Off" Only)
14. Converter Clutch Control Bore Plug
15. Converter Clutch Control Line-up (Diesel "PWM" Only)

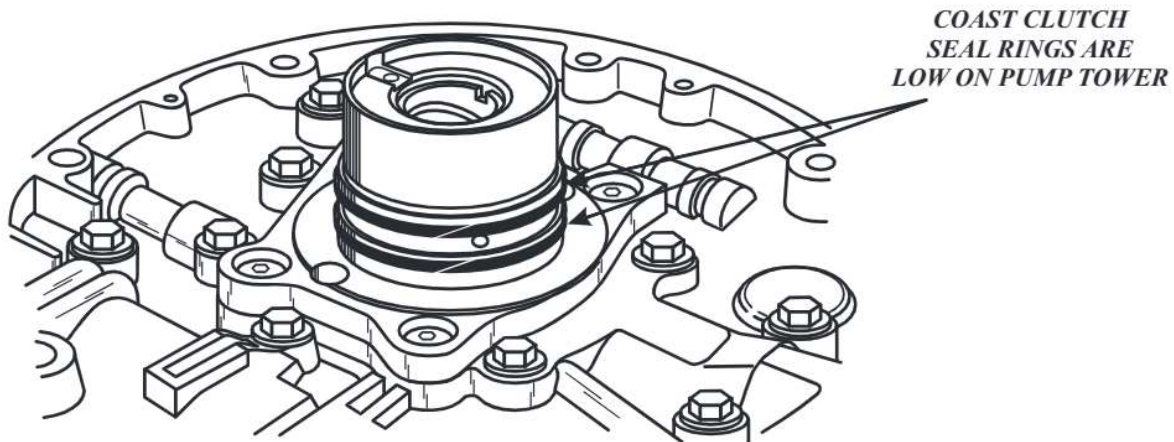
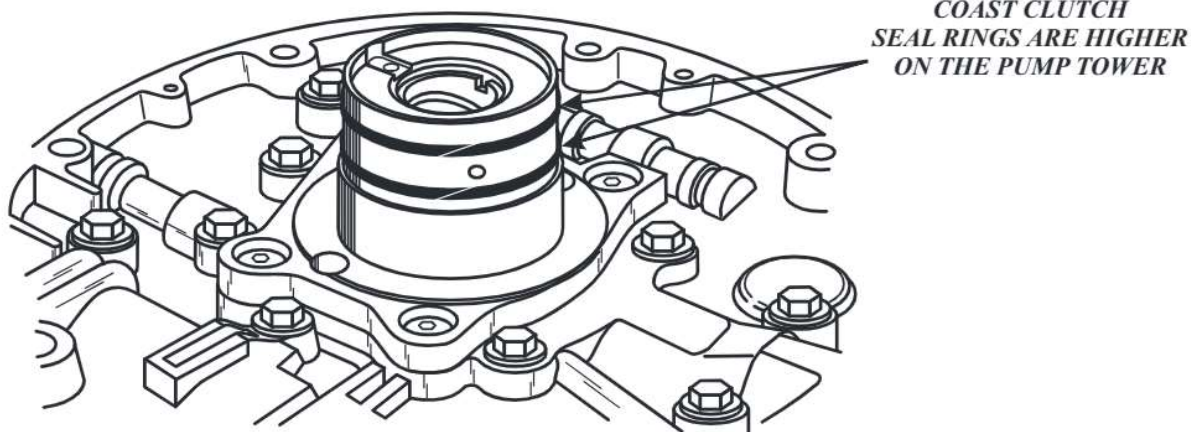
Figure 86

**USED WITH THE "CAST IRON" COAST CLUTCH DRUM  
WITH 5.4L AND 6.8L "WITHOUT" PTO OPTION**

**USED WITH THE "STAMPED STEEL" COAST CLUTCH DRUM  
WITH 5.4L AND 6.8L "WITHOUT" PTO OPTION**

- (4) **STATOR SHAFT ASSEMBLY** - There are now two different Stator Shaft Assemblies with different sealing ring configurations, to accomodate the new coast clutch housing, as illustrated in Figure 86, and are model dependent.

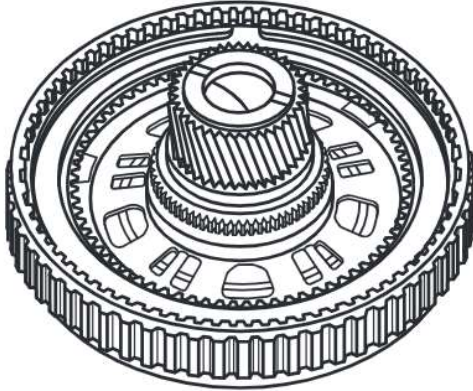
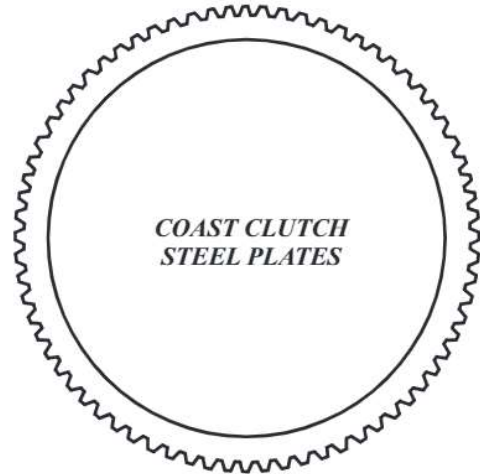
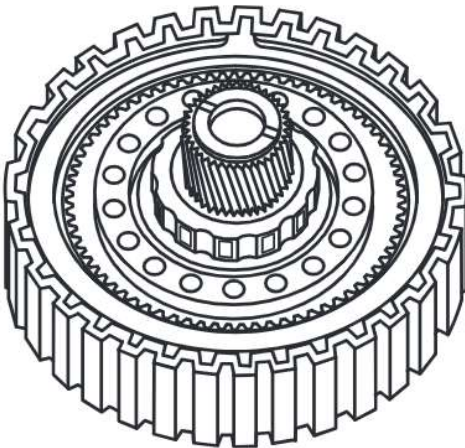
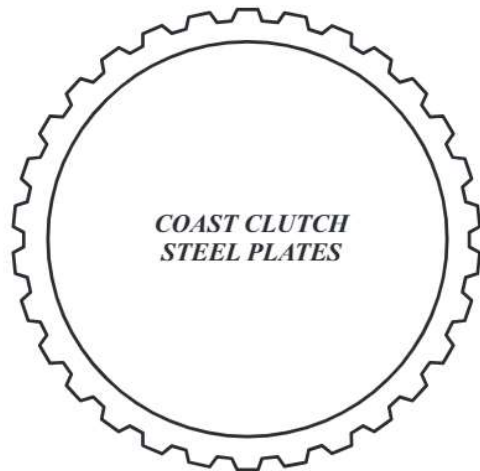
**"CAST IRON" COAST CLUTCH DRUM USED  
WITH 5.4L AND 6.8L "WITHOUT" PTO OPTION**

**"STAMPED STEEL" COAST CLUTCH DRUM USED  
WITH 5.4L AND 6.8L "WITHOUT" PTO OPTION**

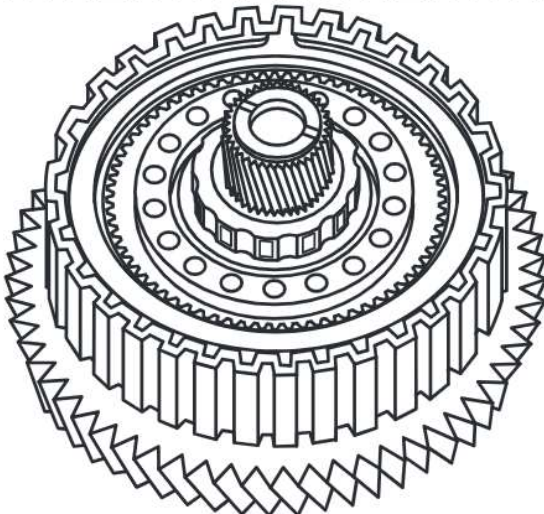
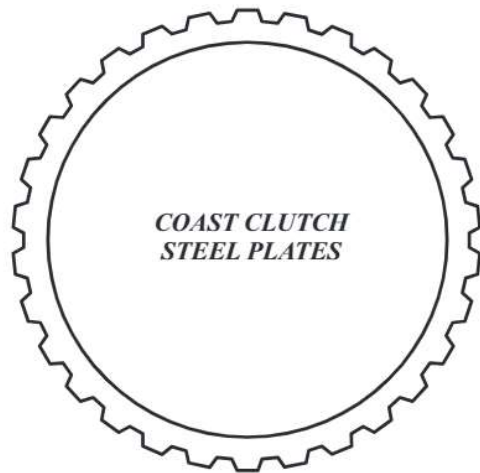
Figure 87

**"STAMPED STEEL" COAST CLUTCH DRUM USED  
WITH 6.8L AND 7.3L "WITH" PTO OPTION**

- (5) **COAST CLUTCH HOUSING** - There is now a "stamped Steel" coast clutch housing that may or may not have a PTO gear pressed onto the housing, that is used in addition to the previous cast iron coast clutch housing, depending on the model and engine size, and is illustrated in Figure 87. This also changes the coast clutch steel plates and the fourth clutch friction plates, as shown in Figures 87 and 88.

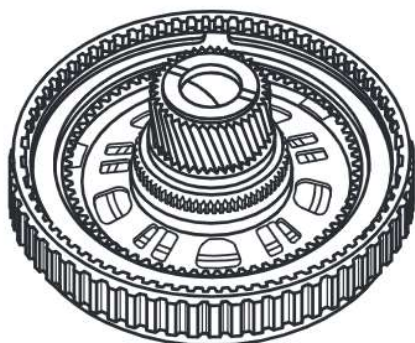
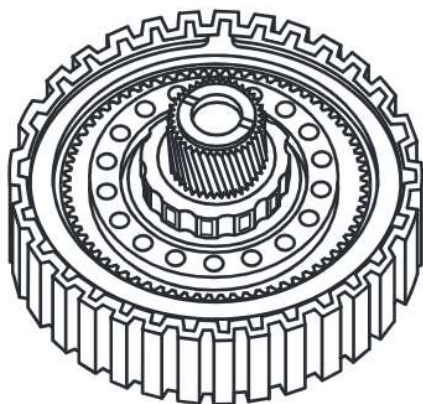
Figure 88

**"CAST IRON" COAST CLUTCH DRUM USED  
WITH 5.4L AND 6.8L "WITHOUT" PTO OPTION**

**"STAMPED STEEL" COAST CLUTCH DRUM USED  
WITH 5.4L AND 6.8L "WITHOUT" PTO OPTION**

**"STAMPED STEEL" COAST CLUTCH DRUM USED  
WITH 6.8L AND 7.3L "WITH" PTO OPTION**
