## FORD E4OD "UPDATE HANDBOOK"

AUTOMATIC TRANSMISSION SERVICE GROUP  
18639 SW 107TH AVENUE  
MIAMI, FLORIDA 33157  
(305) 670-4161

### FORD E4OD "UPDATE HANDBOOK"

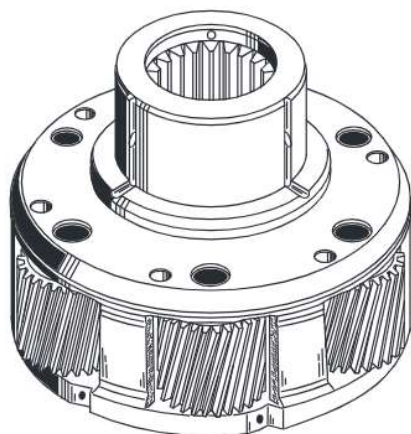
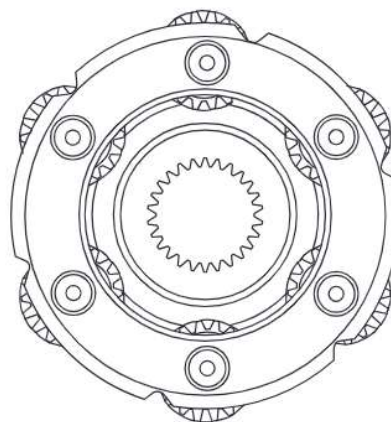
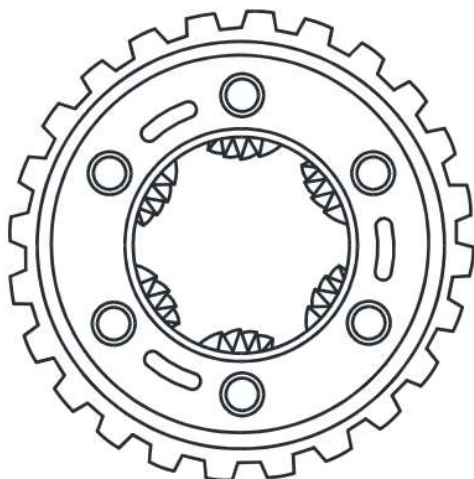
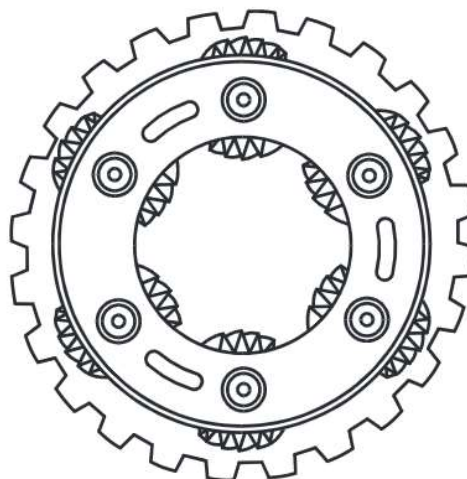
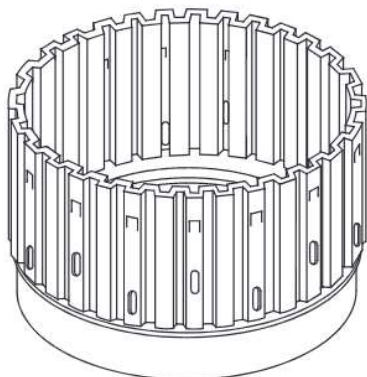
Figure 89

## NEW DESIGN 6 PINION FORWARD PLANETARY CARRIER PART NUMBER F81Z-7A398-CA

## NEW DESIGN 6 PINION REVERSE PLANETARY CARRIER PART NUMBER F81Z-7D006-AA

**REQUIRES 1997-UP DESIGN LEVEL  
REVERSE CLUTCH HUB ASSEMBLY**

**REQUIRES 3 TANG THRUST WASHERS  
ON BOTH SIDES OF REAR CARRIER  
PART NUMBER F0TZ-7A166-D**

**CHANGE:** Beginning at the start of production for all 1998 model E4OD transmissions, *some models* will be equipped with a new design 6 pinion forward planetary carrier, and a new design 6 pinion reverse planetary carrier, as shown in Figure 89.

- (1) FORWARD PLANETARY CARRIER - Now has 6 pinions instead of the previous 4 pinions for increased torque carrying capacity and increased durability (See Figure 89).
- (2) REVERSE PLANETARY CARRIER - Now has 6 pinions instead of the previous 4 pinions for increased torque carrying capacity and increased durability (See Figure 89).

The new design forward planetary carrier *will back service all models* of the E4OD, but it *does require* the latest design forward ring gear hub and bearing assembly, as there are no holes for the previous design thrust washer (See Figure 89).

The new design reverse planetary carrier *will back service all models* of the E4OD, but it *does require* the latest design reverse clutch hub and three tang thrust washer for both sides, as shown in Figure 89.

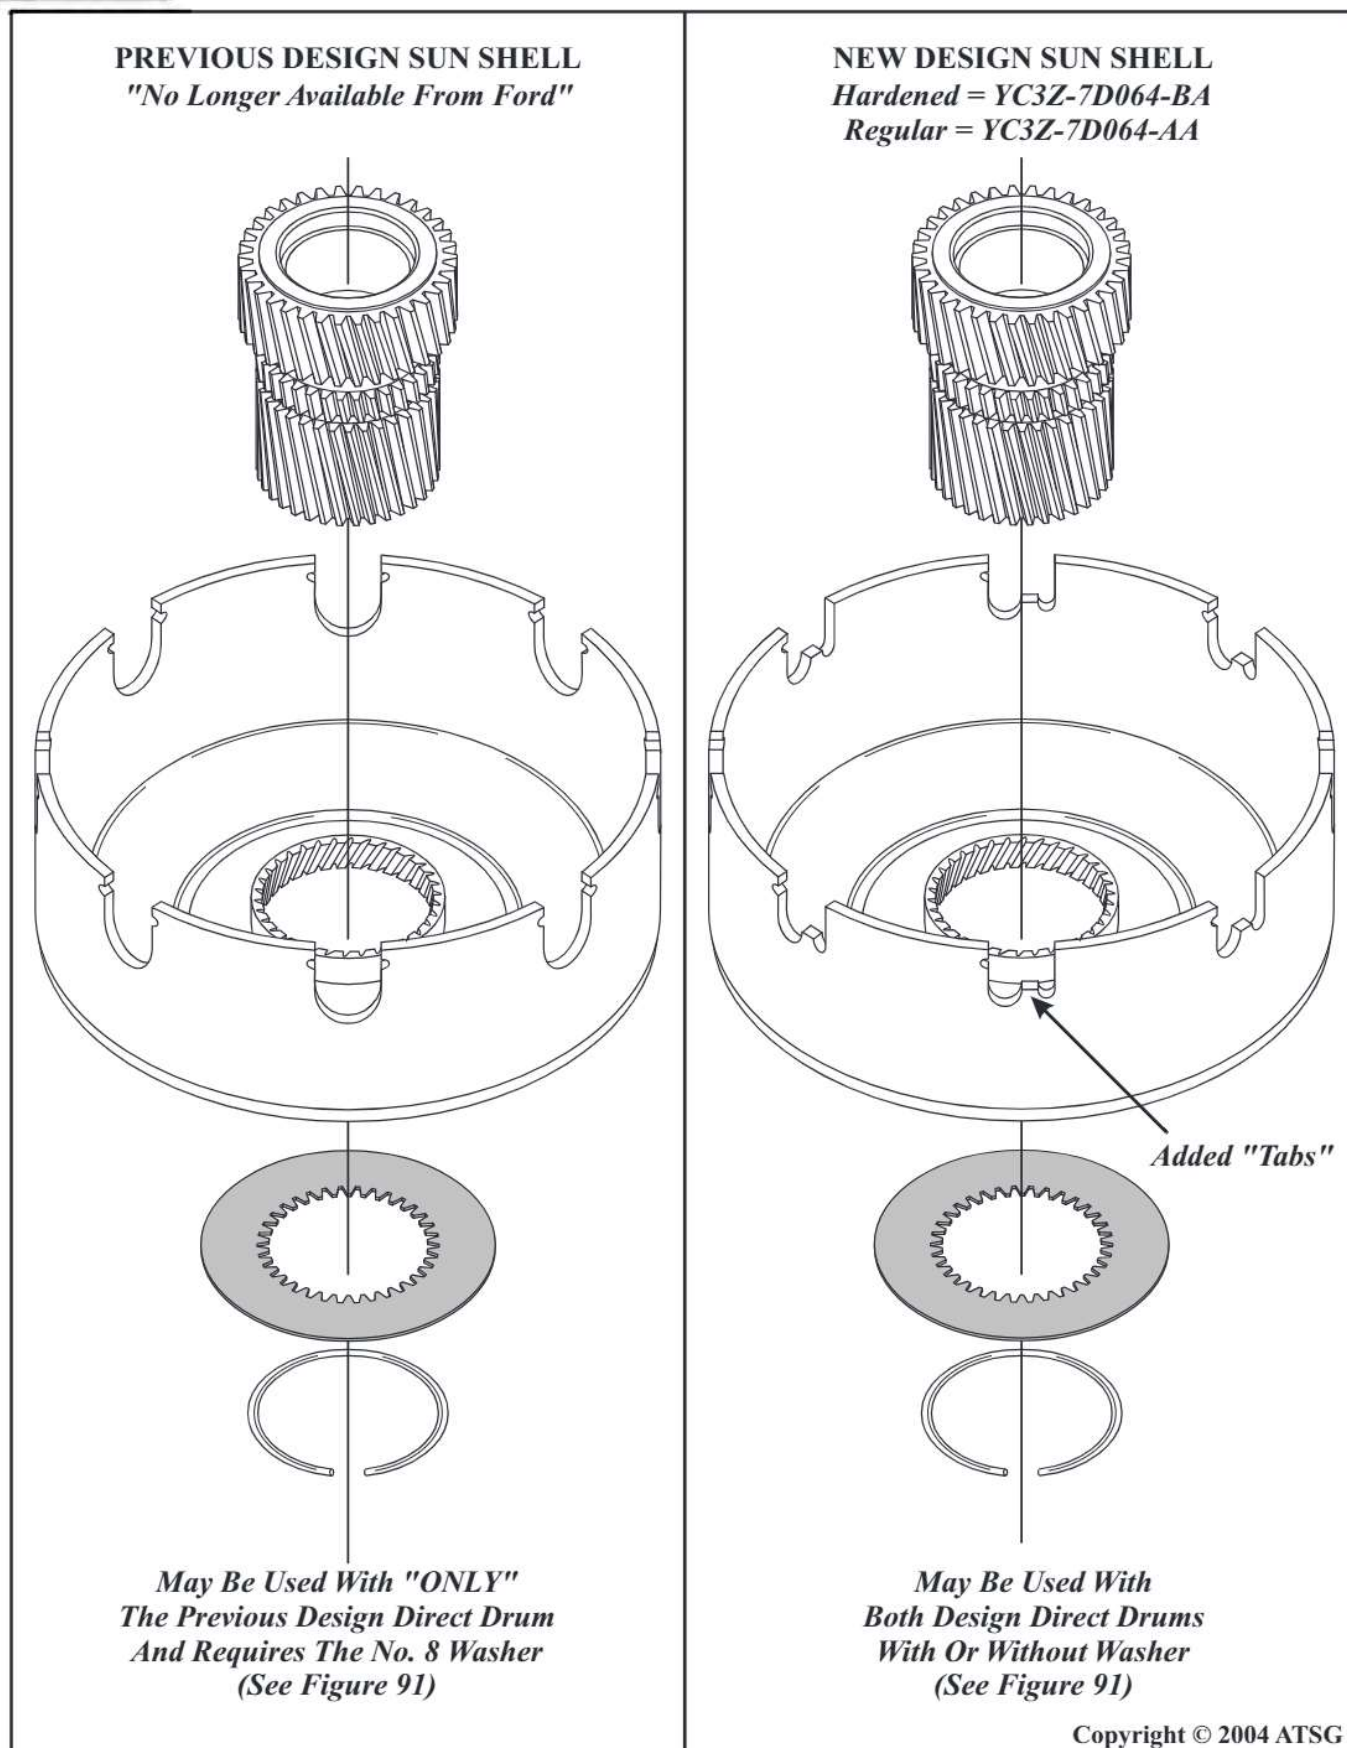
Figure 90

**CHANGE:** There is now a new design Sun Shell with "Tabs" added to the center of the sun shell slots, as shown in Figure 90, implemented by Ford Motor Co. as a running change, during the 2000 model year. This change eliminated the need for the number 8 thrust washer between the forward and direct drums.

- (1) INPUT SUN SHELL - New design have "Tabs" added to the center of the sun shell slots, as shown in Figure 90, which now support the direct drum for the required clearance between the direct and forward clutch housings, and allows elimination of the number 8 thrust washer, as shown in Figure 92.
- (2) DIRECT CLUTCH HOUSING - Manufactured "Without" slots in the center hub, as they were no longer needed to accept the number 8 thrust washer tabs. Both design direct drums are illustrated in Figure 91, and cut-away in Figure 92.
- (3) NUMBER 8 THRUST WASHER - Eliminated (See Figure 91 and 92).

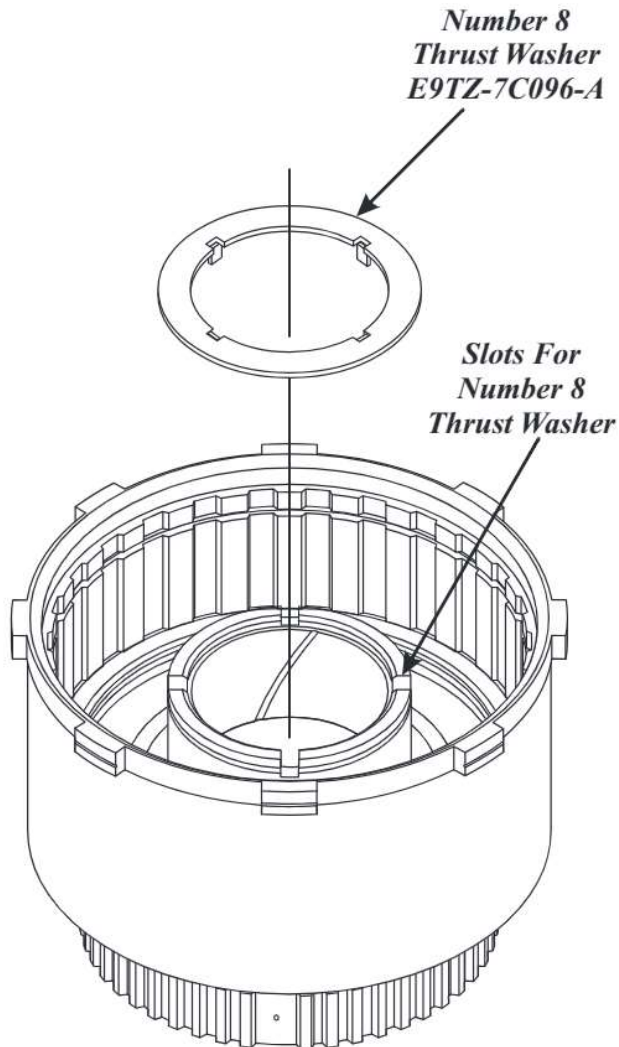
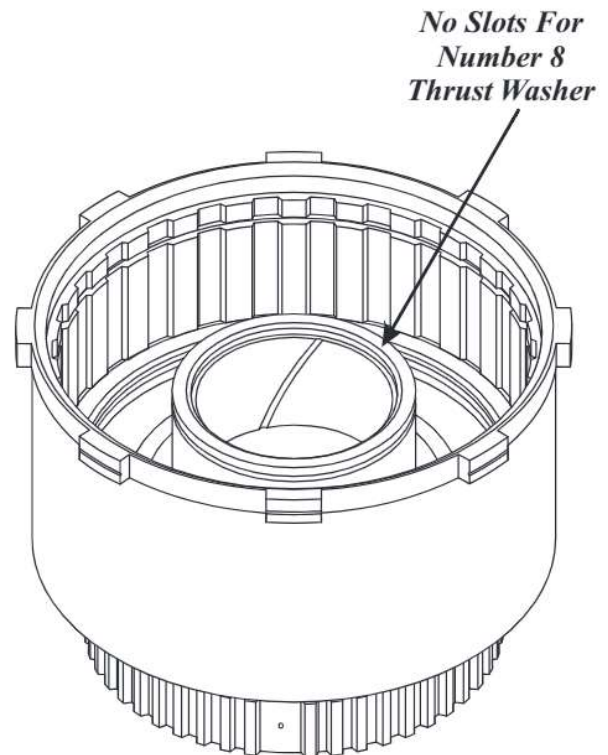
**PREVIOUS DESIGN DIRECT CLUTCH  
DRUM "WITH" SLOTS FOR THE  
NUMBER 8 THRUST WASHER  
PART NO. F81Z-7D044-BA**

*May Be Used With  
Both Design Sun Shells  
(See Figure 90)*

**NEW DESIGN DIRECT CLUTCH  
DRUM "WITHOUT" SLOTS FOR THE  
NUMBER 8 THRUST WASHER  
PART NO. YC3Z-7D044-BA**

*May Be Used With "ONLY"  
The New Design Sun Shell  
(See Figure 90)*

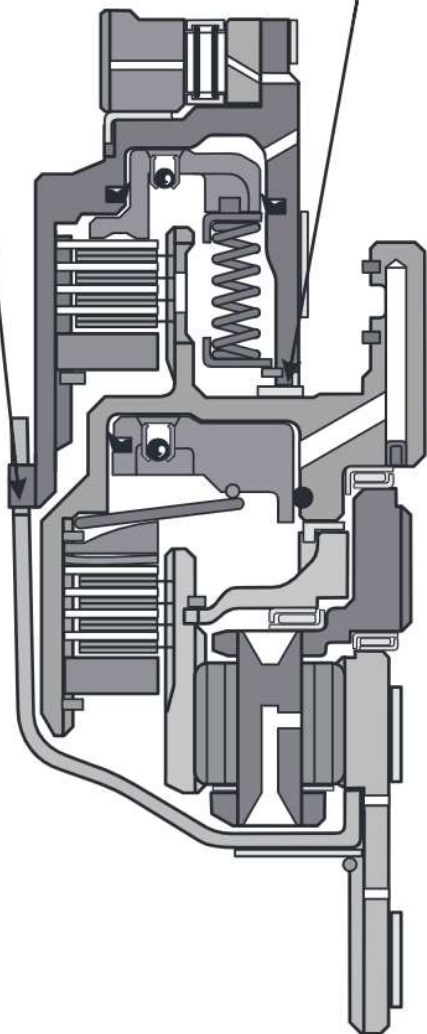
**PREVIOUS DESIGN DIRECT CLUTCH  
DRUM "WITH" SLOTS FOR THE  
NUMBER 8 THRUST WASHER  
AND PREVIOUS SUNSHELL**

*When Direct Clutch Housing  
Is Not Supported Here,*

*The Number 8 Thrust  
Washer Is Required*

**NEW DESIGN DIRECT CLUTCH  
DRUM "WITHOUT" SLOTS FOR THE  
NUMBER 8 THRUST WASHER  
AND NEW SUNSHELL**

*When Direct Clutch Housing  
Is Supported By The "Added"  
Raised Tabs Here,*

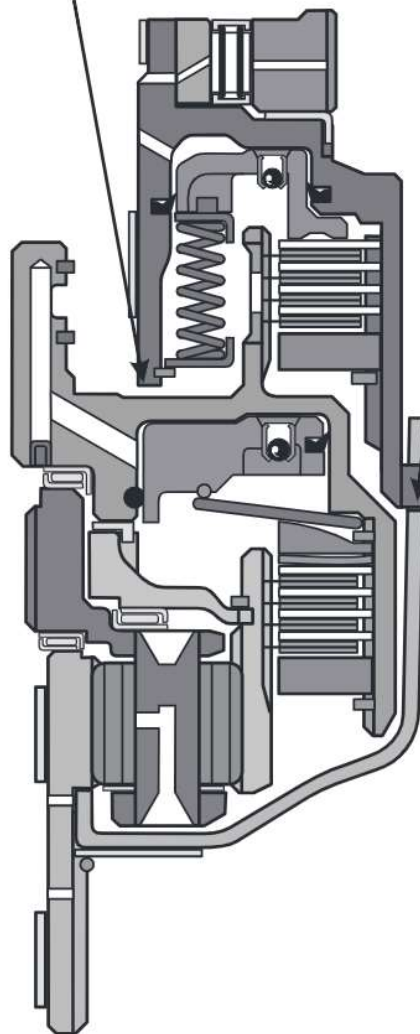
*The Number 8 Thrust  
Washer Is Not Required*

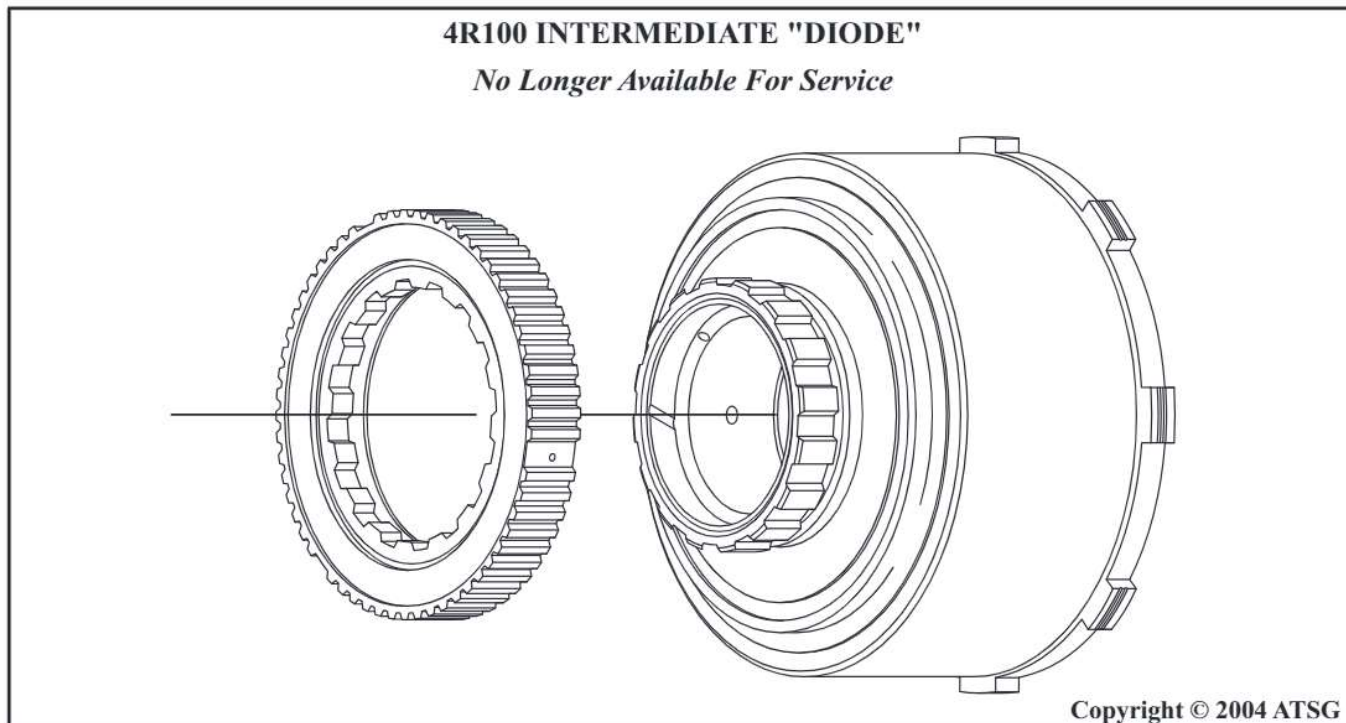
Figure 93

**COMPLAINT:** Some Ford Motor Company vehicles equipped with the 4R100 transmission may exhibit premature failure of the newly introduced Intermediate "Diode" Freewheel device that was installed in model year 2001 and illustrated in Figure 93.

**CAUSE:** The cause may be, more than expected load factors.

**CORRECTION:** The Intermediate "Diode" is ***no longer serviced*** by Ford Motor Company. The part number now supercedes to all of the previous design level parts, which include the direct clutch housing, intermediate sprag assembly, outer race to direct drum thrust washer, and the intermediate friction plates. All of the previous design level parts are illustrated in Figure 94, with the OEM part numbers. The intermediate frictions must be replaced because the tooth count on the outer race between the diode and the sprag are different.

**Special Note:** *ATSG recommends replacing the Intermediate "Diode" during service, even if it has not yet failed, to protect yourself from possible future failures.*

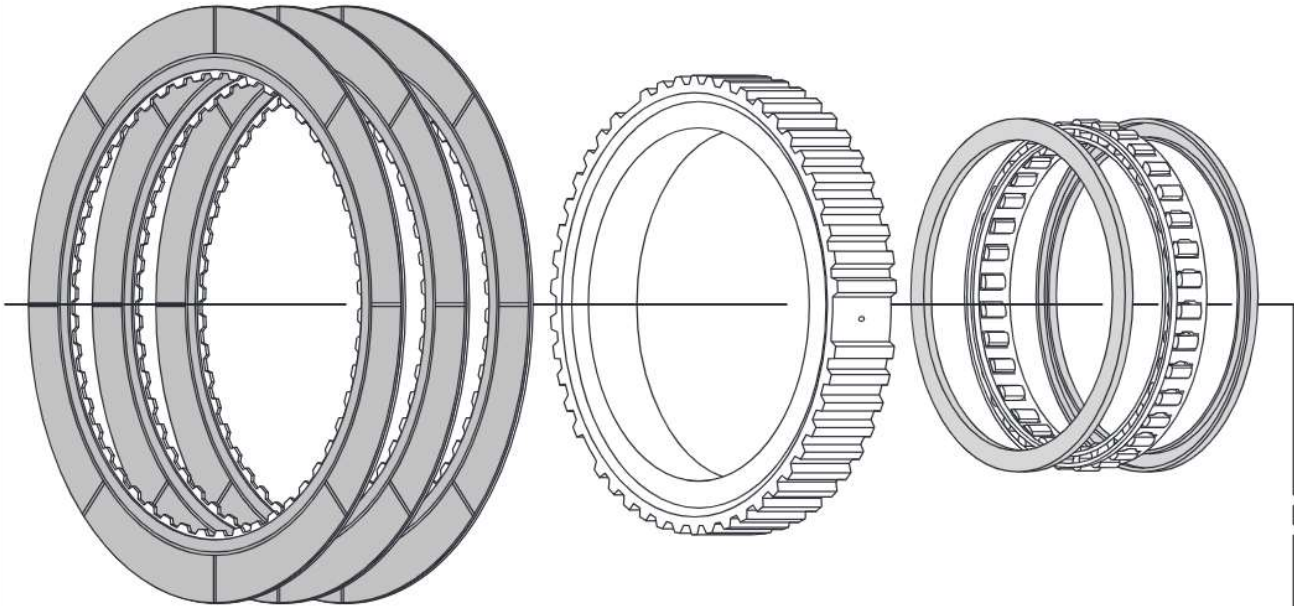
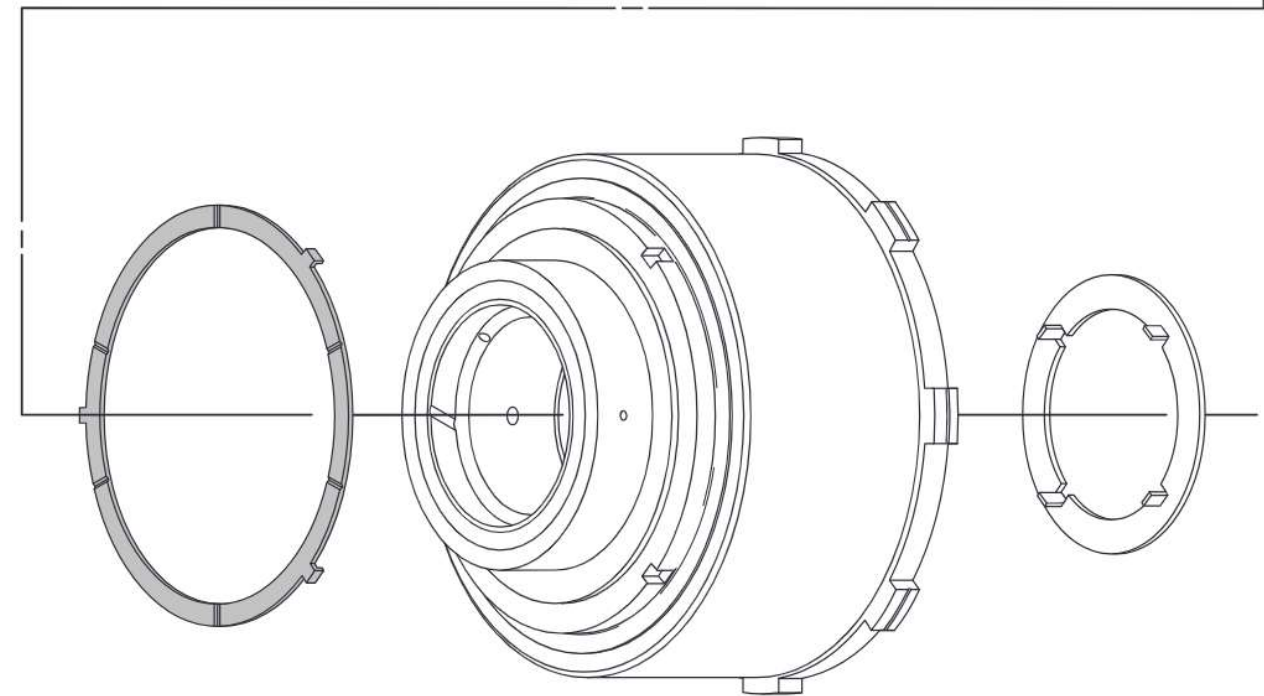
## PARTS NEEDED TO REPLACE INTERMEDIATE DIODE

*Intermediate Sprag Assembly*  
**Part Number E9TZ-7A089-B**

*Outer Race To Drum Thrust Washer*  
**Part Number E9TZ-7G401-A**

*Direct Clutch Housing*  
**Part No. YC3Z-7D044-BA (No Washer)**  
**Part No. F81Z-7D044-BA (With Washer)**

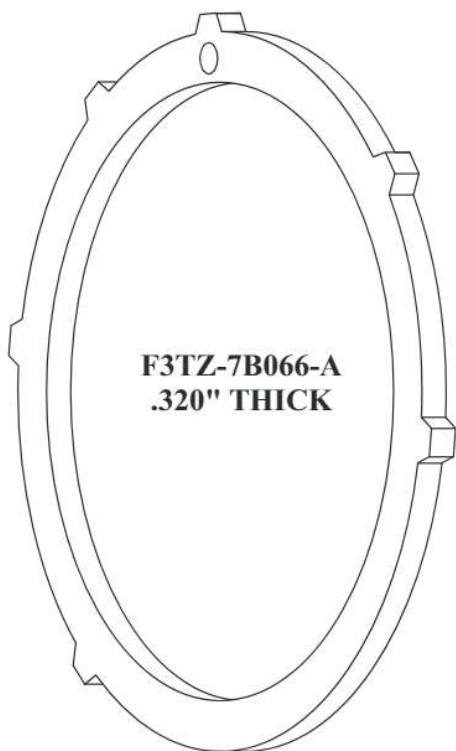
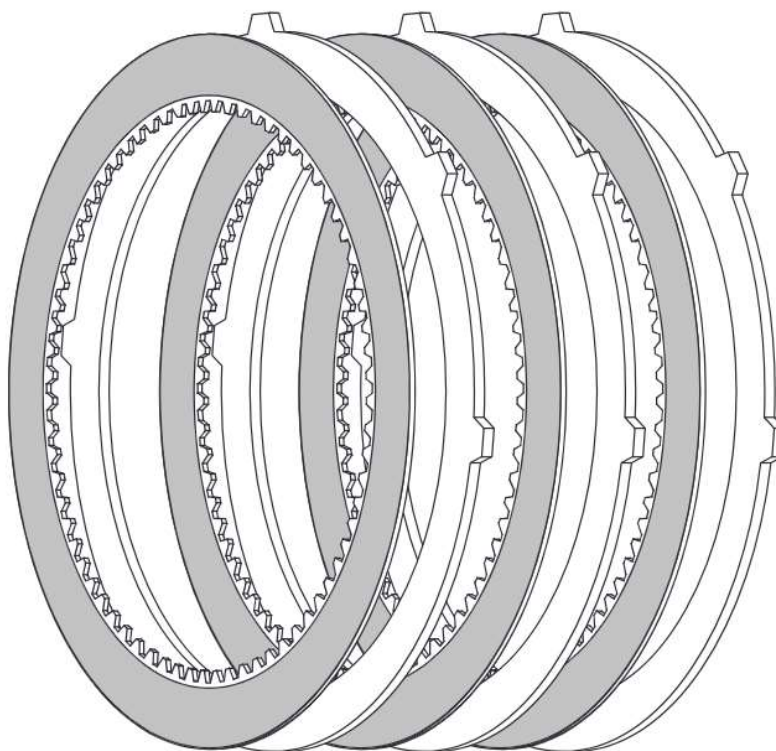
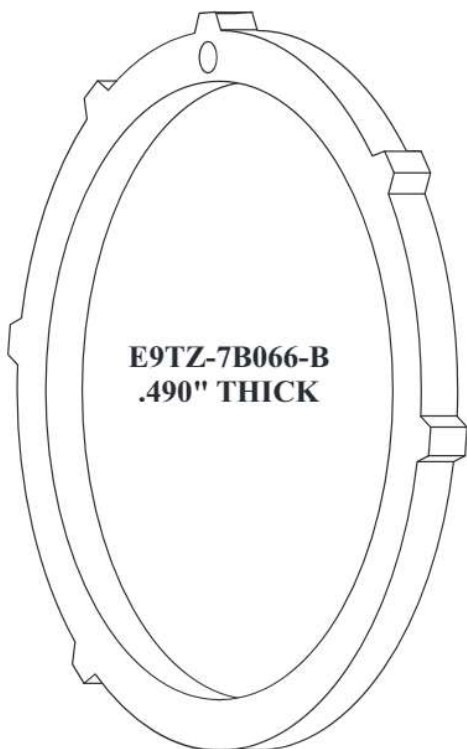
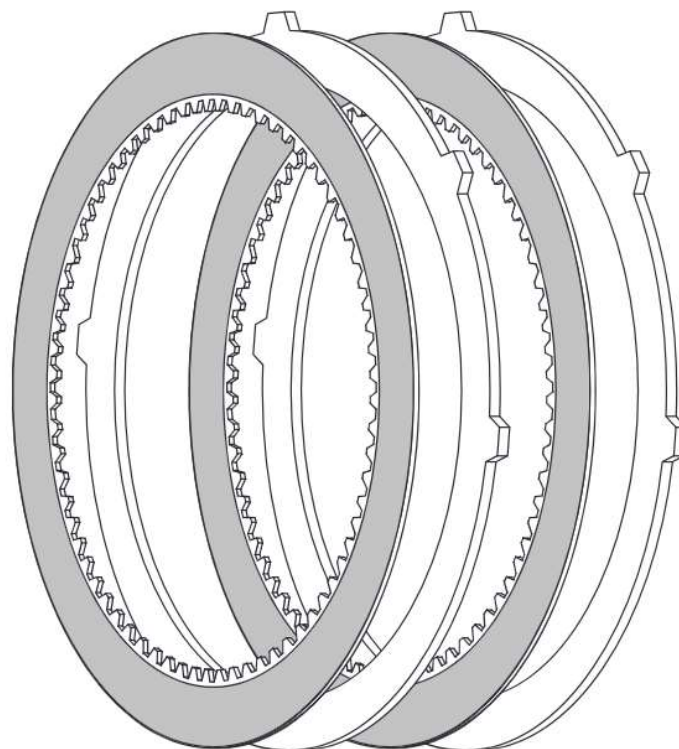
## E4OD 3 PLATE OVERDRIVE CLUTCH STACK-UP

## E4OD 2 PLATE OVERDRIVE CLUTCH STACK-UP

**CORRECTION:** Install 3 clutches in the overdrive clutch pack by purchasing a thinner, .320" thick backing plate, to replace the previous .490" thick backing plate. The 3 clutch backing plate is available under OEM part number F3TZ-7B066-A. Refer to Figure 95 for both the 2 clutch and 3 clutch stack-ups.
