**AUTOMATIC TRANSMISSION SERVICE GROUP**

### **Chrysler A604**

Since the introduction of the Chrysler A604 Transaxle in model year 1990, there have been many engineering changes to improve Pleaseability, Driveability, and Durability concerns. These changes have affected many parts used in the A604 transaxle. This "update handbook" will explain each change, and any parts interchangeability problem created by the change, along with any part numbers deemed necessary.

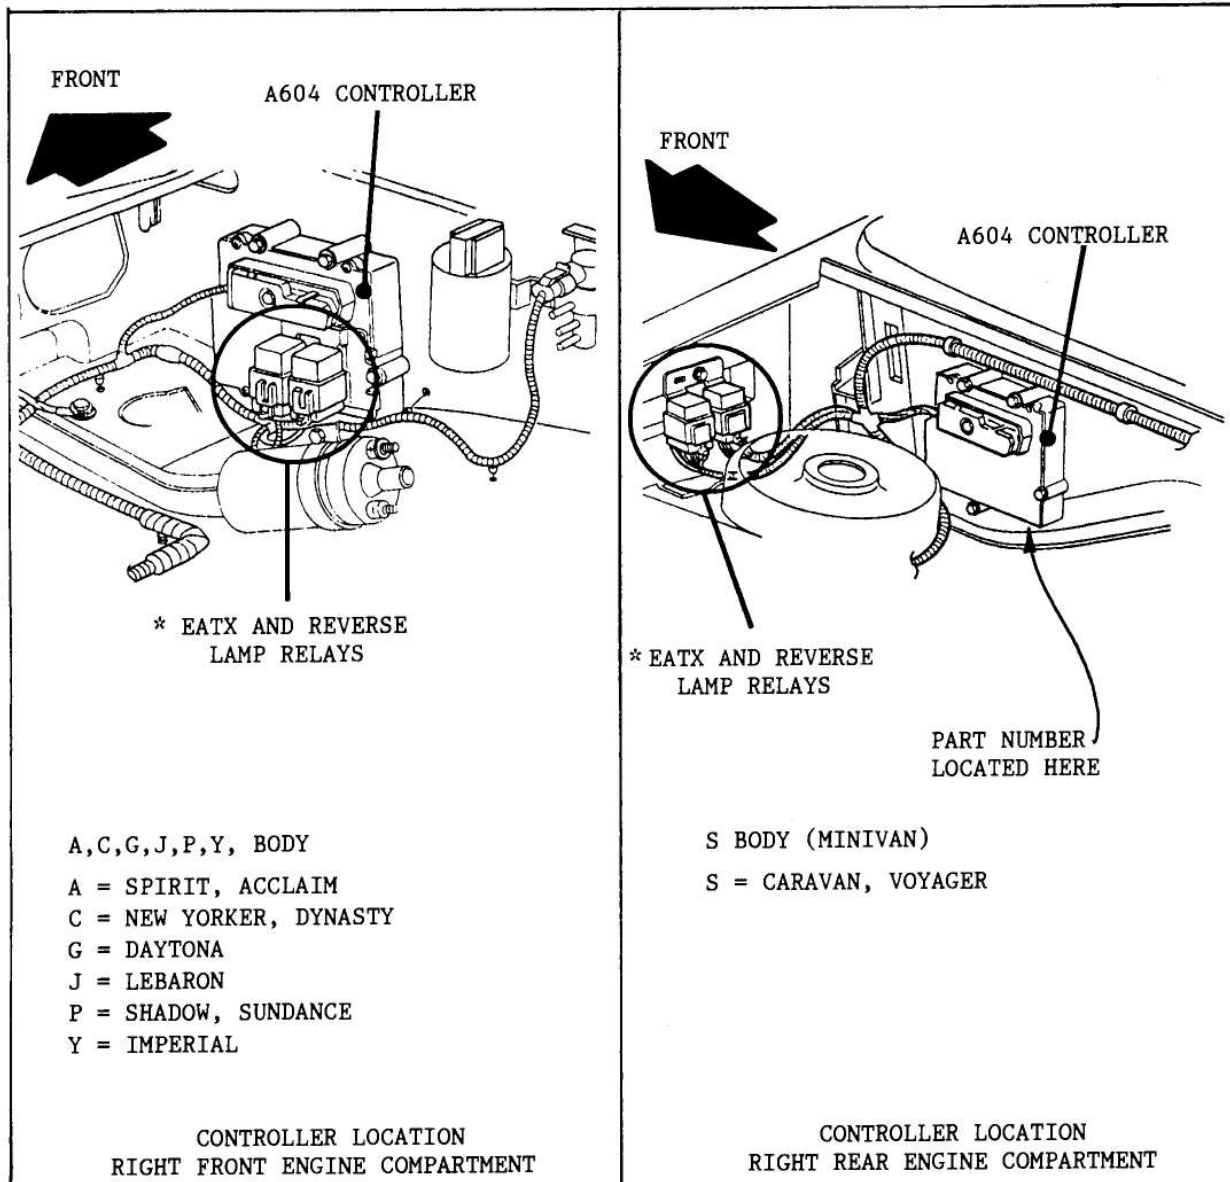
Figure 7

- (1) TRANSAXLE CONTROLLER - The controllers are identified by the last three digits of the OEM part number. The part number is on a sticker that is located on the bottom of the controller (See Figure 7).  
The locations of the controllers will vary depending on the model of the vehicle (See Figure 7)

**NOTE:** When updating earlier controllers, do not Routinely replace the controller P/N 5234678 with P/N 4557120, Unless the customer has encountered highway cycling driveability conditions.  
When updating controller P/N 5234623 or P/N 5234649, by all means use controller P/N 4557120.

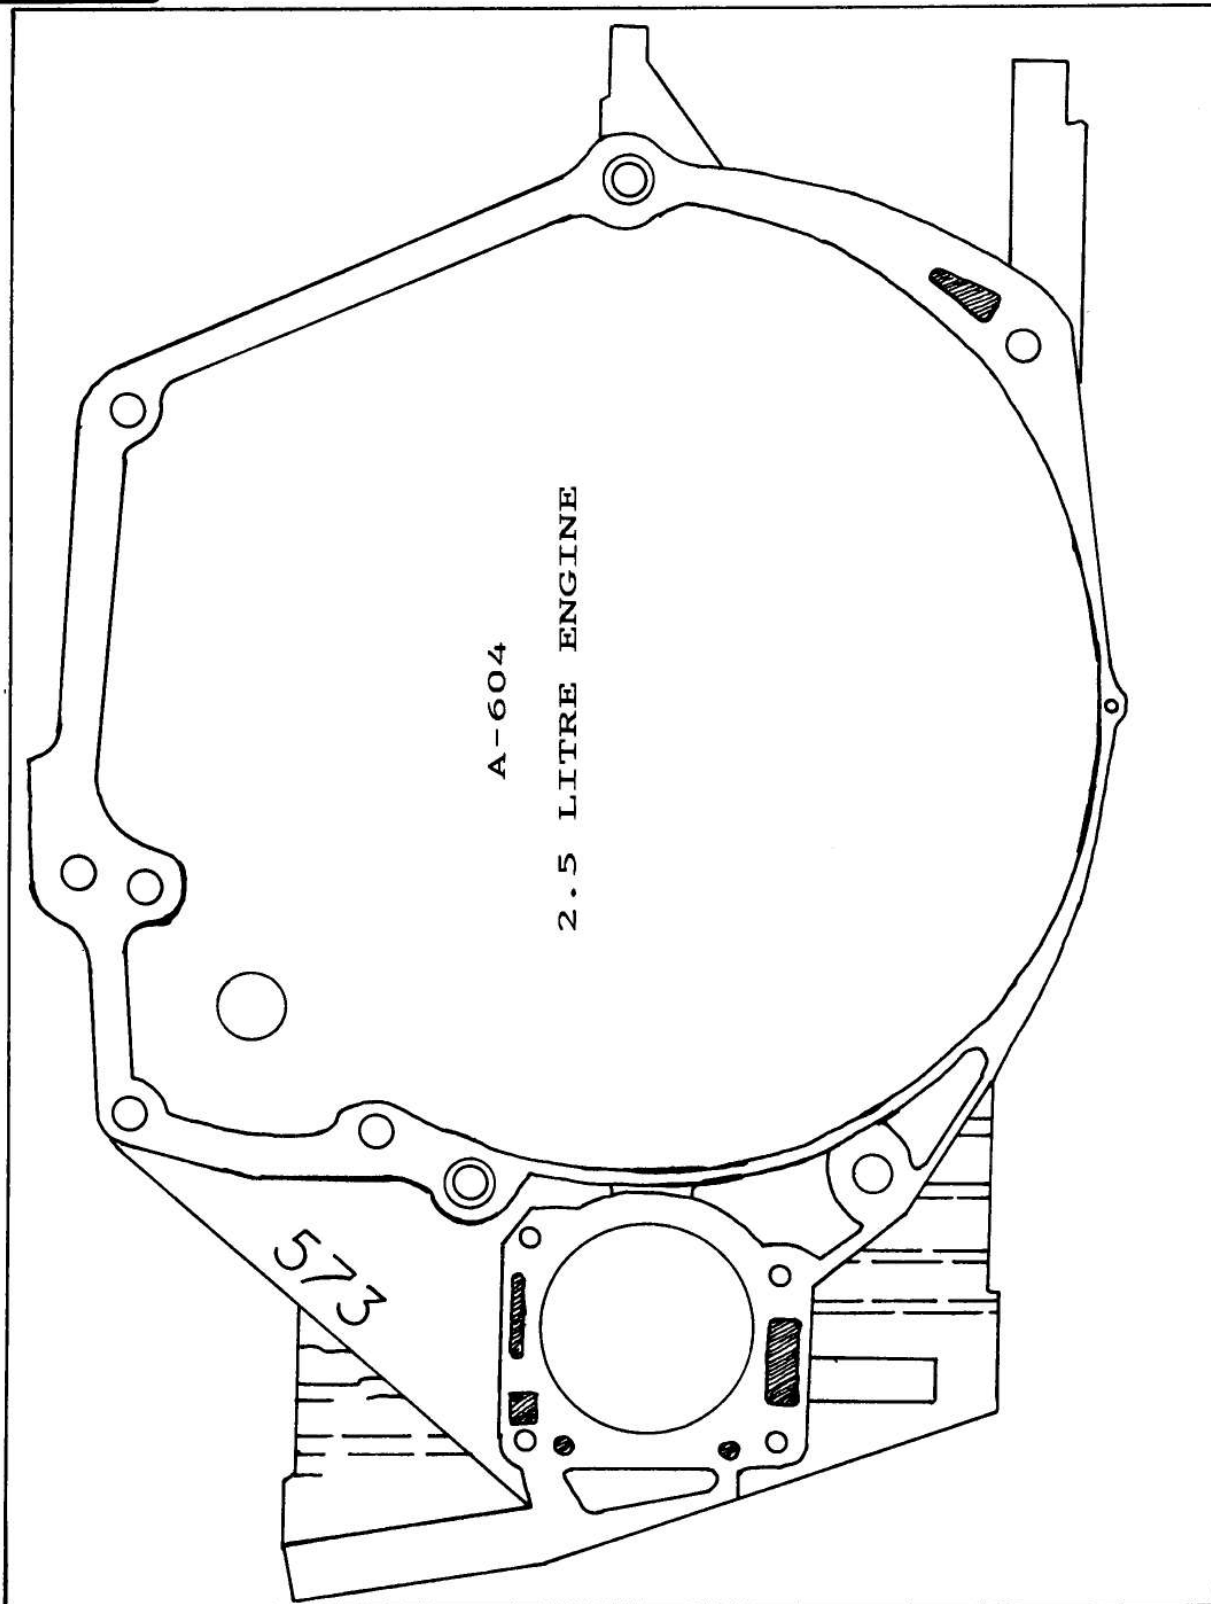
Figure 9  
AUTOMATIC TRANSMISSION SERVICE GROUP

- (1) **TRANSAXLE CASE** - Because of the three different engines that are now used, it requires three different bell housing bolt patterns.  
     For the 2.5 Litre Bell Housing pattern, refer to Figure 9.  
     For the 3.0 Litre Bell Housing pattern, refer to Figure 10.  
     For the 3.3 Litre Bell Housing pattern, refer to Figure 11.
- (2) **TURBINE SHAFT SPLINES** - The 2.5 Litre engine uses a turbine shaft with 22 splines for the torque converter, and the 3.0 and 3.3 Litre engines will use the current 24 spline turbine shaft (See Figure 12).

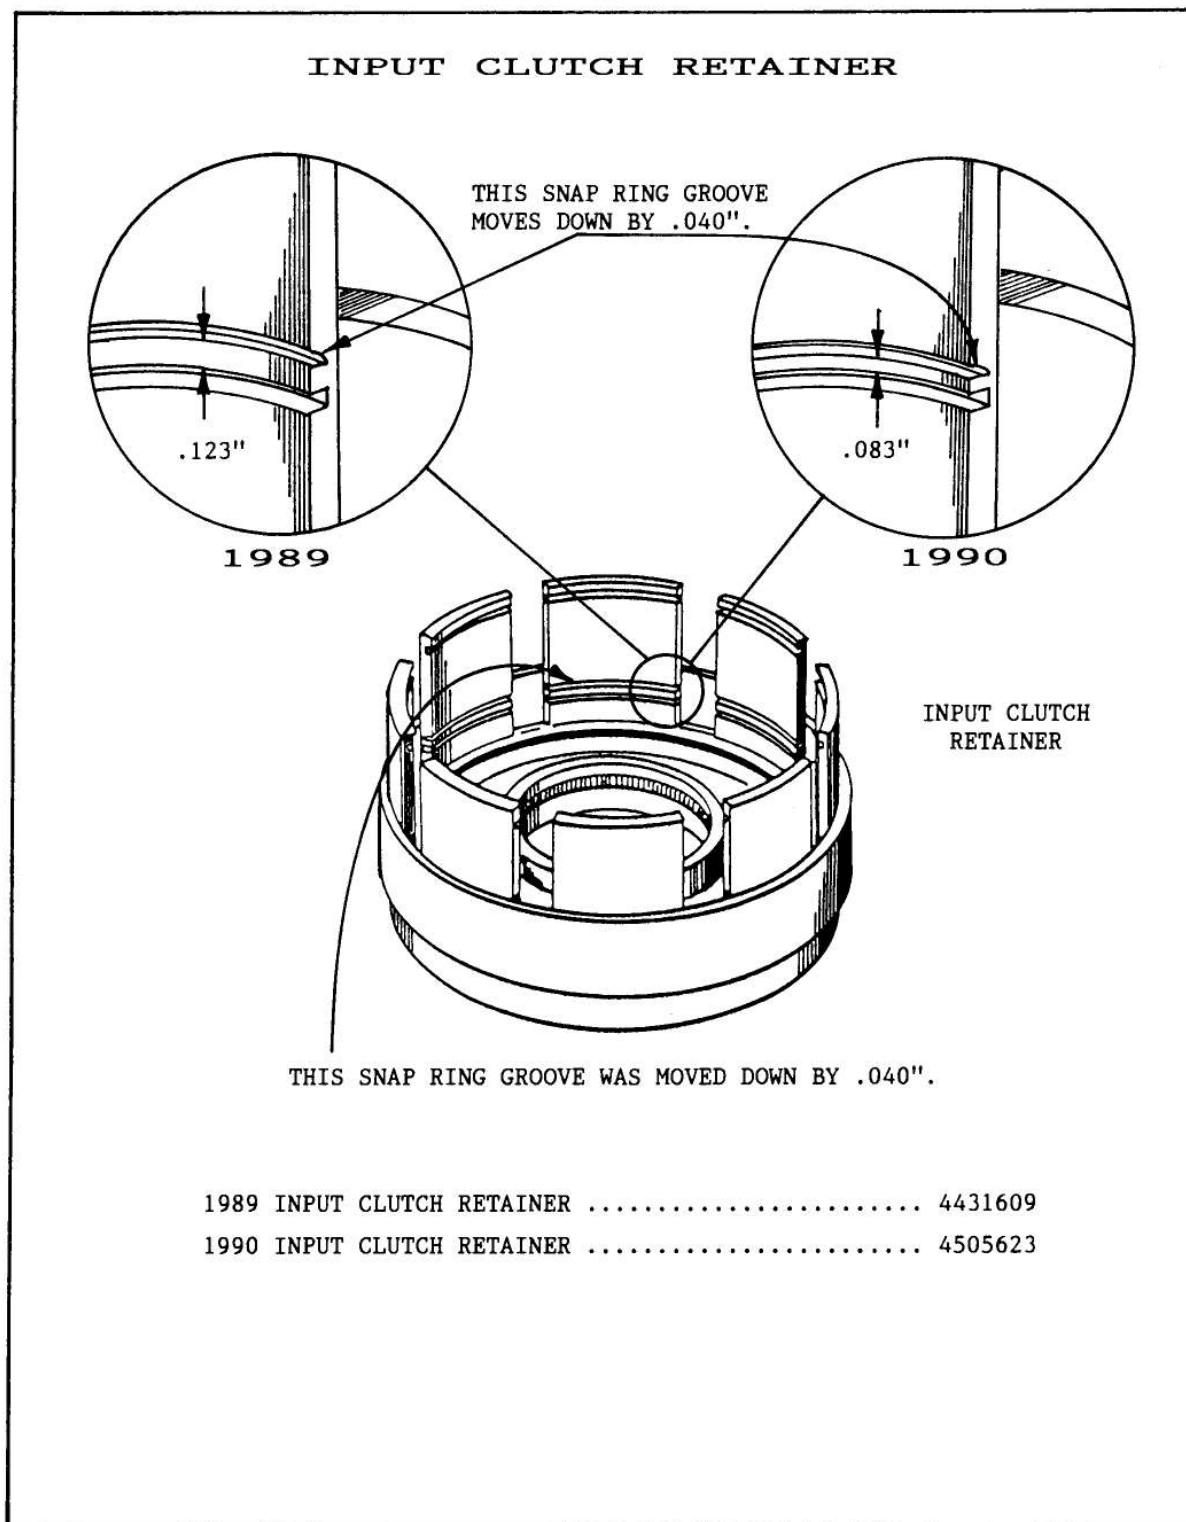
Figure 15

- (4) INPUT CLUTCH RETAINER - The underdrive/overdrive reaction plate tapered snap ring groove was moved "Down" by .040" (Can be Detected Visually) to accomodate the thinner underdrive/overdrive reaction plates (Figure 15). Another change that occurred at the same time is the underdrive clutch outer lip seal groove depth is .040" "Shallower" to accomodate a new underdrive clutch outer lip seal (See Figure 16).

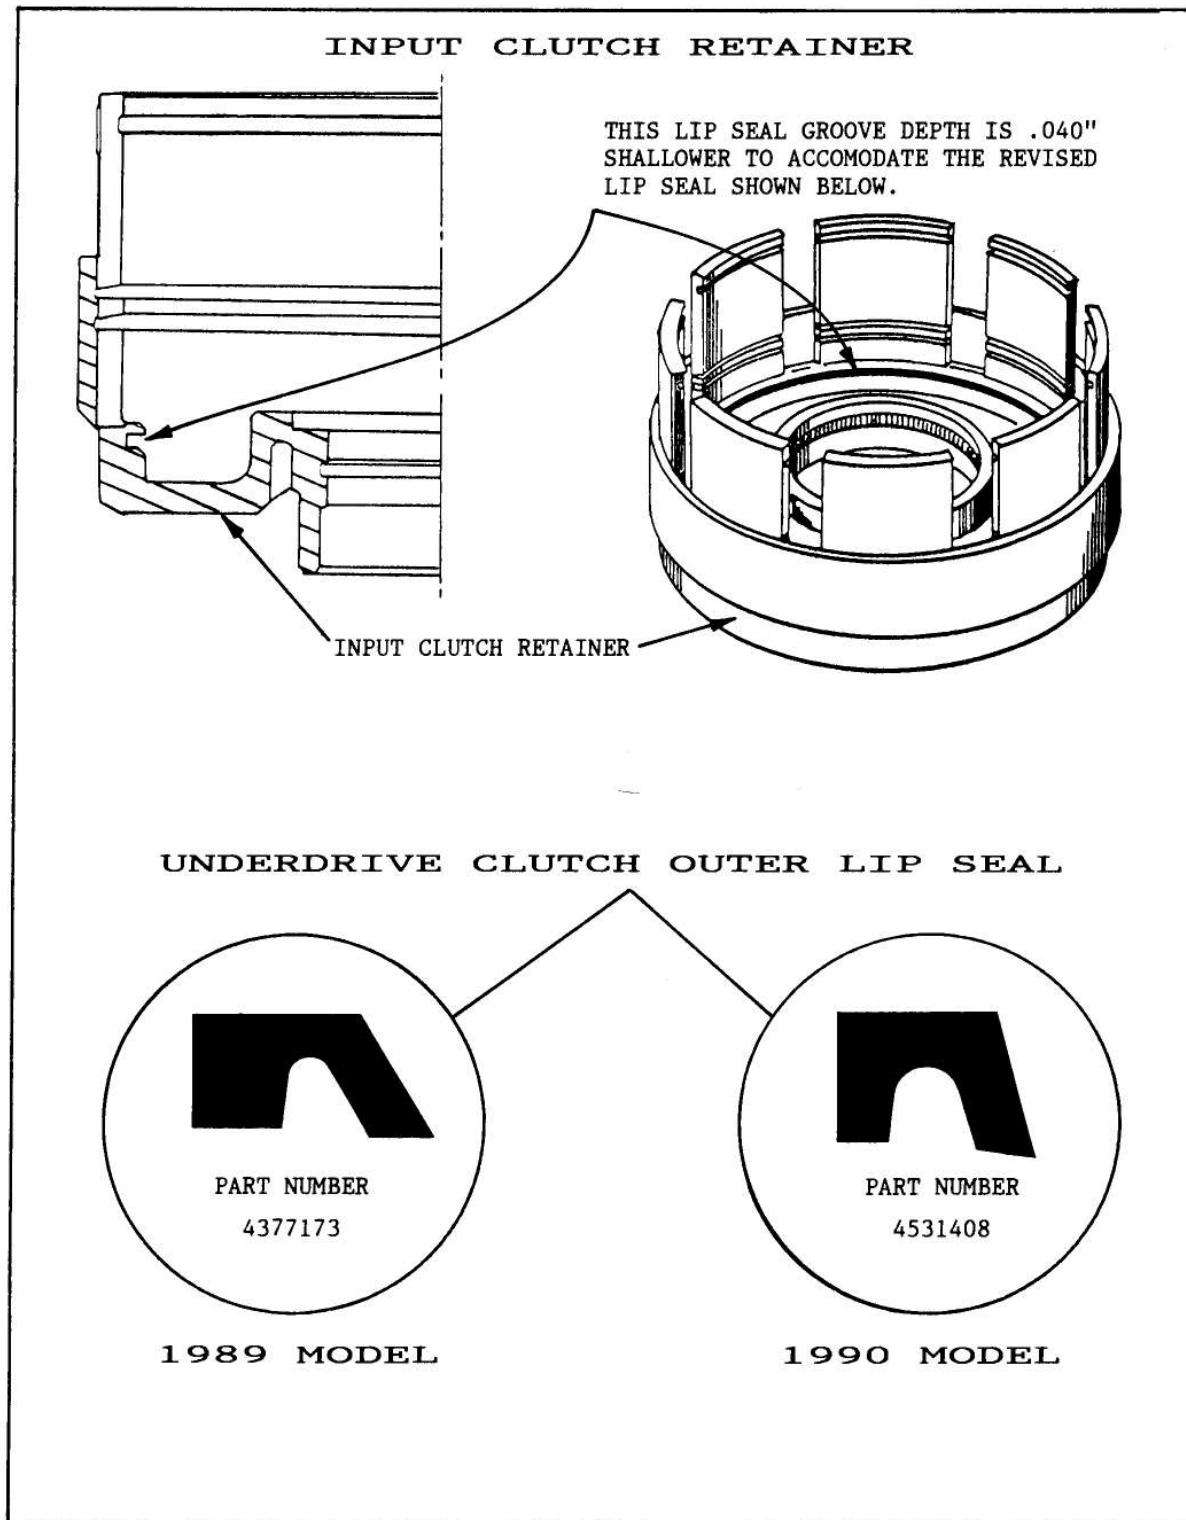
Figure 16

- (6) UNDERDRIVE CLUTCH OUTER LIP SEAL - The lip seal cross section has been reduced by .040" (Smaller in Overall Diameter) to accomodate the change in the depth of the groove in the input clutch retainer (See Figure 16). The OEM part number is printed on the seals for identification. The 1989 (Large) is 4377173, and the 1990 (Small) is 4531408. This will confirm that you have the proper seal for this location (See Figure 16).

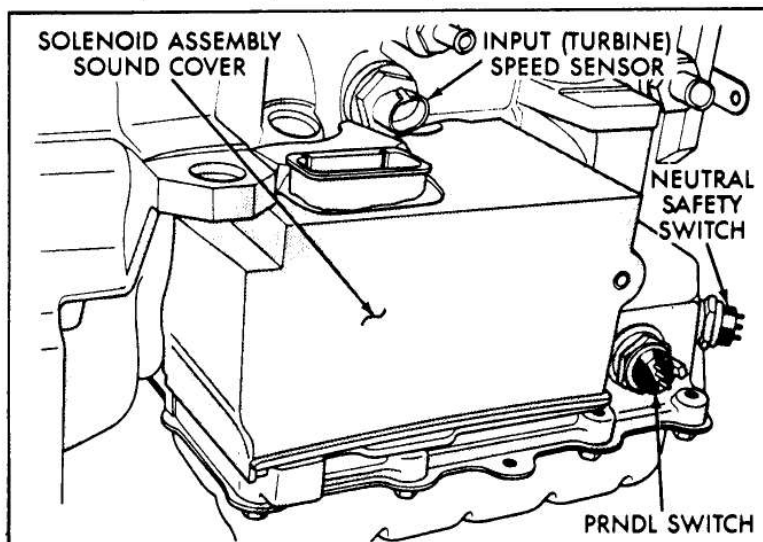
**CHANGE:** PRNODL Switch and Neutral Safety Switch have been changed for the 1990 model year, as well as the vehicle wiring harness connectors. Refer to Figure 17 for location of switches on the transaxle.

**REASON:** Positive locking mechanism, with a weathertight seal, to prevent the connection from becoming loose.

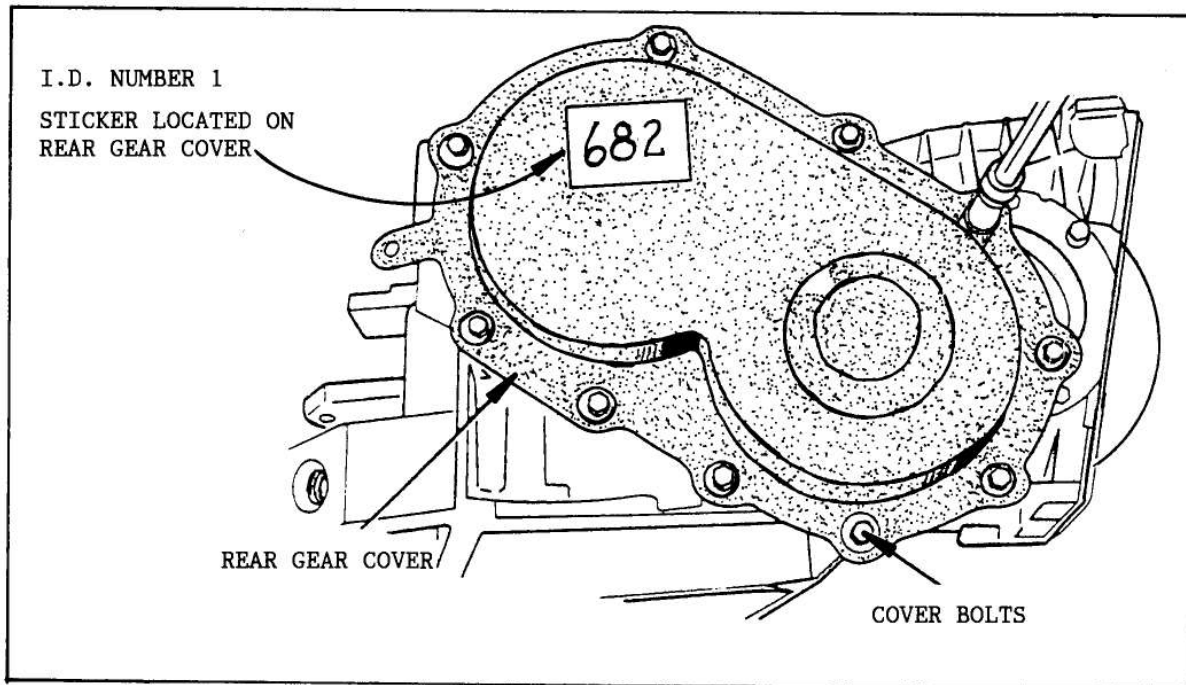
Figure 21

NOT INTERCHANGEABLE. It will be imperative that you identify the trans-axle properly. The transaxle is identified by the "Last 3 Digits" of the OEM part number, and is found on a sticker located on the rear gear cover (See Figure 21). Then refer to the chart in Figure 24 for proper applications.

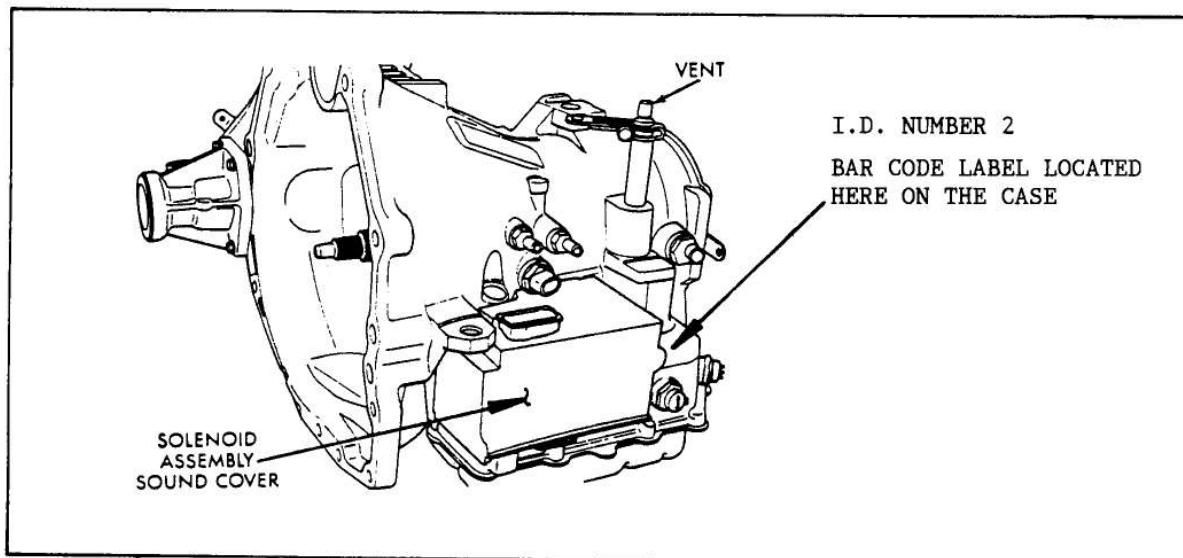
Figure 22

If that sticker is missing, or painted over, there is another bar code decal located on the case directly above the PRNODL and neutral safety switches (See Figure 22).

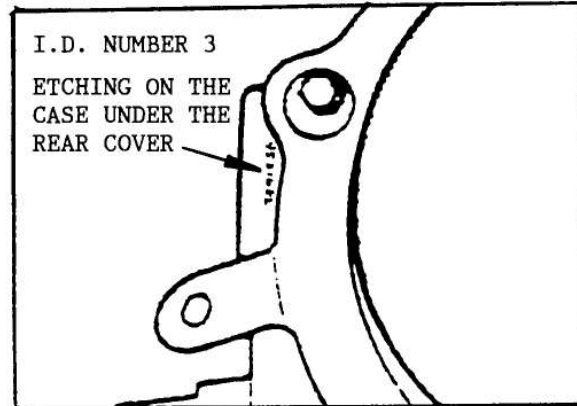
Figure 23

The most permanent form of identification is an etching, in the case, located near the rear gear cover (See Figure 23). It may be necessary to remove the rear cover to see the part number, but if the vehicle has been in service for some time, this may be the only way to identify the unit.

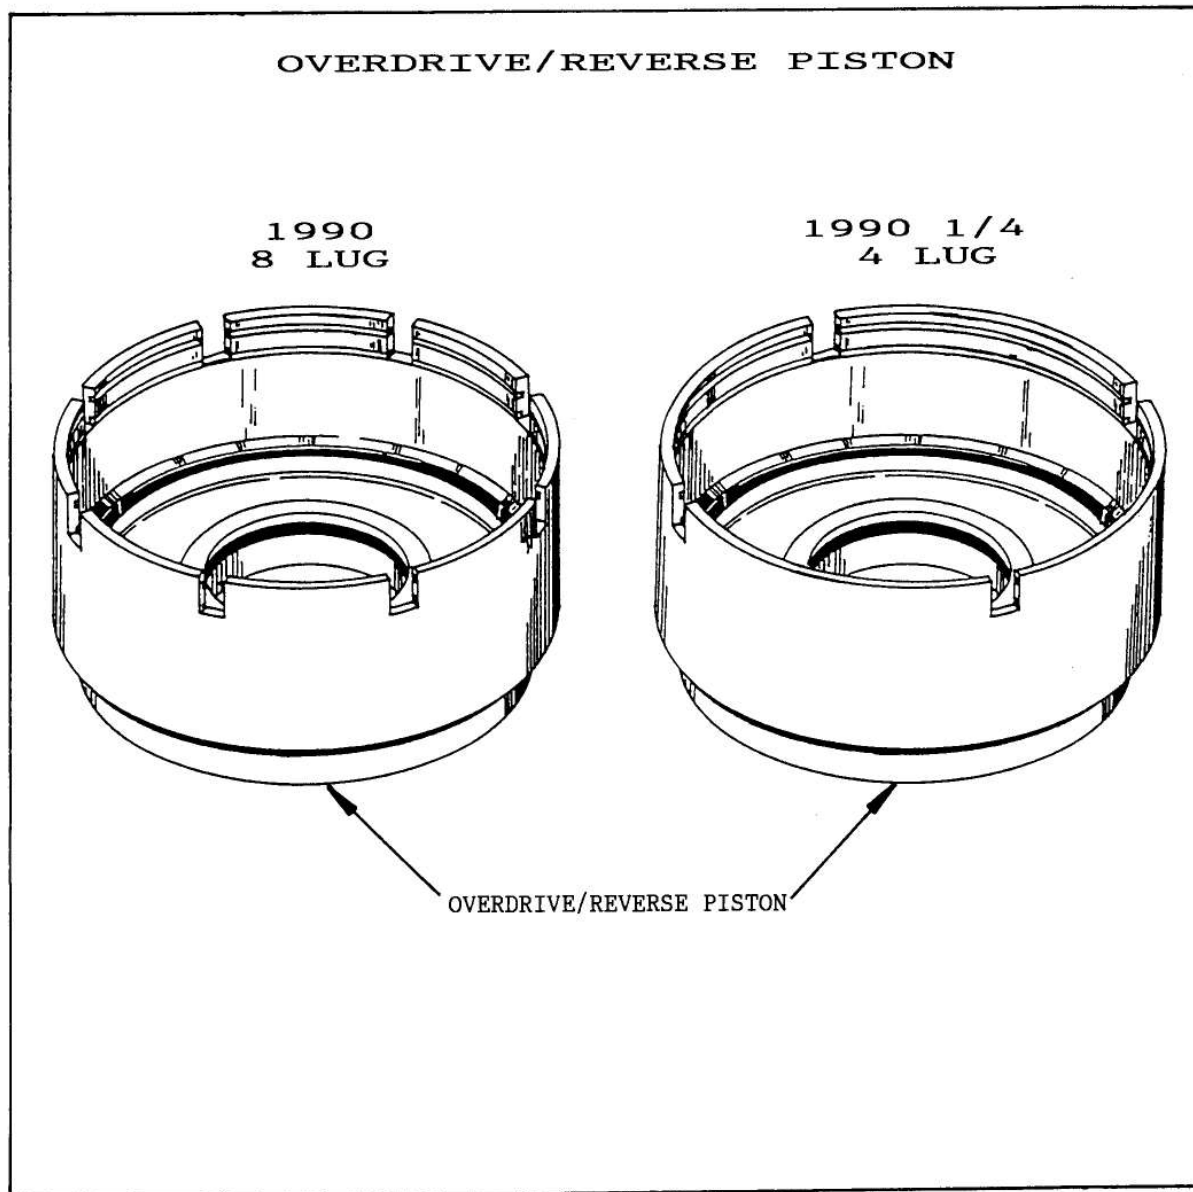
Figure 25

**CHANGE:** A new Overdrive/Reverse Piston has been introduced for 1990 1/4 model transaxles, and features four reaction plate slots instead of eight slots (See Figure 25).

- (1) OVERDRIVE/REVERSE PISTON - The new Overdrive/Reverse Piston has four slots, for the pressure plate lugs, instead of the previous eight slots and can be identified visually (See Figure 25).  
The inside diameter of the new pistons bottom corner also has a larger radius to accomodate a new 1990 1/4 Input Clutch Retainer dimensional change (See Figure 26).
- (2) OVERDRIVE/REVERSE PRESSURE PLATE - The new Overdrive/Reverse Pressure Plate has only four lugs on the outside diameter, instead of the previous eight, and can be identified visually (See Figure 27).
- (3) INPUT CLUTCH RETAINER - The new Input Clutch Retainer has a new radius on the outside diameter, to reduce the chance of damage to the lip seal during assembly (See Figure 28). This retainer has no identification marks, and is tough to identify visually. The OEM part number did not change.

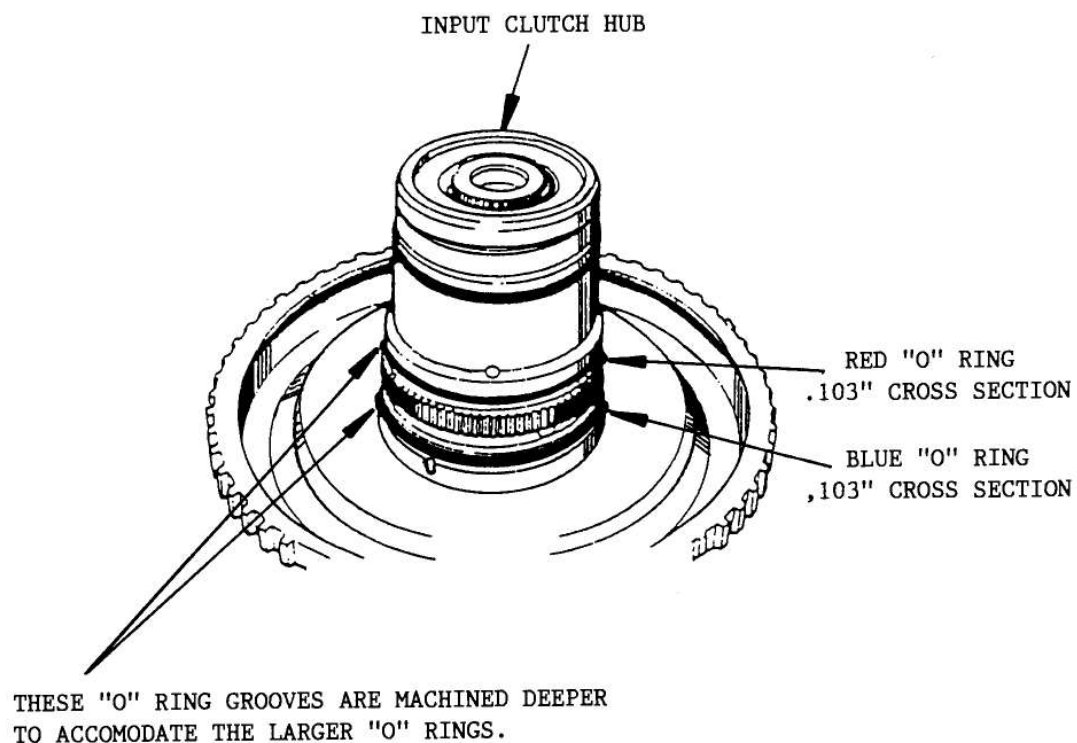
Figure 29

- (1) INPUT CLUTCH HUB - The "O" ring grooves on the Input Clutch Hub are cut deeper to accommodate the larger cross section color coded "O" rings (See Figure 29).

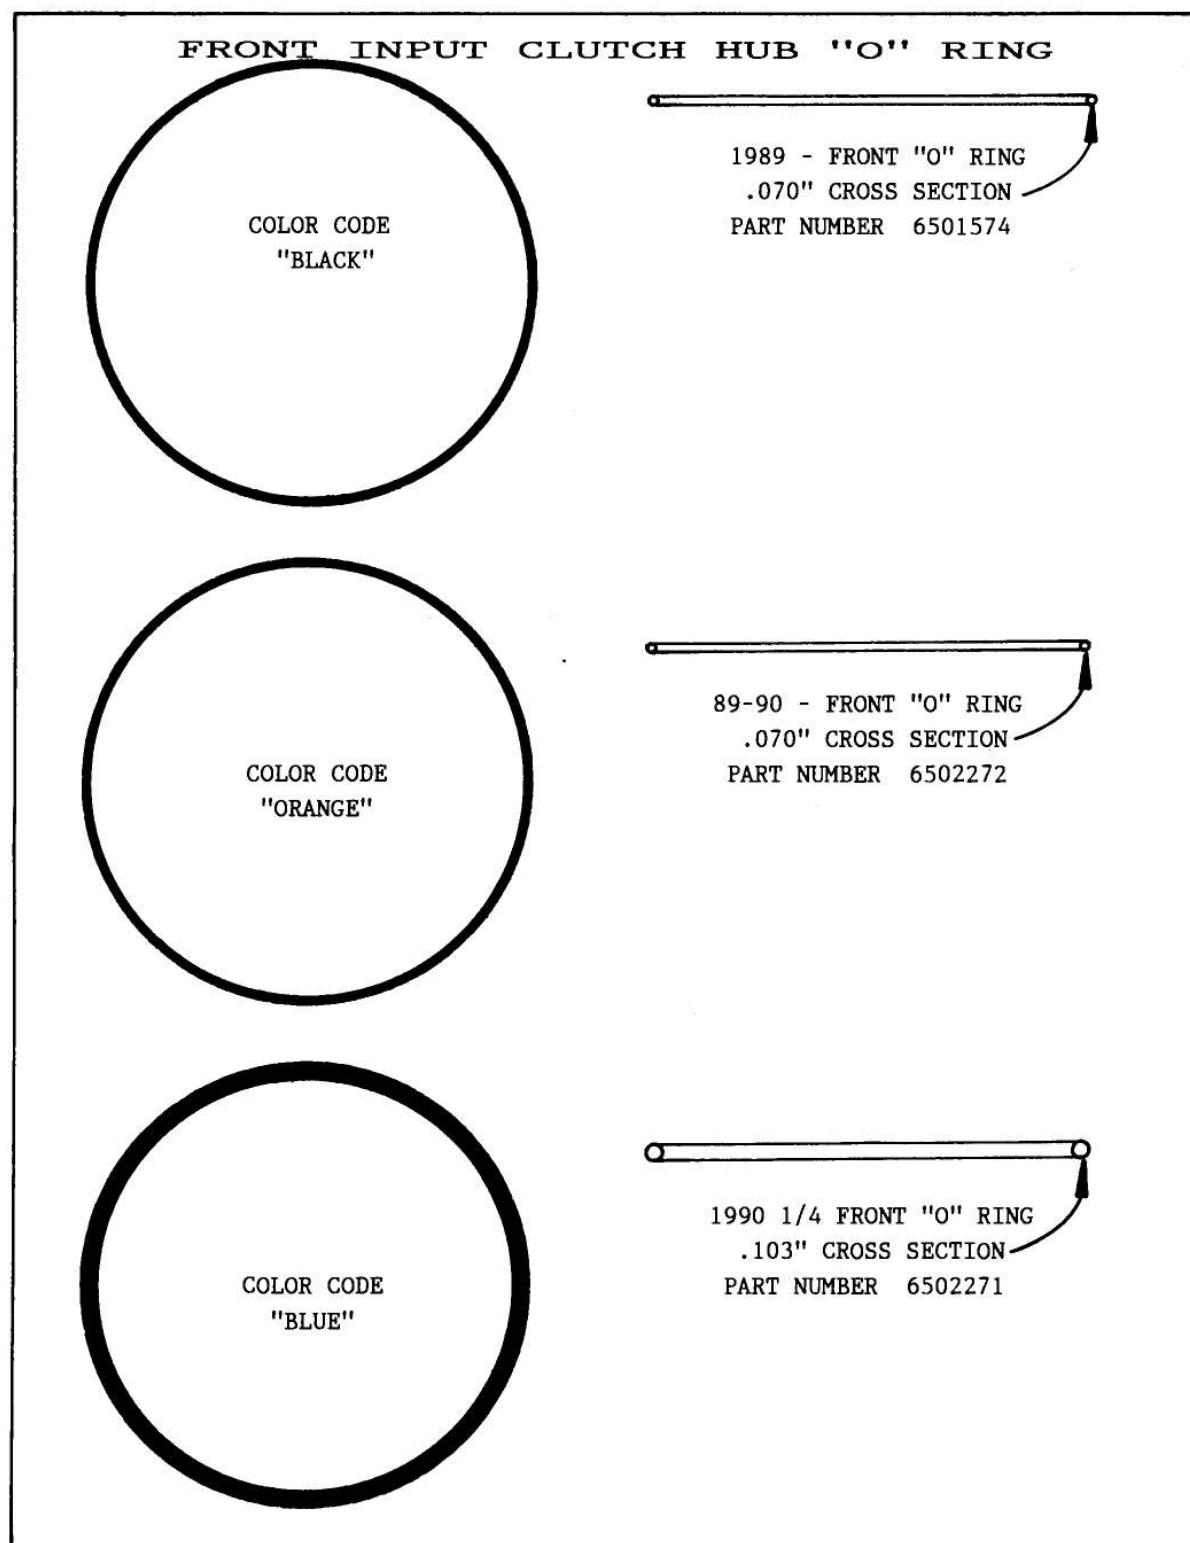
Figure 30

- (2) FRONT INPUT CLUTCH HUB "O" RING - This "O" ring now has a larger, .103" cross section and is color coded BLUE for identification purposes. Remember that this is the 3rd change on this "O" ring. The original "O" ring was BLACK with a .070" cross section, the 2nd design "O" ring was ORANGE with a .070" cross section, and the 3rd design "O" ring is BLUE with a .103" cross section (See Figure 30).

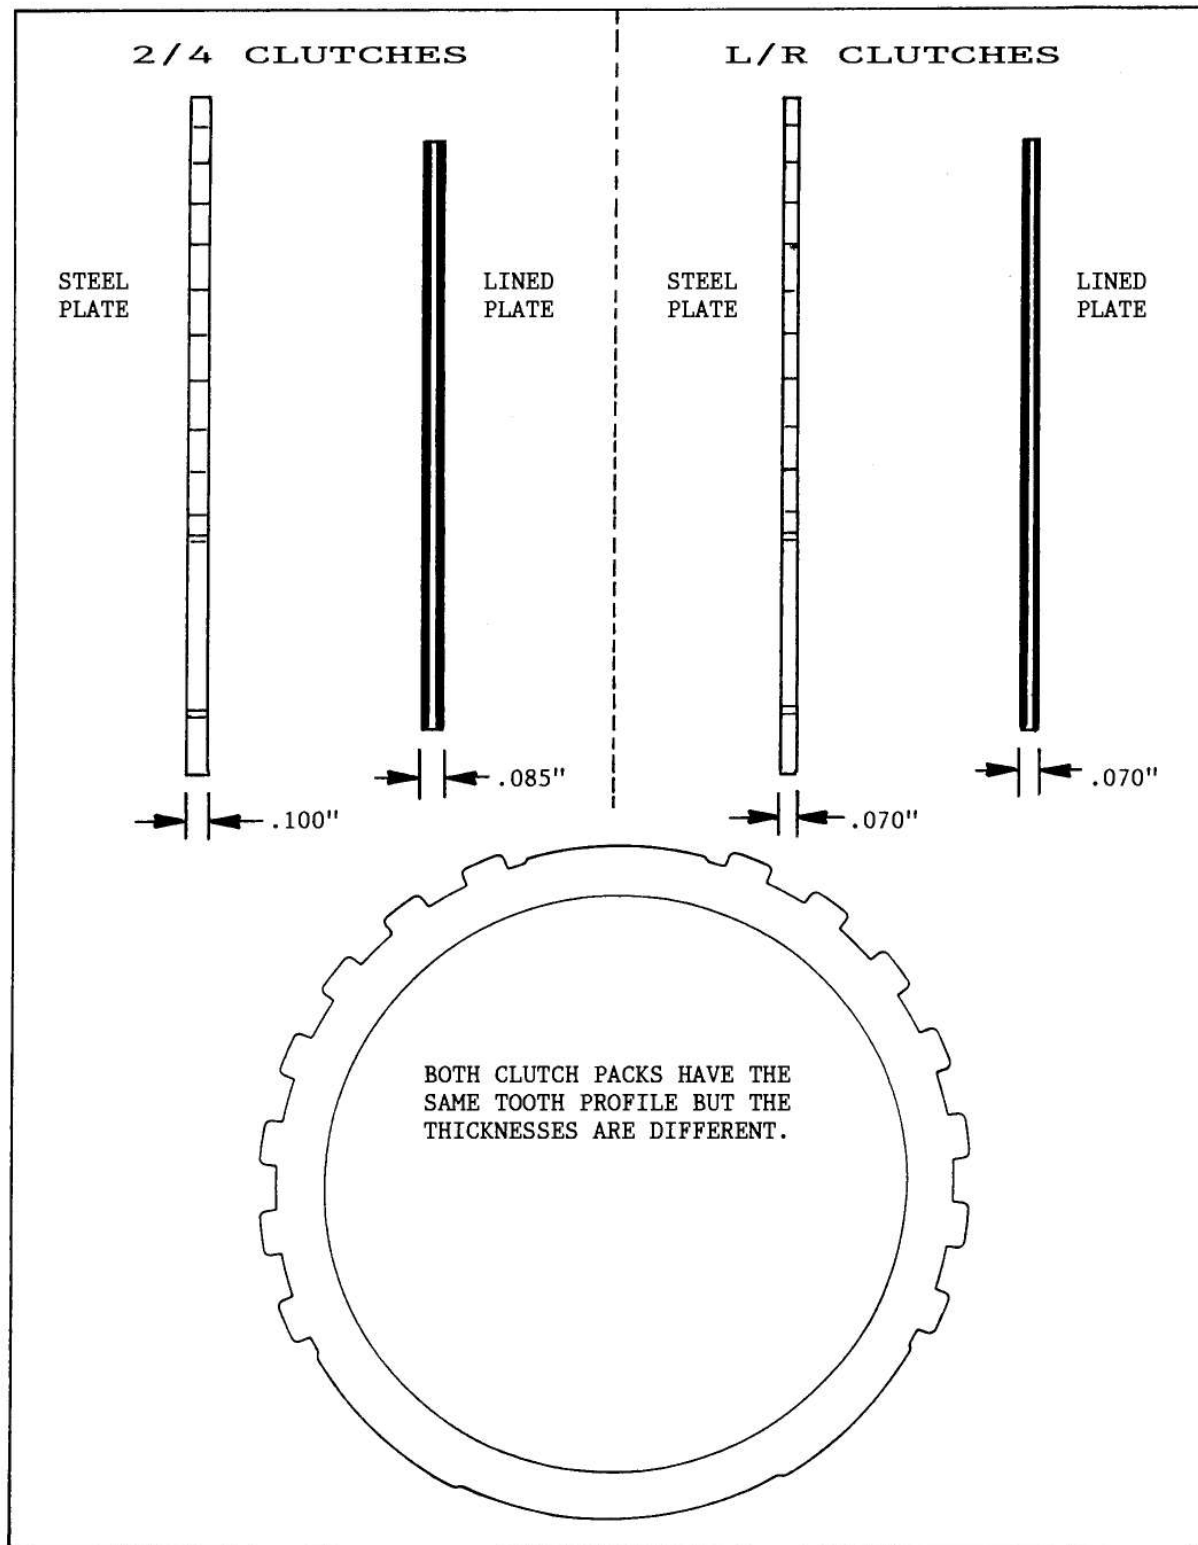
Figure 32  
AUTOMATIC TRANSMISSION SERVICE GROUP

- (1) Both clutch packs, on the steel plates, have the same tooth profile, but the thicknesses are different (See Figure 32).
  - A. 2/4 STEEL PLATE THICKNESS IS .100" (4 Required).
  - B. L/R STEEL PLATE THICKNESS IS .070" (5 Required).
- (2) Both clutch packs, on the lined plates, have the same tooth count and the same lining, but the thicknesses are different (See Figure 32).
  - A. 2/4 LINED PLATE THICKNESS IS .085" (4 Required).
  - B. L/R LINED PLATE THICKNESS IS .070" (5 Required).

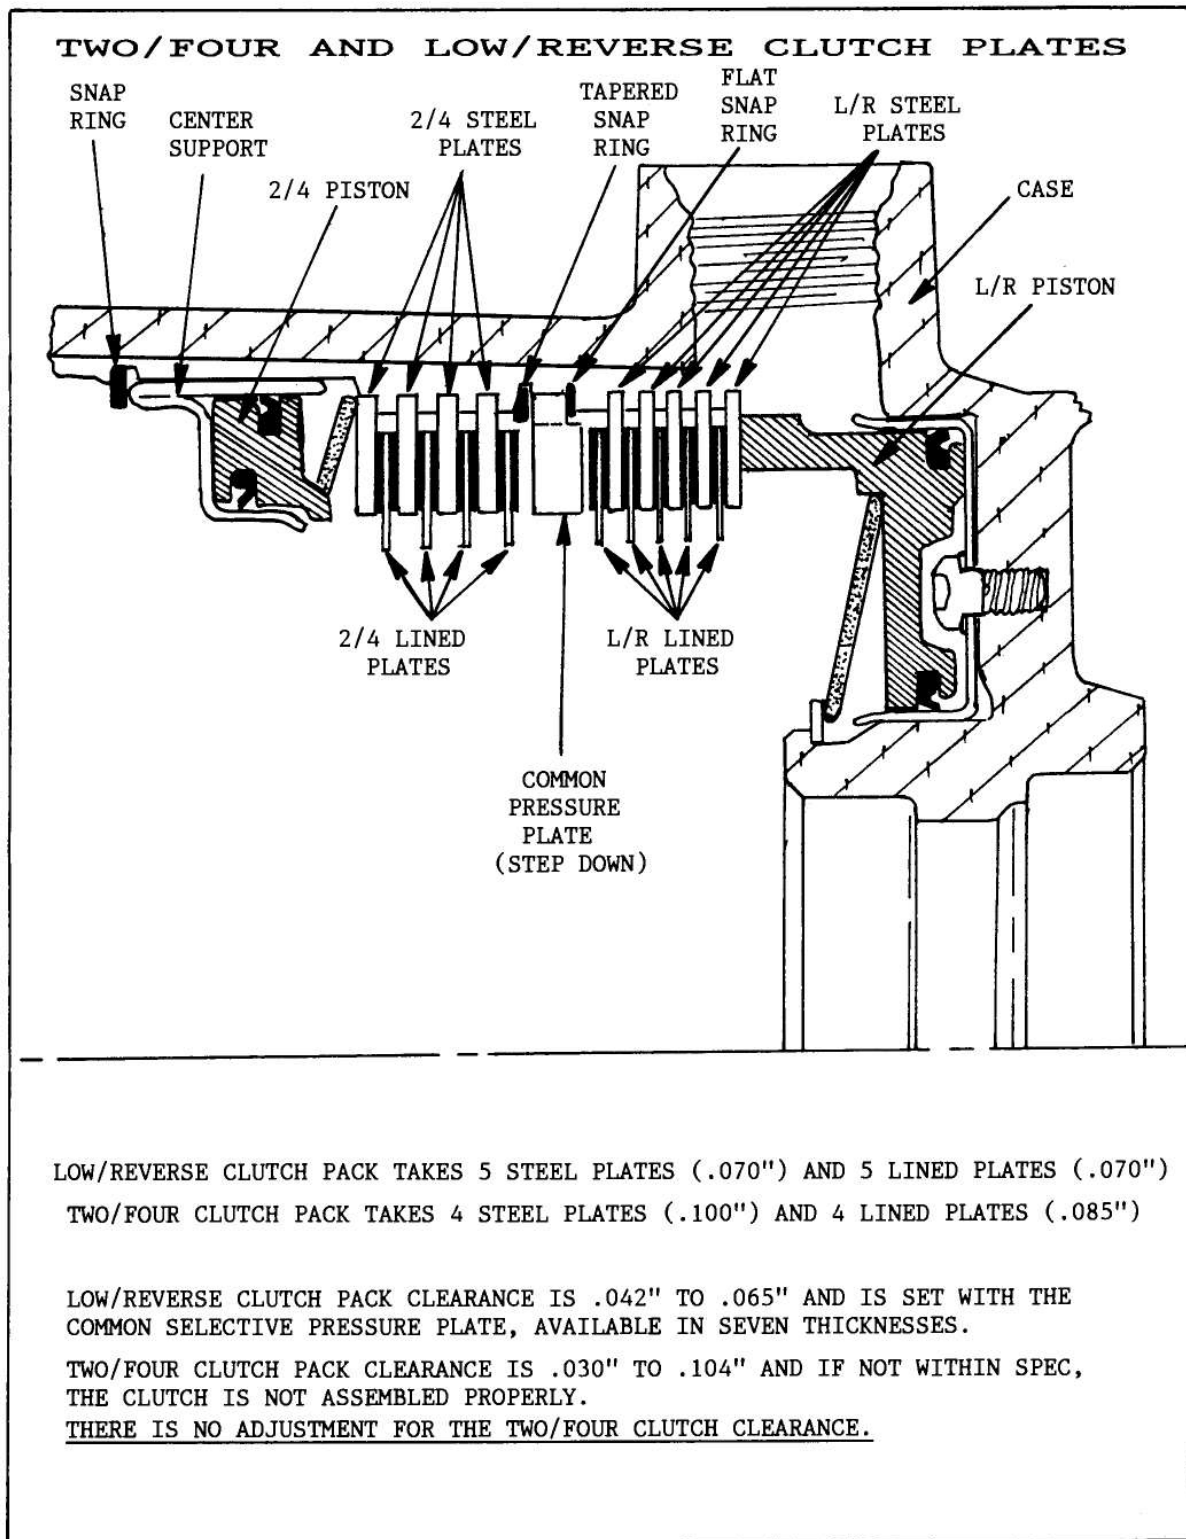
Figure 33  
 AUTOMATIC TRANSMISSION SERVICE GROUP

We have provided you with the proper clutch stack up for these clutch packs, to assist you with proper assembly for the 2/4 and L/R clutch packs. Refer to Figure 33 for proper assembly procedures.
