## UPDATE HANDBOOK AODE, 4R70W, 4R70E, 4R75E

# INTRODUCTION

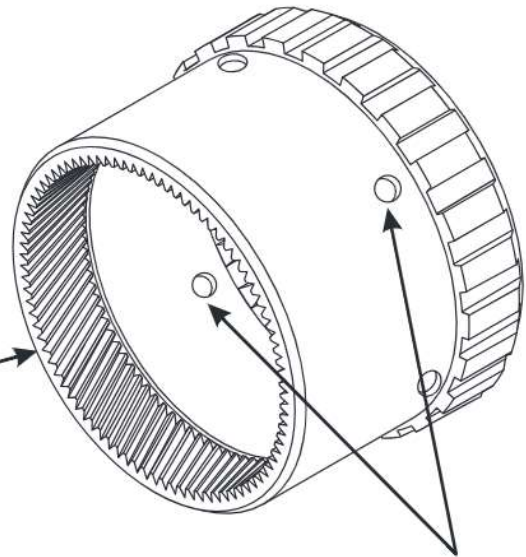
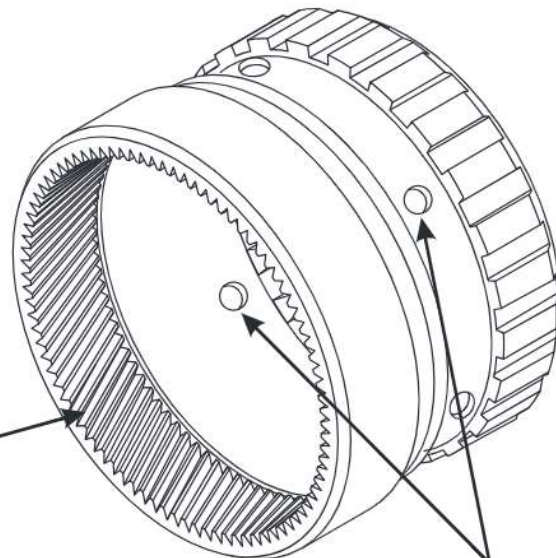
Figure 10

- (2) **OUTPUT SHAFT RING GEAR** - The AOD-E has 72 teeth on the Output Shaft Ring Gear, and the direct drum ***will not*** pass through the front side of the ring gear, as shown in Figure 10.  
The 4R70W has 88 teeth on the Output Shaft Ring Gear, and the direct drum ***will*** pass through the front side of the ring gear, as shown in Figure 10.

**72 TEETH, AND THE RING GEAR  
IS SMALLER IN DIAMETER THAN  
THE 4R70W RING GEAR**

**DIRECT CLUTCH HOUSING CANNOT  
BE REMOVED THROUGH THE FRONT**

**88 TEETH, AND THE RING GEAR  
IS LARGER IN DIAMETER THAN  
THE AOD-E RING GEAR**

**DIRECT CLUTCH HOUSING CAN  
BE REMOVED THROUGH THE FRONT**

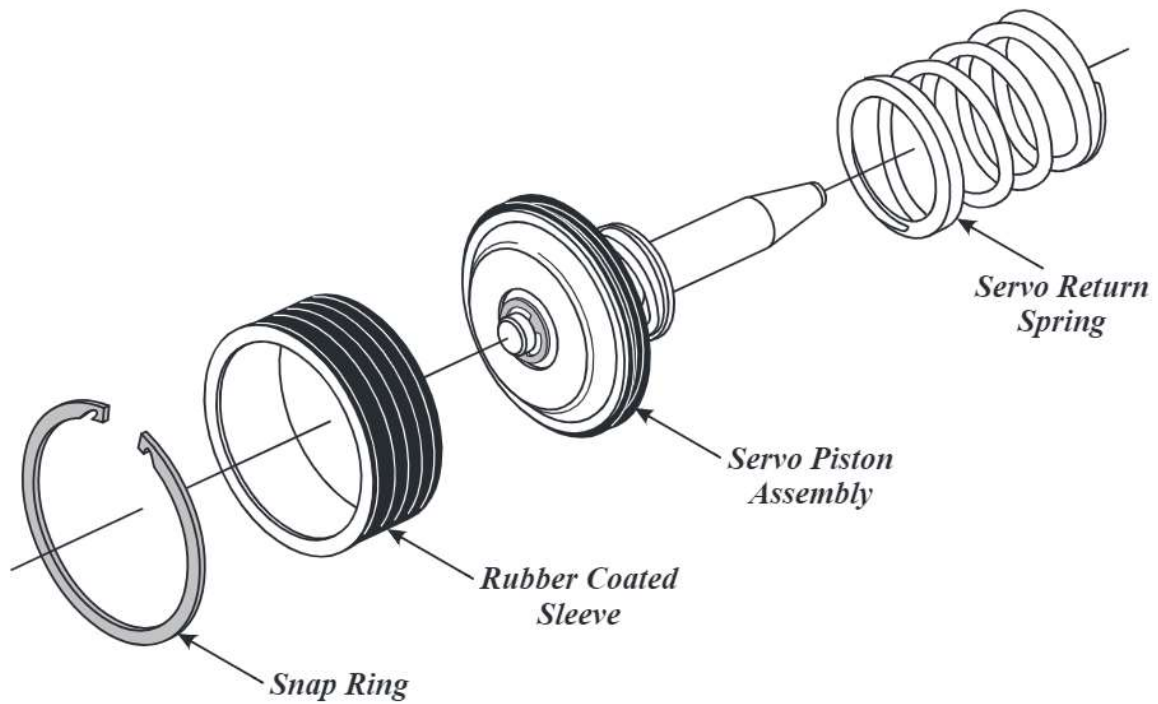
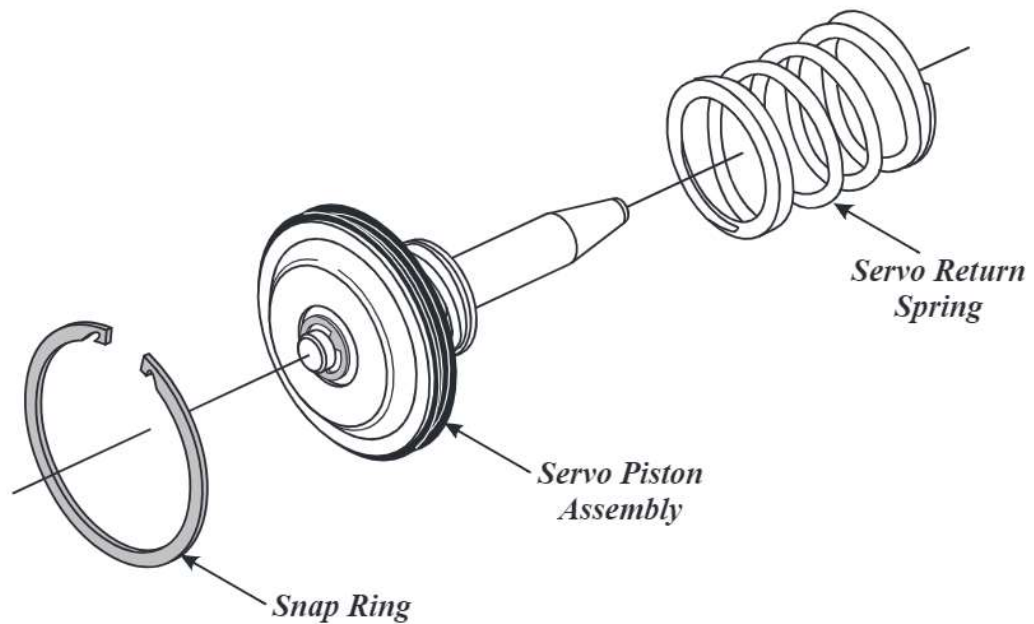
Figure 19

**CAUSE:** The cause may be, a mis-assembled Overdrive Servo Assembly, with the "Rubber Coated Sleeve" omitted. The 4R70W transmission is calibrated with a smaller diameter overdrive servo piston than is the AOD-E transmission. To retain a common case between the two transmissions, an additional "Rubber Coated Sleeve" is required on the 4R70W Overdrive Servo Assembly, as shown in Figure 19.

**CORRECTION:** Install the "Rubber Coated Sleeve" in the Overdrive Servo Assembly case bore, as shown in Figure 19. If your rubber coated sleeve is missing or lost, you *must* purchase the complete Overdrive Servo Assembly, available under part number F3LY-7H188-A. It is not available individually.  
Overdrive servo piston dimensions are shown in Figure 18, to identify the two different overdrive servo pistons.

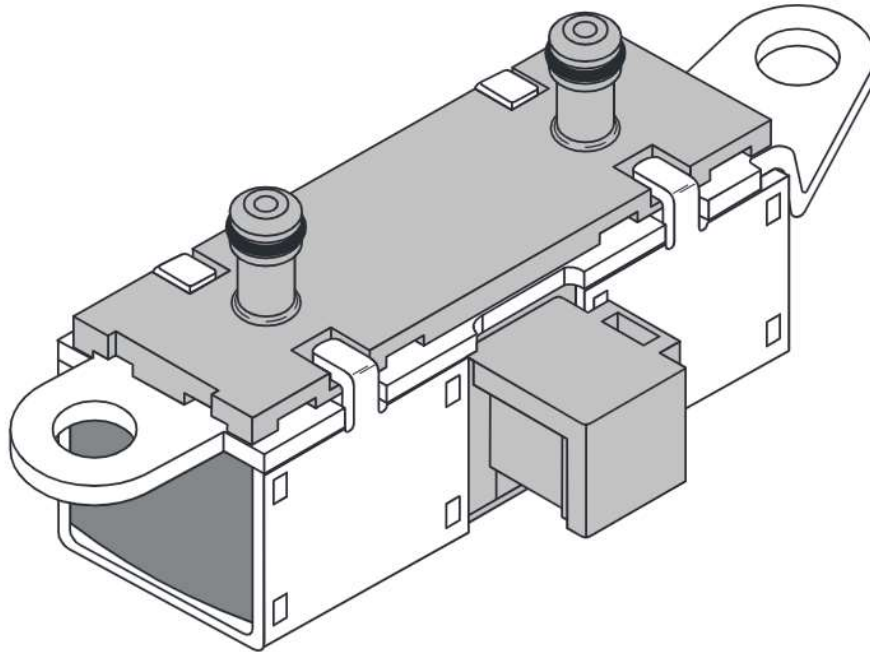
Figure 23

**CAUSE:** The cause may be, a partially clogged Shift Solenoid No. 2, which will stroke the 3-4 shift valve far enough to exhaust *some* of the forward clutch oil.

**SHIFT SOLENOID ASSEMBLY  
PART NUMBER F5AZ-7G484-A**

**CORRECTION:** Install two pressure gages to check line pressure and forward clutch pressure, as shown in Figure 22. With the transmission in Drive, both gages should read the same and should be approximately 55-75 PSI. If the forward clutch gage reads lower than the line pressure gage, *and all internal parts are known to be good*, replace the Shift Solenoid Assembly with OEM part number F5AZ-7G484-A (See Figure 23).

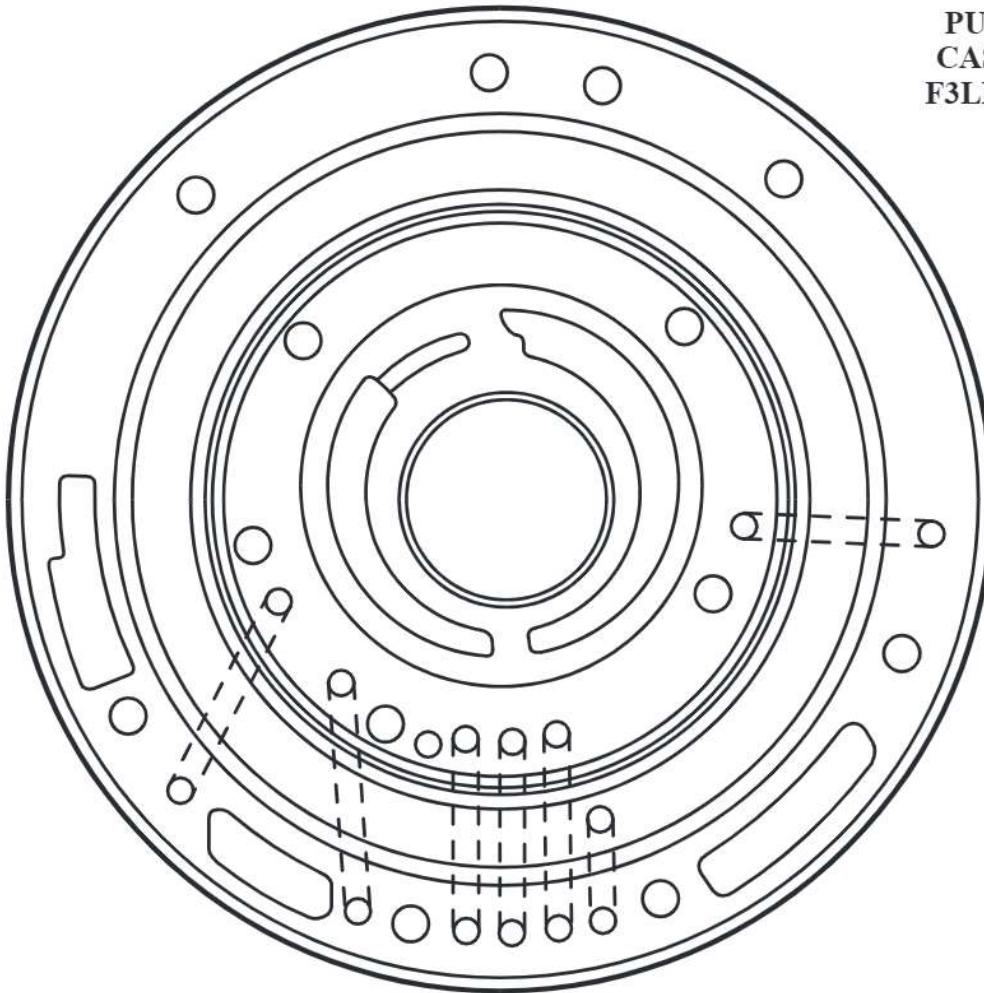
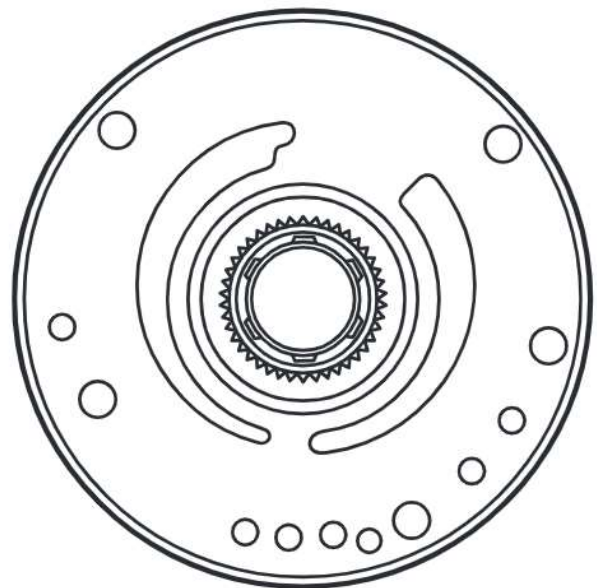
Figure 32

**PUMP BODY  
CASTING NO.  
F3LP-7A105-AA**

**PUMP STATOR  
CASTING NO.  
F2VP-7A109**

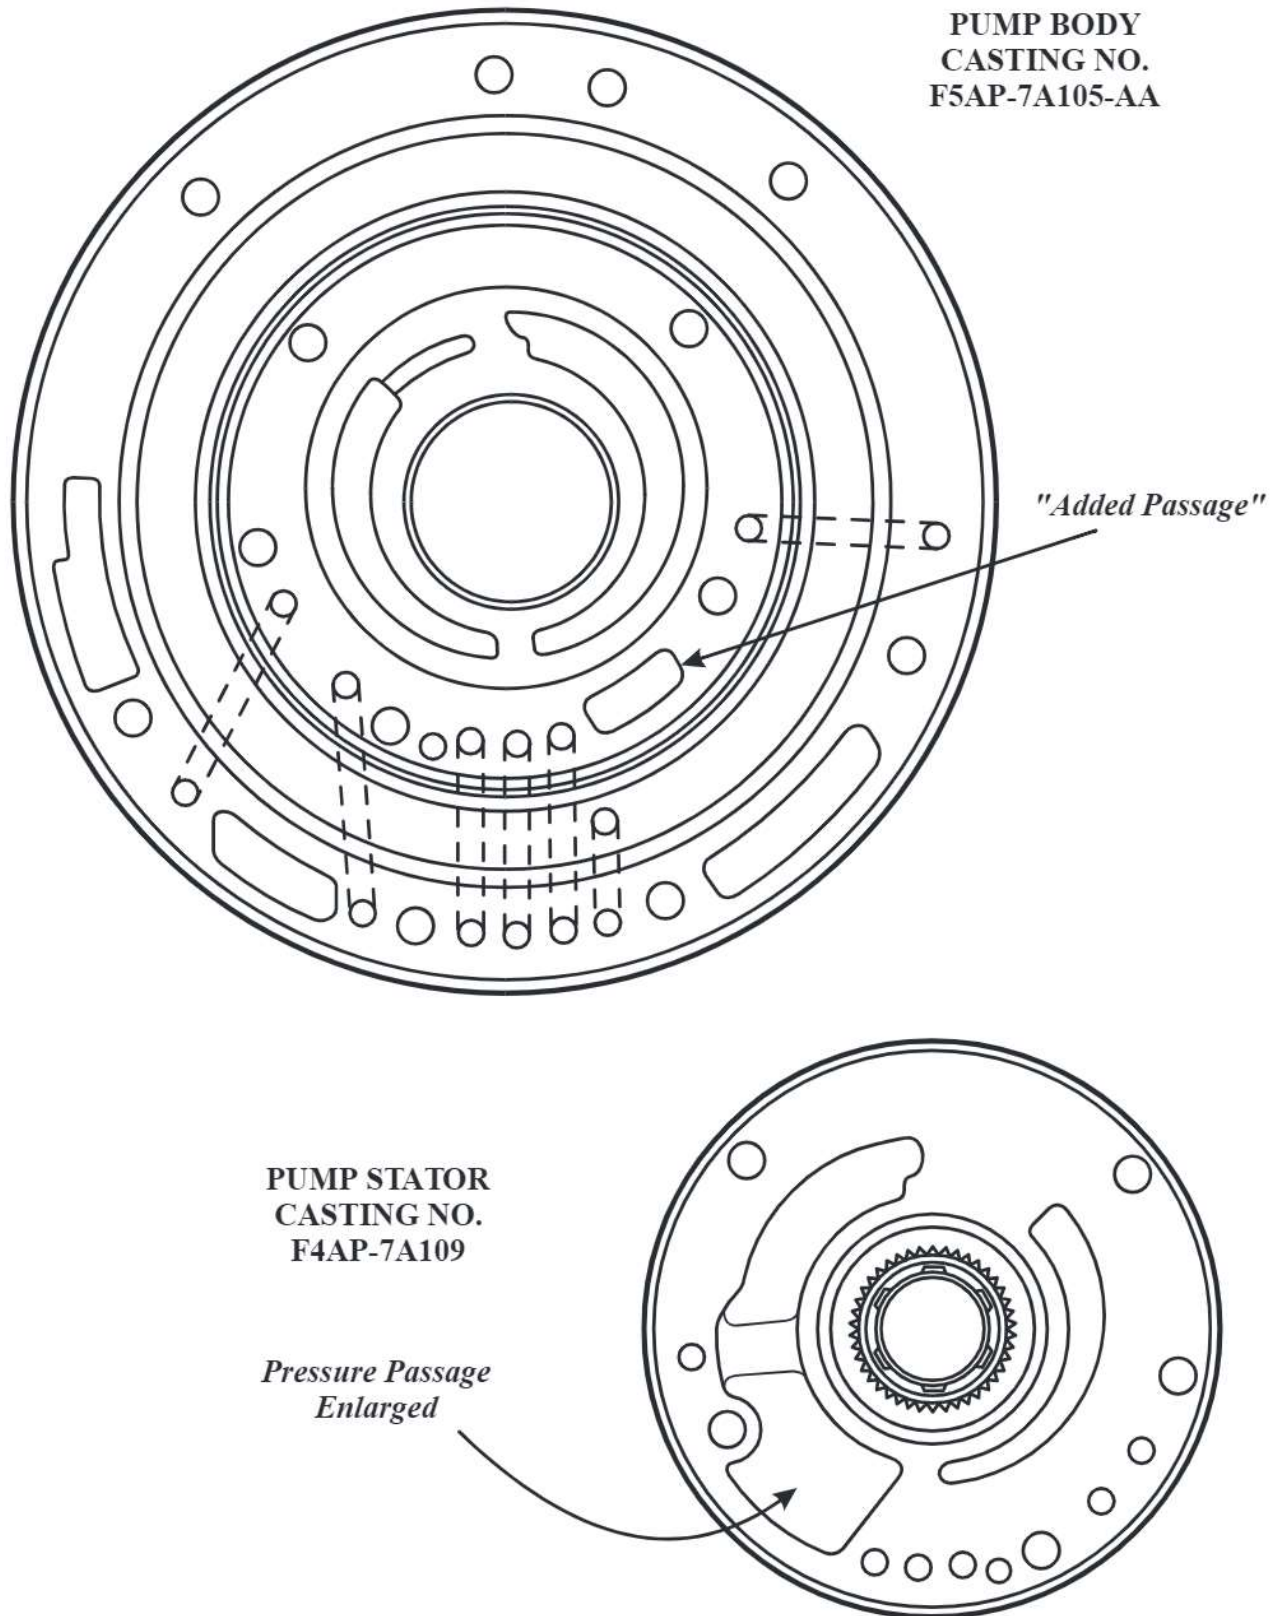
Figure 33

- (1) OIL PUMP BODY - Has an added pressure passage in pump body, shown in Figure 33, and is easily identified by casting number F5AP-7A105-AA located on the front side of pump body.
- (2) OIL PUMP STATOR - Has a much enlarged pressure passage in pump stator as illustrated in Figure 33, and is easily identified by casting number F4AP-7A109 located on back side of the pump stator.

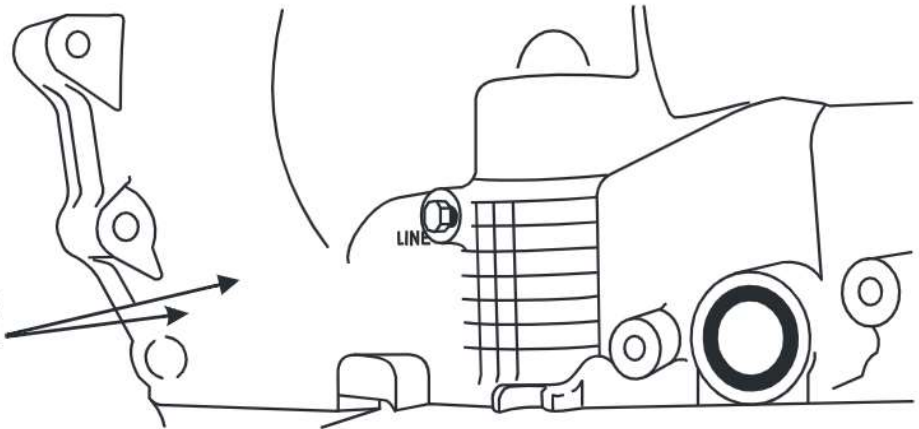
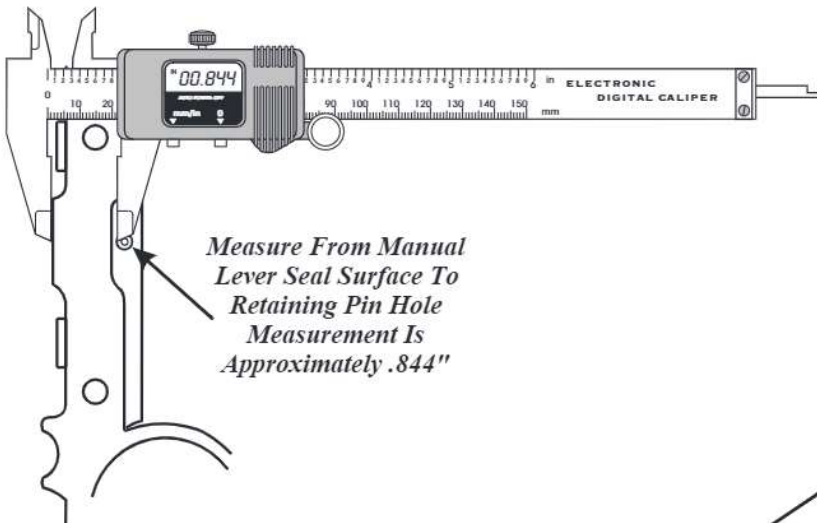
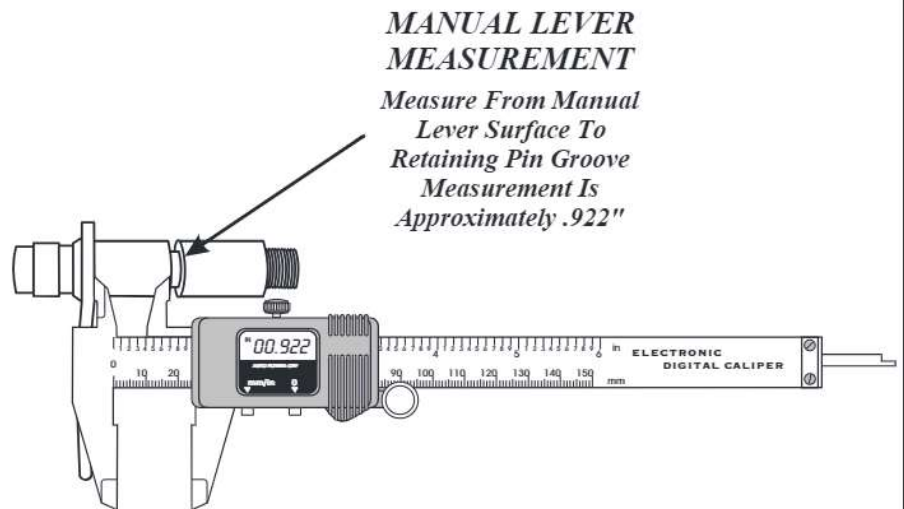
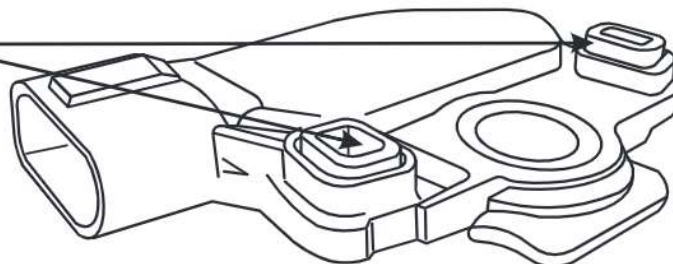
**CAUSE:** The AODE cases are different in thickness when measuring from the manual lever seal surface to the countersink in the manual lever retaining pin hole. See Figure 44 and 45.

**Early Case** - The early case has None or One threaded boss on the lower left side of the case, as shown in Figure 44, and the measurement from the manual lever seal surface to the countersink in the manual lever retaining pin hole is approximately .844", which is also shown in Figure 44.

**Early Manual Shift Lever** - Measure from the back flange of shift lever to the first edge of the groove for the retaining pin, as shown in Figure 44. Early lever will measure approximately .922".

**Early MLPS** - Has the *short* torque limiters, as shown in Figure 44.

*Measure From Manual  
Lever Seal Surface To  
Retaining Pin Hole  
Measurement Is  
Approximately .844"*

*Measure From Manual  
Lever Surface To  
Retaining Pin Groove  
Measurement Is  
Approximately .922"*

*MLPS HAS SHORT  
TORQUE LIMITERS*

**CORRECTION:** It is *mandatory* that the proper parts be installed into the proper case, *as the parts listed above are not interchangeable.* Refer to Figure 44 for the early parts and to Figure 45 for the late parts.

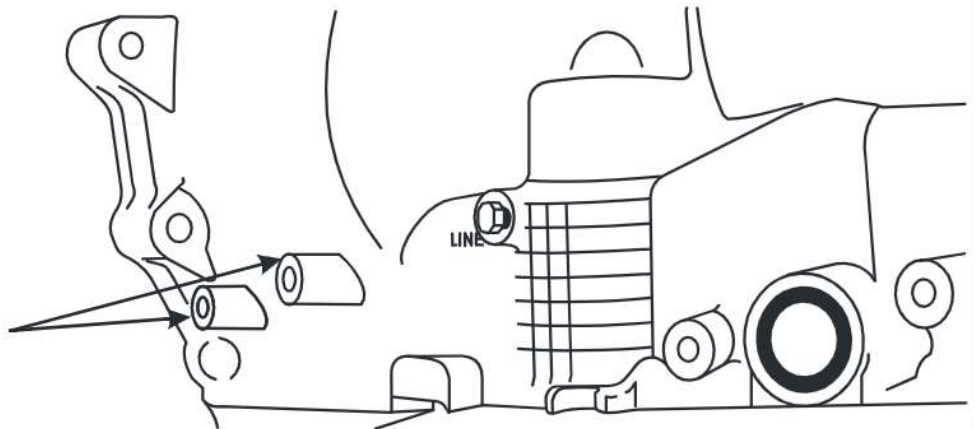
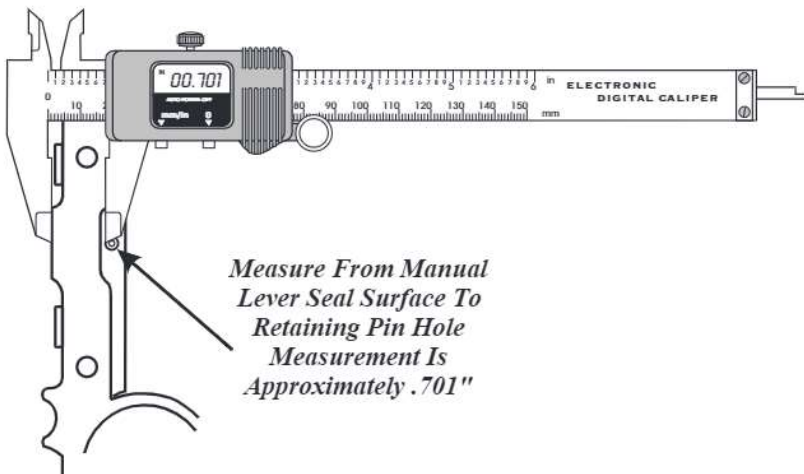
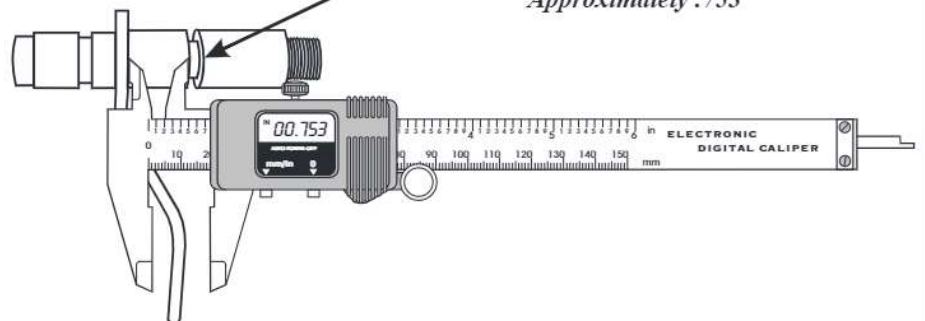
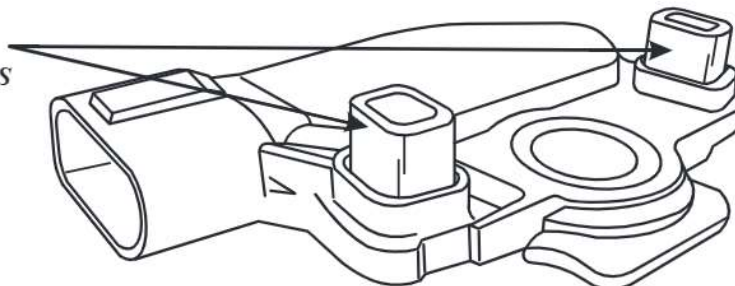
Figure 45

**Late Case** - The late case has Two threaded bosses on the lower left side of the case, as shown in Figure 45, and the measurement from the manual lever seal surface to the countersink in the manual lever retaining pin hole is approximately .701", which is also shown in Figure 45.

**Late Manual Shift Lever** - Measure from the back flange of shift lever to the first edge of the groove for the retaining pin, as shown in Figure 45. The Late lever will measure approximately .753".

**Late MLPS** - Has the *tall* torque limiters, as shown in Figure 45.

*Measure From Manual  
Lever Seal Surface To  
Retaining Pin Hole  
Measurement Is  
Approximately .701"*

*Measure From Manual  
Lever Surface To  
Retaining Pin Groove  
Measurement Is  
Approximately .753"*

*MLPS HAS TALL  
TORQUE LIMITERS*

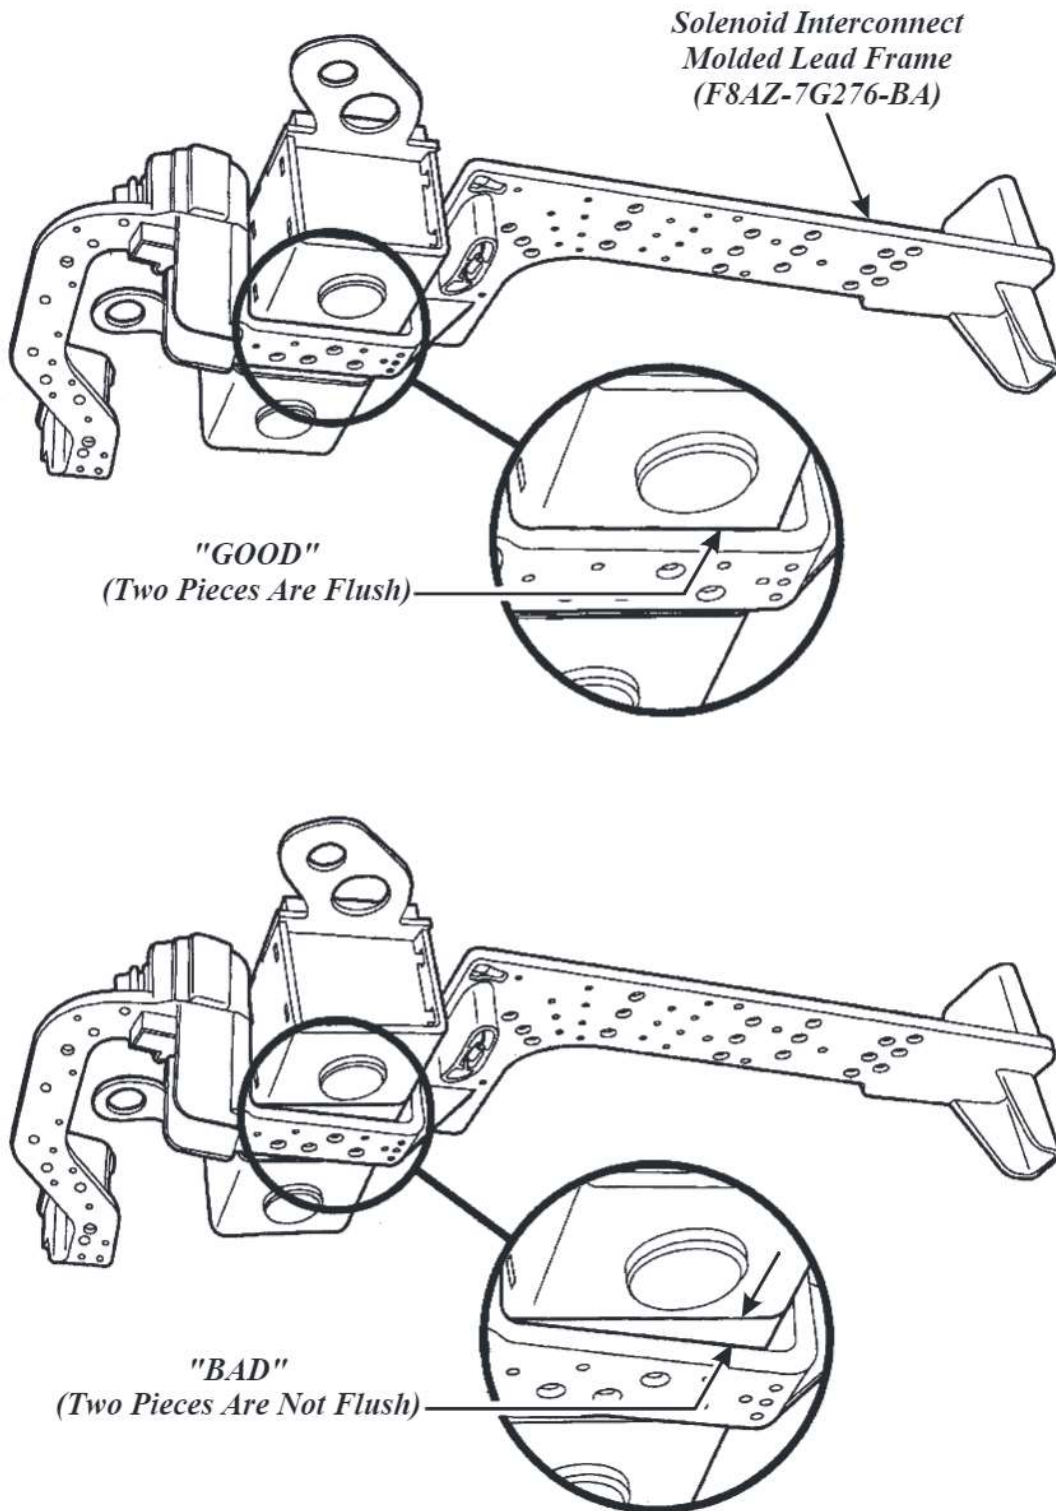
Figure 46

**CAUSE:** The cause may be, the solenoid interconnect molded lead frame not being fully seated on the solenoid pack or the bulkhead interconnect clips not being fully seated between the solenoid interconnect molded lead frame and bulkhead interconnect.

- (3) Verify that the solenoid interconnect molded lead frame is fully seated on all the solenoid connectors as shown in Figure 46. If the solenoid interconnect molded lead frame is fully seated, then gently remove the solenoid interconnect molded lead frame, valve body and the bulkhead interconnect.

- (5) Replace parts as necessary using the part numbers listed below and reassemble unit.

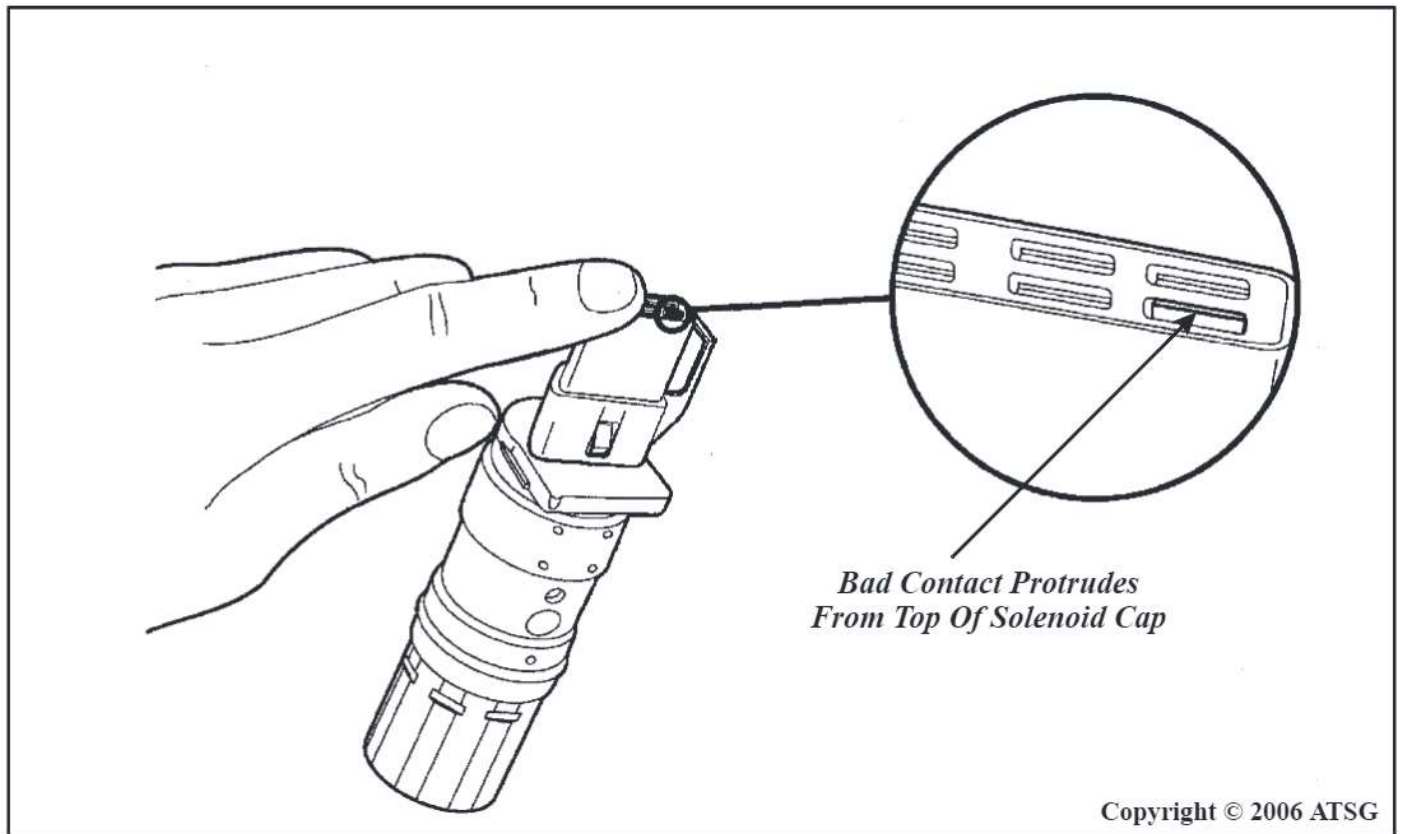
Figure 47

- (4) With the bulkhead interconnect removed, push down on the terminal cover and check to see if any of the terminals are slightly protruding above the plastic cover as shown in Figure 47. Gently pry off the terminal cover using a small screwdriver (See Figure 48). With the terminal cover off, inspect the bulkhead interconnect for spreading terminals as shown in Figure 49.

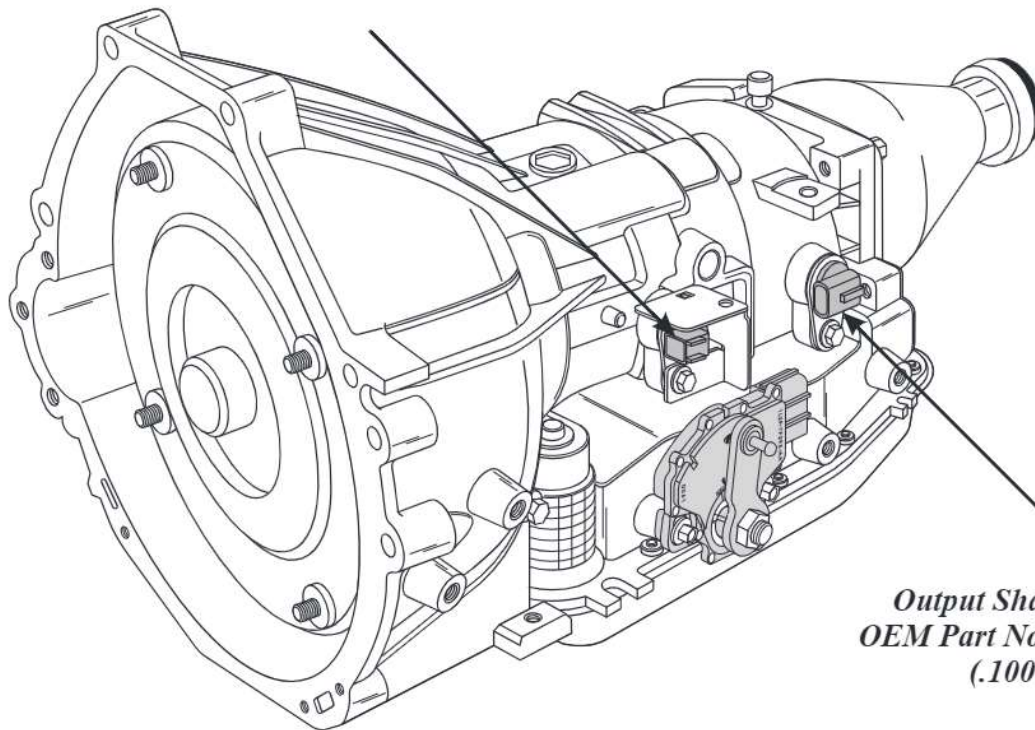
**CHANGE:** Beginning at the start of production for 2004, Ford Motor Company introduced a new rear drive transmission with the designation 4R70E or 4R75E, as shown in Figure 72. This unit is another version of the current 4R70W unit. There has been a Turbine Shaft Speed (TSS) sensor added in the center of the case, as shown in Figure 72, and aligned with a new sun gear shell, as shown in Figure 73. Another change is the rear ring gear with extended parking lugs that now trigger the output speed sensor, as shown in Figure 74. These new units are found only in F150 and E150 series vehicles for 2004. The 4.6L engine will be equipped with the 4R70E and the 5.4L engine will be equipped with the 4R75E, difference being, hardened planetary carrier in the 4R75E.

- (5) OUTPUT SPEED SENSOR - New design has a .100" **shorter** stem to accommodate the new design internal ring gear. Part numbers for all models are found in "Service Information".

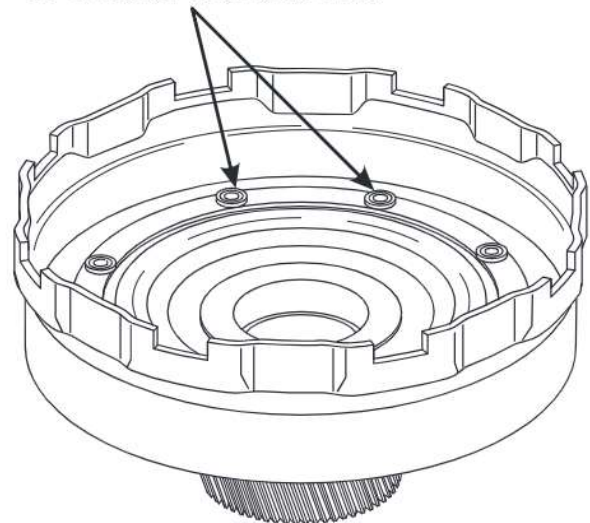
Figure 73

- (3) SUN GEAR AND SHELL ASSEMBLY - The new Sun Shell Assembly is easily identified by the new rivets that retain the sun shell to the sun gear, as shown in Figure 73. The new sun shell is manufactured from a different (non-ferrous) material than the previous shell. The new sun shell material is less magnetic than the previous sun shell.

*New Sun Shell Is Now Riveted  
To The Sun Gear And Hub*

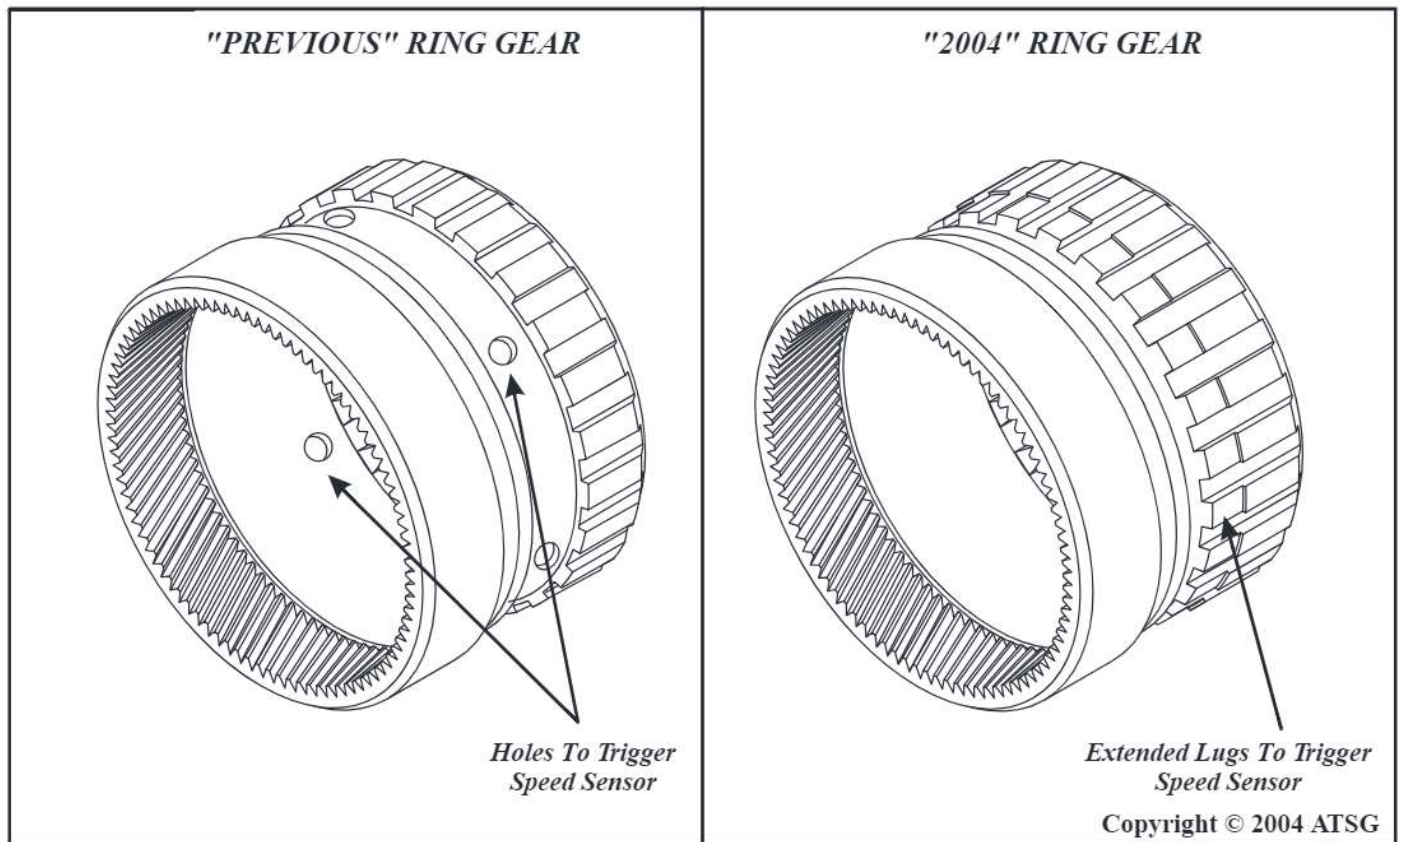
Figure 74

- (4) REAR INTERNAL RING GEAR - Now is manufactured with extended parking lugs on the ring gear to trigger the output speed sensor, instead of the previous design with holes in the ring gear, which would also require a strategy change in the PCM. Refer to Figure 74.

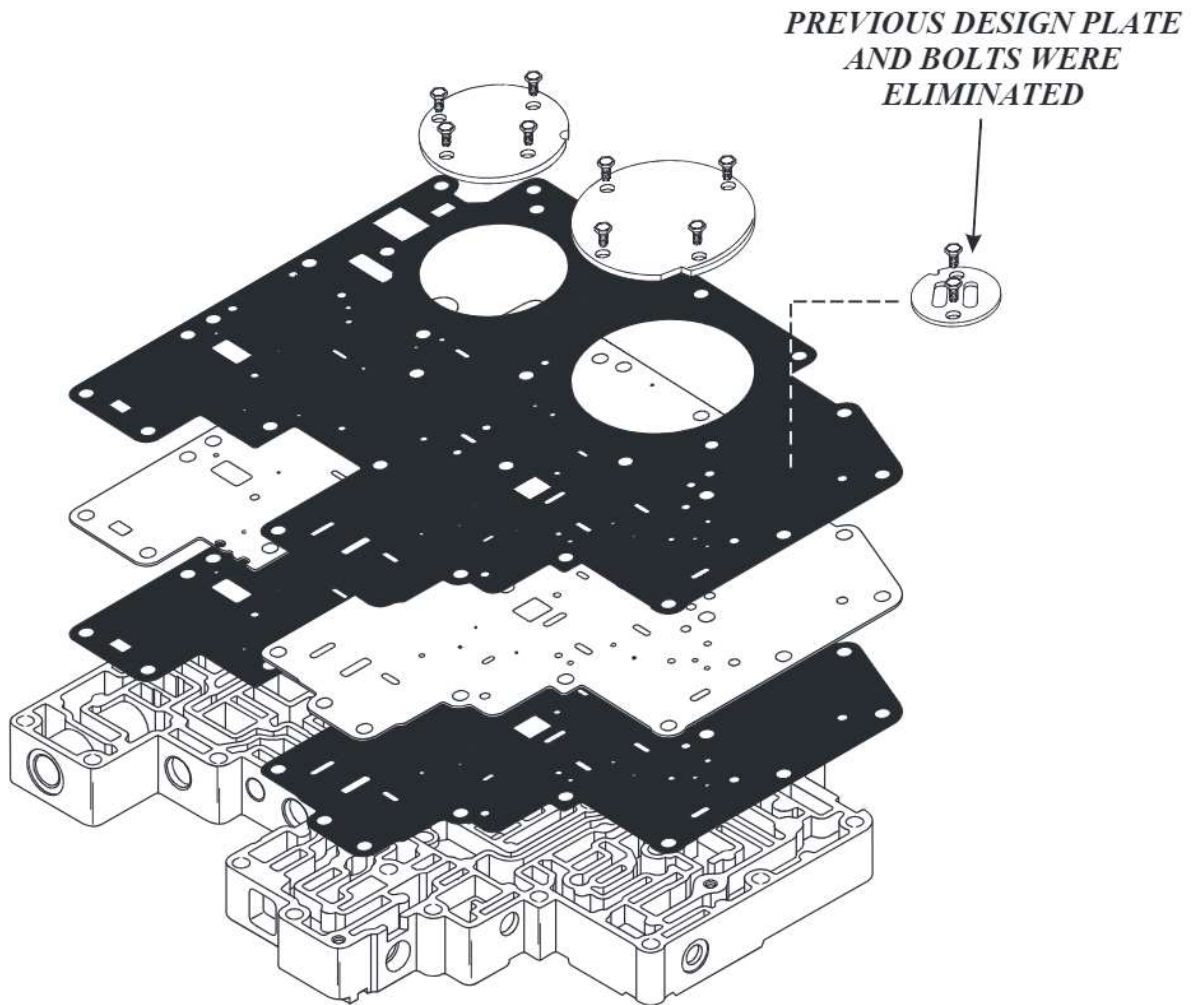
Figure 83

**CAUSE:** The cause may be, that a previous design 2-3 accumulator retainer was used, or the retainer was assembled upside down, when installing it into the case. **NOTE:** 2001 and up Valve Body assemblies, as shown in Figure 83, eliminated the small plate on the spacer plate side over the 2-3 accumulator retainer, which made a taller 2-3 accumulator retainer necessary for 2001 models, shown in Figure 82. When the early 2-3 accumulator retainer (shorter) is used, or if the retainer is installed upside down, the 2-3 accumulator piston may come out of its bore dumping Direct Clutch pressure to an exhaust. Refer to Figure 84 for a cutaway of the correct and incorrect assembly.

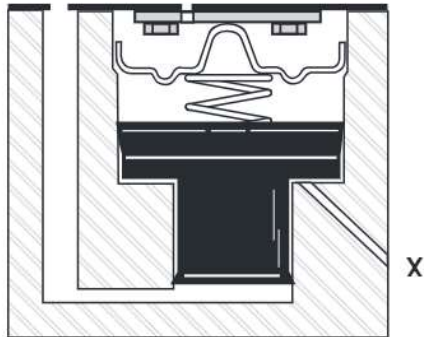
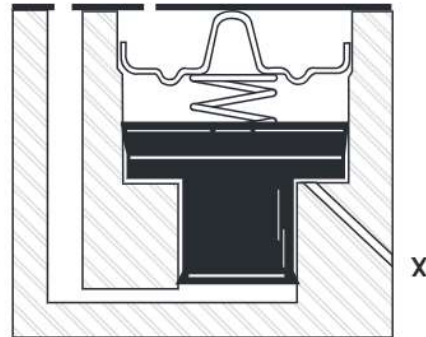
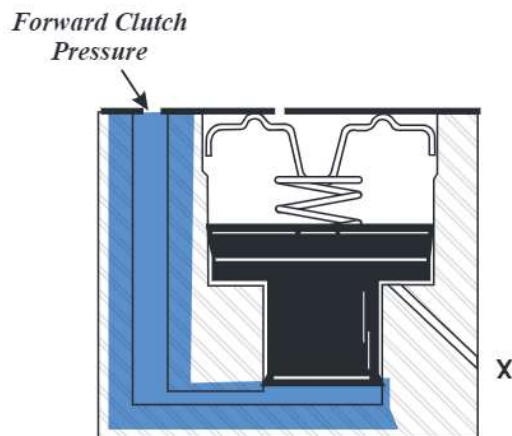
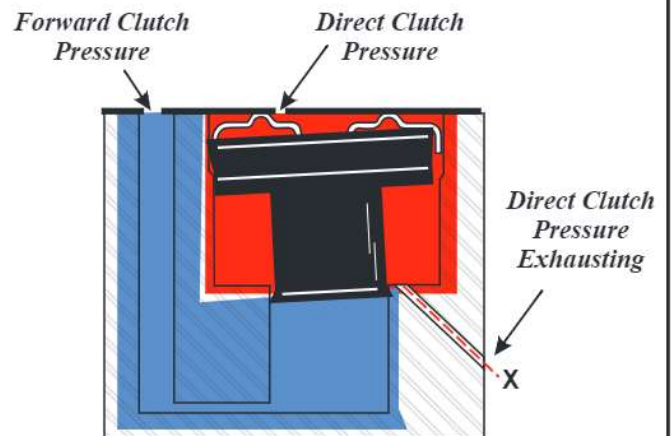
**Note:** When the 2-3 accumulator piston retainer is installed up-side down, as shown here, the accumulator piston may come out of it's case bore and connect the direct clutch to an exhaust.

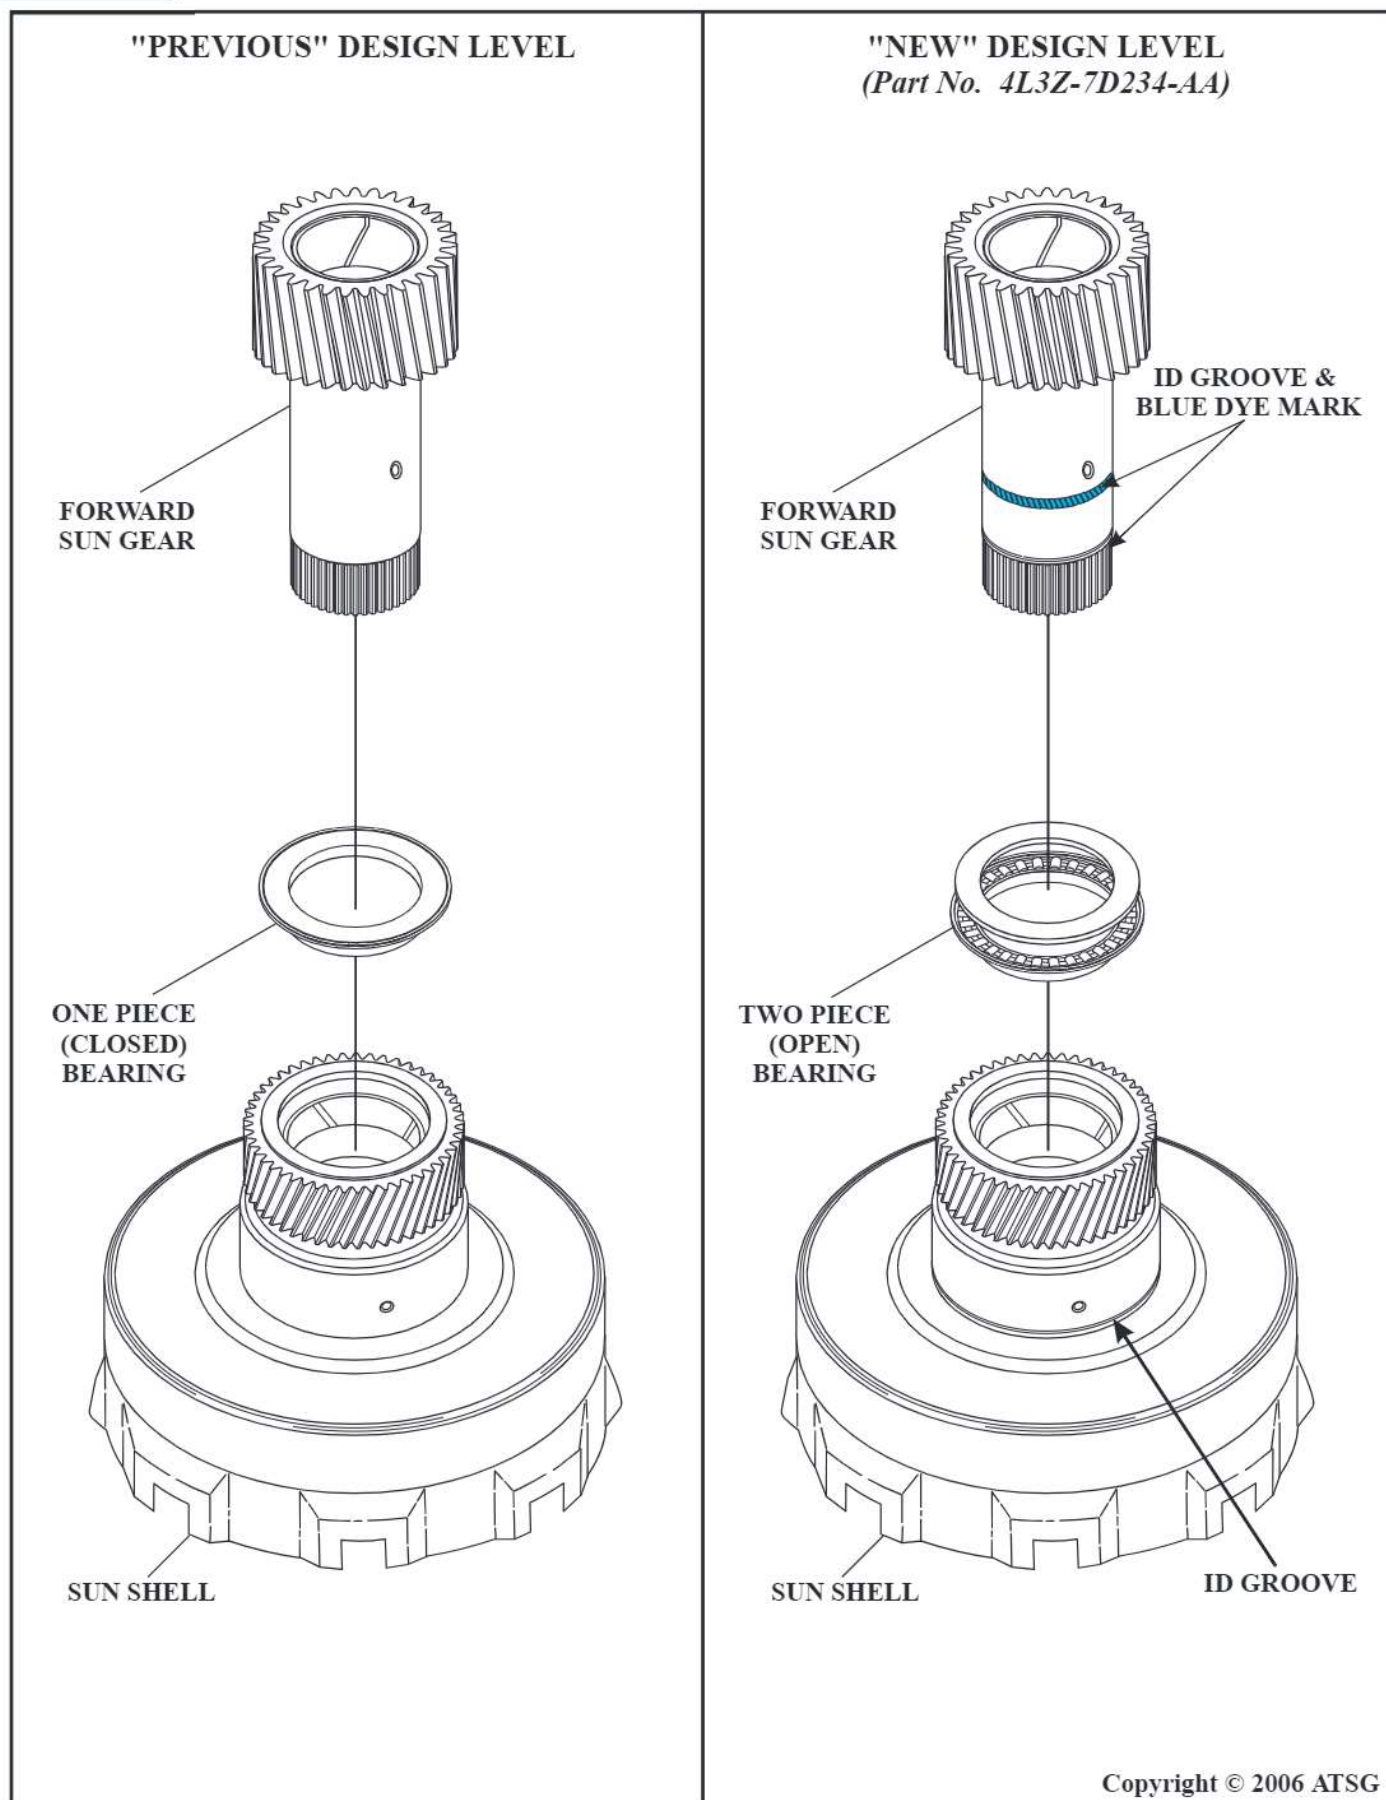
Figure 97

**CHANGE:** There is now available, for *1994-2003 models only*, equipped with the 4R70W transmission, a new service package that contains the forward sun gear, a new design number 5 bearing and new design sun gear shell, as illustrated in Figure 97.
