## UPDATE HANDBOOK AODE, 4R70W, 4R70E, 4R75E

# INTRODUCTION

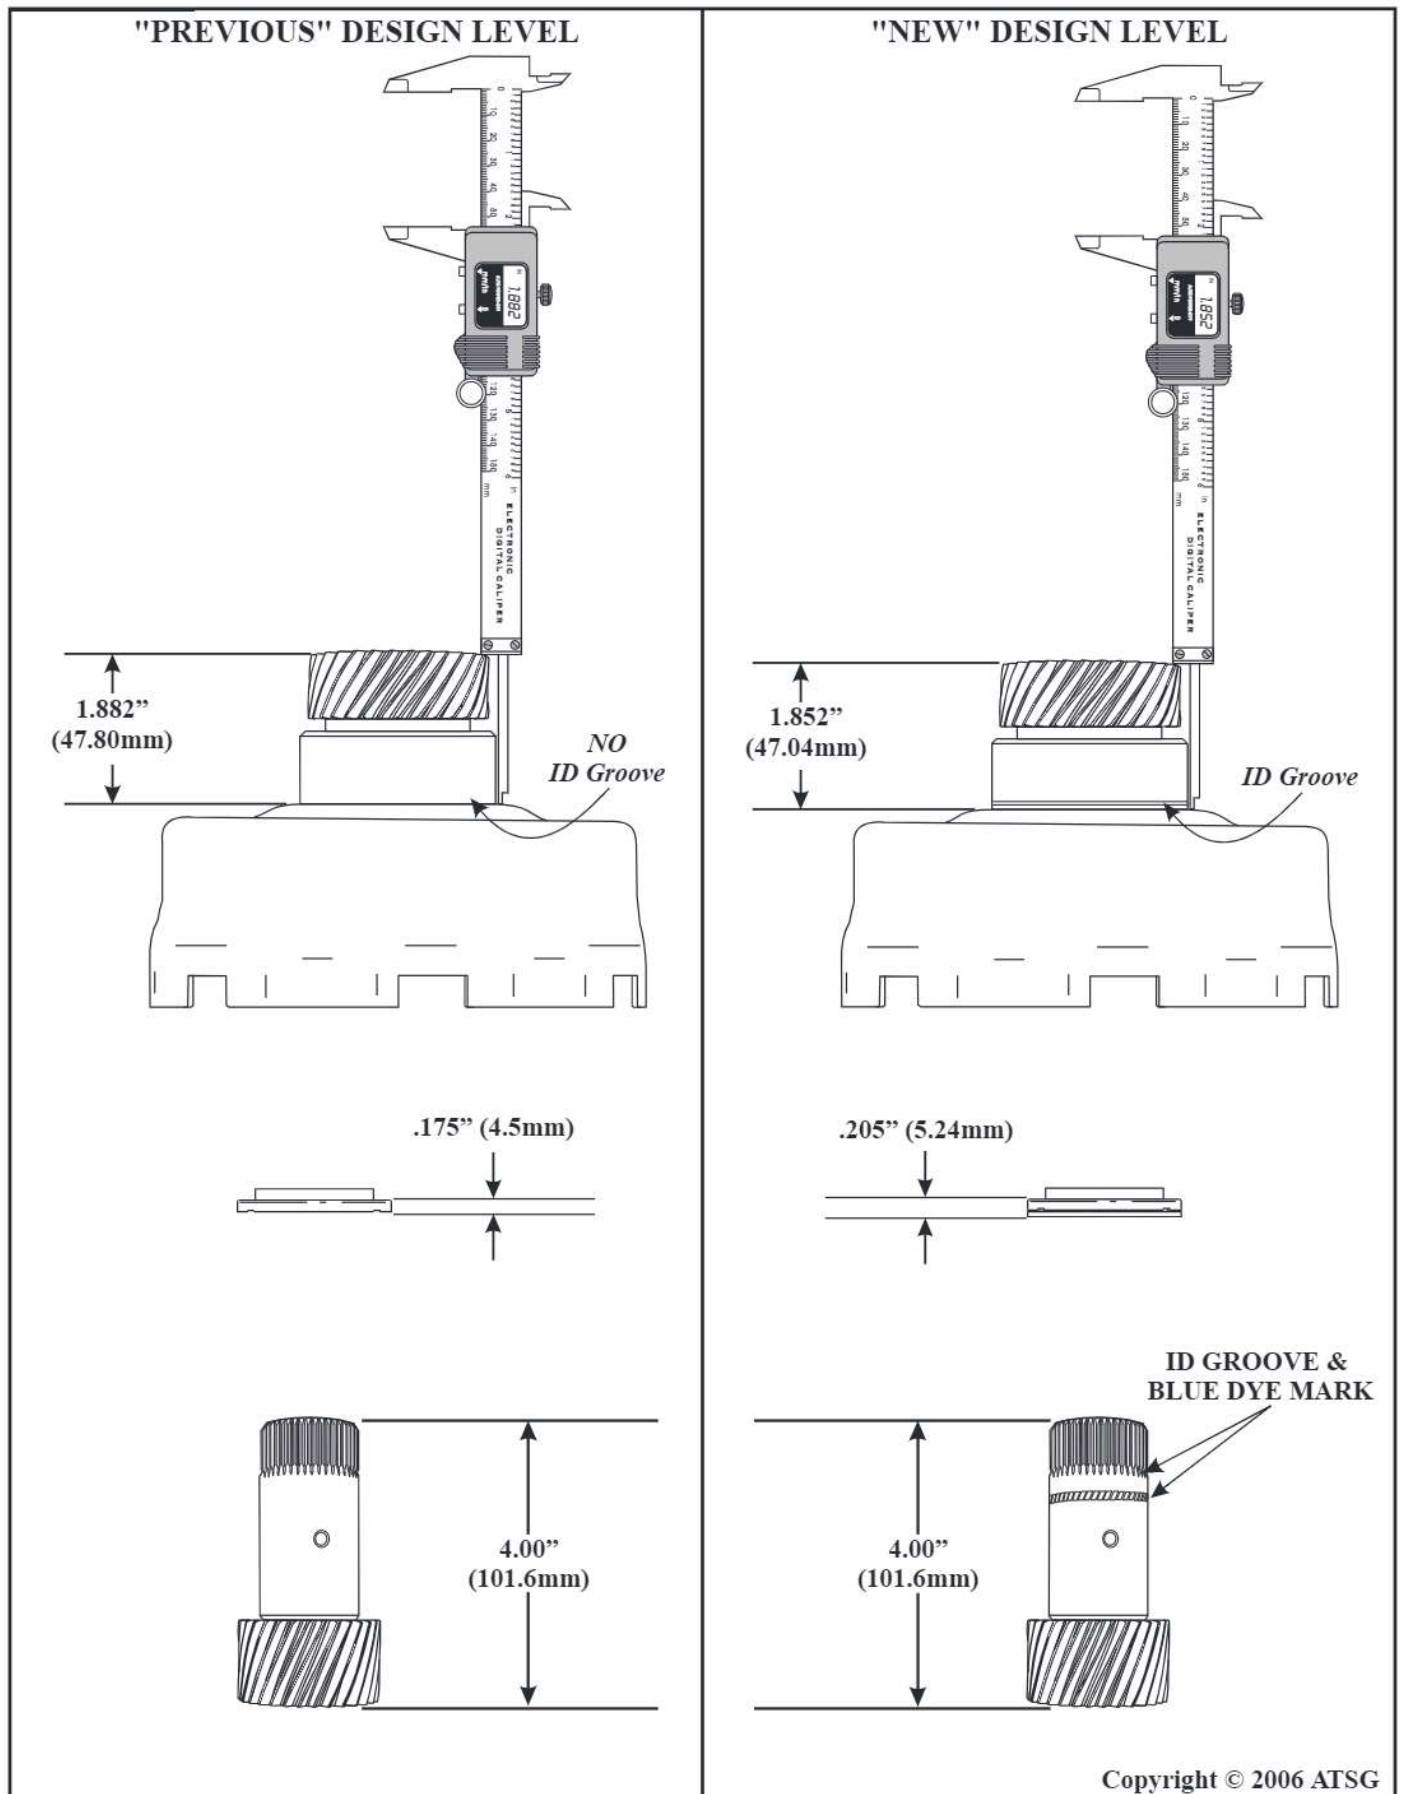
Figure 98

- (1) **NUMBER 5 THRUST BEARING** - The new design number five thrust bearing is now a "two piece open" design (needles exposed) and is .205" (5.24mm) in thickness, as shown in Figure 98. The previous design is a "one piece closed" bearing and is .175" (4.5mm) in thickness, as shown in Figure 98.

- (2) **REVERSE SUN GEAR AND SHELL ASSEMBLY** - The new Sun Gear Shell is shorter, 1.852" (47.04mm) as measured in Figure 98, to accommodate the thicker number 5 thrust bearing. It also has a small groove machined at the base of the bushing journal for identification, as shown in Figure 98. The previous Sun Gear Shell is 1.882" (47.80mm) and does not have an ID groove. Refer to Figure 98.

- (3) **FORWARD SUN GEAR** - Both previous and new Forward Sun Gears are the exact same length, 4.0" (101.6mm). The new design Forward Sun Gear has a groove machined at the base of the splines, and a blue dye stripe for identification purposes, as shown in Figure 98, and appears to have a different hardening process.

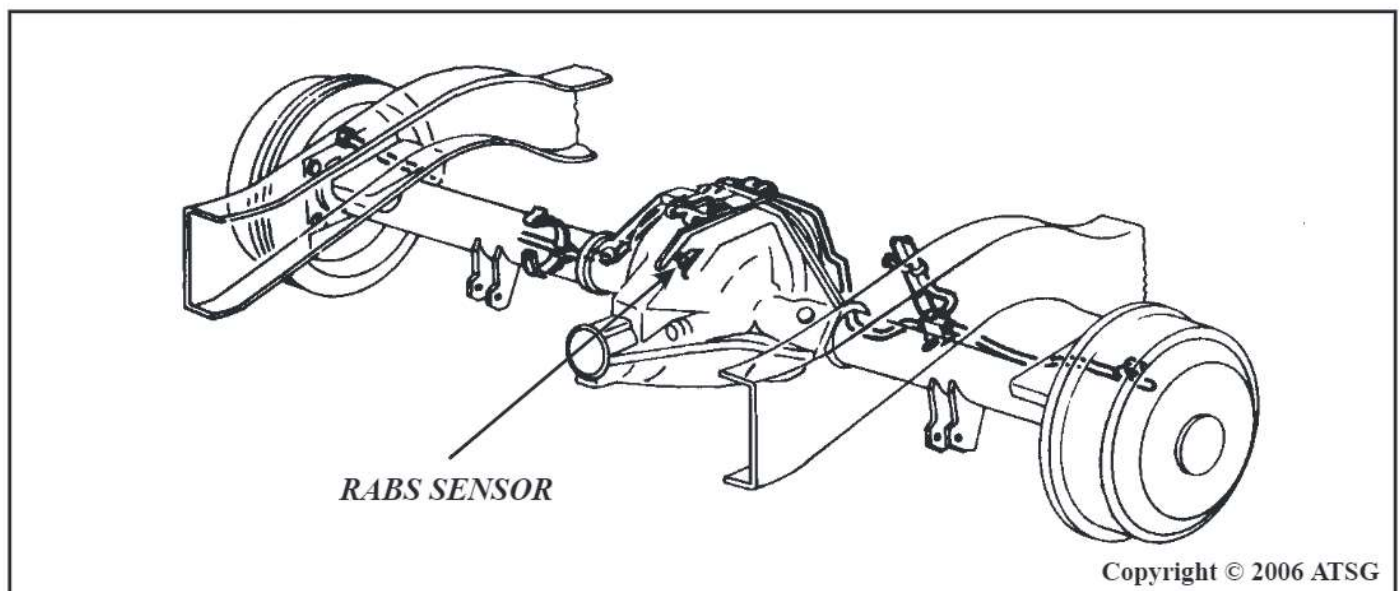
Figure 99

1. A faulty vehicle speed sensor (VSS) known as the Rear Antilock Brake Sensor (RABS) now located in the rear differential (Refer to Figure 99).
2. A loose speed sensor exciter ring on the differential ring gear carrier. (Refer to Figure 100).
3. Excessive use of silicone on the sensor altering the sensor to exciter ring air gap.
4. A deteriorated RAB Sensor connector or wiring.
5. A malfunction of the PSOM (Programable Speedometer/Odometer Module).
6. A loss of power or ground to the PSOM.
7. A faulty PCM/TCM.
8. A faulty Cruise Control Module. Dis-connect cruise control module and perform road test. If problem is eliminated, replace cruise control module.

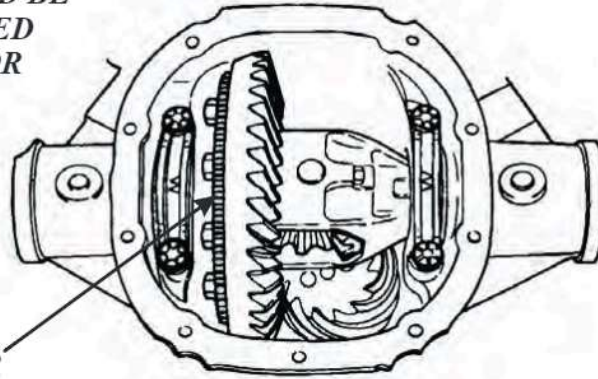
Figure 100

**EXCITER RING SHOULD BE  
TIGHT AND CENTERED  
WITH SPEED SENSOR**
