## AXOD/AXODE (AX4S) UPDATE HANDBOOK

# Technical Service Information

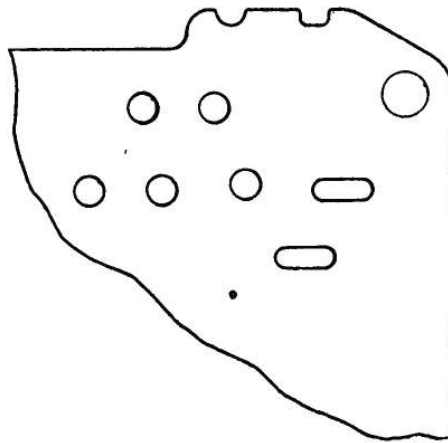
Figure 7

SPACER PLATES WILL NOT INTERCHANGE FROM MODEL TO MODEL

THIS SPACER PLATE FITS "ONLY" THE 10 CHECKBALL OIL PUMP.

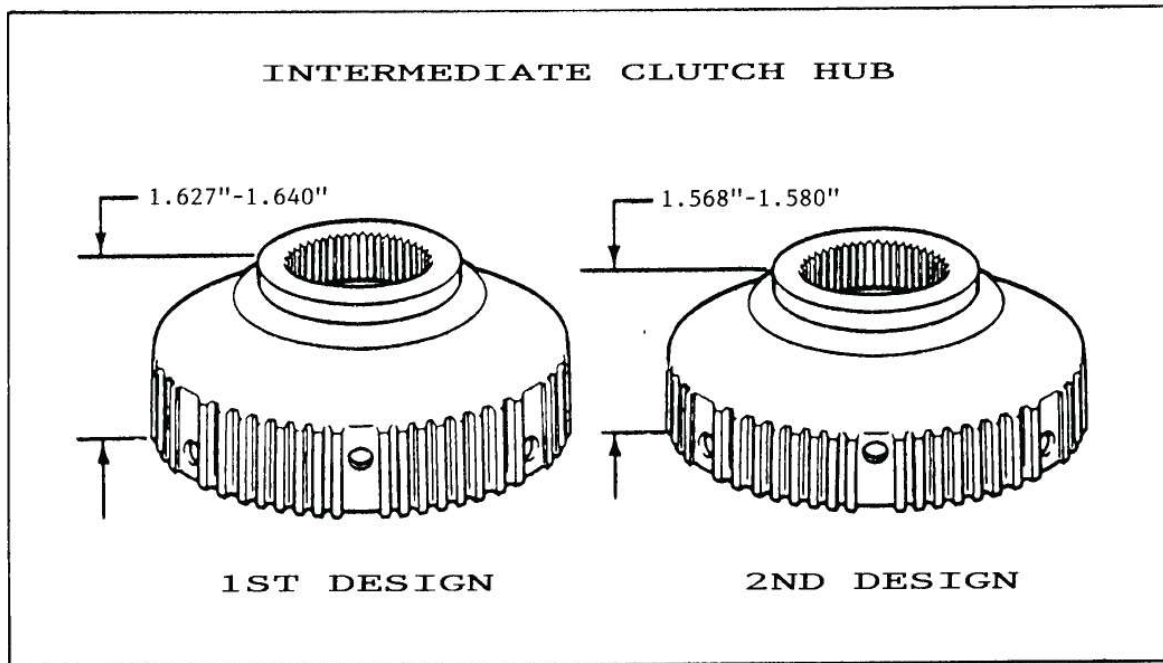
Figure 32

- (2) **INTERMEDIATE CLUTCH HUB** - Overall height was made shorter by approximately .060" with no identifying marks. The hub **MUST** be measured with a dial caliper or depth gage.  
The 1st design hub will measure 1.627"-1.640", and the 2nd design hub will measure 1.568"-1.580" as shown in Figure 32.

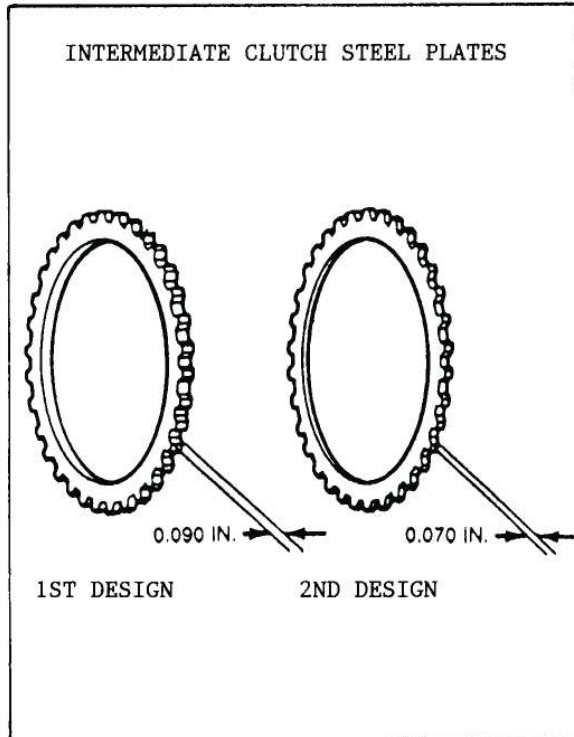
Figure 33

- (3) **INTERMEDIATE CLUTCH STEEL PLATES** - Thicknes was reduced by .020" to help accomodate the added wave plate on 3.8L models, or the added spacer plate on 3.0L models.  
The 1st design steel plates are .090" thick, and the 2nd design steel plates are .070" thick as shown in Figure 33.

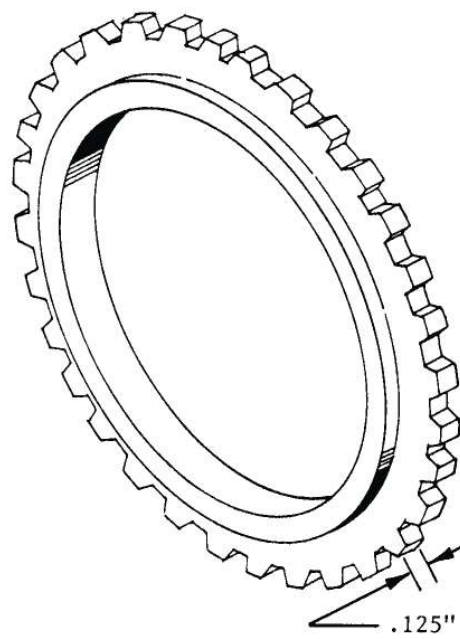
Figure 35

- (4) **INTERMEDIATE CLUTCH PRESSURE PLATE** - Thickness was reduced by .065" to help accomodate the added wave plate on 3.8L models, or the added spacer plate on 3.0L models.  
The 1st design pressure plate is .190" thick, and the 2nd design pressure plate is .125" thick as shown in Figure 35.

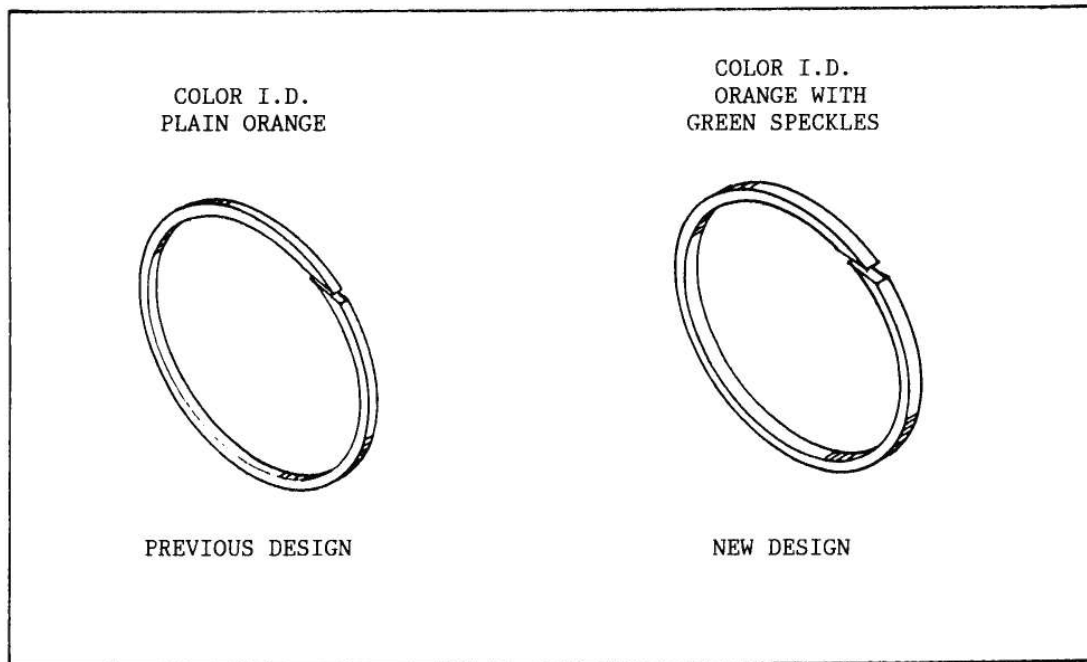
Figure 37

The five sealing rings on the driven sprocket support have been re-designed to help eliminate leakage in this area. The width of the sealing rings has been increased by approximately .015", and the new color identification is orange with green speckles (See Figure 37). The previous design sealing rings were plain orange in color.

The new design sealing rings are available under OEM number E6DZ-7D019-A, and should be used on ALL previous model AXOD transaxles.

DO NOT USE PREVIOUS DESIGN SEALING RINGS.

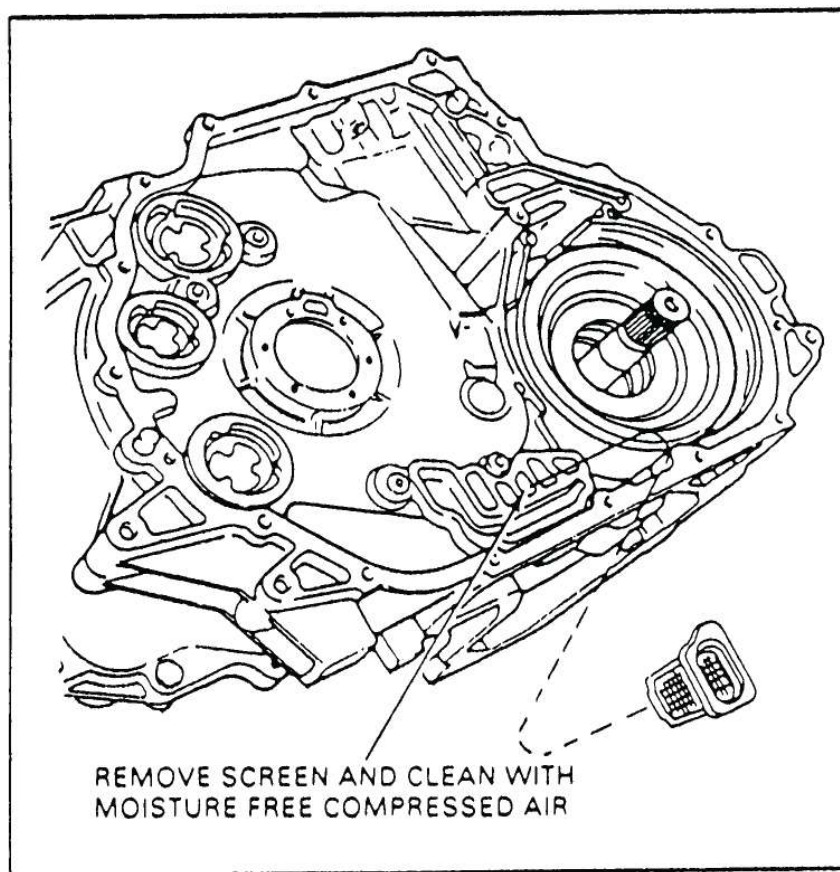
Figure 38

CHANGE: A new filter has been added to the 1989 AXOD 1-2 servo apply circuit as shown in Figure 38.

NOTE: A no forward condition could occur if the filter becomes contaminated.

New Filter ..... E9DZ-7H162-A

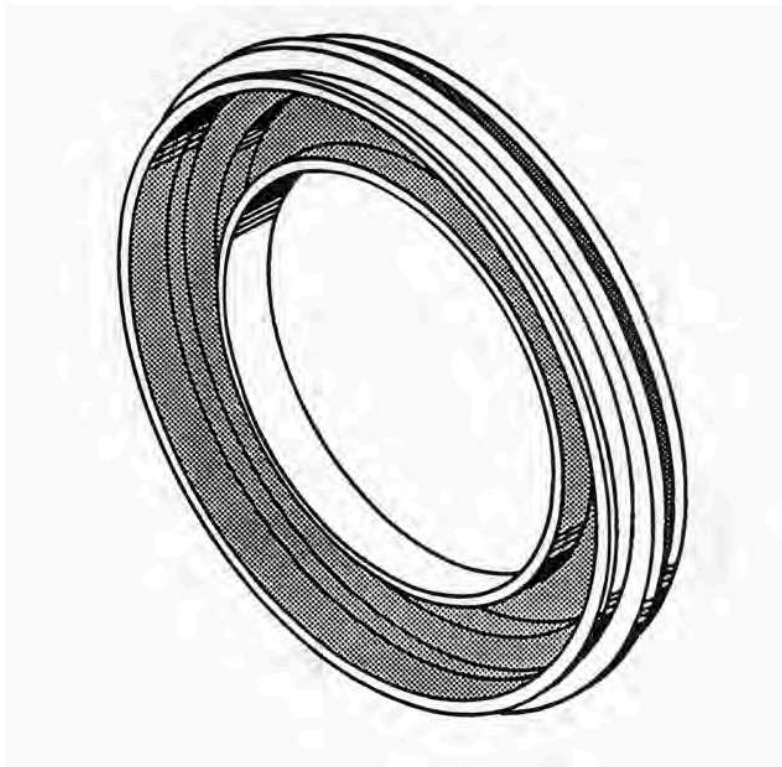
Figure 39

**CHANGE:** The Forward Clutch Piston material has now been changed to "Steel", instead of the previous design aluminum piston, as shown in Figure 39.

**REASON:** To eliminate cracks from occurring in the seal groove and greatly improve durability

- (1) FORWARD CLUTCH PISTON - Now manufactured out of steel, instead of aluminum, and there are no dimensional changes on the piston (See Figure 39).

| Forward Clutch Piston (3.2L "SHO" Models Only) ..... | F4DZ-7A262-B |

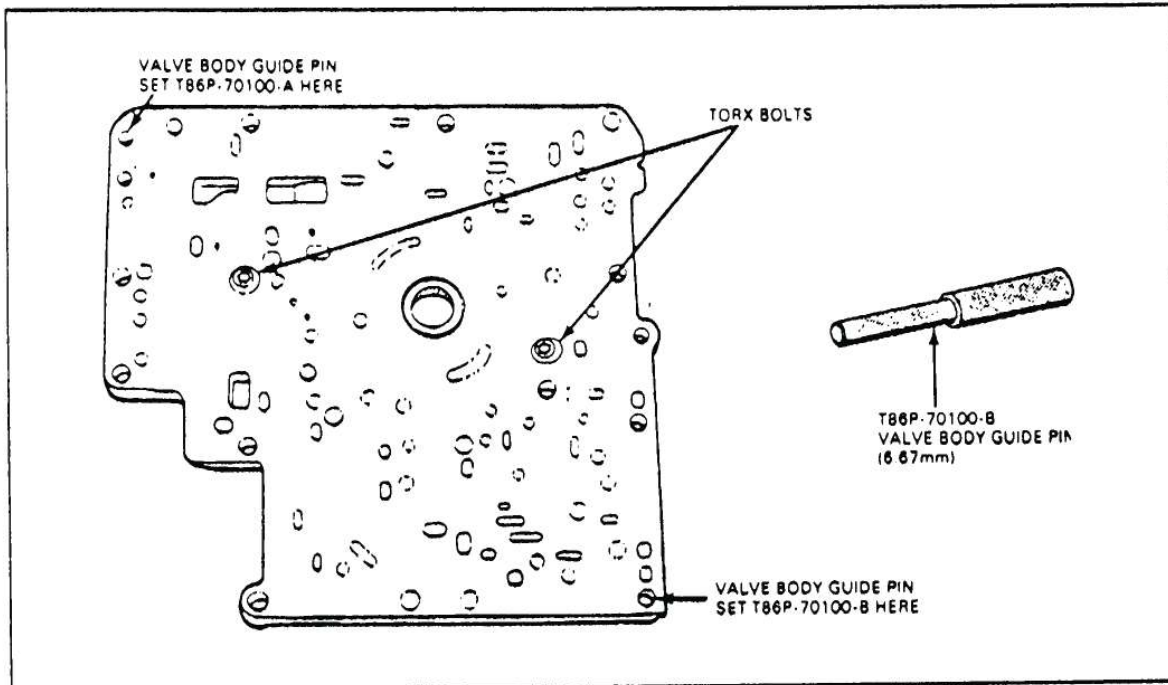
Figure 44

Proper alignment of the oil pump and the valve body are mandatory to prevent premature wear of the oil pump drive shaft and the bearing assembly located in the pump housing. When re-assembling the valve body and oil pump, use the guide pins to assure proper alignment.

1. Position the spacer plate on the pump housing, using a new gasket.
2. Insert valve body guide pin T86P-70100-A (.271" Diameter) and valve body guide pin T86P-70100-B (.262" Diameter), as shown in Figure 44.
3. Install two "Torx" bolts and torque to 7 to 9 ft.lb.
4. Remove both guide pins.
5. Position the spacer plate on the valve body using a new gasket.
6. Insert two valve body guide pins T86P-70100-A (.271" Diameter, as shown in Figure 45.
7. Install two "Torx" bolts and torque to 7 to 9 ft.lb.
8. Position the oil pump on the valve body using a new gasket.
9. Insert pump body guide pin T86P-70370-A and valve body guide pin T86P-70100-C which is .245" in Diameter.
10. Install two valve body to oil pump retaining bolts and torque to 7 to 9 ft.lb.

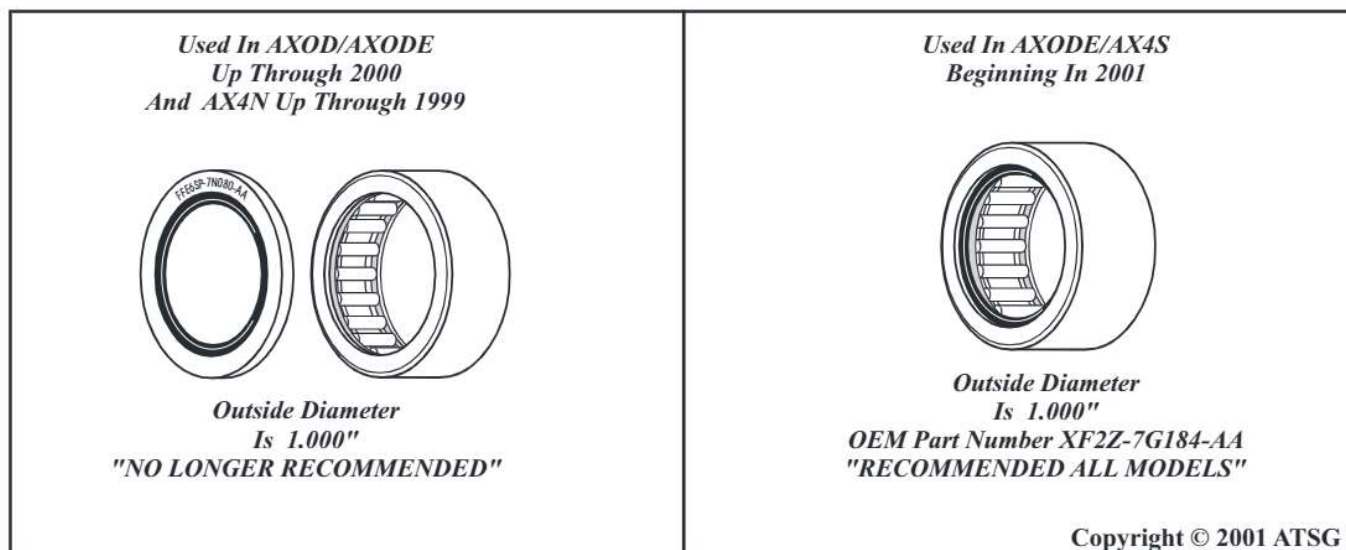
Figure 47

**CHANGE:** Beginning at the start of production for 2001 on all AX4S transaxles, Ford Motor Company introduced a new design pump bearing that includes an integrated seal, as shown in Figure 47. When this new design bearing and seal assembly went into production, it was installed with the ***seal on the valve body side of the pump instead of the rotor side.***

**REASON:** Greatly reduced pump bearing, pump rotor and vane ring failure, for much improved durability and reliability.

Pump Bearing With Integral Seal ..... XF2Z-7G184-AA

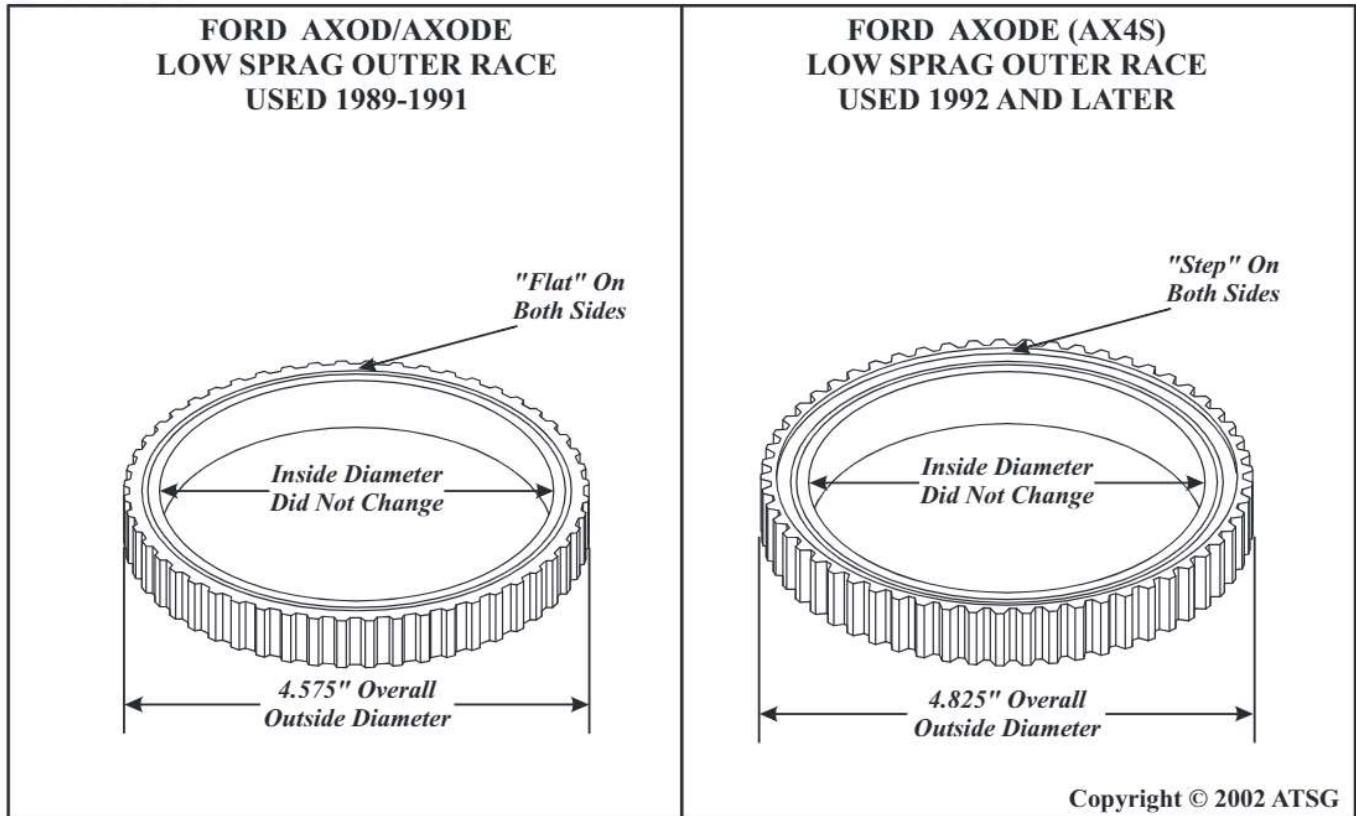
Figure 57

- (1) LOW SPRAG OUTER RACE - The outer diameter of the race was increased from 4.575" to 4.825", and the width of the race was increased from .600" to .725", as shown in Figure 57. ***The Inside Diameter of the sprag race Did Not Change.***

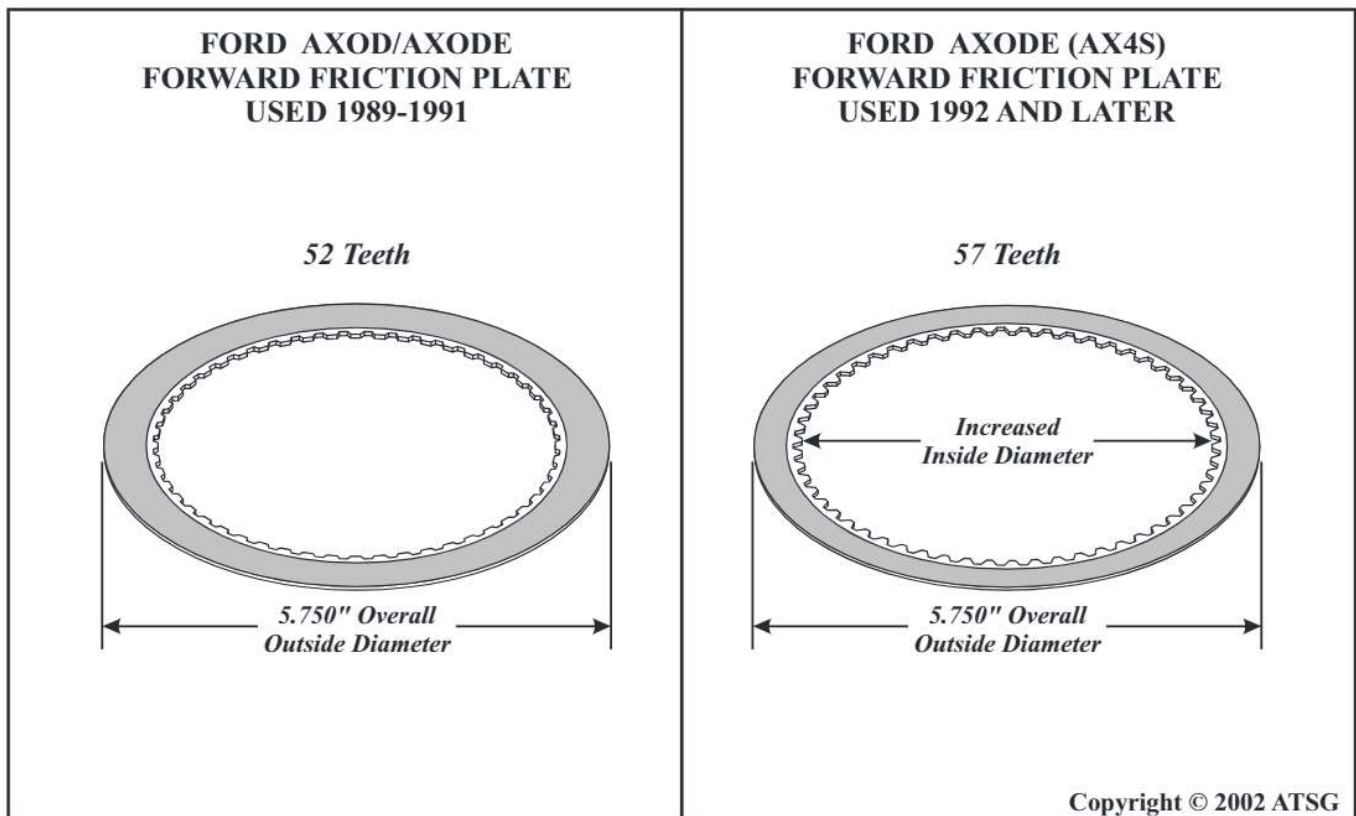
Figure 58

- (2) FORWARD CLUTCH FRICTION PLATES - Have an increased amount of teeth to 57 Teeth from the previous 52 Teeth, to accommodate the increased diameter of the sprag outer race, as shown in Figure 58.

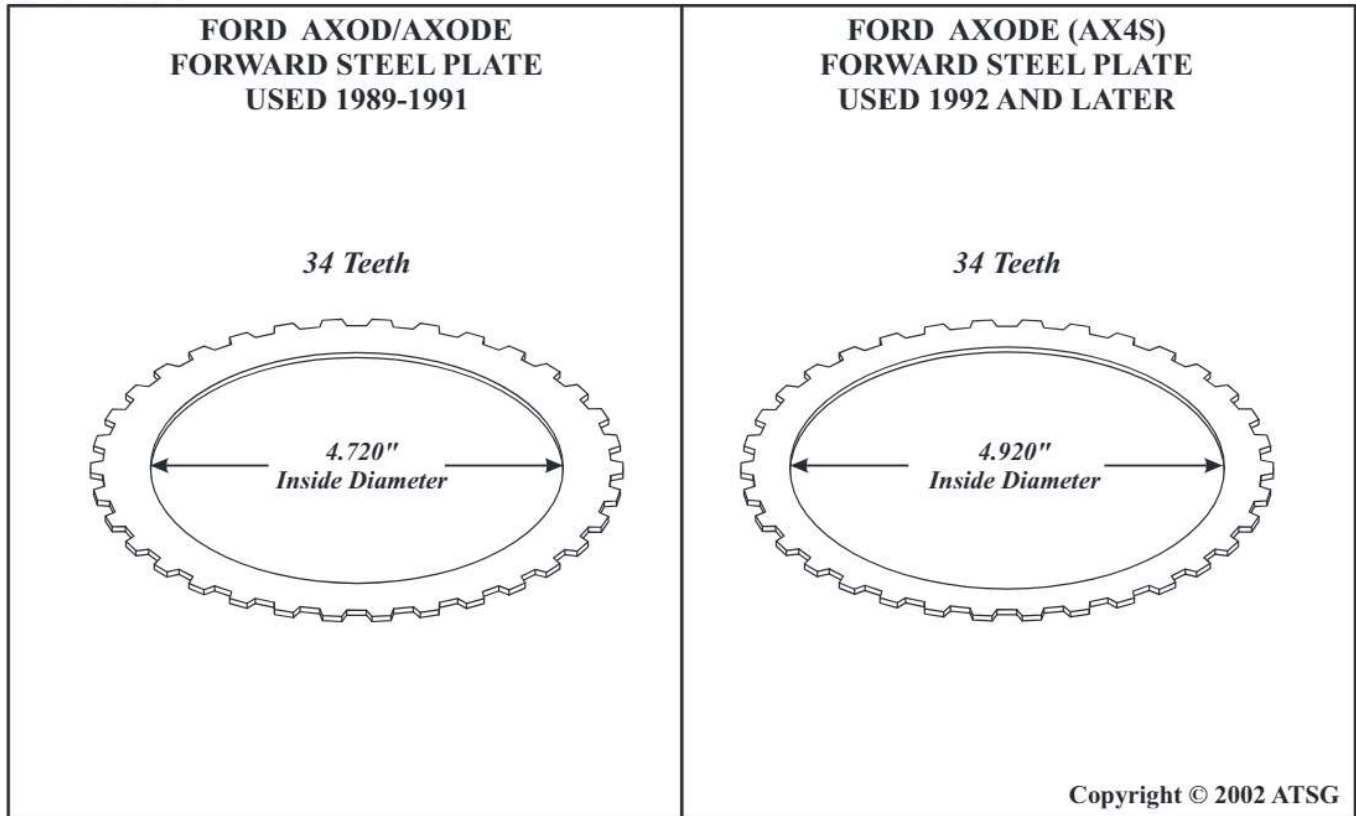
Figure 59

- (3) FORWARD CLUTCH STEEL PLATES - Have an increased inside diameter to 4.920" from the previous 4.720", to accommodate the increased diameter of the sprag outer race, as shown in Figure 59.

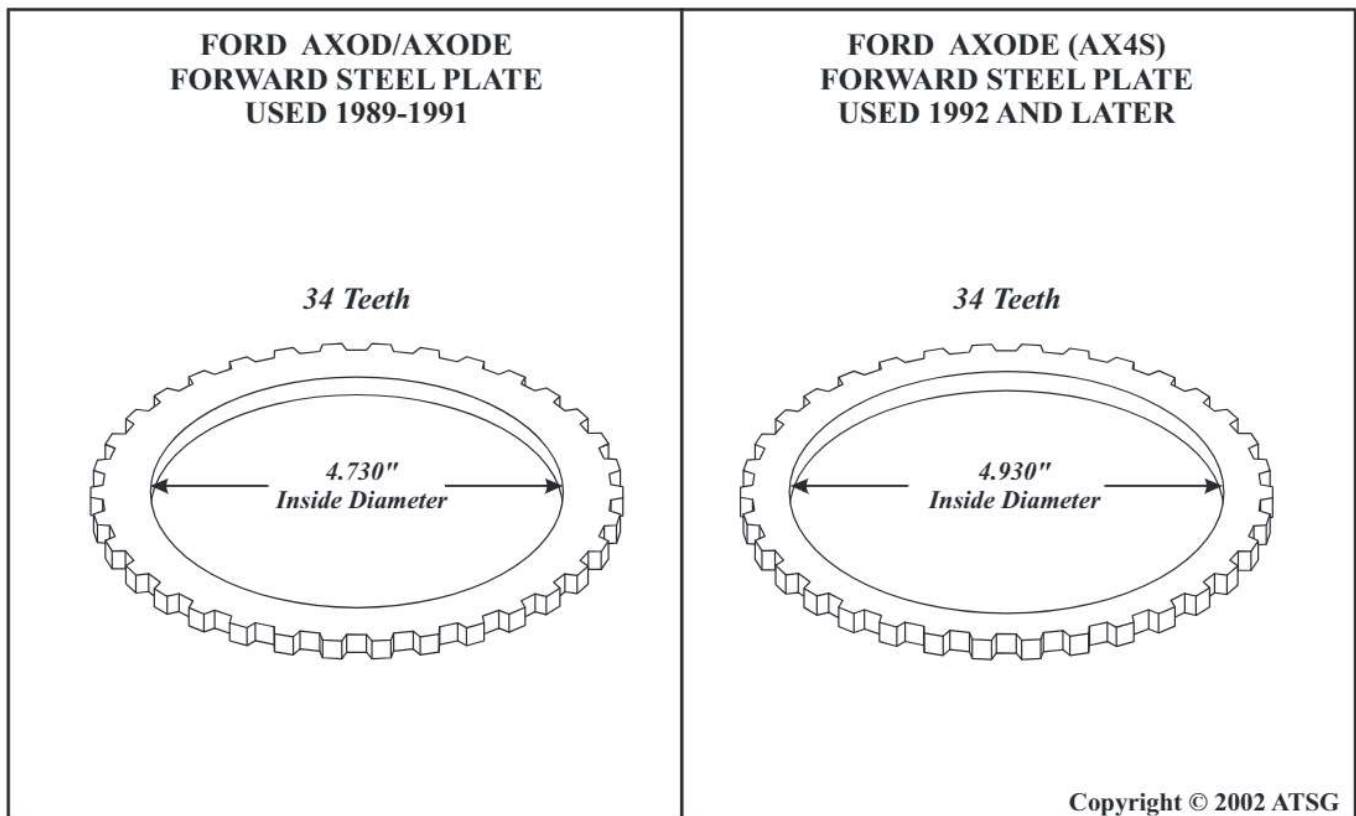
Figure 60

- (4) FORWARD CLUTCH PRESSURE PLATE - Has an increased inside diameter to 4.930" from the previous 4.730", to accommodate the increased diameter of the sprag outer race, as shown in Figure 60.

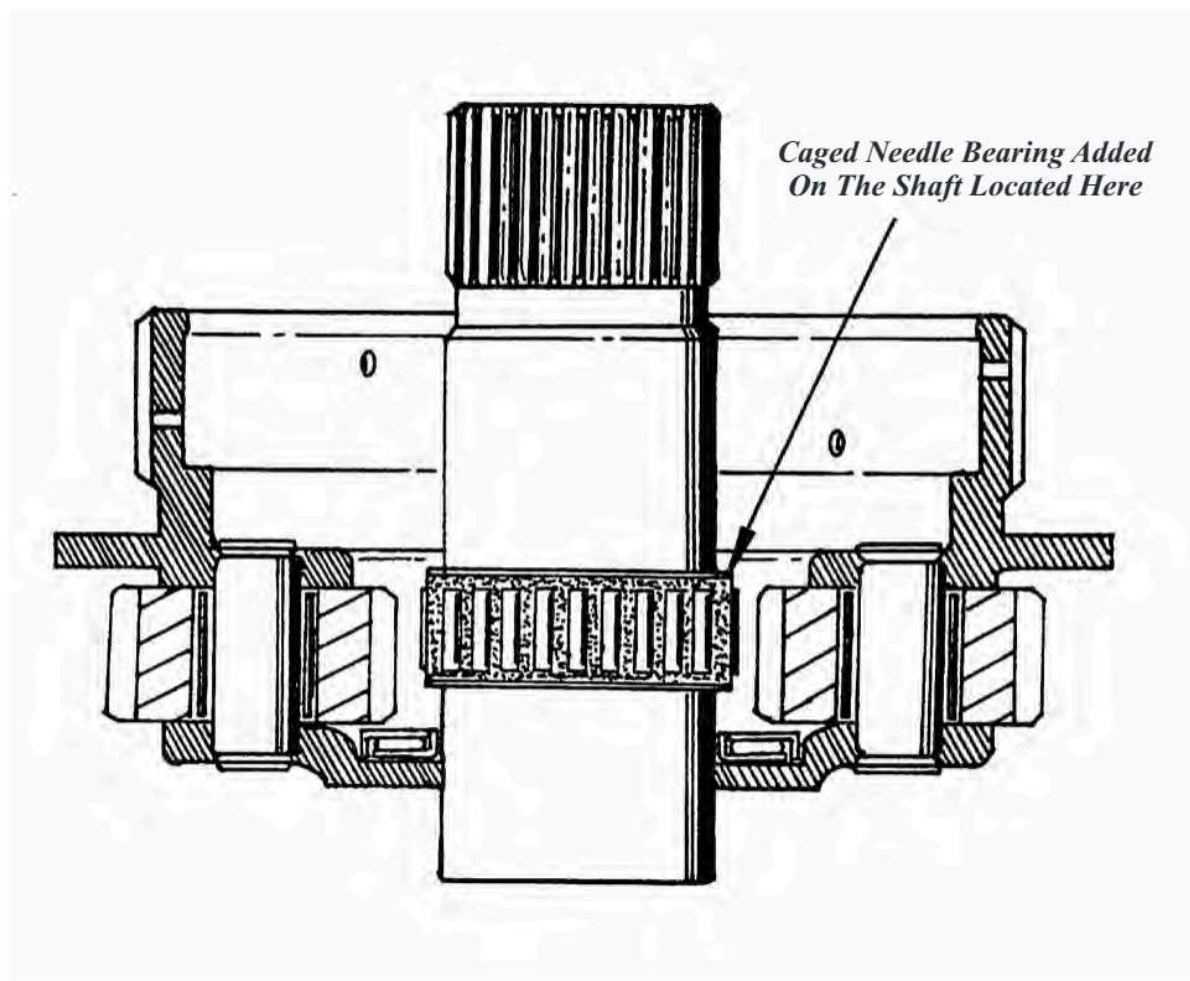
Figure 62

- (1) INPUT PLANETARY CARRIER - New caged needle Bearing added to the shaft on the Input Planetary Carrier, as shown in Figure 62.
- (2) SUN GEAR AND SHELL ASSEMBLY - Single bushing is now located in front of the lube holes in the sun gear, and the area behind is now machined to accommodate the new caged needle bearing, as shown in Figure 63.

When you order an Input Planetary Carrier and/or a Sun Gear and Shell assembly from OEM, they will automatically supercede to the new service package part number F4DZ-7A398-A, which includes both of the new design parts listed above.

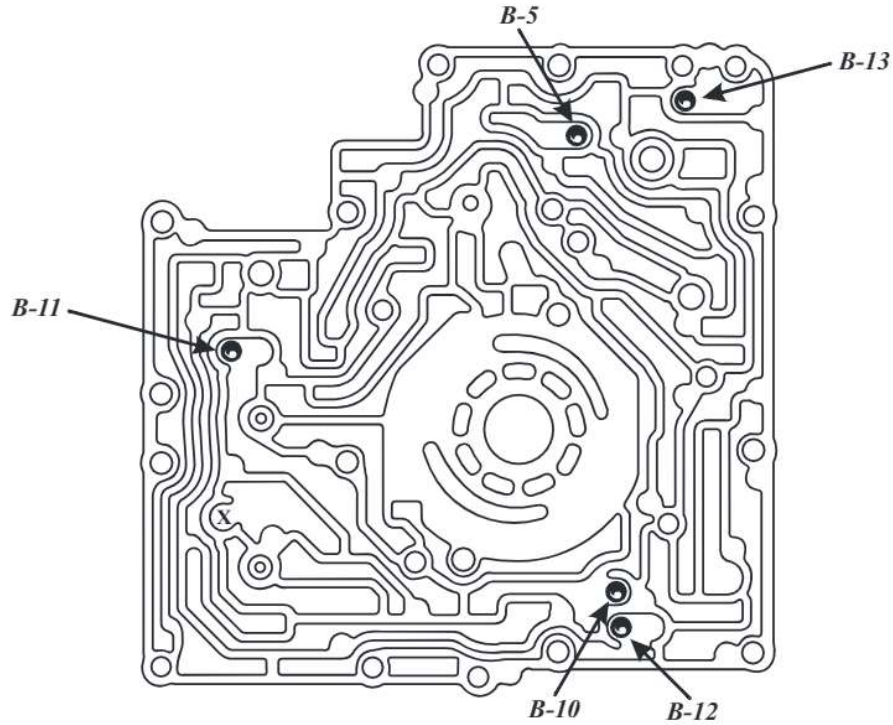
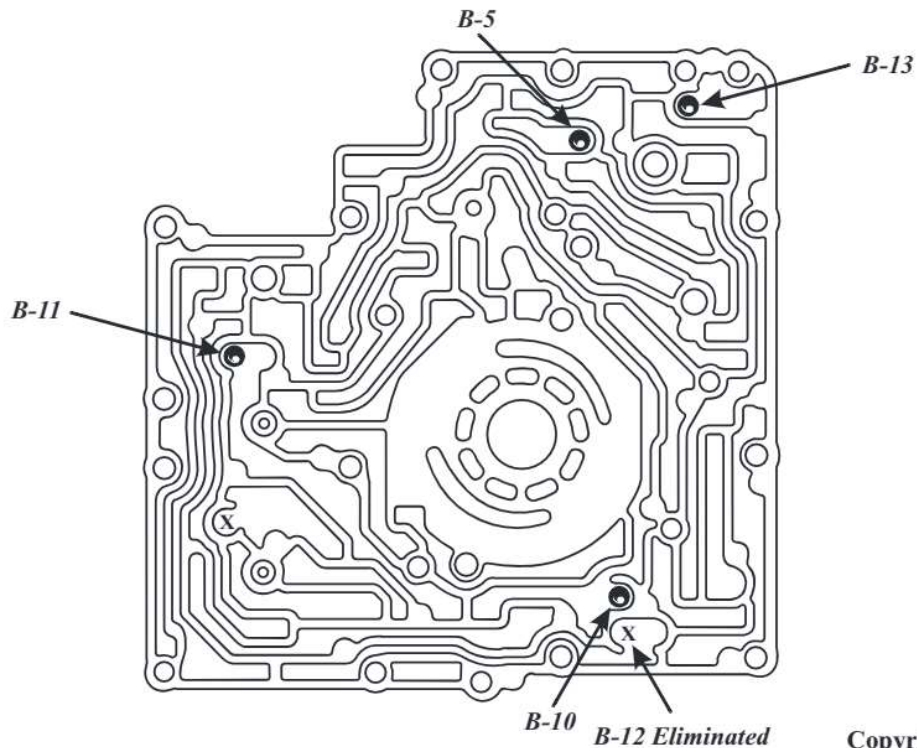
Figure 65

*"Early" 1991 Only - Uses 5 checkballs in the locations shown in Figure 65. Use chart above to determine Early or Late transaxle by serial number.*

*"Late" 1991 Only - Uses 4 checkballs in the locations shown in Figure 65. Use chart above to determine Early or Late transaxle by serial number.*

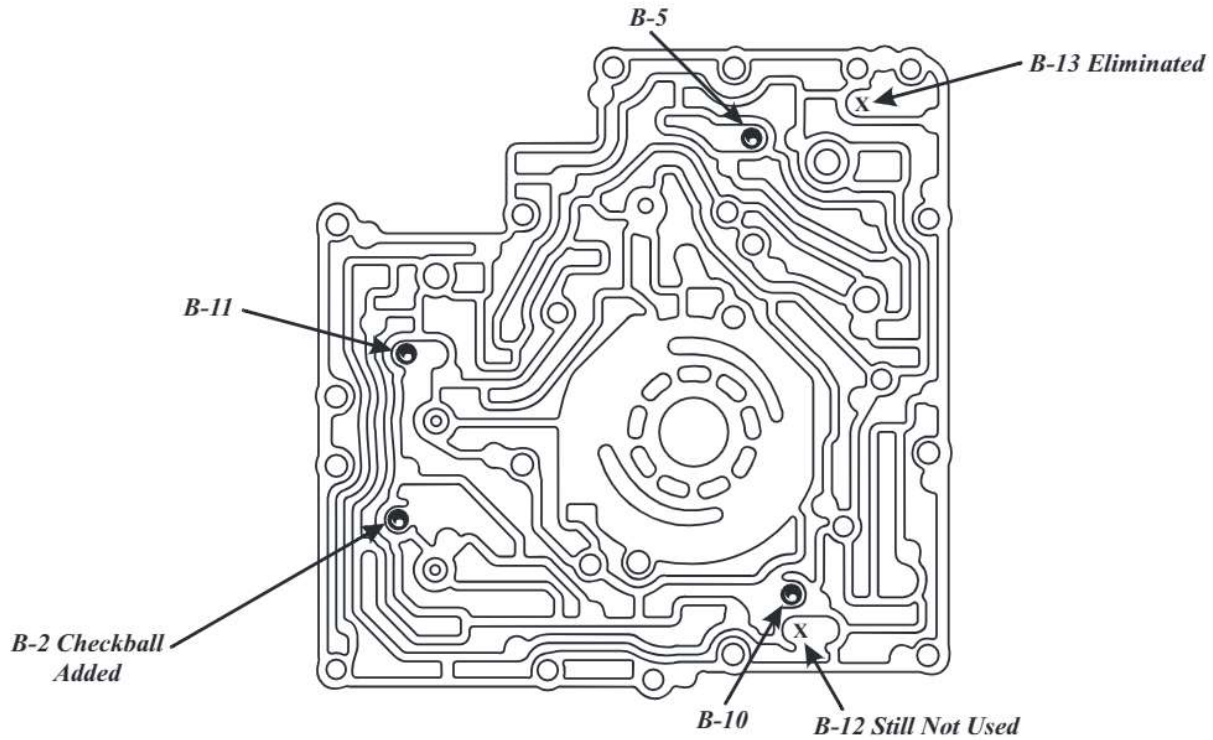
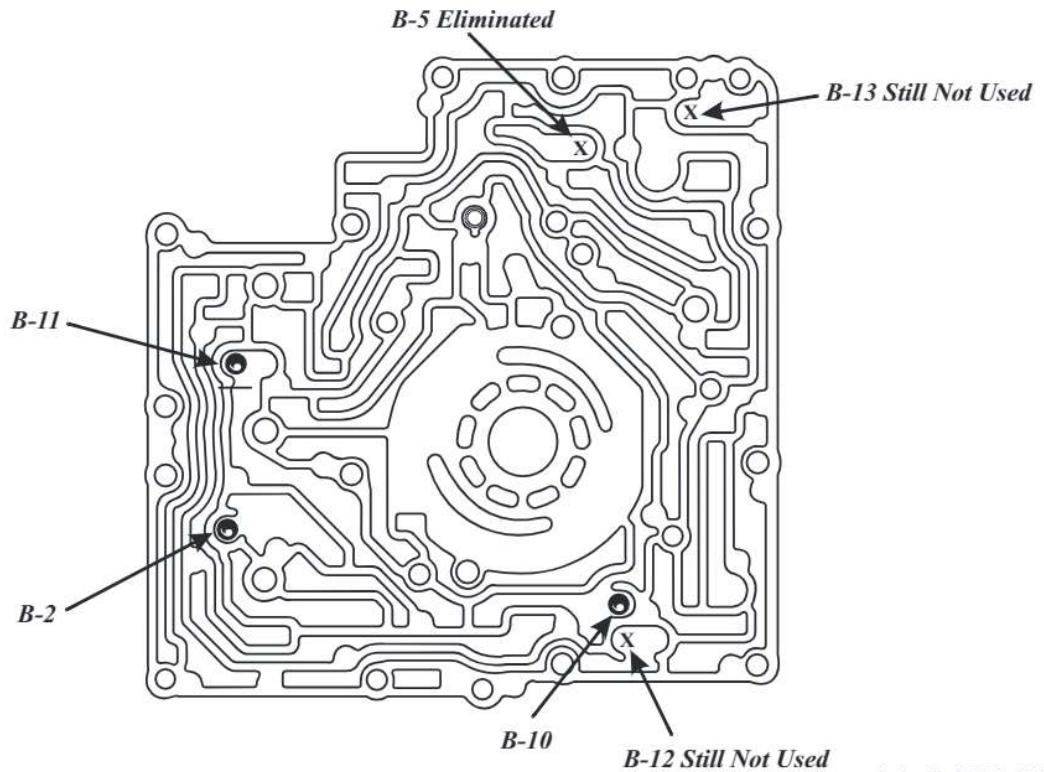
Figure 66

*1992-1998 Only - Uses 4 checkballs but in different locations, as shown in Figure 66. B-13 checkball was eliminated and B-2 checkball was added.*

*1999-2002 Only - Uses 3 checkballs in the locations shown in Figure 66. B-5 checkball was eliminated.*

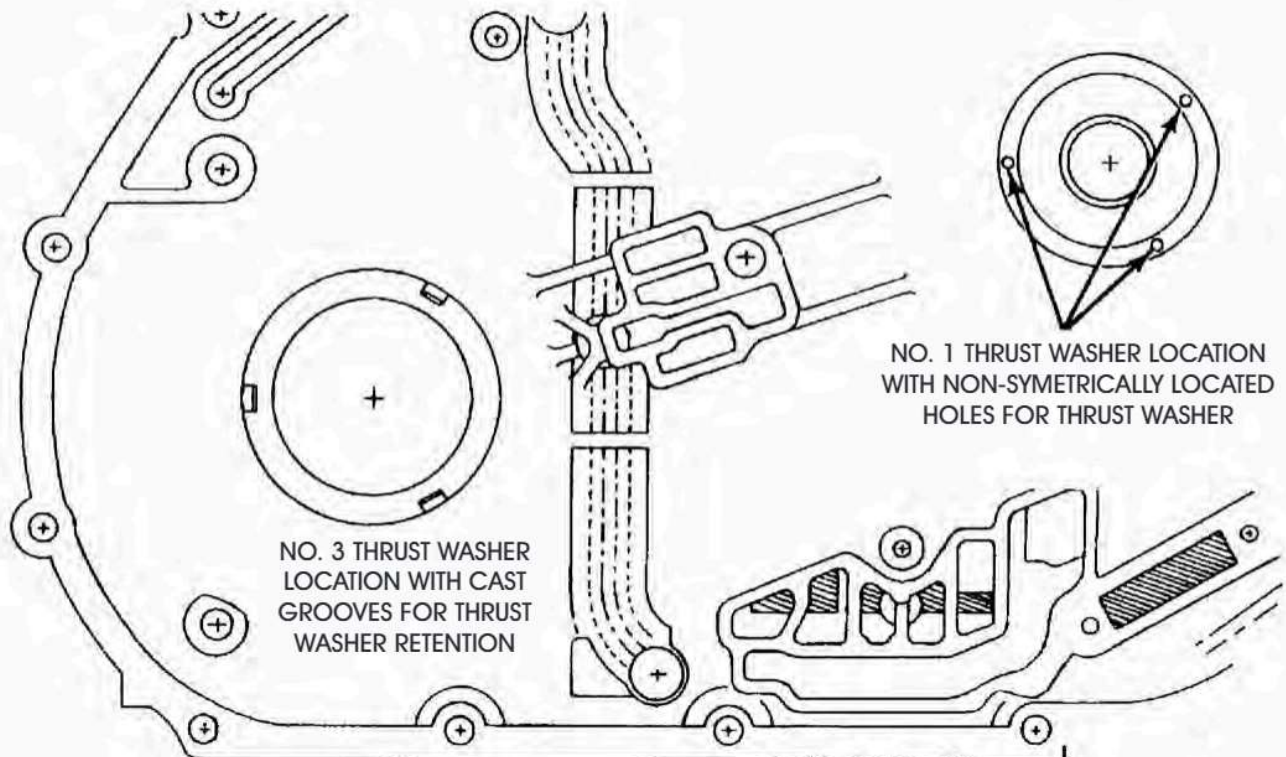
Figure 85

- (3) **CHAIN COVER** - New design will accept either the previous bronze No. 3 thrust washer with the tangs on outside diameter, or the new design Black plastic No. 3 thrust washer with the 3 symmetrically located tabs, as shown in Figure 86.  
The previous design Chain Cover will accept **only** the bronze No. 3 thrust washer with the tangs on the outside diameter, as shown in Figure 85.  
The new design Chain Cover will accept **only** the new design No. 1 thrust washer with 3 symmetrically located tabs, as shown in Figure 86.  
The previous design Chain Cover will accept **only** the previous design No. 1 thrust washer with 3 non-symmetrically located tabs, as shown in Figure 85.

If replacement of the number 1 and/or the number 3 thrust washer becomes necessary, inspect the chain cover in the thrust washer tab areas to determine the correct thrust washers required. Refer to Figures 85 and 86.

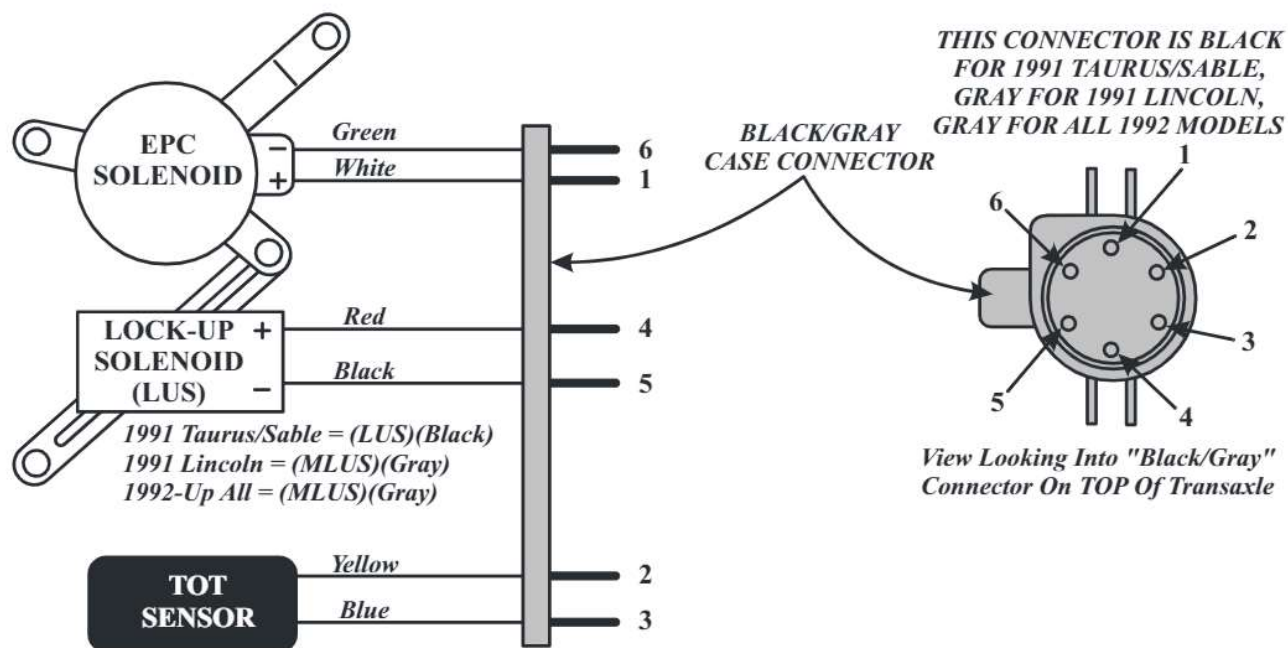
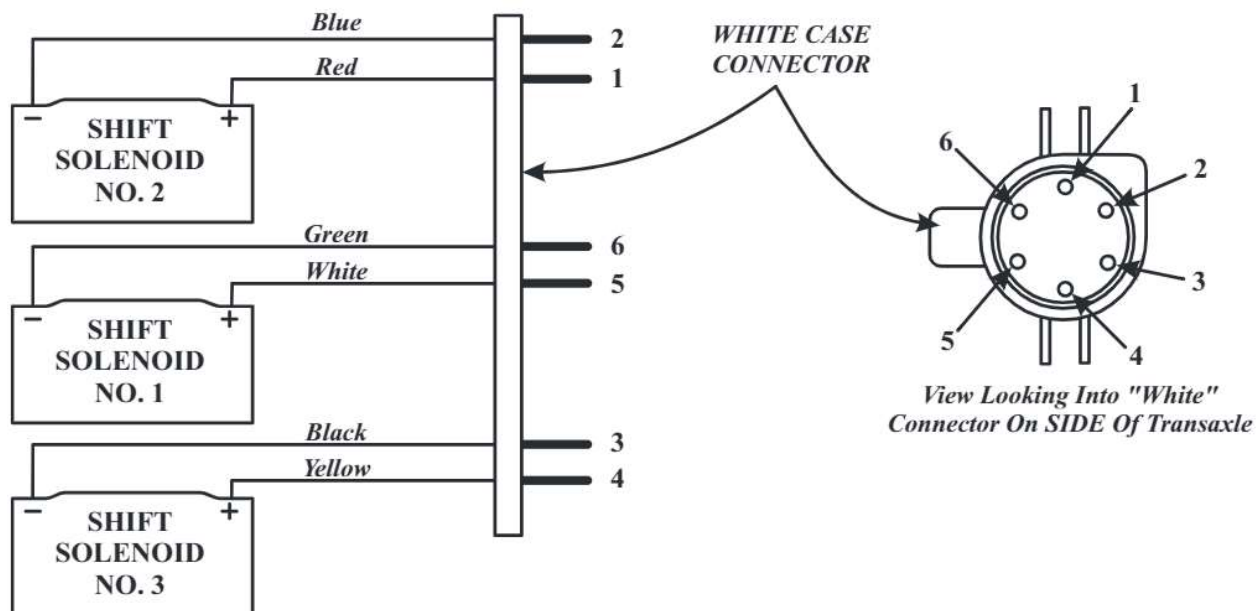
Figure 88

Wires for the Electronic Pressure Control solenoid are fed through pins 1 and 6 of the "Black/Gray" case connector, located on top of the transaxle (See Figure 88). Ohmmeter across terminals 1 and 6 should read 2.5-6.5 Ohms resistance.

Wires for the Modulated Lock-Up Solenoid (MLUS) are fed through pins 4 and 5 of the "Gray" case connector, located on top of the transaxle (See Figure 88). Ohmmeter across terminals 4 and 5 should read 0.75-2.0 Ohms resistance if you have MLUS. The Modulated Lock-Up Solenoid (MLUS) is found on the **Lincoln Only** for the 1991 model year. Taurus/Sable for 1991 are the regular Lock-Up Solenoid (LUS) that is described below. **All models for 1992 model year are MLUS.**

Wires for the Lock-Up Solenoid (LUS) are fed through pins 4 and 5 of the "Black" case connector, located on top of the transaxle (See Figure 88). Ohmmeter across terminals 4 and 5 should read 16-40 Ohms resistance if you have LUS. The Lock-Up Solenoid (LUS) is found on the **Taurus/Sable Only** for the 1991 model year. Lincoln for 1991 is the Modulated Lock-Up Solenoid (MLUS) that is described above. **All models for 1992 model year are MLUS.**

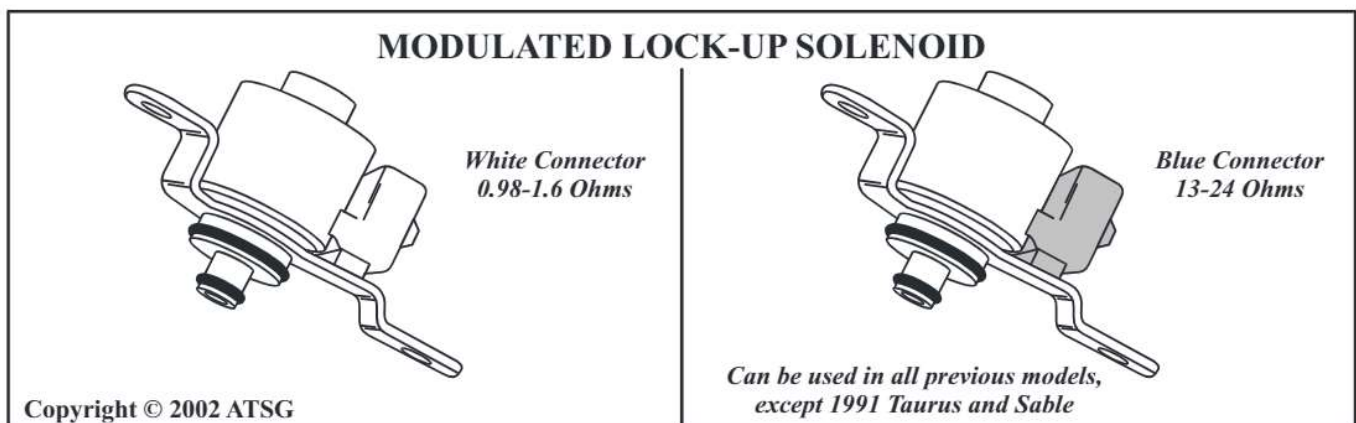
Figure 92

- MODULATED LOCK-UP SOLENOID - The new design MLUS is round, like the previous (1) design solenoid, but has a **blue** connector instead of the previous white, and a resistance value of **13-24 Ohms**, instead of the previous 0.98-1.6 Ohms resistance (See Figure 92).

The O.E. Manufacturer first advised not to interchange the solenoids, but has since backed off of that statement, as the only MLUS now available is the new design with the blue connector and higher resistance. ATSG has seen **no problems** with installing the new design MLUS on the previous model transaxles, **except** 1991 Taurus and Sable which are non-modulated models. Use the chart in Figure 93 to check the resistance of the MLUS through the case connector to determine which solenoid is in the transaxle.

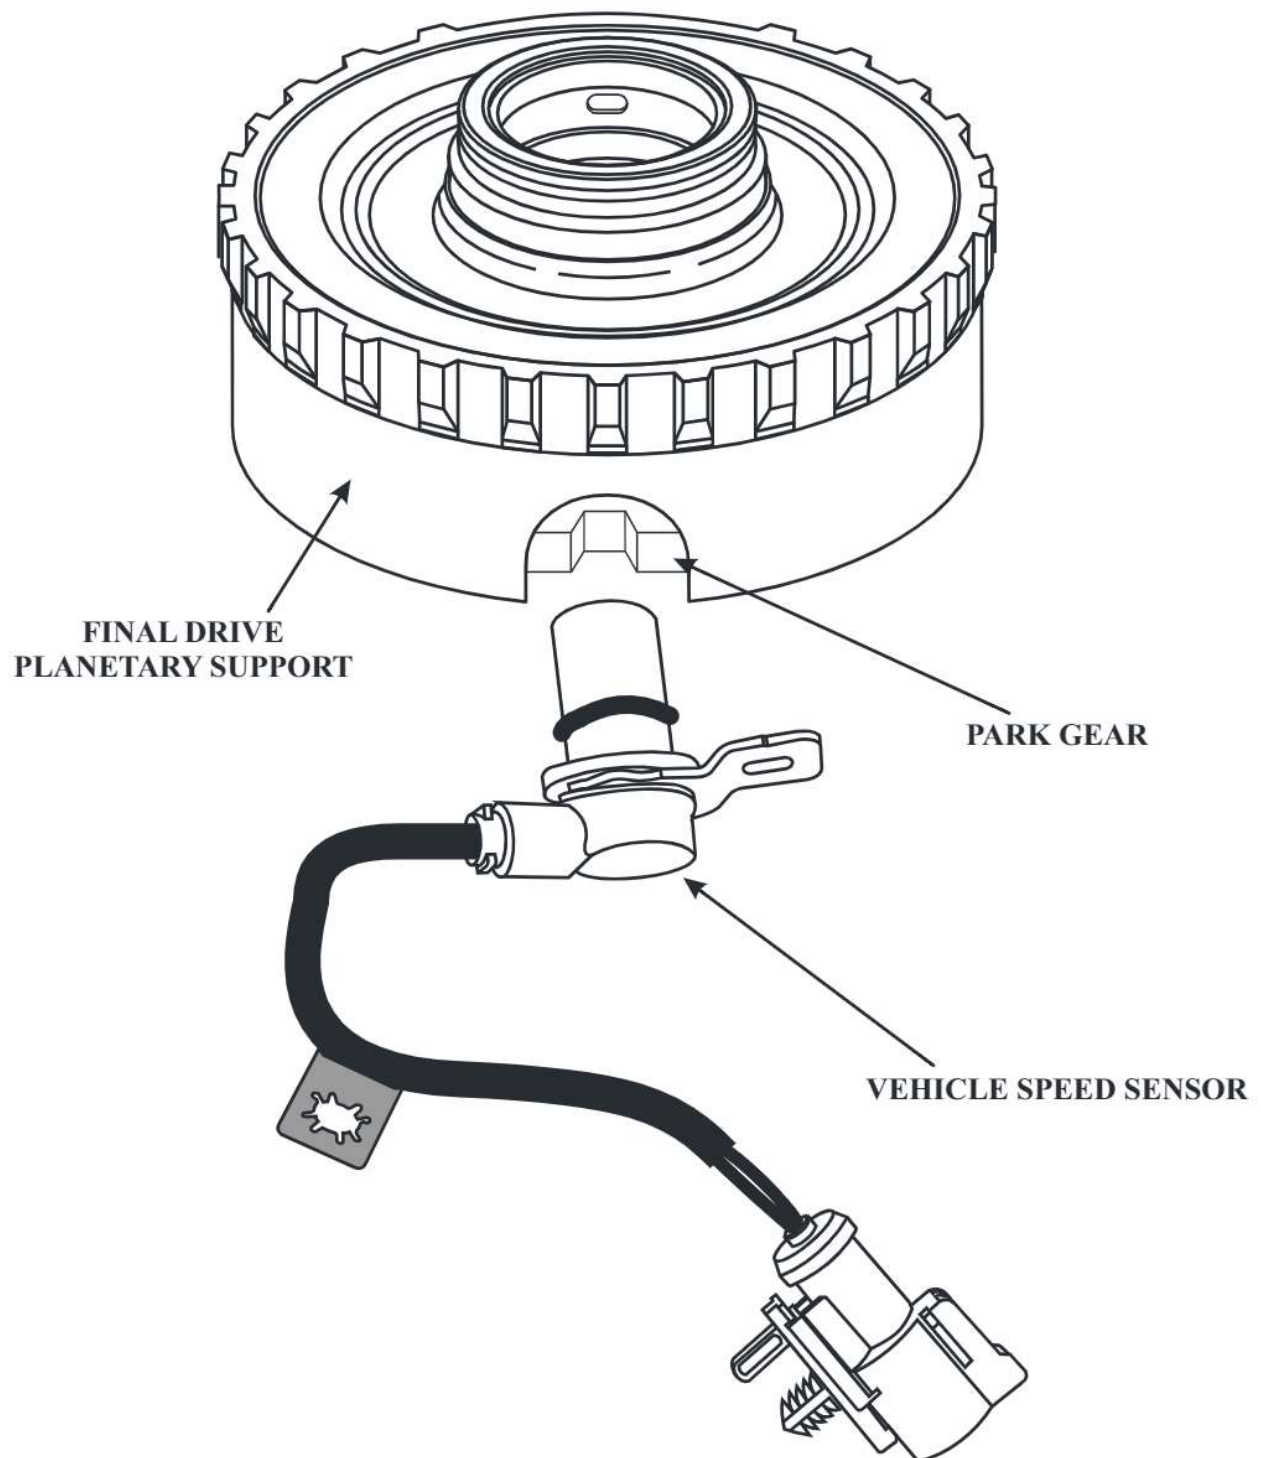
Figure 94

- (1) TRANSAXLE CASE - Changed to accommodate mounting the new design speed sensor so that it is in line with the planetary support and the park gear.
- (2) FINAL DRIVE SUPPORT - Changed to accommodate mounting the new design speed sensor and now has a **"cut out"** for the speed sensor to look through at the park gear, as shown in Figure 94.
