## AXOD/AXODE (AX4S) UPDATE HANDBOOK

# Technical Service Information

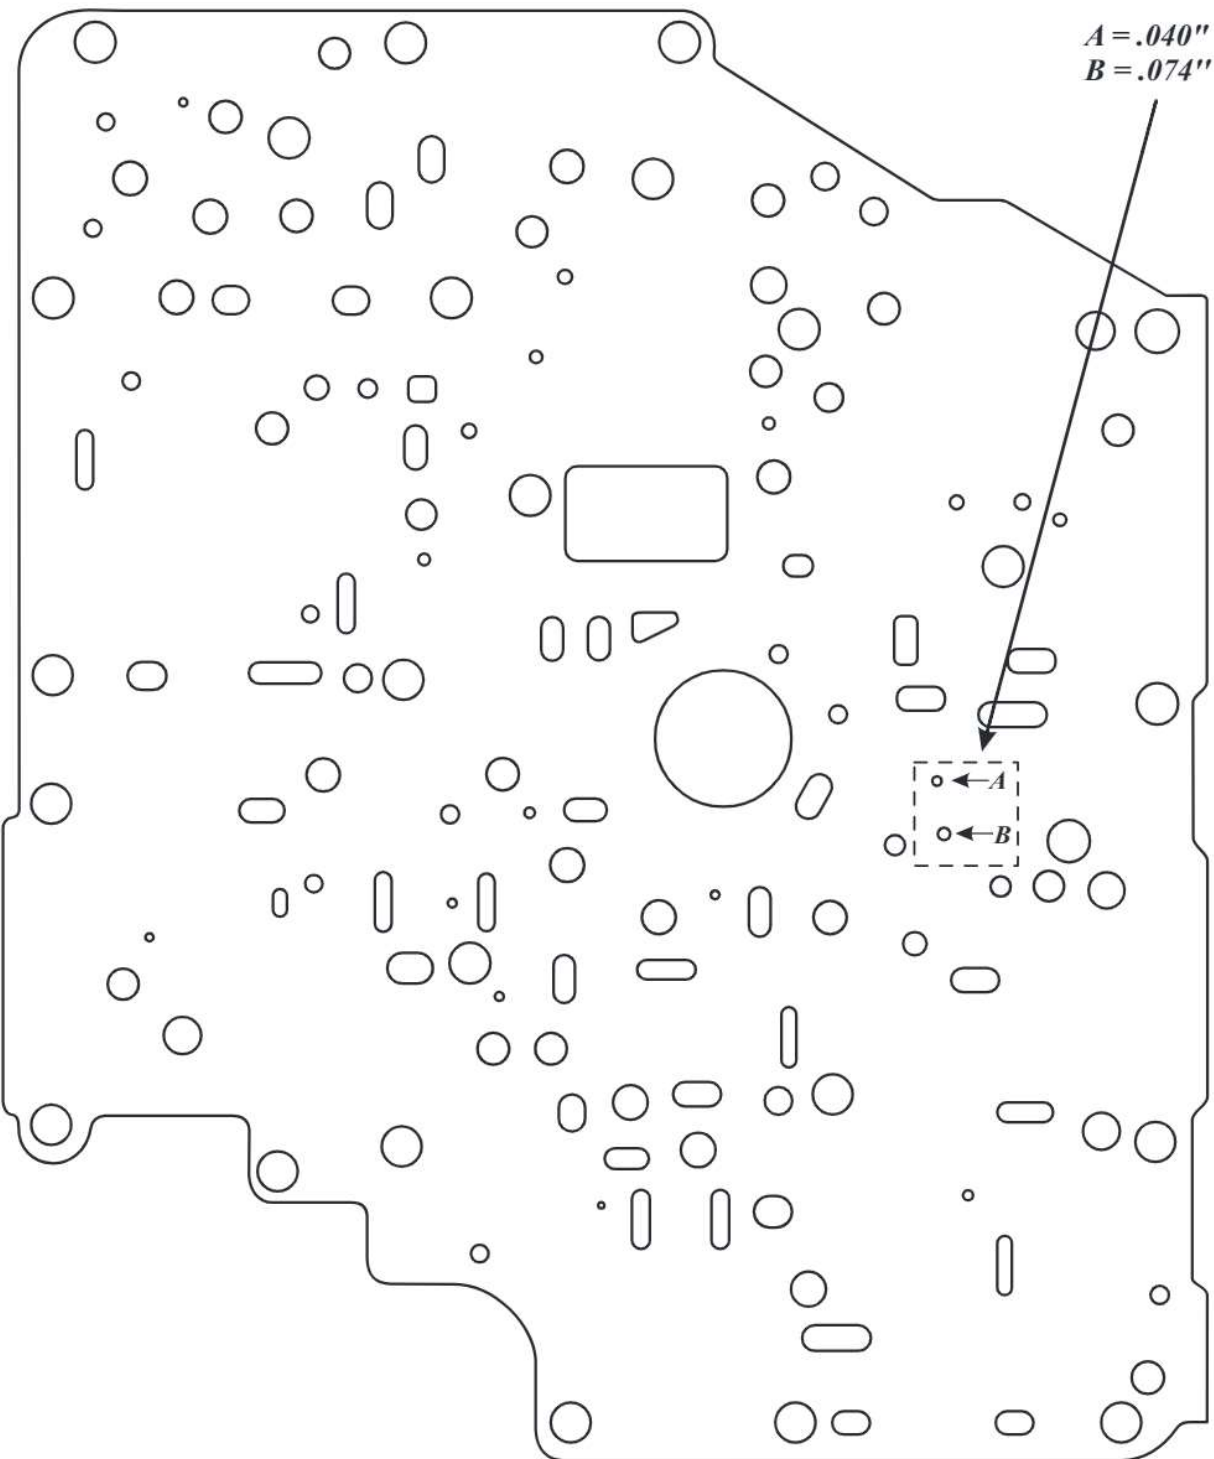
**CAUSE:** The cause may be, a valve body spacer plate designed for the Taurus, Sable, Continental passenger car family, has been installed on a Windstar Van, creating a harsh 1-2 upshift. If the Windstar Van valve body spacer plate, is installed on the Taurus, Sable, Continental family of vehicles, the result will be a soft or flared 1-2 upshift. ***Obviously these two spacer plates are different.*** Refer to Figures 101 and 102, using the two holes over the 1-2 capacity modulator valve area, for identification.

**CORRECTION:** Install the proper valve body spacer plate for the Ford family that you happen to be servicing at this time. Refer to the illustration in Figure 101 to identify the valve body spacer plate for the Windstar Van. Refer to the illustration in Figure 102 to identify the valve body spacer plate for the Taurus, Sable and Continental family.

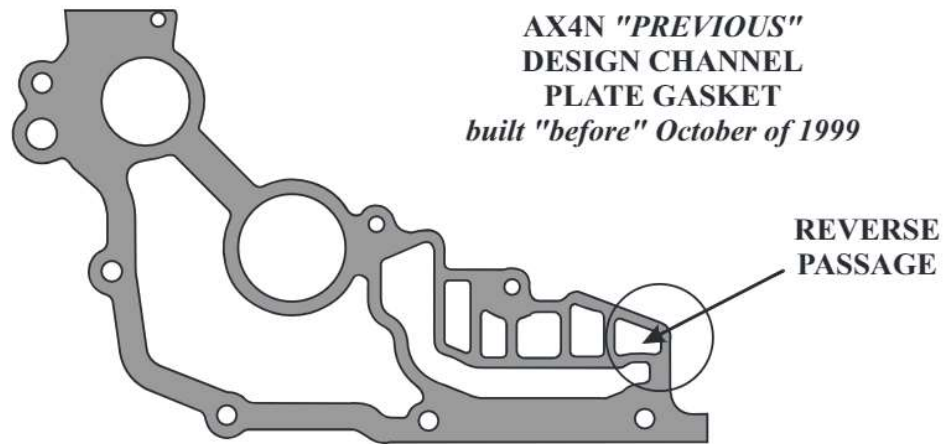
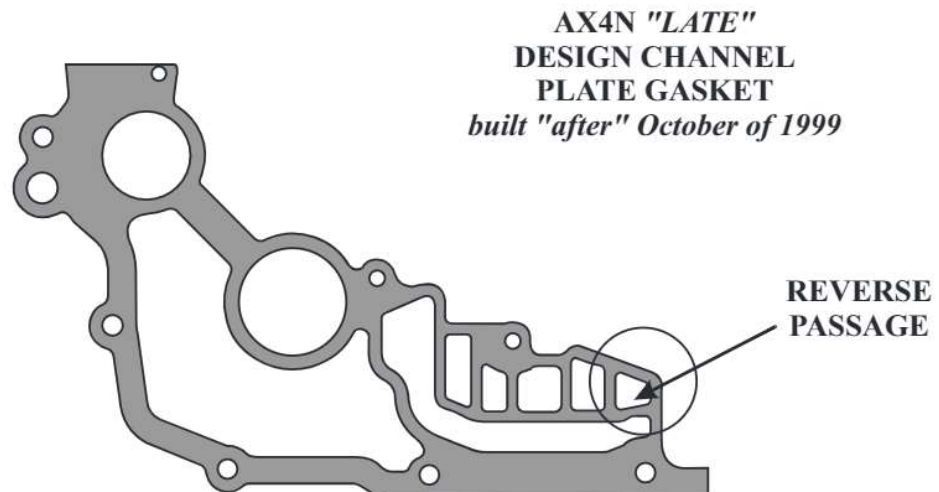
**CAUSE:** The cause may be, that the *Previous Design* Channel Plate Gasket, was used on a *Late Design* case as shown in Figure 103. When this happens, Reverse apply pressure will be exhausted back into the case because of the gasket hanging over the case casting.

**CORRECTION:** AX4S-Refer to Figure 103 to identify the correct Channel Plate Gasket for the application of vehicle you are working on.  
AX4N-Refer to Figure 104 to identify the correct Channel Plate Gasket for the application of vehicle you are working on.
