## AUTOMATIC TRANSMISSION SERVICE GROUP

### THM 125C

Since the introduction of the THM 125 transaxle in model year 1980, there have been many major engineering changes. These changes have affected nearly every part used in the 125 and 125c.

This Update Handbook will explain each change, the parts affected by the change, any parts interchangeability problems created by the change. This Update Handbook will cover all of the changes from start of production up through and including model year 1987, along with common problems, and fixes, for the THM 125 transaxle.

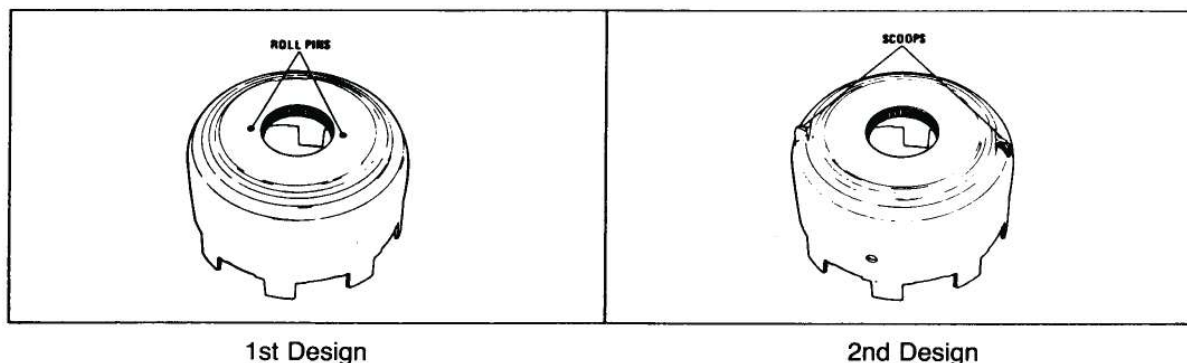
Figure 4

Beginning in early March, 1981, THM 125 transaxles were built with a new design one piece input drum (Sun Gear Shell) to provide better lube oil to the input carrier and improved durability. The low and reverse clutch housing also had to be redesigned to accommodate the revised input drum. See Figures 4 and 5.

The 2nd design input drum (Sun Gear Shell) has scoops stamped into the drum, replacing the 1st design roll pins (See Figure 4). The low and reverse clutch housing is redesigned to allow clearance for the new scoops on the input drum (See Figure 5).

Either the 1st design or 2nd design input drum can be used with the 2nd design low and reverse clutch housing; however, the 2nd design is highly recommended over the previous design.

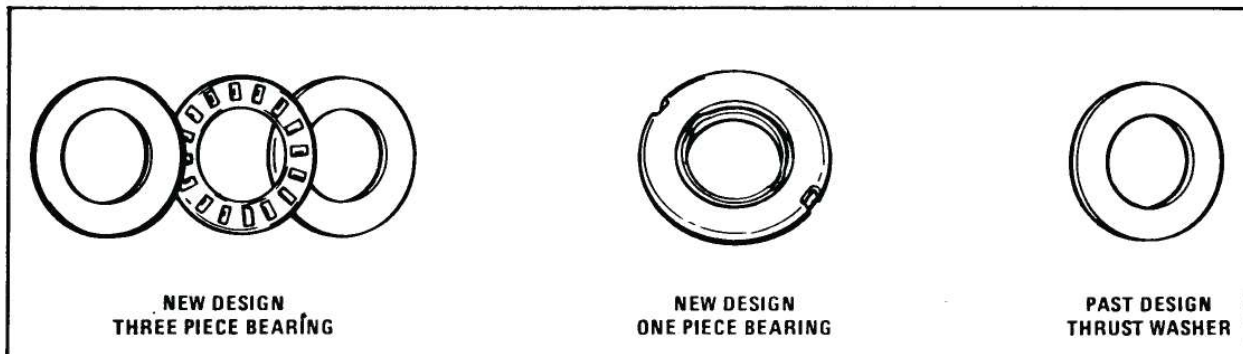
Figure 6

Beginning mid-March, 1981, THM 125 transaxles were built with a new design governor cover bearing in place of the past design thrust washer. This bearing will be one of two designs, (1) a three piece thrust bearing assembly or (2) a one piece bearing (See Figure 6). For service, only the three piece bearing will be used.

- NOTE:** 1) Do not use the three piece bearing assembly or the one piece bearing with the past design governor cover. This combination would not allow proper clearance between the speedometer drive gear and governor cover, causing wear on the governor gear and eventually no upshift.
- 2) Do not use the past design thrust washer with the new design governor cover. This combination would have excess endplay between the speedometer drive gear and the governor cover, causing erratic shifts and speedometer gear wear.

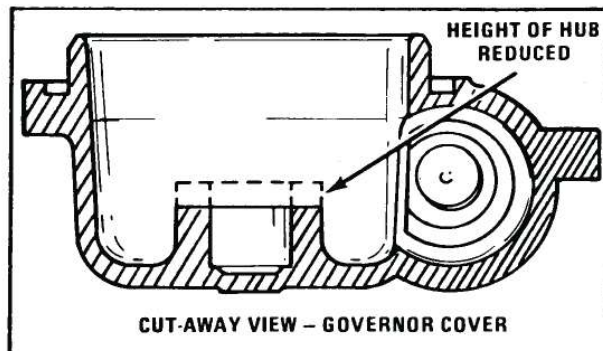
Figure 7

A new design governor cover was also put into production. The height of the governor hub was reduced to allow clearance for the increased thickness of the bearing. (See Figure 7).

This design change was made to reduce friction between the speedometer gear and governor cover during high speed, long distance driving.

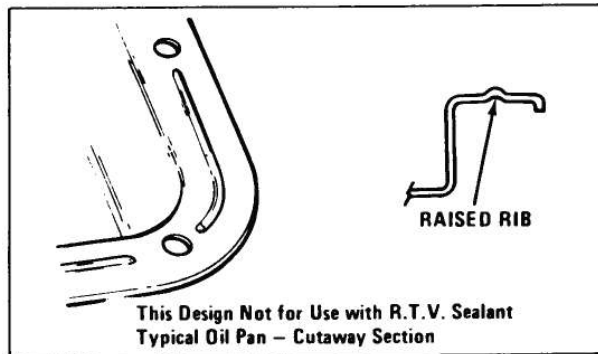
Figure 10

In early May, 1981, some THM 125 transaxles were built with R.T.V. Silicone sealant on the valve body cover and bottom oil pan in place of the cork gaskets. The flange on both the valve body cover and the oil pan were redesigned to eliminate the stiffening rib (Figure 10), making the flange face flat (Figure 11).

Oil pans with raised stiffening ribs on the flange as in Figure 10, must not be assembled with R.T.V. sealant.

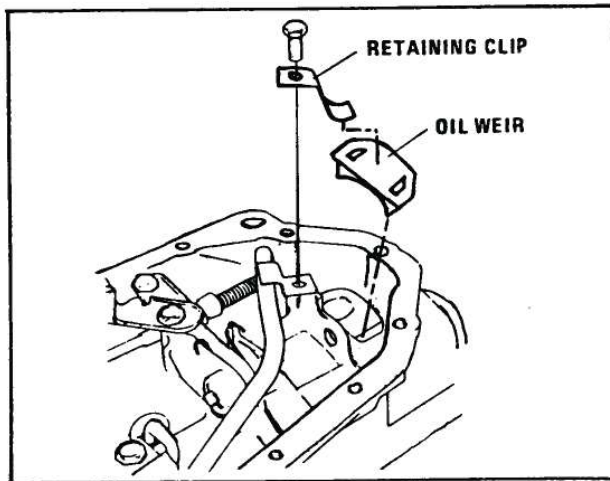
Figure 12

Beginning September, 1981, THM 125 transaxles were assembled with a new part called an oil weir. The oil weir is located in the rear of the case (See Figure 12), and is used to retain more lube flow around the differential Assy.

The extra lubrication was to help eliminate wear patterns in the final drive carrier and on the side gears (See Figure 13).

When the final drive carrier would wear it would first show up as an oil leak at the right hand axle seal. The final drive carrier was also later changed to a hardened surface (Identified by its blackened color), to help eliminate wear in this area.

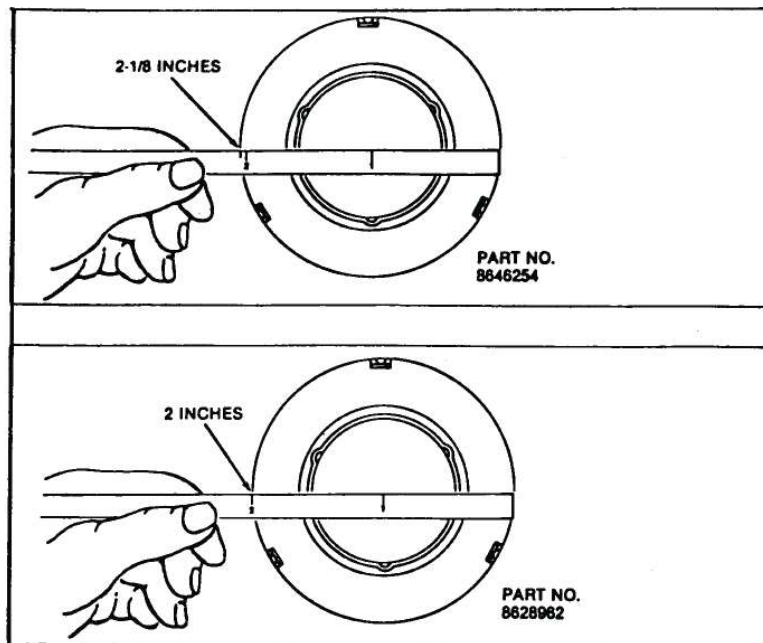
Figure 14

The difference between the two thrust bearing assemblies is the outer diameter size. Also the final drive carrier bearing surface is machined larger to accept the larger outer diameter bearing. See figure 14 for comparison of the bearings.

The two thrust bearings are not interchangeable and damage to the final drive could result if the bearings are mixed.

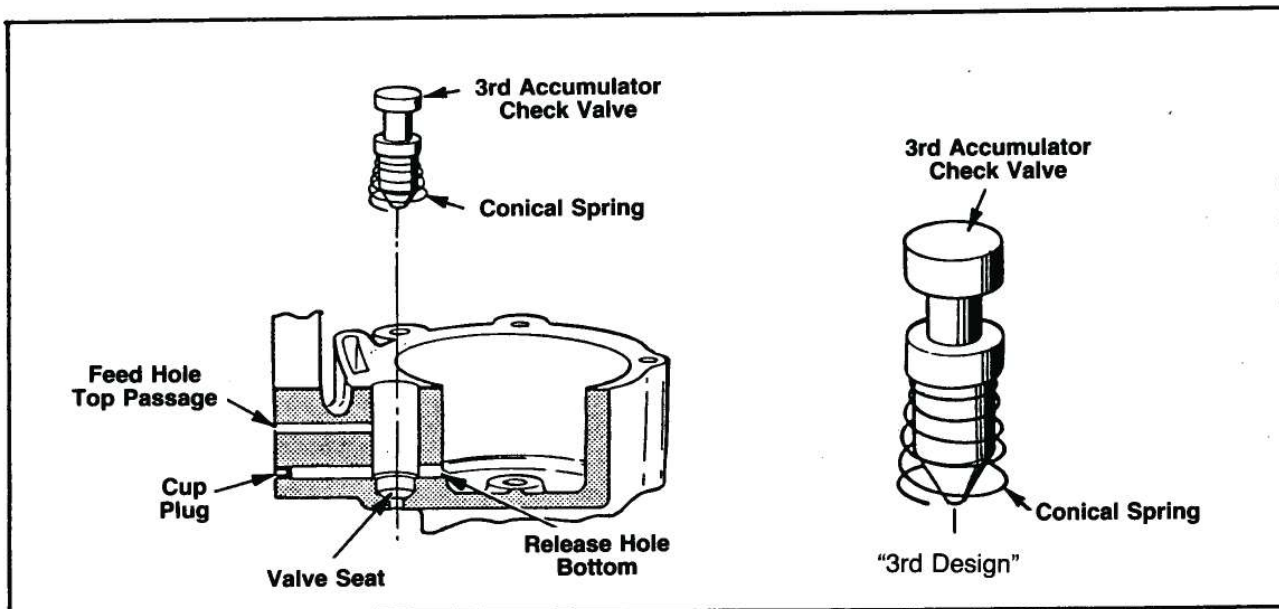
Figure 16

The "Only" 3rd accumulator check valve to be used is shown as the 3rd design in Figure 16, and is available under OEM part number 8643964. Install the new conical valve spring onto the valve (Small end first), and install the assembly into the case bore (Figure 16).

If this valve is leaking the result will be a burnt intermediate band and burnt direct clutch.

If you find a 3rd accumulator check valve like the ones shown in Figure 17, discard them and replace with the 3rd design (8643964).

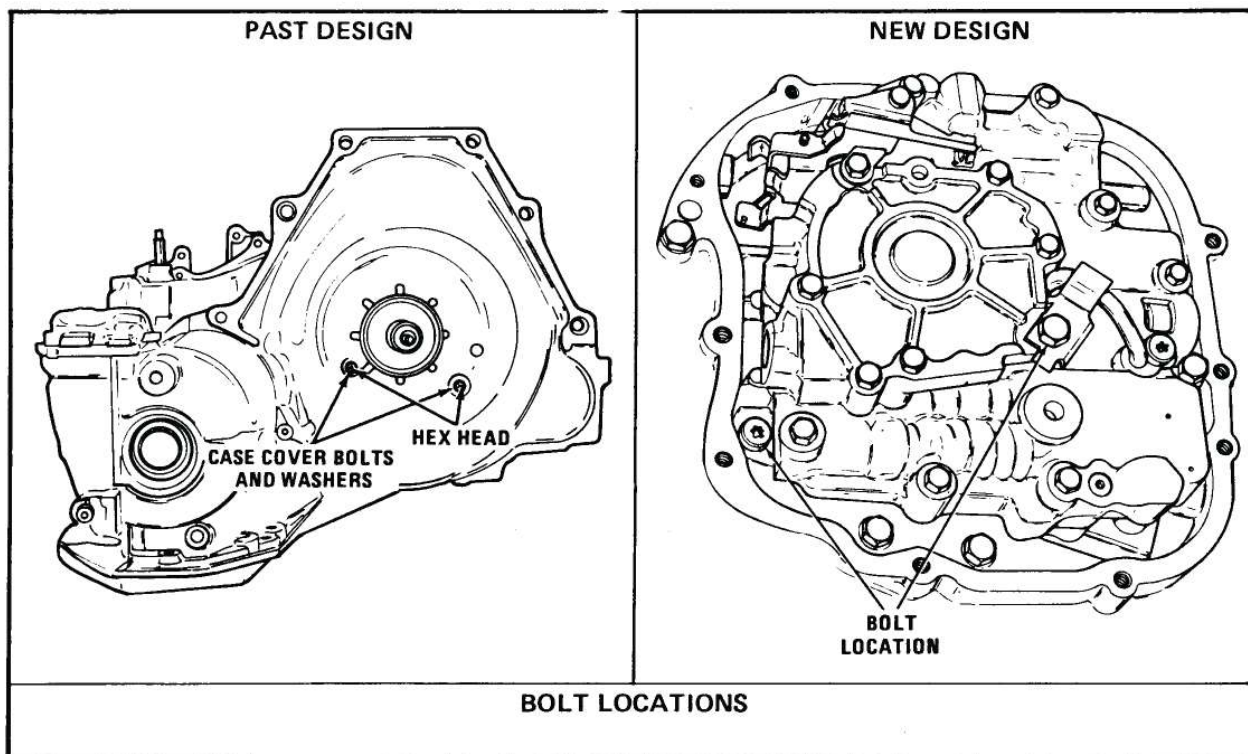
Figure 23

Beginning in late April, 1981, THM 125 transaxles were built with a new design case and case cover. This design change relocated the case to case cover bolts from inside the bell housing to the case cover area to eliminate a possible oil leak location. (Figure 23)

The new design parts and the past design parts are not interchangeable.

When installing the new design bolts, thread sealer must be used on the threads, and the bolts torqued to 15 ft.-lbs.

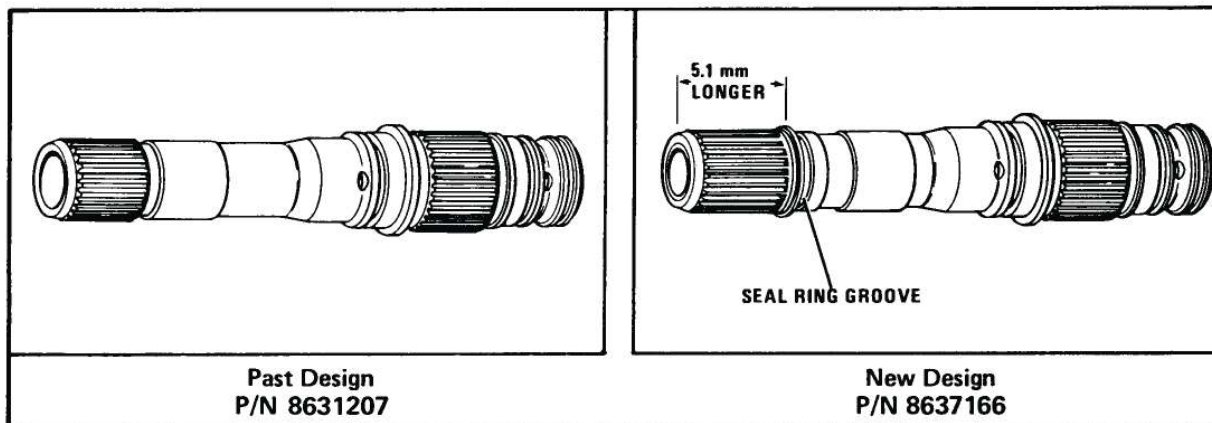
Figure 24

This required a new design turbine shaft, and oil pump drive shaft. The splines of the new design turbine shaft are 5.1mm (.200") longer than the non lock-up, and has an added "O" ring groove (See Figure 24). The new design oil pump drive shaft is 23.7mm (.933") longer than the non lock-up and has 15 teeth on the oil pump spline instead of the past design 20 teeth (See Figure 25). The spline change was implemented to provide more load bearing surface on the teeth to help eliminate stripping of the rotor splines.

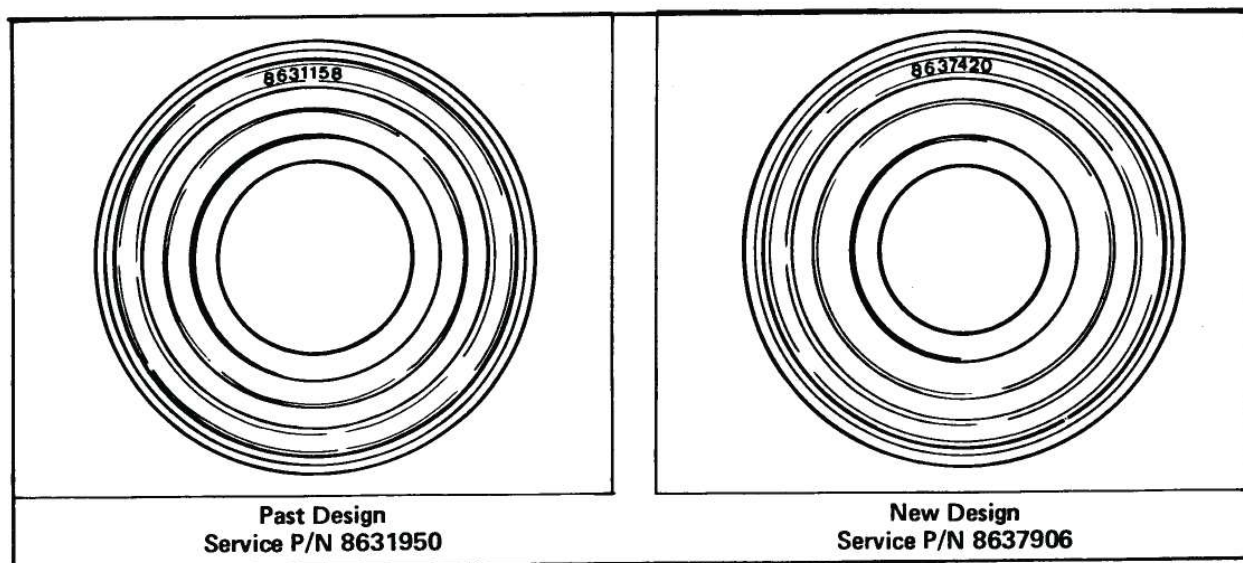
Figure 26

The converter housing seal was also redesigned at the same time, with an additional metal flange pressed into the back of the seal. The additional flange helps retain the garter spring during installation. The new design converter housing seal can be identified by part number 8637420 on the seal. The past design converter housing seal will either have no identification number or will have part number 8631158 on the seal (See Figure 26).

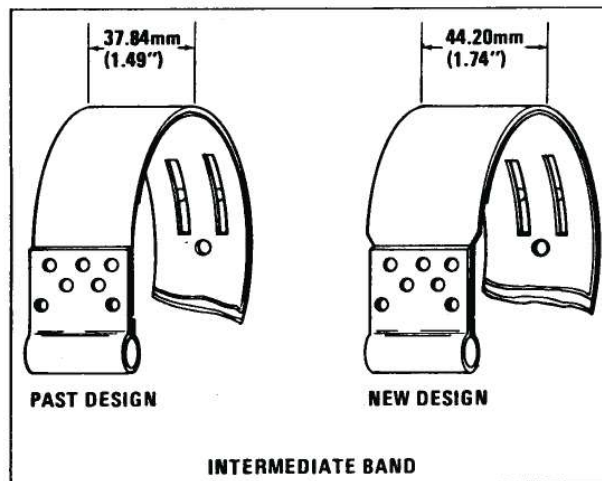
Figure 28

Beginning mid-August, 1981, THM 125C transaxles were built with a new (Wider) design intermediate band assembly (P/N 8637623), and a new designed direct clutch housing assembly (P/N 8637976). See Figure 28. The new design direct clutch housing has a wider surface area on the drum outside diameter to accommodate the new wider intermediate band assembly, and improve intermediate band durability.

The narrow design direct clutch housing can only be used with the narrow design intermediate band. Do not use the wide intermediate band assembly on the narrow design direct clutch housing assembly or interference will destroy the intermediate band.

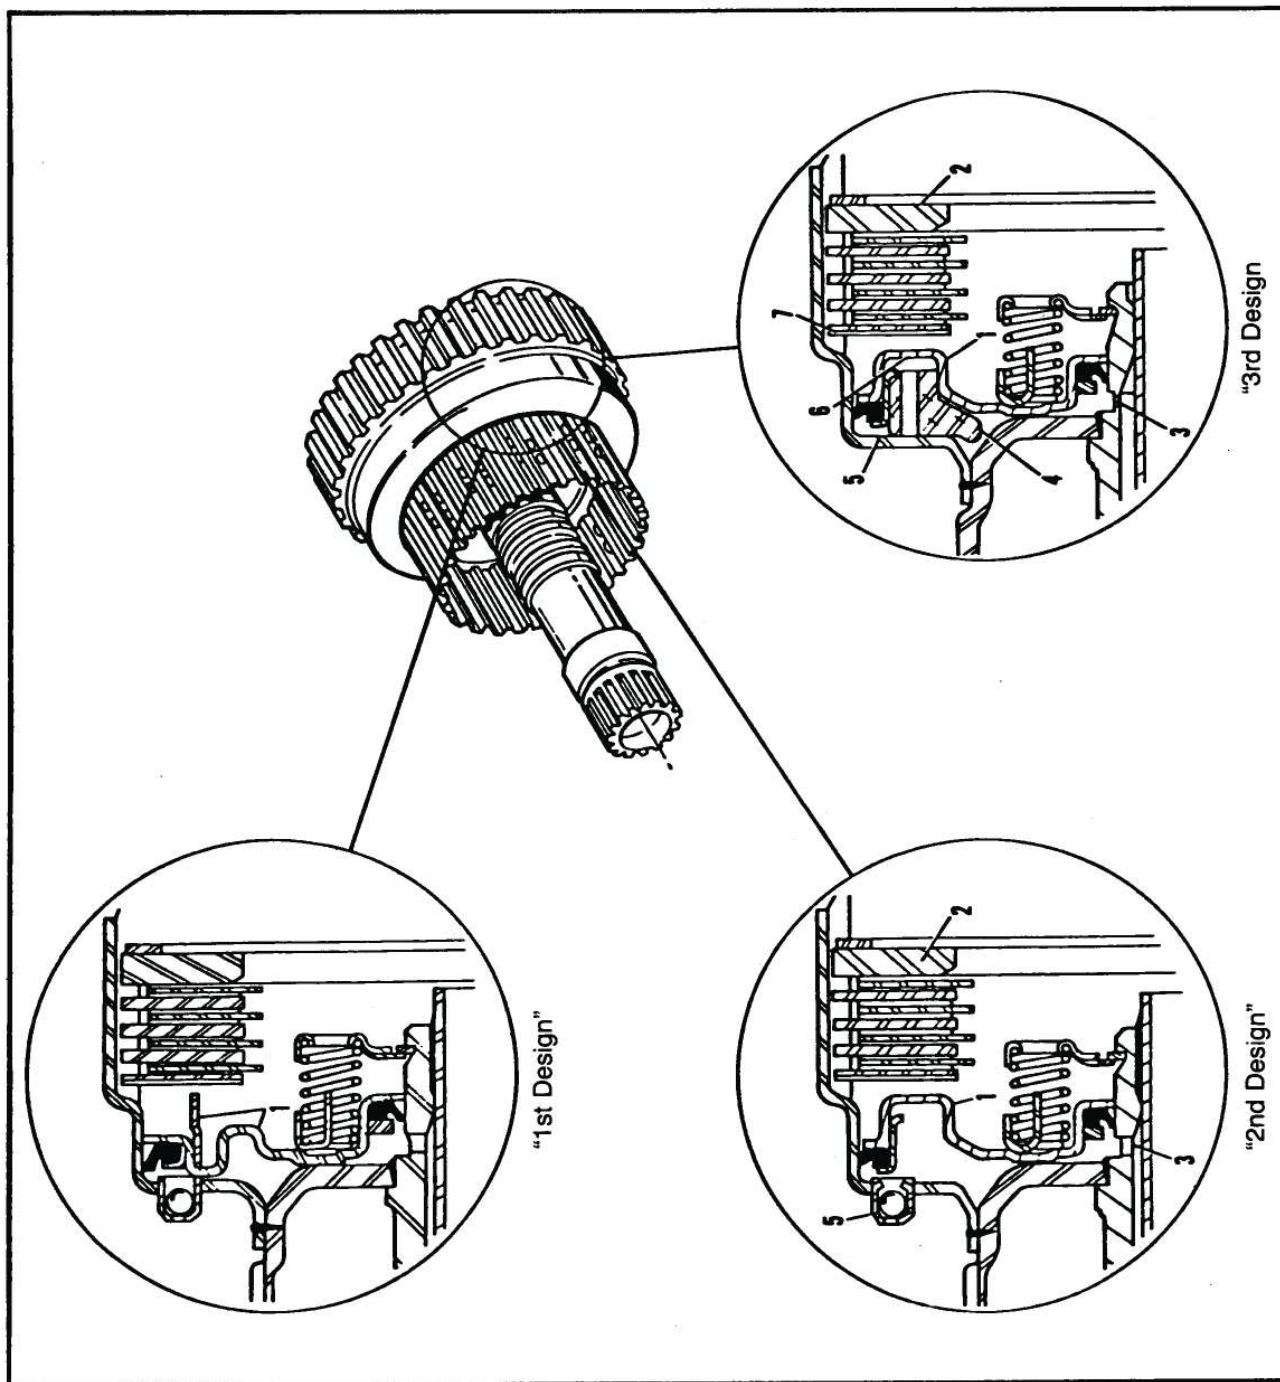
Figure 30

- 1) The forward clutch piston was redesigned, eliminating the apply ring (See Figure 30).
- 2) The backing plate was made selective to control clutch pack clearance.

- 1) The forward clutch feed orifice was made smaller, (Figure 30, Item 3) and an oil displacement insert was added (Figure 30, Item 4).
- 2) The check ball capsule was eliminated and two exhaust holes were added to the new forward clutch piston (Figure 30, Item 6). When the piston is applied the exhaust holes will seal against the wave plate.

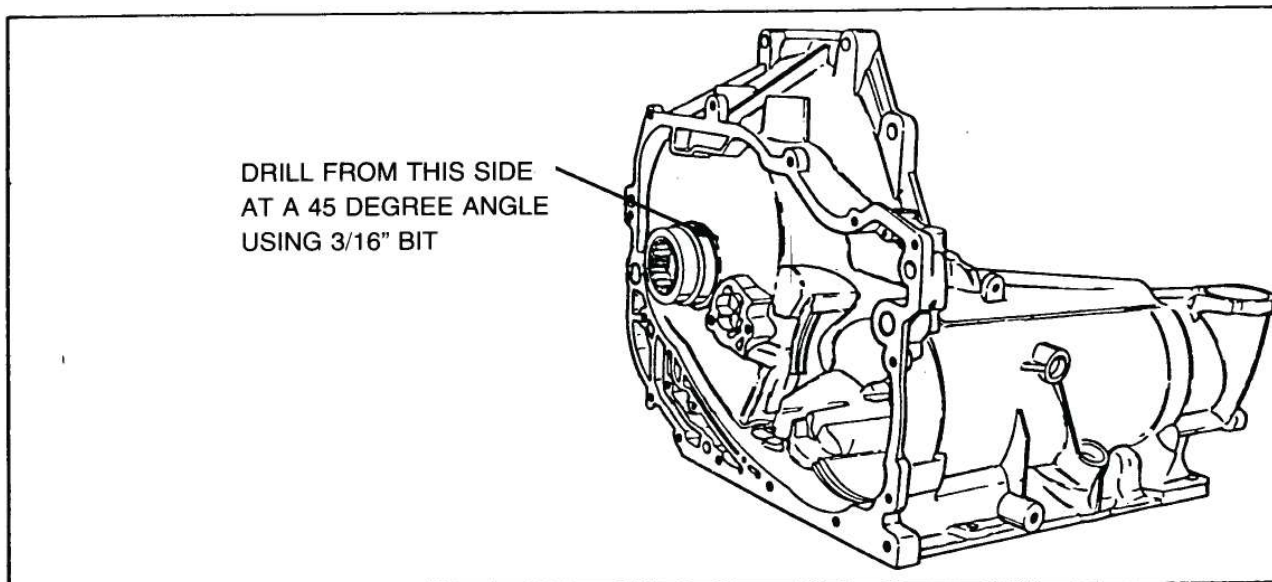
Figure 32

Some THM 125/125C transaxles may experience an oil leak from the bell housing area, which is due to the front converter seal coming out of the case bore. This condition results from an oil pressure build up behind the converter seal, which forces the converter seal out of its seat in the case bore.

When servicing any THM 125/125C transaxle for this condition, it is recommended that an oil drainback hole be drilled into the converter seal bore of the transaxle case (See Figure 31).

Drill from the case cover side, a 3/16" minimum diameter hole, at the 11 or 1 O'clock position. It is very important that the hole be drilled at this location so as not to lose our lube oil to the drive sprocket support bearing. Position the drill at about a 45 degree angle when drilling (See Figure 32). The hole must be drilled through so that it exits inside the radius of the seal bore diameter. See Figure 31. Use care not to touch the seal bore diameter with the drill bit.

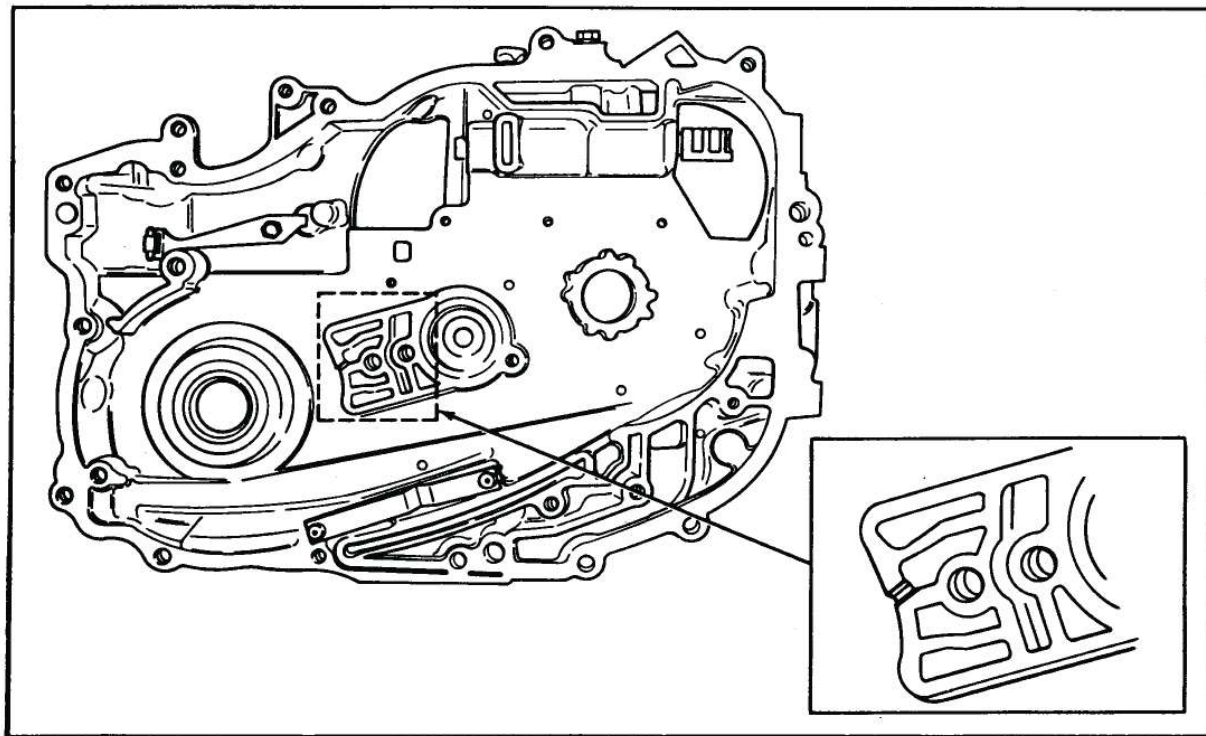
Figure 52

Beginning in April, 1984, a slot was added to the case cover of the THM 125/125C transaxle (See Figure 52). The slot was added to the "Drive Feed" oil circuit to allow transmission fluid to spray onto the drive link (Chain) to provide additional lubrication.

The slot is a "V" shaped groove cut into the case cover in the area and direction as shown in Figure 52. The slot can be added to a previous case cover if great care is taken on the depth and the angle, with a small chisel.

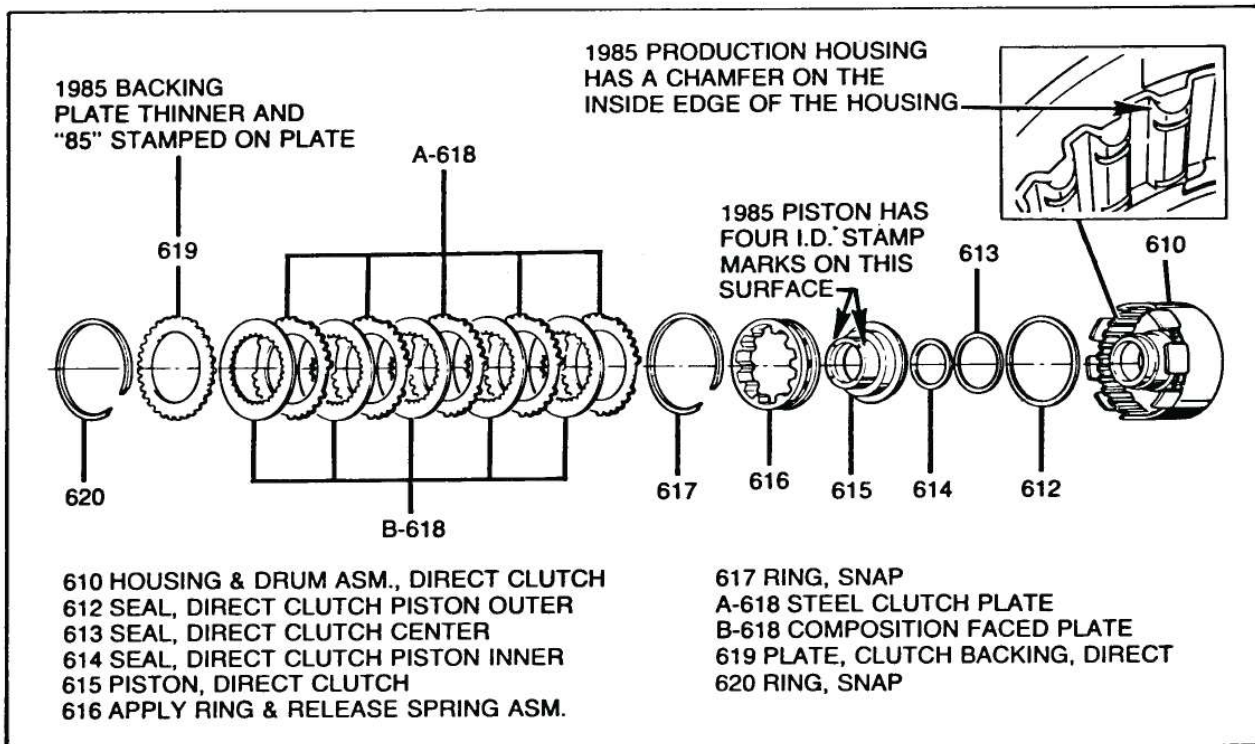
Figure 54

- 2) The 1985 direct clutch backing plate is thinner than previous models, and can be identified by "85" stamped on the backing plate (See Figure 54).
- 3) The 1985 direct clutch piston is a different height than previous models, and can be identified by four stamp marks on the top surface (See Figure 54).

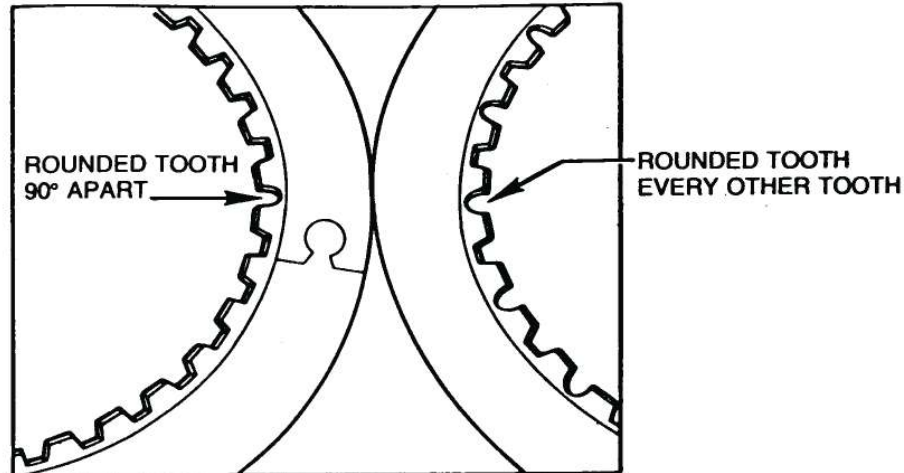
Figure 55

- 1) The 1985 forward and direct lined clutch plates are .010" thinner than previous model lined clutch plates. The 1985 lined plates are identified by a rounded tooth every 90 degrees around the plate, or by a rounded tooth every other tooth (See Figure 55).

THE 1985 FORWARD AND DIRECT COMPOSITION CLUTCH PLATES ARE APPROXIMATELY 0.254 mm (.010") THINNER THAN PREVIOUS MODEL YEAR COMPOSITION PLATES. THE 1985 COMPOSITION PLATES ARE IDENTIFIED AS SHOWN ABOVE AND THE CLUTCH PACK MAY CONTAIN ONE OR BOTH TYPES.

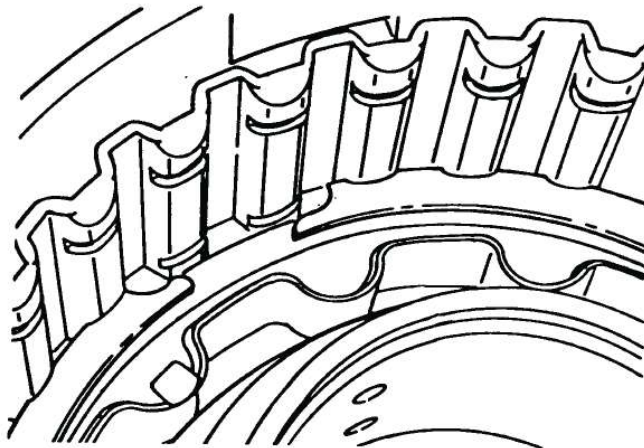
FIGURE B

**SERVICE NOTE:** THE SNAP RING THAT RETAINS THE APPLY RING AND RELEASE SPRING ASSEMBLY MAY NOT APPEAR TO BE FULLY SEATED IN THE SNAP RING GROOVE WHEN INSTALLED. THIS IS DUE TO THE GROOVE NOT BEING CUT AS DEEP AS PREVIOUS MODEL YEARS (SEE FIGURE B). WHEN INSTALLING THE SNAP RING USE A DOWNWARD AND OUTWARD PRESSURE TO ENSURE PROPER SEATING (SEE FIGURE A).

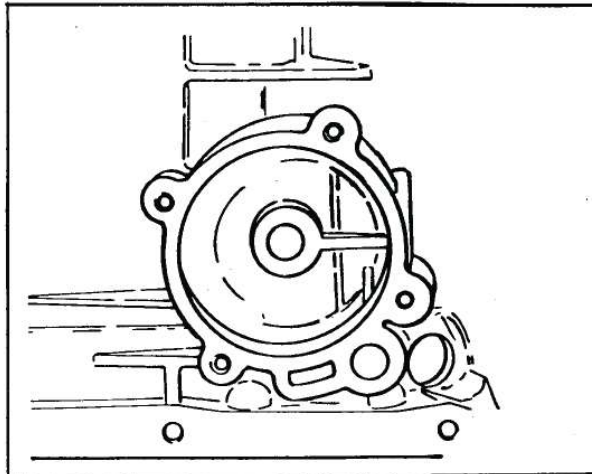
Figure 60

Beginning April 11, 1985 for Canadian models, and April 15, 1985 for U.S. models, THM 125/125C transaxles were produced using a case with the air bleed orifice behind the intermediate servo eliminated. See Figure 60. Figure 59 shows the previous design.

Either transaxle case can be used for all applications on 1984 or later models.

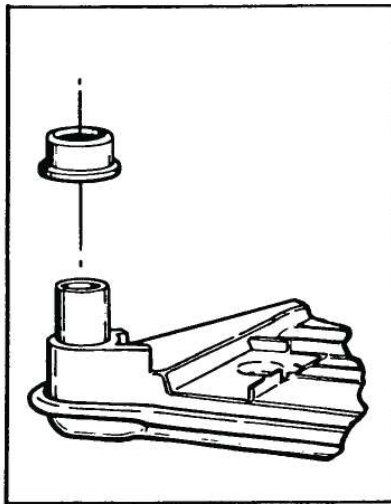
Figure 61

Beginning January, 1986, THM 125/125C transaxles were produced with a redesigned oil filter and seal assembly (See Figure 61). Previous design oil filter and seal are shown in Figure 62.

The 2nd design was to eliminate a slipping in all ranges condition under hard acceleration and/or cornering maneuvers, caused by an oil pressure drop due to a cut or improperly seated oil filter seal.

Either design oil filter can be used to service all years and all models as long as the proper seal is used based on the design of the oil filter neck. The "O" ring seal is used only with the short shouldered filter neck (1st Design Figure 62), and the lip seal is used only with the long shouldered filter neck (2nd Design Figure 61).

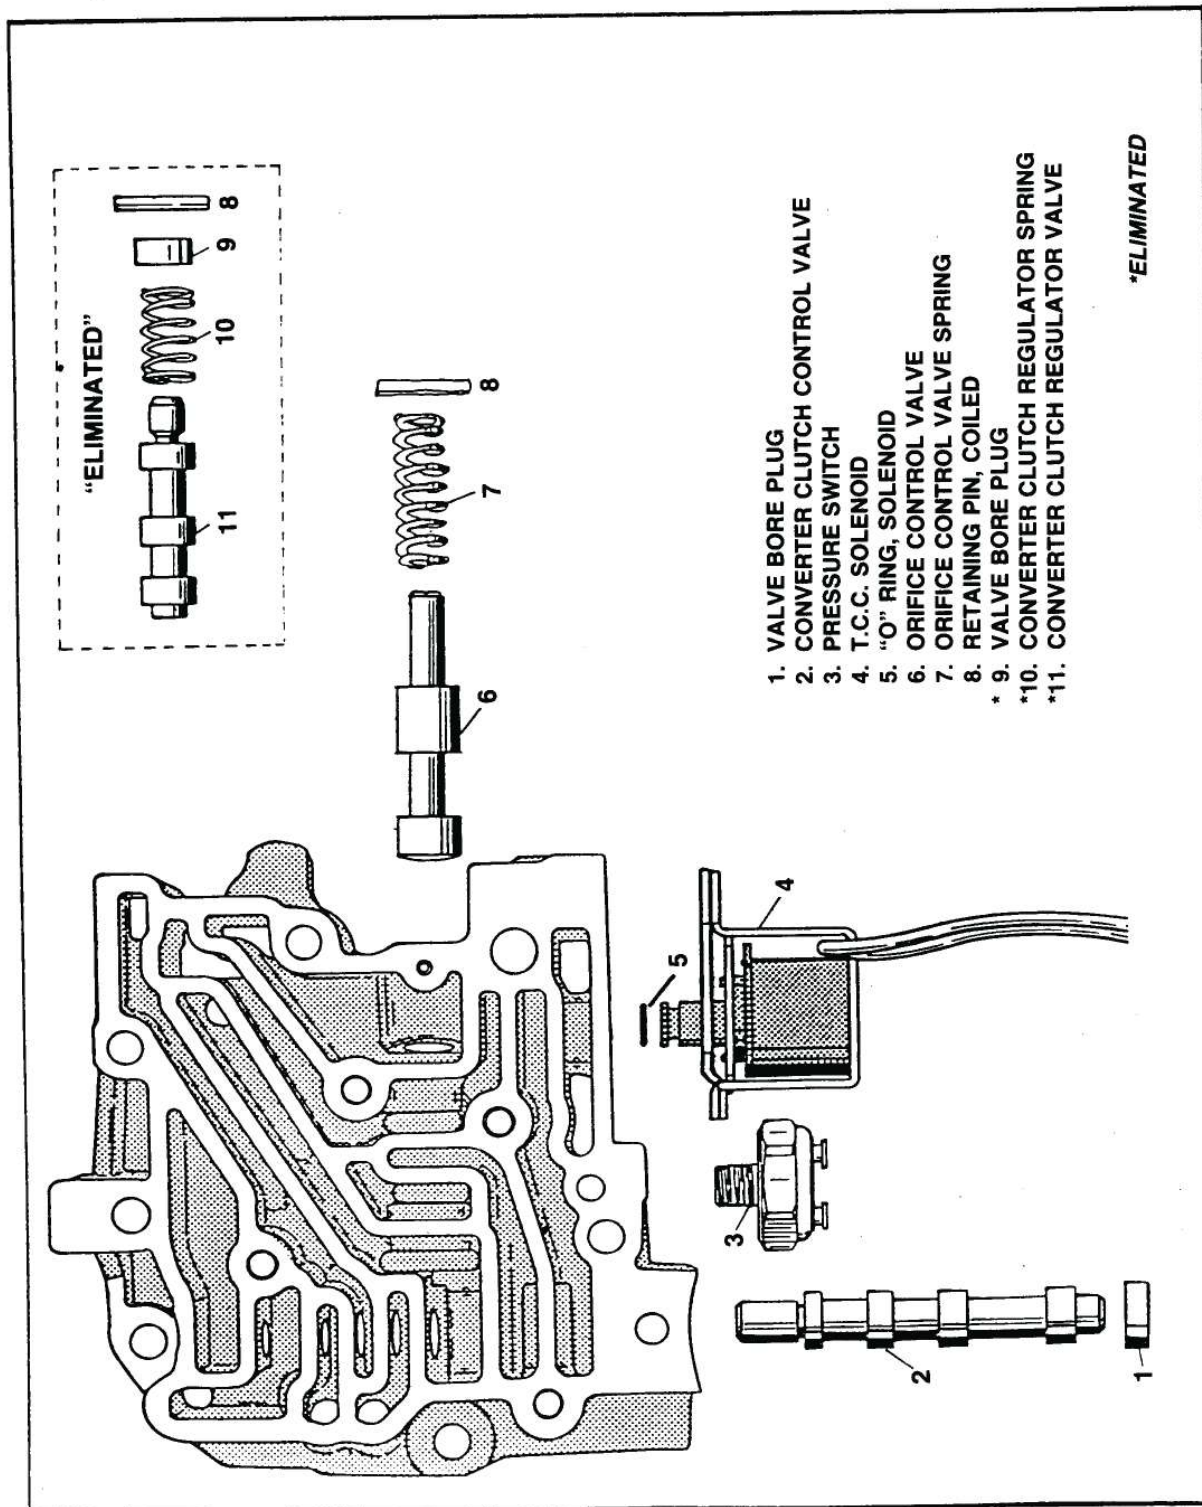
Figure 64

1. Auxiliary Valve Body (See Figure 64).
2. Auxiliary Valve Body Cover Gasket (See Figure 65).
3. Valve Body and Pump Assembly - Oil channel changes.

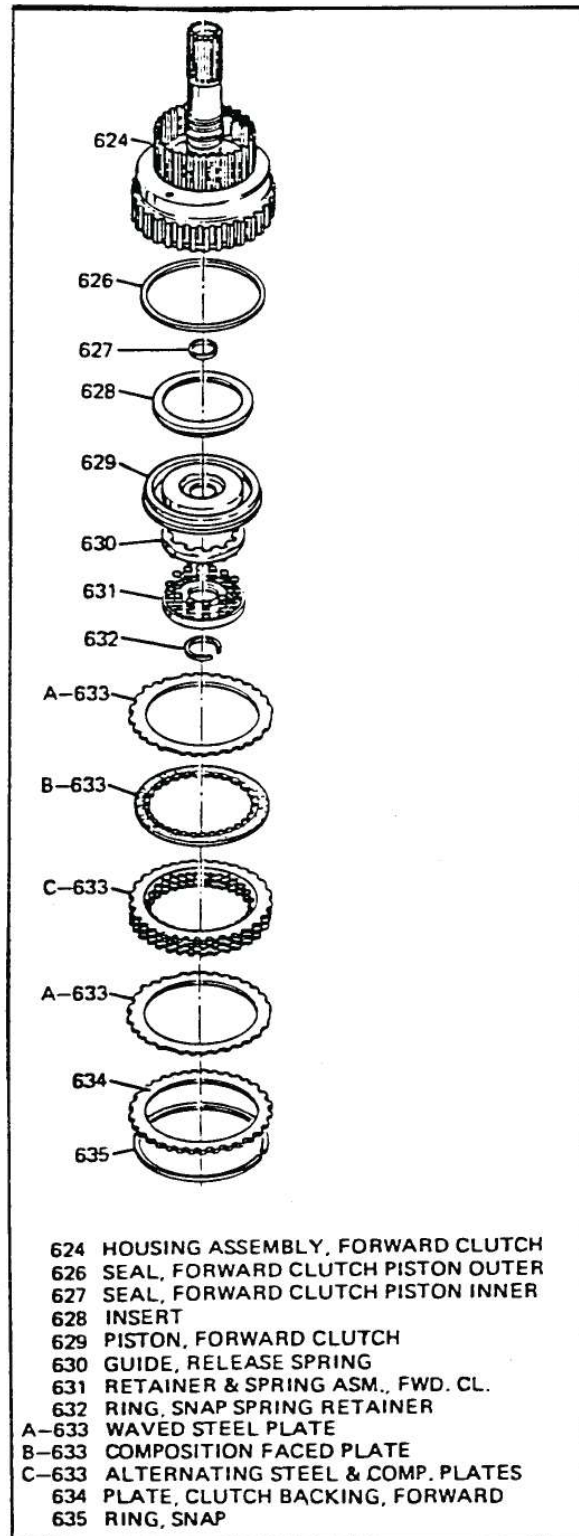
Figure 66

Addition of a wave plate, one on each end of the forward clutch pack for a total of two, in the forward clutch housing (See Figure 66).

Will retro fit, and is recommended, back to 85 and 86 only. Not compatible with 1984 and earlier models.

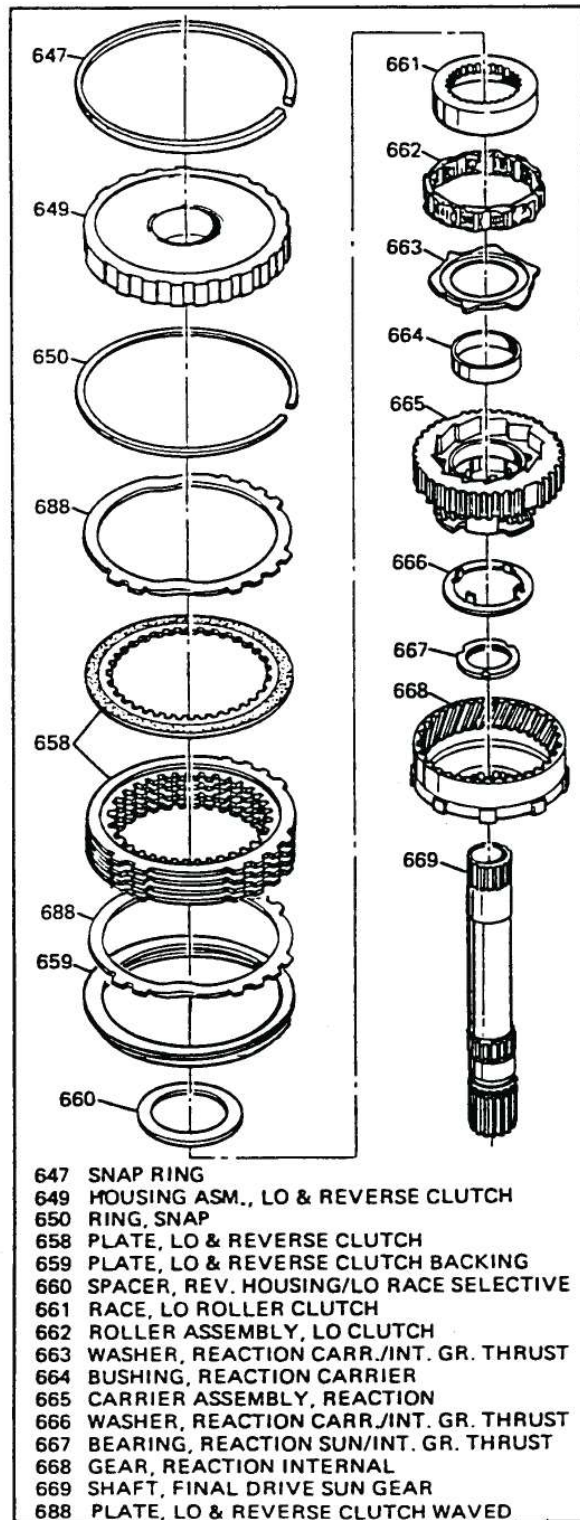
Figure 67

Addition of a wave plate, one on each end of the low and reverse clutch pack, for a total of two (See Figure 67).

1. Two Wave Plates (See Figure 67).
2. Low and Reverse Backing Plate, External lugs removed and now selective (See Figure 67). Backing plate stamped "6", "7", "8", "9", with "6" being the thinnest and "9" being the thickest.
3. Low and Reverse Piston, now cast aluminum instead of stamped steel.

Will retro fit, and is recommended, as long as compatible parts are used. It will only fit back to 1984, not to be used in 1983 or earlier.

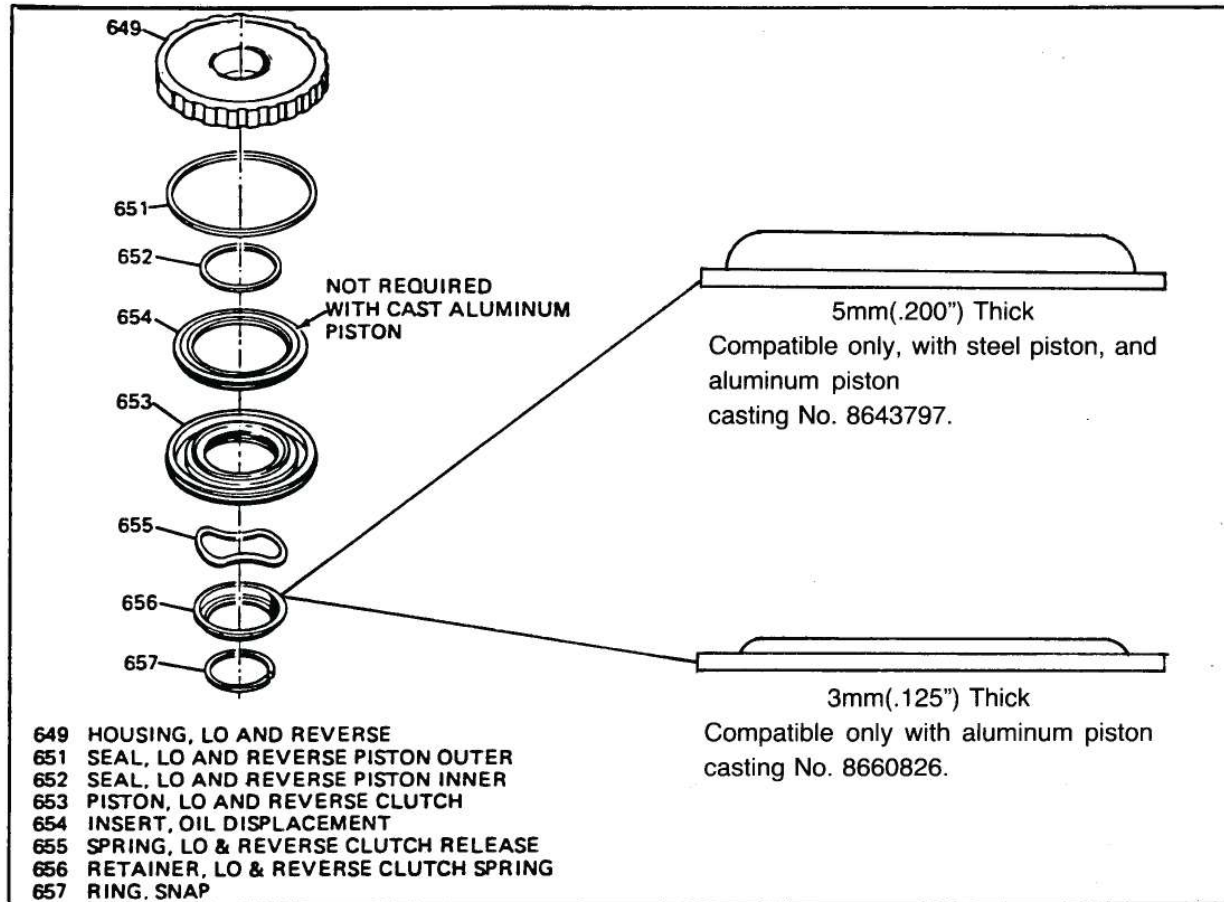
Figure 68

**CAUTION:** There are two different cast aluminum low and reverse pistons, casting No. 8643787, and casting No. 8660826. They use different retainers and are not compatible (Figure 68).

4. Low and Reverse Clutch Spring Retainer (See Figure 68).

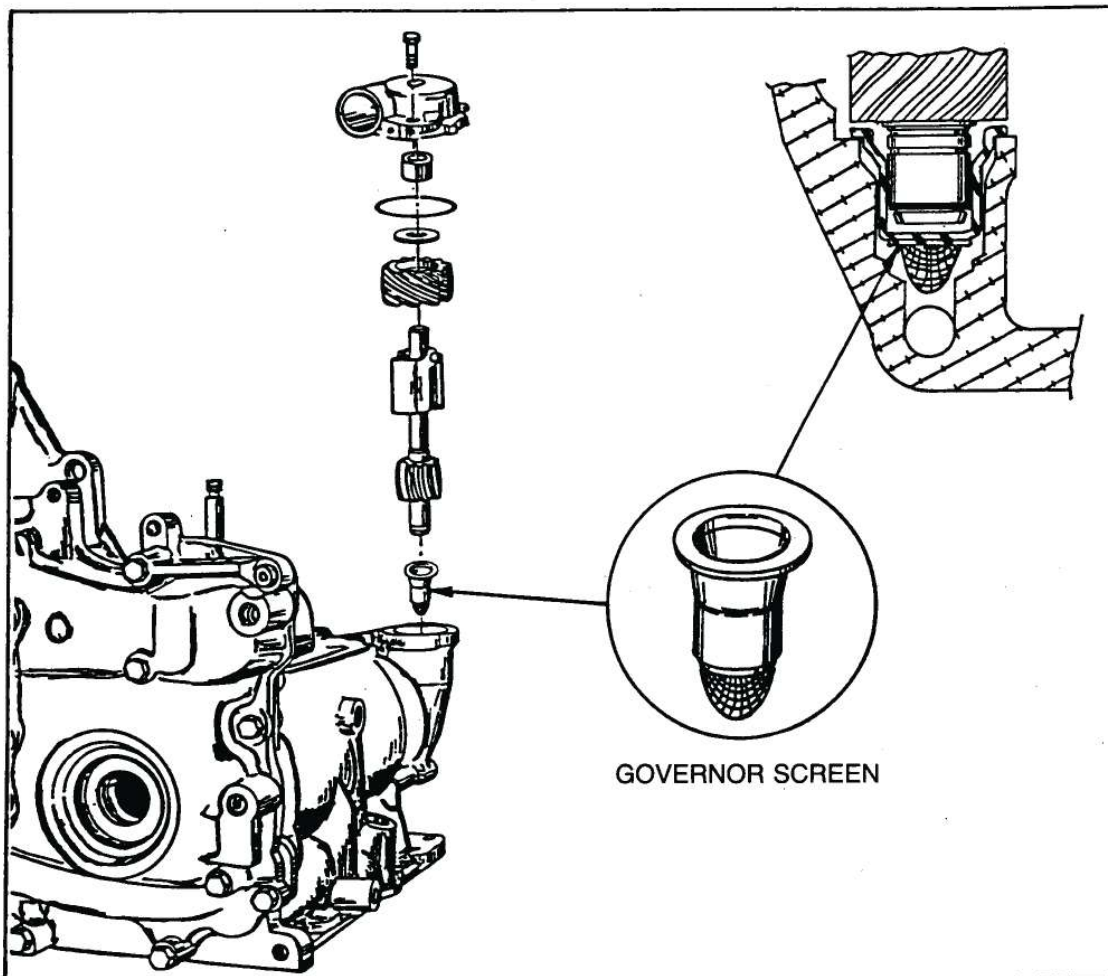
Figure 70

The governor screen was added in 1987 to the governor sleeve in the case, to minimize the possibility of sediment entering the governor assembly and preventing the governor balls from seating properly (See Figure 70).

A machining change was necessary in the case to make room for the new governor screen, thus it will not retro-fit to previous models.

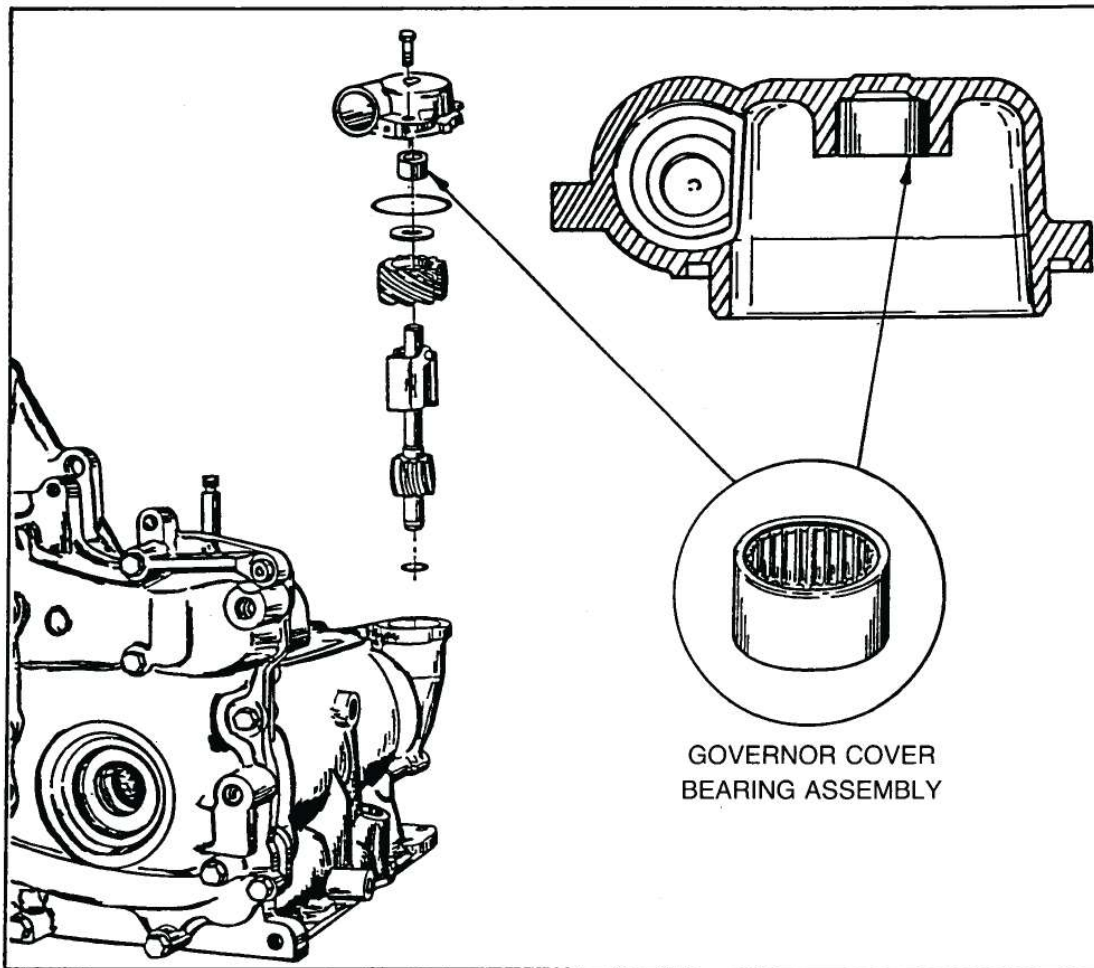
Figure 71

A caged needle bearing assembly has been added to the governor cover beginning in model year 1987 (See Figure 71).

The new governor cover and bearing assembly will interchange with the previous models, as an assembly.

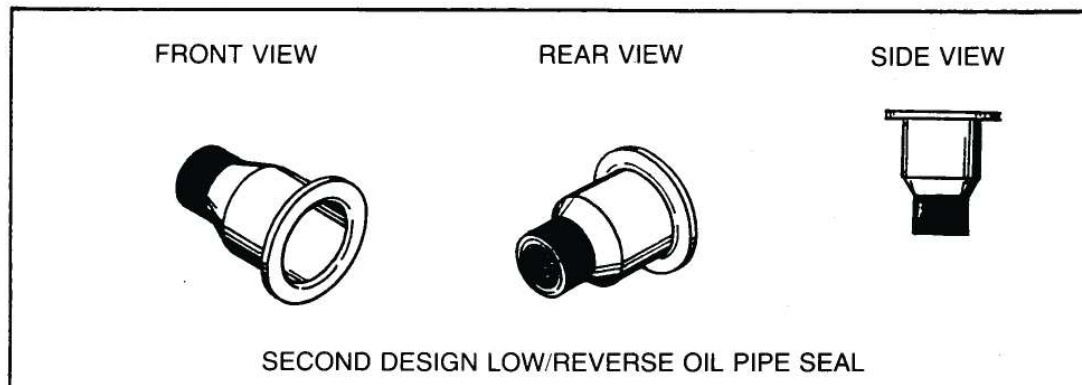
Figure 72

For 84 days in 1987, (Julien Date 012 to Julien Date 096), General Motors built approximately 500,000 THM 125C transaxles using a new design Low/Reverse oil pipe seal (See Figure 72). In April 1987, they returned to the original design seal (See Figure 73).

The new seal must be ordered separately.

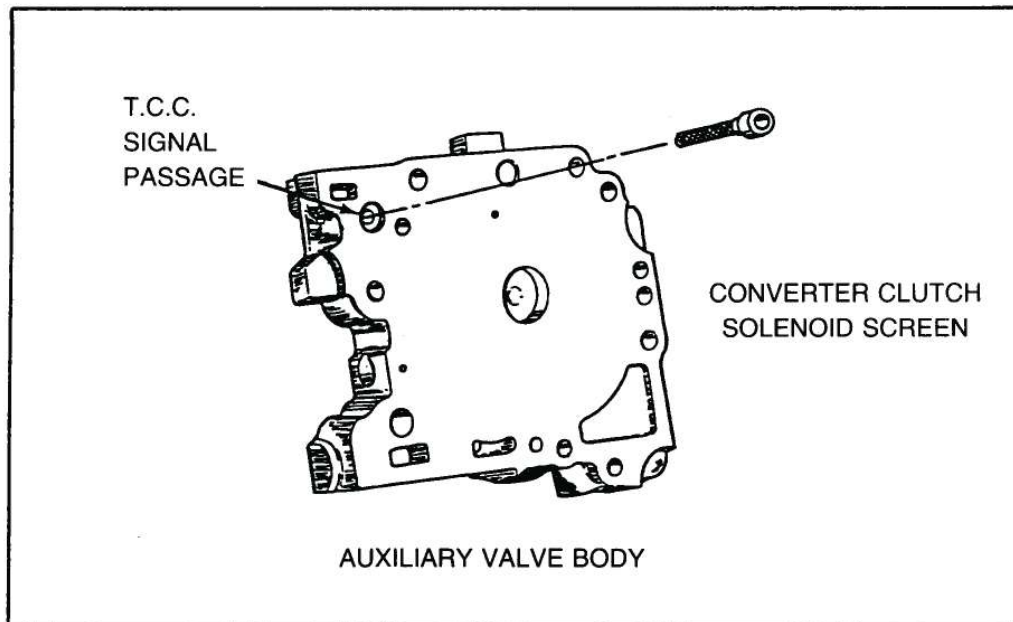
Figure 74

A TCC filter has been added to the TCC signal passage in the auxiliary valve body, beginning in March, 1987 (See Figure 74). This will reduce the possibility of sediment entering the converter clutch solenoid.

If the solenoid gets contaminated with sediment, it could result in a complaint of engine stalling when selector is placed into drive or reverse.

The filter cannot be used in previous models because of a machining needed on the auxiliary valve body.
