## AUTOMATIC TRANSMISSION SERVICE GROUP

### THM 125C

Since the introduction of the THM 125 transaxle in model year 1980, there have been many major engineering changes. These changes have affected nearly every part used in the 125 and 125c.

This Update Handbook will explain each change, the parts affected by the change, any parts interchangeability problems created by the change. This Update Handbook will cover all of the changes from start of production up through and including model year 1987, along with common problems, and fixes, for the THM 125 transaxle.

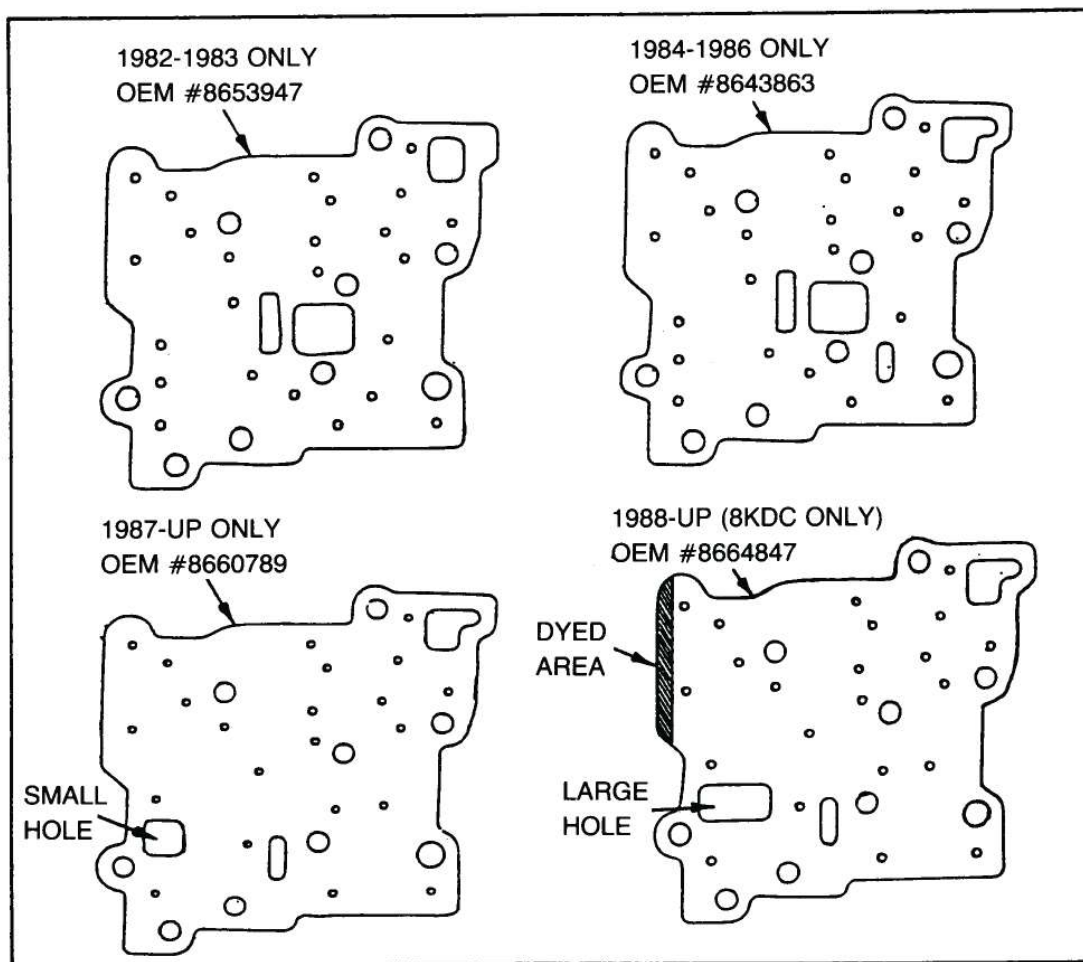
Figure 76

The new gasket has a larger hole than the 1987 gasket, and a dyed area on the gasket for identification (See Figure 76).

This now makes four (4) auxiliary valve body cover gaskets for the THM 125C, and they "CANNOT" be interchanged with each other. (See Figure 76).

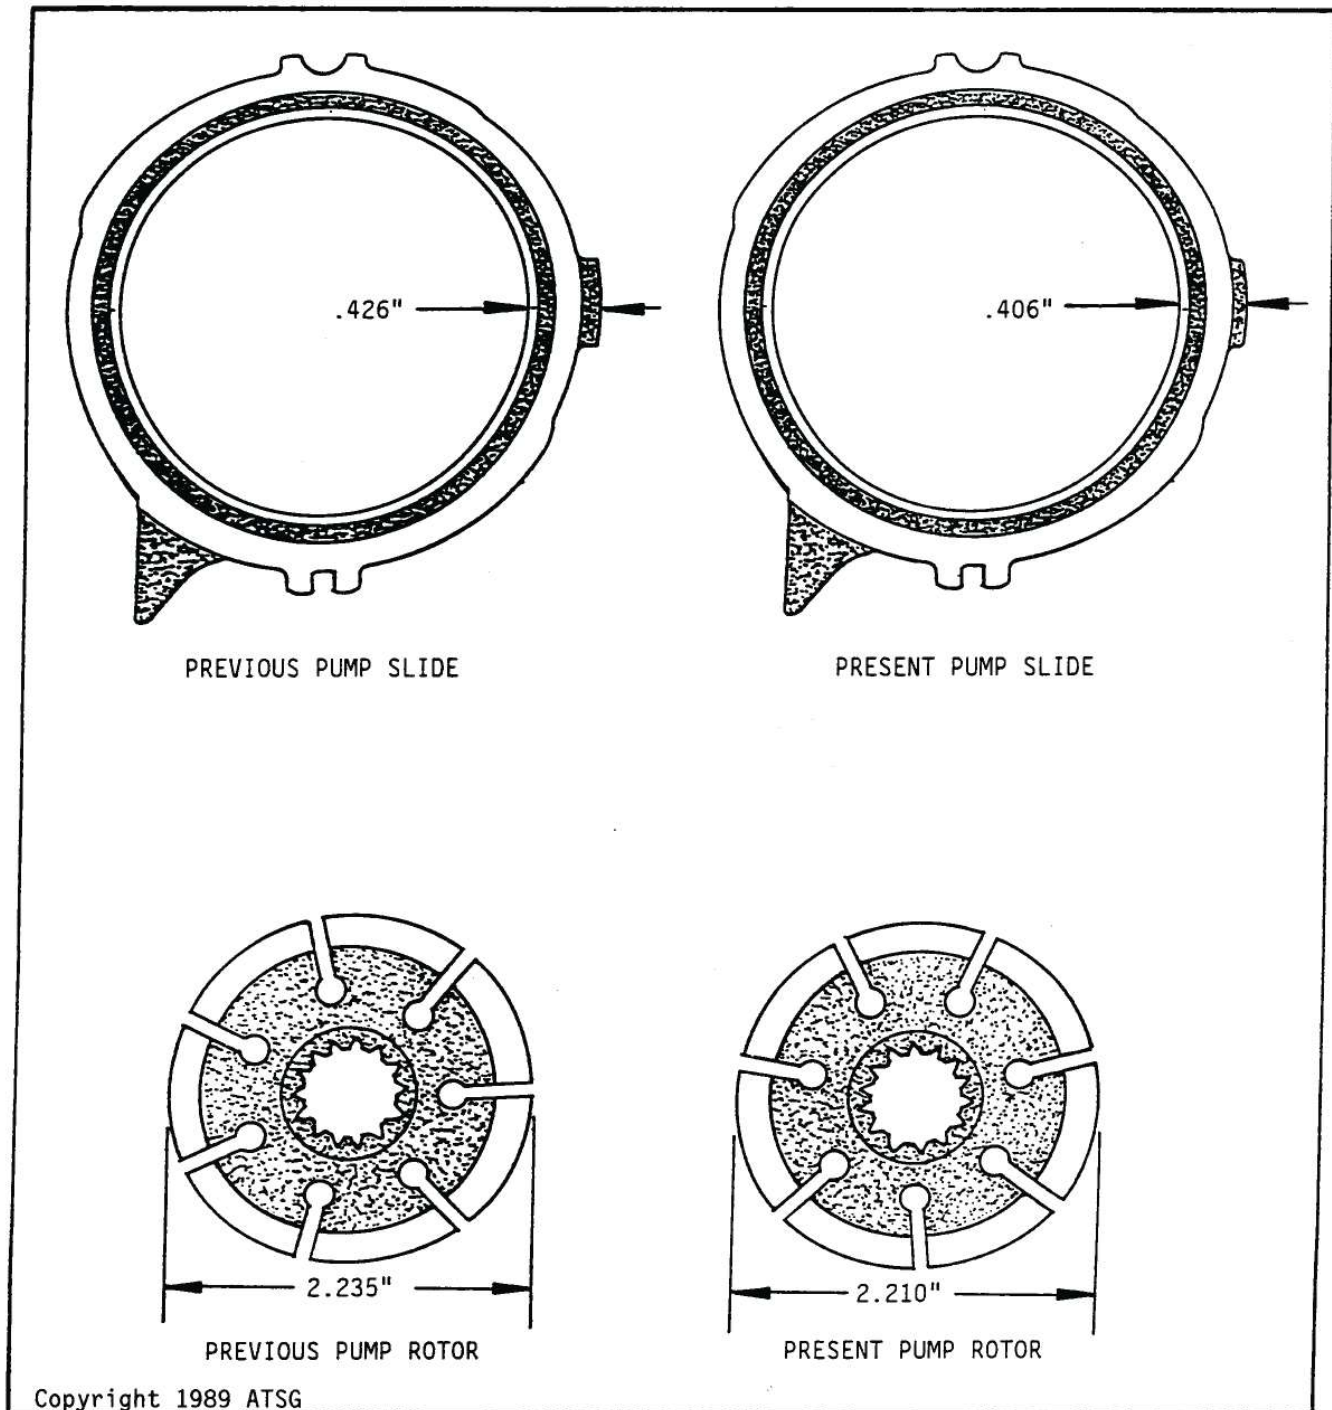
Figure 77

**CHANGE:** Beginning in late 1985, the dimensions of the pump rotor and pump slide changed (See Figure 77).

- (1) PUMP ROTOR - The outside diameter of the rotor was made smaller. The previous rotor O.D. was 2.235", and the present rotor O.D. is 2.210". (See Figure 77).
- (2) PUMP SLIDE - The height of the pump slide stop was made shorter. The previous pump slide stop measures .426", and the present pump slide stop measures .406" (See Figure 77).

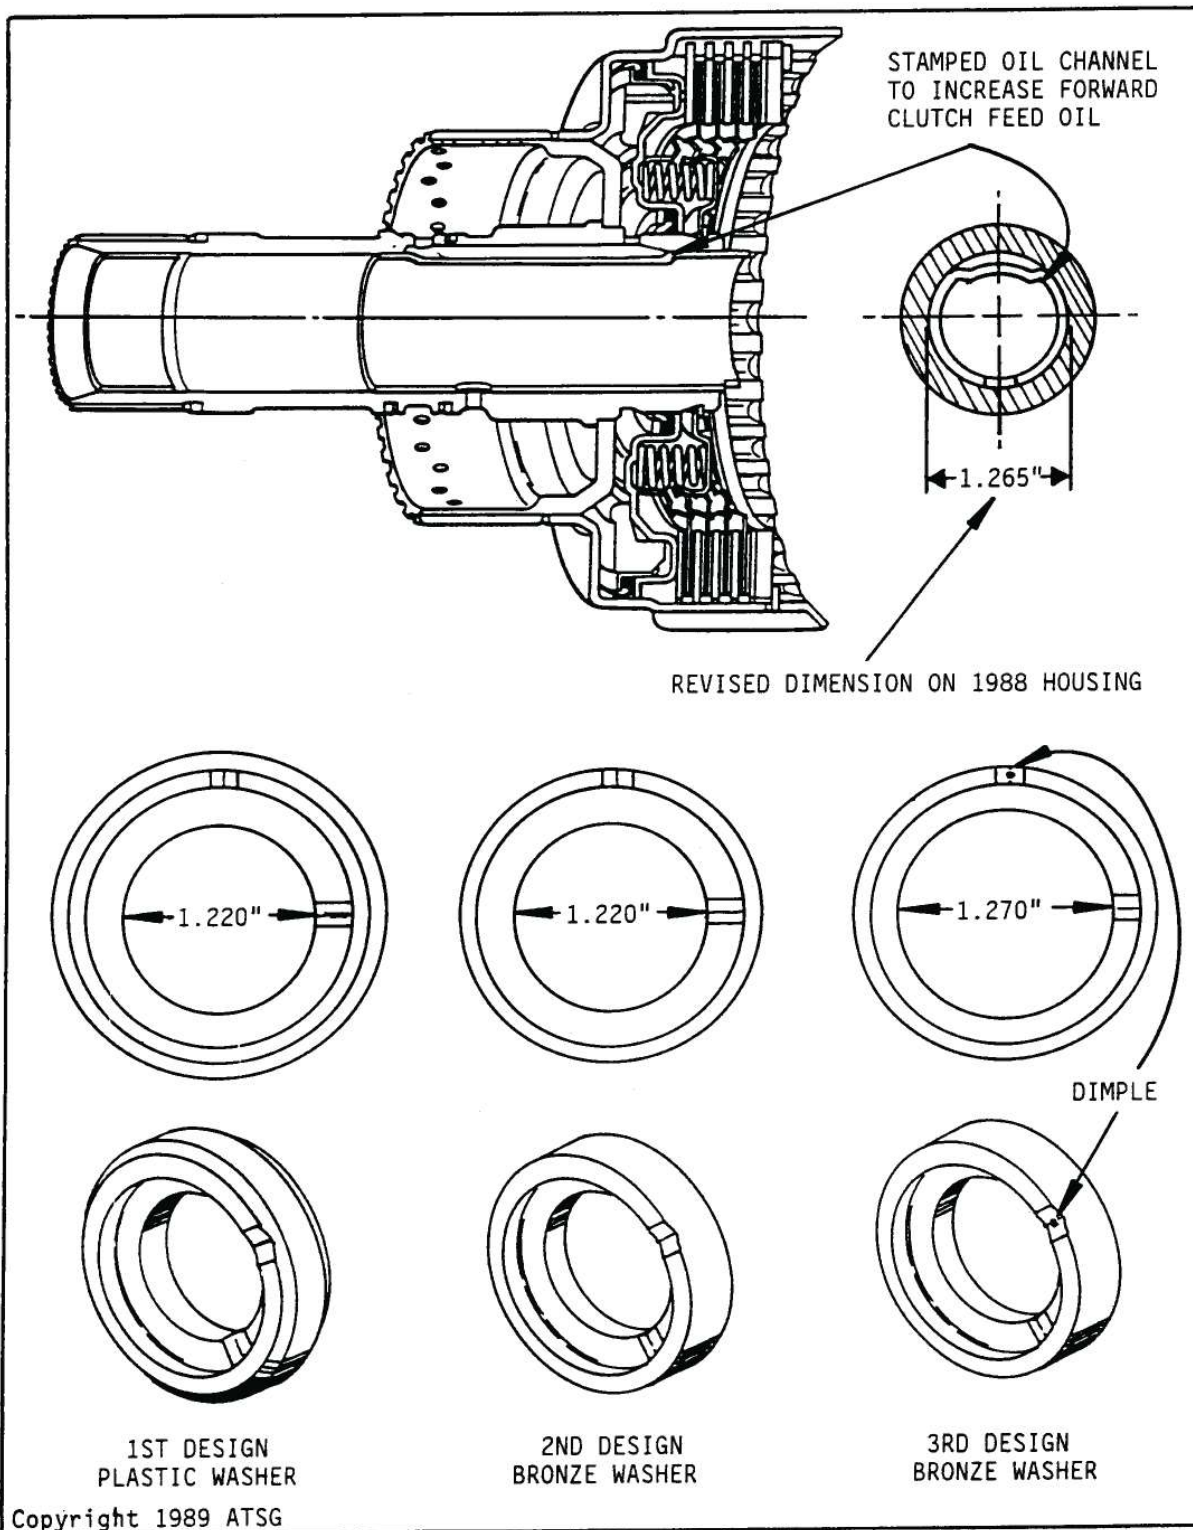
Figure 78

**REASON:** The new housing contains a new stamped channel which increases forward clutch feed oil, providing a quicker neutral to drive engagement. (See Figure 78).

- (1) FORWARD CLUTCH HOUSING - Contains a stamped channel which increases the flow of forward clutch feed oil, and there is a revised dimension where the bronze washer is located (See Figure 78).
- (2) BRONZE THRUST WASHER - Revised dimension on the inside diameter of washer to fit the new clutch housing, and identified with a dimple stamped on both sides of the washer (See Figure 78).

- (1) The new forward clutch housing will retro fit back to all previous models but you MUST use the 3rd design "Dimpled" washer.
- (2) The 1st design plastic washer, and the 2nd design bronze washer will not fit the new forward clutch housing.
- (3) If the 3rd design "Dimpled" bronze thrust washer is used on the previous forward clutch housing, it will create premature wear on the housing and washer.
