**AUTOMATIC TRANSMISSION SERVICE GROUP**

**REVISED EDITION**

## INTRODUCTION

Since the introduction of the THM 440-T4 Transaxle in April, 1984, there have been many major engineering design changes. These changes have affected nearly every part used in the THM 440-T4. This Update Handbook will explain each change, the parts affected by the change, and any parts interchangeability problems created by the change.

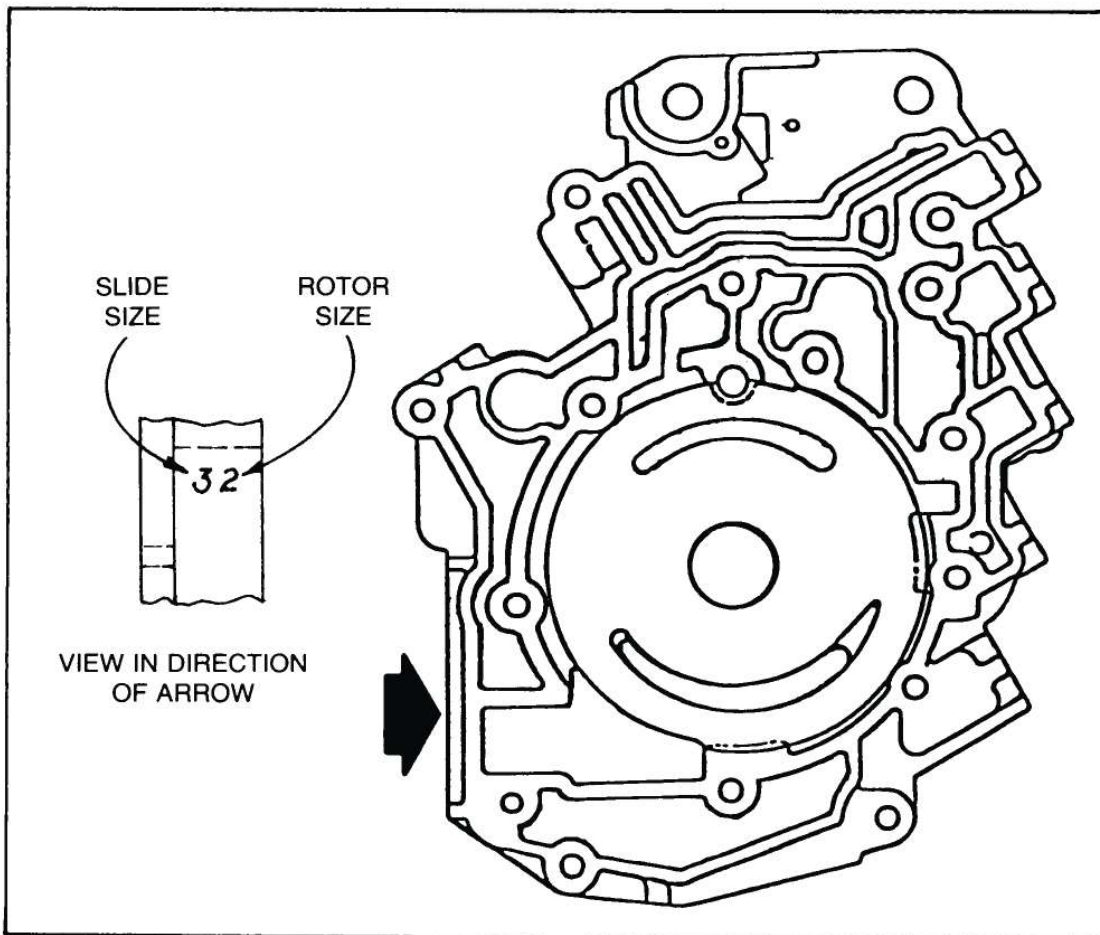
Figure 1

The 440-T4 pump has 5 selective slide sizes, 5 selective rotor sizes, and unlike any other transmission, 3 selective vane sizes. Since there are 5 selective slides, and 5 selective rotors, this obviously makes a possibility of the pump pocket depths being different from one pump body to another. Hydramatic has provided an easy method to identify which size slide and which size rotor a particular pump body was machined for. On the side of the pump body, opposite the 3rd and 4th clutch switches, will be a two number ink stamp (Example 32). The number closest to the machined surface towards the valve body, will indicate the size of the slide, and the following number will indicate the size of the rotor (See Figure 1). In the example used, we have a No. 3 slide, and a No. 2 rotor.

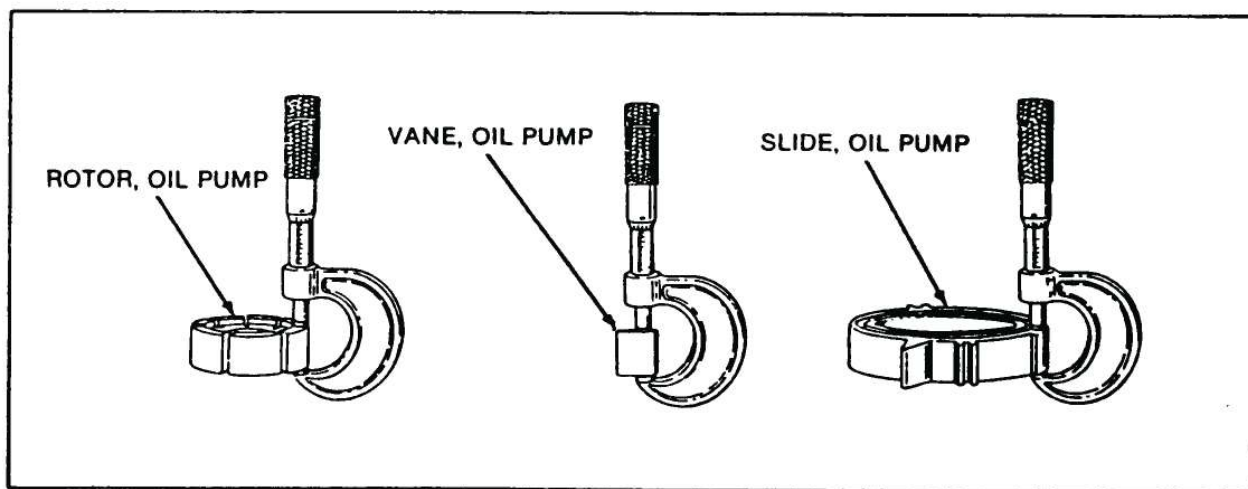
Figure 2

If your ink stamp identification is gone, all you have to do is measure the original slide and rotor thickness accurately using a micrometer. You will have to have a micrometer capable of measuring in tenths of thousands. To obtain the most accurate reading measure on flat, undamaged surfaces (See Figure 2). Using the original part measurement, order replacement parts according to the selective chart in Figure 3.

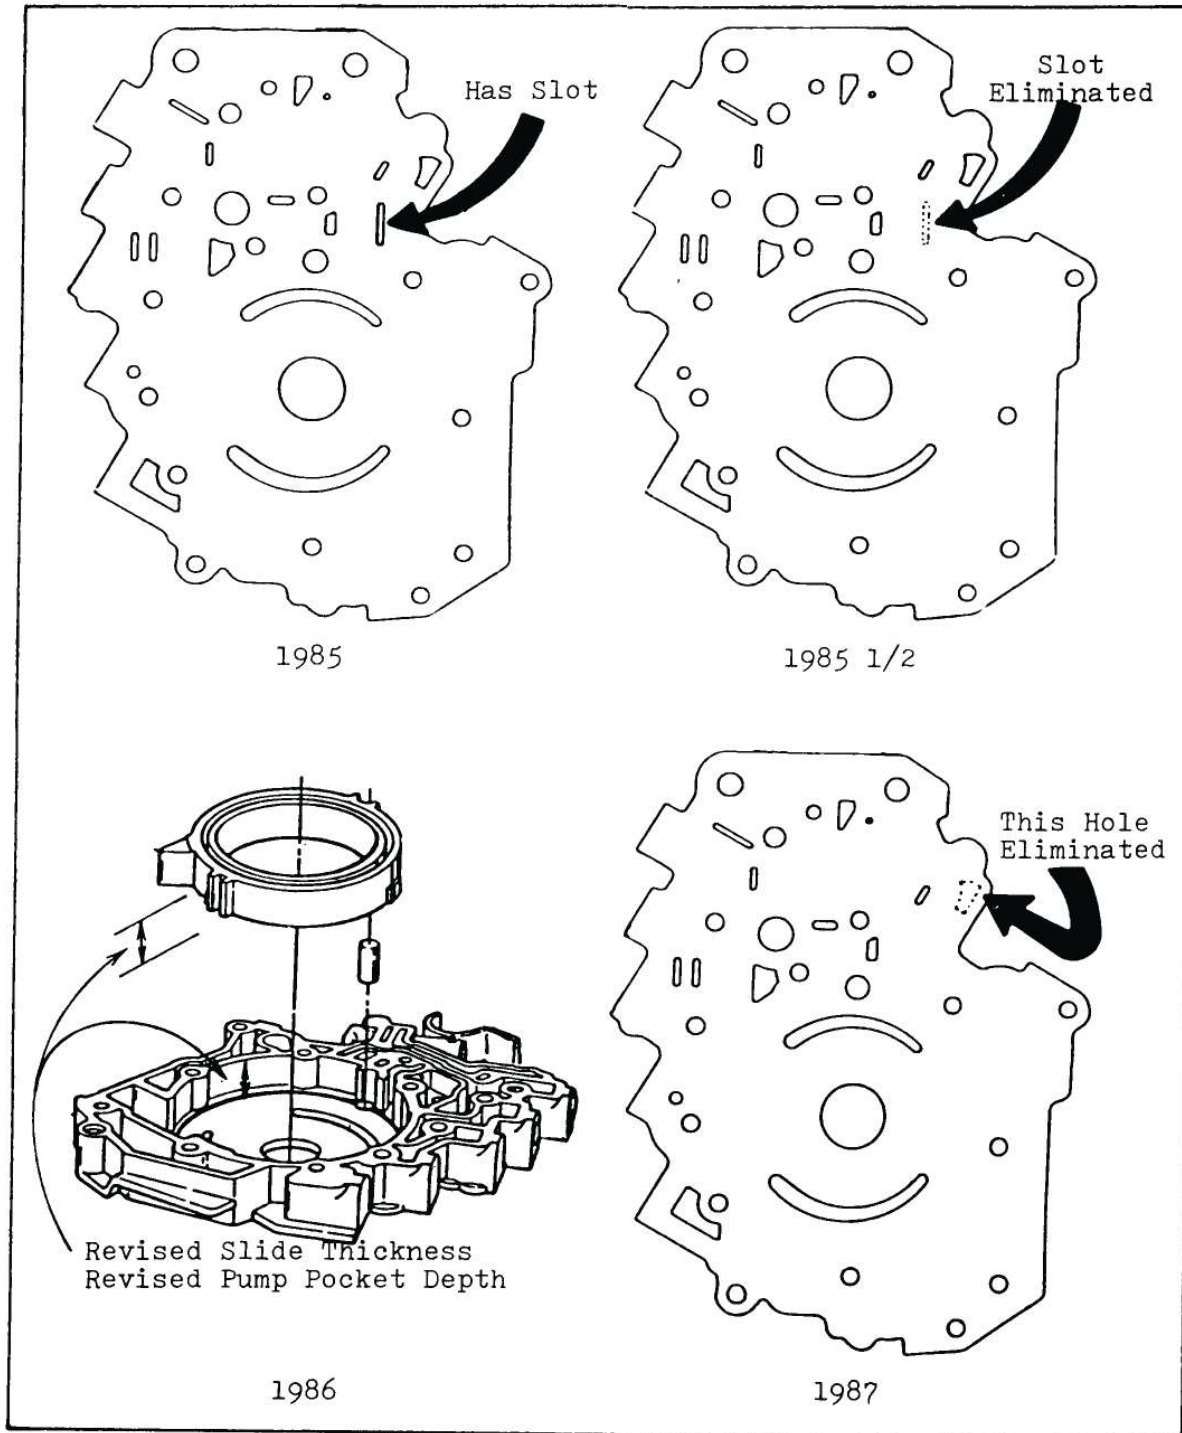
Figure 5

| 1985 | Identification: | Has slot in pump body (See Figure 5). |
| 1985 1/2 | Identification: | Slot in pump body was eliminated (See Figure 5). |
| 1987 | Identification: | Hole eliminated in pump body (See Fig. 5). |
| | Reason: | Improved 3-2 downshift. Modulator oil was fed thru the hole in pump body to stroke the 3-2 coastdown valve. Improved 3-2 downshift could be obtained by using servo release oil to stroke the valve, so hole was eliminated and the 3-2 maneuver pipe was added to carry servo release oil to the 3-2 coastdown valve in pump body (See Figure 6). This also made a change in the pump cover necessary with an additional hole and seal to accept the 3-2 maneuver pipe. |

| | Interchangeability: | Will retro fit back to 85 1/2, and is recommended. The 3-2 maneuver pipe must be used with it. Not interchangeable unless 3-2 maneuver pipe is used. |

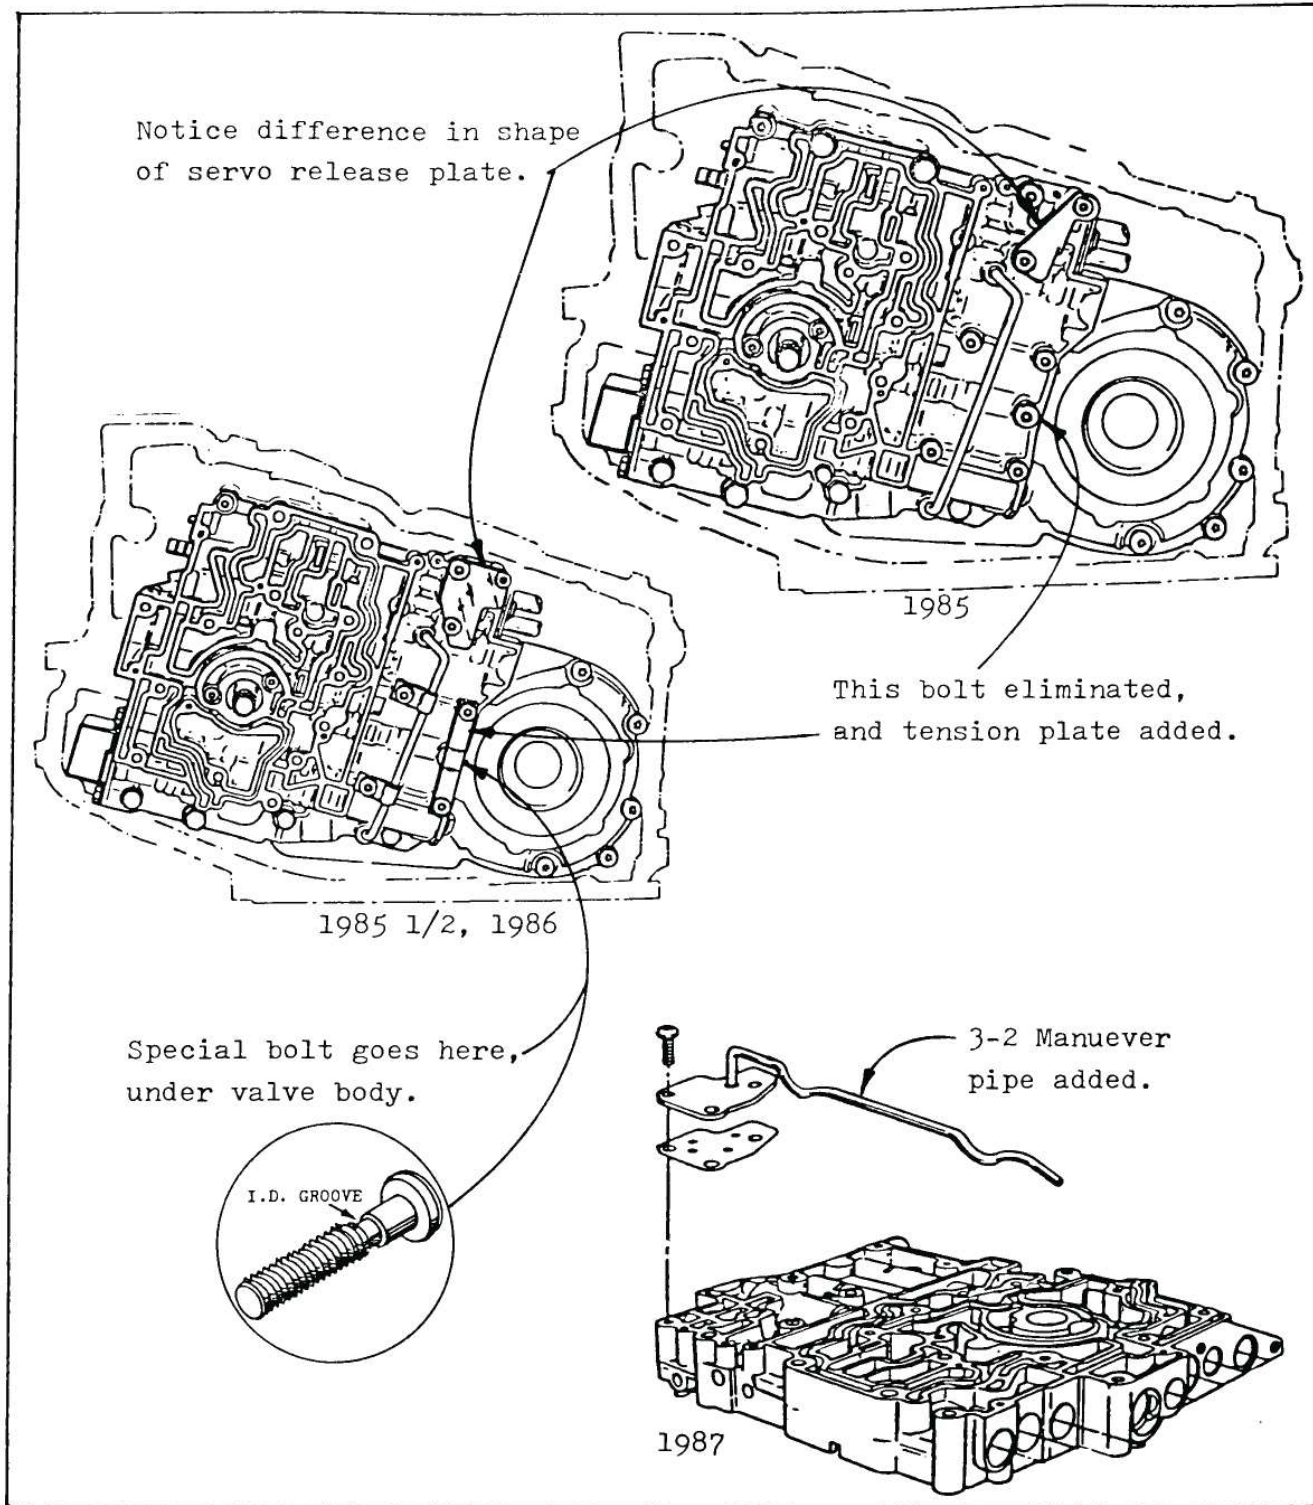
Figure 8

| 1985 | Identification: | Notice difference in shape of 1-2 servo release plate. Also extra bolt in valve body (See Figure 8). |
| 85 1/2, 86 | Identification: | Notice difference in shape of 1-2 servo release plate (See Figure 8). Extra bolt eliminated in valve body to make room for the addition of 3-2 TV bias valve in valve body (See Fig. 9). Special bolt added under valve body in channel plate, and addition of tension plate (See Figure 8). |
| 1987 | Identification: | Addition of 3-2 maneuver pipe (See Figure 8). |

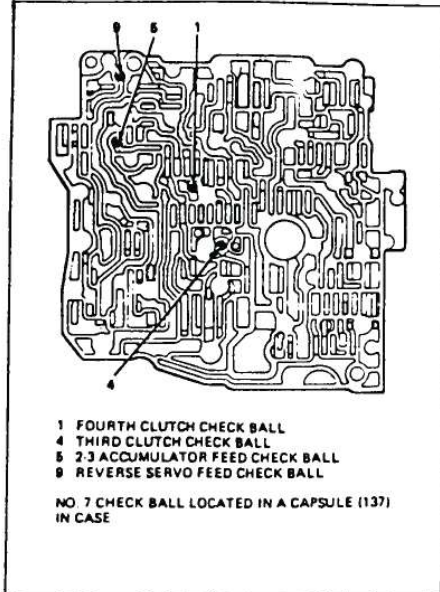
Figure 10 (1985 Only)

Refer to Figure 10 for 1985 locations.

If the second design gasket (See Figure 10), is used on the 1985 channel plate (Figure 17), it allows PRN oil to enter the reverse servo feed circuit and applies the reverse band. The end result will be, that the transaxle will be in reverse and park at the same time because we also have the input clutch on in park in the 440-T4.

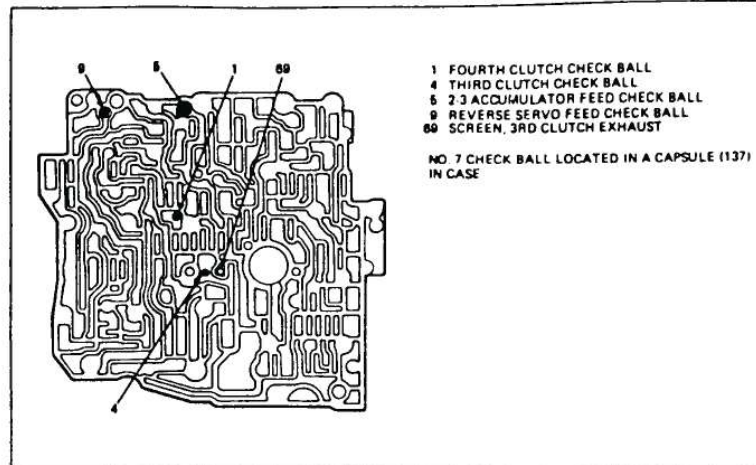
Figure 11 (1985 1/2-up)

Refer to Figure 11 for 1985 1/2 and up locations. Notice that the number 5 check ball moved, and at the same time became larger in diameter. 1985 1/2 and up, the No. 5 check ball is 3/8" diameter. All of the others are 1/4" diameter.

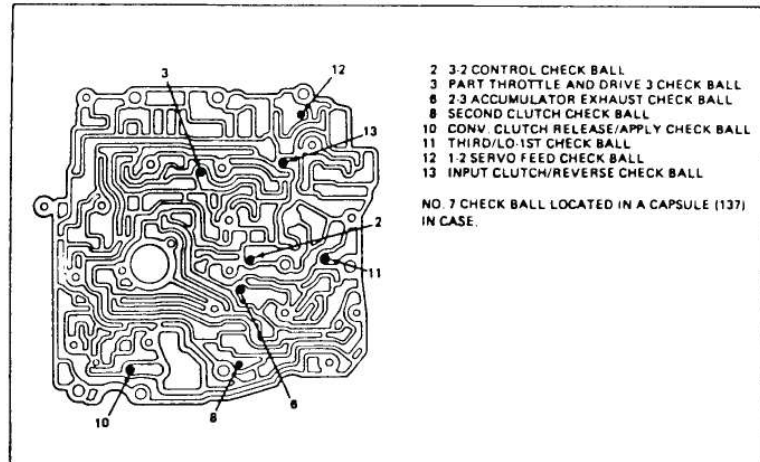
Figure 13

The check ball locations in the channel plate did not change. Refer to Figure 13.

NOTE: No changes in channel plate check ball locations.

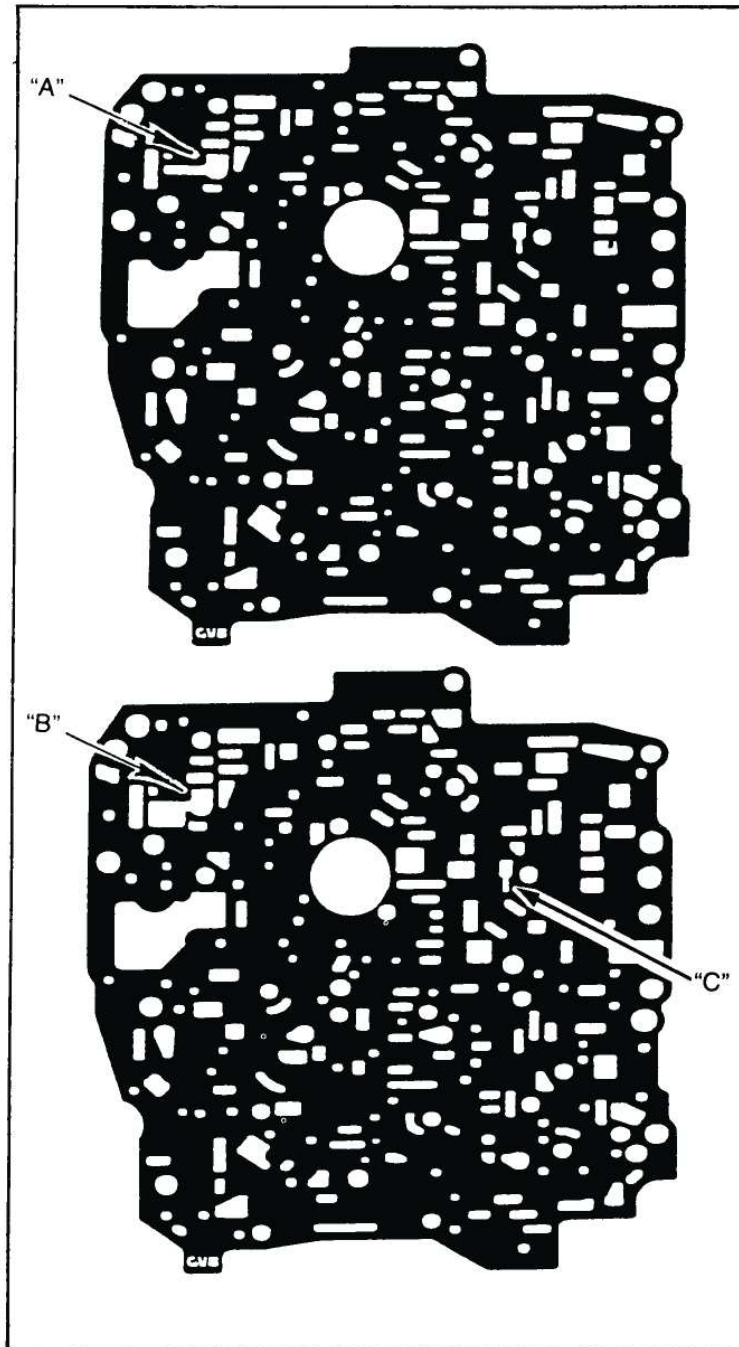
Note the difference in the "Pipe Stem" between "A" and "B", Figure 16. This change occurred about Oct. 1985.

In June 1987 the "Finger" shown at "C", Figure 16 was made Approx. .020 wider.

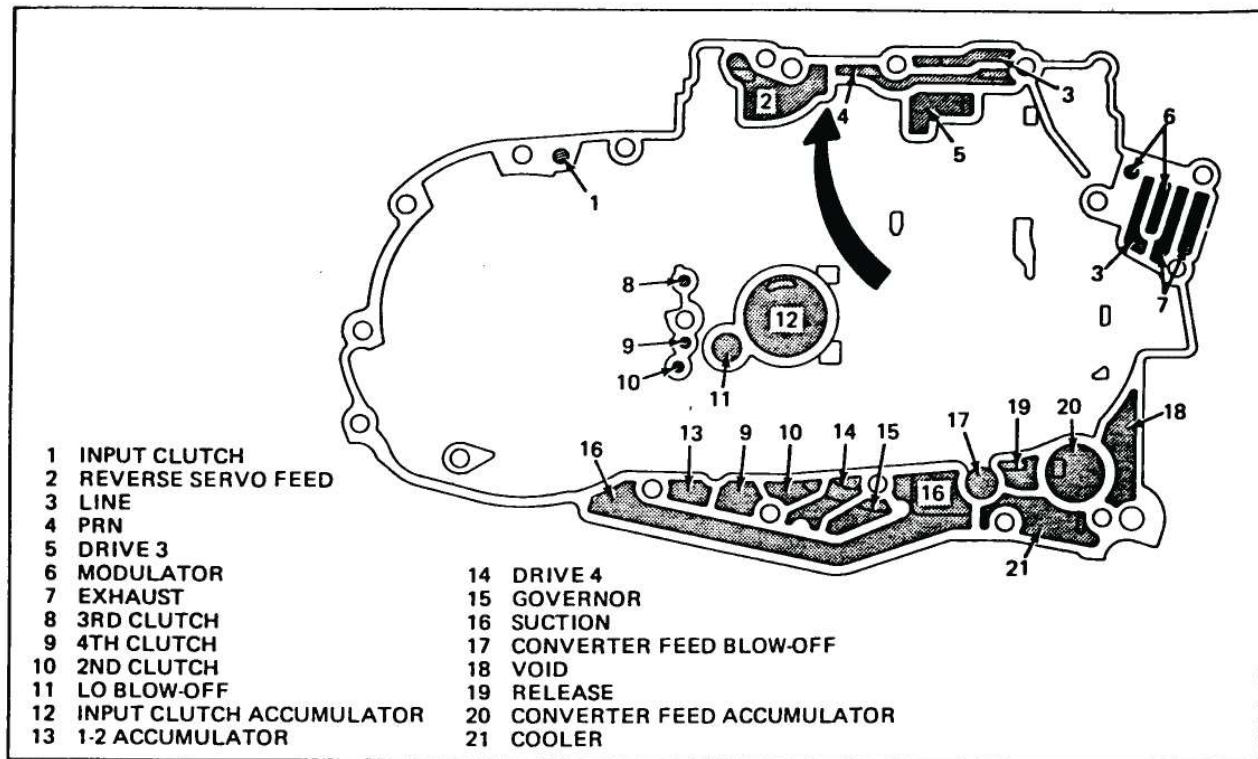
Figure 17 (1985 Only)

- 1985**
- Identification:** The easiest way to identify the channel plates apart is the location of the dam in the upper channel plate worm track area. (See Figure 17 and Figure 18). The dam was moved to an area directly under the upper dowel pin bore.
- Reason:** Complete change in hydraulic system for improved 3-2 downshift.
- Interchangeability:** 1985 will work with 85 hydraulics only. CANNOT MIX PUMP, VALVE BODY, OR CHANNEL PLATE.
- 1985 1/2, 1986, and 1987 will interchange as long as calibration requirements are met.

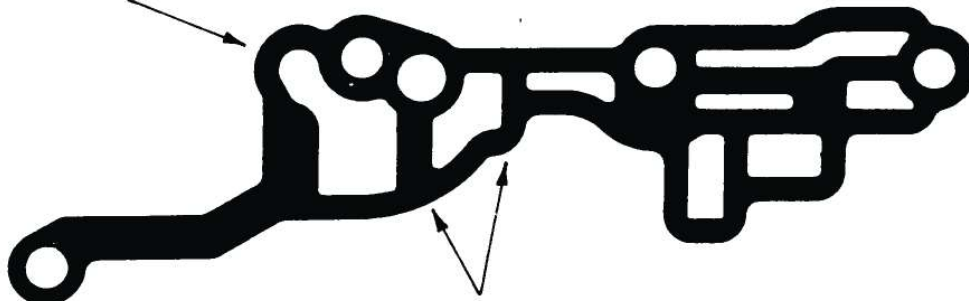
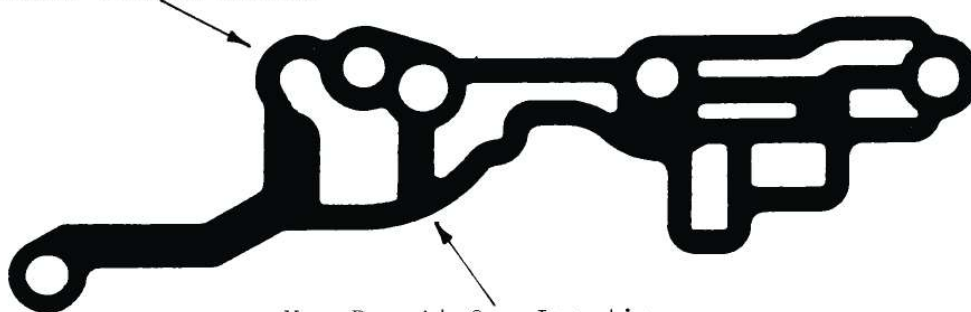
Figure 19

- 1) The upper channel plate gasket was changed to match movement of the dam in the channel plate (See Figure 19).

Has Dam At Both Locations.  
(Will Work On Either Channel Plate)

Has Dam At One Location.  
(Will Work Only On 1985 1/2 And Up)

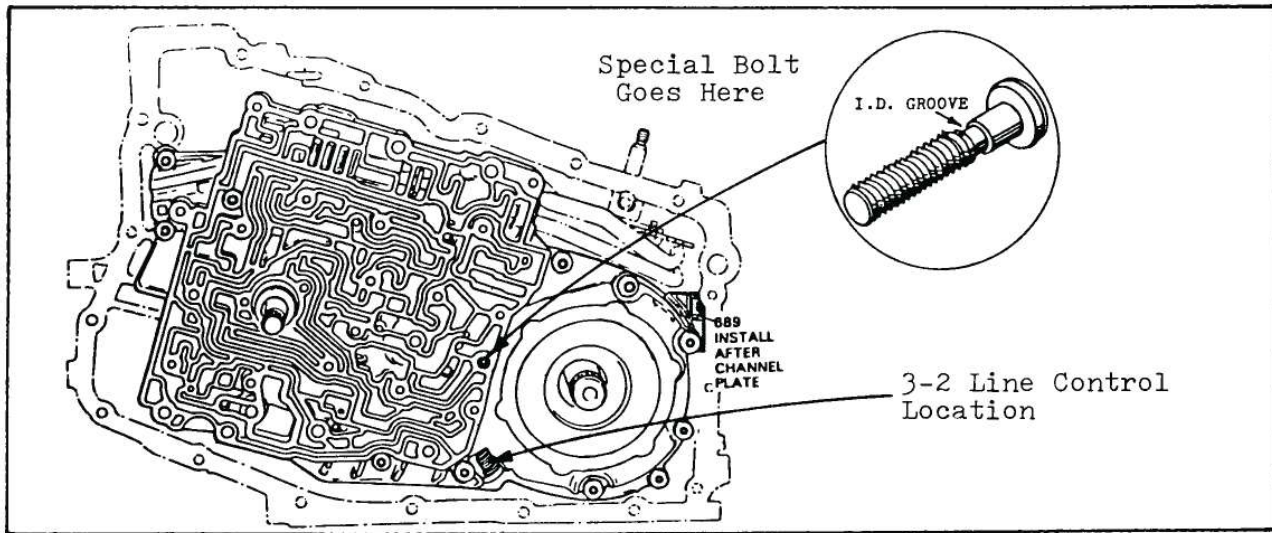
- 2) The 3-2 line control valve located in the channel plate (See Figure 20 For Location), was changed from a single valve, to a two piece valve (See Figure 21). The 2 piece is connected together with a small clip that has a bad habit of breaking, and will create no 3-2 downshift.

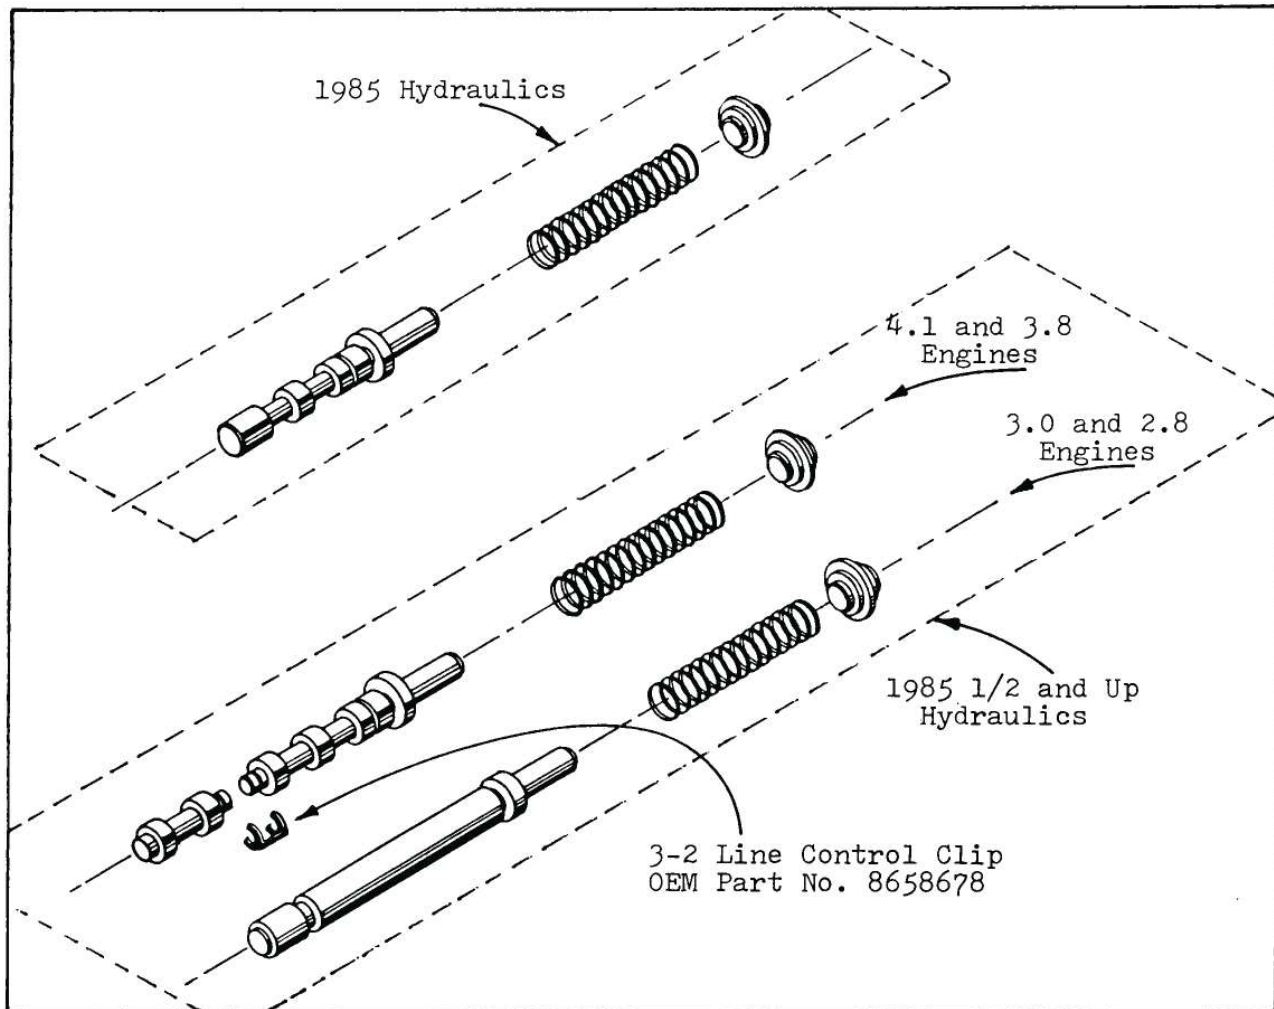
Figure 21

Also notice (See Figure 21) that there are 2 line ups for the 85 1/2 and up models. The 2 piece 3-2 line control valve is used on 4.1 Cadillac, and 3.8 Buick engines. The "Plug" that is also shown (Figure 21), is used on 3.0 Buick, and 2.8 Chevrolet engines.

This makes the channel plates non-interchangeable on these models. This also affects the valve body spacer plate, and makes the spacer plate non-interchangeable on these models.

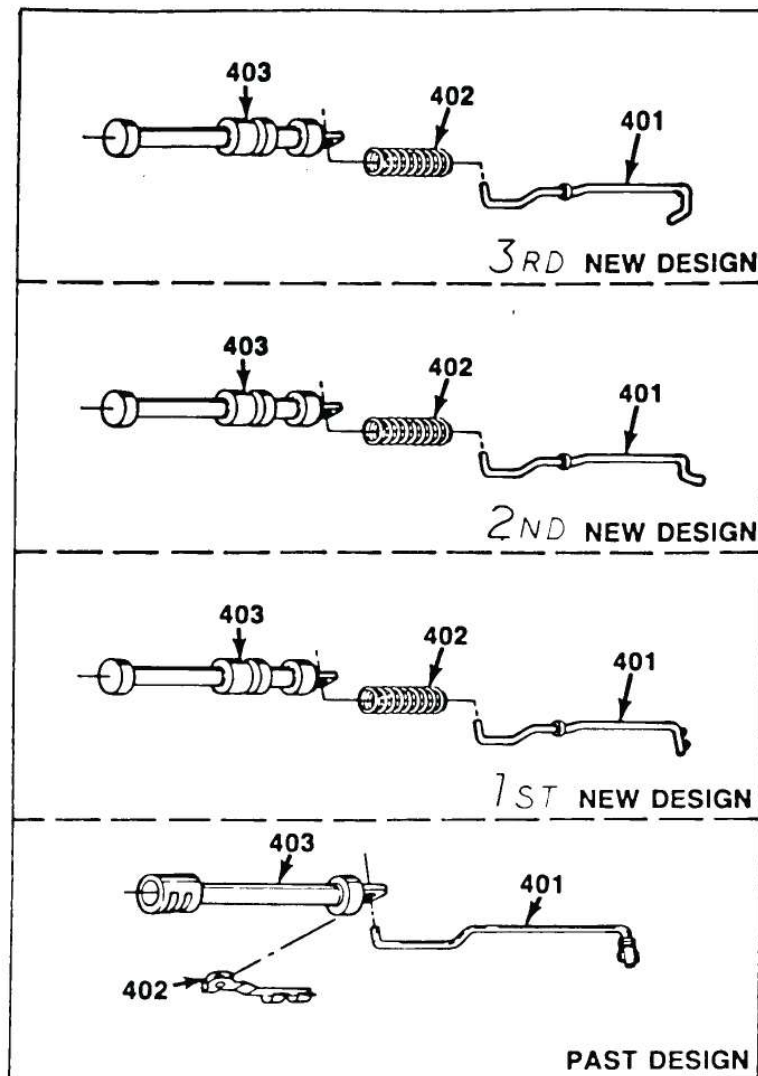
Figure 22

- 3) There has also been some re-design of the manual valve, retainer clip, and manual link to assist in the assembly process (See Figure 22).

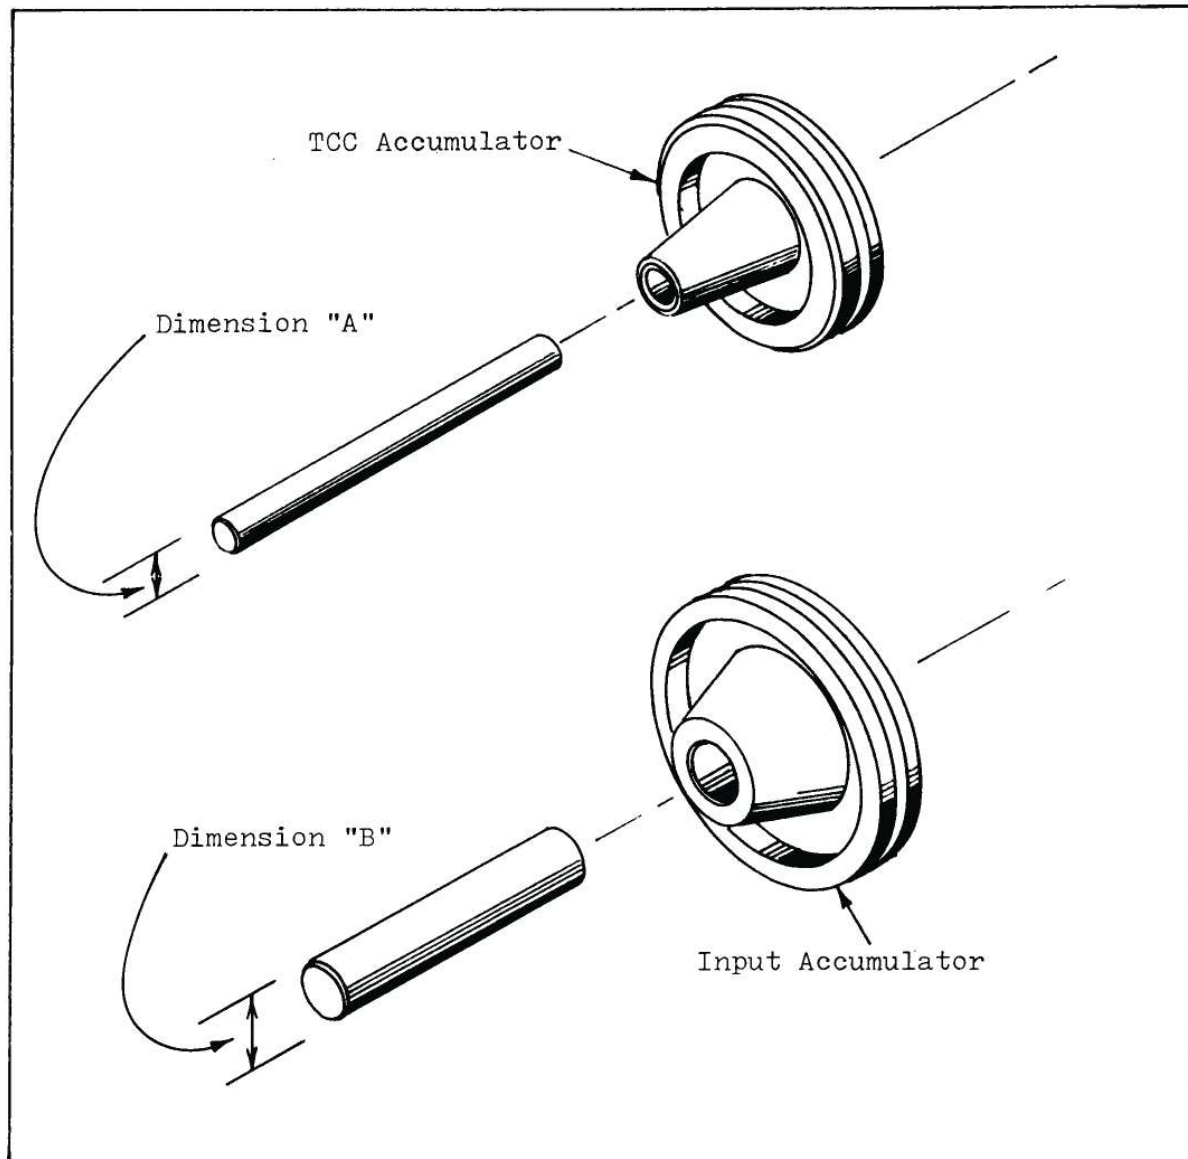
Figure 23

When the TCC accumulator pin is worn, or mismatched, TCC shudder is the result.

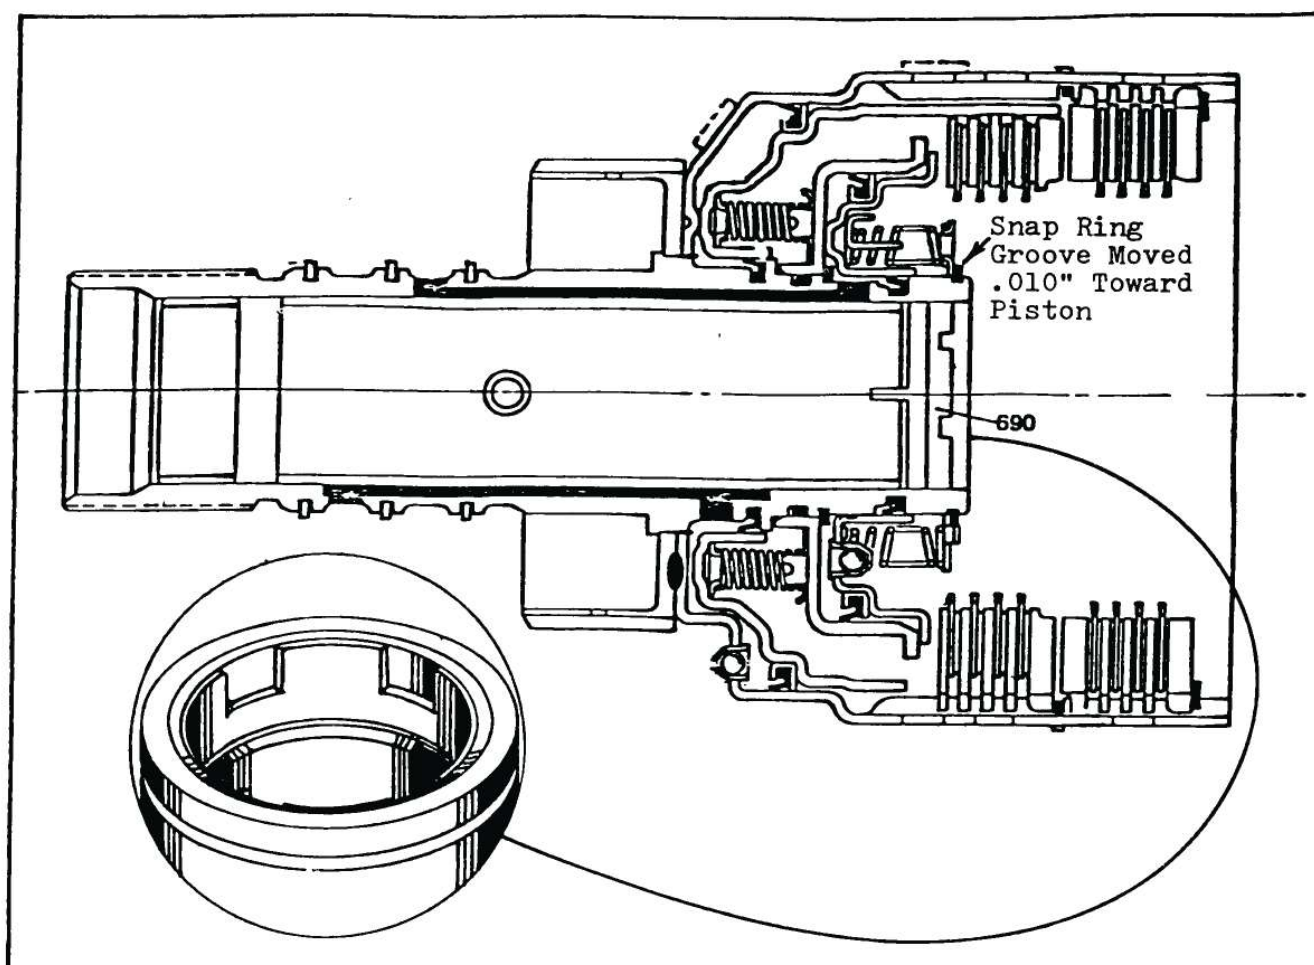
Figure 42

This Sleeve(690) has notches in it to accept the tangs of the "Top Hat" washer to prevent the washer from spinning in the housing.  
(See Inset, Figure 42).

If 2nd design housing is purchased, be sure to remove Sleeve(690) from old input housing and re-install in the new input housing.  
(See Inset, Figure 42).

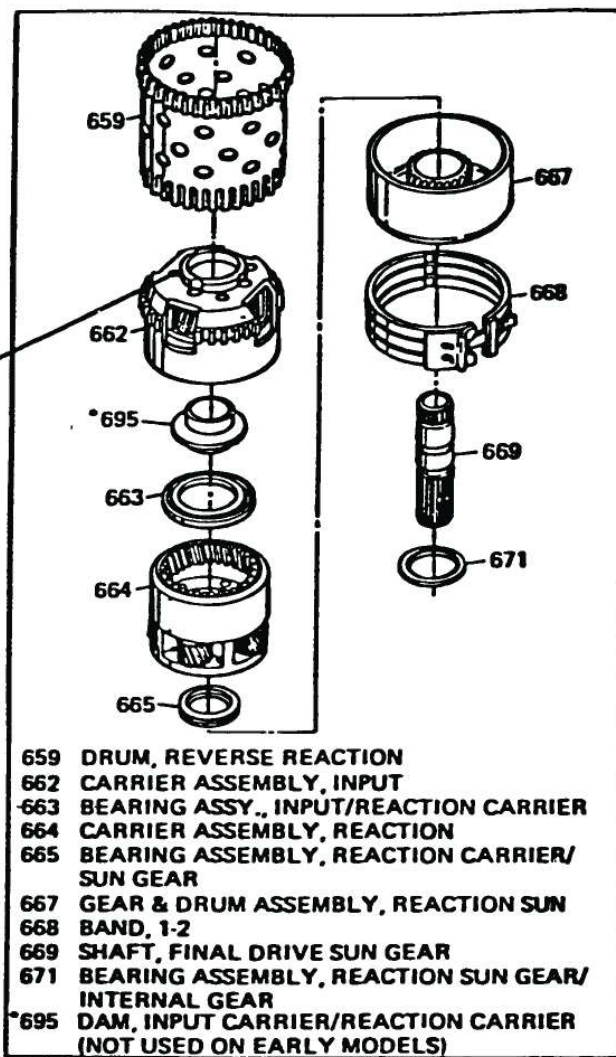
Figure 46

CAUTION: The input carrier must be replaced or modified as per specifications in Figure 46. If not replaced or modified, an interference will result and damage to the transaxle. The lip protruding on top of the input carrier must be machined to meet the dimension shown in Figure 46. Extra care must be used in the machining process, as the torrrington bearing will not come out of the input carrier.

There is now available a service kit, available under OEM part No. 8662906, That will get you all of the input sprag pieces needed, plus the input carrier. The input carrier included in this kit will have the inside diameter bored for the lube dam update. This means that if you are installing this kit into a model that happened not to include the lube dam, you must also purchase the lube dam, the 2nd design output shaft, and the 2nd design final drive sun gear shaft (See Plastic Lube Dam Update portion of this manual).

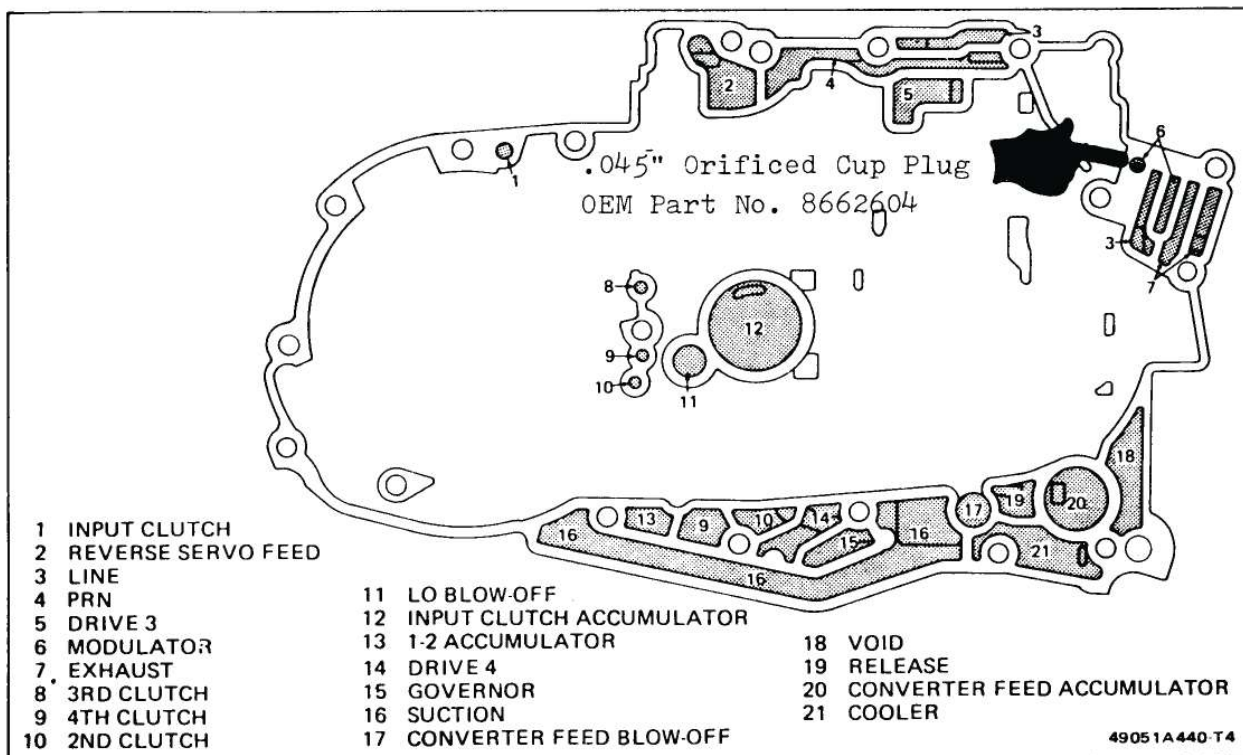
Figure 53

- 1) Vacuum Modulator - Late design has plunger sticking out of modulator (See Figures 54 and 55).
- 2) Modulator Valve - Redesigned to be compatable with "Plunger" style modulator. (Stem Removed--See Figures 54 and 55).
- 3) Channel Plate - Orificed cup plug added to channel plate to stabilize modulator valve action (See Figure 53).

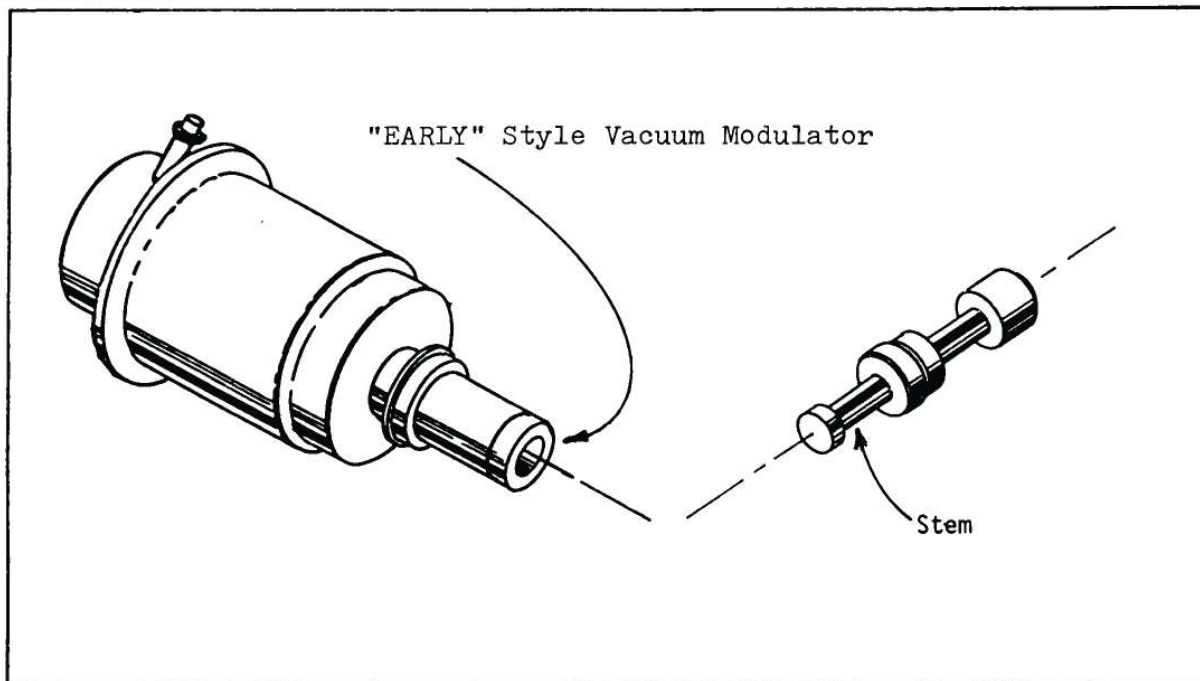
Figure 54

Change: Modulator redesigned on the end that goes into transaxle.  
(Compare Figures 54 and 55). Occured Approx. July, 1986.

If you install the early style modulator on top of the late style valve, you lose all modulator boost, and clutch damage will occur in about 15 minutes of normal vehicle operation.

**CAUTION:** Be certain, if changing modulators, that you have compatable parts together. You cannot install the late style modulator on top of the early style valve, but you can go the other way very easily.

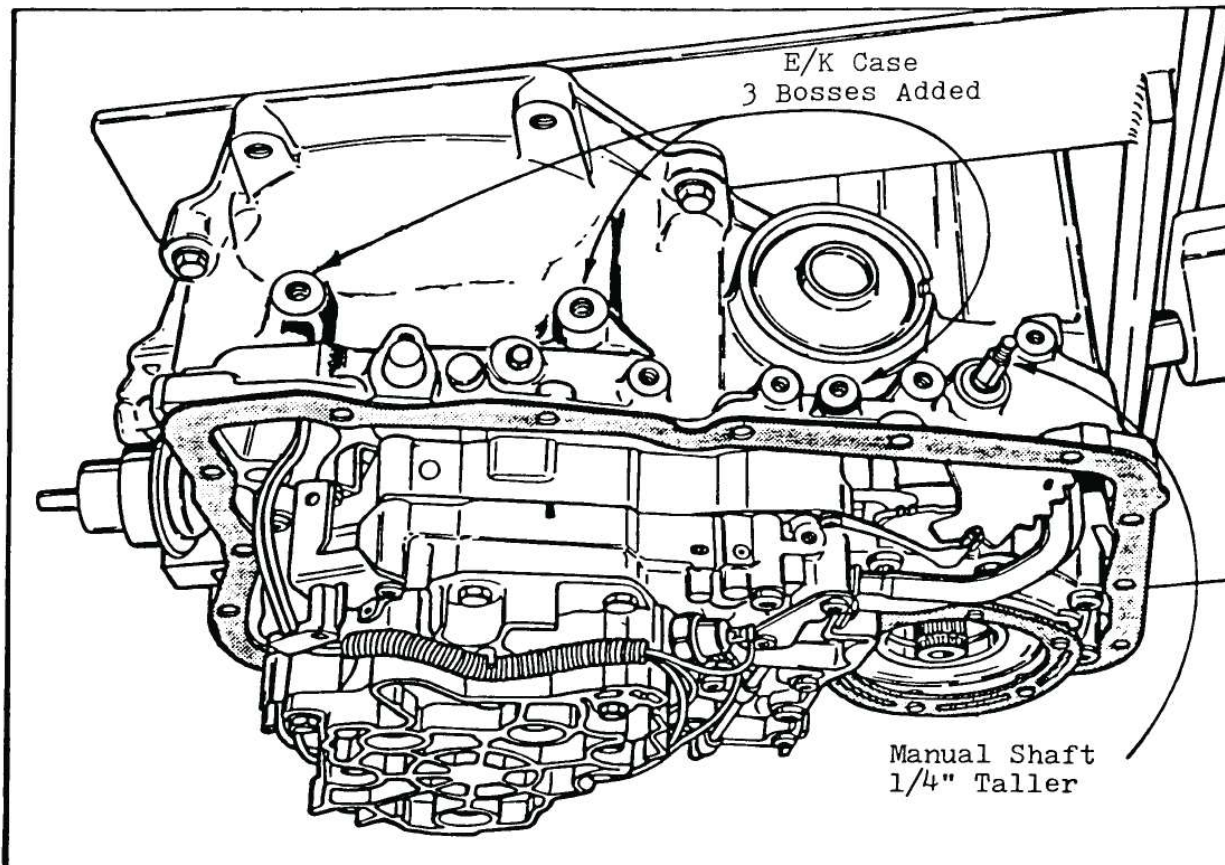
Figure 56

**Change:** Transaxle Case Assembly - 3 bosses added to transaxle case assembly (See Figures 56 and 57).

- 1) Transaxle Case - 3 bosses added to the case assembly (See Figures 56 and 57). The larger bosses on top of the case are for mounting purposes in the "E" and "K" bodies only. The smaller boss is for fuel line bracket in the "E" and "K" bodies only (See Figure 56). We can immediately see why it is called the E/K case.
- 2) Manual Shaft - The manual shaft is 1/4" longer on the E/K cars only.

Will retro fit backwards, but would not be smart to waste an E/K case on a non E/K vehicle, as they are in short supply.

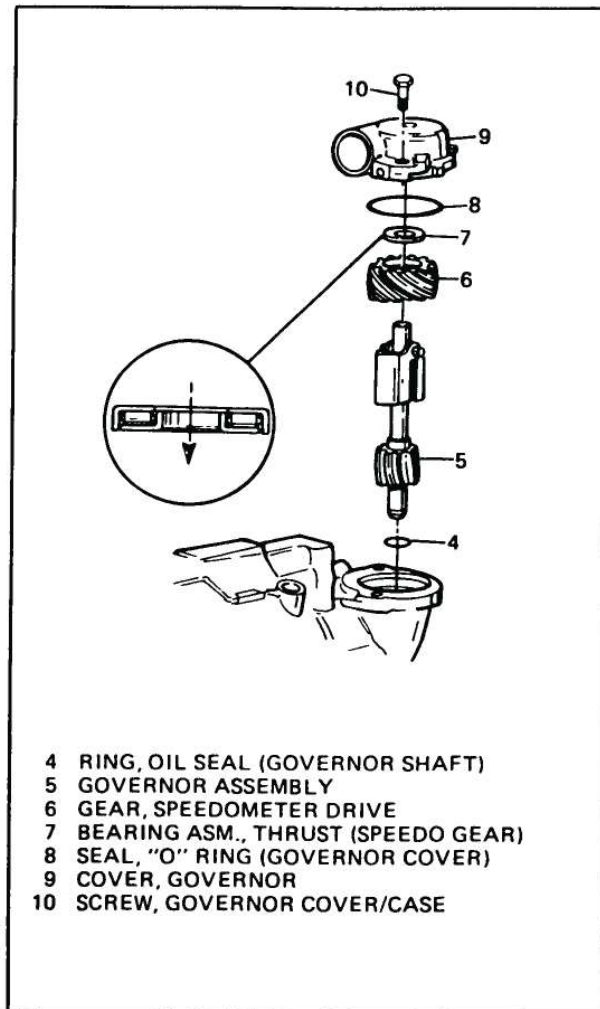
Figure 58

- 1) Governor Cover - Redesigned and speed sensor added to governor cover (See Figures 58 and 59).
- 2) Speedometer Gear - Replaced by 14 tooth rotor (11 Tooth on Allante) That is pressed on governor shaft (See Figure 59).

Not Interchangeable.

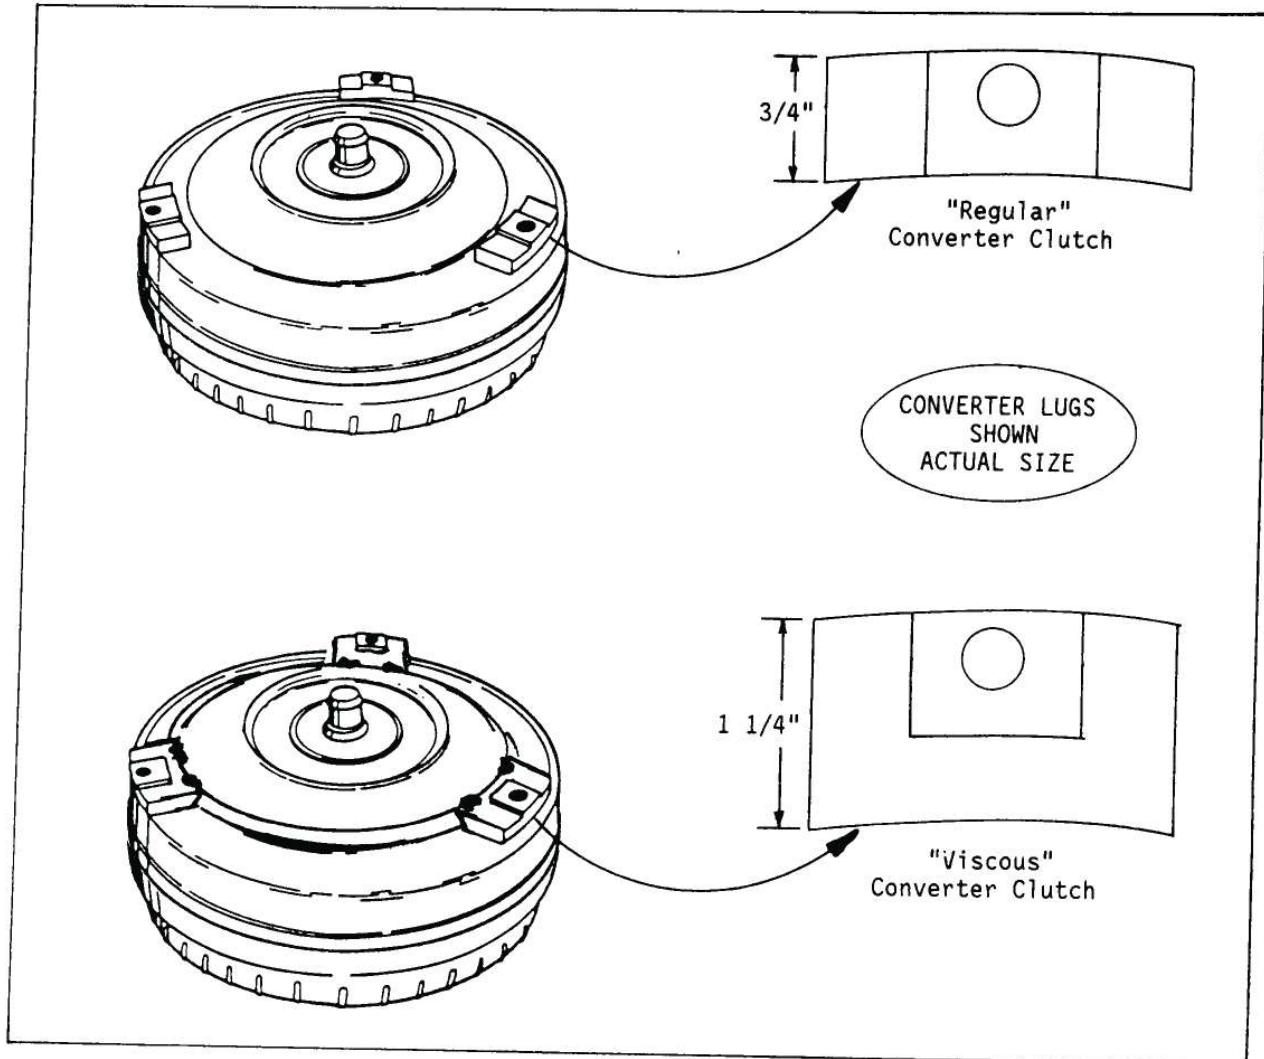
Figure 60

Identification of the "VISCOUS" converter from the "REGULAR" converter, can be done very easily externally. Notice the difference in the size of the converter drive lugs (see Figure 60). The profile of the converter covers are also different, but takes a closer look to detect, than do the drive lugs.

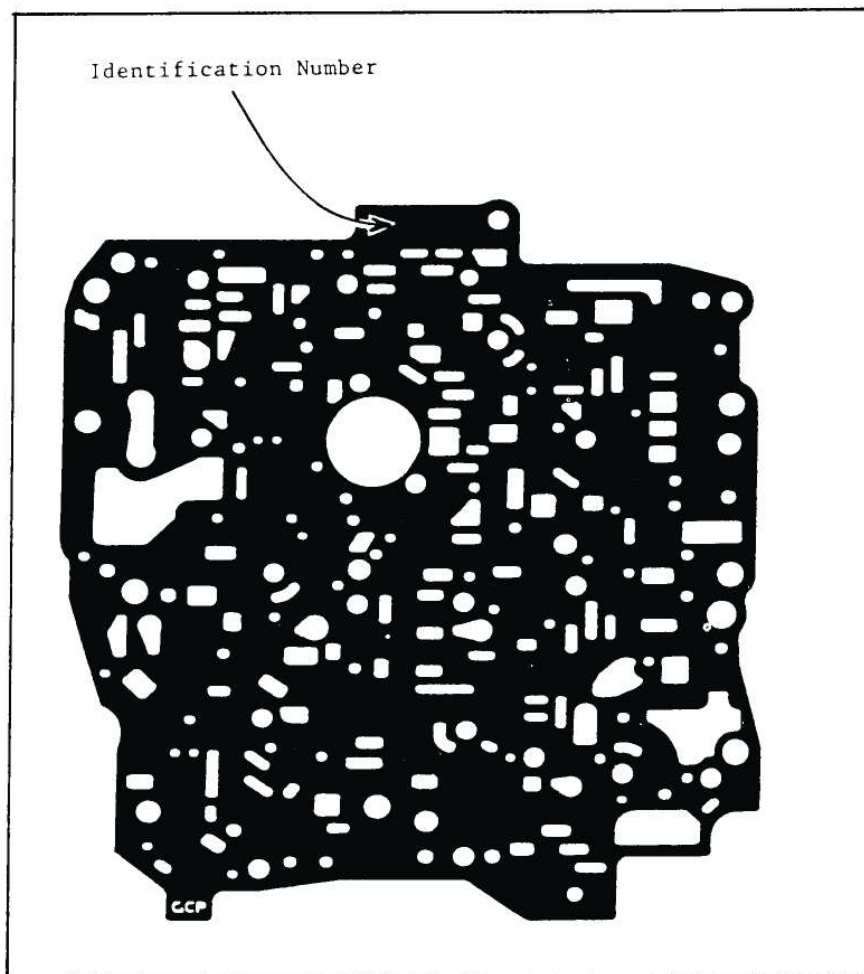
Figure 64

1985 and 1985 1/2 model valve body gaskets "ARE NOT" interchangeable. Ink stamped on each gasket is a 3 digit identification number, in the location shown in Figure 64.
