**AUTOMATIC TRANSMISSION SERVICE GROUP**

**REVISED EDITION**

## INTRODUCTION

Since the introduction of the THM 440-T4 Transaxle in April, 1984, there have been many major engineering design changes. These changes have affected nearly every part used in the THM 440-T4. This Update Handbook will explain each change, the parts affected by the change, and any parts interchangeability problems created by the change.

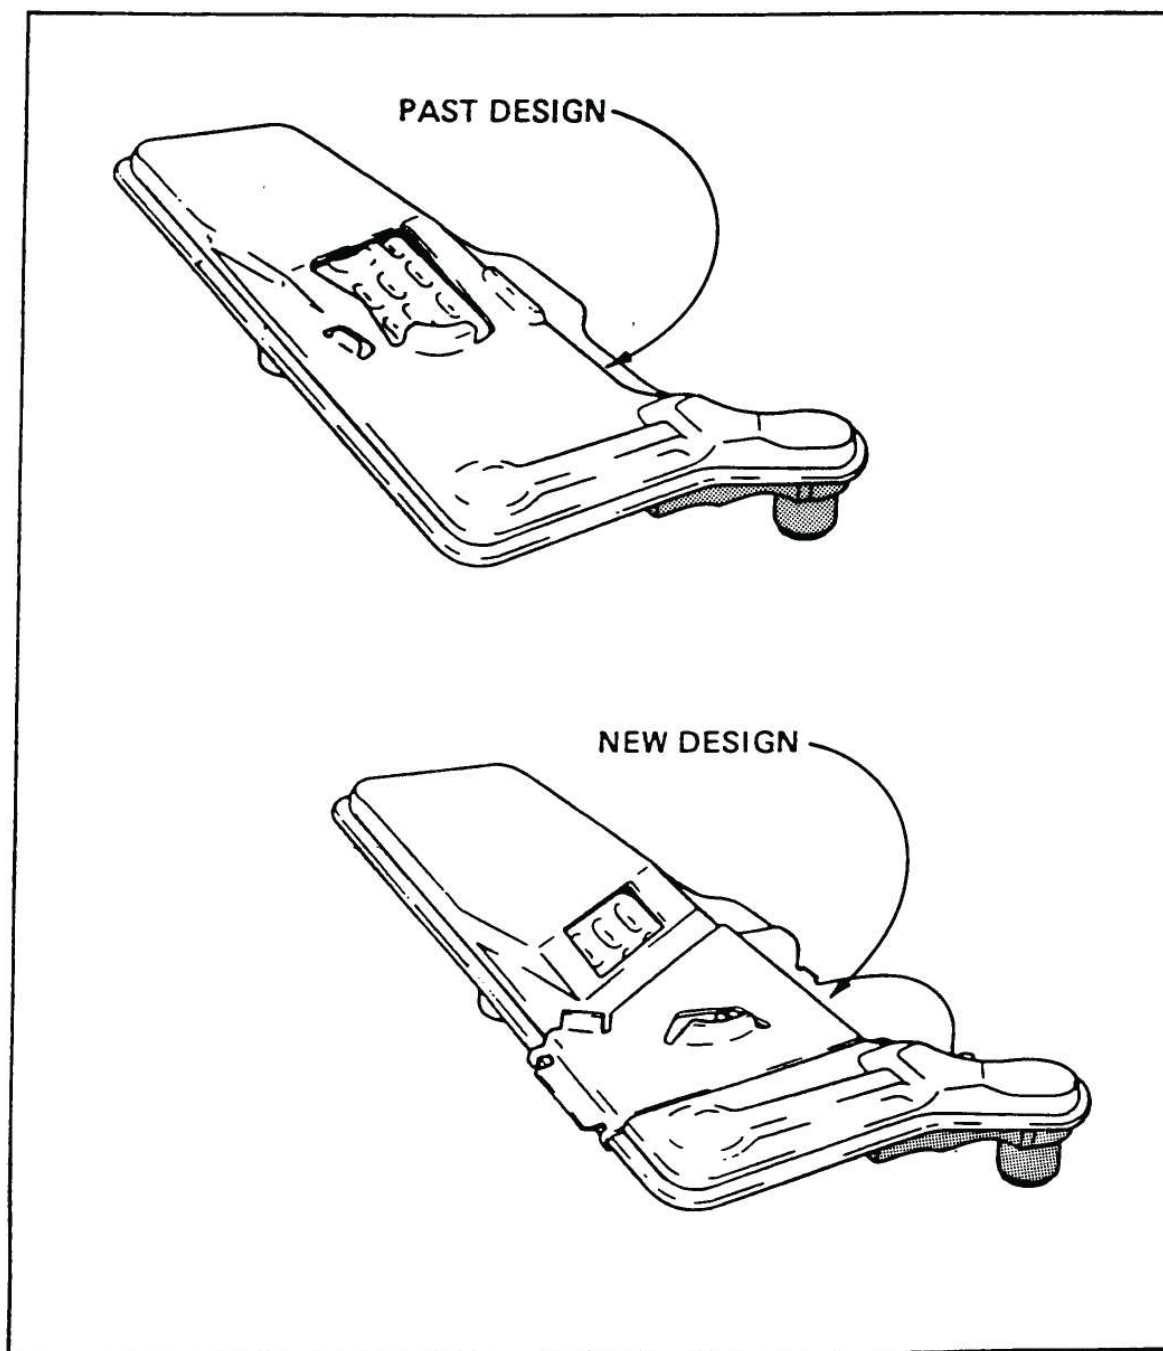
Figure 68

CHANGE: Oil Filter Assembly - Added baffles to oil filter and revised inlet (See Figure 68).

Additional baffles were installed on the new design filter and the inlet was revised (See Figure 68). Starting April 6, 1987 (Julien Date 096), all THM 440-T4 transaxles were built using the new design filter with the new inlet and baffle design.

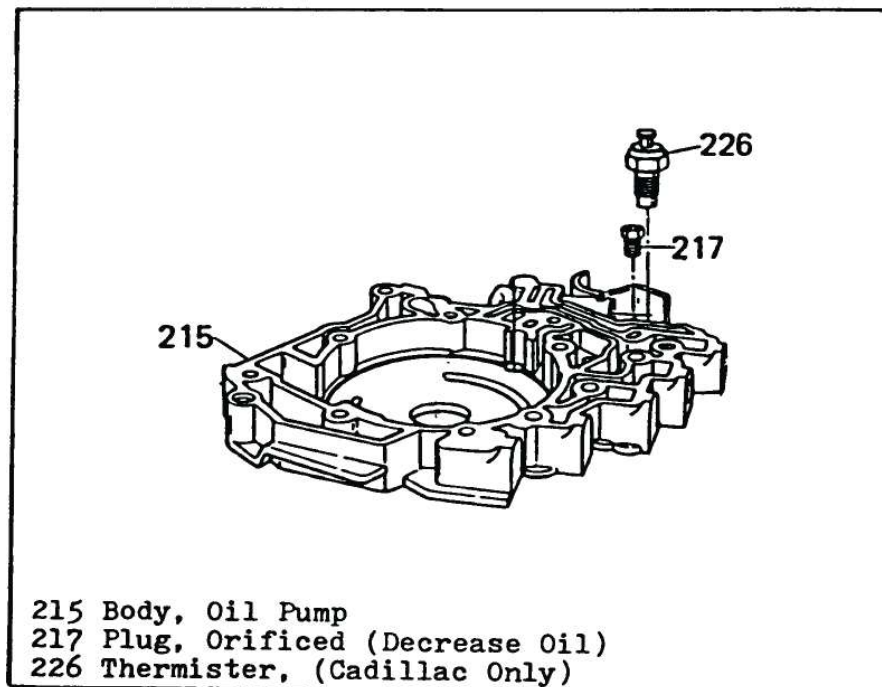
Figure 72

**CHANGE:** Thermister located in oil pump housing moved into cooler line (See Figures 72 & 74). Temperature switch in channel plate was also eliminated (See Figure 73).

- (1) Thermister - Removed from pump housing (See Figure 72).
- (2) Temperature Switch - Eliminated (See Figure 73).
- (3) Cooler Line - Temperature Sensor added (See Figure 74).
- (4) Case Connector - "E" terminal that normally carried the thermister wire is now empty (See Figure 75).
- (5) Vehicle Wiring Harness.

**NOTE:** SOME EARLY 1988 CADILLAC MODELS MAY HAVE "NO" COOLER FLOW CREATED BY NEW TEMPERATURE SENSOR IN COOLER LINE. CHECK COOLER FLOW ON "ALL" 1988 CADILLAC MODELS AND REPLACE COOLER LINE ASSEMBLY WITH OEM PART NUMBER 25036979 IF NECESSARY.

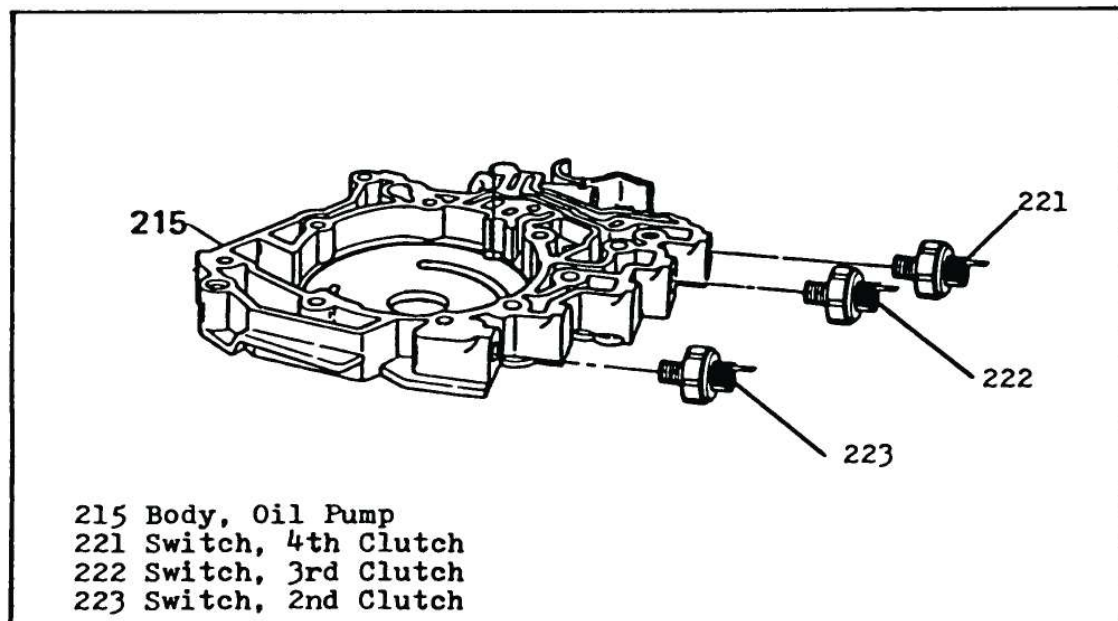
Figure 76

- (1) Pump Body - Drilled and tapped for 2nd clutch switch.  
(See Figure 76).
- (2) Valve Body - Extra hole drilled in valve body to carry 2nd clutch oil to pump body.
- (3) Case Connector - Now round black connector (Same as Cadillac), and "E" terminal now carries 2nd clutch signal wire (See Figure 77).
- (4) Transaxle Wiring Harness - Extra wire in harness for 2nd clutch signal to ECM (See Figure 77).
- (5) Vehicle Wiring Harness

The same switch is used in all three locations, OEM Part No. 8658040, and is a N.C. single prong switch.

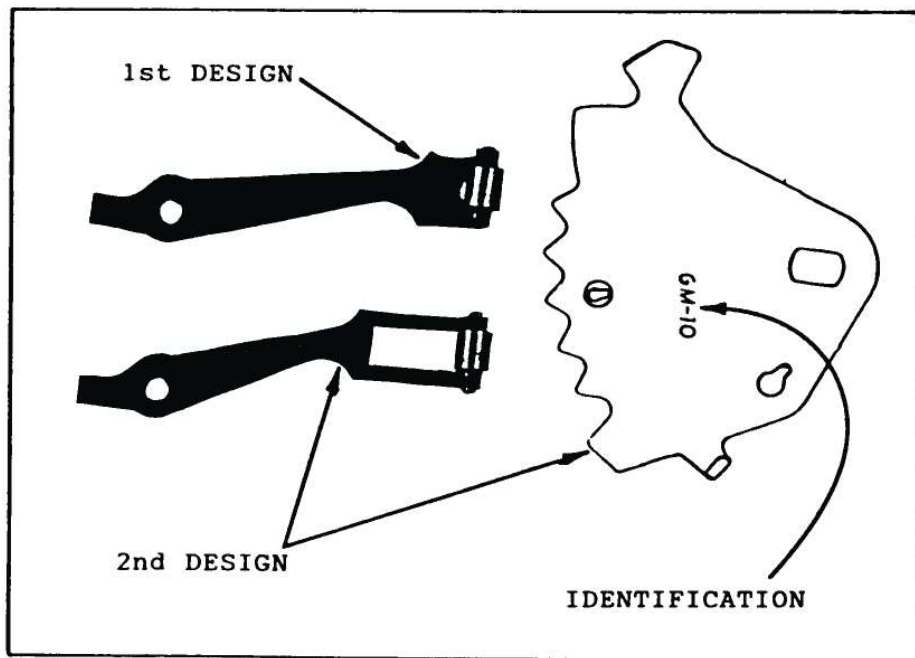
Figure 78

- (1) Detent Roller and Spring Assembly - Different profile.  
(See Figure 78)
- (2) Inside Detent Lever - Different profile on the detents only.  
2nd design can be identified by "GM-10" stamped into detent  
lever as shown in Figure 78.

Will retro fit back on all models but, 2nd design Inside  
Detent Lever "MUST" be used with the 2nd design Detent Roller  
and Spring Assembly (See Figure 78).  
DO NOT MIX THESE PARTS.

Spring and Roller, Detent (2nd Design).....8662737  
Lever, Inside Detent (2nd Design).....8662736

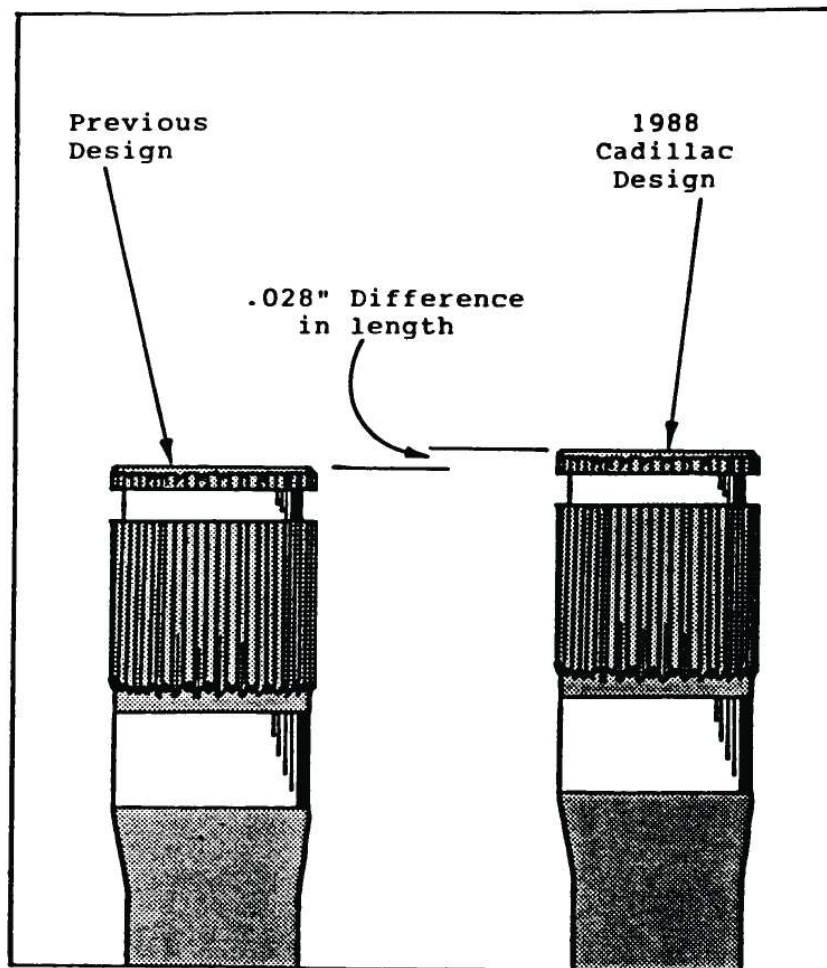
Figure 80

- (1) Differential Side Gears - Revised dimension (Thicker), and they have 16 teeth instead of previous 15.
- (2) Differential Pinion Gears - Revised dimension, and have 10 teeth instead of previous 11.
- (3) Side Gear Thrust Washers - Revised dimension.
- (4) Pinion Gear Thrust Washers - Revised dimension.
- (5) Differential Housing - Revised dimensions (Internal), to accept new side gears and new pinion gears.
- (6) Differential Pinion Shaft - Black in color to identify the new design final drive assembly (See Figure 79). Also is a smaller diameter.
- (7) Output Shaft - Longer (.028"), so that it will extend through the thicker side gears, to get "C" clip installed. The longer output shaft can be identified by green paint on the end of the shaft opposite the "C" clip end (See Figure 80).

Final Drive Assembly, 3.33 Ratio (2nd Design).....8662777  
 Output Shaft (2nd Design).....8661039

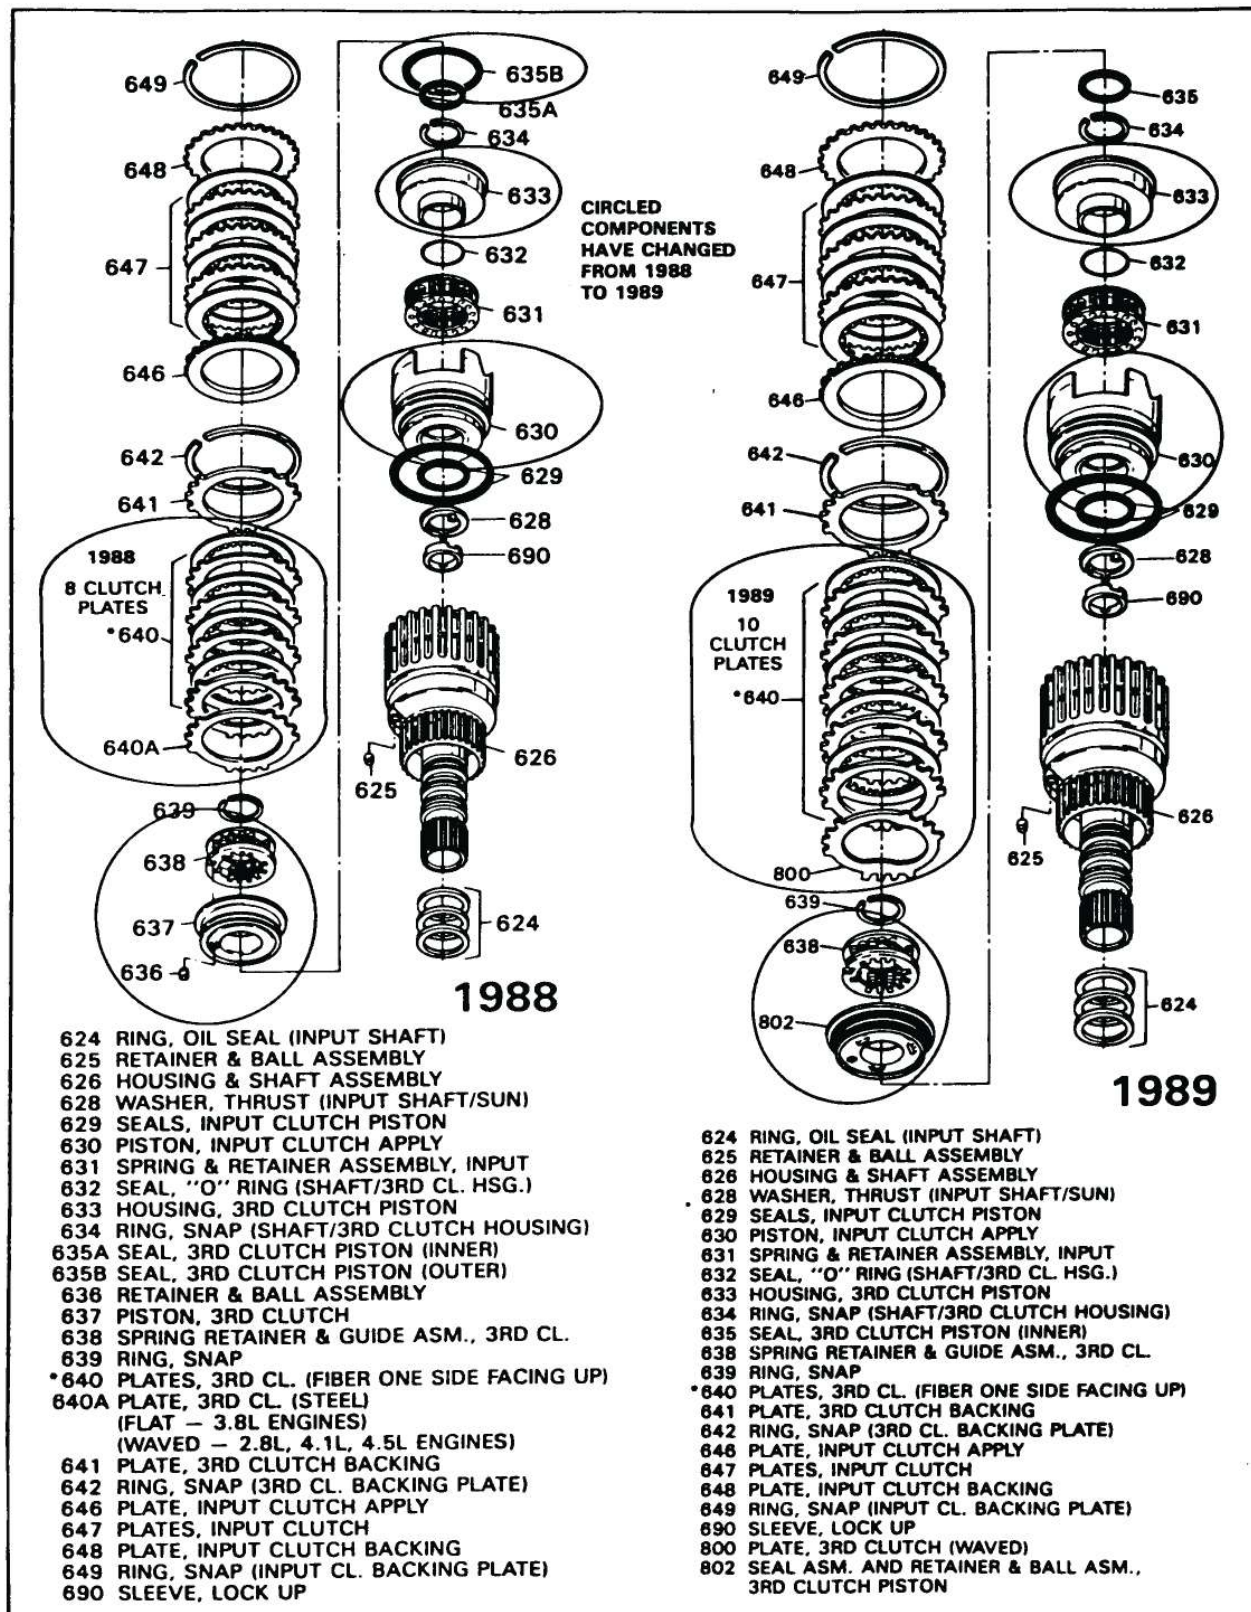
Figure 81

**CHANGE:** The single sided 3rd clutch plates were "Increased" from the 8 plate clutch pack to a 10 plate clutch pack for all 1989 model THM 440-T4 transaxles (See Figure 81).

"DO NOT USE BOTH IN THE SAME PACK"

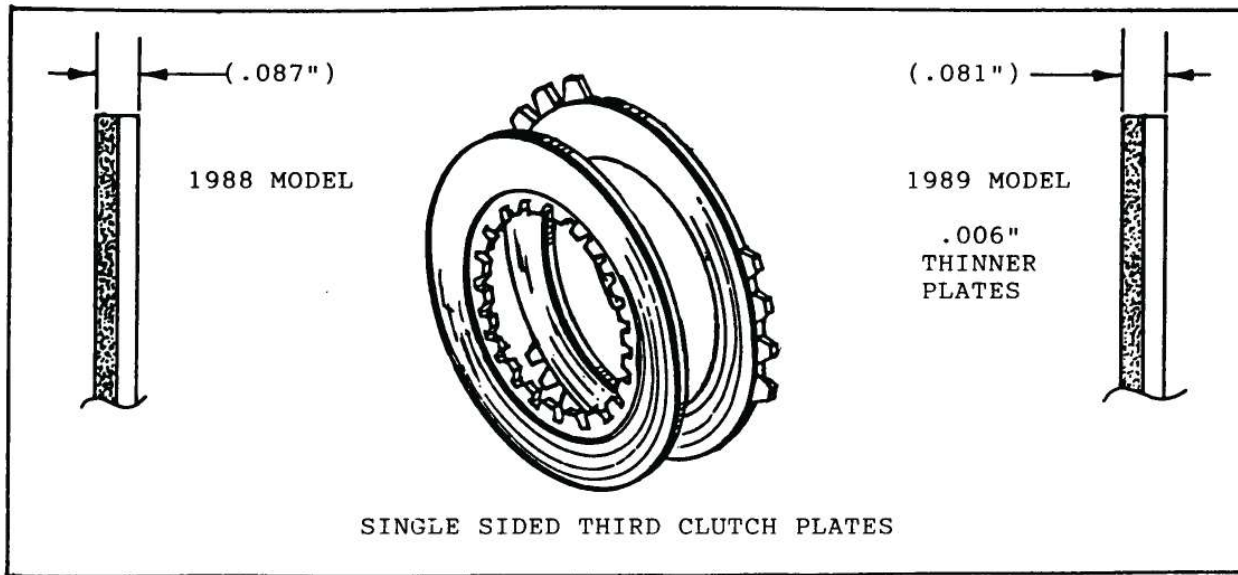
Figure 82

- (1) Single Sided 3rd Clutch Plates - Both inside and outside spline plates are .006" thinner for 89, to make room for the two additional plates (See Figure 82).

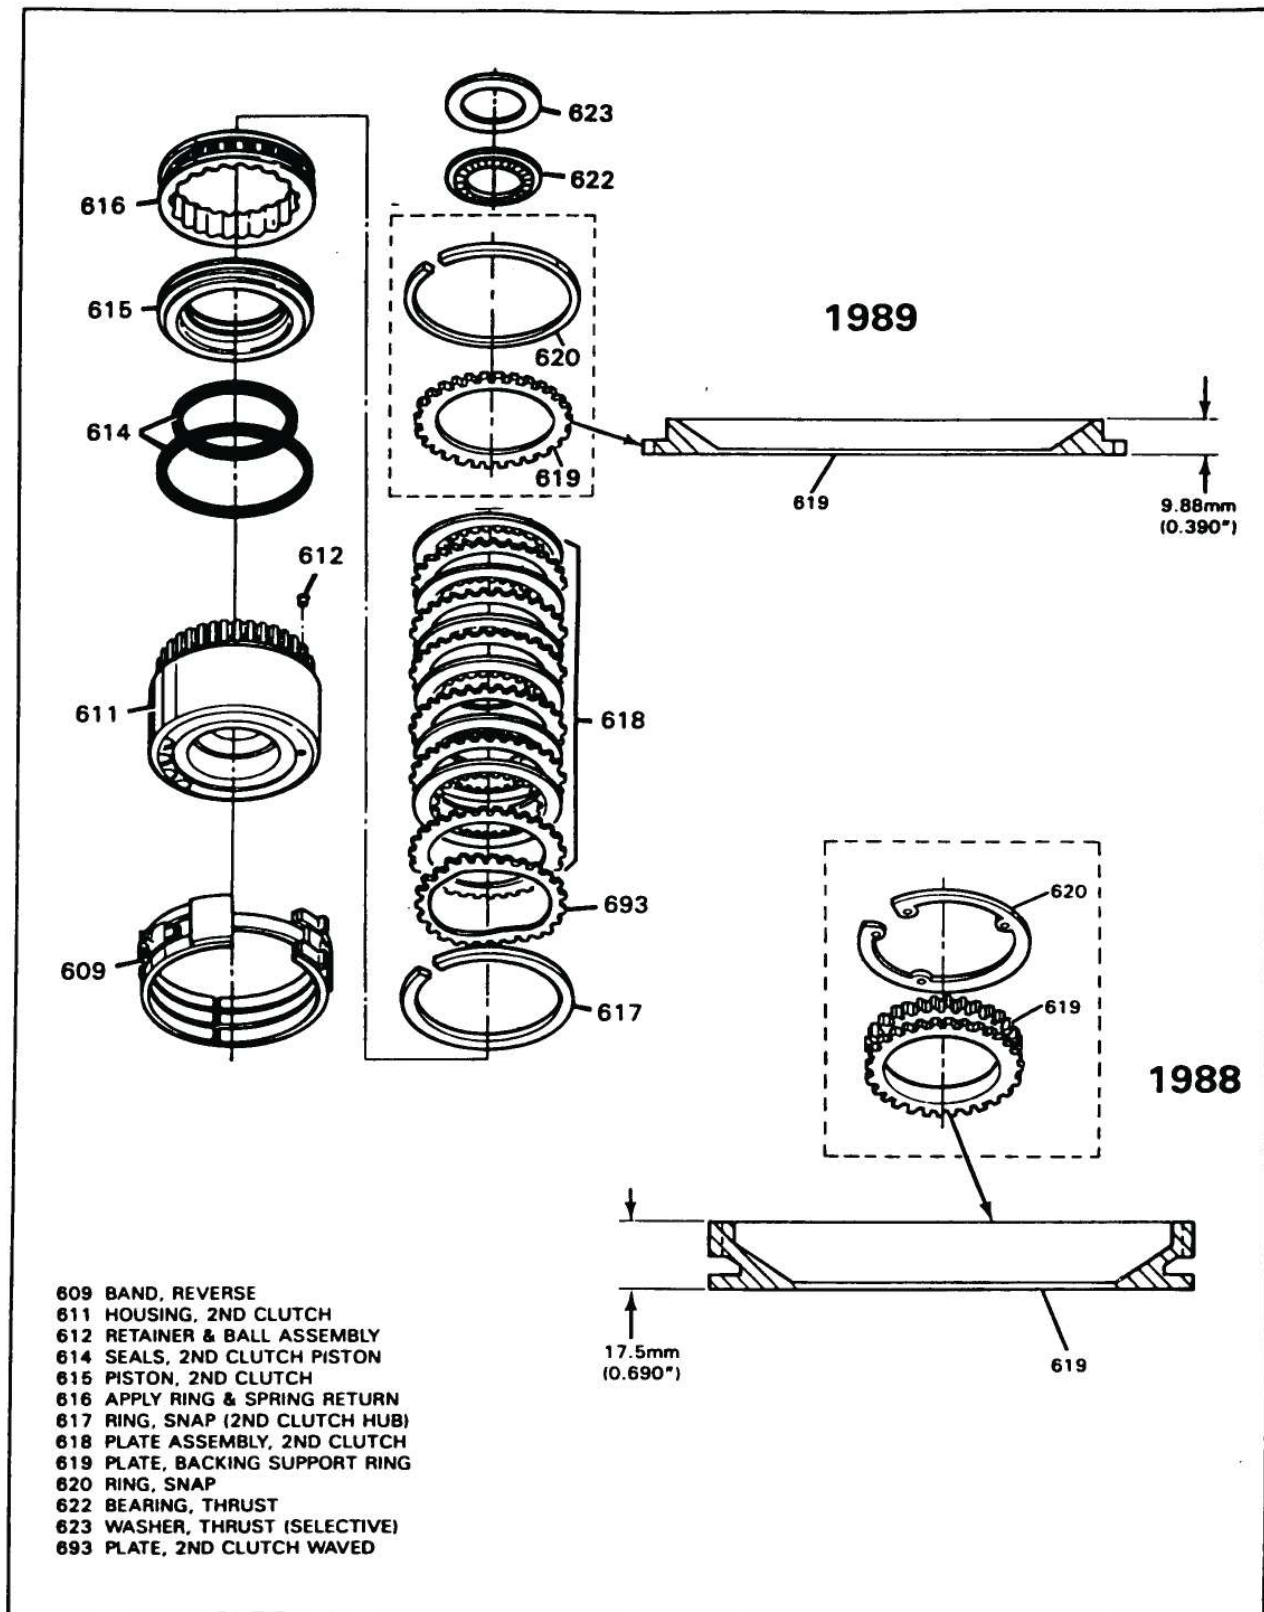
Figure 88  
89

**CHANGE:** 2nd Clutch Backing Plate was redesigned (See Figure 88).

- (1) 2nd Clutch Backing Plate - "Windows" in backing plate are eliminated which makes the backing plate less prone to warpage. Also notice (See Figure 88) that the support ring has been eliminated from the backing plate and is no longer used, because "Engine Torque Management" was added as an ECM function. This was one of the reasons for the addition of the 2nd clutch switch in 1988.
- (2) 2nd Clutch Backing Plate Snap Ring - The new snap ring is only half as wide as the previous models and must be used with the third design backing plate.

2nd Clutch Backing Plate (3rd Design).....8668566  
 2nd Clutch Snap Ring (3rd Design).....8668567

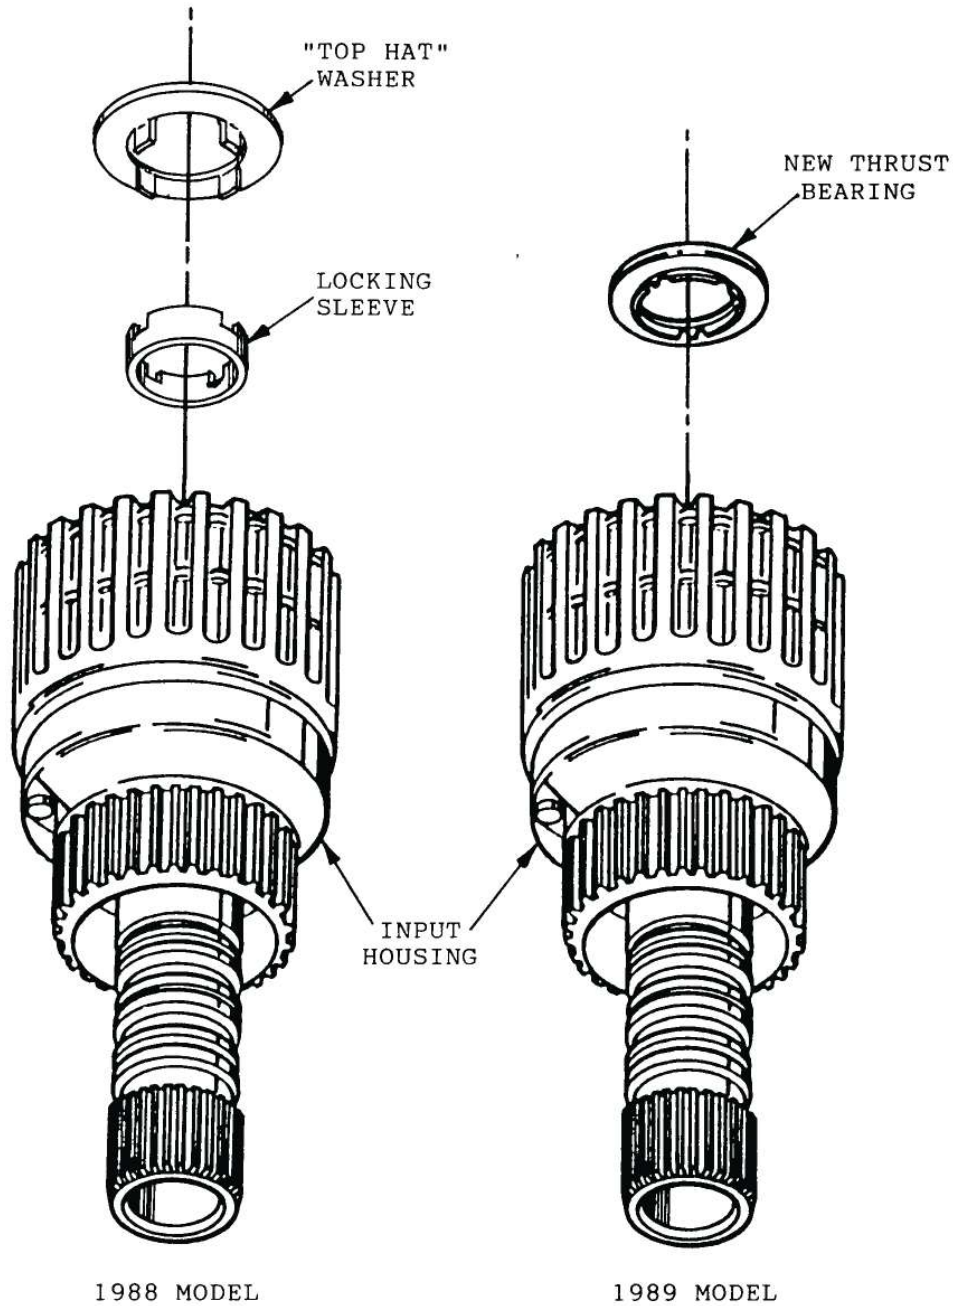
Figure 89

**CHANGE:** A new Thrust Bearing Assembly replaces the "Top Hat" Thrust Washer and Lock Up Sleeve in the input housing. (See Figure 89). The new bearing and related parts went into production on all 1989 models on November 28, 1988 (Julian Date 333).

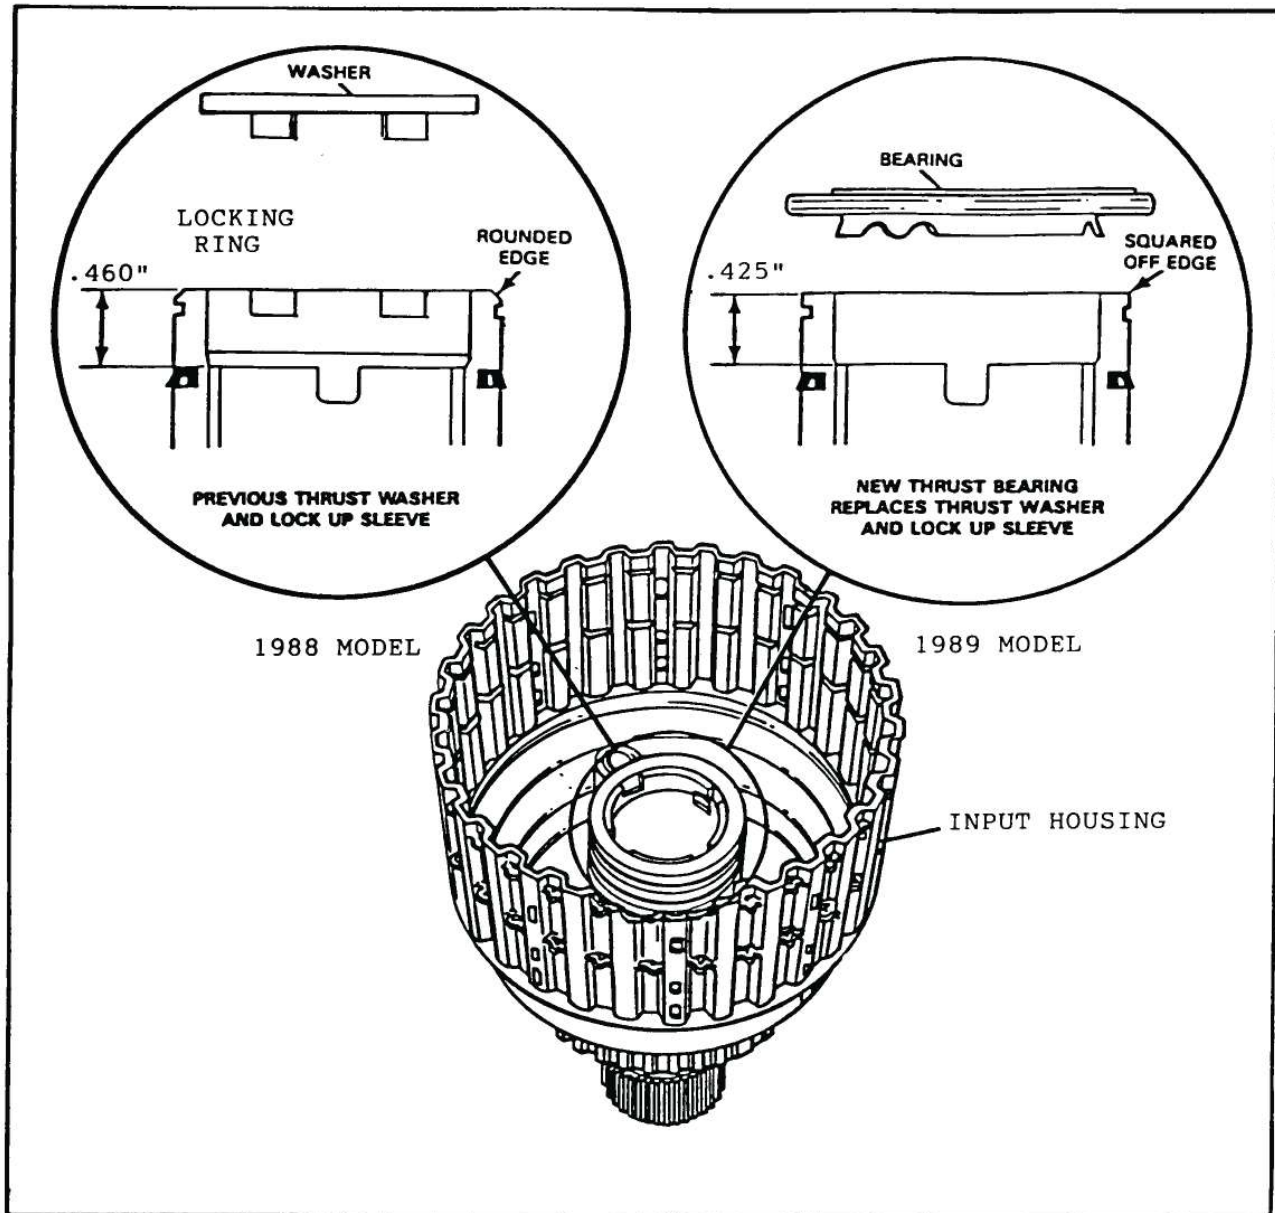
Figure 90

- (1) Input Housing - Surface on the input housing where the new bearing assembly rides, has been reduced by .035" to accommodate the increased thickness of the new bearing (See Figure 90).
- (2) "Top Hat" Thrust Washer - Eliminated (See Figure 90).
- (3) Lock Up Sleeve - The lock up sleeve is no longer needed and has been eliminated (See Figure 90).
- (4) 3rd Roller Clutch Lube Dam - The inside diameter has been increased by .256" to accommodate the larger diameter new bearing, and the lip on the lube dam eliminated for increased lube flow to the 3rd roller assembly (See Figure 91).
- (5) 3rd Roller Clutch Inner Race - Has been machined .040" thinner to accommodate the increased thickness of the new bearing assembly (See Figure 91).

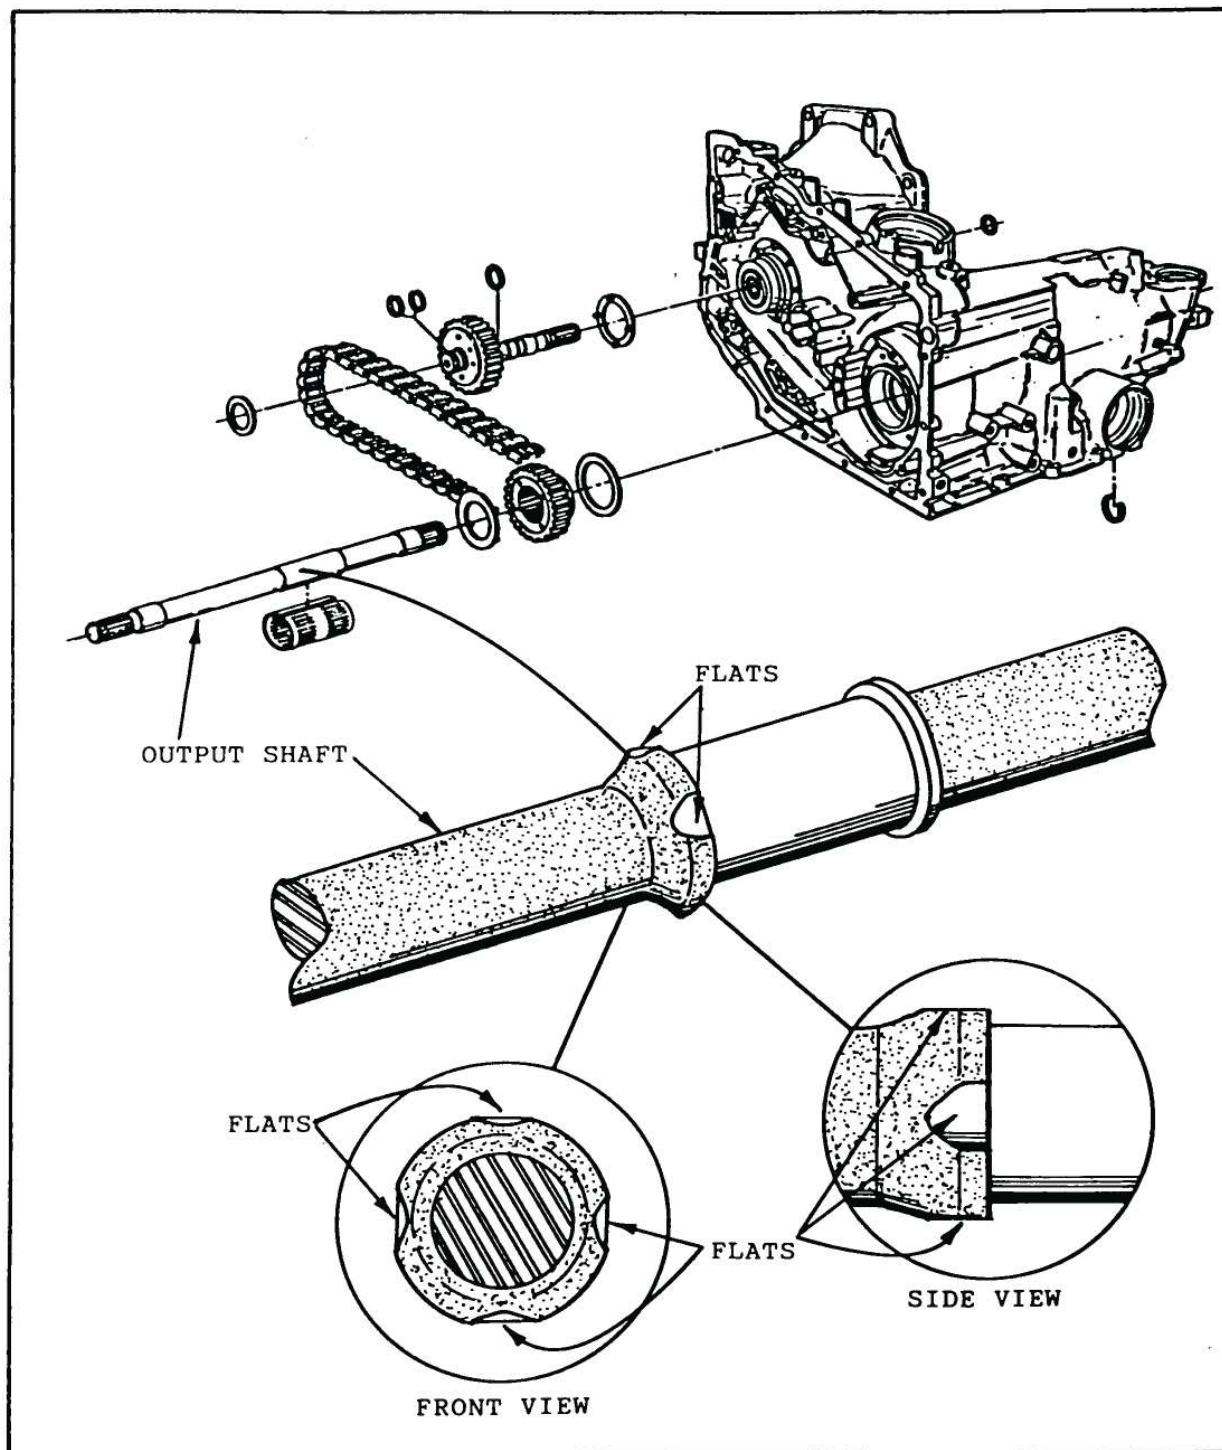
Figure 92

#### 3RD ROLLER CLUTCH AND INPUT SPRAG FAILURE

- COMPLAINT:** Repeated failure of the 3rd Roller Clutch and/or the Input Sprag Assembly.
- CAUSE:** Lack of lube oil to 3rd Roller Clutch and Input Sprag.

- CORRECTION:** Modification as follows, of the parts indicated, will increase lube flow to both the 3rd Roller Clutch and the Input Sprag.
1. **MODIFY OUTPUT SHAFT:**  
Grind four (4) flats on the Output Shaft at the front of the bearing in the locations shown in Figure 92.

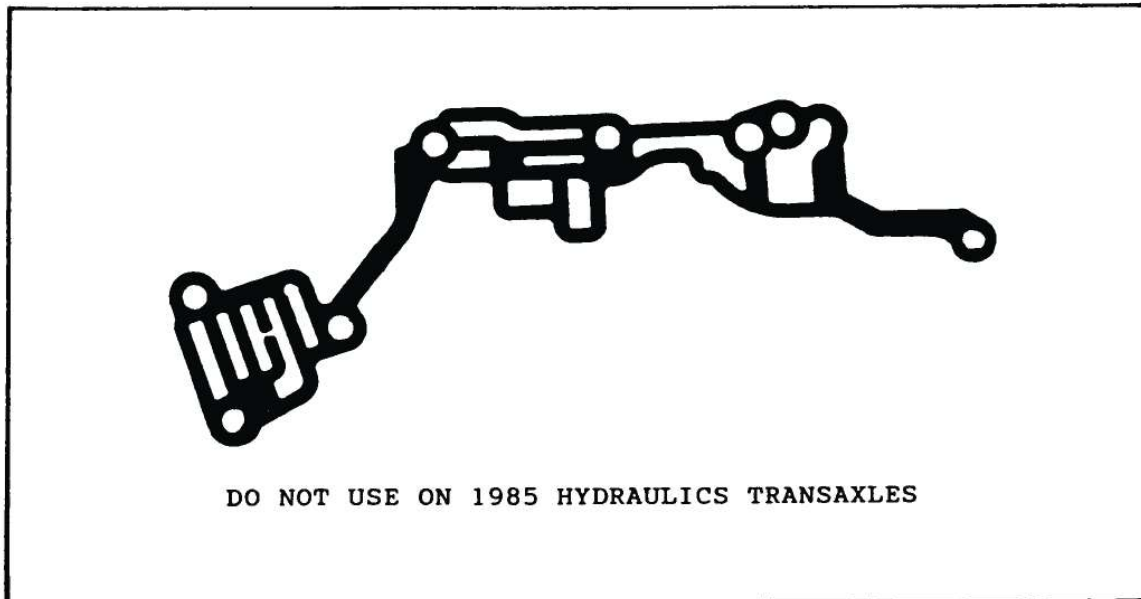
Figure 95

**CHANGE:** Upper Channel Plate Gasket (See Figure 95).

- (1) Upper Channel Plate Gasket - The Upper Channel Plate Gasket and Modulator Port Gasket are now connected together as one gasket (See Figure 95).

The new design Upper Channel Plate Gasket will most likely "Not Appear" in aftermarket gasket sets, as the previous design gaskets will work fine.
