## THM 4L60-E/4L65-E "UPDATE HANDBOOK"

***AUTOMATIC TRANSMISSION SERVICE GROUP***

*Updated  
January, 2003*

### **THM 4L60-E/4L65-E**

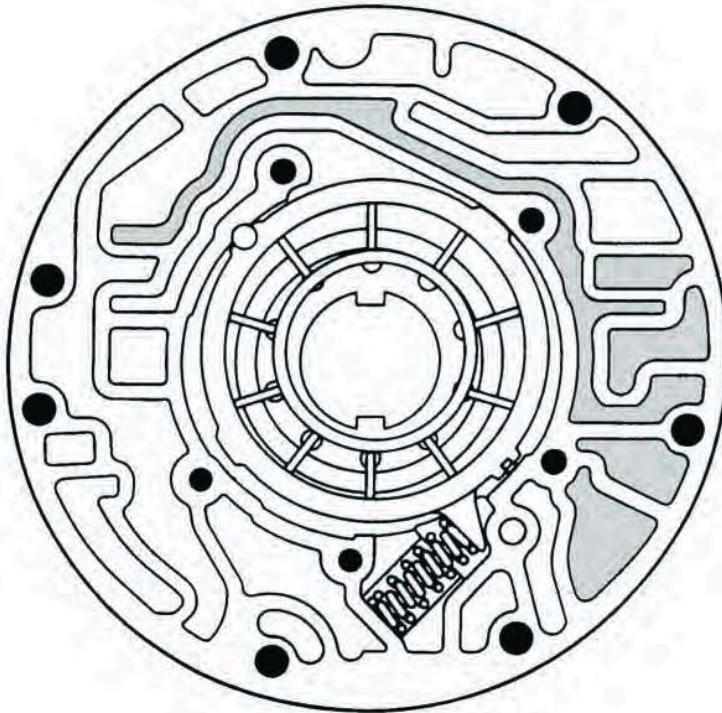
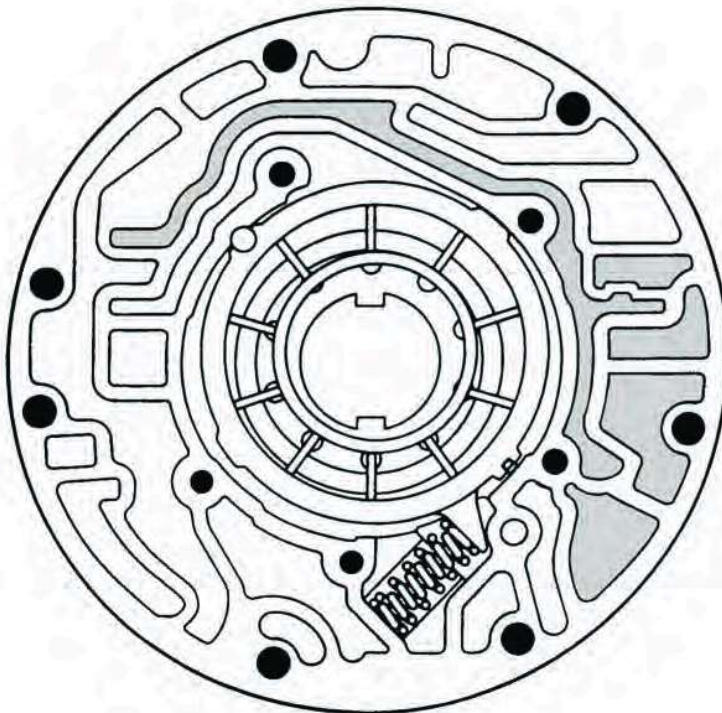
Figure 3

SHADED AREAS ARE DIFFERENT  
BETWEEN THE "PWM" AND THE  
NON PWM PUMP BODY

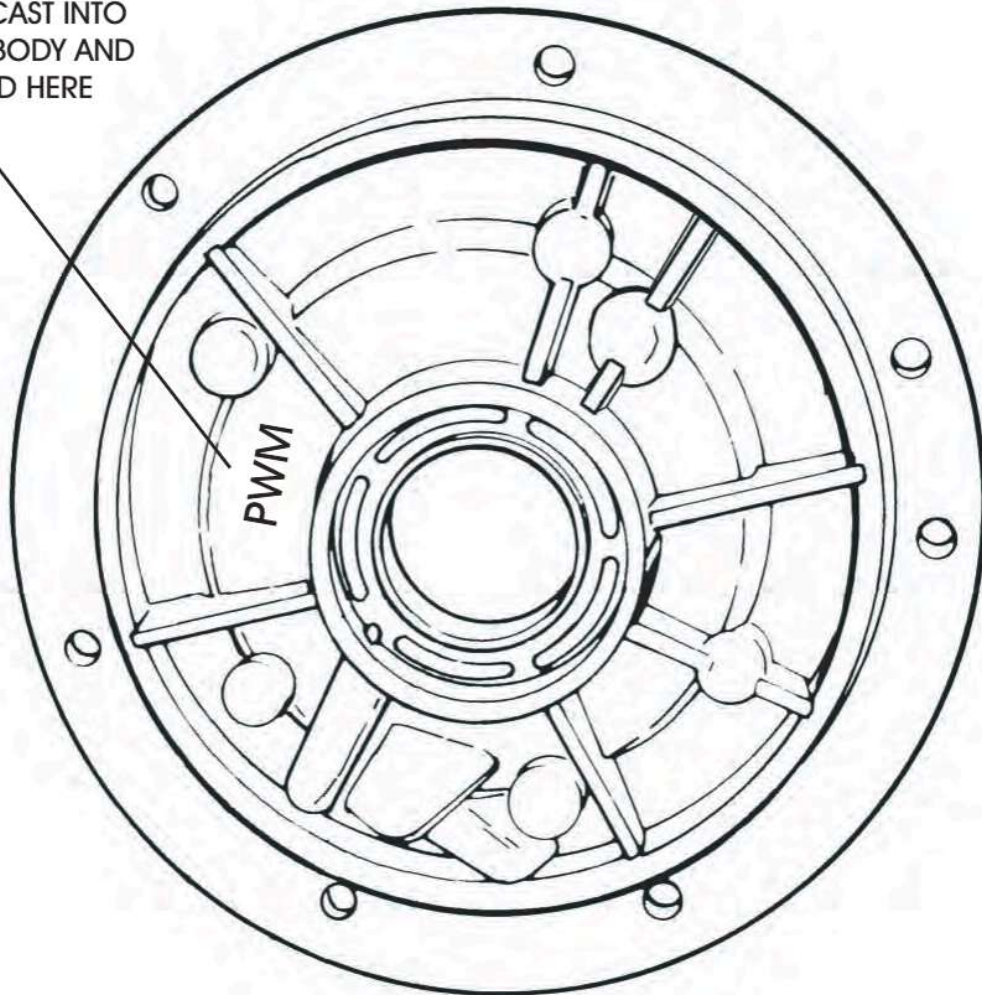
Figure 4

"PWM" IS CAST INTO  
THE PUMP BODY AND  
LOCATED HERE

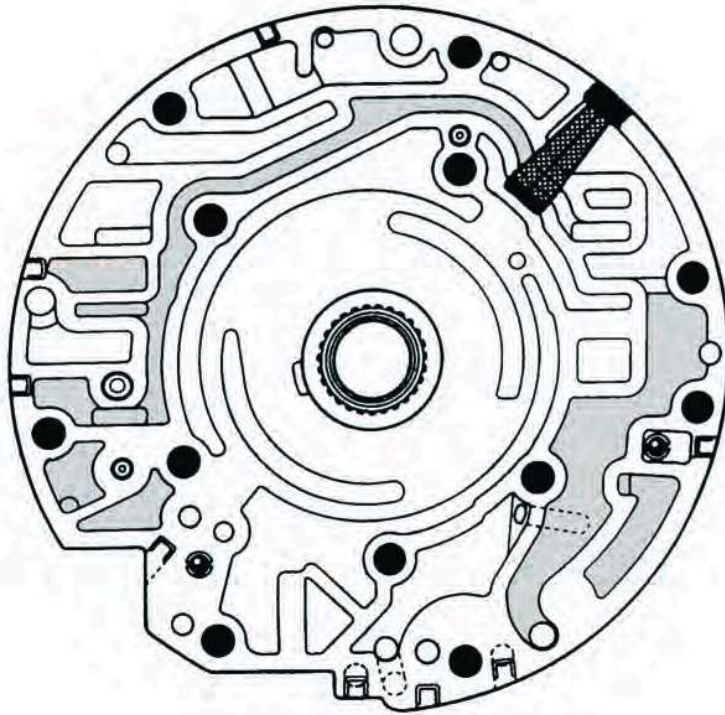
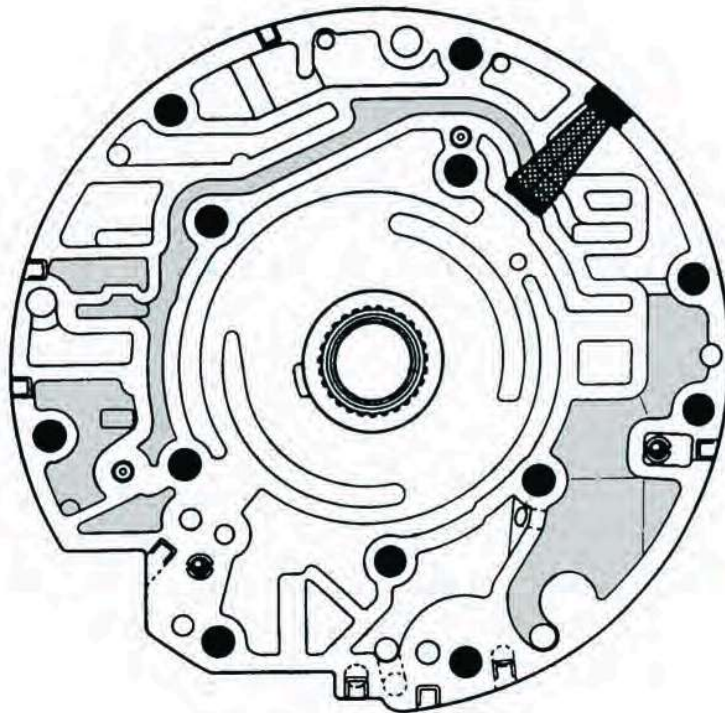
SHADED AREAS ARE DIFFERENT  
BETWEEN THE "PWM" PUMP COVER  
AND THE NON PWM PUMP COVER

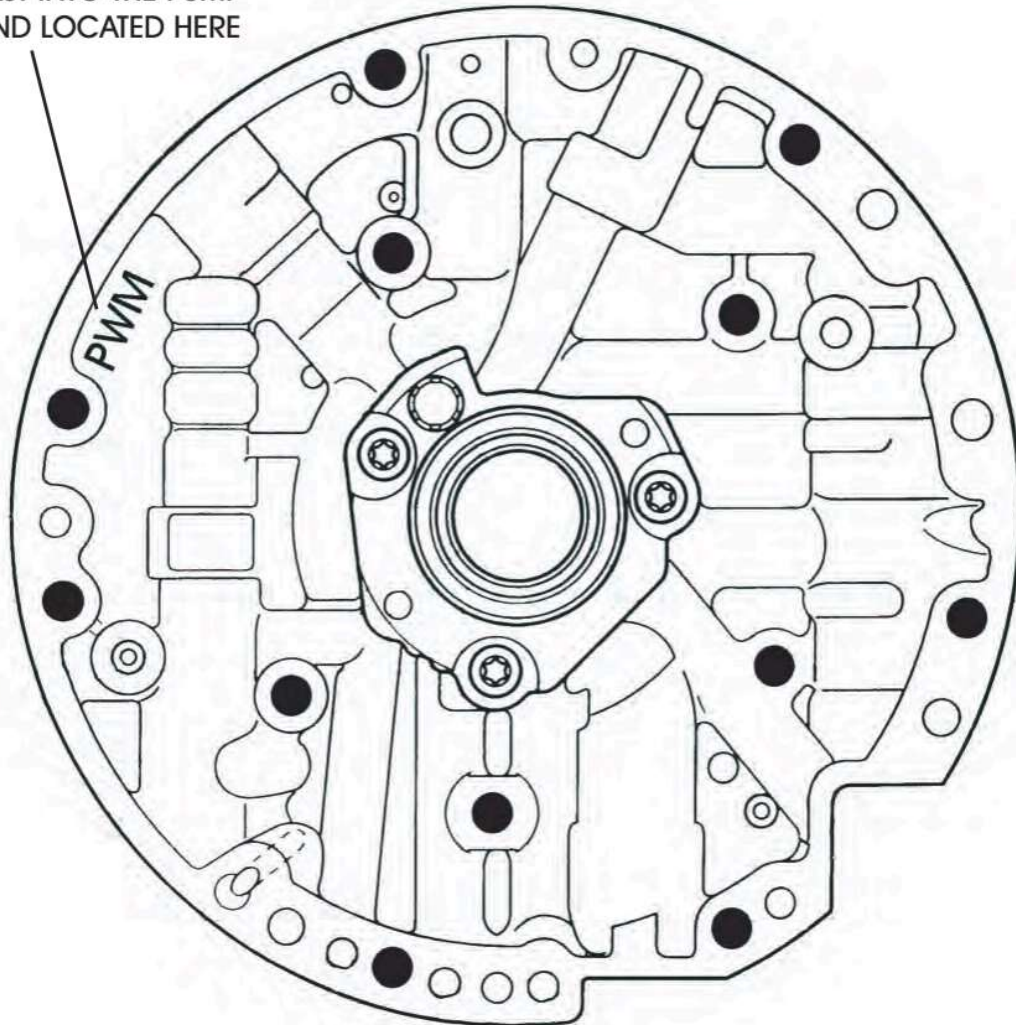
Figure 6

"PWM" CAST INTO THE PUMP  
COVER AND LOCATED HERE

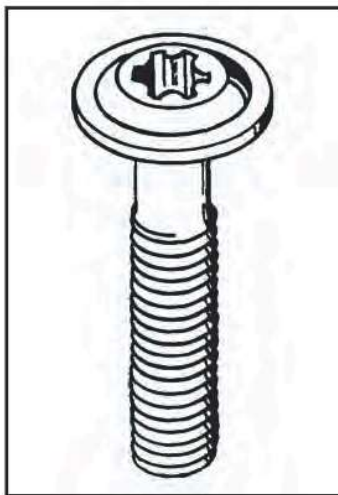
**USE "TORX-PLUS 50-IP" BIT ONLY  
ON BELLHOUSING BOLTS**

**"TORX PLUS 50-IP"  
OK TO USE**

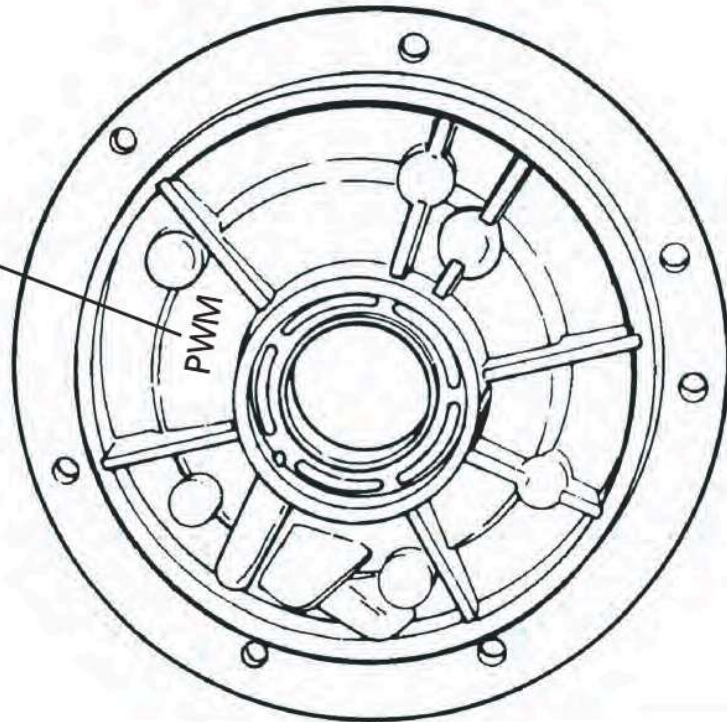
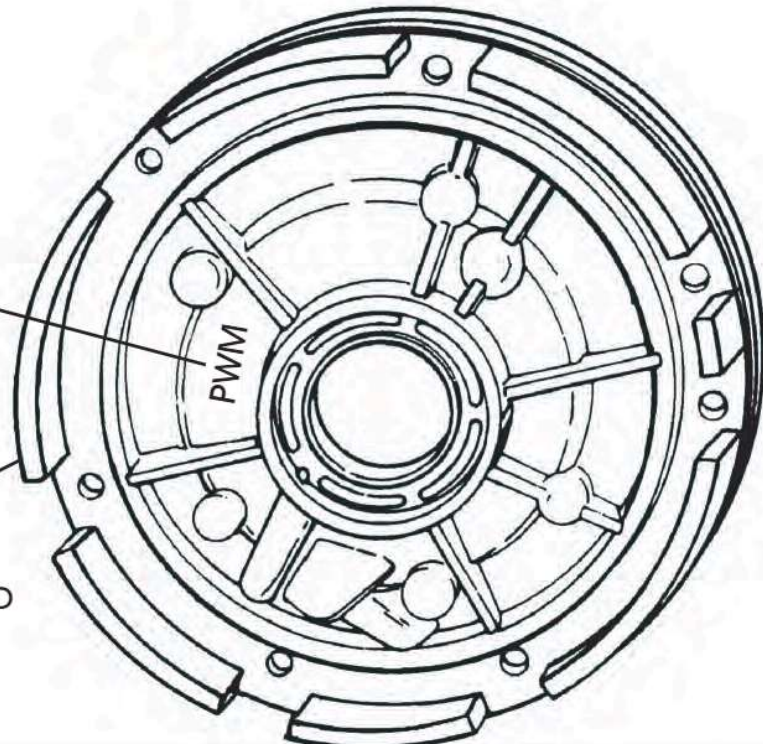
Figure 2

"PWM" CAST INTO PUMP BODY  
AND LOCATED HERE

ADDED MATERIAL AND MACHINED  
TO CENTER THE BELLHOUSING

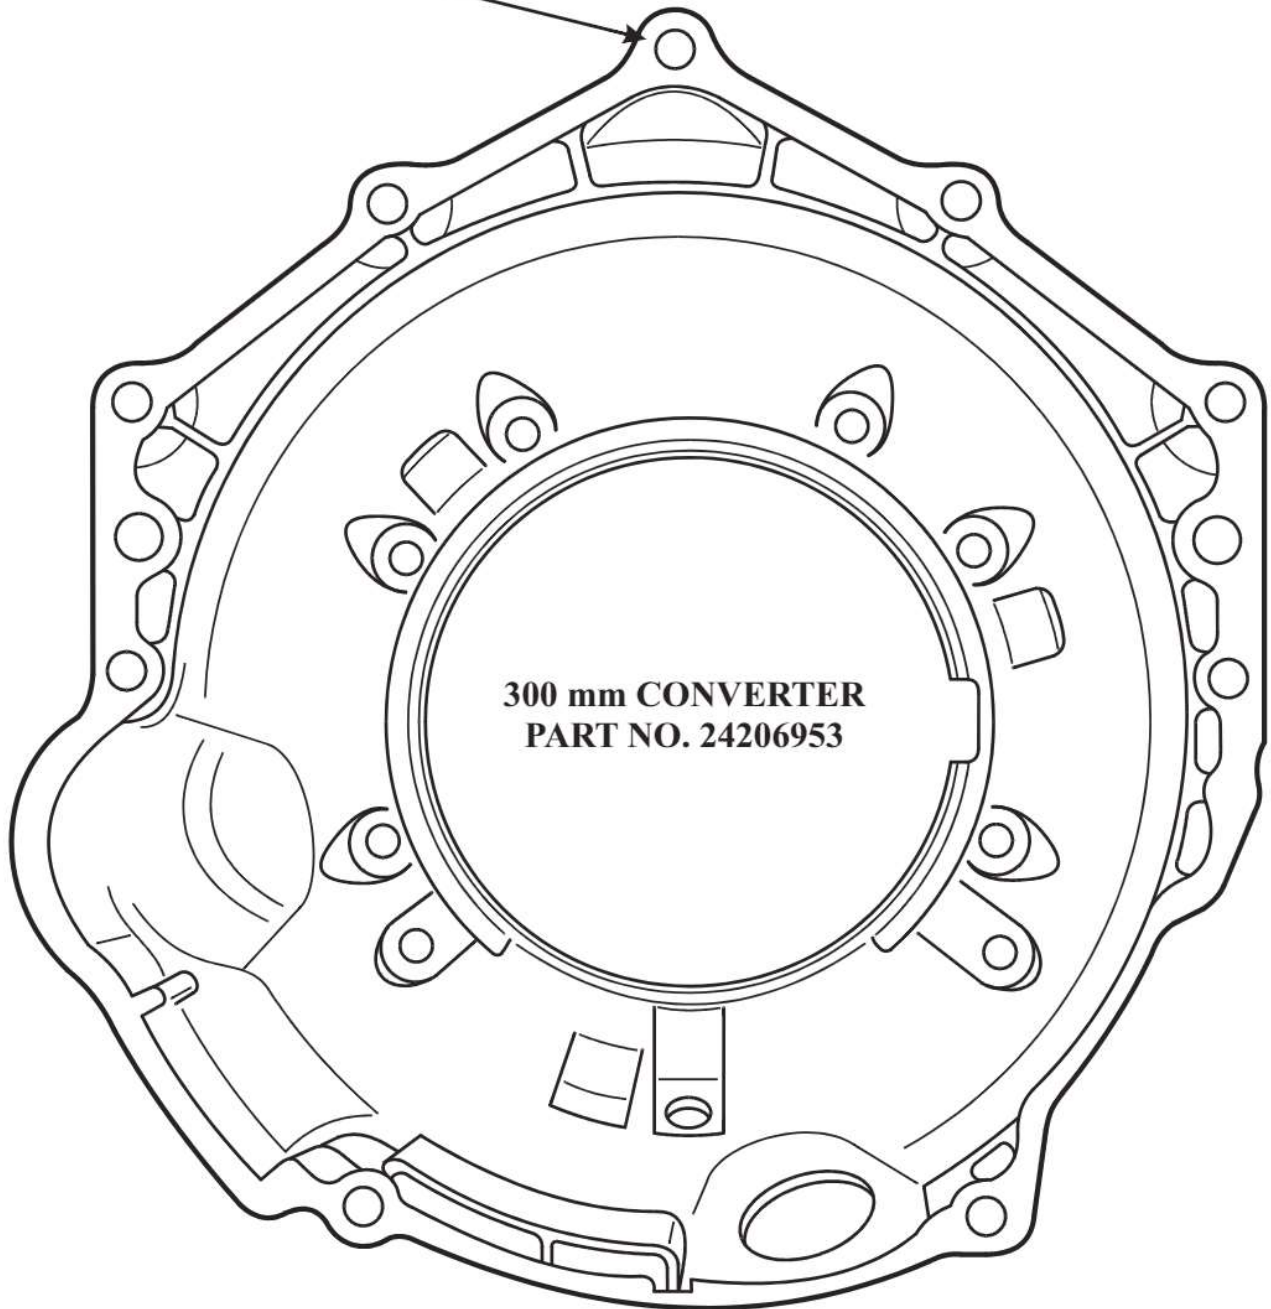
Figure 1

**ADDED BOLT HOLE AND  
IS APPROX. 1/4" DEEPER**

*This style bellhousing and the 300mm torque converter also require a new design turbine shaft and stator shaft that are approximately 1/4" longer than other models.*

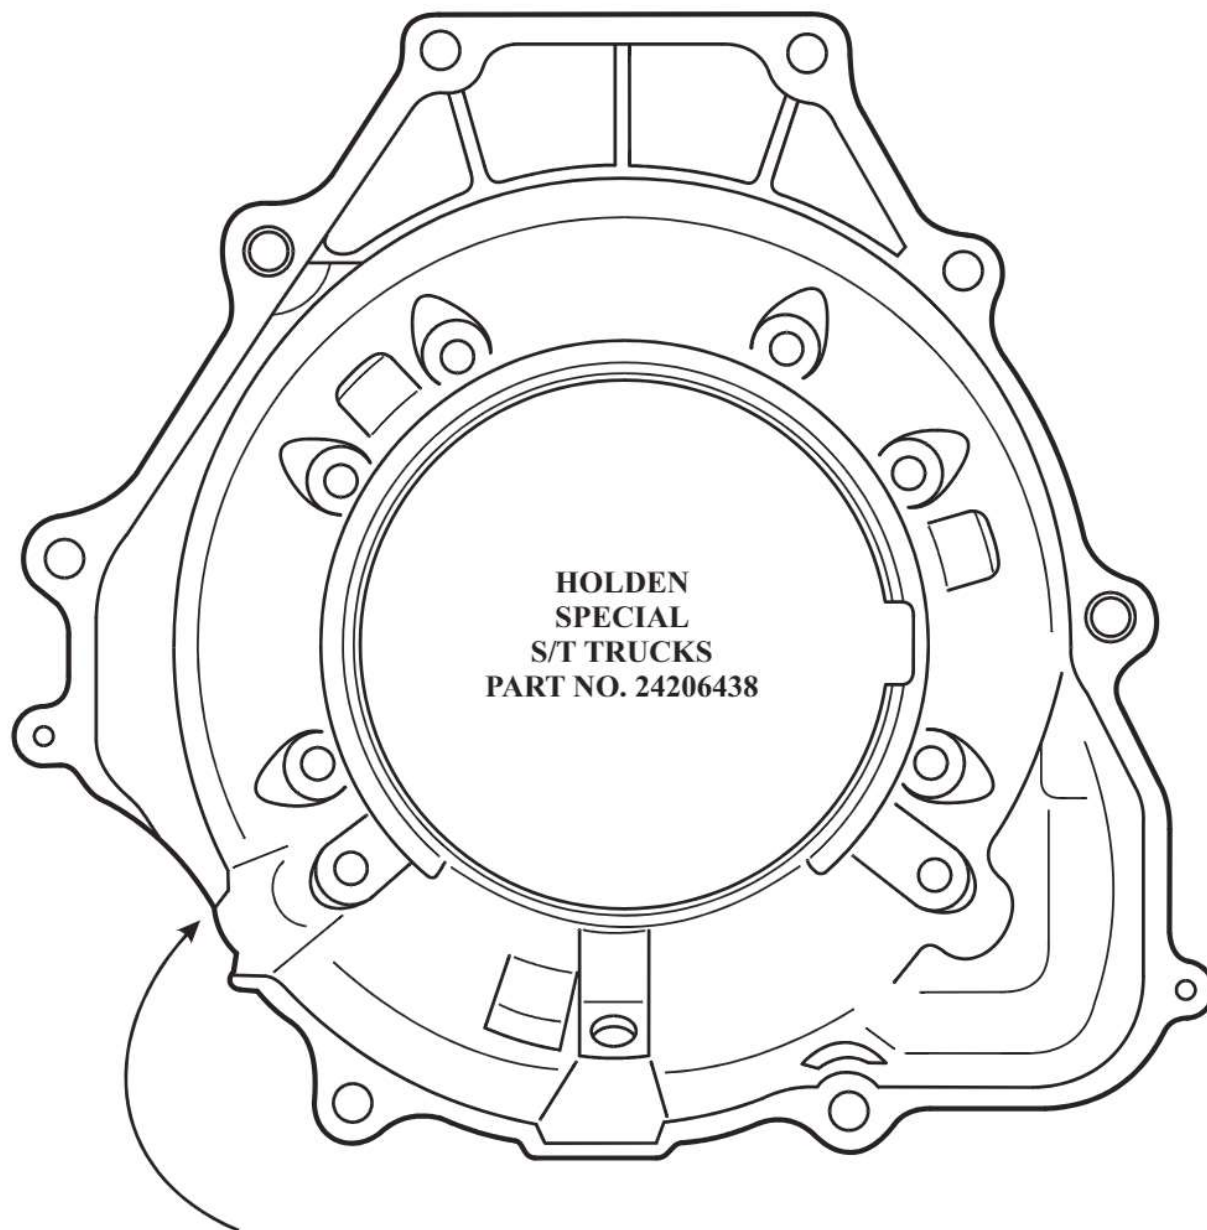
Figure 6

The Bellhousing shown in Figure 6, is the Holden "Special" S/T Truck bell that is export only and shipped mainly to Australia. This bell has part of the housing cast out as compared to the Regular S/T Truck bell that is shown in Figure 7.

**SECTION CAST OUT  
OF BELLHOUSING**

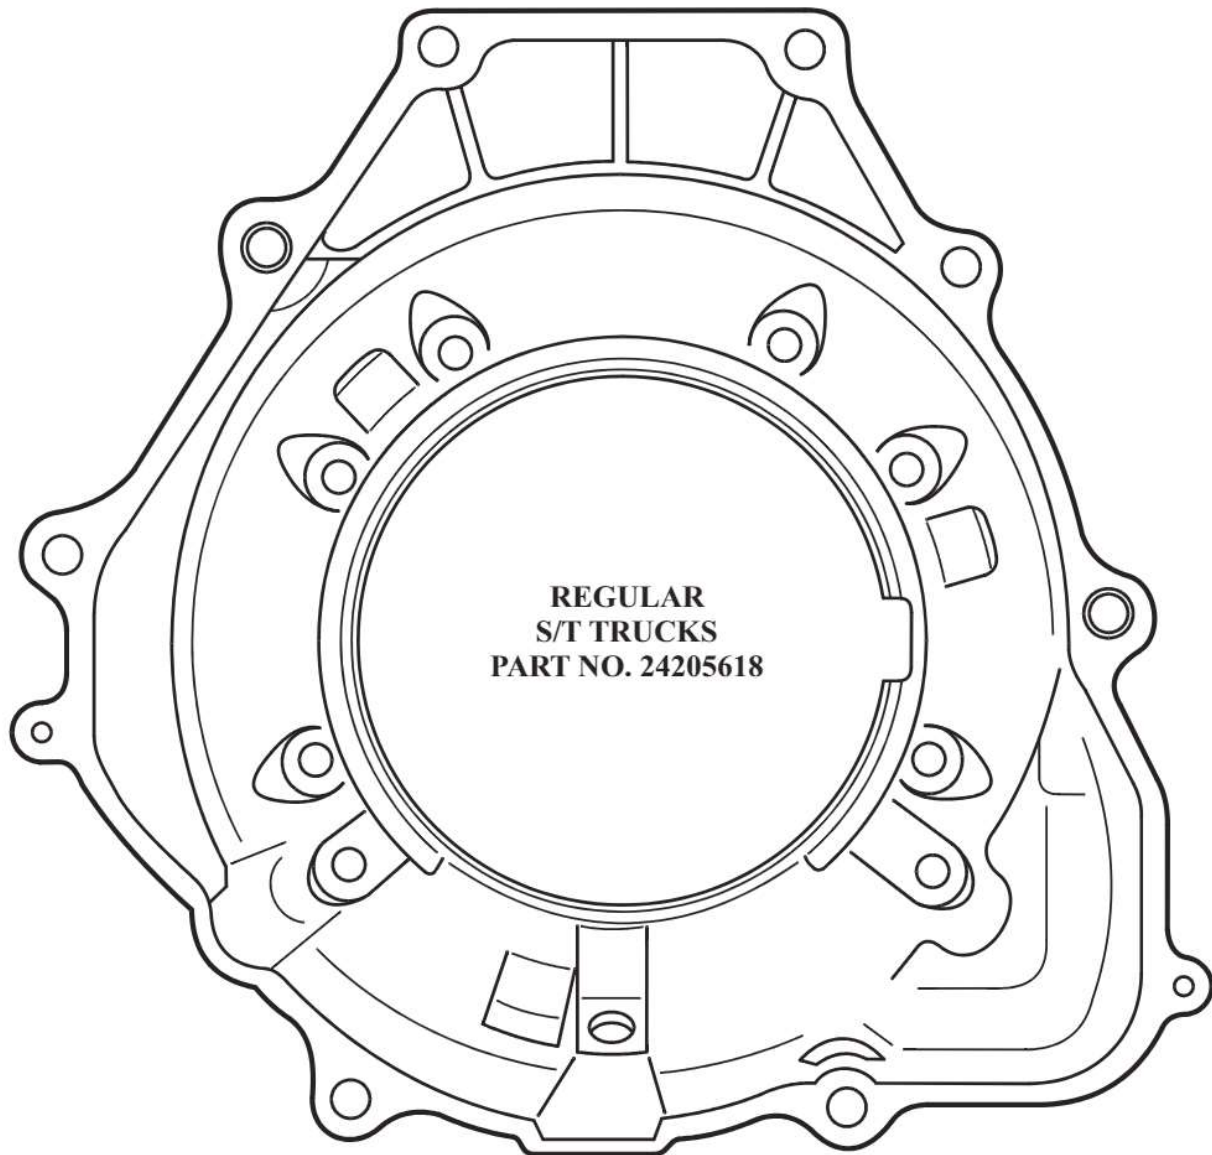
Figure 7

The Bellhousing shown in Figure 7, is the Regular S/T Truck bellhousing used in North America and is cast different than the export S/T Truck bellhousing shown in Figure 6.

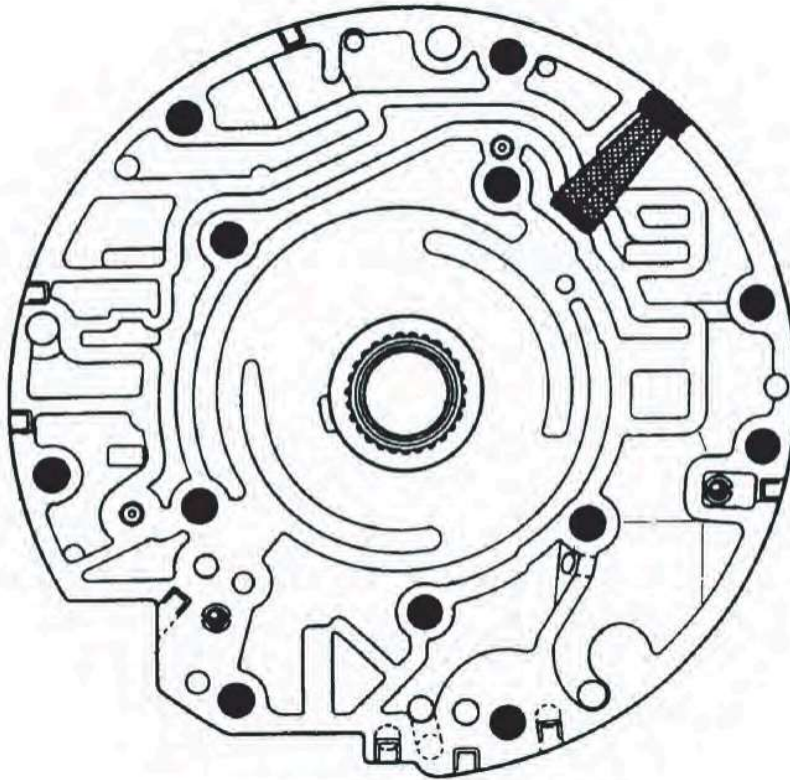
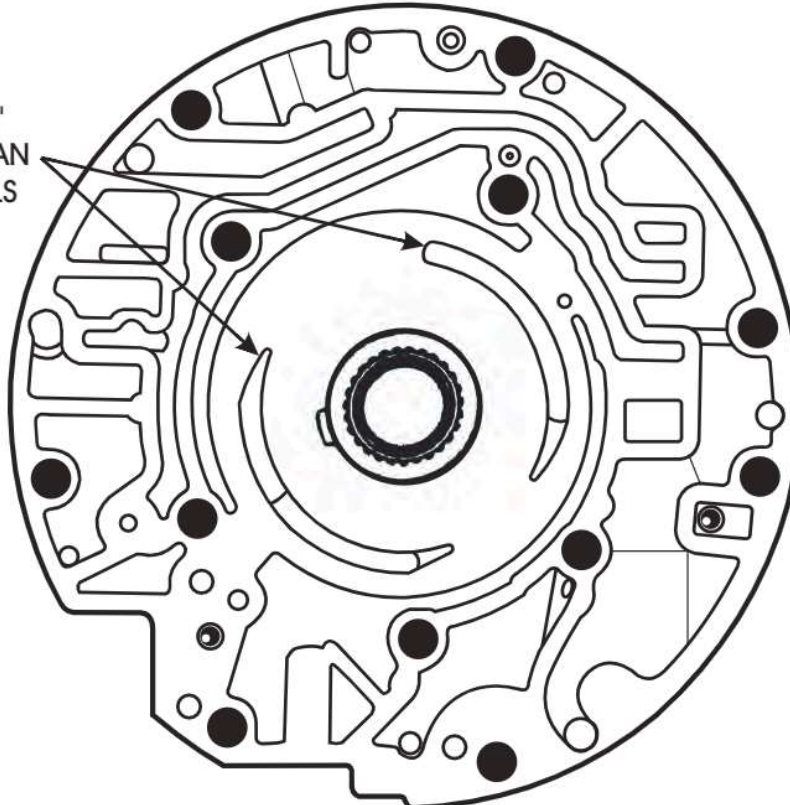
Figure 2

"PORTING SLOTS"  
ARE DIFFERENT THAN  
PREVIOUS MODELS

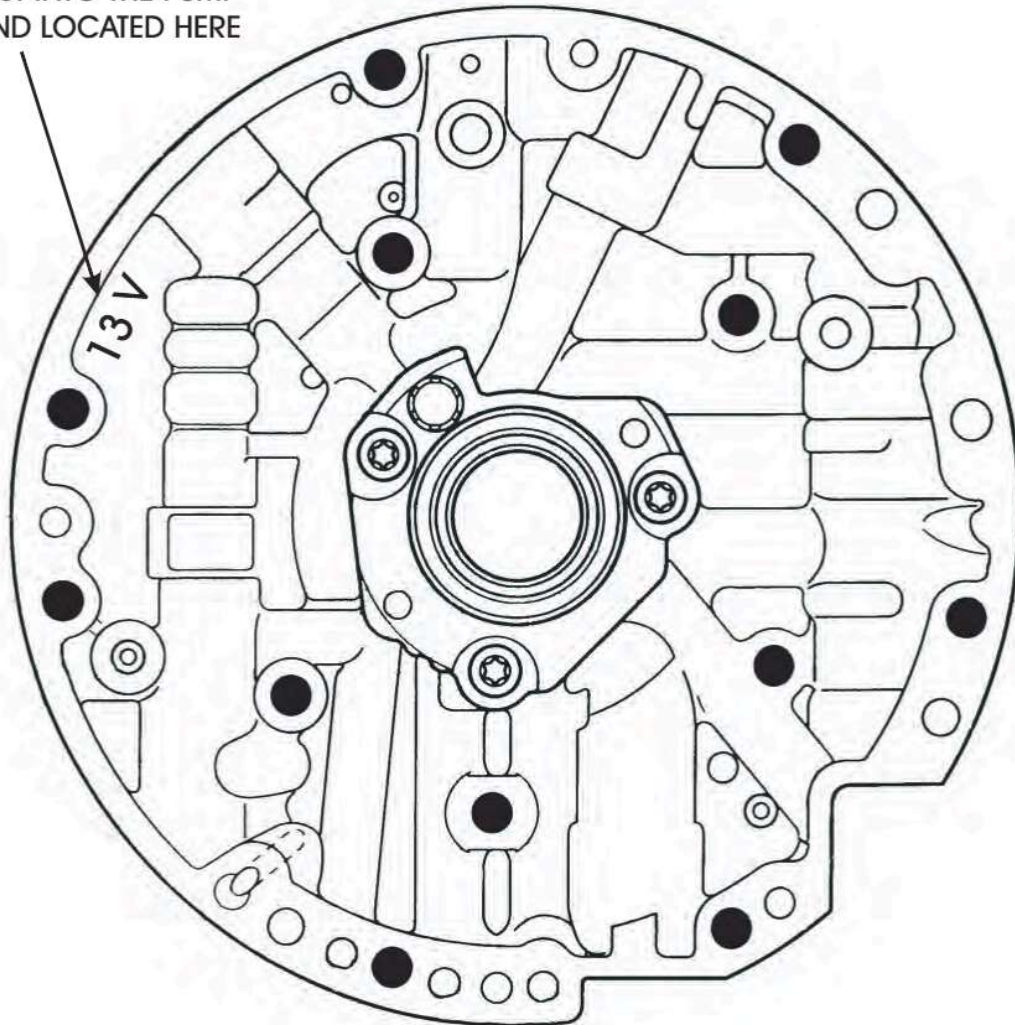
Figure 3

"13 V" CAST INTO THE PUMP  
COVER AND LOCATED HERE

***THIS PUMP COVER WILL NOT INTERCHANGE WITH PREVIOUS MODELS.  
IT MUST BE USED WITH THE 13 VANE ROTOR AND SLIDE.***

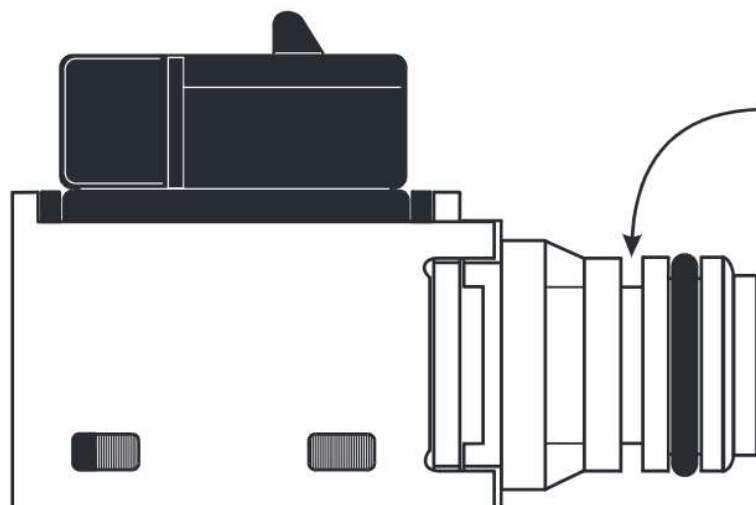
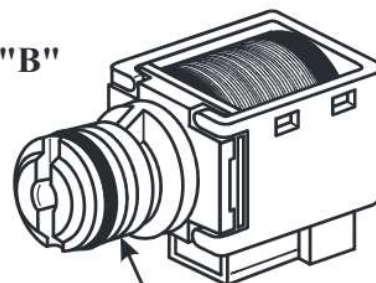
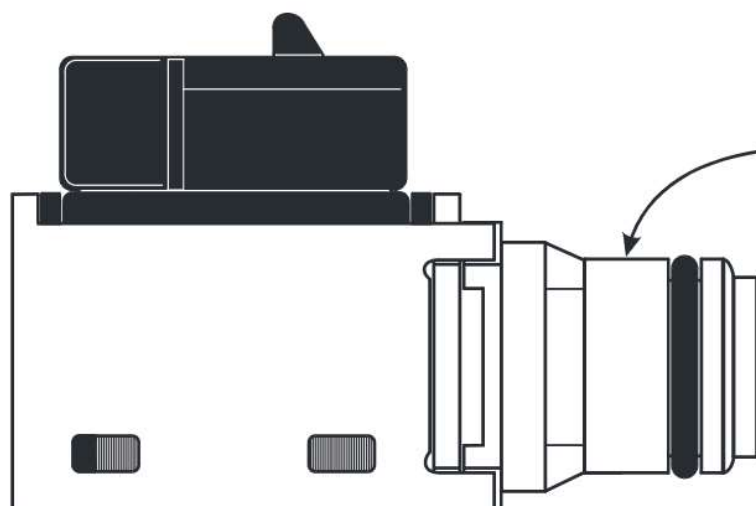
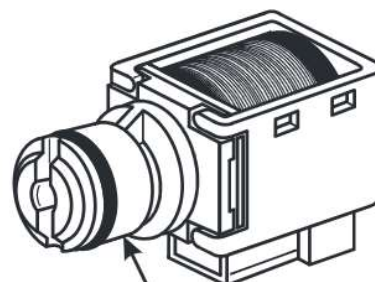
Figure 2

THIS GROOVE REMOVED  
TO PREVENT MIS-ASSEMBLY,  
AS RETAINING CLIP CAN BE  
INSTALLED IN THIS GROOVE

GROOVE REMOVED  
AND WILL RETRO-FIT  
BACK TO ALL MODELS

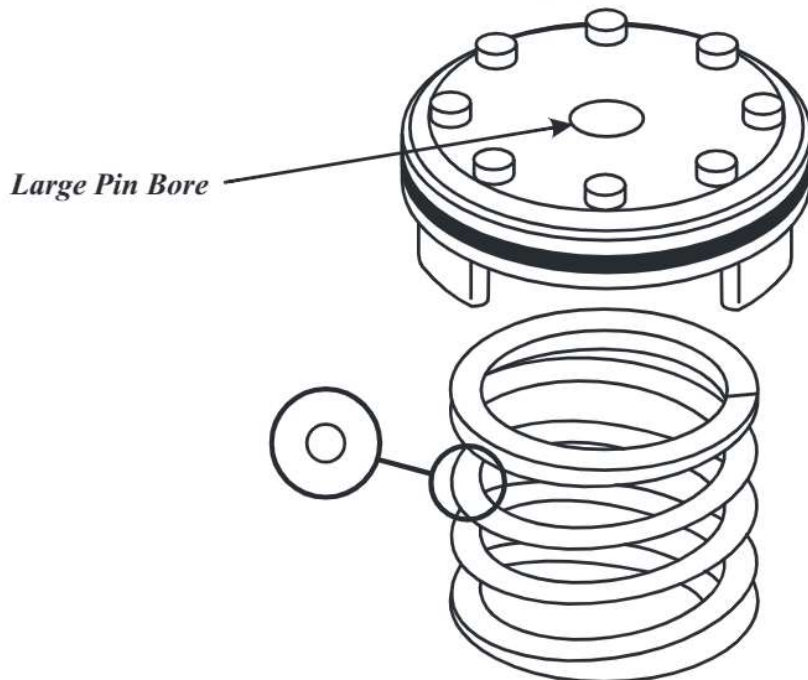
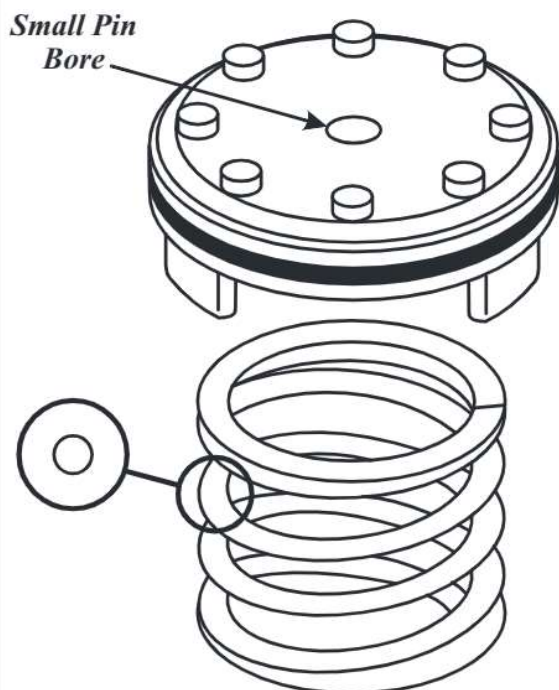
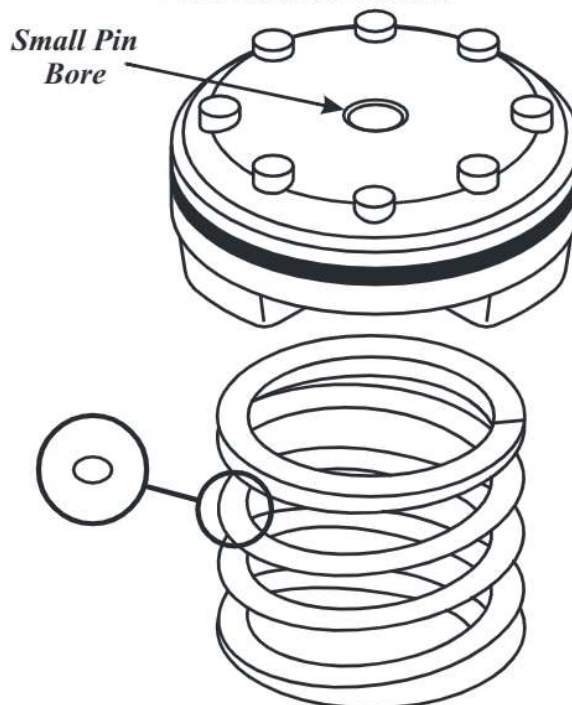
Figure 1

**CHANGE:** Beginning on May 11, 1998 (Julian Date 131) all THM 4L60-E transmissions were built with a new design plastic 1-2 Accumulator Piston, and an ovate (oval) wire outer accumulator spring, to replace the previous design aluminum piston and round wire outer accumulator spring, as shown in Figure 1.

Refer to "Service Information" below for the proper service package part numbers if replacement is necessary.

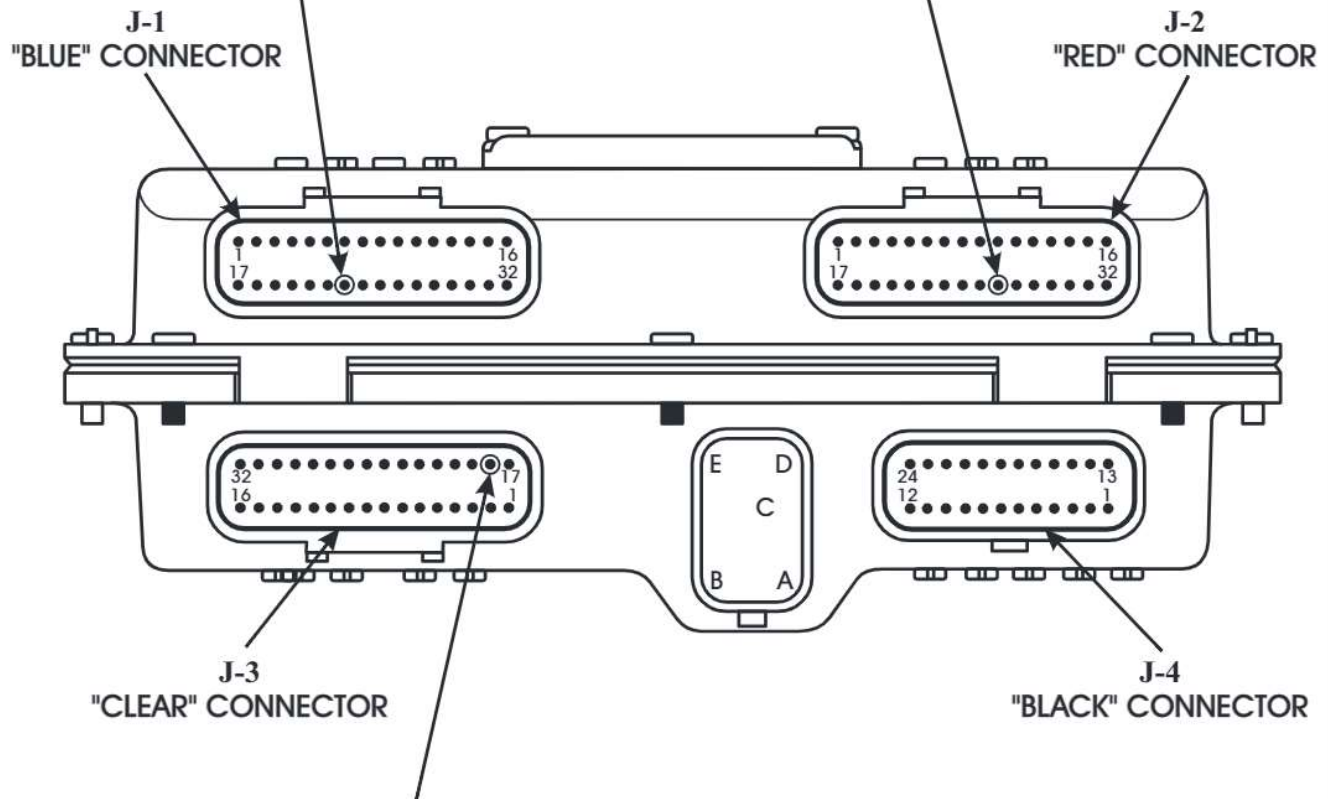
**CAUSE:** Bad ground connection from one printed circuit board to the other.

INSTALL THE OTHER END OF THE INCLUDED JUMPER WIRE THAT WAS PREVIOUSLY INSTALLED INTO THE CLEAR CONNECTOR, INTO CAVITY LOCATION 26 OF THE RED CONNECTOR.

REMOVE THE WIRE AND TERMINAL FROM LOCATION 18 ON THE CLEAR CONNECTOR, AND INSTALL ONE END OF THE INCLUDED JUMPER WIRE INTO LOCATION 18 ON THE CLEAR CONNECTOR.

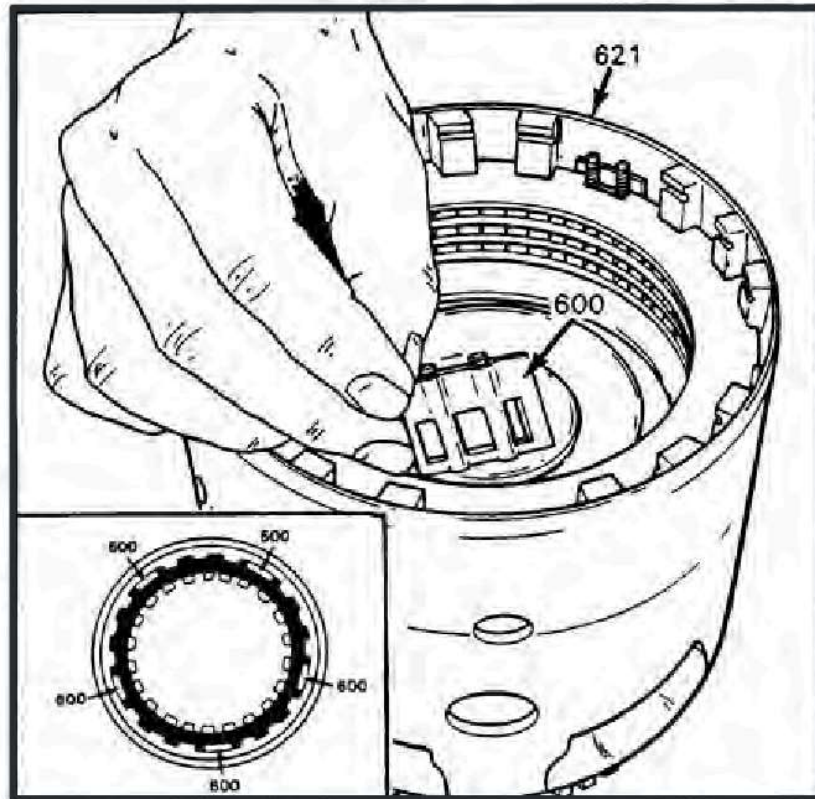
Figure 2

**CAUSE:** The cause may be, not using the high energy clutch plates, and the thick (.106") steel plates, or not enough line pressure rise with throttle opening.

**RE-USE THE 3-4 LOAD RELEASE SPRINGS  
IN THE NEW DESIGN CLUTCH PACK ONLY**

*Re-install the 3-4 load release springs when you are using the .106" thick steel plates, 7605 high energy lined plates, new design 3-4 apply ring, new design one piece apply plate and new design backing plate.*

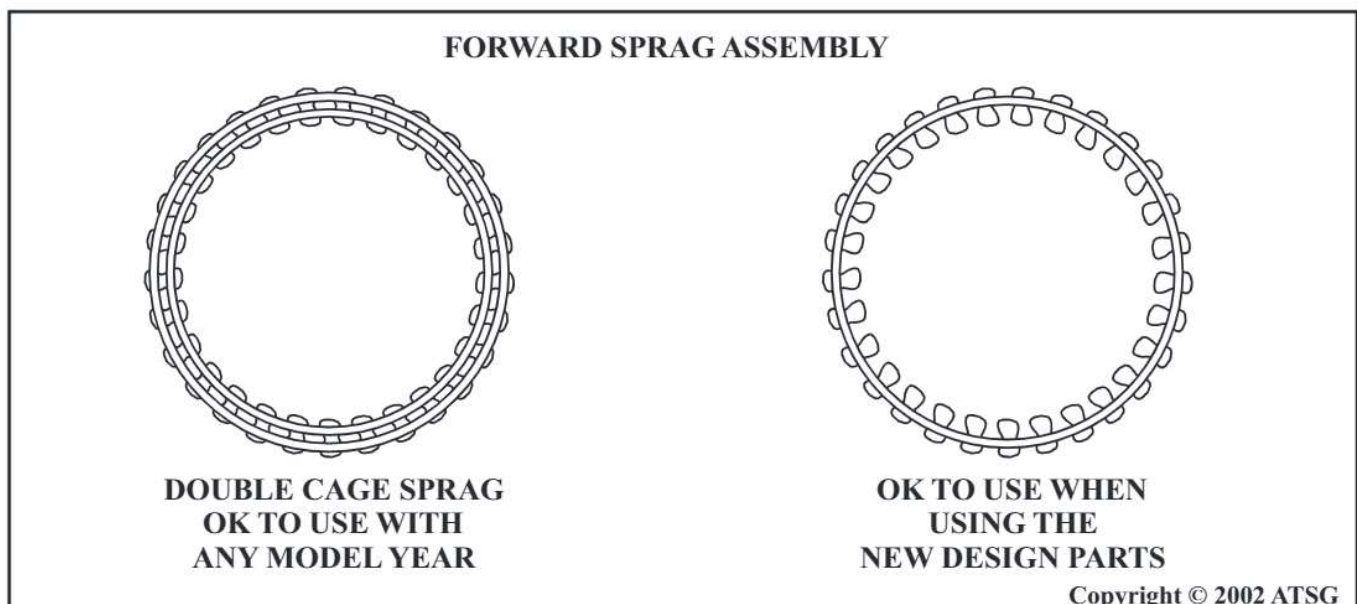
Figure 1

The 29 element single cage "SKF" sprag and cage is available from Raybestos.

The 29 element dual cage sprag is available from Borg Warner.

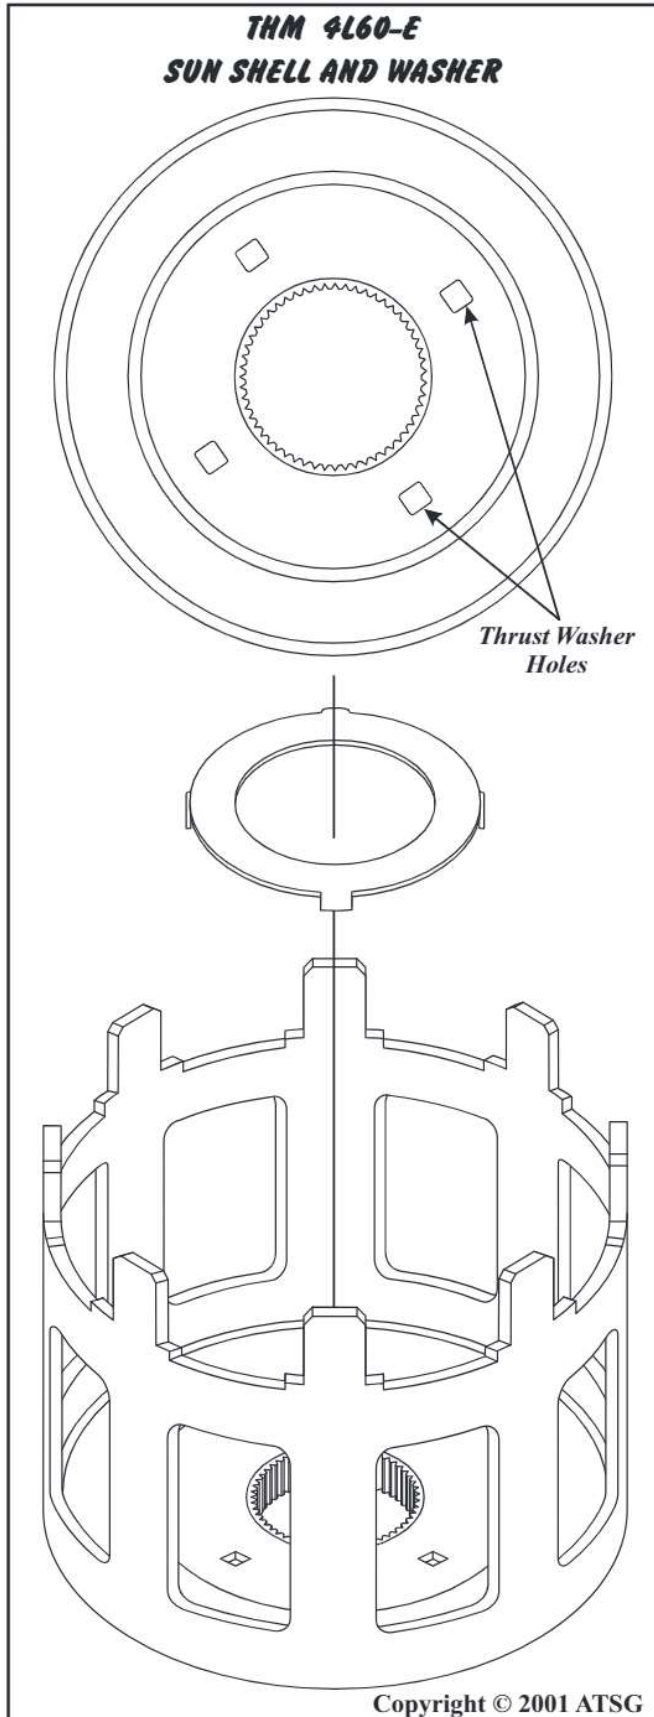
Figure 1

**CHANGE:** Beginning at the start of production for model year 2001, General Motors introduced a new transmission designated THM 4L60-EHD with many engineering changes. Currently this unit is found in all 2001 Cadillac Escalade and any vehicle with 6.0L engine or larger, that was previously equipped with the THM 4L60-E transmission. One of the changes includes a new design sun gear shell and thrust bearing to replace the previous design washer, as shown in Figures 1 and 2.

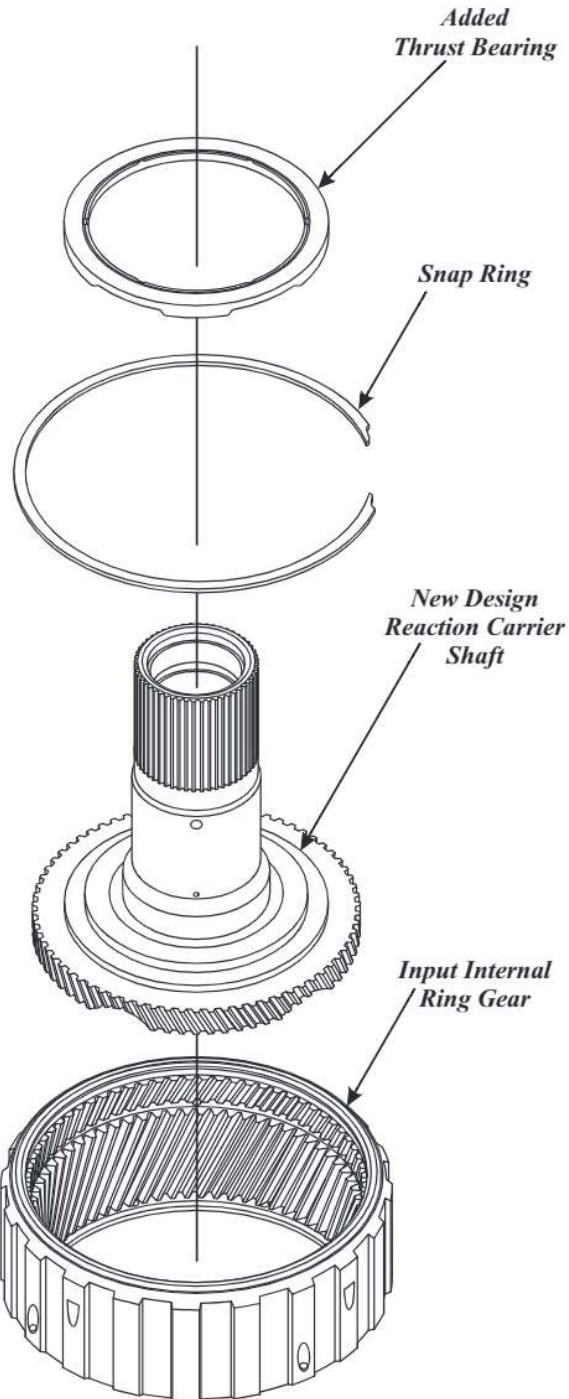
Figure 3

## THM 4L60-E/4L65-E REACTION SHAFT WITH BEARING INSTALLED

*Thrust Bearing Is Installed With "Lips"  
Facing Down And Snaps Into Place  
As Shown*

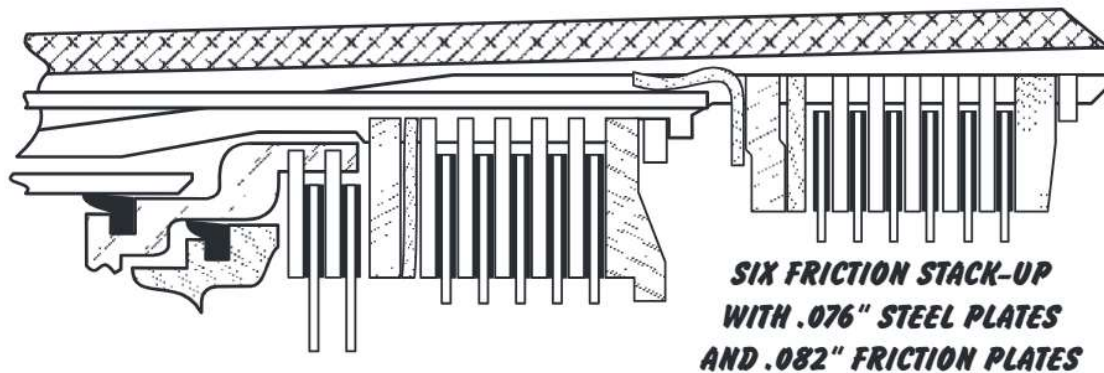
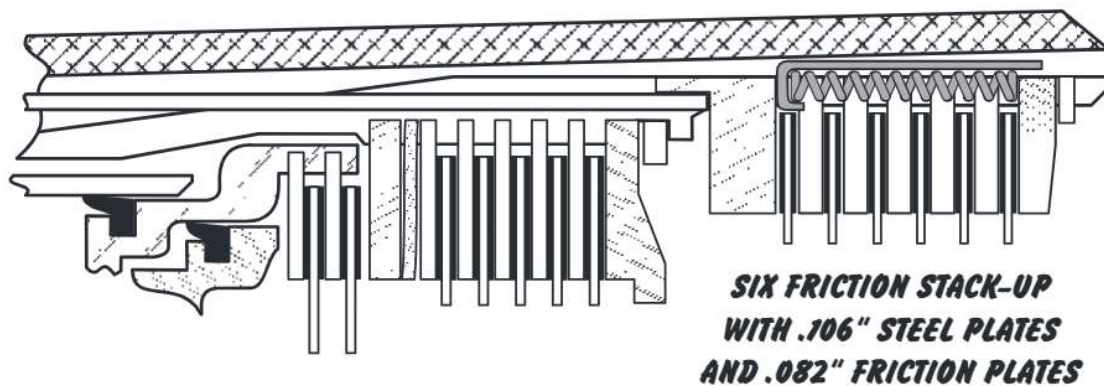
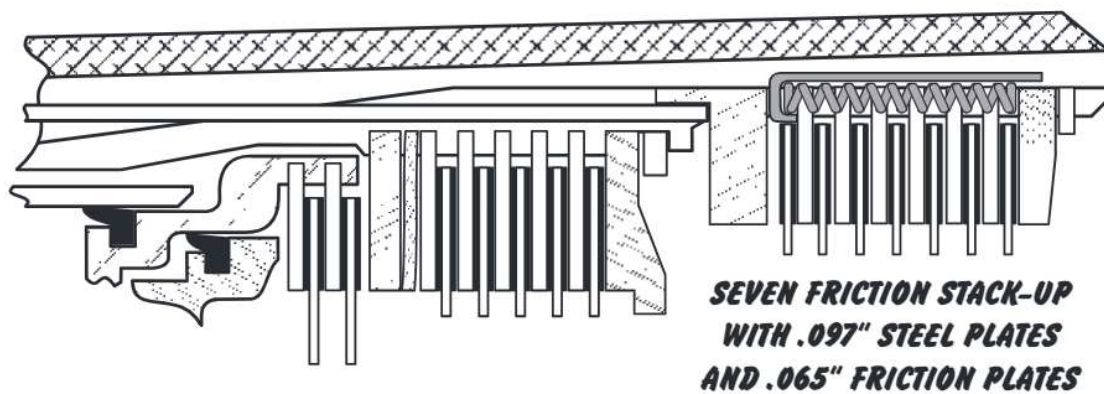
Figure 1

**CHANGE:** Beginning at the start of production for model year 2001, General Motors introduced a new transmission designated THM 4L65-E (M32) with many engineering changes. Currently this unit is found in all 2001 Cadillac Escalade and any vehicle with 6.0L engine or larger, that was previously equipped with the THM 4L60-E transmission. One of the changes includes adding a seventh lined plate to the 3-4 clutch pack, as shown in Figure 1, with no dimensional changes to the input housing. There is a "Kitted" Service Package available from OEM under part number 24220129, as shown in Figure 2.

## CONTENTS OF SERVICE PACKAGE PART NUMBER 24220129

- 7 .065" Thick High Energy Friction Plates
- 6 .097" Thick Steel Plates
- 1 .218" Thick 3-4 Apply Plate
- 1 3-4 Apply Ring (Same As Previous, Stamped "7")
- 5 3-4 Load Release Springs (Same As Previous)

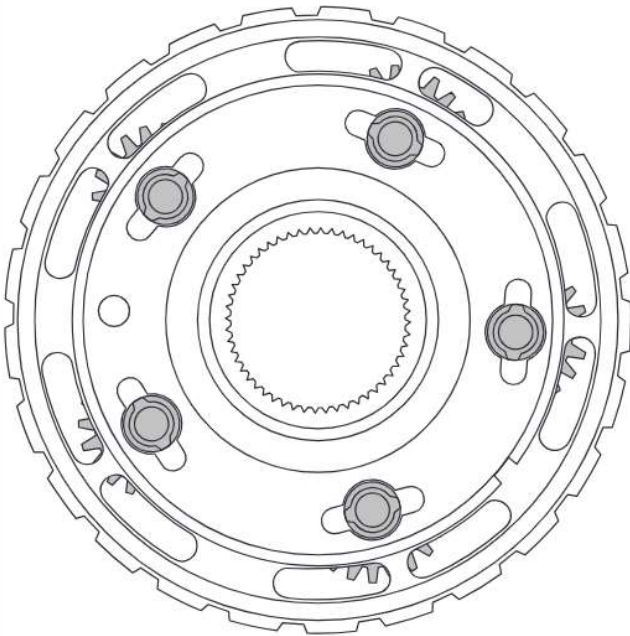
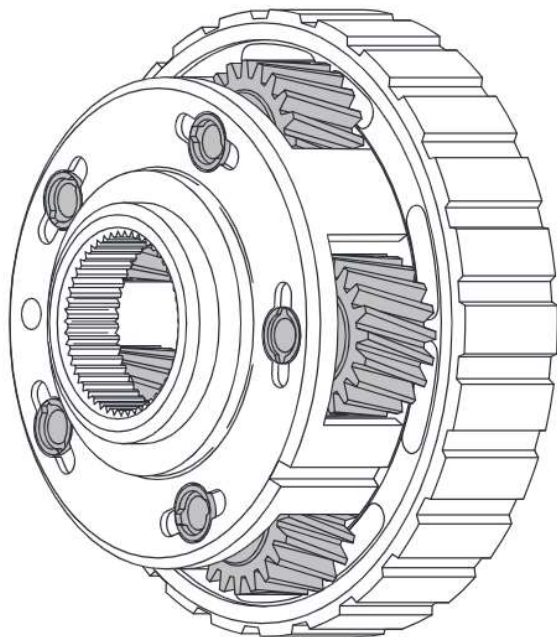
Figure 1

**CHANGE:** Beginning at the start of production for model year 2001, General Motors introduced a new transmission designated THM 4L65-E with many engineering changes. Currently this unit is found in all 2001 Cadillac Escalade and any vehicle with 6.0L engine or larger, that was previously equipped with the THM 4L60-E transmission. One of the changes includes adding a 5 pinion reaction(rear) planetary carrier and a 5 pinion input (front) planetary carrier, as shown in Figures 1 and 2, with no dimensional changes to the related parts.

***ATSG has recieved several calls on these units with the reaction (rear) ring gear broken. Since the part number changed but the dimensions did not, it would be logical to assume that the manufacturing process changed in some manner. Our recommended procedure, at this time, is to replace it with a reaction ring gear from a THM 4L60-E transmission and available under OEM part number 8667055.***

**THM 4L65-E  
5 PINION REAR CARRIER**

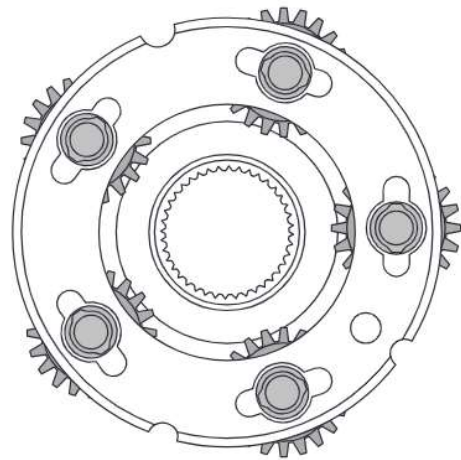
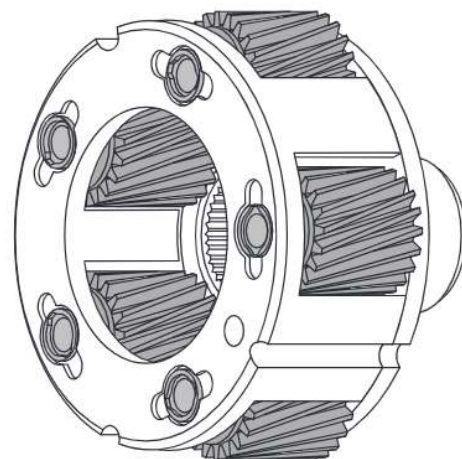
Figure 2

**THM 4L65-E  
5 PINION FRONT CARRIER**
