## THM 4L60-E/4L65-E "UPDATE HANDBOOK"

***AUTOMATIC TRANSMISSION SERVICE GROUP***

*Updated  
January, 2003*

### **THM 4L60-E/4L65-E**

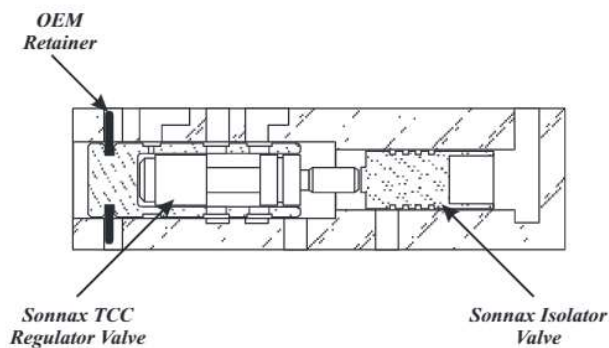
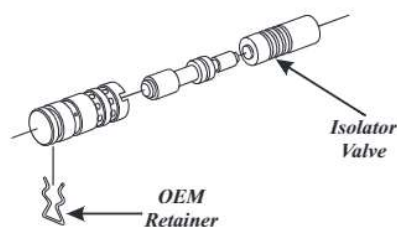
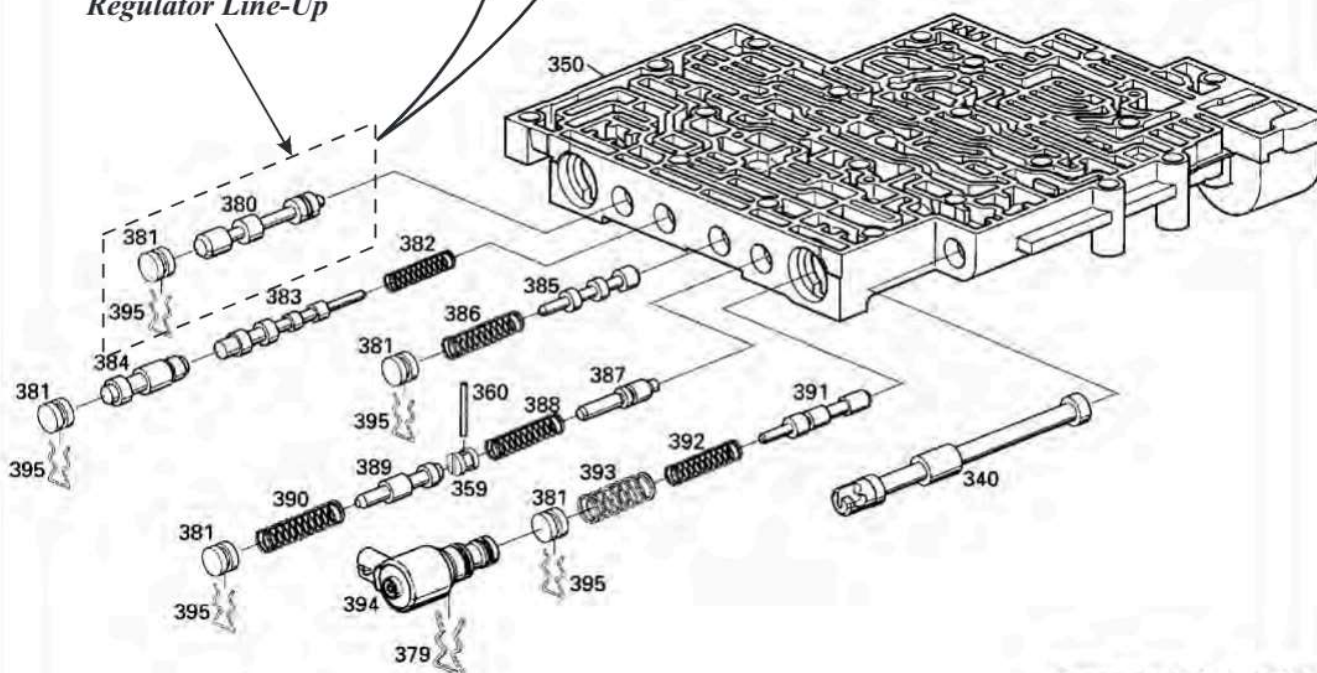
**CAUSE:** The cause is usually Torque Converter Clutch slippage, created by a badly worn valve body casting in the Converter Clutch Regulator Valve bore.

## 1993-1994 NON-PWM MODELS ONLY ASSEMBLY PROCEDURE

**CORRECTION:** Sonnax manufactures two different kits to repair the current valve body castings, both of which require a reamer, also available from Sonnax. One of the kits, Sonnax part number 77754-03K, fits 1993 thru 1997 model transmissions, but they require different assembly processes. Refer to Figure 1 for the 1994-1994 models and Figure 2 for the 1995-1997 models, for the proper assembly. The other kit, Sonnax part number 77754-04K, fits only the 1998 and later ECCC models, as it is a different calibration. Refer to Figure 3 for proper assembly of the 1998 and later models. The reamer required is the same for either kit and is available under Sonnax part number 77754-R2.

**Sonnax kit for 93-94 NON-PWM Models:**  
Install Isolator Valve as shown below  
and use OEM retaining clip.

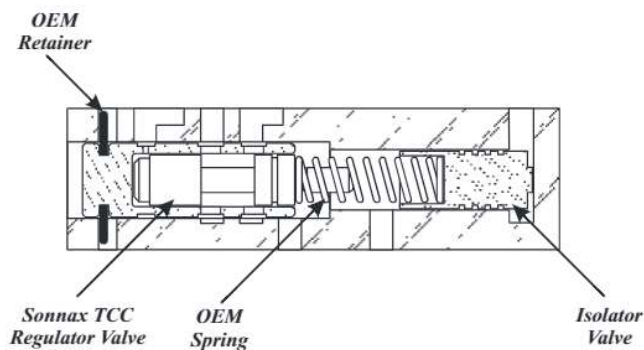
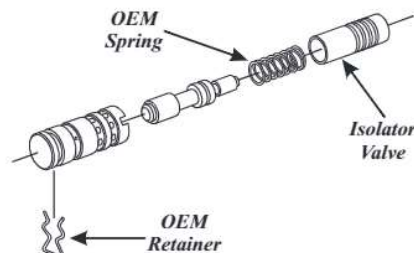
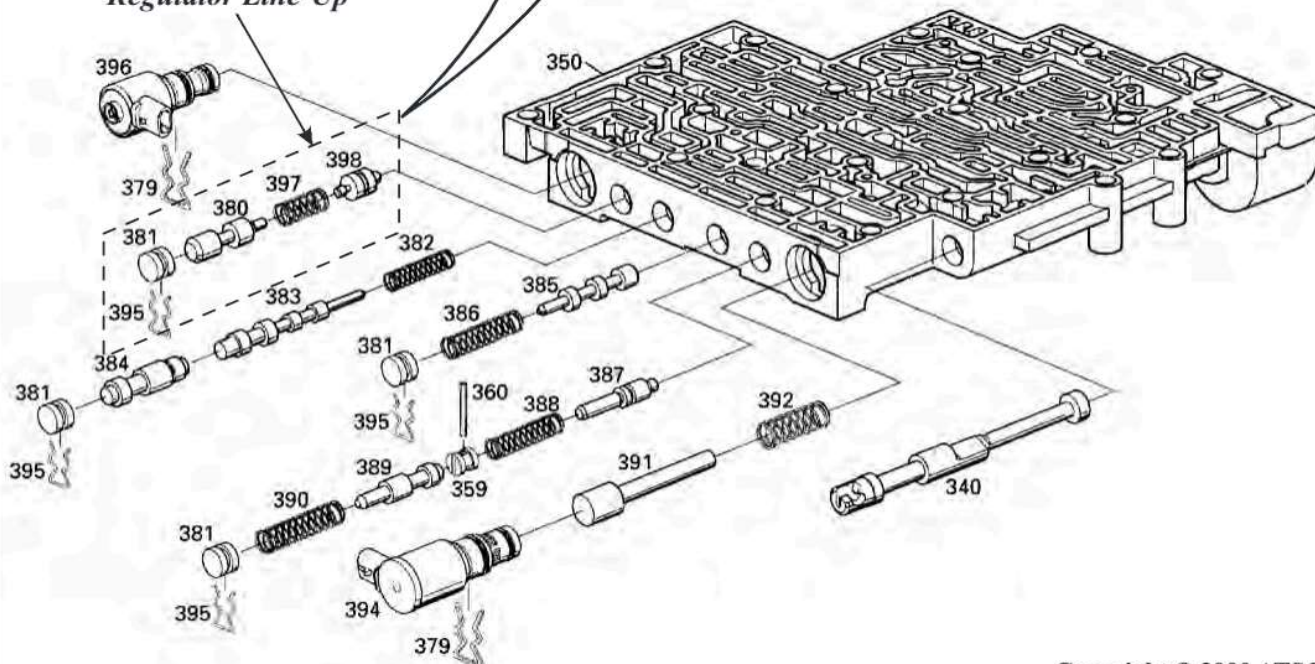
Figure 2

## 1995-1997 PWM MODELS ONLY ASSEMBLY PROCEDURE

**Sonnax kit for 1995-1997 PWM Models:**  
Install Isolator Valve as shown below  
and use OEM spring and clip.

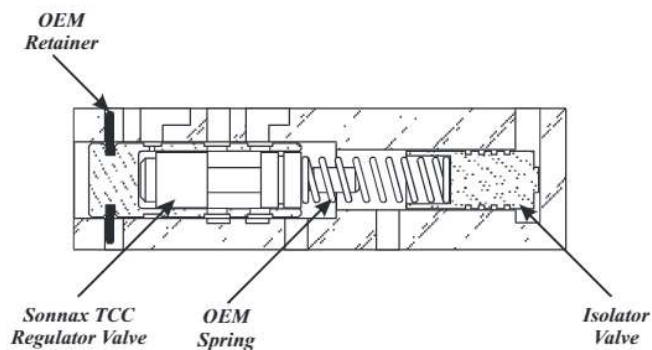
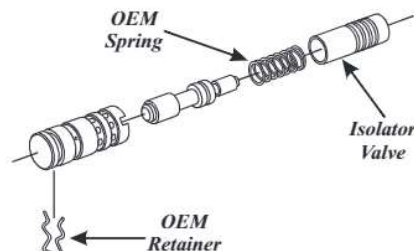
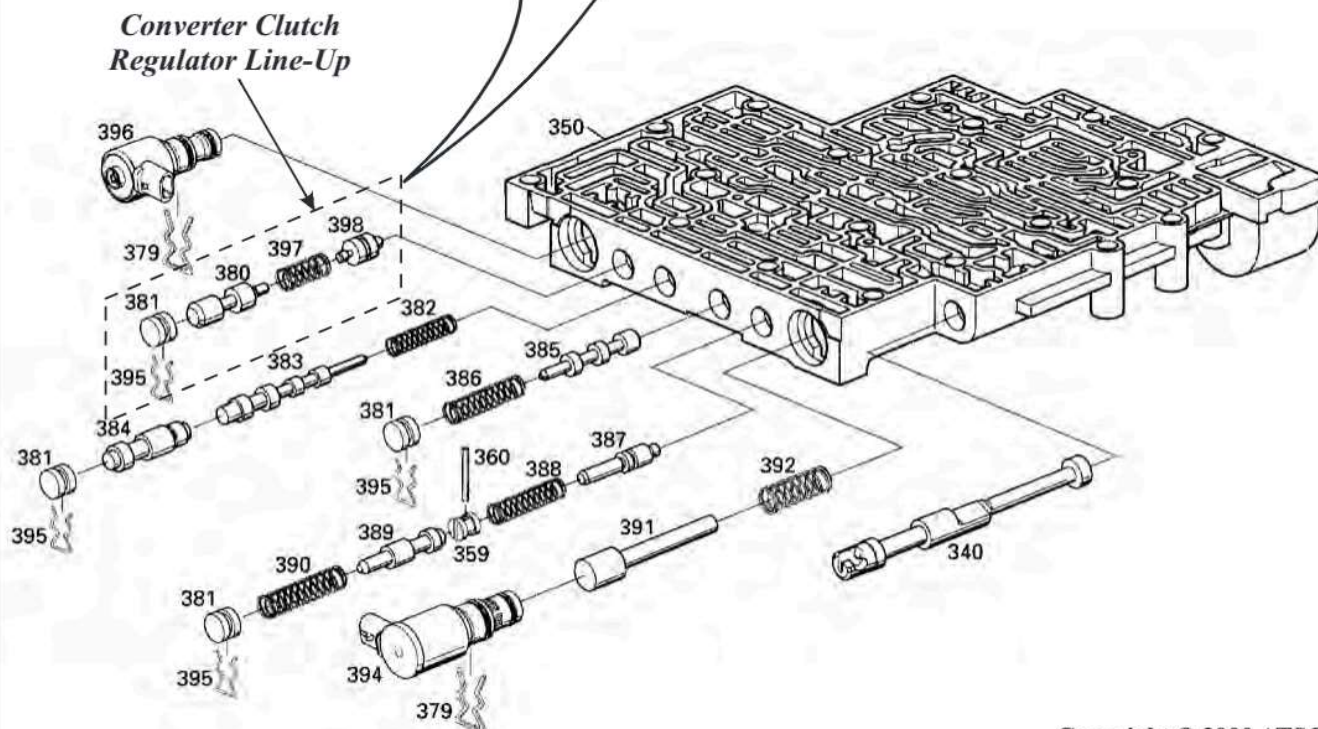
Figure 3

1998-Up Models, The TCC Regulator Valve is .440" in diameter, which is the same diameter as the Isolater Valve, and is **not recommended** for the earlier models.

## 1998-UP ECCC MODELS ONLY ASSEMBLY PROCEDURE

**Sonnax kit for 1998-UP ECCC Models:**  
Install Isolator Valve as shown below  
and use OEM spring and clip.
