## **4L60E/65E/70E- 4L80E/85E DIAGNOSTIC CODE BOOK**

### **INTRODUCTION**

The GM 4L60E/65E/70E-4L80E/85E Diagnostic Code Book is designed to provide the technician with a step by step diagnostic approach to each and every transmission code available from 1991 to the 2007 model year. This manual can be used in collusion with any type of scanner utilized in retrieving these codes from the computer. As an aid to the technician, component location is recognized throughout the manual.

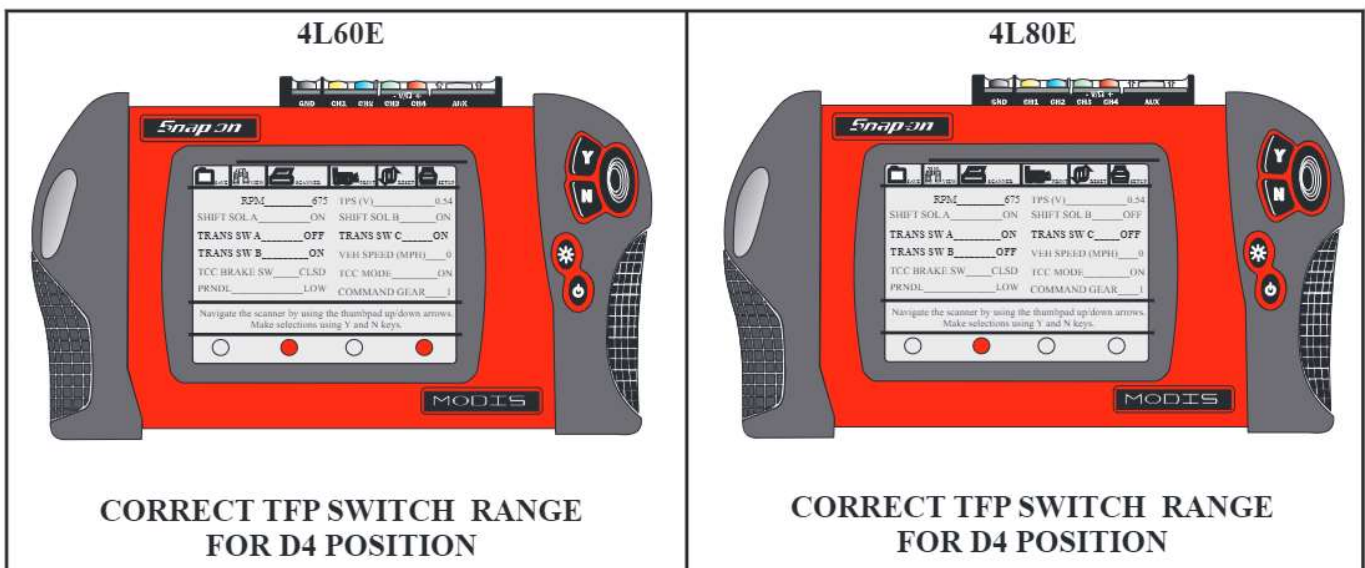
Figure 79

- Using the scan tool data list, (Refer to Figure 79), see if the TFP Switch is ranging correctly for the individual gear shift positions.
- Disconnect the transmission case connector and verify that circuits 1224, 1225 and 1226, located at case connector terminals "N", "P" and "R", (1991 - 93 4L80E are terminals "D", "E" and "F"), have approximately 12 volts on them, if they do not, either the wiring is the problem or the PCM is faulty, (Refer to Figure 83).
