## MERCEDES 722.3 AND 722.4

## INTRODUCTION

### MERCEDES 722.3, 722.4

Mercedes first introduced the "722" models in model year 1980. The 722.3 is found in most models and the 722.4 is found in the 190 vehicles. This manual covers the procedures necessary to overhaul and repair both of these units. This manual also covers the differences between the units in the valve body and governor. The basic internal components such as the pump, gearsets, drums clutches and bands are the same. This manual includes both the original manufacturers information along with some of the engineering changes and updates.

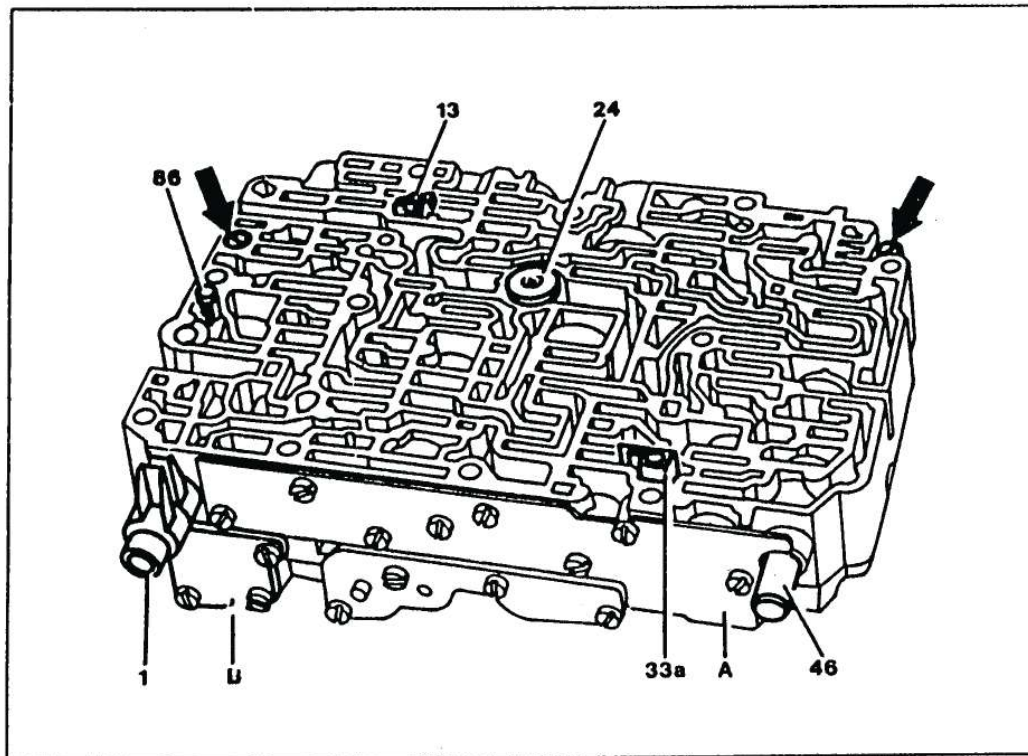
Observe cleanliness when working with the valve body. Do not use fuzzy rags because this can cause hanging of valve and cross leaks. remove screws indicated by arrows, remove valves (13,24,86) and retainer (33a).

**INSTALLATION NOTE;**  
Tighten screws lightly so that housings are able to move so as to install all the screws. Insert valves (13,24,86) and retainer (33a) in housing.

| 13 | Plate check valve with bore | 33a | clamped retainer B2 valve |

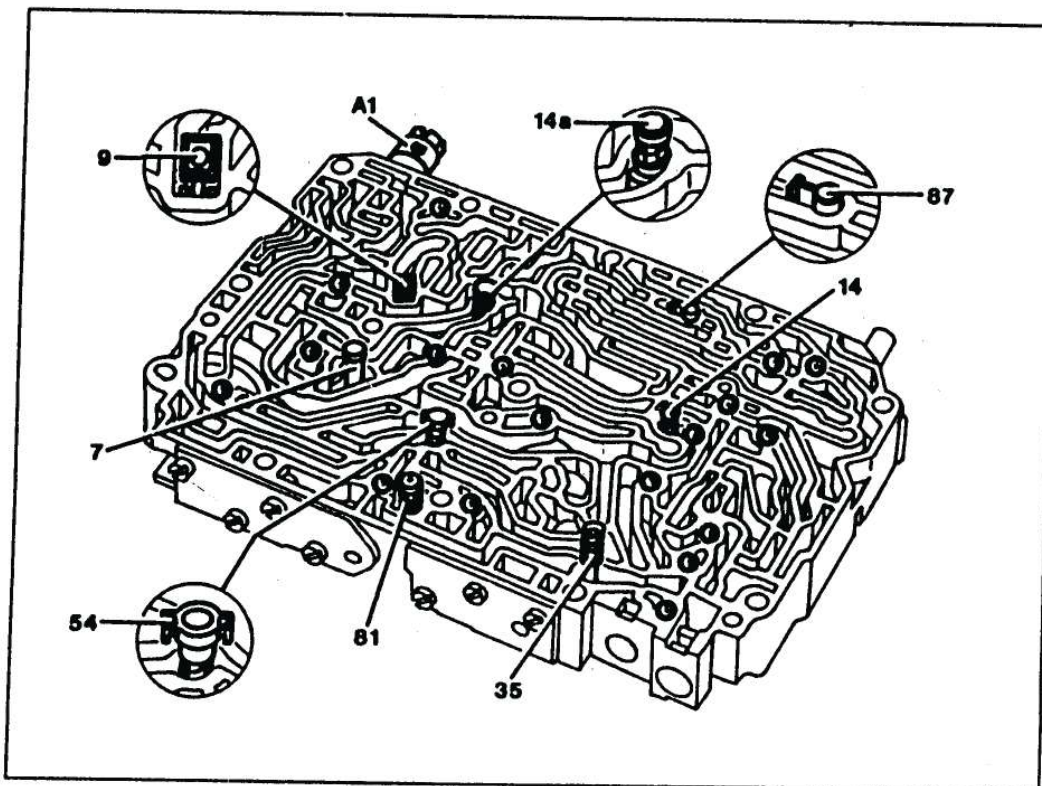
Remove valves, filter and shift pin.

A1 Manual Valve  
7 Shift valve K1  
9 Check valve (white)  
14 check balls (19)  
14a Pressure valve

35 Shift pin lube pressure  
54 Check valve  
81 Sieve filter  
87 Throttle Valve

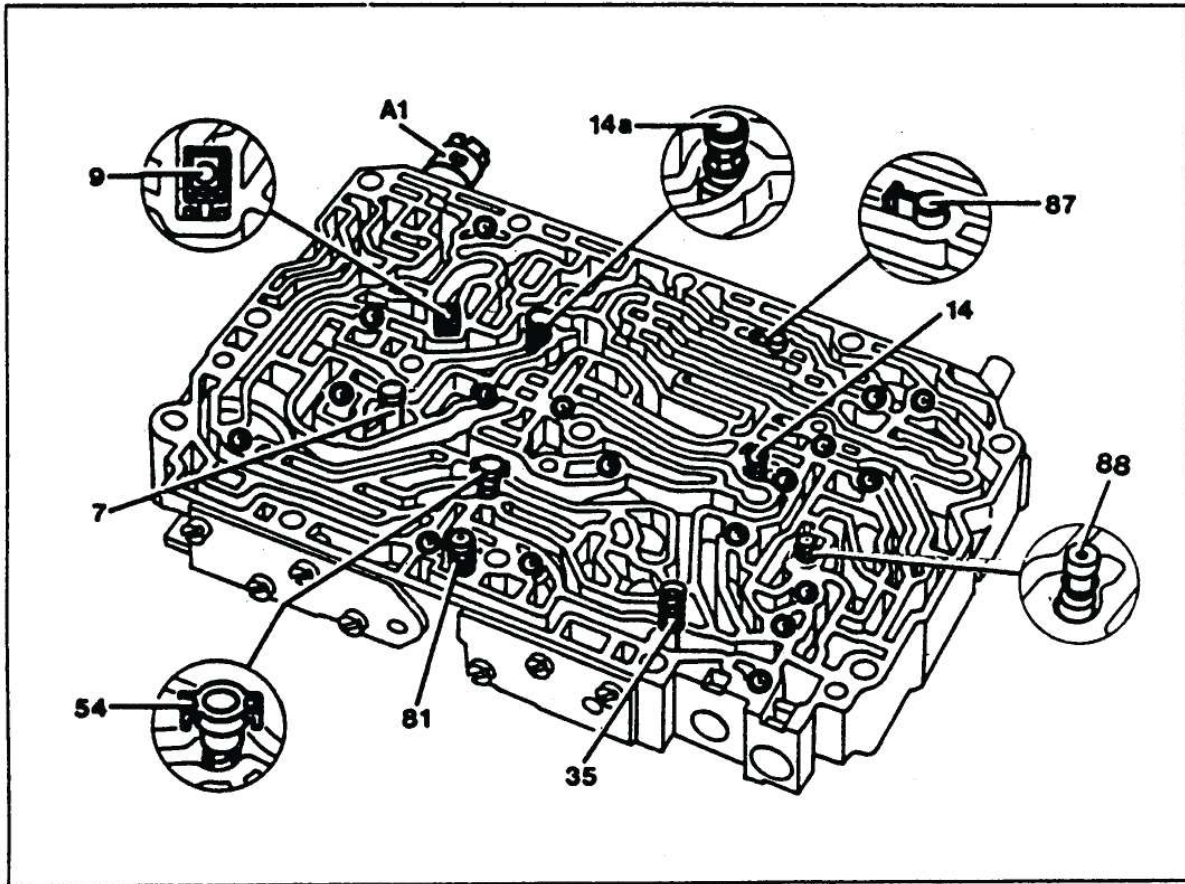
### Mercedes Model 722.4

A1 Selector Valve  
 81 Strainer  
 7 Locking valve K1  
 9 Check valve without bore  
 14 Valve balls (18 or 19)

14a Pressure valve (check ball)  
 54 Check valve  
 87 Restrictor valve K2  
 35 Lubricating pressure shaft spring  
 88 Check valve with restrictor

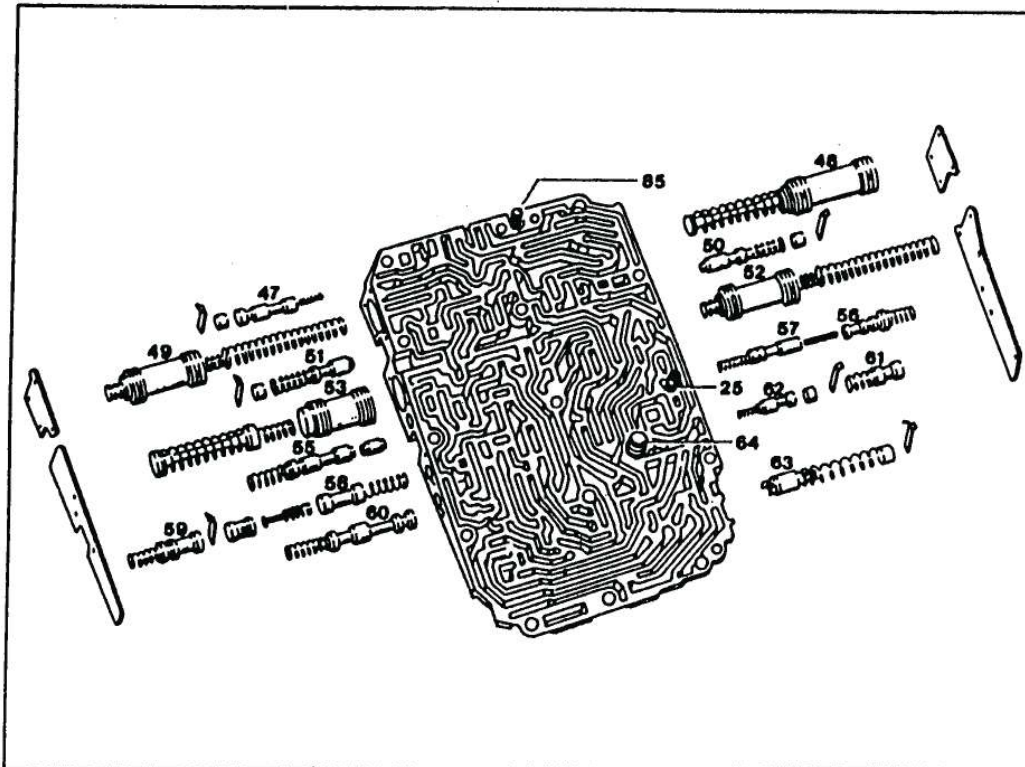
The arrow indicates the position of the allen screw for full throttle control pressure. Turning clockwise results in earlier full load or kick-down upshifts. Turning counter-clockwise results in later upshifts.

- 25 Relief valve (modulator press)
- 47 Regulator valve shift pattern
- 48 Damper K1
- 49 Damper K2
- 50 Regulator valve damper K1
- 51 Regulator valve damper K2
- 52 Damper B1
- 53 Damper switch on
- 55 Lock-out valve RB2
- 56 Shift valve deceleration

- 57 Regulator valve damper B1
- 58 Regulator valve damper, switch on 59
- 59 Shift valve K2
- 60 Release valve B2
- 61 Lock-out valve deceleration
- 62 Lock-out valve RV1
- 63 Damper, kick-down
- 64 Lubrication pressure valve
- 85 Pressure limitation valve.

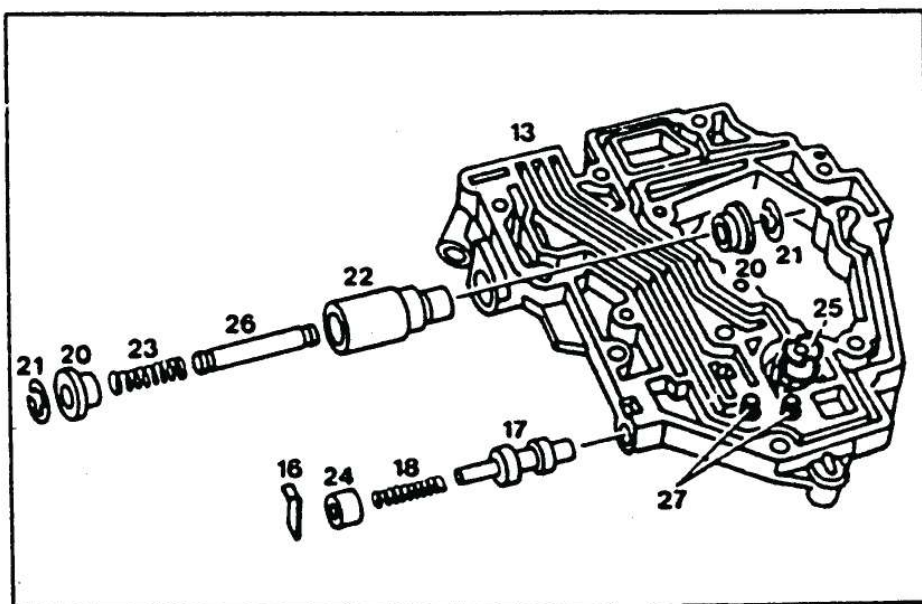
The tightening torque is 8 NM

- 13-Bottom cover
- 16-Retaining plate
- 17-Secondary pump check valve
- 18-Spring
- 20-Bushing
- 21-Locking element
- 22-Locking valve
- 23-Spring
- 24-Plug
- 25-Valve
- 26-Pin
- 27-Strainer

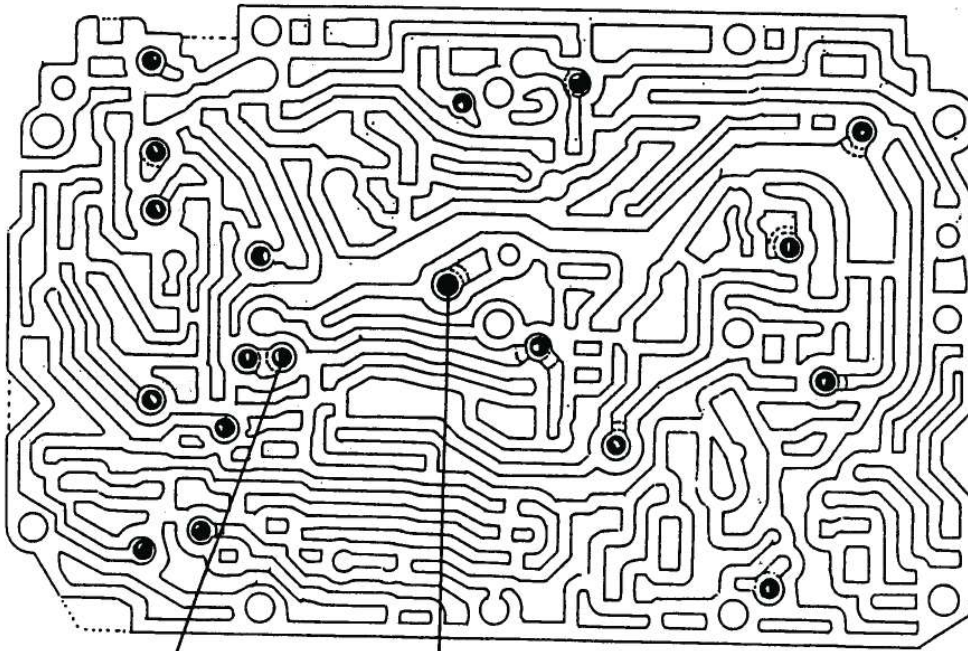
(18) .215 STEEL CHECK BALL LOCATIONS

ONE .220 RUBBER BALL HERE

PLACE SPRING UNDER THIS BALL

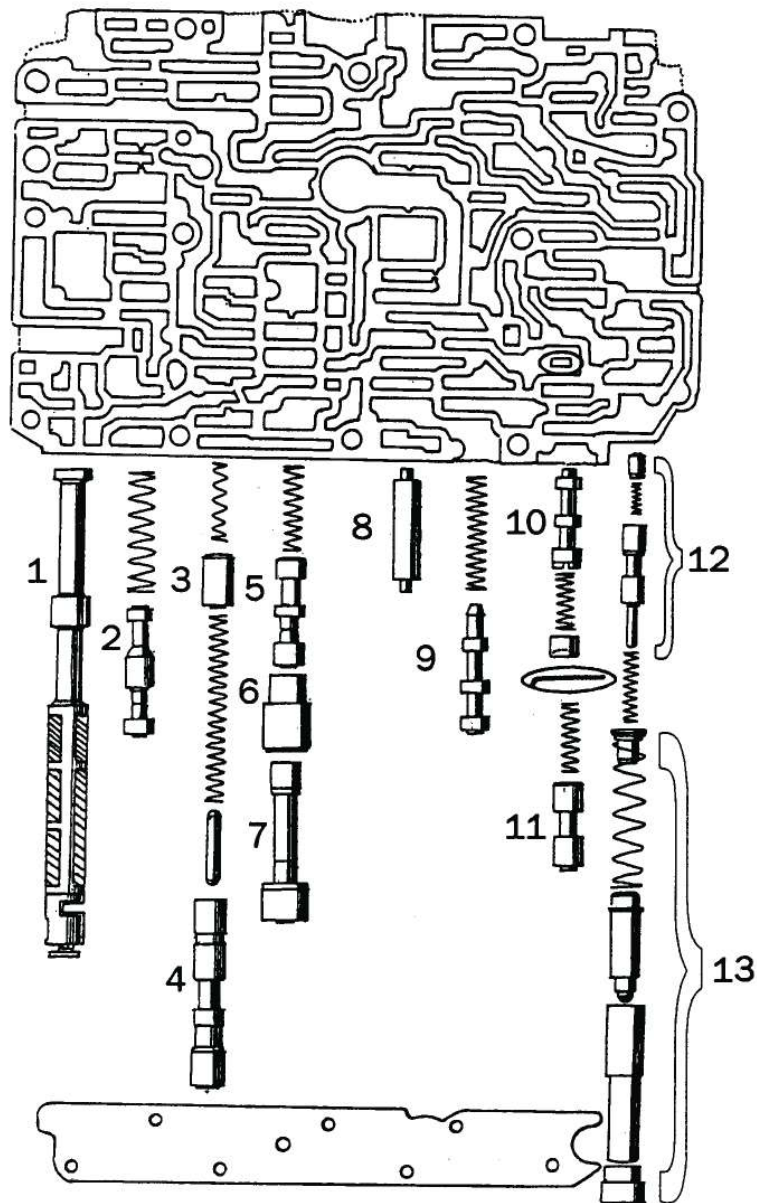
# Technical Service Information UPPER VALVE BODY (TOP VIEW)

1. MANUAL VALVE
2. CONVERTER ADAPTION CONTROL VALVE
3. 3-4 PLUNGER COMMAND VALVE
4. 3-4 COMMAND VALVE
5. 1-2 COMMAND VALVE
6. 1-2 COMMAND VALVE SLEEVE
7. 1-2 PLUNGER COMMAND VALVE

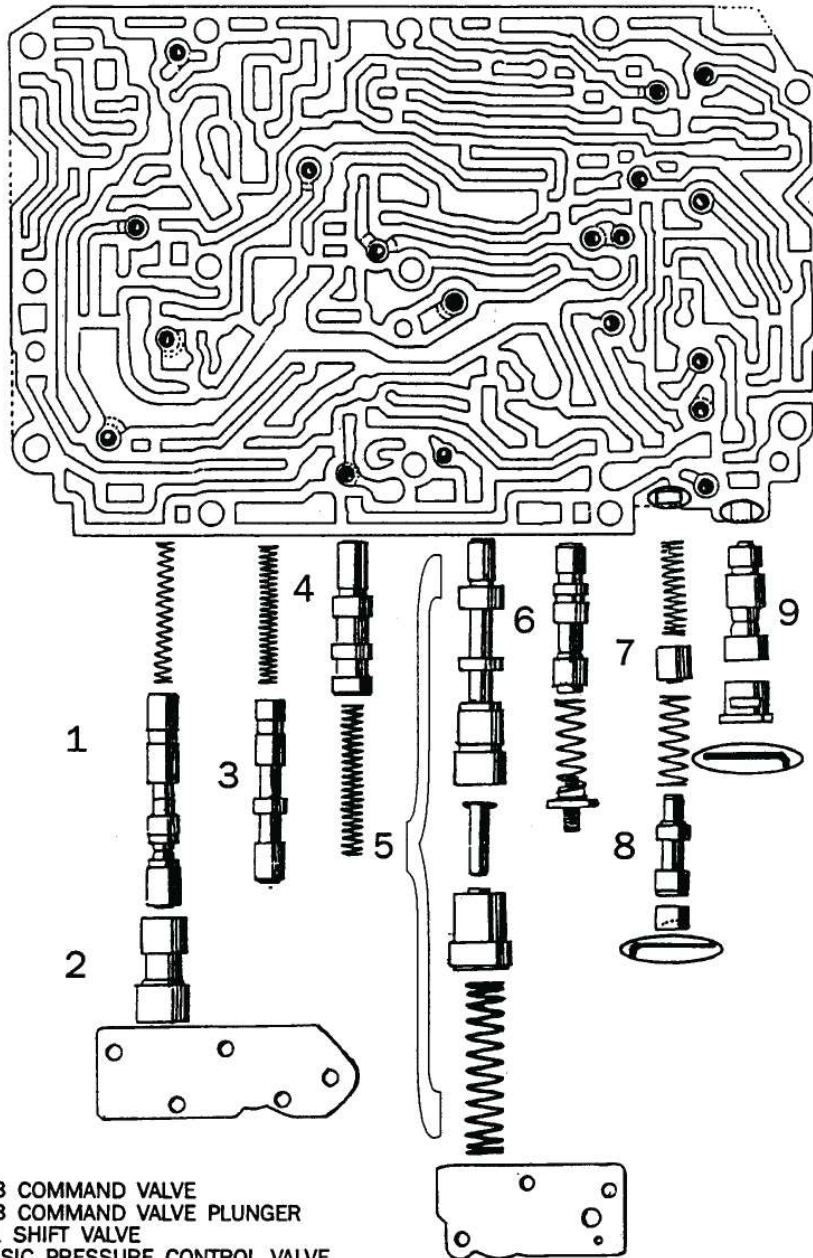
## UPPER VALVE BODY (BOTTOM VIEW)

1. 2-3 COMMAND VALVE
2. 2-3 COMMAND VALVE PLUNGER
3. B1 SHIFT VALVE
4. BASIC PRESSURE CONTROL VALVE
5. WORKING PRESSURE CONTROL VALVE
6. FULL THROTTLE CONTROL VALVE
7. B1 PLUNGER CONTROL VALVE
8. B1 CONTROL VALVE
9. GOV. PRESSURE BOOST VALVE

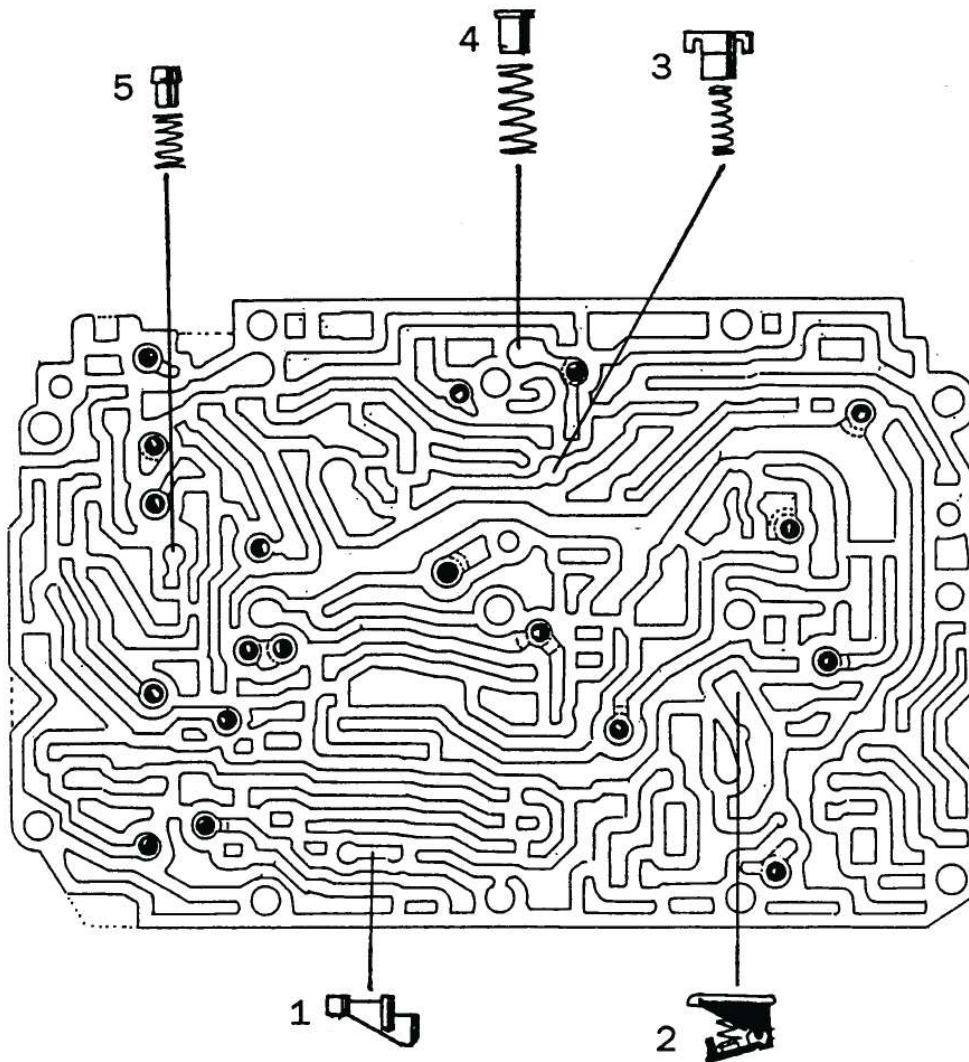
### UPPER VALVE BODY (BOTTOM VIEW)

1. THROTTLE CHECK VALVE
2. PLATE TYPE CHECK VALVE
3. CHECK VALVE WITH STRAINER
4. THROTTLE CHECK VALVE WITH STRAINER - ORIFICE .032
5. THROTTLE CHECK VALVE - ORIFICE .032

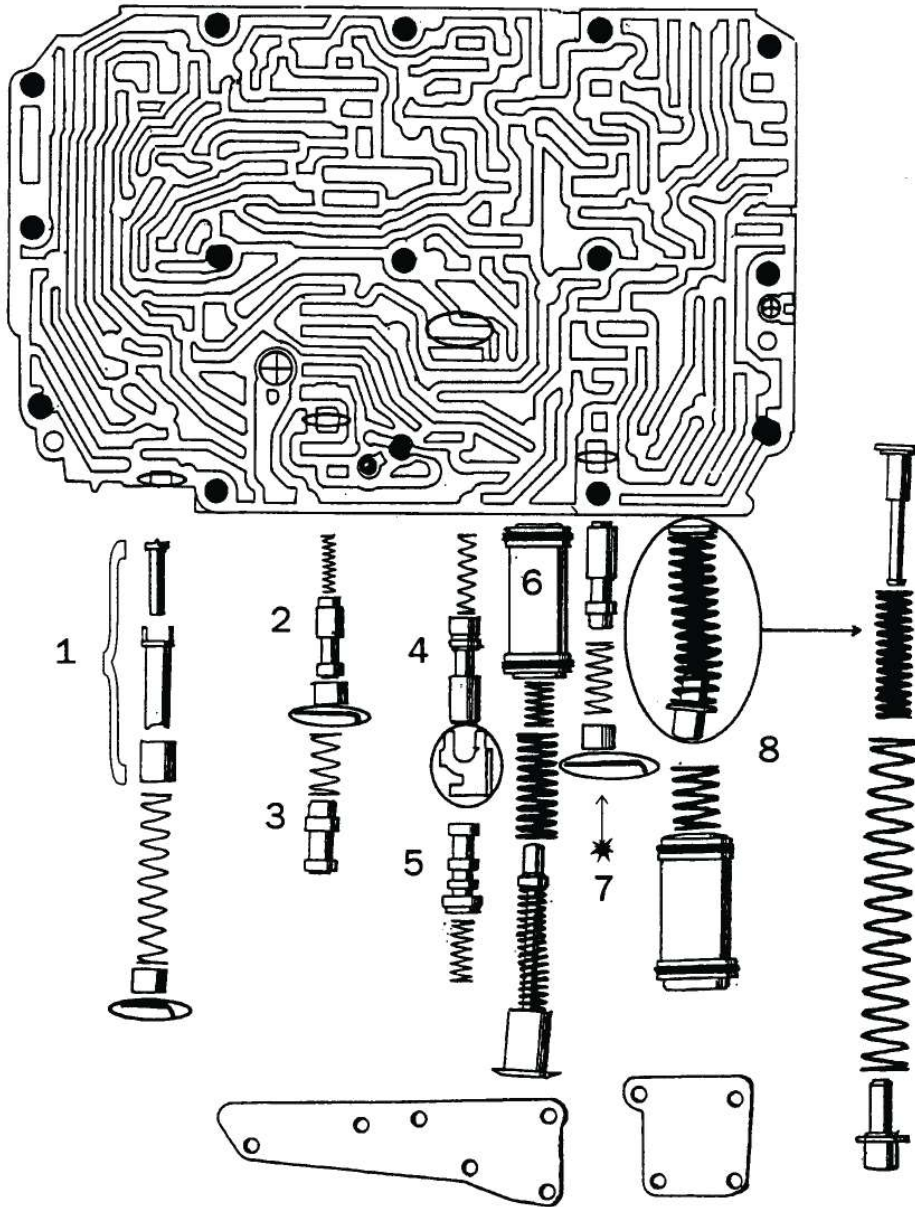
## LOWER VALVE BODY (FRONT VIEW)

1. ACCUMULATOR KICK DOWN
2. RV1 SHUT OFF VALVE
3. BRAKE CIRCUIT SHUT OFF VALVE
4. B1 ACCUMULATOR CONTROL VALVE

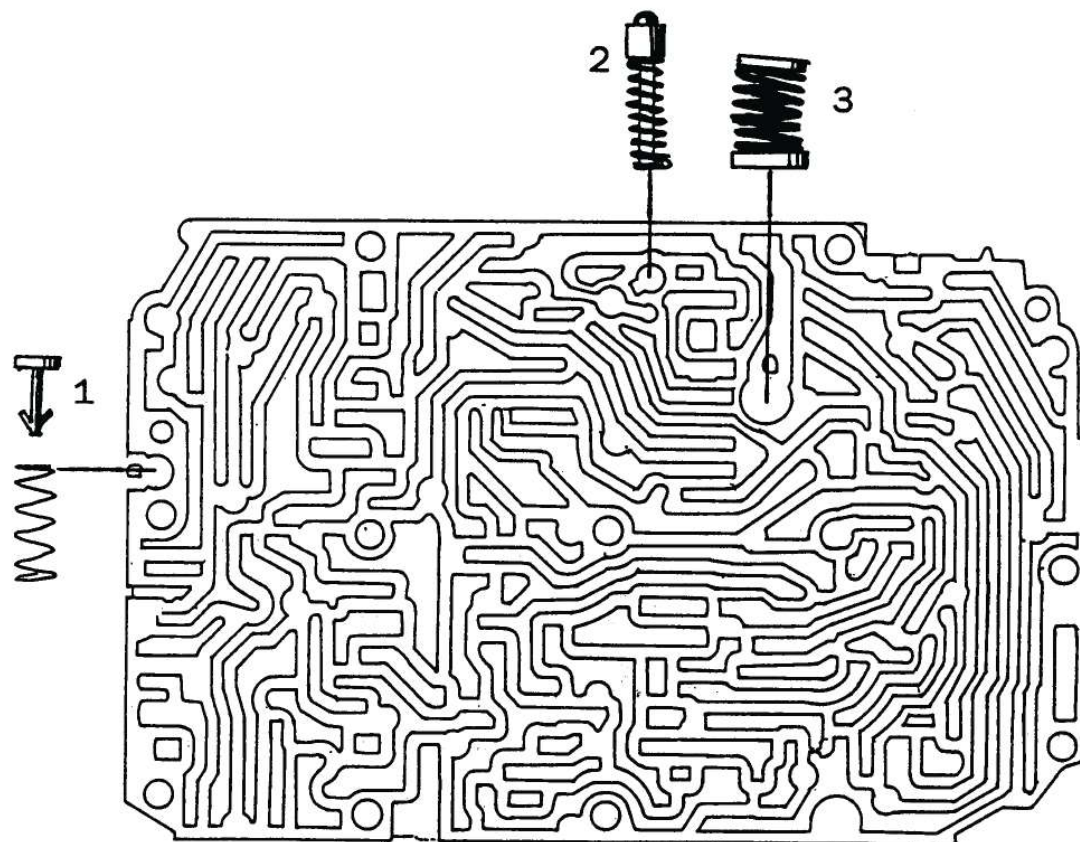
## LOWER VALVE BODY

1. PRESSURE LIMITING VALVE
2. MODULATING PRESSURE RELIEF VALVE
3. LUBRICATING PRESSURE VALVE

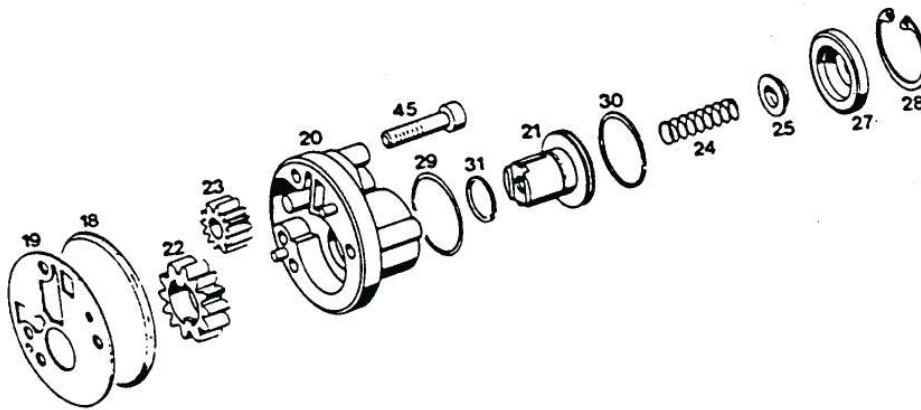
### REAR PUMP ASSEMBLY

18-O-ring  
 19-Intermediate plate  
 20-Pump housing  
 21-Shut off piston  
 22-Pump drive gear  
 23-Pump driven gear  
 24-Compression spring  
 25-Spring retainer  
 27-Closing cover  
 28-Locking ring  
 29-O-ring  
 30-Teflon ring  
 31-Teflon ring  
 45-Hex Socket screw

Replace  
 Check for damage and wear  
 Check for damage and wear  
 Check for damage and wear  
 Check for damage and wear  
 Check for damage and wear

Check for wear  
 Check for damage and wear

Replace  
 Replace  
 Replace  
 Tighten to 8 Nm

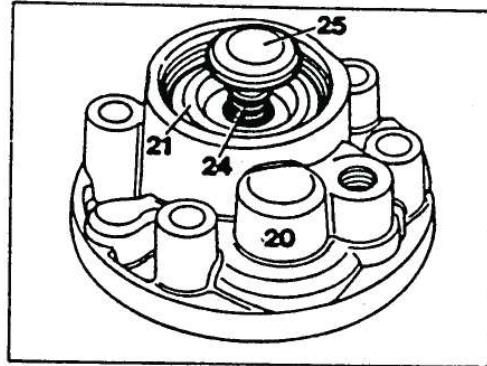
19-Remove switch-off piston (21) together with pressure spring (24) and spring plate (25) from transmission.

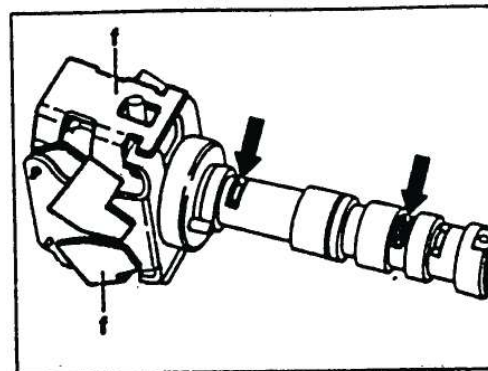
26- Move centrifugal weights (f) and check control valve for easy motion in openings (arrows).

The control valve must be easy to move, wash out and blow out governor as required. If it is not possible to free up the control valve in this manner, then replace the governor.

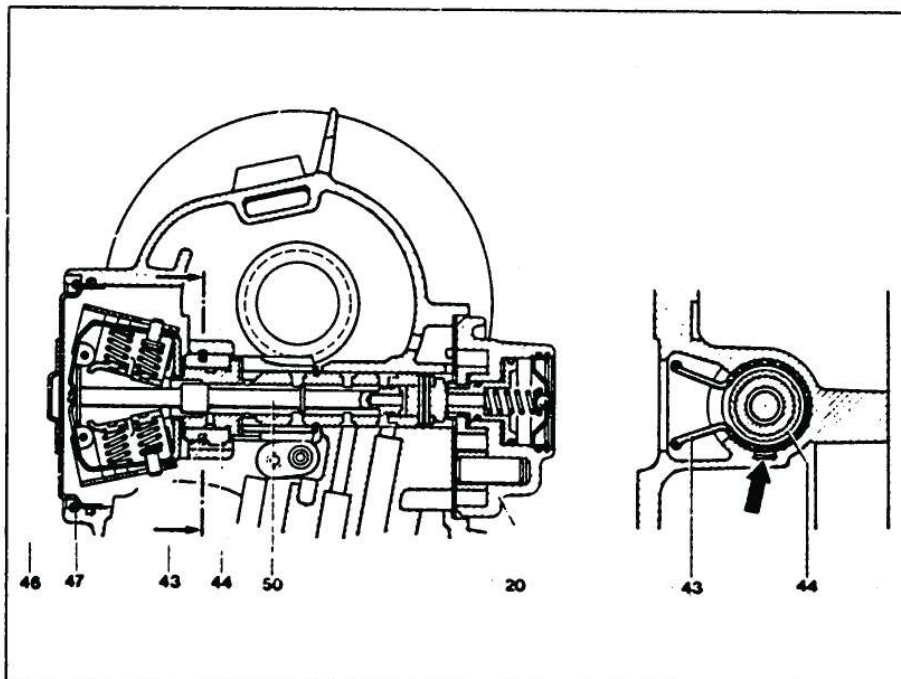
### GOVERNOR ASSEMBLY 722.4

20-SECONDARY PUMP  
43-LOCK RING  
44-BEARING RING

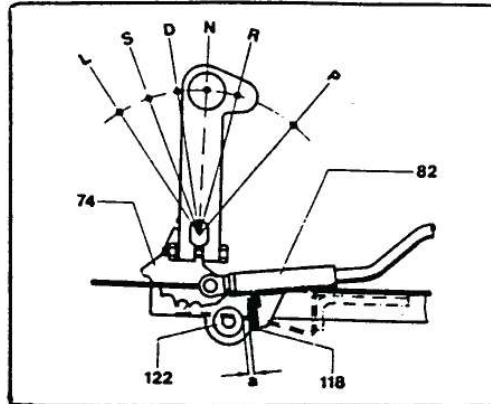
137-Check play "a" between shut off plunger (122) and stop on spring linkage (82), and adjust if necessary. The play "a" is adjusted to 0.4 - 1.0mm in position "N" by means of the plastic clip (118). The plastic clip is available in two thicknesses.

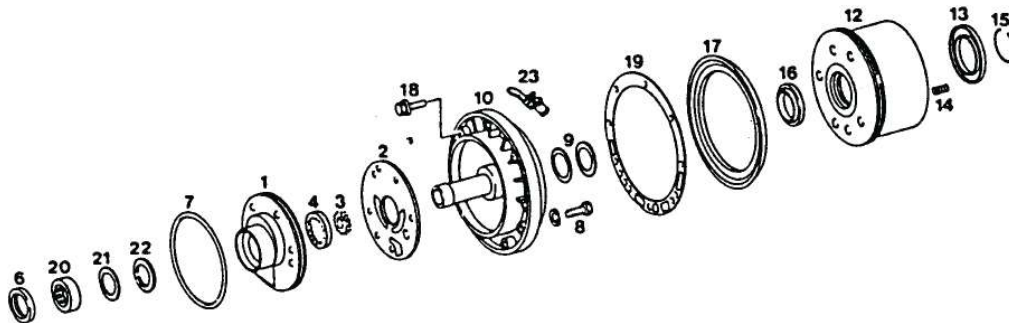
### FRONT PUMP ASSEMBLY

| 1-Pump housing | Check for damage and wear |
| 2-Intermediate plate | Check for damage |
| 3-Pump wheel, driving | Check for damage and wear, lube for assembly |
| 4-Pump wheel, driven | Check for damage and wear, lube for assembly |
| 6-Radial sealing ring | Check for damage and wear |
| 9-Teflon rings | Check for damage and wear |
| 10-Cover | Check for damage |
| 12-Piston | Check for damage and wear |
| 16-Lip sealing ring | Check for damage and wear |
| 17-Lip sealing ring | Check for damage and wear |
| 19-Gasket | Check for damage replace if necessary |
| 20-Radial roller bearing | Check for damage and wear |
| 21-Thrust washer | Check for damage |
| 22-Sealing washer | Check for damage |
| 23-check valve | Check for damage |

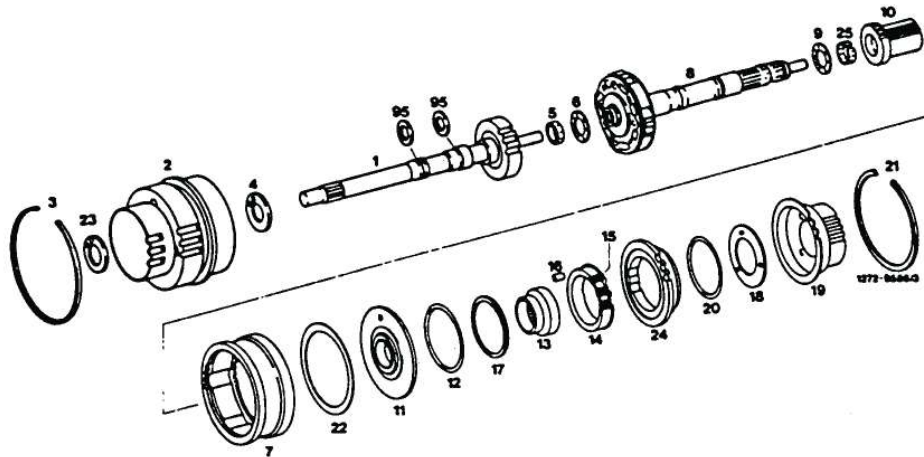
# PLANETARY ASSEMBLY

| 1 Input shaft | Check for damage and wear |
| 2 Front gear assembly | Check for damage and wear |
| 4 Axial bearing | Check for damage and wear |
| 5 Radial bearing | Check for damage and wear |
| 6 Axial bearing | Check for damage and wear |
| 8 Output shaft | Check for damage and wear |
| 9 Axial bearing | Check for damage and wear |
| 10 Sun gear behind gear assembly | Check for damage and wear |
| 11 Supporting disk | Check for damage and wear |
| 13 One-way roller clutch-inner race | Check for damage and wear |
| 14 Roller cage | Check for damage |
| 16 Cyl rollers | Check for damage and wear |
| 18 Thrust washer | Check for damage and wear |
| 19 Inner plate carrier K2 with one-way roller clutch-outer race | Check for damage and wear |
| 23 Axial bearing | Check for damage and wear |
| 24 One-way roller clutch-outer race | Check for damage and wear |
| 25 Radial bearing | Check for damage and wear |

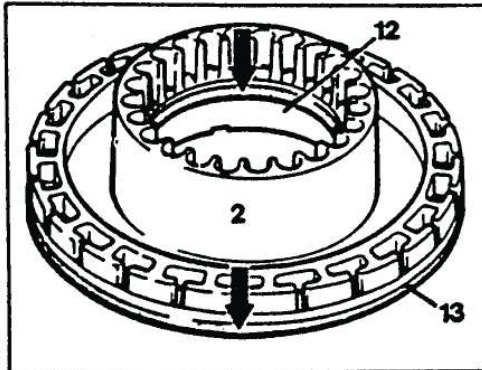
Replace lip seals (12 and 13).

Insert lip seals (12 and 13) into piston (2) so that sealing lip points down (direction of arrows).

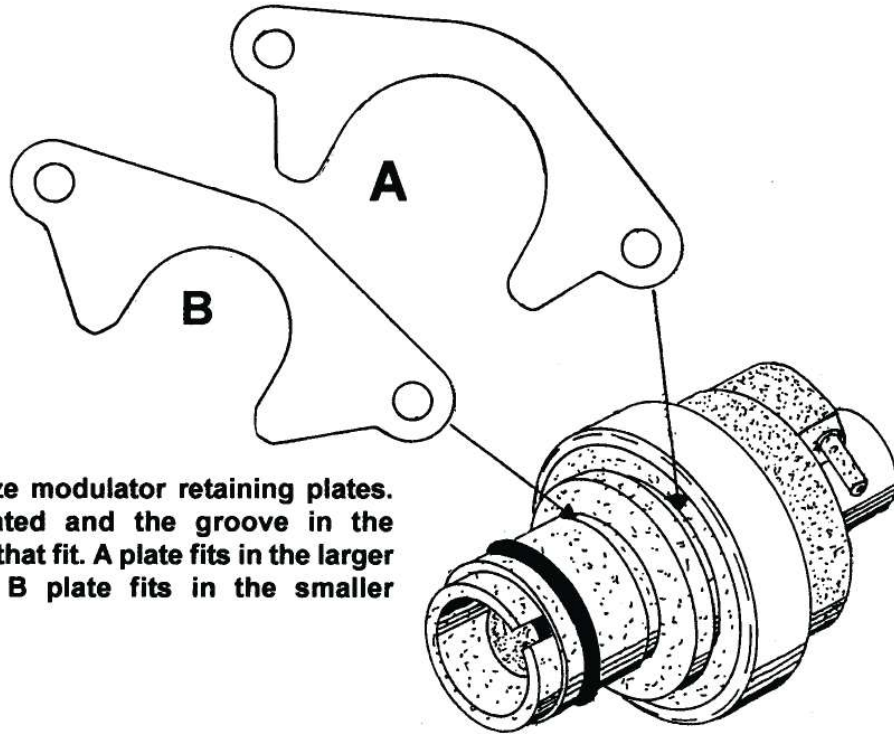
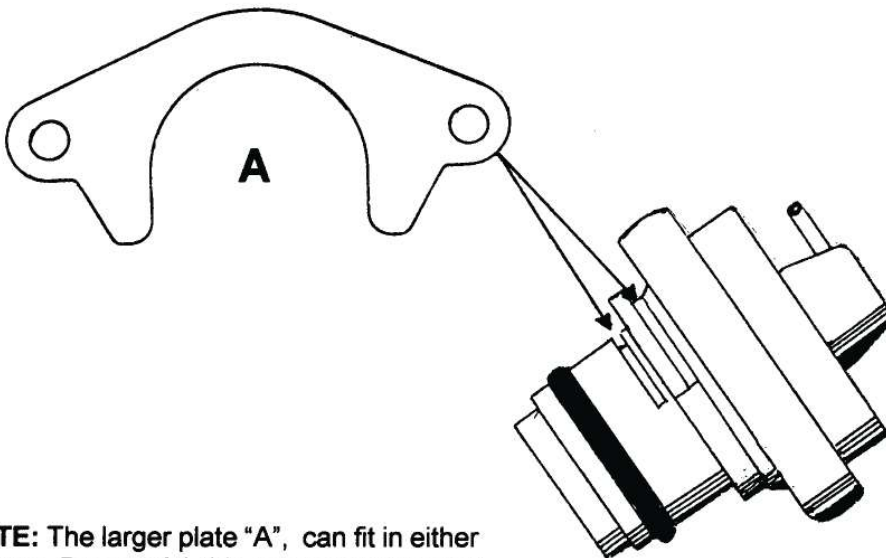
**MODULATOR BRACKETS 722.3 and 722.4**

There are two size modulator retaining plates. They are illustrated and the groove in the modulator where that fit. A plate fits in the larger groove and the B plate fits in the smaller groove.

**NOTE:** The larger plate "A", can fit in either groove. Be careful this mis-positioning of the retaining plate will effect shift quality and can cause leakage.

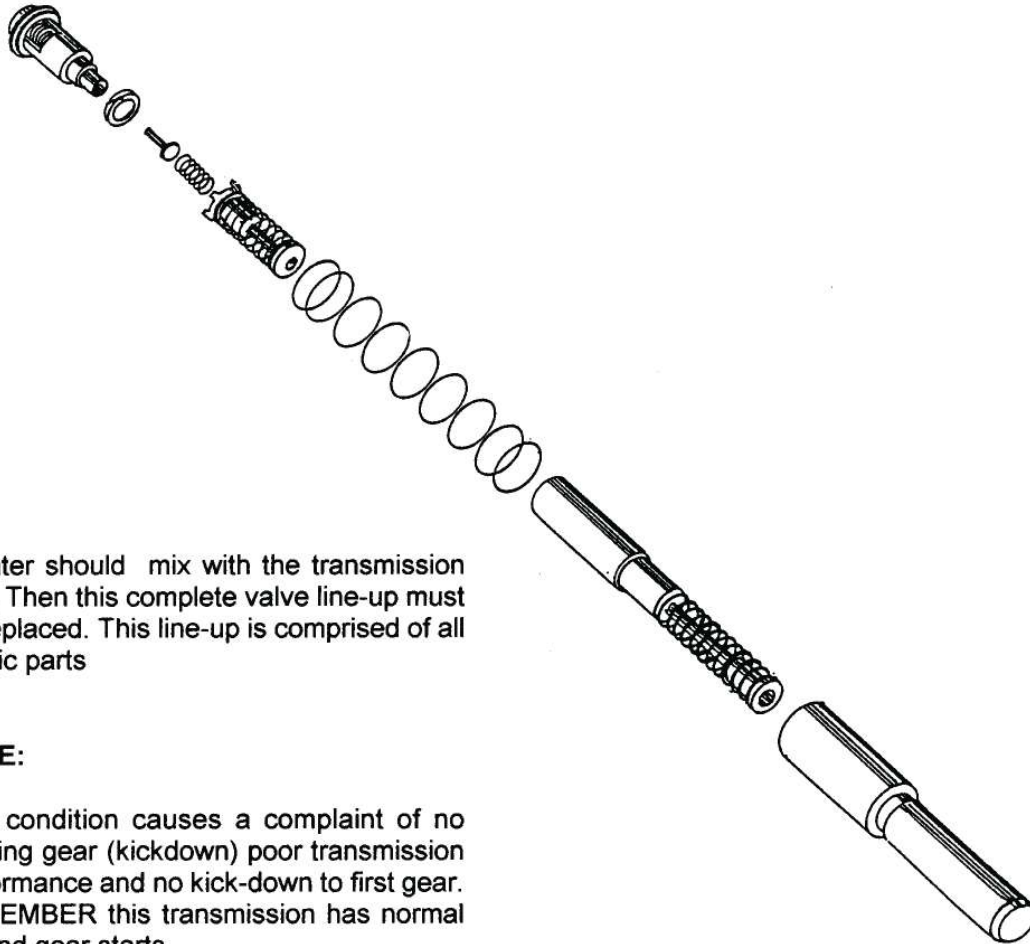
The TV valve line-up is different in the Mercedes models 420 SEL, 560 SEL and SL models. This change was made the the 1986 model year. Figure 1 illustrates the valve line-up.

If water should mix with the transmission fluid, Then this complete valve line-up must be replaced. This line-up is comprised of all plastic parts

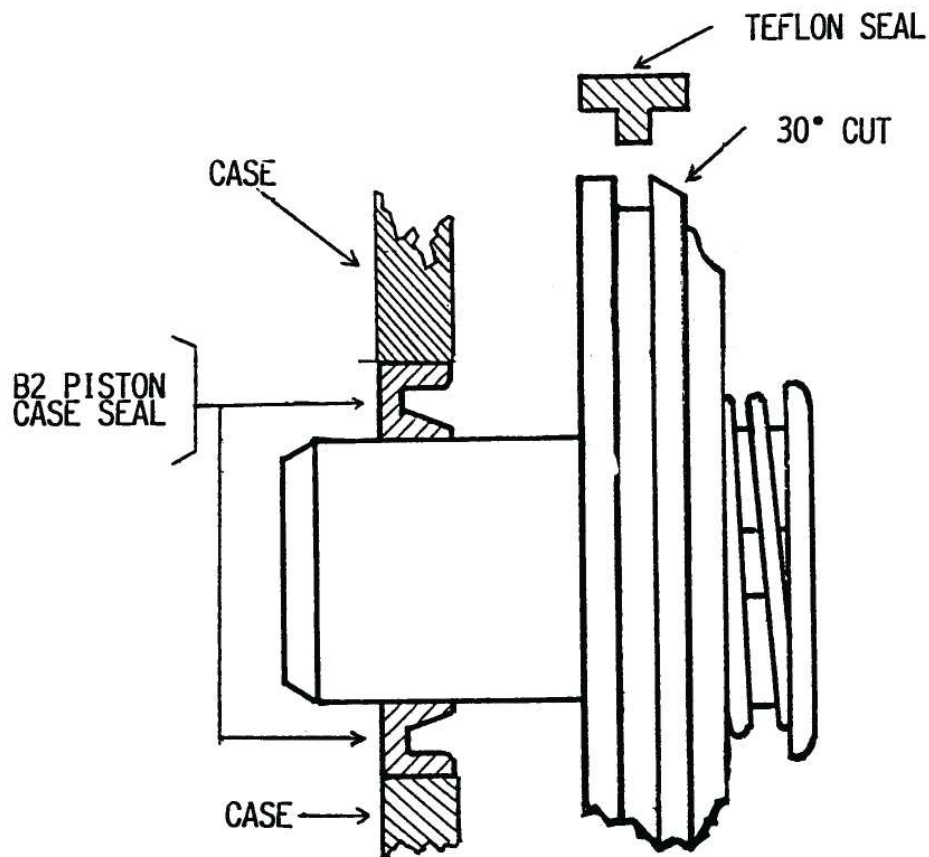
**CORRECTION:**Make a 30 degree chamfer around the out diameter of the top (outside land) on the piston. The servo cover side, as shown in Figure 1.

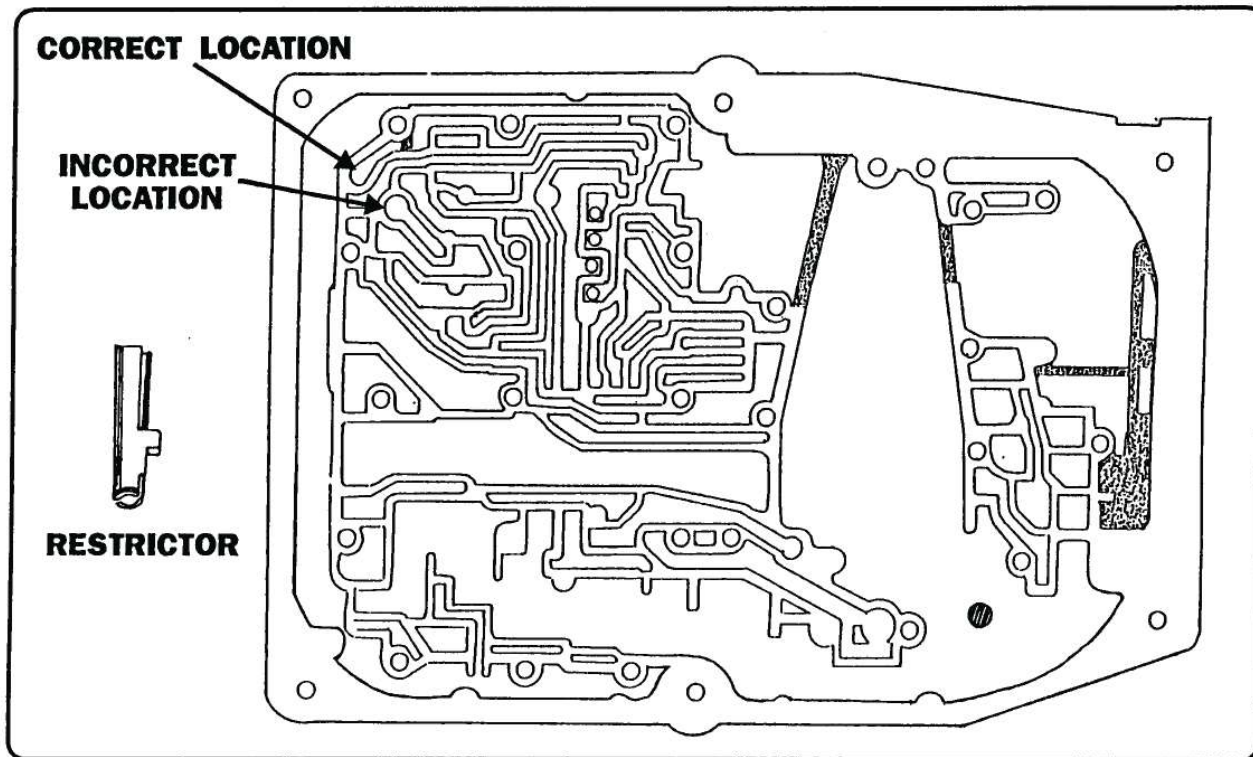
**Figure 1**

**CORRECTION:** Install the Mercedes tapered oil restrictor Part no. 123 277 0319. into the transmission case as shown in Figure 1. Note that the restrictor goes in tapered end first and fits snug in the case.

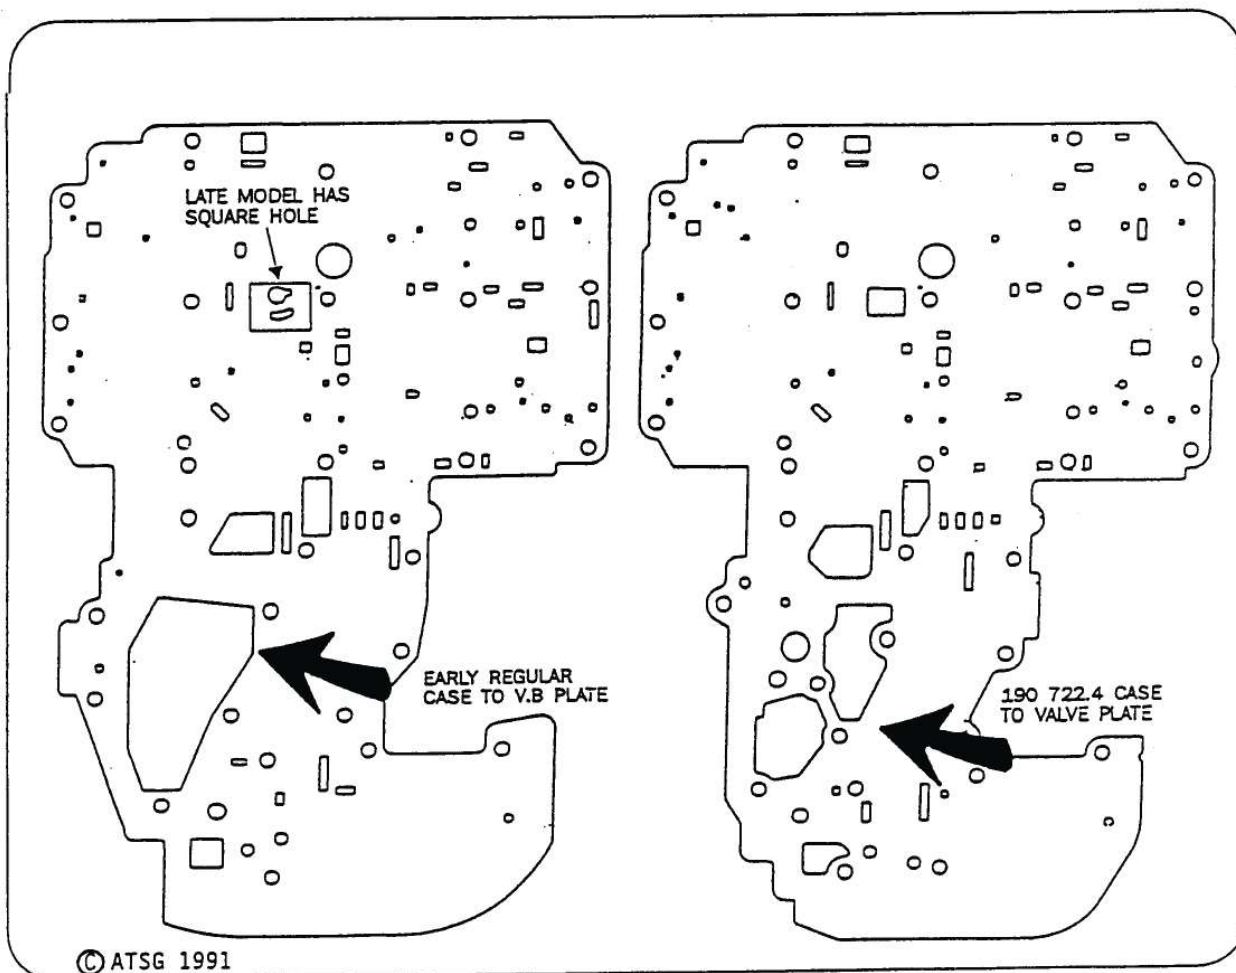
We have illustrated the separator plate ID in Figure 1 for both the regular 722.3 valve body and the 722.4 which is the 190E plate. You will note that the "regular" six bolt pan plate has a large opening where as the 190E opening is split. The arrows point to the locations on the plate. The regular plate (722.3) has a late and early version. The early will NOT fit the late valve body but the late will fit the early. Note the difference. The late has a square hole instead of the two orifices in the early. This is the position of the valve body screen.

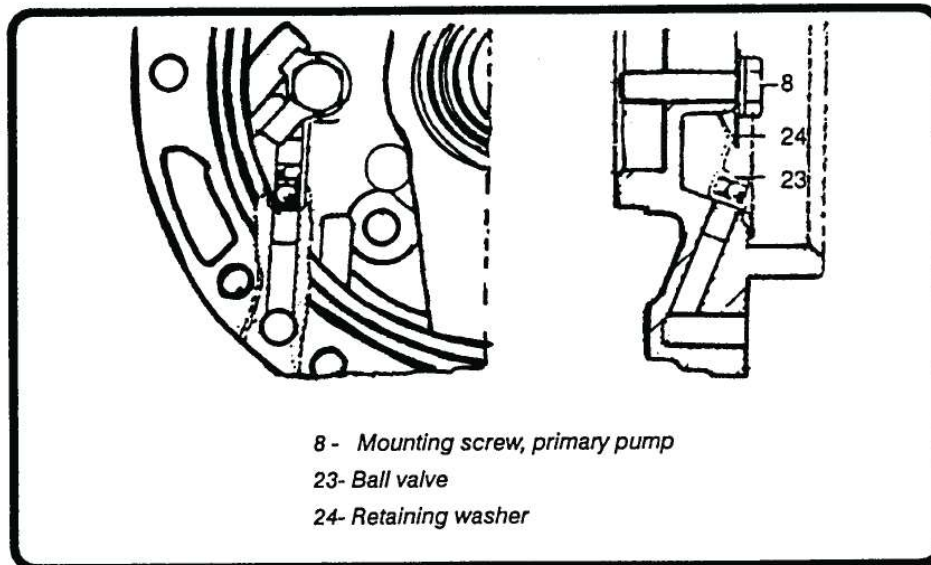
**NOTE:** Take ball from package only shortly before installation, otherwise the plastic becomes brittle when it dries out and can break during installation.

8 - Mounting screw, primary pump  
23- Ball valve  
24- Retaining washer

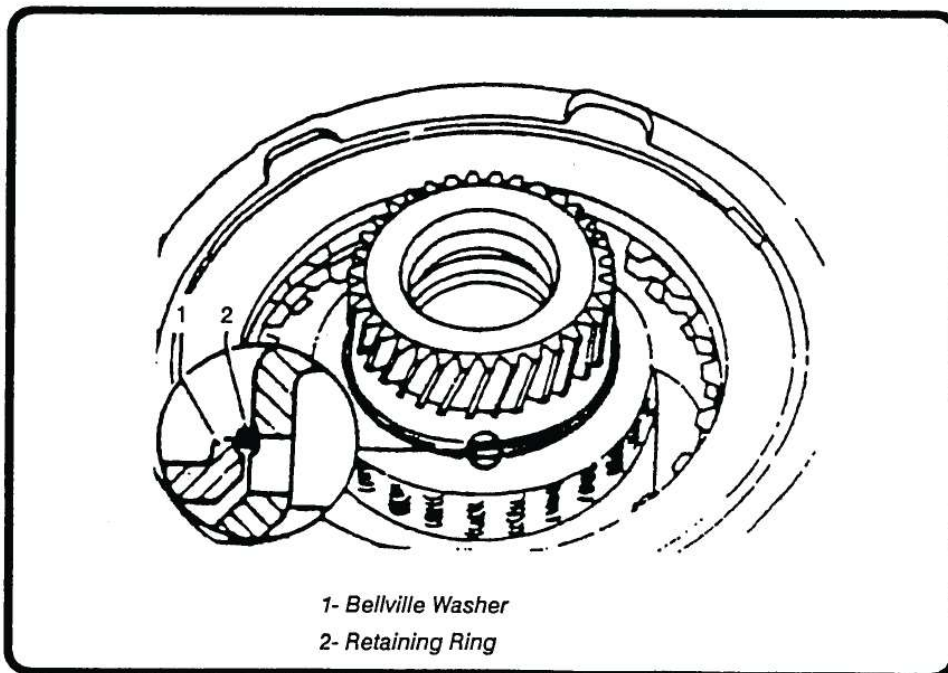
**NOTE:** *If the transmission is disassembled for repairs, check to be sure the retaining ring sits properly in it's groove, or if the bellville washer already is pushed over the retaining ring. In this case, replace steel disks K-1, retaining ring, and bellville washer.*

1- Bellville Washer  
2- Retaining Ring

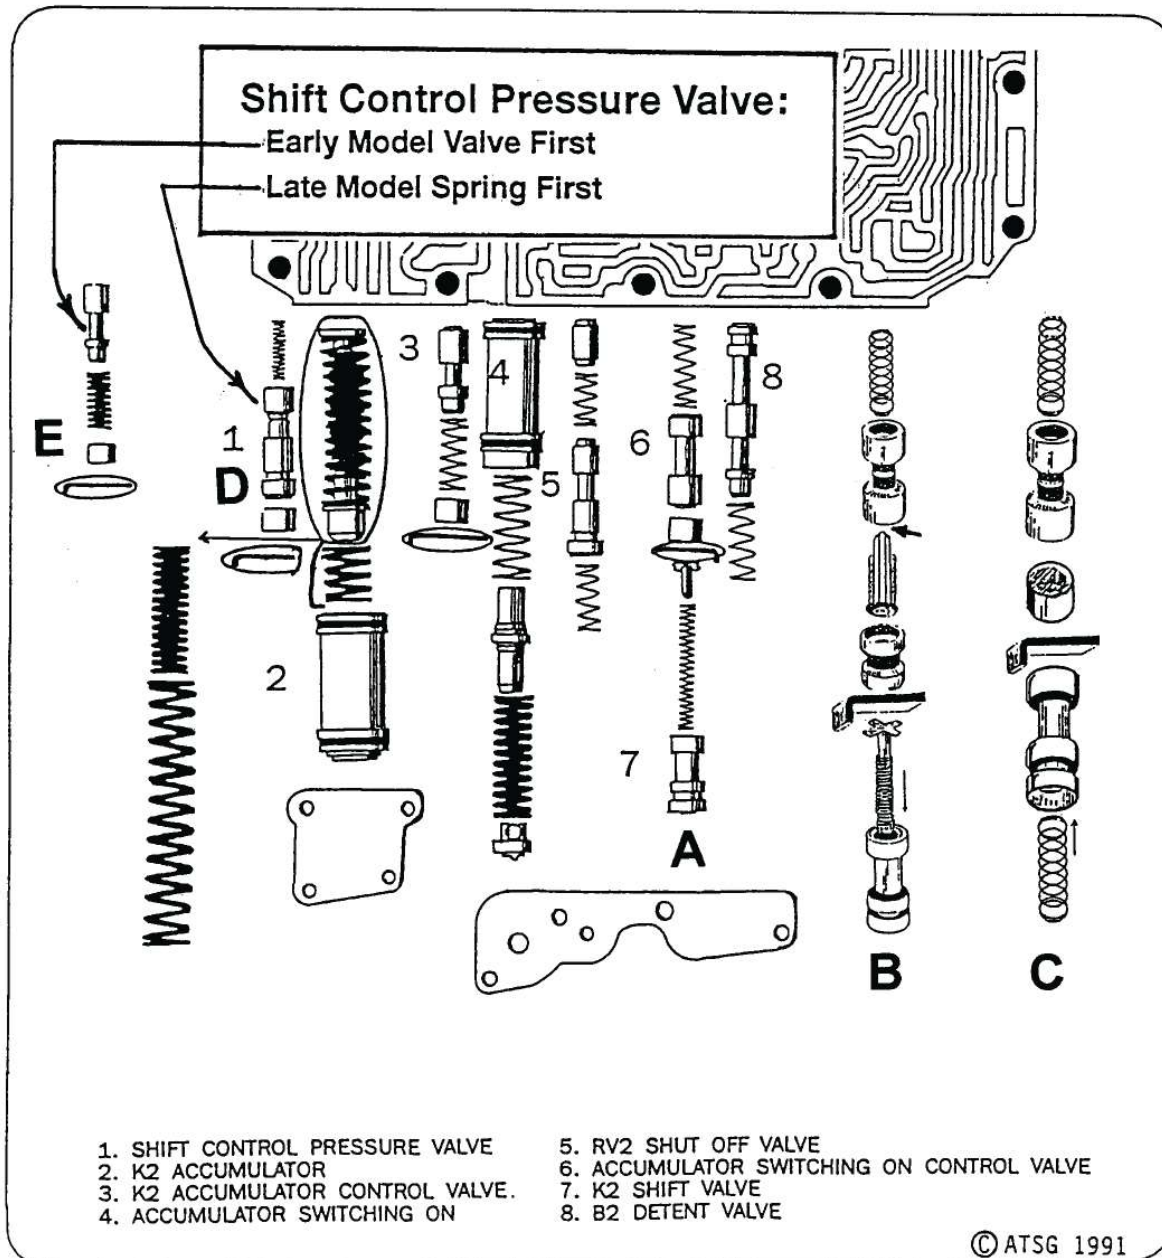
The "D" and "E" shift control pressure valves can be found to be installed valve first then spring (early) or spring then valve (late). Be sure to check valve type and line-up.
