## FORD CD4E

## **INTRODUCTION FORD CD4E**

The FORD CD4E is a computer controlled, four speed automatic overdrive transaxle and first appeared in the 1994 Probe with the 2.0 Liter engine. This unit is also found in the Ford Contours and the Mercury Mystique. This manual covers the procedures necessary for diagnosis, teardown, repair and overhaul of the CD4E transaxle.

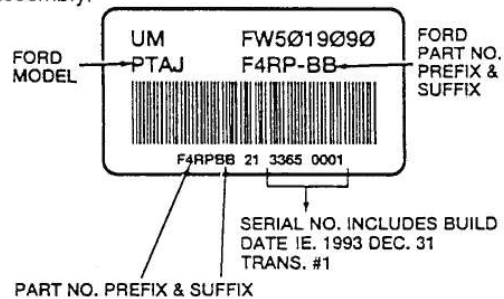
When servicing the transaxle, refer to the identification tag located on the rear of the transaxle case and on the bottom of the main control cover assembly.

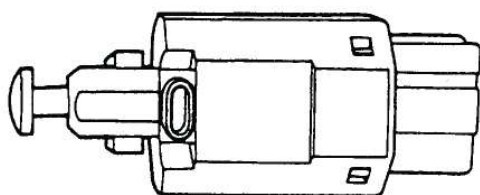
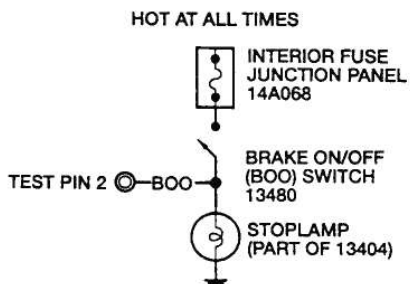
The Brake On/Off (BOO) Switch signals the Powertrain Control Module (PCM) when the brakes are applied. The BOO switch is closed when the brakes are depressed and open when they are released.

**Transaxle Function:** Disengage Torque Converter Clutch (TCC) when brake is applied.

**Symptoms:** Failed "ON" - TCC will not engage at less the 1/3 throttle.

Failed "OFF" or Not Connected - TCC will not disengage when brake is applied.

| Three Digit DTC | Component | Description | Condition | Symptoms |
|---|---|---|---|---|
| 536 | BOO | Brake not actuated during self-test. BOO switch circuit failed. | Brake not cycled during KOER. Brake On/Off circuit failure. | Failed ON or not connected – converter clutch will not engage engage at less than 1/3 throttle. Failed OFF – converter clutch will not disengage when brake is applied. |

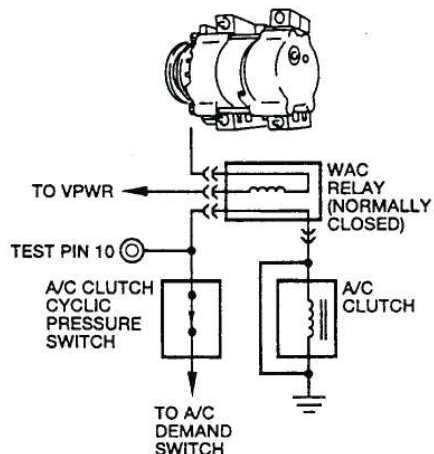
### Air Conditioning Clutch (ACC) 2884:

The A/C Cyclic Switch is located on the suction accumulator/drier of an OEM factory-installed air conditioning system. When the ACC switch contacts close, the Powertrain Control Module (PCM) receives a signal voltage from the ACC switch indicating that the air conditioning compressor clutch is engaged.

**Transaxle Function:** The PCM uses the ACC switch signal to adjust line pressure to compensate for the additional engine load.

**Symptoms:** If the ACC switch fails with closed contacts, line pressure will be slightly low with air conditioning OFF. If the ACC switch fails with open contacts, line pressure will be slightly high with air conditioning ON.

| Three Digit DTC | Component | Description | Condition | Symptoms |
|---|---|---|---|---|
| 539 | A/C | A/C switch error. | A/C or Defrost ON condition may result from A/C clutch being ON during Quick Test. | Failed ON – EPC pressure slightly low with A/C off. Failed OFF – EPC pressure slightly low with A/C on. |

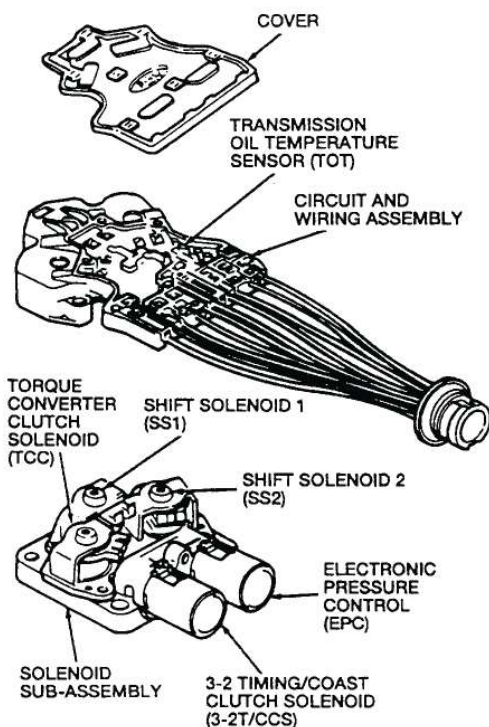
- Electronic Pressure Control (EPC) solenoid
- Shift Solenoid #1 (SS1)
- Shift Solenoid #2 (SS2)
- 3-2 Timing / Coast Clutch Solenoid (3-2 T/CCS)
- Torque Converter Clutch (TCC) solenoid

The PCM controls the operation of the transaxle through wiring to the solenoid valve body assembly mounted on the main control assembly. An electrical connector from the solenoid valve body assembly fastens to the top of the transaxle case, where it connects to PCM wiring.

The solenoid valve body assembly is serviced as one part when any of its components require replacement.

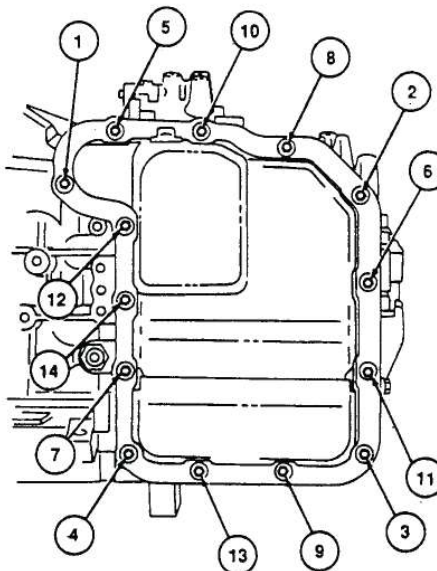
Use an 8mm socket to remove the fourteen main control cover bolts in the sequence shown.

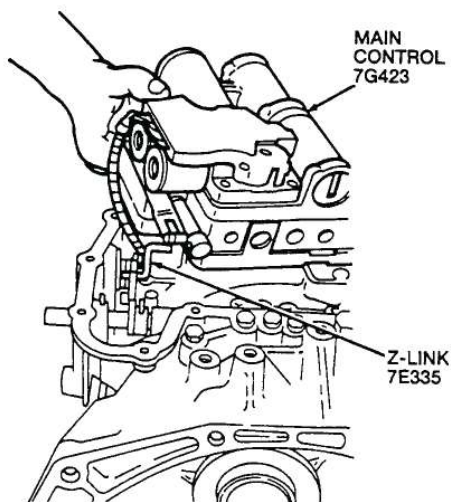
Pull the main control slightly away from the transaxle case. Disconnect the Z-link from the manual valve.

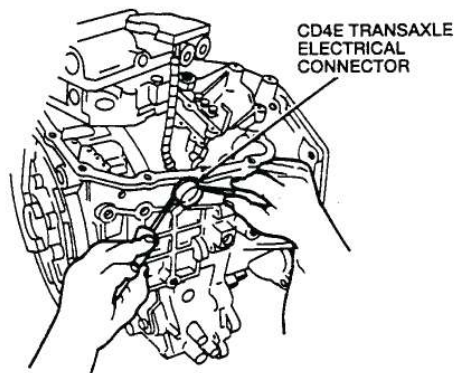
Squeeze the retainer tabs of the electrical connector and remove the connector from the bore in the case. Inspect the O-ring for damage.

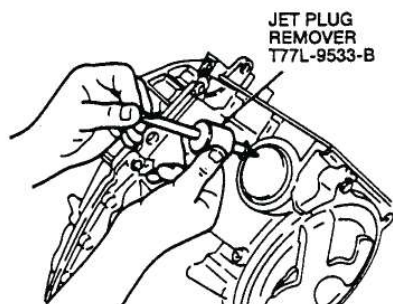
Remove servo cover cap from the transaxle case using Jet Plug Remover T77L-9533-B. Discard servo cover cap.

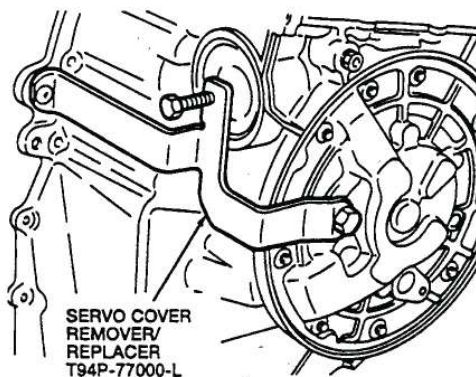
Using a 17mm socket, attach the Servo Cover Remover/Replacer T94P-77000-L to the oil pump assembly.

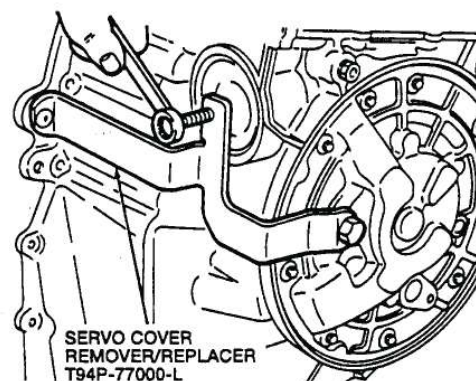
### WARNING: SERVO AND SERVO COVER ARE UNDER HIGH SPRING FORCE.

Use a 15mm socket and screw in the bolt to compress the servo cover assembly and remove the servo cover retaining ring.

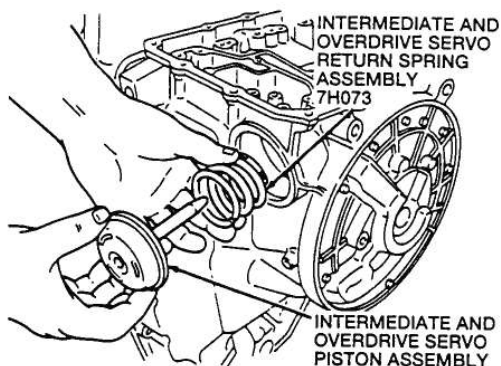
Remove the intermediate and overdrive servo piston and return spring.

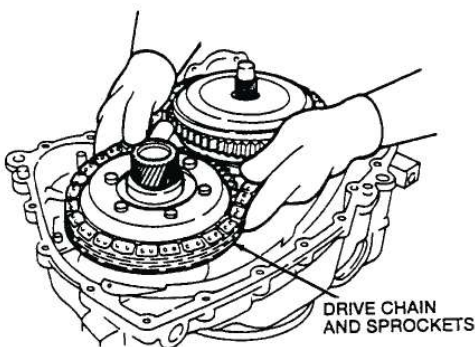
Lift the drive chain assembly, driven sprocket assembly, and the Reverse / Overdrive ring gear assembly together from the transaxle case.

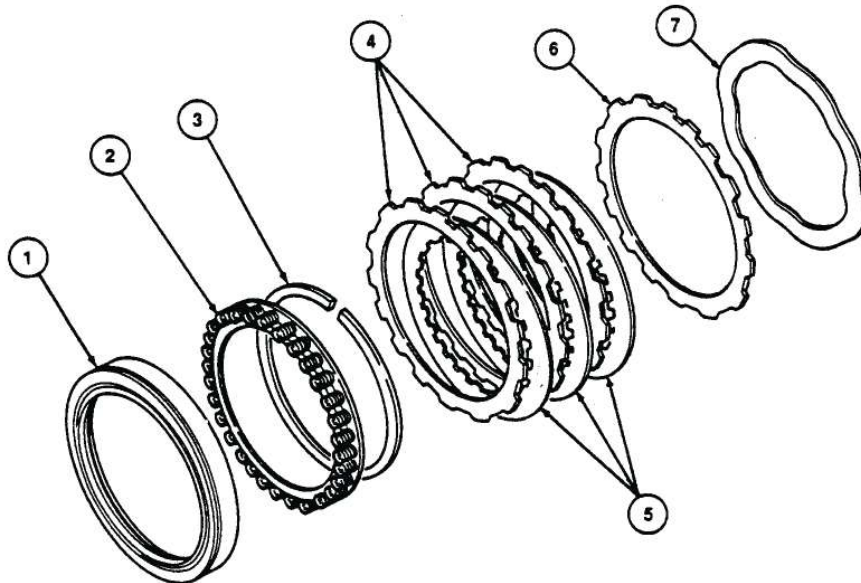
## Low / Reverse Clutch

| Item | Part Number | Description |
|---|---|---|
| 1 | 7D402 | Low / Reverse Clutch Piston |

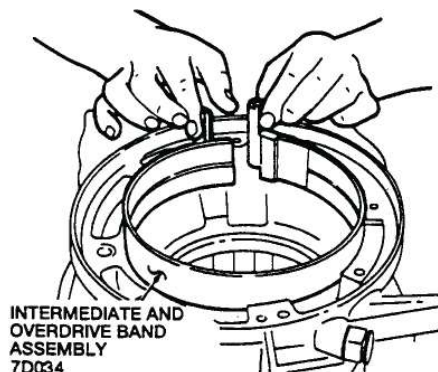
Slide the intermediate and overdrive band assembly from the case.

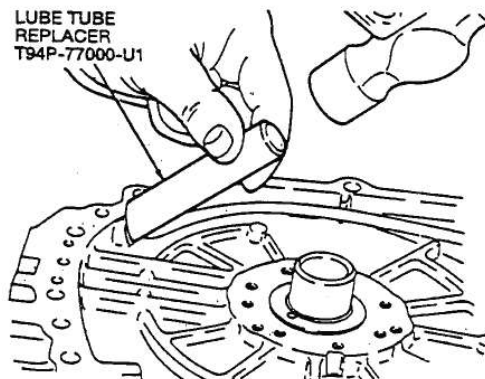
LUBE TUBE REPLACER T94P-77000-U1

Seat the end of the differential lube tube with a Lube Tube Replacer T94P-77000-V1 (part of Lube Tube Replacer Set T94P-77000-U).

Use an 8mm socket to install and tighten the differential lube tube bolt to 13 N·m (10 lb-ft).

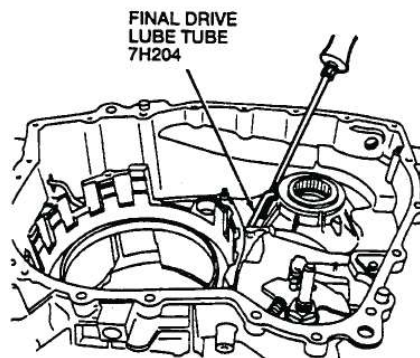
Use a screwdriver to remove the final drive lube tube from the transaxle case.

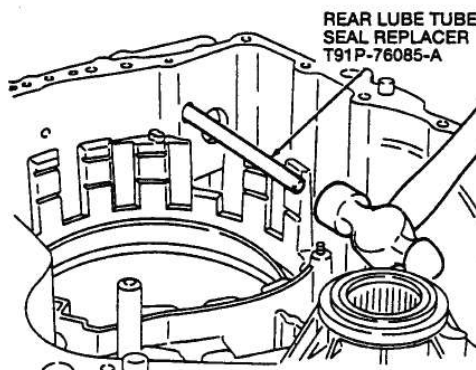
Use Rear Lube Tube Seal Replacer T91P-76085-A to remove the final drive lube tube seal from the transaxle case.

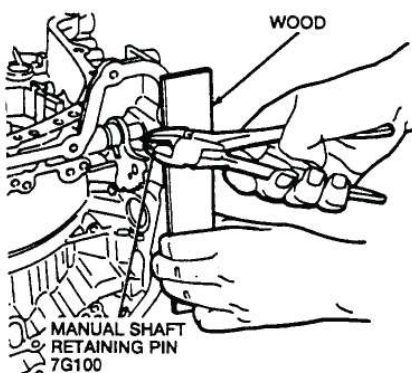
Protect the case with wood and use a pair of side cutters to remove the manual shaft retaining pin (7G100). Discard the manual shaft retaining pin.

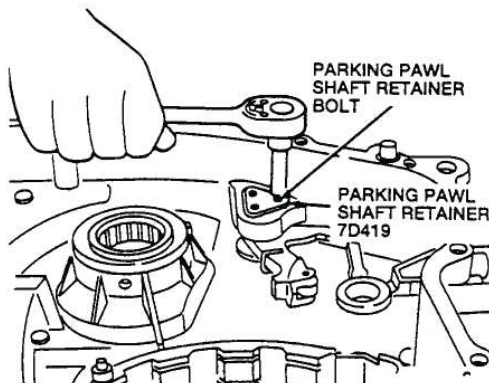
Install the parking pawl shaft retainer and bolt assembly. Use a 7mm socket to tighten the parking pawl shaft retainer bolt to 8 N-m (6 lb-ft).

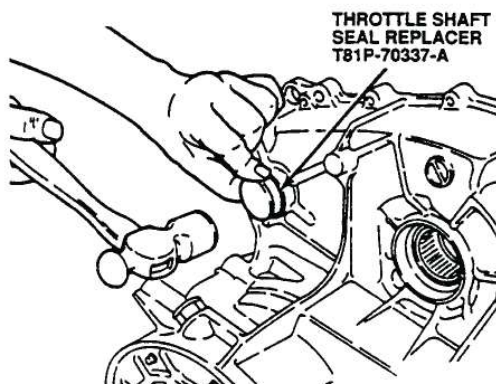
Use Throttle Shaft Seal Replacer T81P-70337-A or equivalent to install the manual control lever seal.

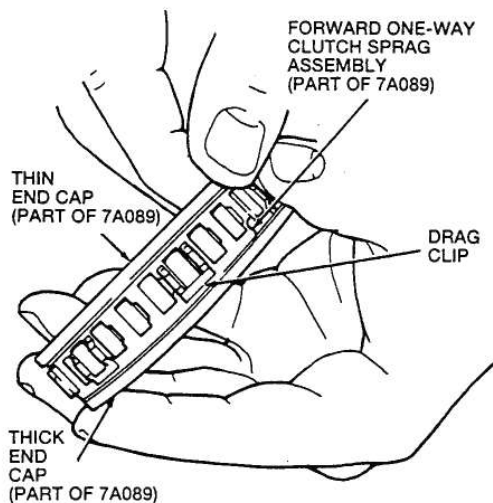
Separate the sprag assembly and end caps from the outer race. Note the position of the end caps. They are of different thickness and are not interchangeable.

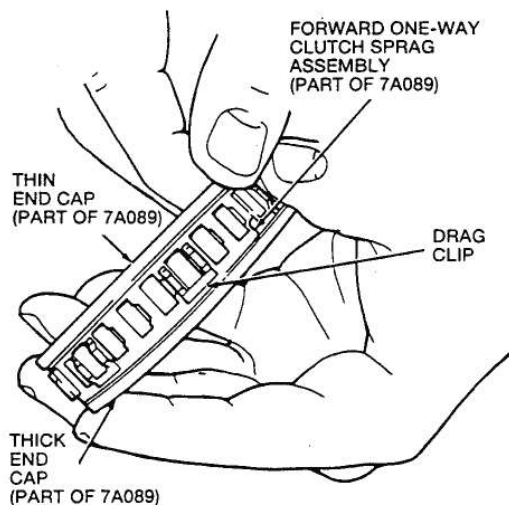
Assemble the forward one-way clutch sprag assembly and end caps.

Use Sprag Replacer T94P-77000-J to install the sprag assembly and end caps in the outer race.

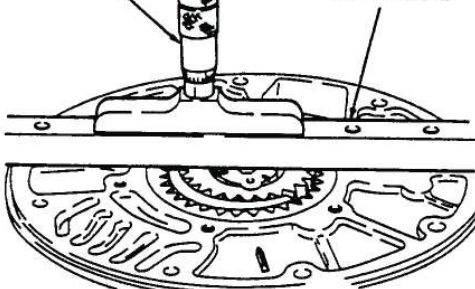
GAUGE BAR  
T97P-77000-Q

The allowable clearance for each gear is .027 to .060mm (0.001 to 0.002 inch). If the clearance exceeds the specification, replace the oil pump assembly.

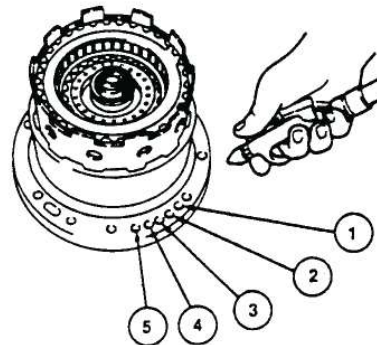
With each application of air you should hear the apply of a clutch pack. A hissing or high pitched squeal indicates that a seal is damaged or torn. Investigate to find the source and make necessary corrections.

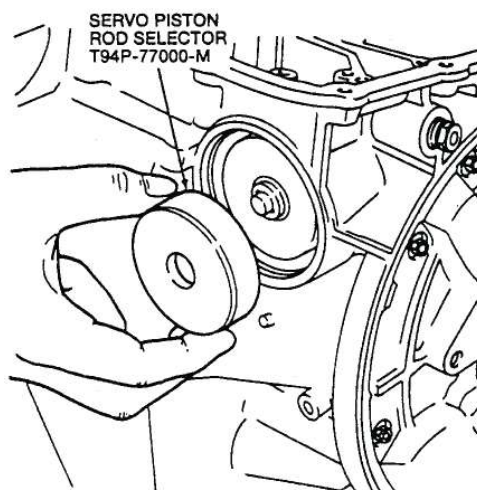
Install Servo Piston Rod Selector T94P-77000-M on the piston.

NOTE: Legs of the tool fit into servo cover retaining ring groove.

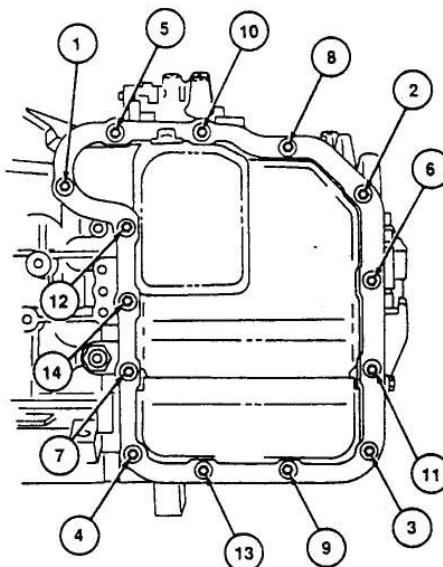
Install the fourteen main control cover bolts.  
Tighten the main control cover bolts 20 N·m (15 lb-ft) in the sequence shown.
